**PRESERVING THE LIGHTHOUSES OF MARTHA'S VINEYARD**

Martha's Vineyard Historical Society

Date: 8-20-99

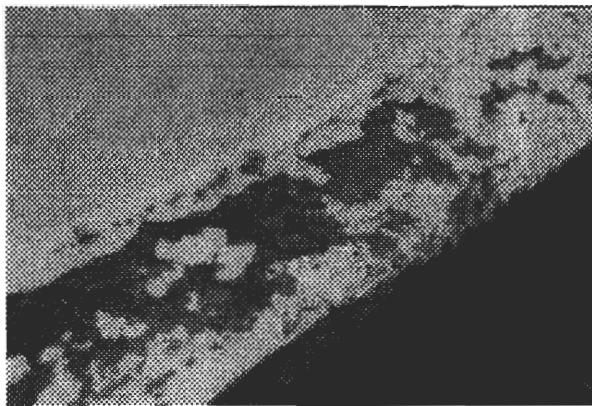
Figure 9

surface problem, save for the concrete skirt outlining the base of the structure, shown to the left here. There is no real concern for damage to the stability of the lighthouse due to this damage. A simple

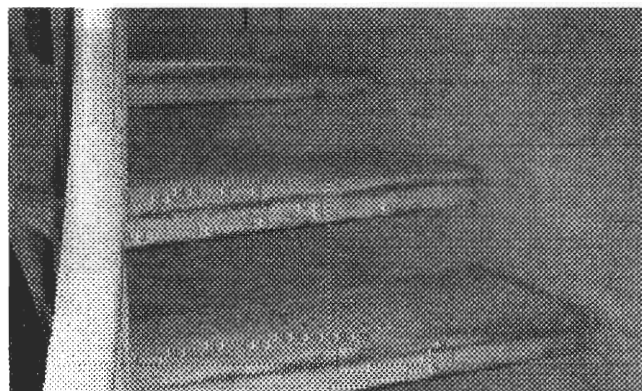
Figure 10

The interior of the East Chop lighthouse seemed very stable as the brick-lined walls showed no sign of stress or degradation. The stairs leading up have rust eating away at

the surface as depicted here, and the handrail is made of varnished wood.

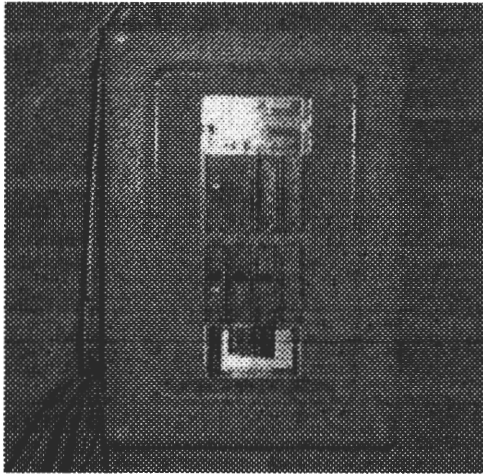
**Figure 11**

There is a great concern about moisture damage in this lighthouse. Interior components are collecting rust, which could spell disaster for some of the sensitive electronic components.

Notice the rust damage near the switches. Over time, the metals could move from the rust, and

possibly cause a fire-starting short. All it takes is for one live wire to touch another, and sparks will occur. Coupled with the high voltages involved in illuminating the light, a short is a dangerous concern indeed. Even with the brick lining, a fire would mean disaster to the interior woodwork.

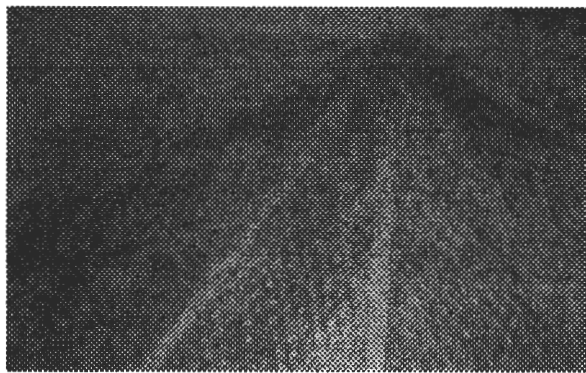
**Figure 12**

The metal platforms have taken a beating as well. Shown here is a picture of a platform with the surface rusting away. These platforms service many people from tours to keepers. The surface rust indicates paint failure due to foot

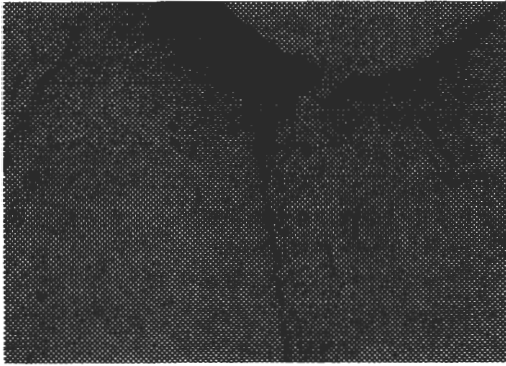
**Figure 13**

Moving our inspection to the inner cupola section, we immediately notice paint peeling and cracking on the ceiling, above where the beacon sits. A sample section of

ceiling with paint peeling and cracking is displayed here. This indicates there is a moisture leak to be concerned with. The moisture damage in the inner cupola section does not stop at the ceiling. The walls on the interior are also steadily collecting their own rust, and desperately need a new coat of paint, as well as a

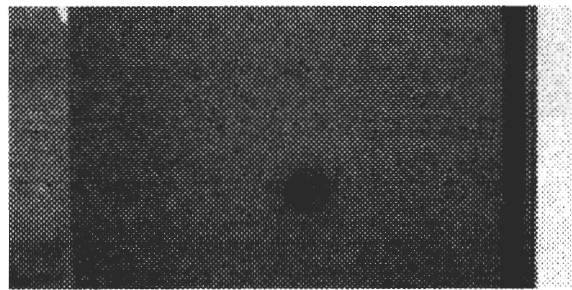
**Figure 14**

good seal against moisture. Shown here is a sample wall behind a ‘cabinet,’ which displays to the public the metal shell that encompasses the lighthouse’s outer skin, showing the pitted rust. Notice as well that there is wood lining inside the ‘cabinet’

door, which separates the shell from the interior woodwork of the metal. This gives moisture a place to collect, which could be very damaging to the longevity of the

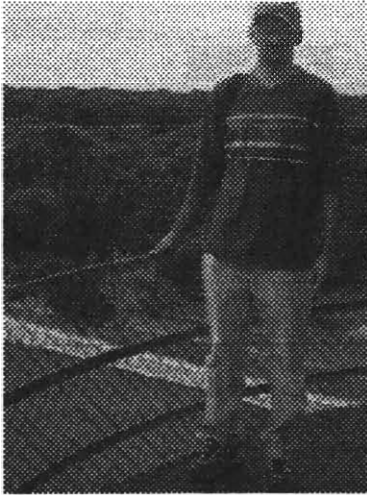
**Figure 16**

The outer cupola section causes much concern as far as weathering and water damaging the operational components. Shown here is the pane along the windows facing the light. There are leaks along the windows above where the door to the inner cupola section is. The

rust caused by these leaks could be devastating to the integrity of the light housing, as

well as to the sensitive electronic components, which operate the actual light function. Notice the rust underneath the paint right at the point where glass meets metal. Water will eventually destroy these seals, and more water damage will occur inside the housing. The railing along the outer cupola area is shown here. Vincent Salemi is 6'3" tall, and the rail meets his waist. This height of the rail seems

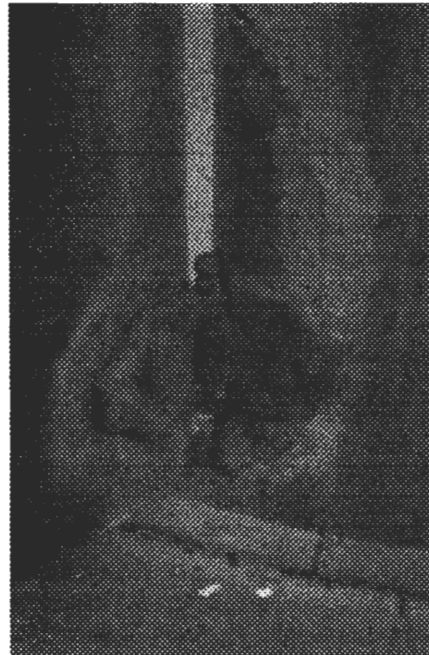
**Figure 17**

The porthole door from inner cupola to outer cupola has also received extensive rust damage. This is where the initial leak started, and this is a functional piece, with many places for water to hide. The hinges supporting the door are rusting out as well as the metal area around the hinges where water collects. Notice how the paint cracks upward, indicating the water seeping under the paint via the rusted areas.

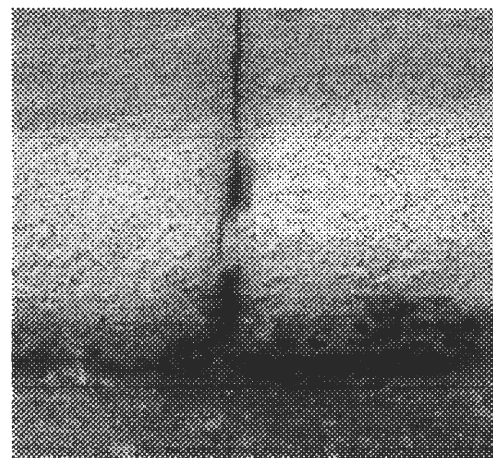
**Figure 20**

The exterior of the Edgartown lighthouse is in fair condition. There are no major visible problems, but a few points of interest are to be noted here. First, the windows are made of plywood with a frame painted on them, as depicted to the right. There are rust crack lines

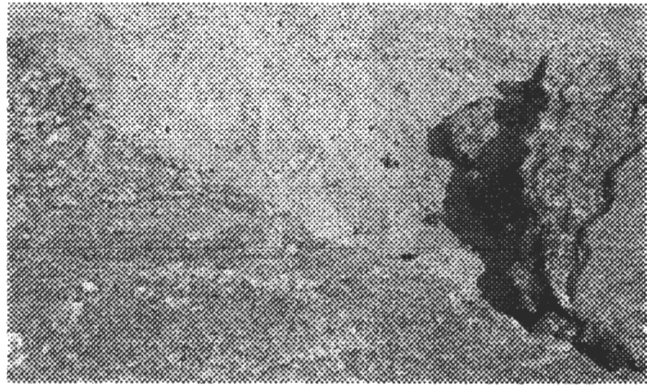
**Figure 21**

the concrete skirt foundation near the south side. A picture of the crumbling concrete is displayed here to the right. The door to the lighthouse has numerous dents, with chipped paint. The concrete steps leading to the door are cracking and breaking apart.

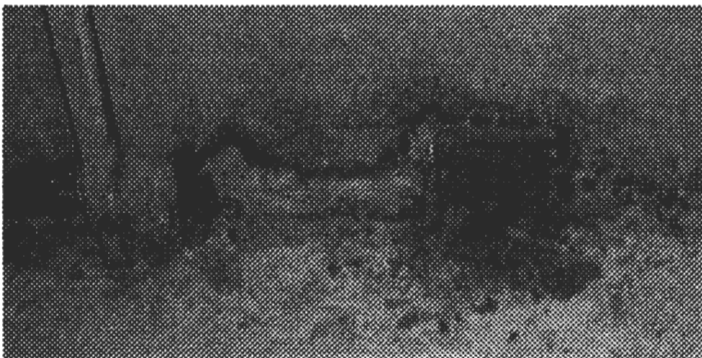
**Figure 22**

single ladder leads over 20 feet to the inner cupola section, which is not conducive to tour traffic. The base of the interior is seriously rusted at the seam between the metal and the

Notice the 'outlining' of the rust around the seams and welds.

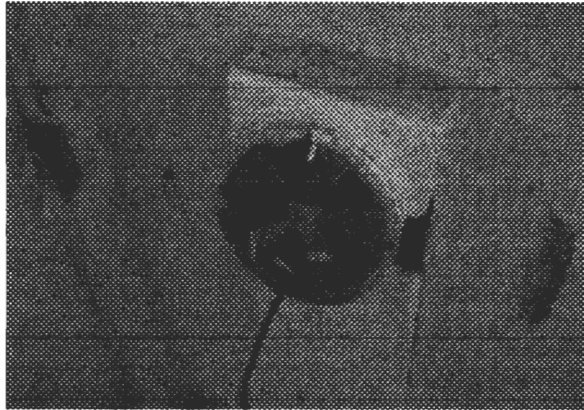
**Figure 23**

Shown here is a picture of the damage around the vents, clearly displaying the rusted out-jut vent housing. The paint all around this area is cracking and peeling, indicating moisture seepage.

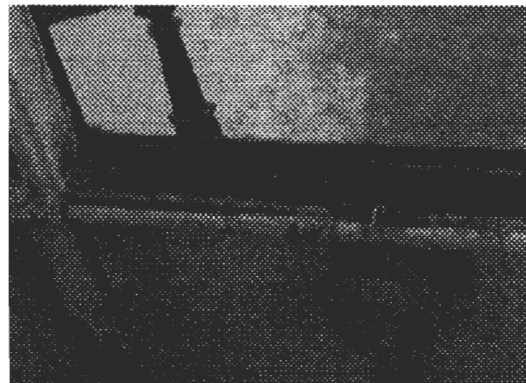
**Figure 25**

The inside window-sill is in poor condition as well, indicating a leak around the sills, causing a great deal of rust damage. The rubber seals holding the windows in place are decaying as well. Shown here is a picture of the rusting sills and the poor rubber seal. The

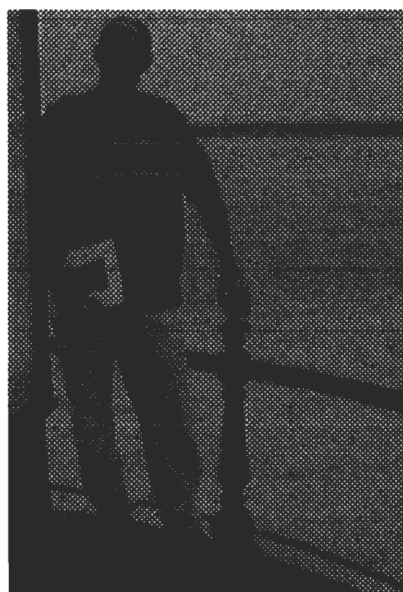
**Figure 27**

section is not doing as well either. The same subject used earlier, Vincent Salemi, is depicted here next to the hand-rail. Notice that the railing only reaches his mid thigh. This is completely unsafe, and Geoffrey White is making plans for a rail on the inside of this one that will be tall enough for code. A more thorough analysis of the stress these rails can hold is in the “Hand-Rail Stress Analysis” section.

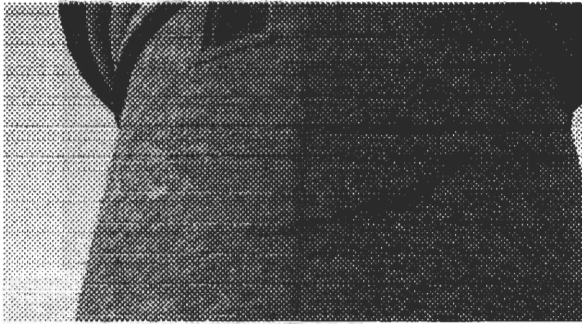
Roughly twenty feet up on the lighthouse is an abrasion where an antenna wire rubbed against the brick on the outside. These gouges are no structural or leaking

problem, as the wire has been removed/restrained, and there is no more rubbing to worsen the condition of the marks, shown here. The top 5-6 inches of

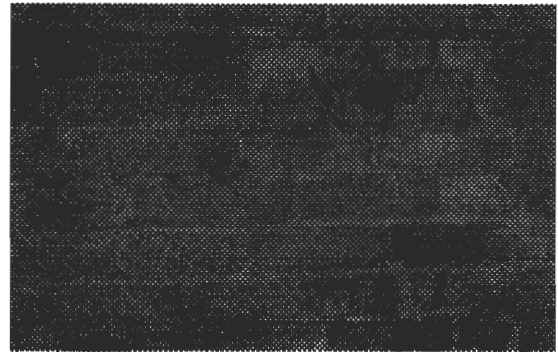
**Figure 36**

epoxy paint. One of the largest concerns in the tower is the mold that collects on the brick. As mentioned in the "Historical Background" section, mold on the bricks can release deadly spores. Shown here is a picture of the mold

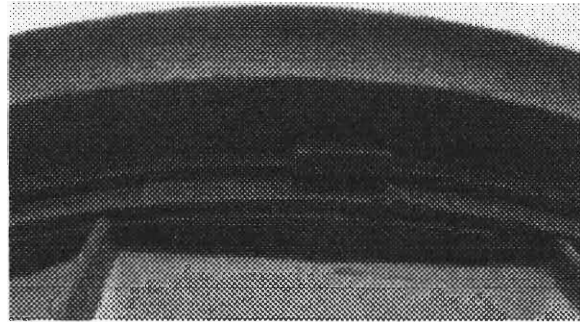
**Figure 38**

save for the metal ladders on the outside of the cupola leading onto the upper landing. Notice the rust destroying the iron ladder. This ladder services people touring the light, and needs to be replaced for the safety of the tourists, and keepers alike. The outer cupola seam holding the windows in place is in good condition except for missing pieces in window sills, which will rust the rest of the metal from the inside out.

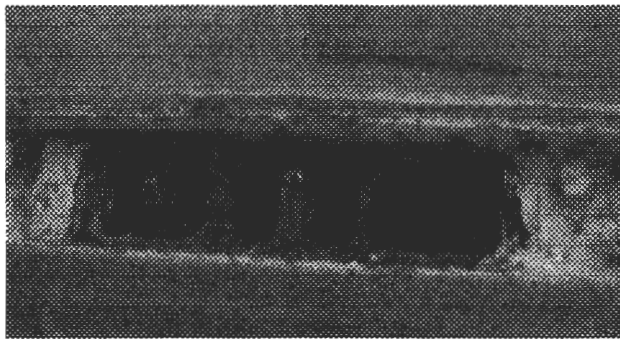
**Figure 39**

area are almost rusted away. The corrosion here is heavy, indicating high moisture levels

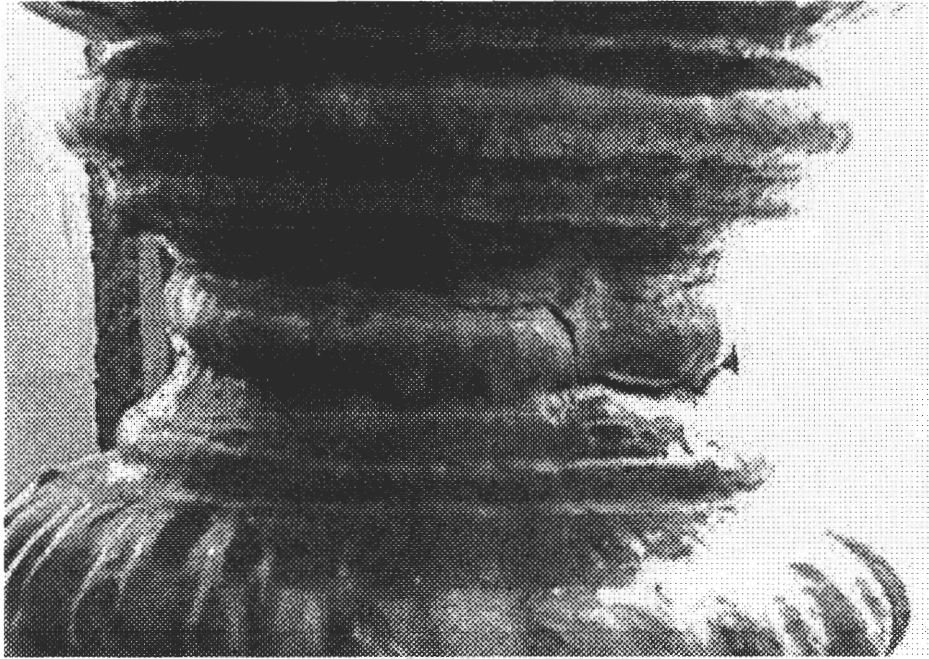
**Figure 45**

Post 11 deflected when all the rest did not. A closer inspection of the post revealed a crack in the base of the vertical, as shown in figure 45. This will have to be addressed in order for the new handrail to be safely installed.

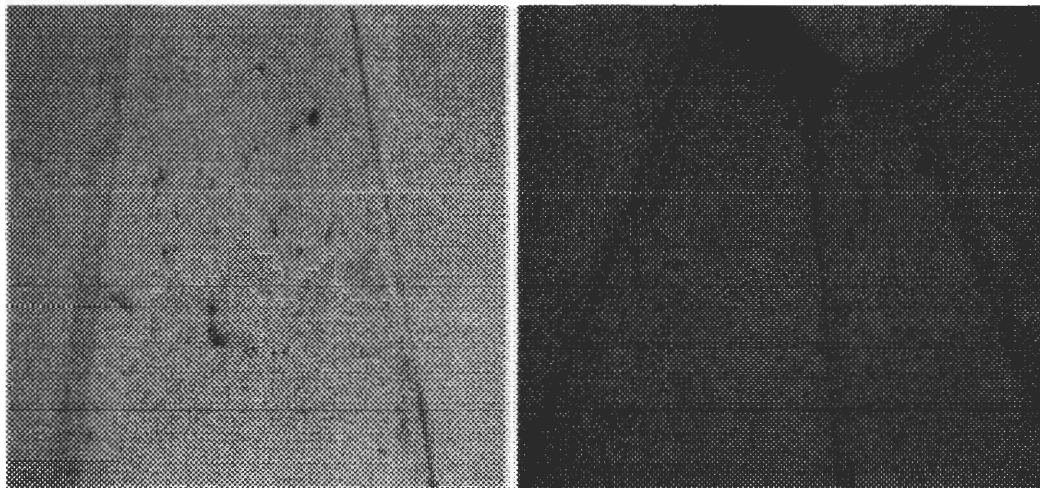
**Figure 48**

The ceiling of the lantern room is another area of concern. The paint on the ceiling panels is still peeling off and will continue to do so. There have not been any

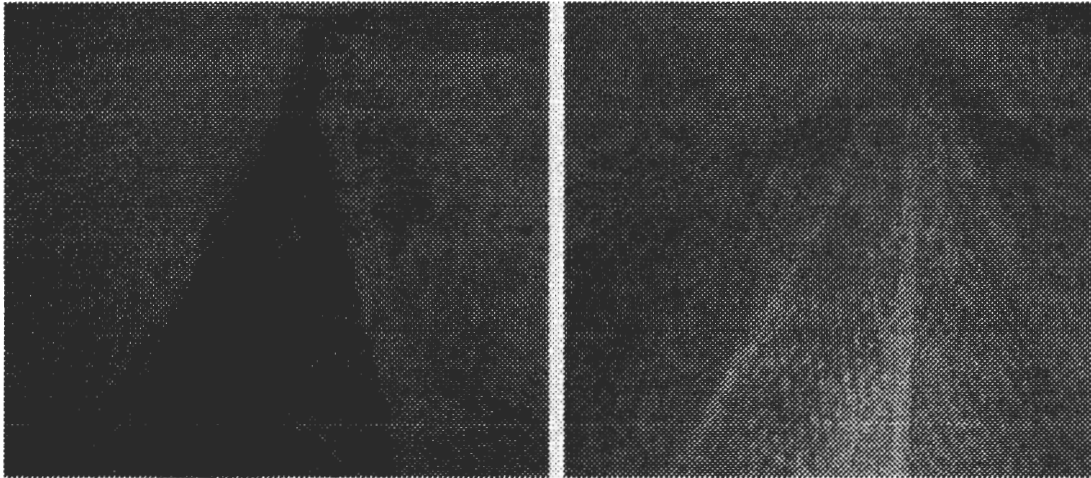
**Figure 49**

The floor of the room below the lantern room has been accustomed to rust. It seems to have been scrubbed well or treated within the last two years however the rust continues to be a problem. This rust will need to be removed before the floor is

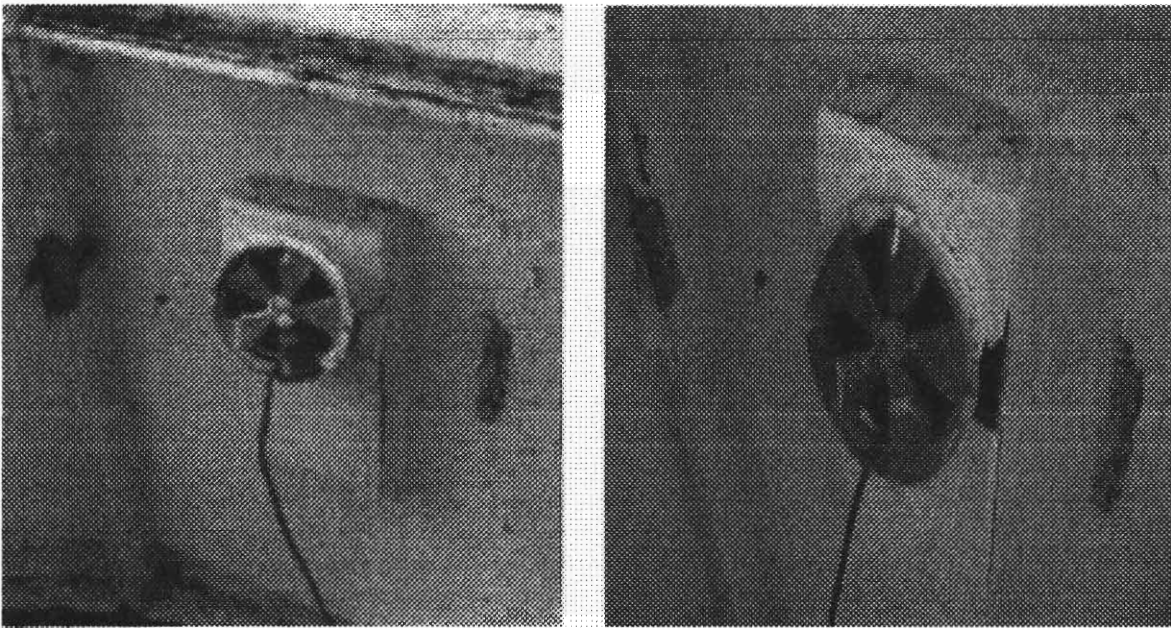
**Figure 50**

The Edgartown lighthouse is in the greatest need of repair and has continued to decline over the past couple of years. Rust seems to be the foremost concern here, since it is everywhere and will cost the most to restore. The lantern room should be a high priority in the full restoration of the lighthouse due to its state of dilapidation. The vent shown in these pictures is in working order, but moisture is still building up within the lantern. As can be seen in both pictures, rust has settled into each of the joints, on the

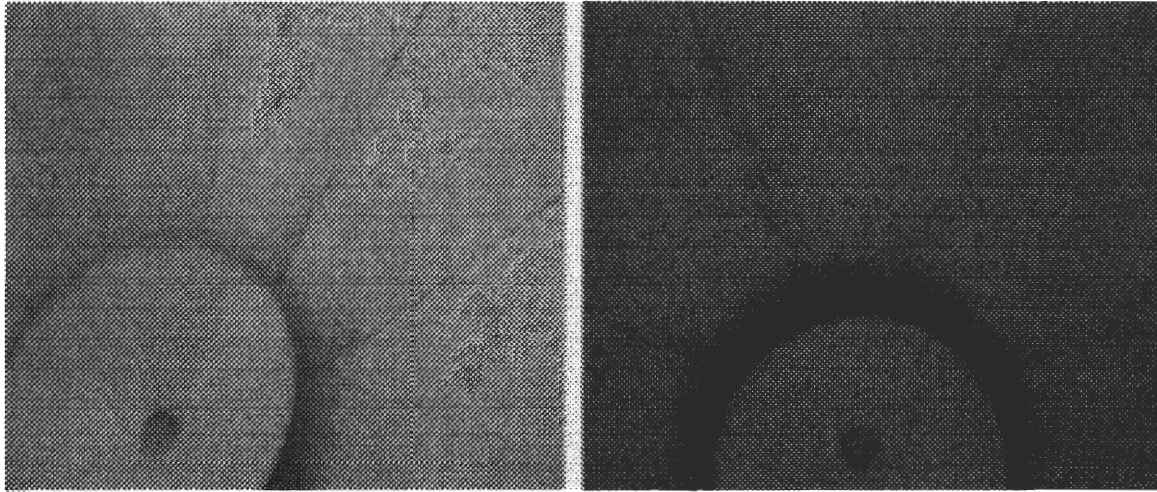
**Figure 51**

The ceiling of the lantern room has not shown a significant deterioration over the two year period. There has been no improvement in this area, and the paint continues to

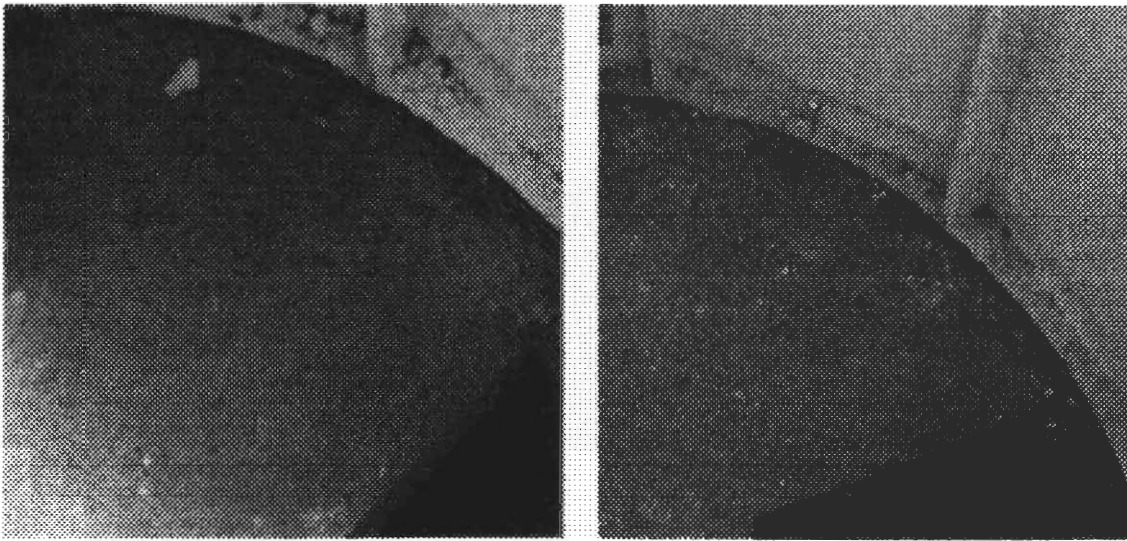
**Figure 52**

The floor of the lantern room is plagued by the same rust problems as the rest of

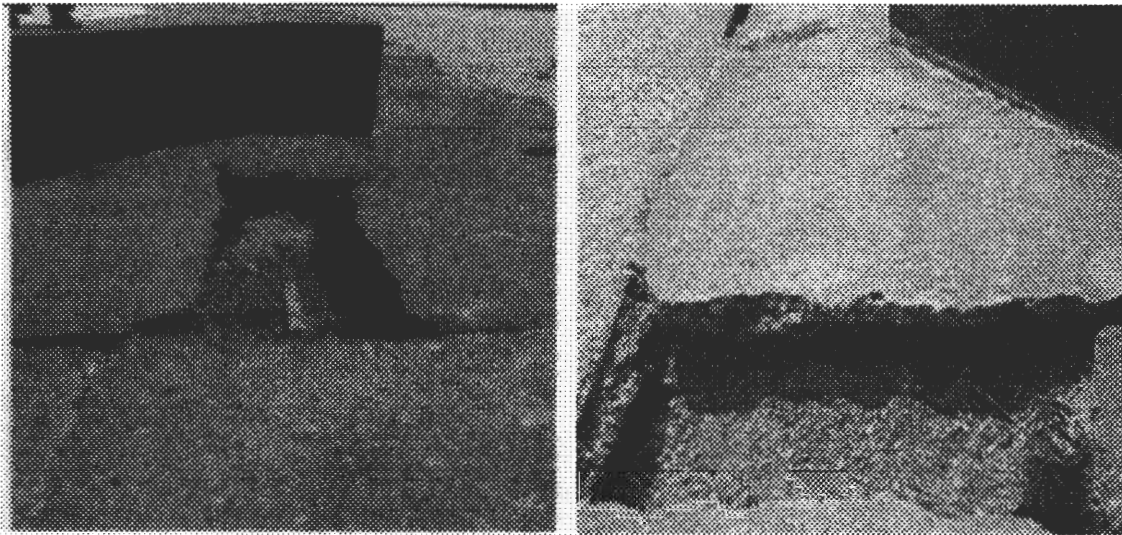
**Figure 53**

The concrete skirt that surrounds the tower foundation has been a hazard for some time and needs to be addressed. This hole in the concrete slab seems to have been

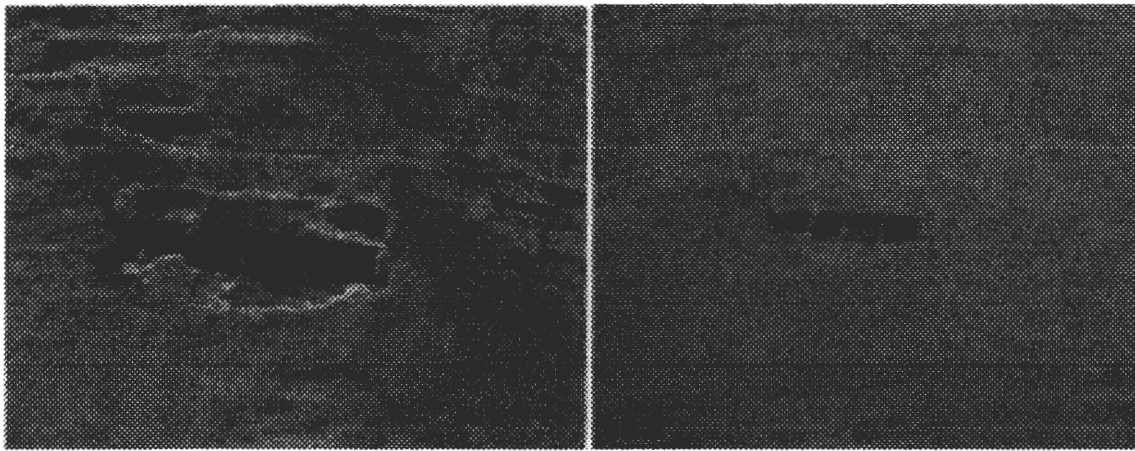
**Figure 54**

The Gay Head Light is a brick tower, presenting a totally new set of difficulties for the MVHS. The problems faced by this lighthouse are unique from those at East Chop and Edgartown, and entail entirely unique solutions. This light is isolated atop the cliffs at Gay Head, vulnerable to the elements and the most violent storms. Due to the constant attacks of nature, the masonry tower is in poor shape, with large sections of deteriorating mortar and brick. The area pictured is a section of the tower exterior which
