Designing a Culvert Management System for the Town of Spencer, MA

A Major Qualifying Project

Date: March 26, 2015

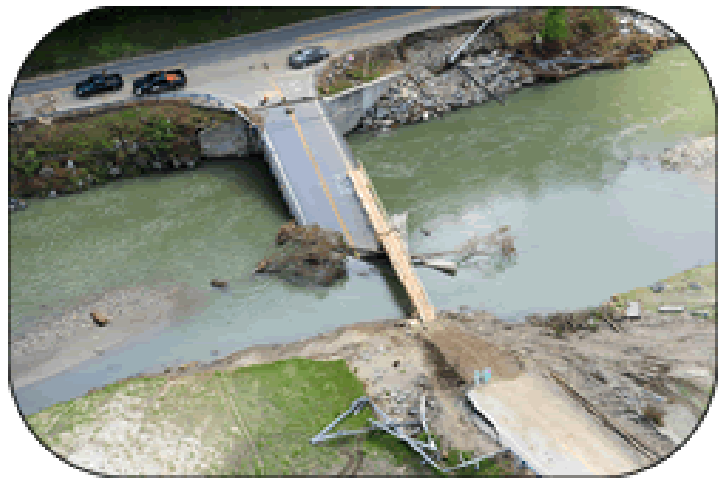
Figure 1: Rochester Bridge in Vermont

The impacts of Hurricane Irene throughout the State of Vermont in August of 2011 were tremendous and daunting simply because of the vast area of destruction. Rivers and streams grew, after 7" of rain in some places, unproportioned to any infrastructure in place. 225

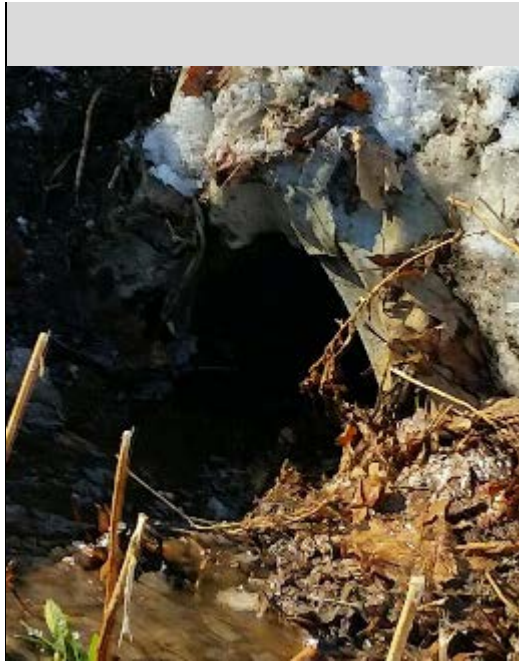
INLET

- ❖ Natural debris clogging at inlet and outlet
- ❖ Strong sulfuric smell in area
- ❖ Cracking in road above culvert

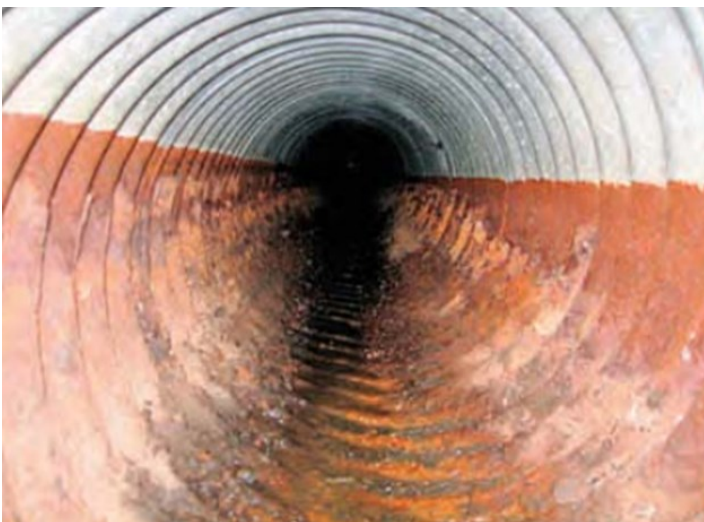
Poor

Perforations visible and/or connection hardware failing (metal). Heavy abrasion and scaling with exposed steel reinforcement (concrete). Heavy abrasion or scour damage (plastic). Displaced mortar and/or blocks, holes in invert area (masonry).²

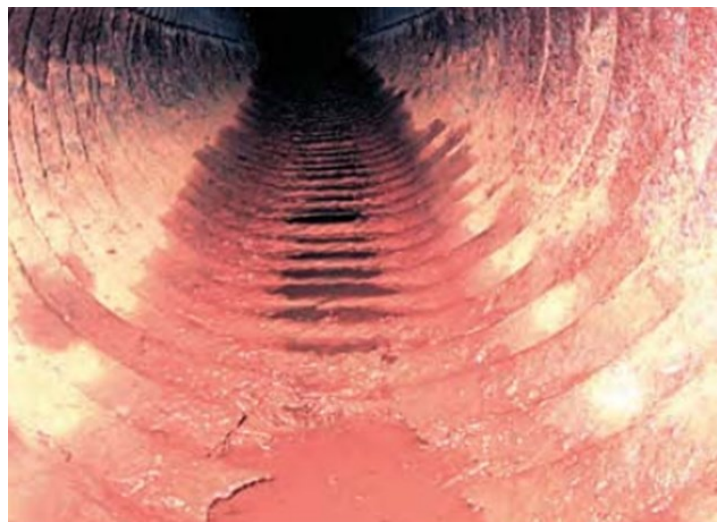
Critical

Holes or section loss with extensive voids beneath invert and/or embankment/roadway damage. Holes and gaps with extensive infiltration of soil, bedding, or backfill material (masonry).²

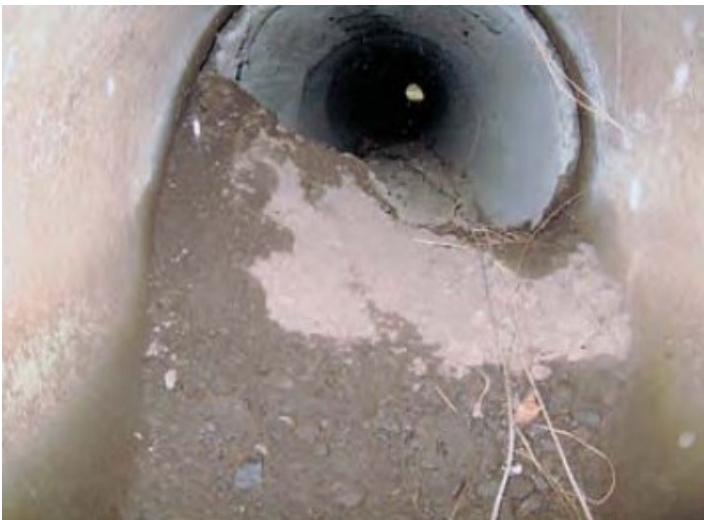
Poor

Significant separation of joints and seams between 1" to 3"; infiltration of backfill into culvert; voids visible in fill through offset of joints.¹

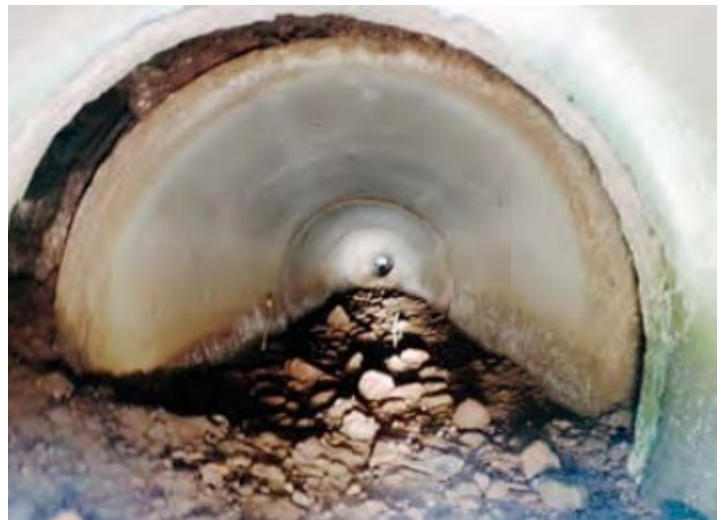
Critical

Severe separation of joints and seams greater than 3"; infiltration of backfill into culvert; large voids visible in fill through offset of joints.¹

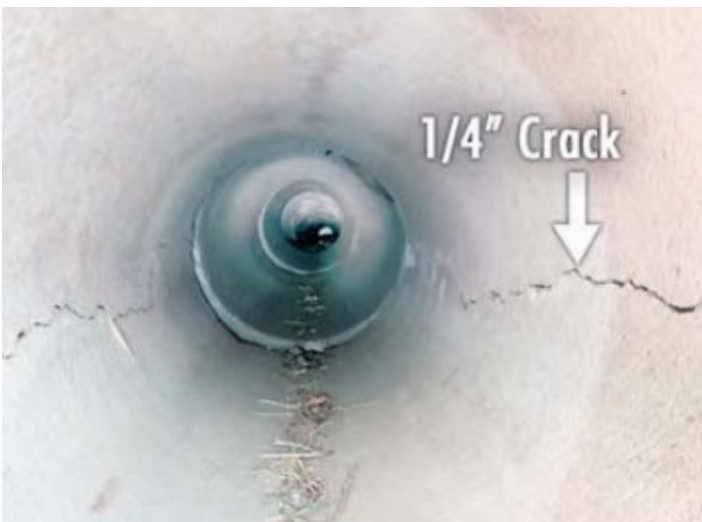
Poor

Longitudinal cracks between 1/8"-1/4" in width, spalls larger than 1/2" deep, and spalls have exposed rebar.¹

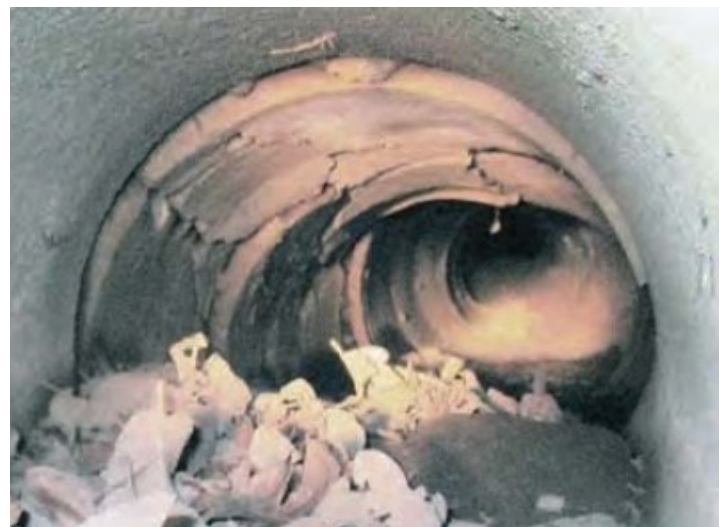
Critical

Severe cracking and spalls greater than 1/2" on culvert walls, sections of culvert are partially collapsed, major corrosion of rebar.¹
