Brutalist Building Retrofit

A Major Qualifying Project
Submitted to the Faculty
of the
WORCESTER POLYTECHNIC INSTITUTE
in partial fulfillment of the requirements for the
Degrees of Bachelor of Science in Architectural Engineering

March 23, 2018

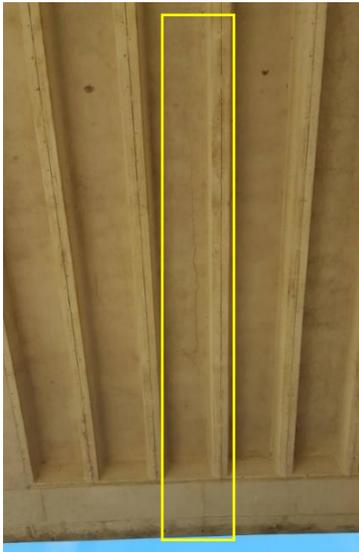
<i>Cracks</i>	
<u>Observation</u>	<u>Photo</u>
<p>A long horizontal exterior crack running North to South along the ribs on the underside of the Bridge outlined with a yellow box.</p>

We observed 18 horizontal cracks running North to South along the underside of the art studio bridge and along the interior of the art studio (Table 1 **Error! Reference source not found.**). The horizontal cracks observed on the interior and exterior are not the same crack due to the following reasons. First, we observed 5-10 interior cracks per art studio room as well as multiple long interior cracks running along the hallway as shown in Table 1.2. We observed and recorded 22 exterior cracks as shown in Appendix D. The exterior cracks were much more spread out along the 646 ft Art Studio Bridge and did not extend as long. Overall, we observed more interior cracks than exterior cracks. Second, according to the drawings, there is a layer of insulation between the exterior concrete ribs and the

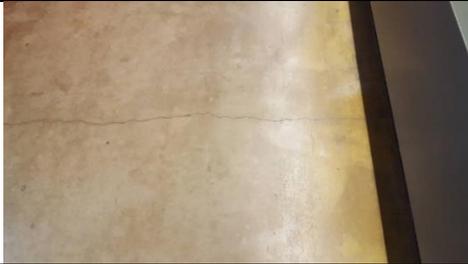
<p>A long horizontal interior crack running North to South along the hallway floor slab of the Bridge.</p>

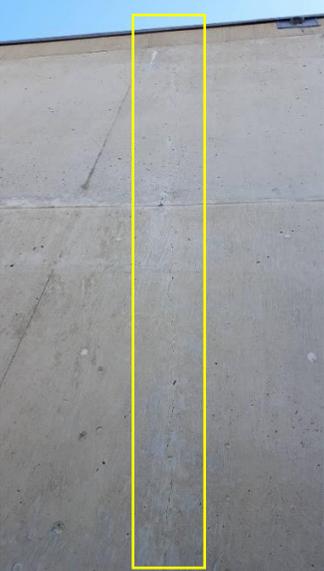
<p>A vertical long crack, outlined by the yellow box, running top to bottom located on the West Elevation of the Bridge</p>

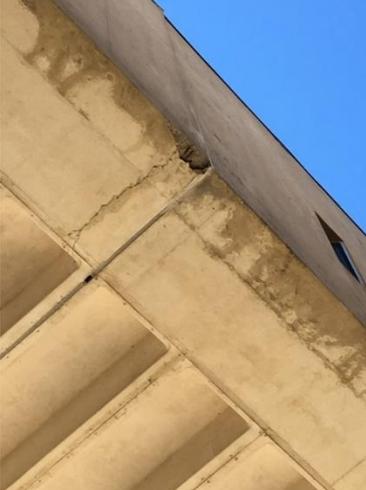
<p>A large crack and potential spall running North to South near an expansion joint on the underside of the Bridge.</p>

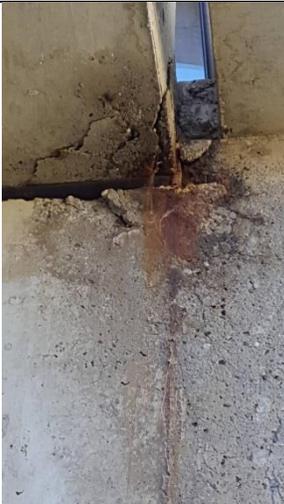
<i>Spalls and General Deterioration</i>	
<u>Observation</u>	<u>Photo</u>
Concrete beginning to spall underneath the Ramp leading to the Side door on the East Elevation

We observed signs of possible general deterioration in various areas on the building. Certain patches of the bridge and the walls of the rest of the building appeared rougher and slightly eroded with more sand and aggregate being visible. This may be due to a combination of the freeze-thaw cycle that New England experiences often and heavy exposure to the weather such as wind and rain. Overtime, the top layer of the concrete cement paste diminishes and the thickness of the concrete covering over the underlying reinforcement decreases.

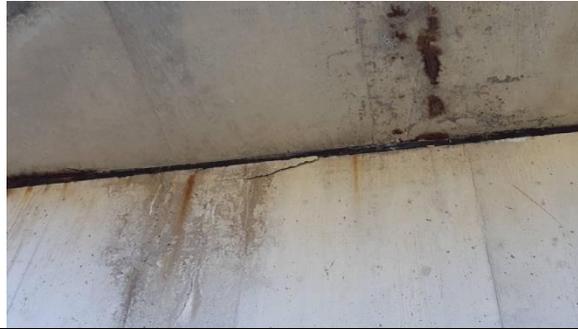
A second area of concrete beginning to spall underneath the Ramp leading to the Side door on **the East Elevation**

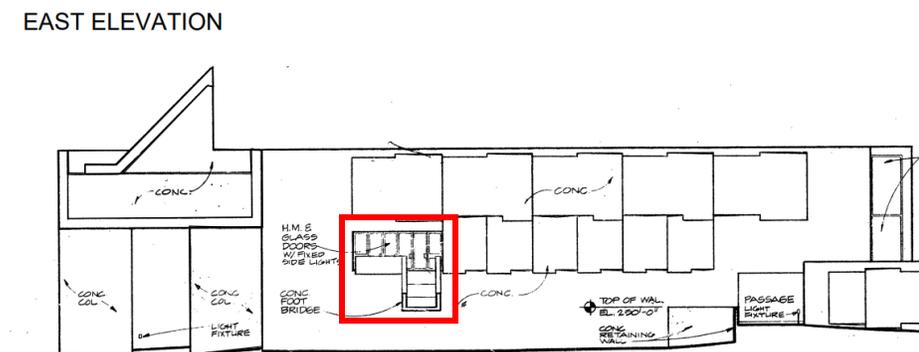
Figure 34: East elevation entrance ramp outlined by the red box.

One area of concentrated deterioration and a developing spall we found was located on the East Entrance Ramp leading up to Building B, outlined in a red box on Figure 34.

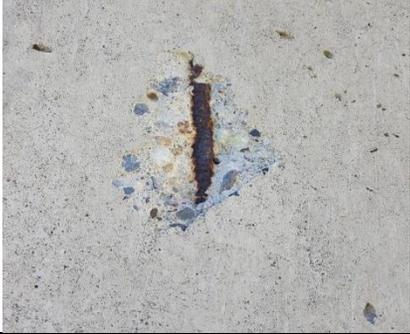
<u>Observation</u>	<u>Photo</u>
Exposed rebar and deterioration of the concrete on the East Elevation Wall

According to the Field Reports issued during February 1971 through January 1972, many issues were found concerning concrete construction work (A period Examination... pg.152). For example, entries from June 3 and June 10 require the formwork to be tighter to reduce stone pockets and loss of matrix. August 26 and September 9 entries refer to concrete formwork not being cleaned or repaired prior to placing columns. An important entry from the old field reports is from June 3, 1971 point 4-j which states, "A minimum of 1" cover for slab reinforcing steel is still not being maintained due to incorrectly sized slab bolsters."⁴³ This is one potential cause for the exposed reinforcement observed on the site visit, shown in Table 3. The past repairs shown in Table 3 are evidence of previous spalls or large cracks.

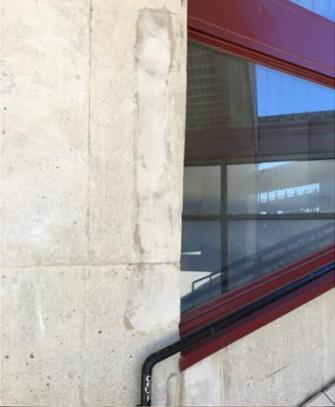
Evidence of previous spall repairs on South Elevation near entrance stairs.

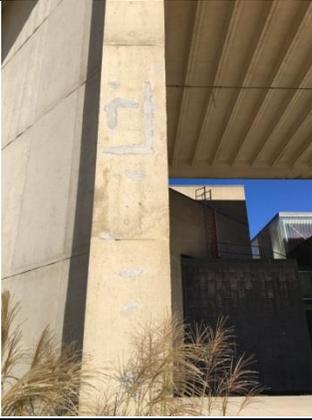
Evidence of previous spall repairs on the triangle supports under the Bridge.

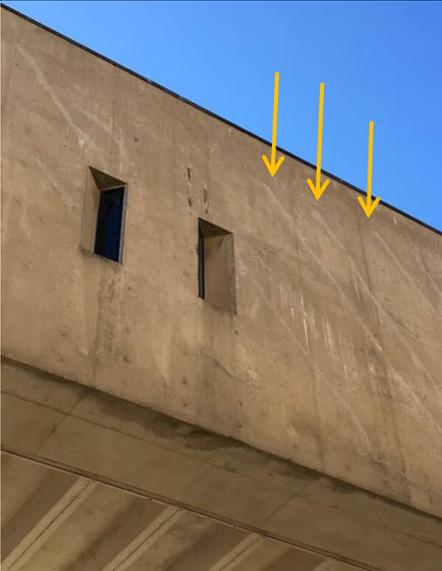
<u>Observation</u>	<u>Photo</u>
Efflorescence (indicated with yellow arrows) located on the North Elevation of the Bridge.

The Fine Arts Center has an abundance of efflorescence on all sides of the building. The white streaks are numerous, especially on the bridge. Efflorescence is caused by excess water soaking into the concrete structure. The water migrates to the surface collecting salt along the way. When the water evaporates, the crystalline salt brought to the surface stains the concrete white. Efflorescence itself is not a structural issue, but the excess water that causes it can also cause internal rebar and structural damage that does not always show on the exterior of the building. Noticing efflorescence in multiple places all along the wall is an aesthetic issue that creates an unclean visual. Beyond that, the walls showed generally staining with no signs of damage in those areas.

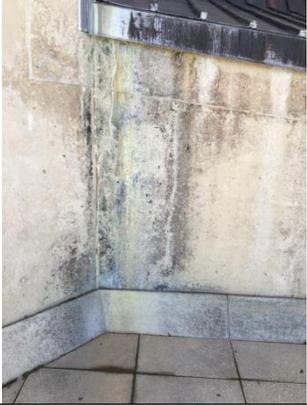
<p>Dark Staining on South Elevation under copper flashing</p>

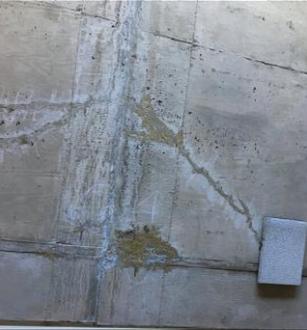
<p>Dark Staining on the interior ceiling of Art Studio 435</p>
