# Gilbertville Mill Restoration Project

A Major Qualifying Project  
Submitted to the Faculty of the  
Department of Civil and Environmental Engineering at  
Worcester Polytechnic Institute  
in partial fulfilment of the requirements for the  
Degree of Bachelor of Science

This project is a plan for implementation of a 2009 UMASS Amherst Master's Thesis to redevelop the site of a mill in Gilbertville, MA. The goal is to take the site, which contains several 19th century buildings that serve a diminished purpose in today's economy, and turn it into a living, modern, artistic community center. The project team will explore all relevant design considerations and use the associated standards to determine the viability of the plan. Furthermore, the team will design any necessary changes to the structural system of the mill and provide a cost estimate of them all.

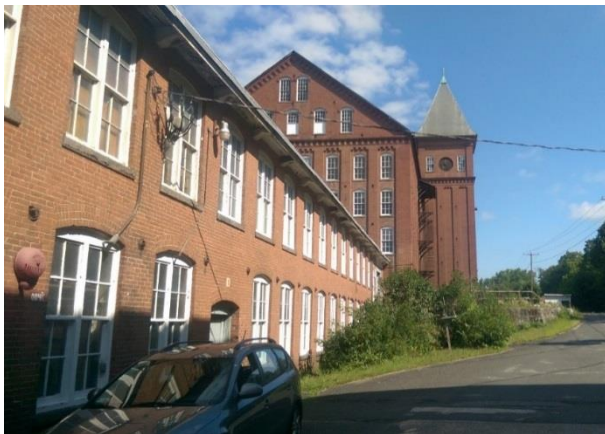
Figure 5: W-2, W-1, and the Clock Tower, Picture taken during the first site visit in August.

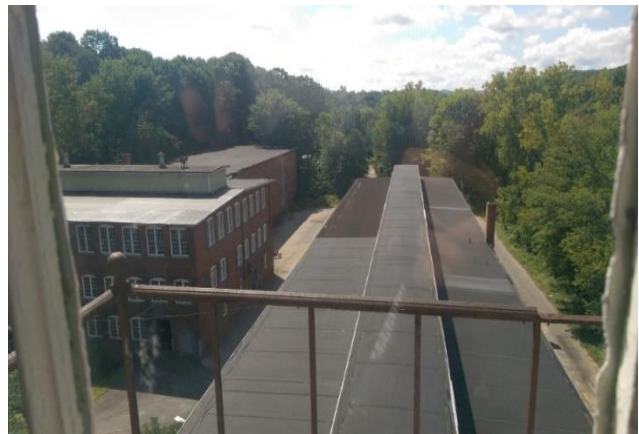
Figure 4: W-2 and the East Buildings, as seen from W-1-5.

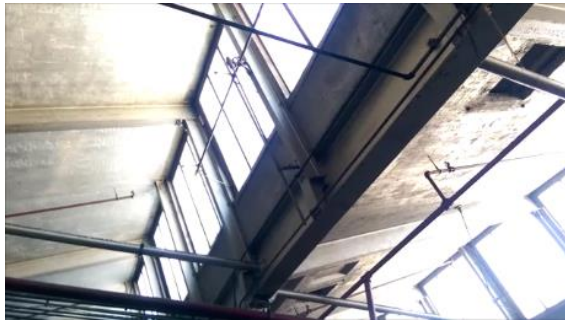
Figure 6: The Saw-tooth roof of W-3

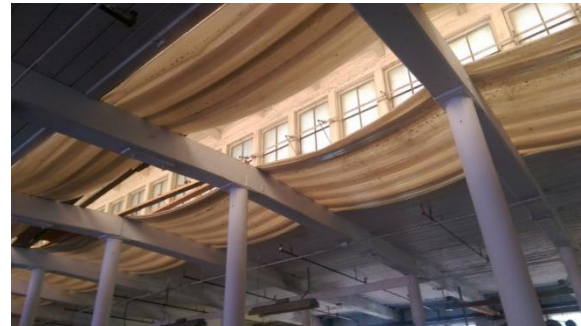
Figure 7: Inside W-2-1

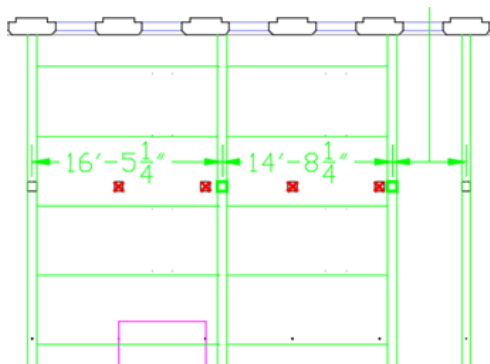
Figure 12: W-1-5 Floor Framing Layout #1

One particular issue that the team found with the architectural plan for the W-1-5 floor was that plan had shown structural rods going through tenant's living spaces. The team deemed that this would interfere with the tenant's level of comfort and decided to develop two new flooring layouts, with which

the removal of intrusive rods was included. The first layout option is shown in Figure 11. Here, joists, spaced six feet on center are attached to beams thirteen feet in length with a tributary width of
