Investigation of Fire Impact on Structural Steel through Case Studies

A Thesis Report

WORCESTER POLYTECHNIC INSTITUTE

Date: May 4, 2006

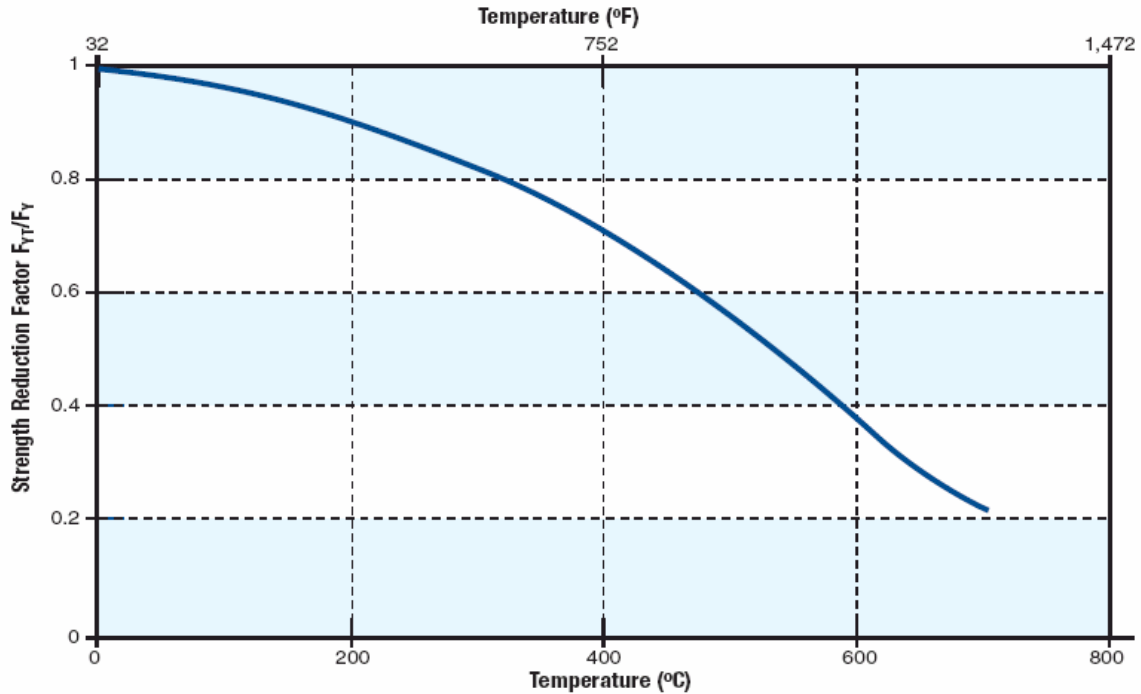
Figure 32 - Strength of Steel at Elevated Temperatures (qt. Milke, 2002)

The next step in the analysis process was to examine the shear tab connections where the failure appeared to have begun. In *Appendix B of the World Trade Center Building Performance Study* (Fisher, 2002), the three-bolt capacity, double shear capacity, and the tensile capacity of the shear tab connections were calculated at room temperature and at 550° Celsius. This was done by adjusting the yield strength values of the bolts by a factor determined from Figure 32 below; extracted from *Appendix A, Overview of Fire Protection in Buildings, WTC Building Performance Study*.

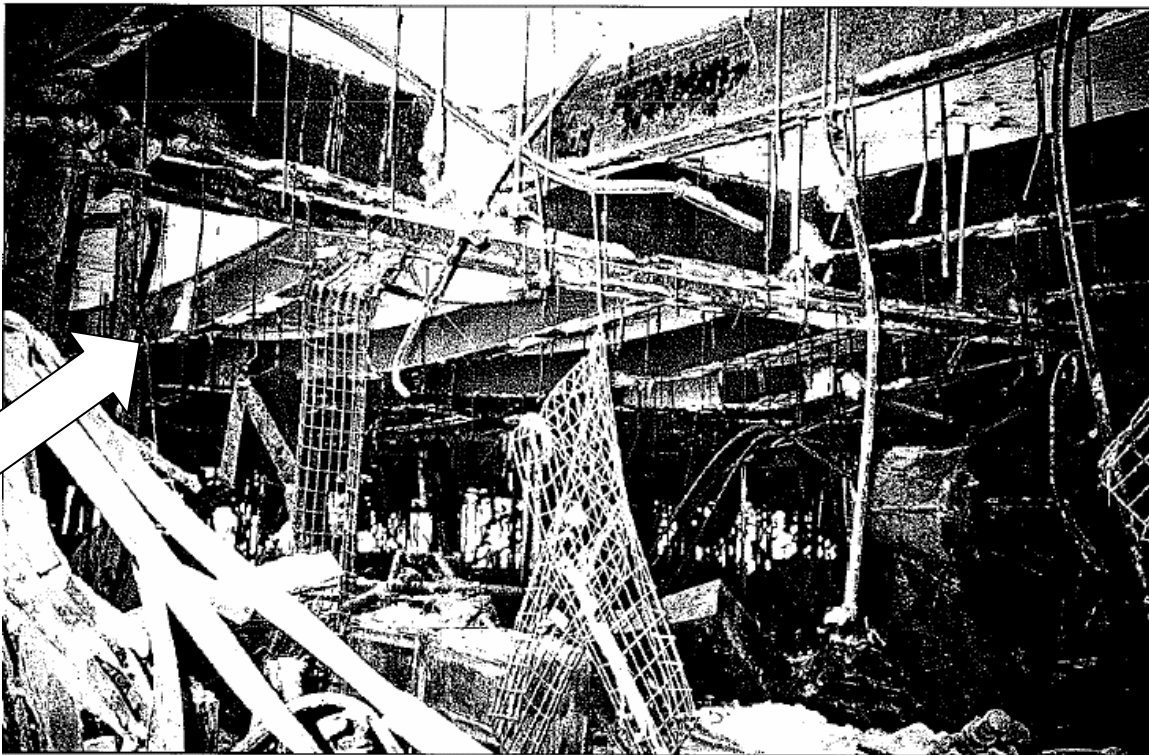
Figure 34 - Catenary Action in WTC 5

system. “The influence of membrane tensions in the slab cannot be ignored, particularly when a fire compartment is subject to high horizontal restraint from surrounding cool, stiff structure, or when it is vertically supported around its perimeter at protected lines of support. When the double-curvature deflections of floor slabs become large the influence of tensile membrane action can become very important in supporting the slab loading,” (Huang, 2002). This tensile membrane action or catenary action can be useful in preventing a progressive collapse; however if the tensile forces developed are larger than the tensile capacities of the connections, the system will fail. This is the mode of failure that was believed to have occurred in the World Trade Center 5 column tree assemblies (Barnett, 2002). In Figure 34 below, one can see the catenary action developed in the upper floors that had typical structural framing.

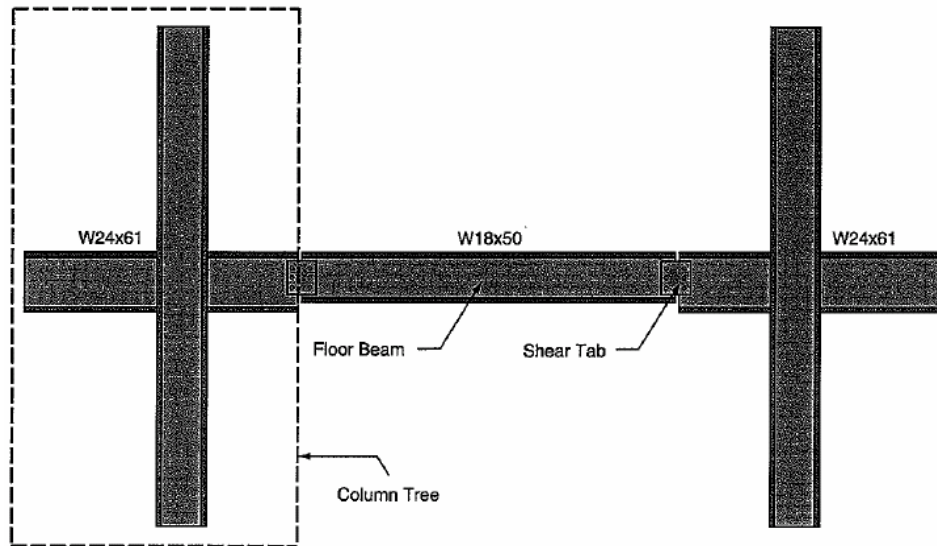
Figure 61 - Typical Column Tree System (Barnett, 2002)

caused shear connectors of the column tree assemblies to fail initiating collapse from the eighth floor through the fifth floor.

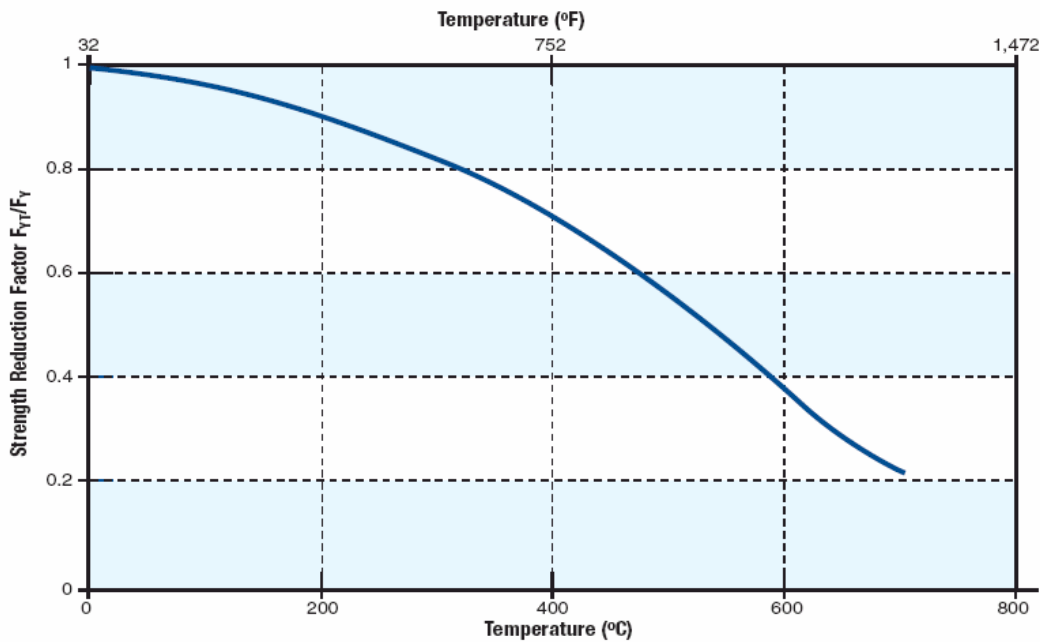
Figure 72 - Strength of Steel at Elevated Temperatures (qt. Milke, 2002)

The next step in the analysis process was to examine the shear tab connections where the failure appeared to have begun. In *Appendix B of the World Trade Center Building Performance Study* (Fisher, 2002), the three-bolt capacity, double shear capacity, and the tensile capacity of the shear tab connections were calculated at room temperature and at 550° Celsius. This was done by adjusting the yield strength values of the bolts by a factor determined from Figure 26 below; extracted from *Appendix A, Overview of Fire Protection in Buildings, WTC Building Performance Study*.

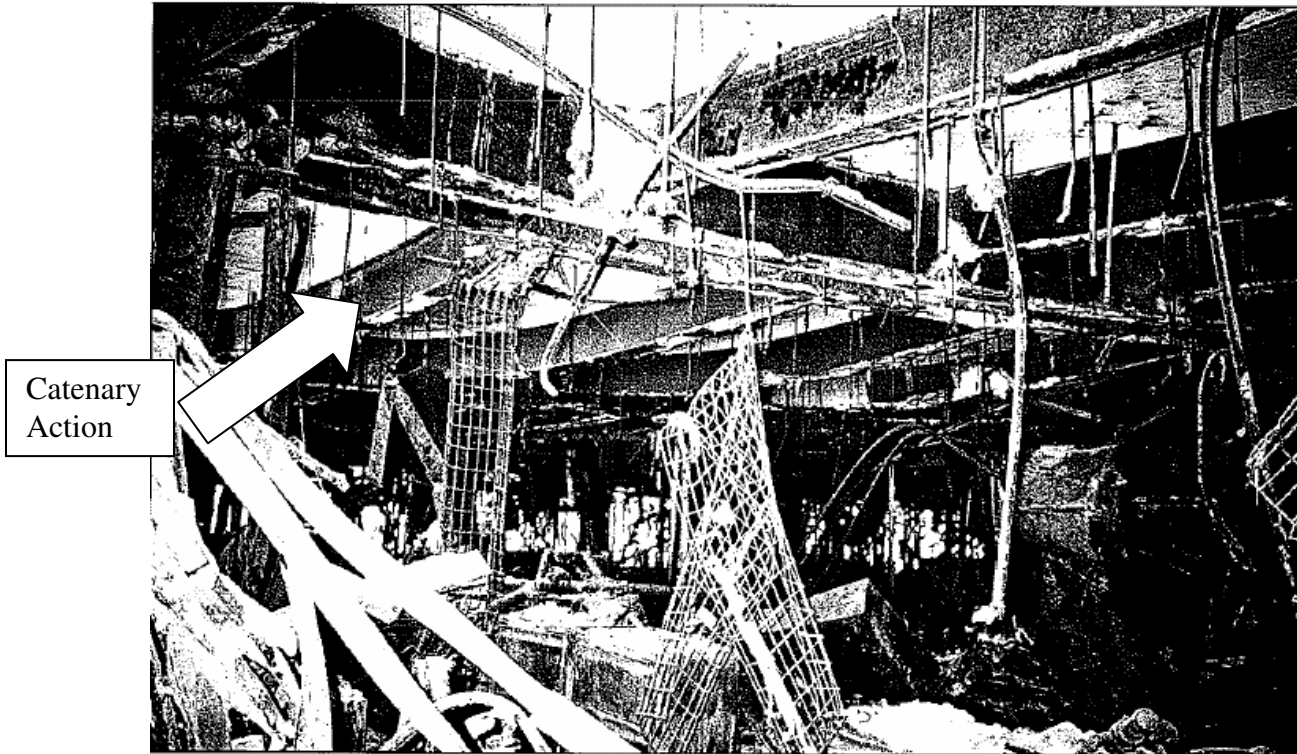
Figure 73 - Catenary Action in WTC 5

determined that when fire temperatures were below 400°C the slab acted as an extension of the compression flange of the structural steel and had little influence on the system, but when temperatures exceeded 500°C the slabs became a very influential part of the system. “The influence of membrane tensions in the slab cannot be ignored, particularly when a fire compartment is subject to high horizontal restraint from surrounding cool, stiff structure, or when it is vertically supported around its perimeter at protected lines of support. When the double-curvature deflections of floor slabs become large the influence of tensile membrane action can become very important in supporting the slab loading,” (Huang, 2002). This tensile membrane action or catenary action can be useful in preventing a progressive collapse; however if the tensile forces developed are larger than the tensile capacities of the connections, the system will fail. This is the mode of failure that was believed to have occurred in the World Trade Center 5 column tree assemblies (Barnett, 2002). In Figure 34 below, one can see the catenary action developed in the upper floors that had typical structural framing.
