Project Number: ZAZ-11AB

GE Aviation-Rolls-Royce Stator Assembly Improvements

A Major Qualifying Project Report

Date: 12/16/2011

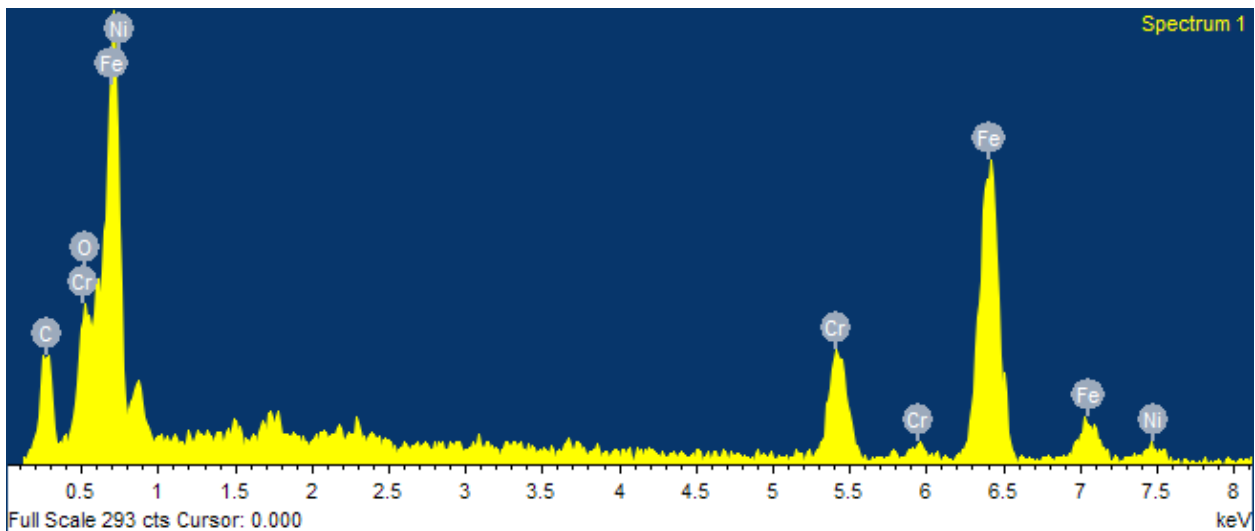
Figure 10: EDS graph of the surface elements on the airfoil.

The results of Site 1 show high concentrations of iron and chromium, which is to be expected from the alloy of stainless steel as it is comprised of (EMS 70755). Between the range of 1 keV and 5 keV, there is some noise in the graph, signifying that there are trace elements being picked up by the analysis. Due to limitations in the precision of the EDS analysis, the team was unable to identify what these materials were. A more sensitive analysis method would need to be utilized in order to accurately determine the composition of these trace materials.

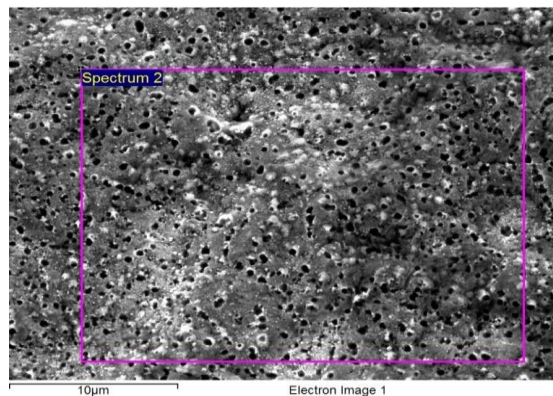
Figure 11: The surface of the honeycomb material as captured by the SEM.

Based on the surface analysis of Site 2, the honeycomb, it is apparent that there are lesser concentrations of more materials. The honeycomb is comprised of a nickel based alloy (AMS 5536M). As with the airfoil examination, the same energy range (1 keV – 5 keV) shows traces of other elements. There were four spectrums recorded of the honeycomb, the other graphs are available in Appendix F.

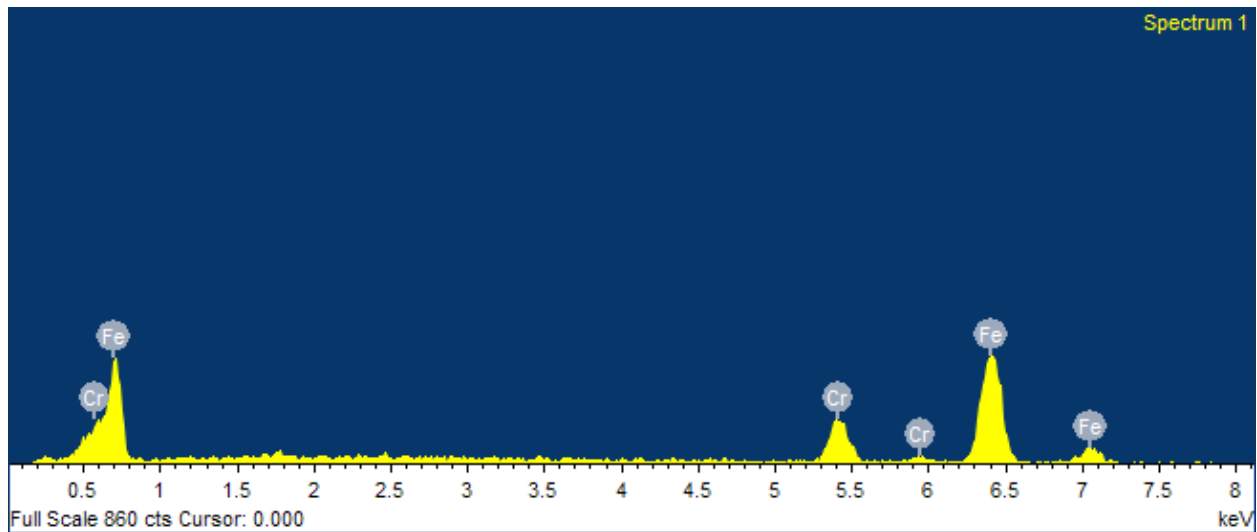
Figure 14: EDS graph of the surface elements on the outer ring.

The results of the EDS on Site 3, the outer ring of the assembly, exhibited much clearer peaks and significantly less noise than the other spectrums. There were three spectrums recorded of the honeycomb, the other graphs are available in Appendix F.
