Restoring Mrigadayavan Palace:

Understanding Causes of Concrete Deterioration and Determining Viable Concrete Rehabilitation Methods

The Mrigadayavan Palace
Foundation

C Term 2022

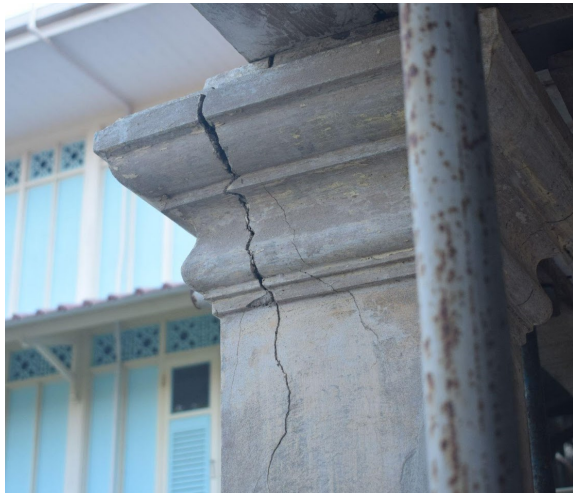
Figure 8. Examples of cracks in concrete columns at the Palace

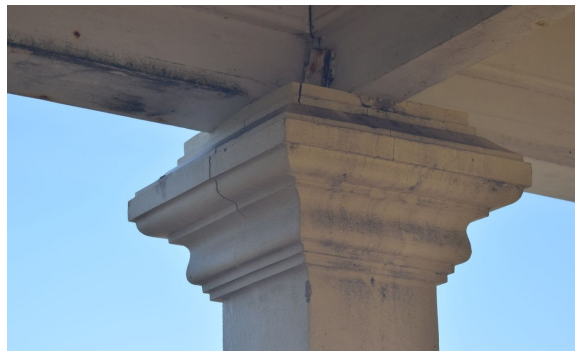
Figure 13. Cracks that form on the special design on top of a column

From observations, the diameter of the steel reinforcement in the concrete columns is approximately 9 to 10 millimeters. The size of the steel reinforcement that is used in the concrete columns is identical throughout the Palace. Furthermore, the steel reinforcement embedded at the top of the original concrete column was not for extra support for the whole concrete column, but it was there to support the special design that the top of the concrete column had. Any cracks or corrosion that exist on this special design would not affect the stability of the rest of the column. Cracks on the special design on top of the column can be seen in *Figure 13*.

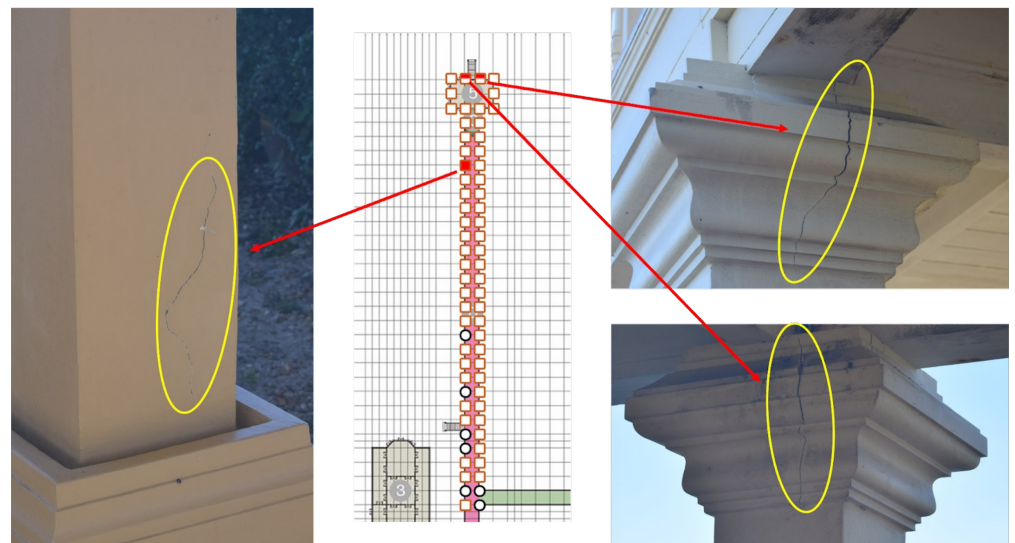
look into this area with photos of the cracks in the area can be seen in *Figure 16*. In this area, a total of sixty-six concrete columns were recorded. Fifty-nine concrete columns or 89.4% of the columns in this area had steel reinforcement throughout the body, and only seven concrete columns had steel reinforcement at the top and base of the column. This area was renovated about three years ago which makes it the most recently renovated area. Only three cracks in concrete columns were observed in this area and the pattern of cracks was all vertical. Two of them were found at the top of the column and one column had cracks in all three locations.

Figure 16. Area one: outer court bathing pavilion

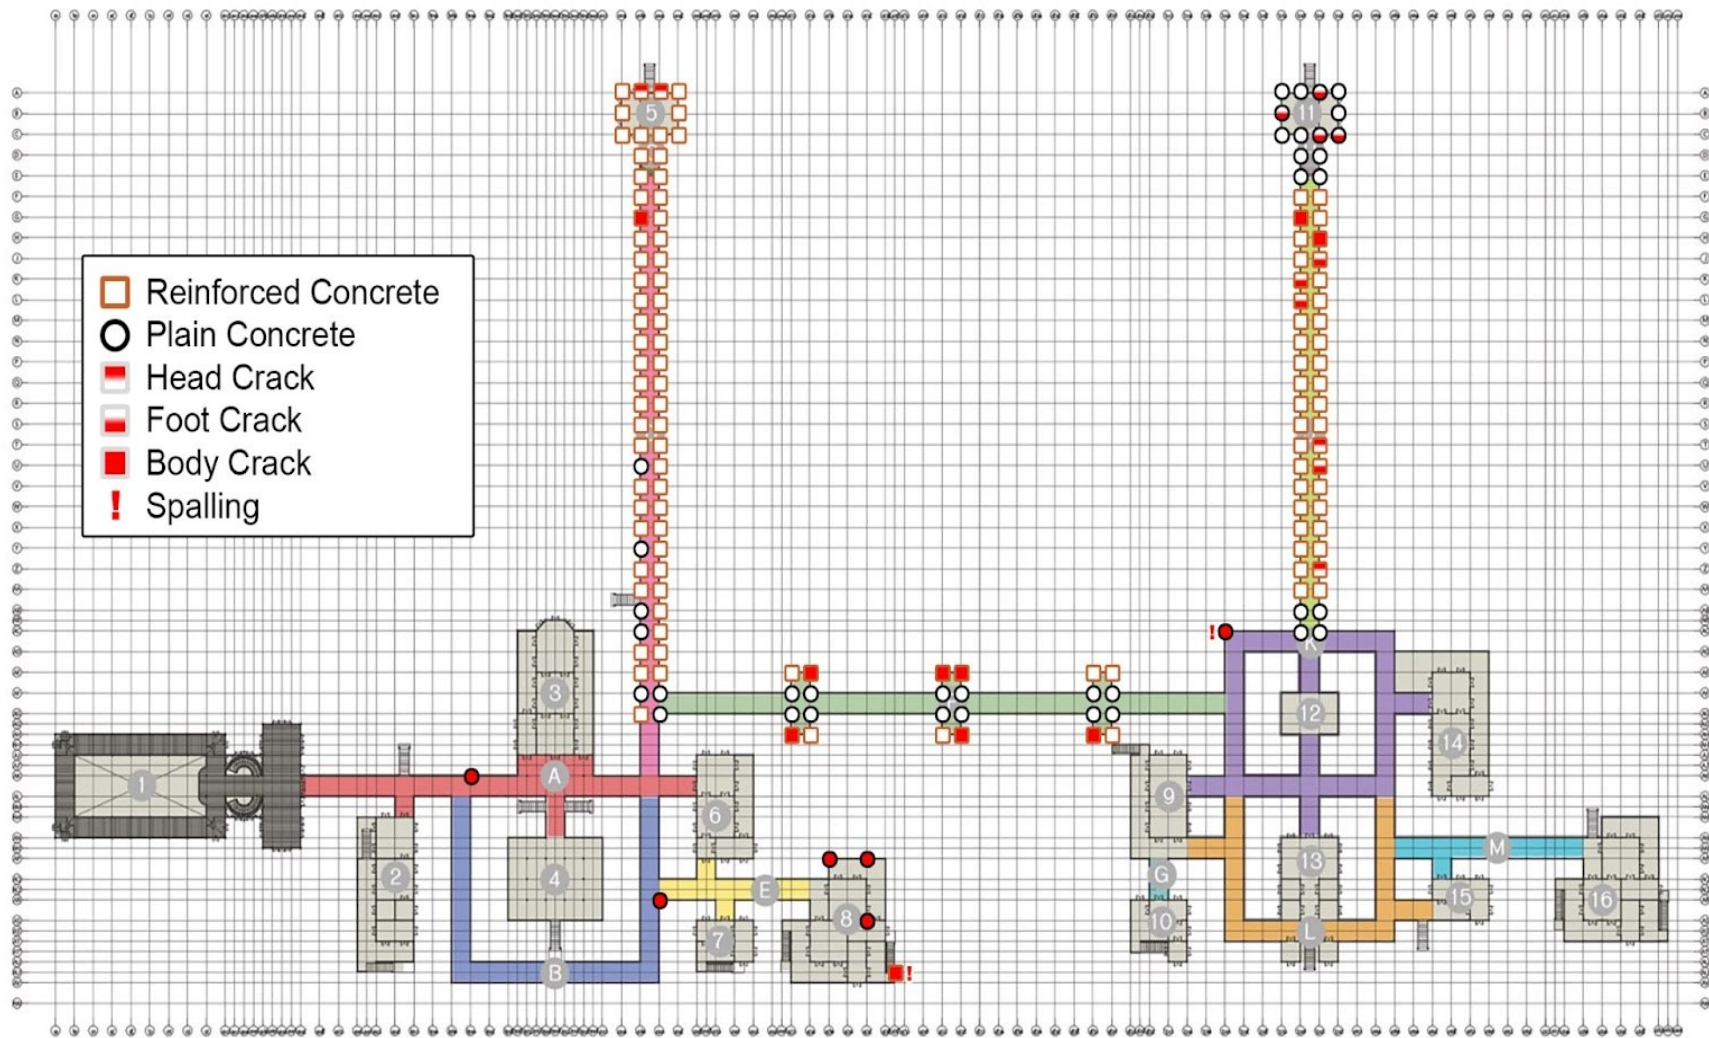
Figure 15. Location of damaged columns in the selected sampling area

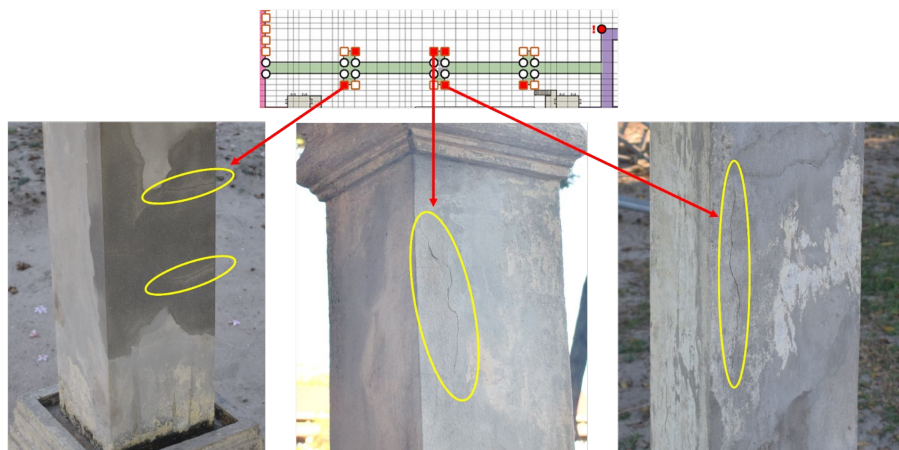
For area two (middle-box), the **linking corridor between the two courts**, a closer look into this area with examples of the cracks in the area can be seen in *Figure 17*. A total of twenty-four concrete columns were recorded in this area. In the recorded data, twelve concrete columns of 50% of the concrete columns had steel reinforcement throughout the body and twelve concrete columns had steel reinforcement at the top and base of the column. This area was last renovated about thirty years ago. There were six columns in this area that had cracks in all three locations and it all happened to the columns that had steel reinforcement throughout the body of the column.

Figure 17. Area two: linking corridor between the two pavilions

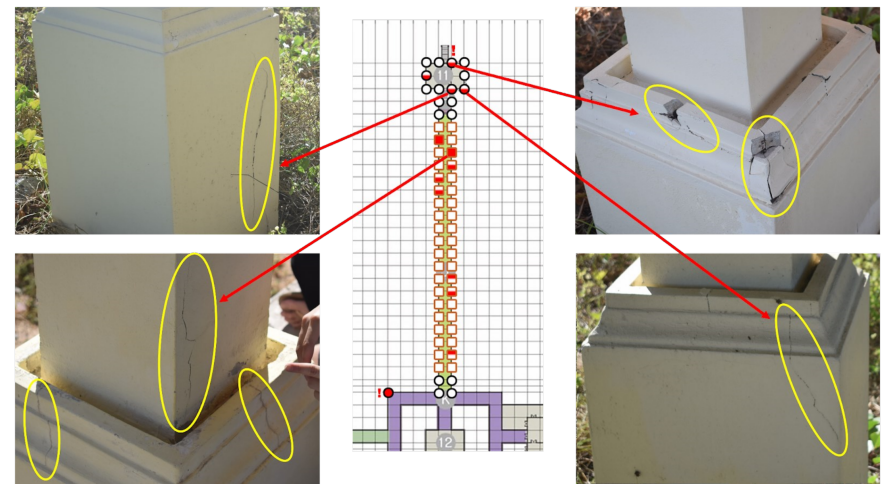
Figure 18. Area three: inner court bathing pavilion

For area three (right-box), the **Inner Court Bathing Pavilion**, a closer look into this area with examples of the cracks in the area can be seen in *Figure 18*. In this area, a total of fifty-eight concrete columns were recorded. Forty concrete columns or 69% of the concrete columns in this area had steel reinforcement throughout the body, and eighteen concrete columns had steel reinforcement at the top and base of the column. This area was renovated about thirty years ago as well. Eight columns had steel reinforcement throughout the body that had cracks in them, and four columns that had steel reinforcement at the top and base that had cracks in them. Both vertical and horizontal crack patterns were observed in this area. Most of the horizontal cracks in the sampling area can be found in this area.

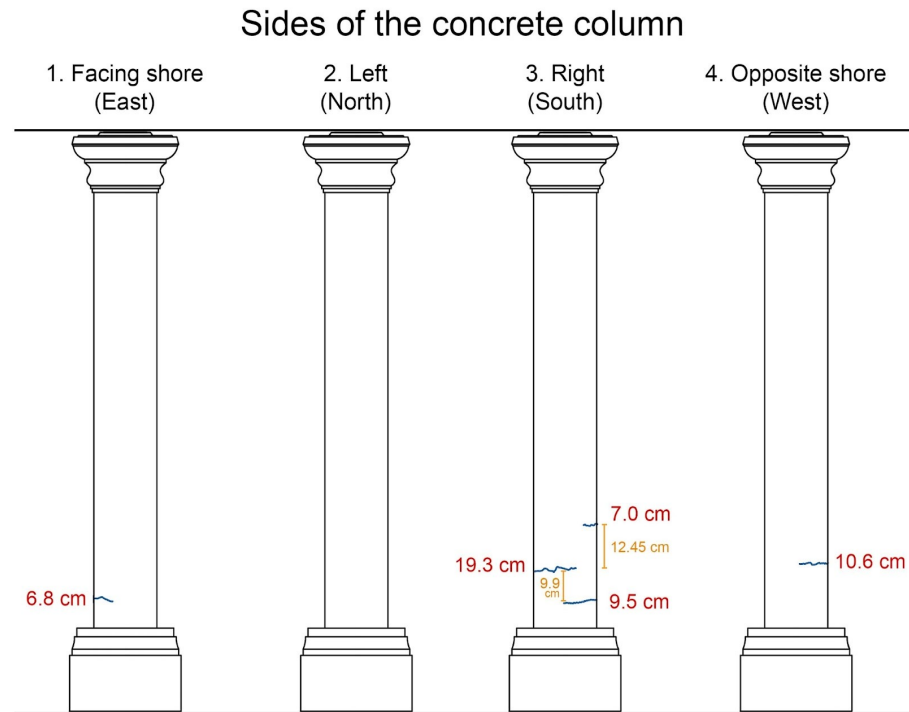
that lengthy. Based on observation, the cracks on the columns were mostly on the surface and were very shallow in depth. An example of the crack map of cracks on the concrete columns can be seen below in *Figure 20*. This specific crack map only shows the dimension of length. The width was not measured because it was too small to get an accurate measurement.

Figure 20. Example of a crack map on concrete columns with length measurements

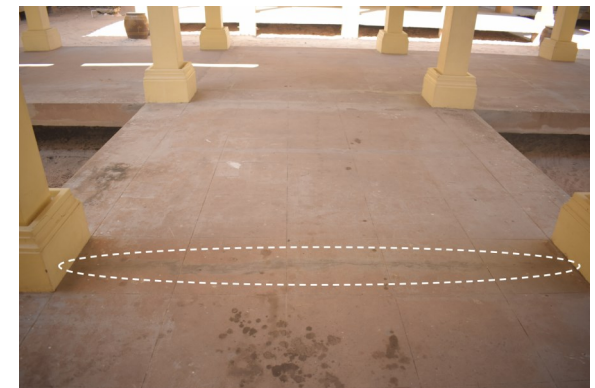
the concrete walkways or concrete floor base were observed to be mainly on the surface. The areas with the most deterioration problems were in the Samutphiman, section 6, and Pisansakorn, section 14, as seen in the map in *Figure 9*. The majority of the cracks were mostly near or between the concrete columns. Some cracks on the concrete floor extended from one column across to the other columns as shown in *Figure 22*.

Figure 22. Cracks in the concrete walkway between two columns

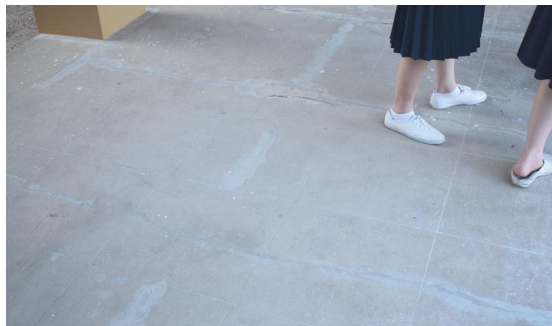
Small-scale repair processes happened throughout the years, as walkways showed some signs of minor repairs. The timeline of the repairs is uncertain due to the lack of past restoration records. Nevertheless, differences in concrete color on the walkways in *Figure 23* showed that the concrete patching technique had been done in the past restorations. When cracks occurred on the concrete walkway, the new concrete paste would be used to patch up on the surface.

Figure 23. Signs of the difference in concrete colors in the concrete walkways

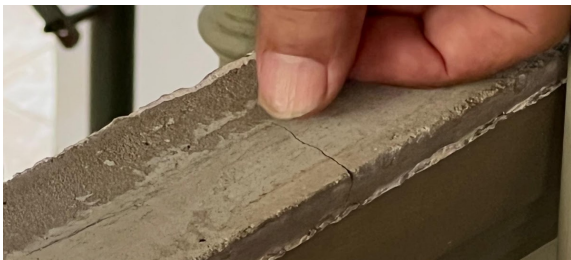
The panels are a modular grid system of three meters by three meters, each module has nine individual panels of various dimensions and painted designs. These panels were then painted and have never been restored. Within each of the nine panels in each grid, there is steel reinforcement in each panel. Using the metal detector to scan for the existence of the steel reinforcement, the team discovered that the pattern of the inner steel reinforcement was a four-by-four metal bar grid. These steel-reinforced ceiling panels have been supported by wooden frames and are held up by a complex truss system in the roof. From the observations, a minor crack at the edge of the concrete ceiling panels was observed on the displayed ceiling panel *Figure 25*.

Figure 25. Concrete crack due to uneven weight distribution of wood framework

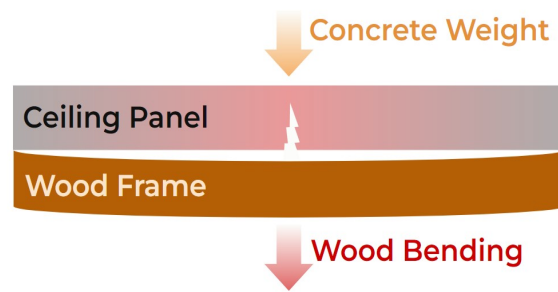
Figure 26. Schematic explanation of the crack in the concrete ceiling panel

Architectural errors and deterioration played a major role in causing **cracks** on the concrete ceiling panels. After discussion with the Palace Foundation, it was determined that the cracks on the concrete ceiling panels were caused by the instability of the wood framework. As time passes, the wood framework that supports the weight of the concrete panels bends. This creates an uneven weight distribution of concrete panels onto the wood framework. The arched part of the wood framework could support less weight of the concrete pane causing concrete ceiling panels to crack in the middle area between two edges as explained by *Figure 26*.

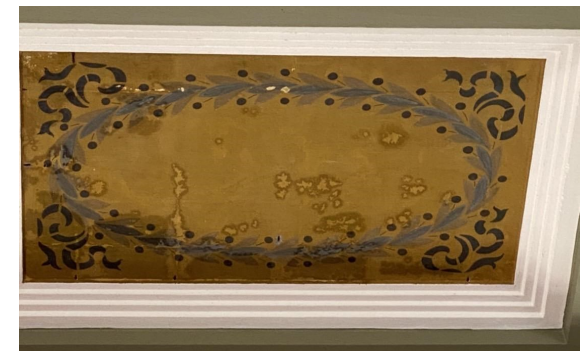
The effect of roof leakage is one of the main causes of corrosion for concrete ceiling panels. Roof leakage damaged both the appearance and physical state of the concrete. As the ceiling panels are made out of gray concrete which contains high breathability and permeability, it allowed water and vapor to seep through from the leaks in the roof. *Figure 27* shows pale marks with a droplet-like shape on the surface. These **stains** are caused by water that came in through the roof and seeped through the concrete panel and formed drops on the lower side of the panel. These droplet stains resulted in an unappealing appearance.

Figure 27. Pale marks with a droplet-like shape on the surface of a ceiling panel

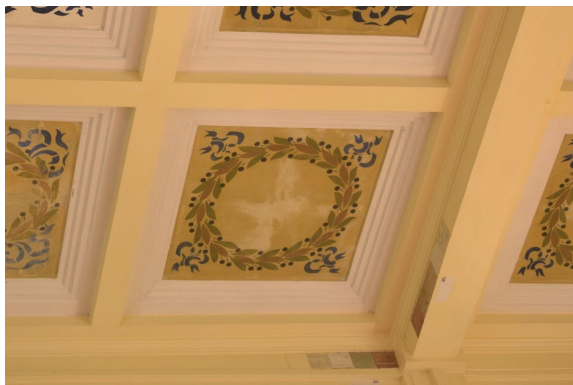
steel affected both the appearance of the concrete panels and their physical state in terms of cracks.

Figure 28. Plus sign marks with a yellow-like color due to rust on the steel rods
