00C004I  
MFD-PL 99-47

## **Products Liability**

This project report is submitted in partial fulfillment of the degree requirements of  
Worcester Polytechnic Institute.

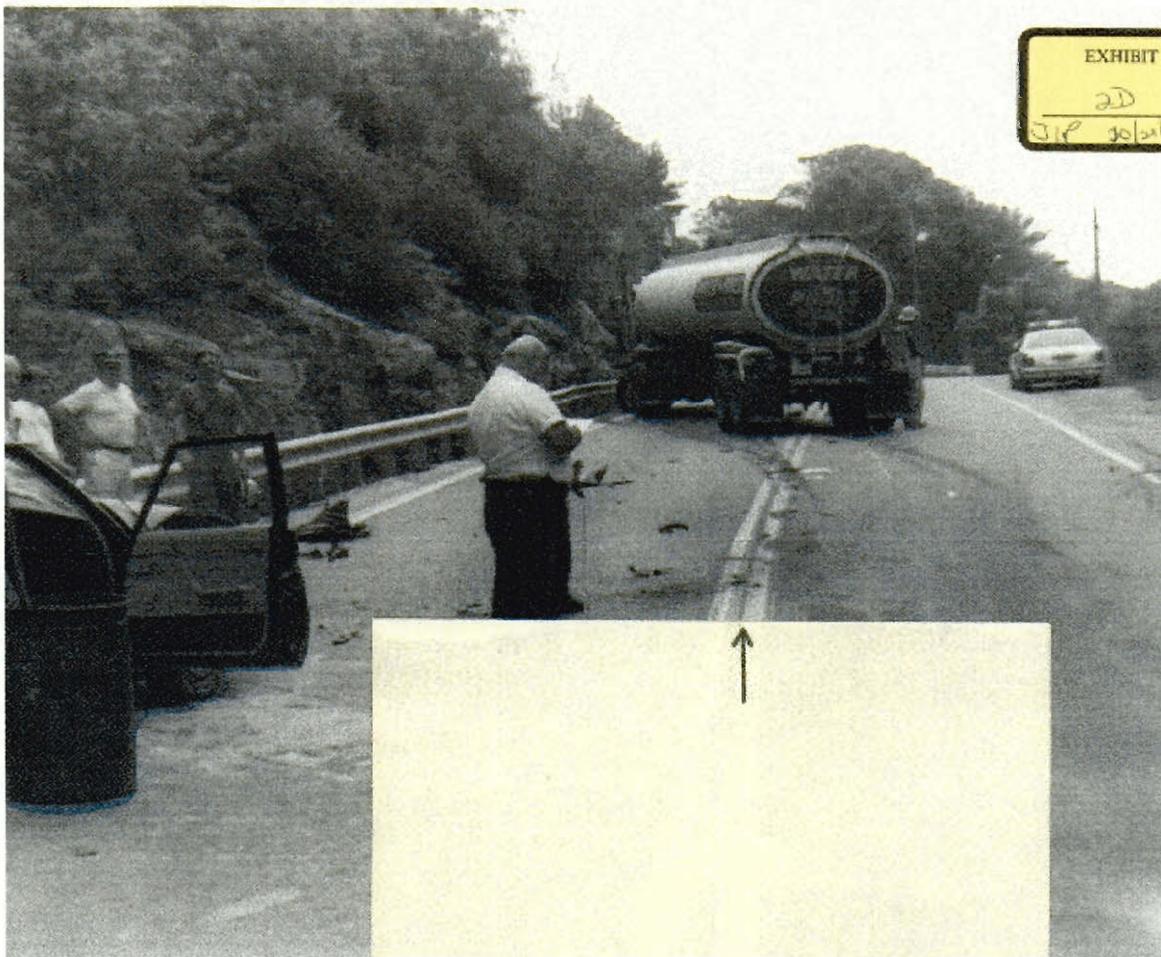
- 2a. Picture was taken at the scene at the time of the accident. It shows the final positions of the two vehicles and where the gouge marks are positioned.
- 2b. Picture was taken at the time of the accident. Shows the final resting places of the two vehicles.
- 2c. Picture taken at the time of the accident. Shows the damage to the front left of the truck.
- 2d. Picture taken after truck was towed from the scene. Shows tire damage.
- 2e. Picture taken years following accident. Massive car damage.

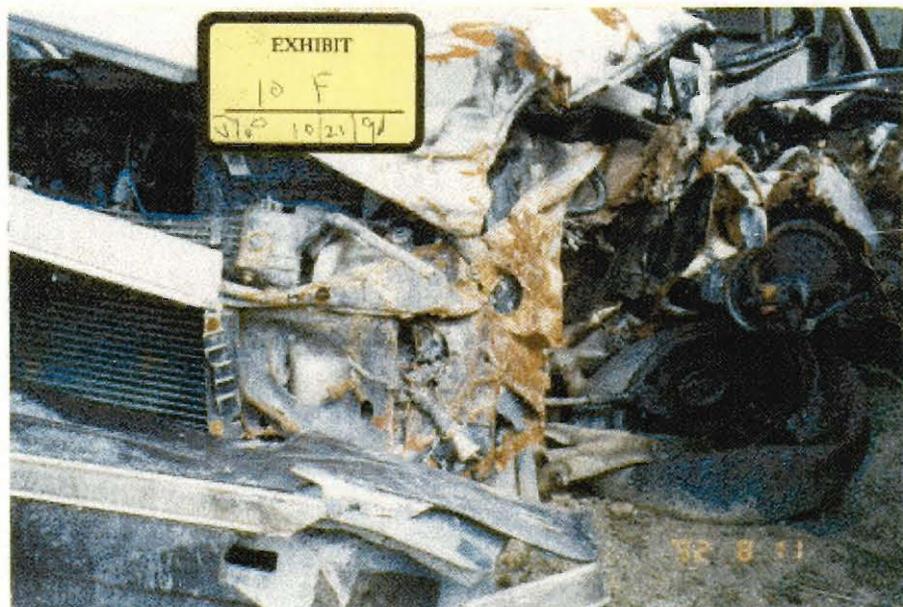
2e.

traveled up onto the car half the rim and the tank would be out of harms way. The damage on Mrs. Hernandez's car as seen in picture 2e shows that the left front wheel is completely crushed and the hood and fender are damaged. Although the roof of the car is not damaged with scrapes that would come from the truck. Also on the hood of the car there were black rubber marks that could only be caused by the left front wheel of the truck. This makes us infer that the truck smashed the front fender and drove over the wheel of the car. At this point the car started a violent rotation that kept the truck from driving over the roof of the car. This rotation also caused the circular tire mark that was left on the road. When the heavy truck crushed the wheel of the smaller car, Mrs. Hernandez's car continued to rotate causing the skid to be curved. The tractor-trailer then dropped from the car back onto the road causing the gouge in the road on the trucks lane of travel. The gouge may have been caused by the shocks coming in contact with the road momentarily due to the violent drop. Also other debris that had come from its underside may have come in contact with the road and caused the gouge.
