RIO PIEDRAS CONSERVATION MANAGEMENT PLAN

RÍO PIEDRAS AT
THE AQUEDUCT COMPLEX

May 2009

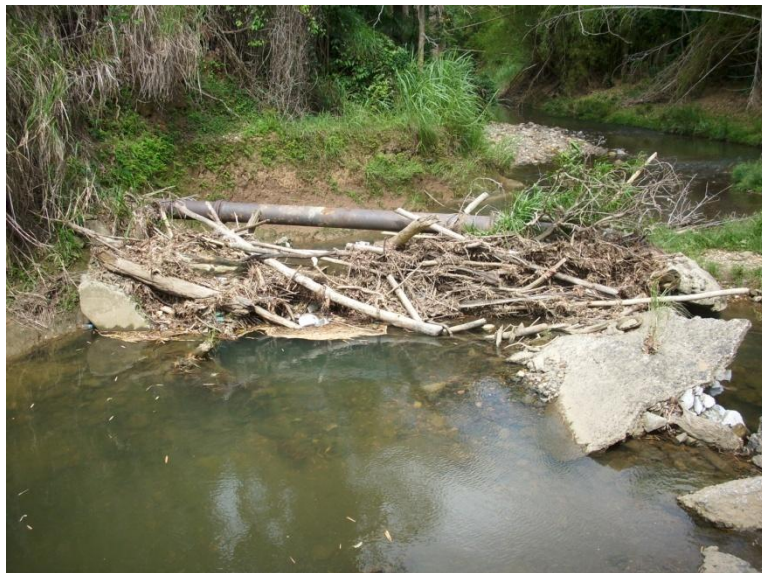
interval other than the debris collection in the water. In the water of Interval 1, a collection of natural debris has created a dam which diverted water flow from its normal path that can be seen

Figure 7: Natural Dam of Zone 1

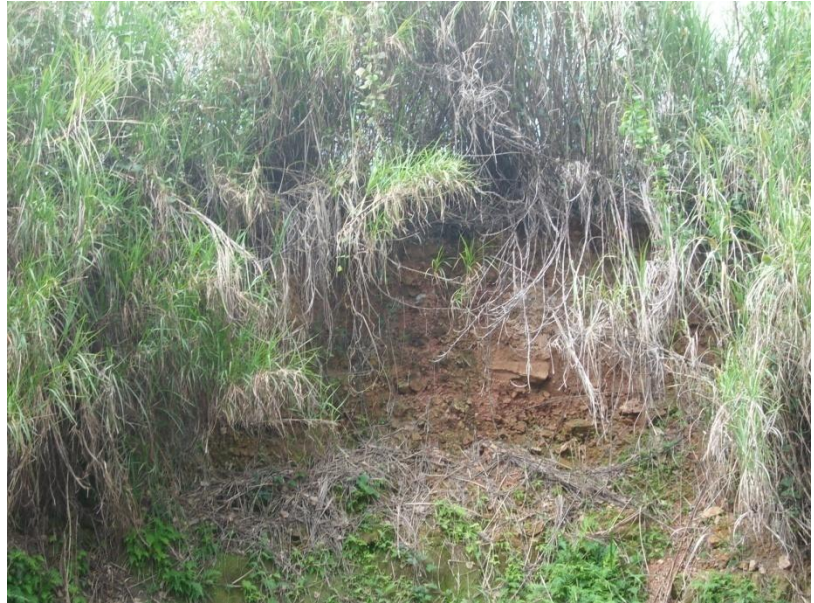
Figure 8: Erosion of Zone 1 and *Calopogonium coeruleum* Overhang

a density of 1.244 g/cm^3 . The typical density of clay is approximately 1.2 g/cm^3 , and this sample is consistent with this value. The clay has many larger rocks within it and is extremely eroded. This clay sample covers a majority of Zone 1, from the start of the aqueduct to approximately fifteen meters after the natural dam. The eroded clay bank is almost vertical and covered by *Calopogonium coeruleum* and in places by the Helecho fern, all of which is demonstrated in Figure 8. The complete Soil Density results can be found in Appendix III.

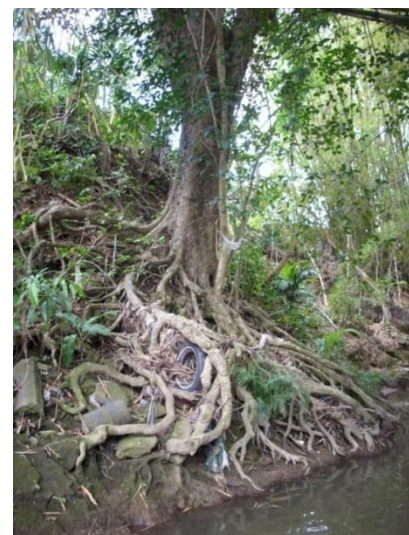
Figure 11: Indian Almond, Sparse Undergrowth, and Tire Debris of Zone 3

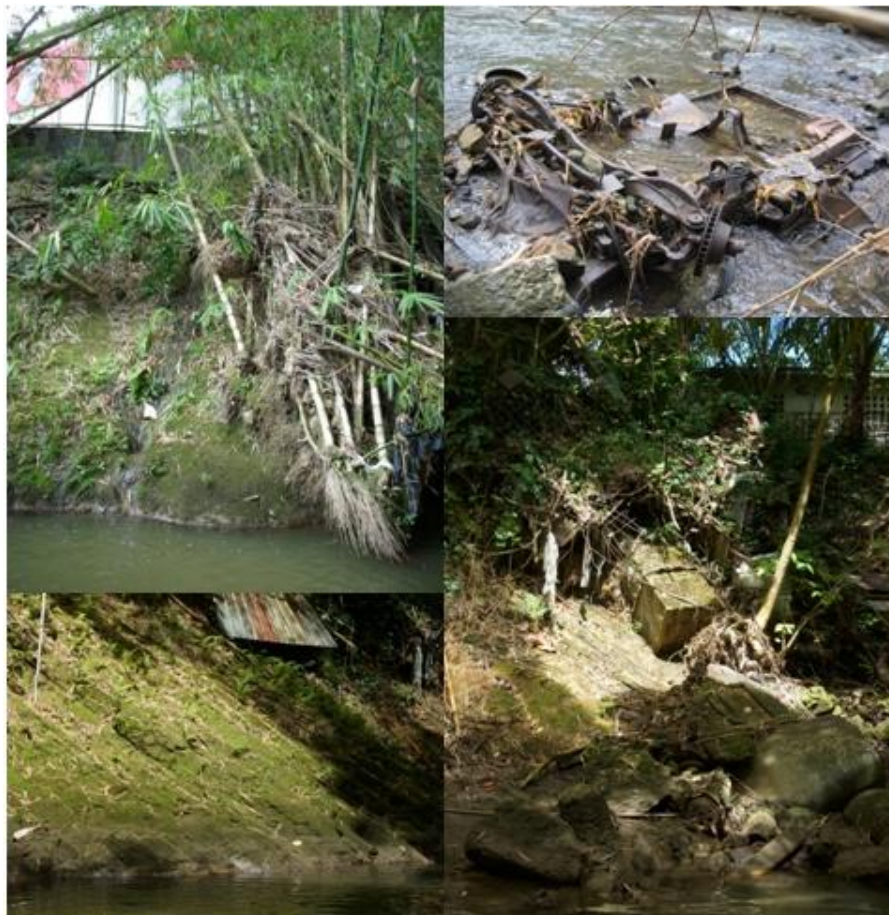
Figure 13: Features of Zone 4

the verge of falling into the river. The moss covered banks are very steep and house various sized rocks. This zone distinguishes itself because it accommodates Bamboo and is surrounded by numerous buildings. These features may be the cause of the severe erosion and urban dumping that also distinguish the zone. Recognizable features can be seen in Figure 14 and Figure 15.

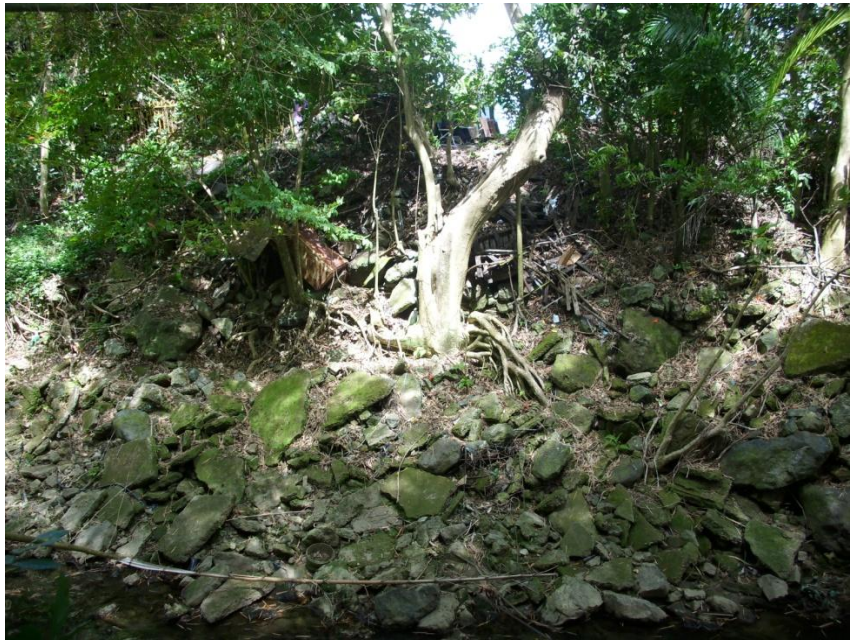
Figure 16: Zone 5 Rock Bank and Urban Development

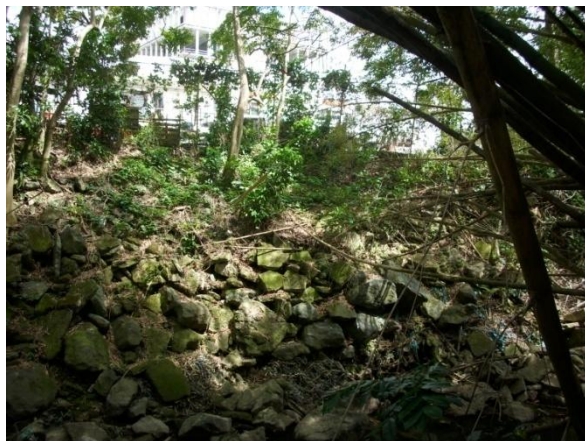
Figure 17: Rock Embankment of Zone 5

two rocks and displays a clay consistency and a density of 1.435 g/cm^3 . The hard packed clay displayed no roots or organic matter. This result demonstrates that the rock embankment damages the surrounding soil because the rocks create channels of fast moving runoff. These channels do not allow top soil to deposit. This combination of rocks and hard packed clay is unable to sustain life that will help the erosion problems.

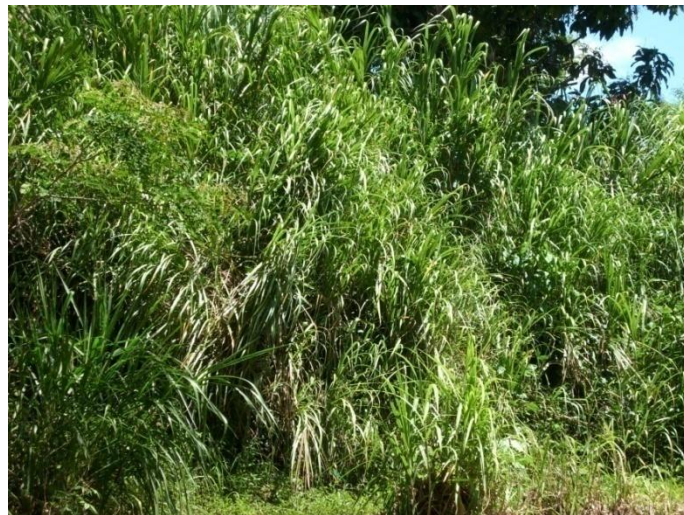
Figure 20: Excessive Elephant Grass of Zone 6

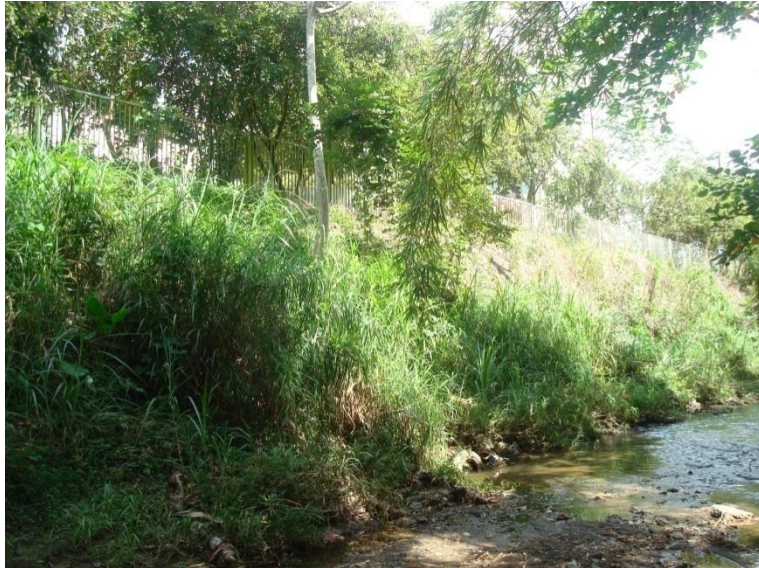
Figure 21: Fence and Thin Riparian Zone of Zone 6

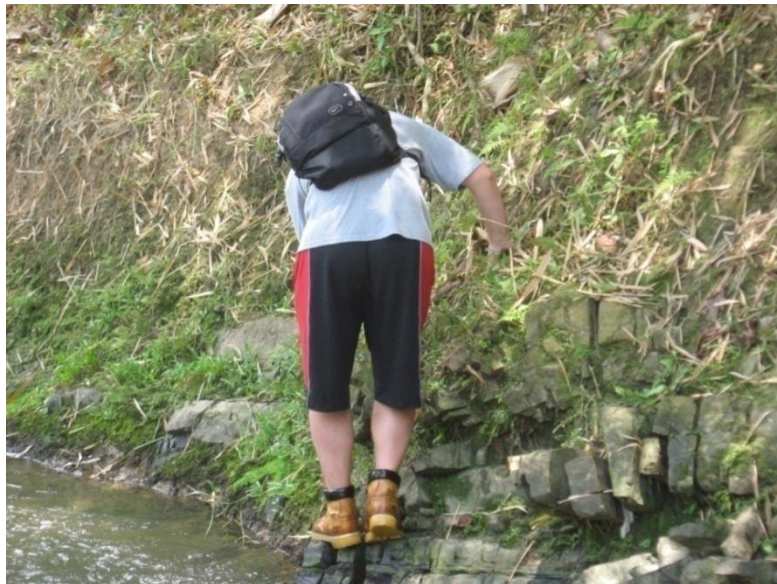
Figure 22: Extreme Grade near the Aqueduct of Zone 7

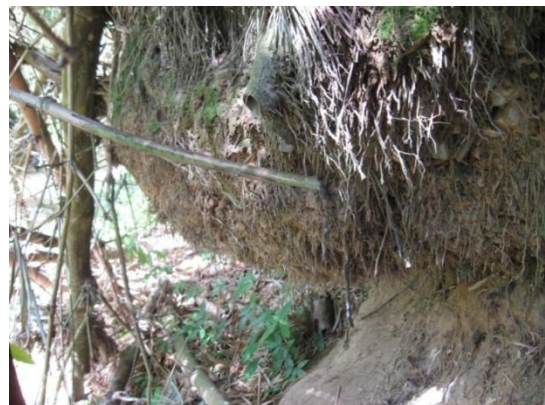
Figure 25: Erosion with Zone 9

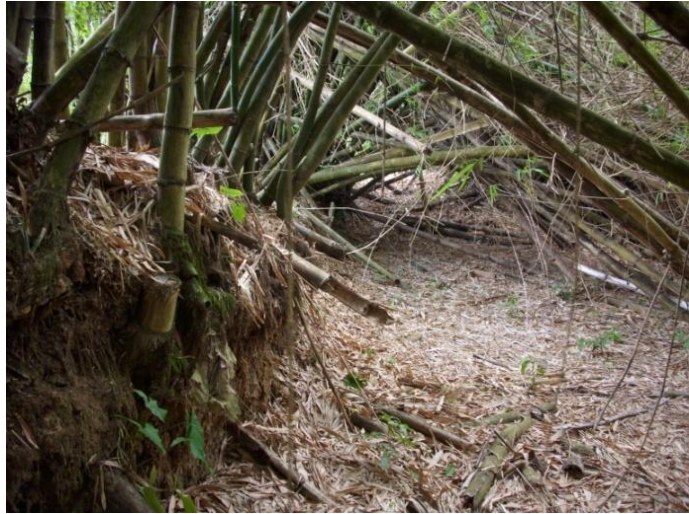
Figure 27: Falling, Dying, and Excessive Bamboo of Zone 10

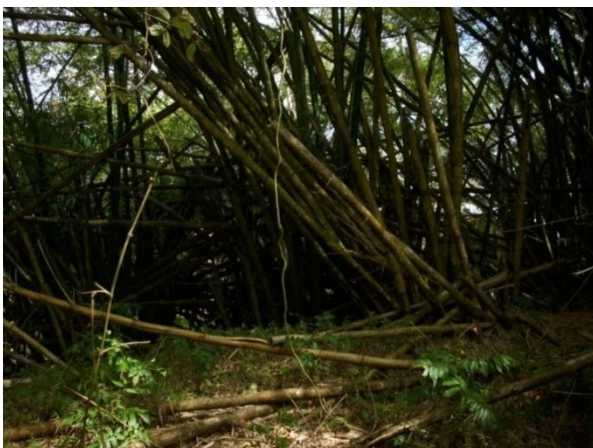
Figure 29: Bamboo Debris of Zone 11

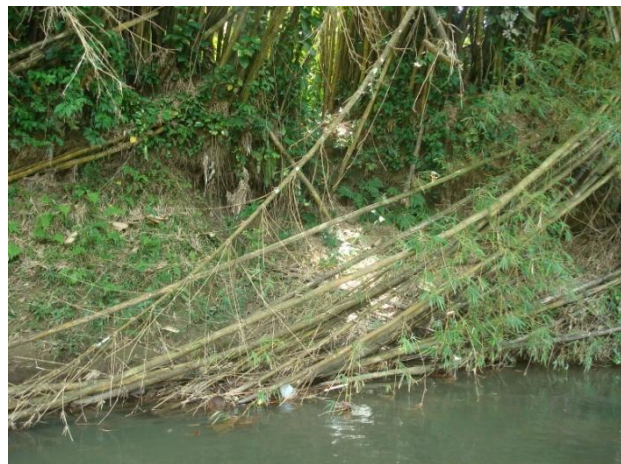
Figure 32: Fallen Debris of Zone 13
