Preserving Venetian Bell Towers Through Virtual Experiences

Documenting the Bells and Bell Towers 'de Ultra'

This project aimed to aid in the preservation of Venetian bell towers by updating Venice Project Center bell tower databases through documenting their state and creating virtual experiences. It was achieved by collecting extensive written, visual, and audio data of the towers and bells. A rotating camera was then used to create 3D virtual tours of the 17 bell towers and 71 bells documented in the sestieri of Dorsoduro, San Polo, and Santa Croce. Most towers and bells were in fair to good condition, with only three towers needing major repairs and two needing bell repairs. The resulting data was added to bells.veniceprojectcenter.org. Concurrently, a mobile data collection application was created to assist future groups and campanologists in recording consistent and comprehensive data.

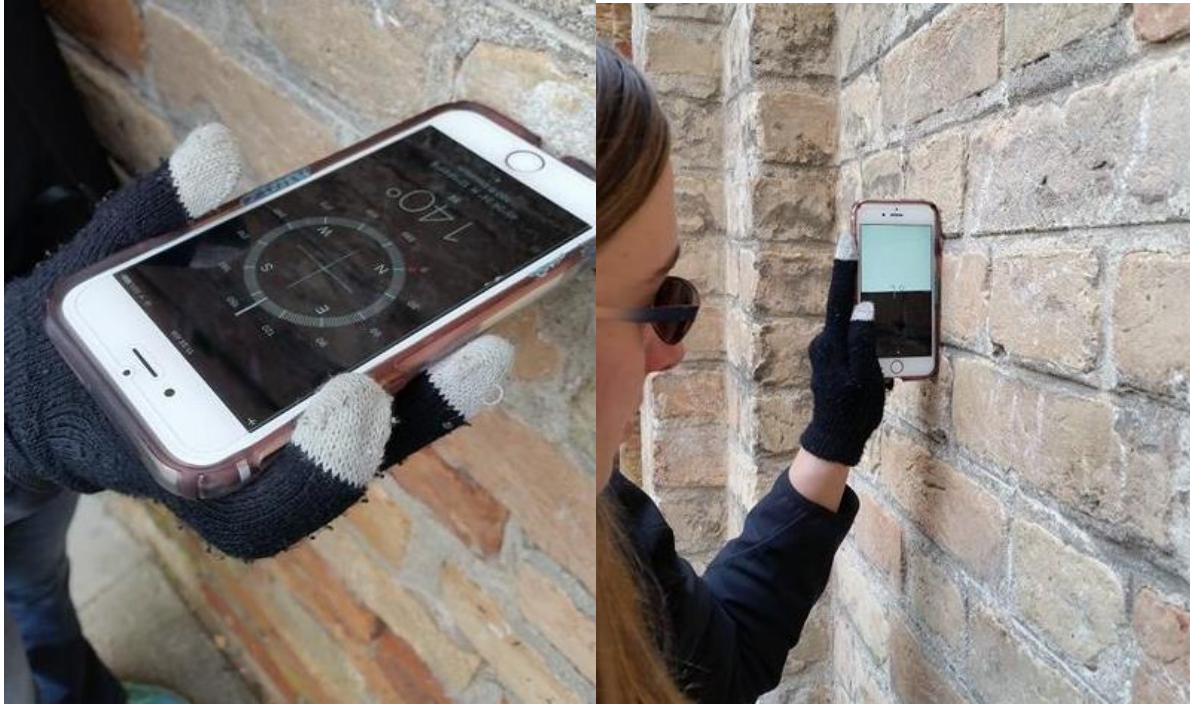
Figure 15 - Left: Measuring the Orientation of the Tower, Right: Measuring the inclination of the a tower

To measure the orientation and inclination of the bell tower, we used the compass application on our smartphones. For the orientation, we would put the bottom of the phone against the front wall of the tower and read the degrees displayed. To measure the inclination of the tower, we used the level application in the compass, put the side of the phone against the tower, and recorded the degrees. These two processes are show below in Figure 15

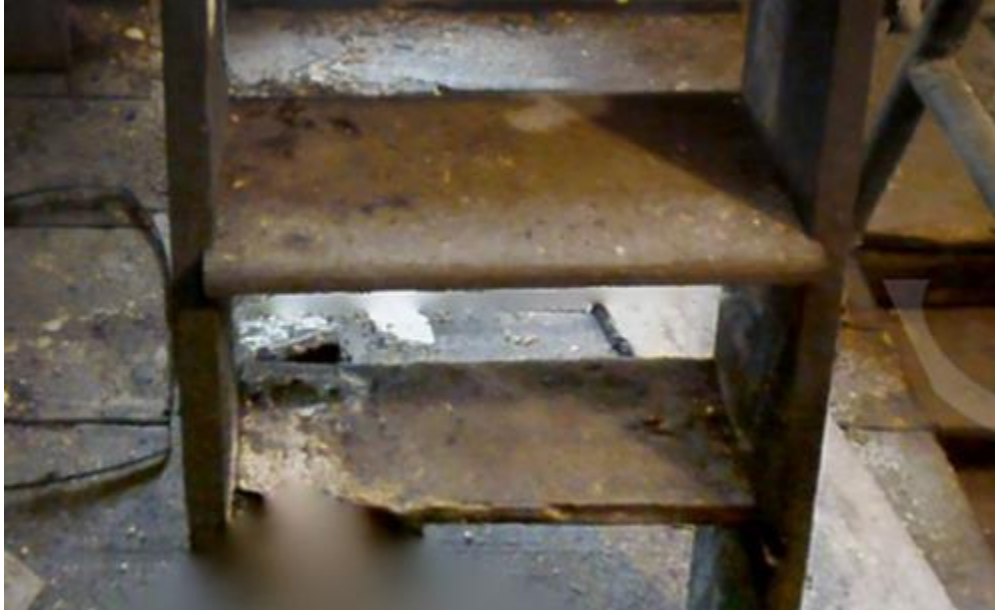
Figure 18 - Example of a bad step in Gesuati

The stairs in the shaft are one of the main safety concerns of the tower. As we ascended the tower, the number of bad steps were logged (example below in Figure 18) as well as the cleanliness and sturdiness of them. The number of stairs for each landing was how many stairs it took to reach the next landing. The sturdiness and cleanliness rankings were on a scale from 1 to 5, with 1 being the worst and 5 being the best. An example of a 1 Ranking and 4 Ranking are shown below in Figure 19. The presence of a railing and its sturdiness were also recorded.

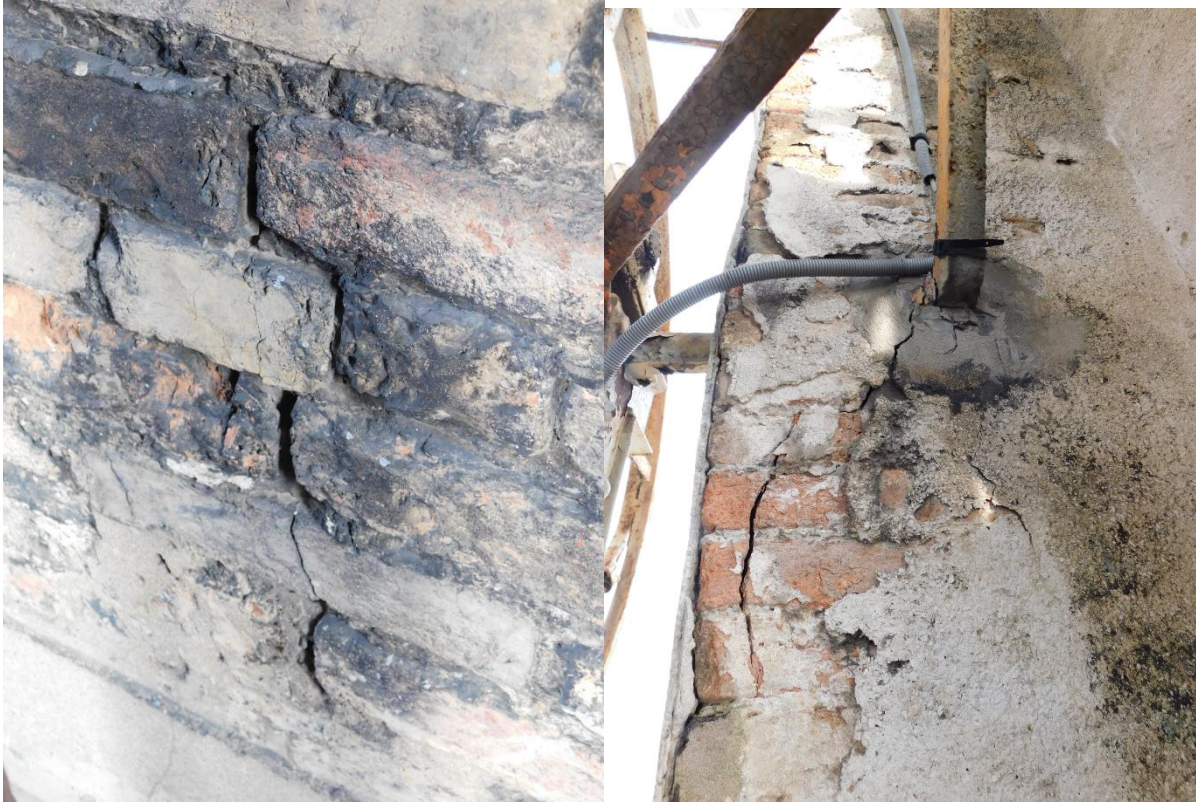
Figure 23 - Examples of an insignificant (left) vs. a significant (right) crack

Lastly, if there were any significant cracks in the walls, we documented their location and their size. A significant crack is a crack that goes through the middle of bricks rather than around the seams. As seen in Figure 23, the picture on the left shows an insignificant crack between the seams of the bricks and the picture on the right is a significant crack because it cuts bricks into two pieces. The benefit of documenting the size of the cracks is that it can be determined if the crack is getting worse in the future.
