Repairing and Repurposing the Foundouks of Rabat's Medina

Sponsor: Prefecture of Rabat

Abstract

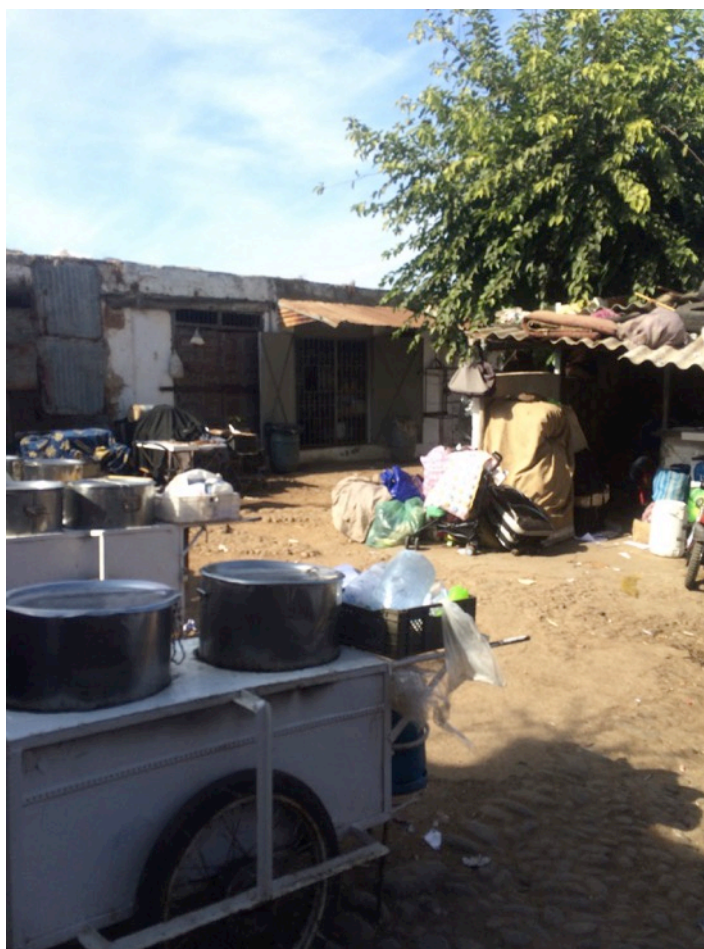
Figure 8. Foundouk in the Mellah

From our initial research and findings from visits to foundouks in Rabat, there seems to be three types of foundouks that are found in the medina. One of the types of foundouks is the classic style donut shaped two floor building, with all rooms facing a central, open courtyard. This building is the one that is most commonly found in both visits and research. The main features that distinguishes this type of foundouk is its large entranceways as well as the small evenly spaced rooms on the second floor which were used to house people and the larger rooms on the ground floor that were used to stable livestock. Usually, there are also pillars at separate the walkways outside of rooms from the open space and are used to support the second floor. These foundouks were used as stopping points for merchants and traders, but often times functioned as workshops and living corridors, especially in the medinas. All three of our project's foundouks fall into this

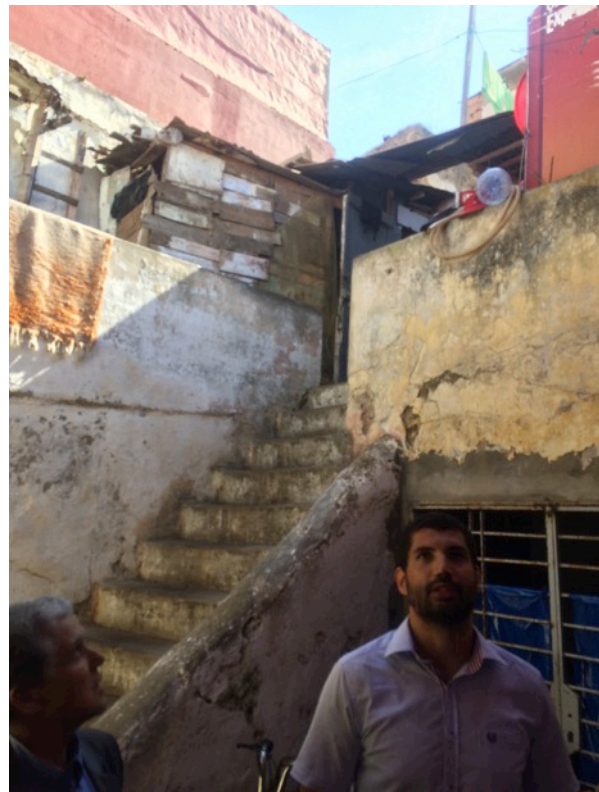
Figure 9. Foundouk Essaboun

The third type of foundouk is a residential space, that doesn't have the open courtyard the other two types have. It also doesn't have the donut shape that is typically associated with a foundouk. These foundouks have a small doorway that leads into the main courtyard. The courtyard in the foundouks that we saw was covered by a makeshift roof, but was originally open. These foundouks have two floors with the rooms organized more sporadically and not in the standard evenly sized and spaced manner of other foundouks.

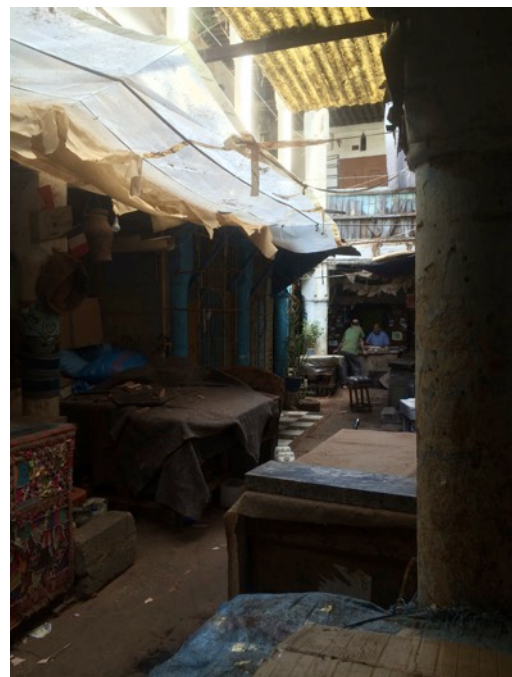
Figure 12: Set up of the foundouks. 33

Rue de Consults, the road the three foundouks are located on, is one of the main roads of the medina. More than that it is a prominent market road that has shops that sell all the various types of crafts you can find in the Medina, including pottery, clothes, rugs, leather goods, wood working, etc. What makes the

foundouks location on Rue de Consul different than other shops is that they are located down alleys off the road. These alleys that lead to the foundouks sell the items that the residents produce out front, along the road, to compete with the other shops on the road. The advantage that the foundouks have on Rue de Consults is that they have greater space after going down the alley and into the foundouks then the other shops on the road. This provides an opportunity for the foundouks, along with better marketing of the buildings, to have people come down the alleys into the foundouks and do their shopping there.

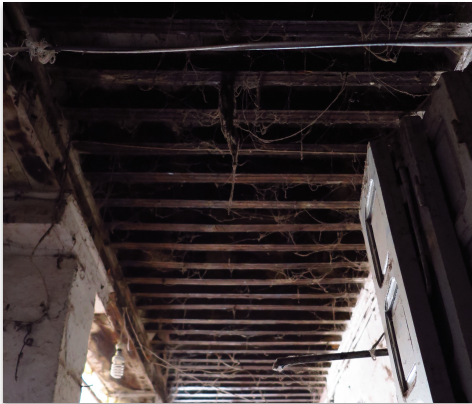
Figure 15. Roof of foundouk Al Khayatene

The qualities that lead to the categorization of the ceilings to be in disrepair or ruin are that they have started to slope and the supports around them are breaking.

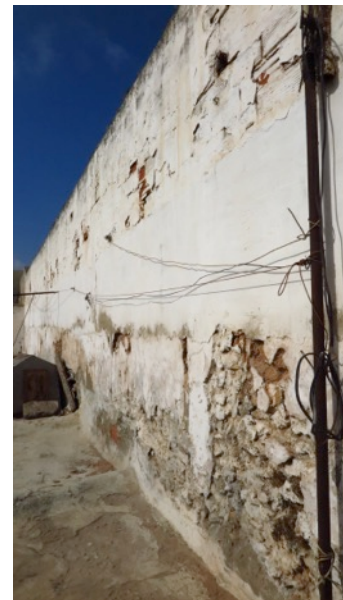
Figure 17. Wall of foundouk Jdilda

The quality of the walls is similarly in disrepair because of the chipped paint, prevalent cracks and water damage

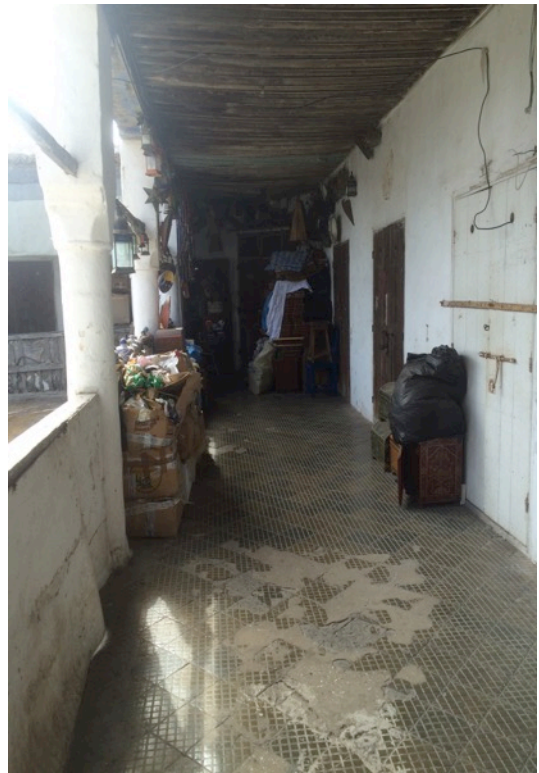
Figure 18. Floor of foundouk Jilda

The floors, while not completely in disrepair, have sections that are poor and therefore the whole floor should be replaced. The sections of the floor that are poor are cracked, damaged, or missing it's tiling all together. The floors are also quite uneven and slope off in sections, making it a hazard when walking

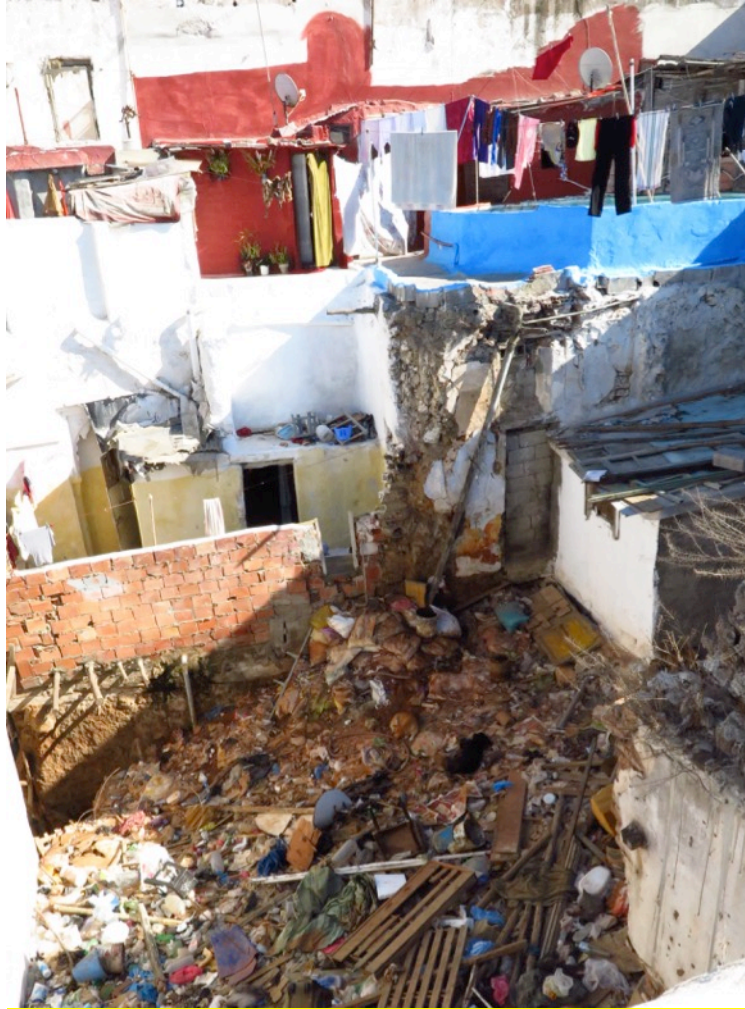
Figure 20. Collapsed Section of Ben Aissa

The second reason why foundouk Jdilda is in better condition is because it is used less than both Ben Aissa and Al Khayyatene. While Ben Aissa and Khayyatene use a majority of their shops to employ leather workers, cobblers, rug makers, etc, the shops at Ben Aissa only have a few shops open everyday. Part of this is the variable schedule to which some of the shop owners are open but the other major part of it is that many of the shops are not used. Also since a large portion of the 2nd floor of foundouk Jdilda is residential, it is hardly used to the level that the upper floors are in foundouk Ben Aissa and Al Khayyatene. There are also ruined and collapsed sections in foundouk Ben Aissa, figure 20, and not foundouk Jdilda, which instantly lend to the building being in better shape.

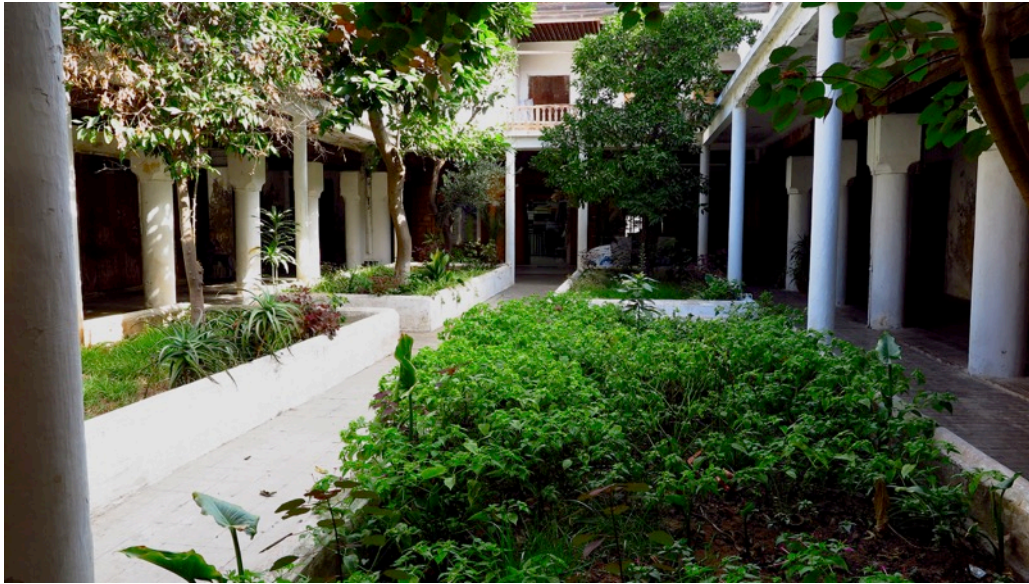
Figure 23 Courtyard of Foundouk Jdilda

In its current state the courtyard of Foundouk Jdilda is already quite appealing. It is split up into four different sections with walkways between them and fruit trees in each one of the sections. However, there is much potential for physical improvement. When our group visited Meknes there were gardens on the inside of the medina. These gardens gave you a welcoming view when you arrived and overall improved the aesthetic appeal of the courtyard. It was easy to tell that they were cared for on a daily basis and that there was a great amount of effort dedicated to their maintenance. If these same ideas were implemented into foundouk Jdilda it would make the courtyard feel more welcoming and encourage people to explore the foundouk. In order to do this it is necessary to implement major changes to the maintenance of the current plants as well as add new plants to put in alongside the old ones. In order to maintain the authenticity of the space and its historic nature, we suggest putting cactus or an herb such as fennel or mint into the flowerbeds.

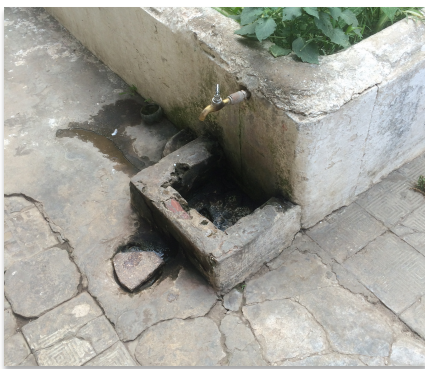
Figure 24: Spigot before

The upkeep of the physical state of the courtyard is also a main concern when addressing the needs of the courtyard. Currently the tiles in the courtyard, as well as the spigot, are in disrepair. The tiles are broken or completely missing in sections and the spigot has since lost its physical appeal and traditional design. When we visited Meknes our group was first drawn to the beautiful fountains that were in the squares. The spigot in Jdilda is not a fountain but should follow the design of the fountains in Meknes. In

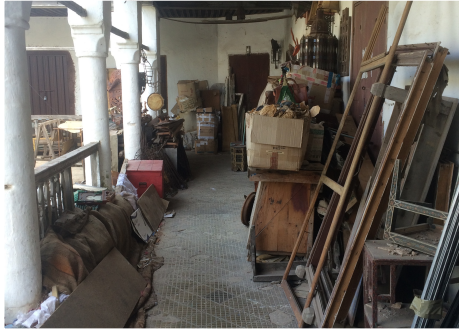
Figure 29 Hallway on second floor of foundouk Jdilda

The 2nd floor of foundouk Jdilda currently has several uses. On the right side after you come up the stairs there are three shops that are regularly open. The hallway is currently used as storage for personal items because the previous room they had stored it in has collapsed. To the left of the steps there are seven rooms, three of which are currently being used as housing. The idea for the renovation of this floor is to keep its use the same, but work to renovate and restore the space. There are two steps that are needed in order to accomplish our goal for this floor. The first one is a general organization of the shops. Currently there are many personal items that are clogging the main walkway and making the general setting look less

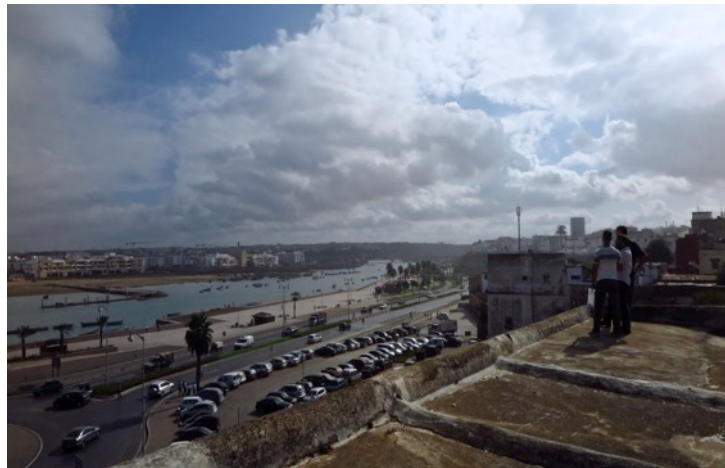
Figure 32 View off the roof of foundouk Jdilda

Jdilda is the area of the foundouk that is being used utilized the least. Figure 32 shows the view from the roof of Foundouk Jdilda. As discussed in section 4.4, there are a few rooms close to the

Rue de Consults which are inhabited, but other than that the rest of the roof is left unused. We have developed two different ideas for this floor, both of which take into account the people living in the rooms and the amount of money available to the Prefecture.

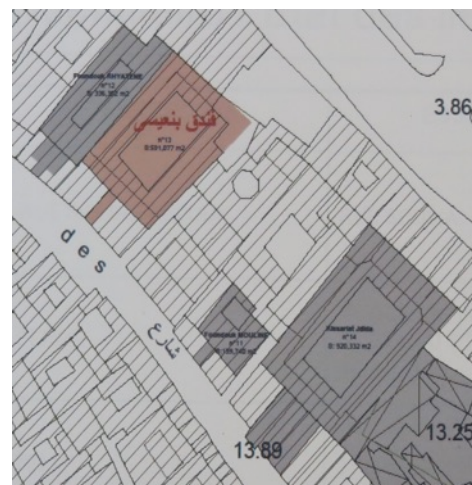
Figure 34: Location of foundouk Jdilda in relation to foundouk Ben Aissa/AL Khayyatene

The three foundouks we have chosen lend themselves perfectly to collaboration. In the findings section 4.4 we detailed that foundouk Ben Aissa and foundouk Al Khayyatene are connected via the roof and are also located only a few shops down the street

from foundouk Jdilda. This means that it would be easy for the three foundouks to work as a single productive unit. Figure 34 shows the location of the three foundouks on Rue de Consults.

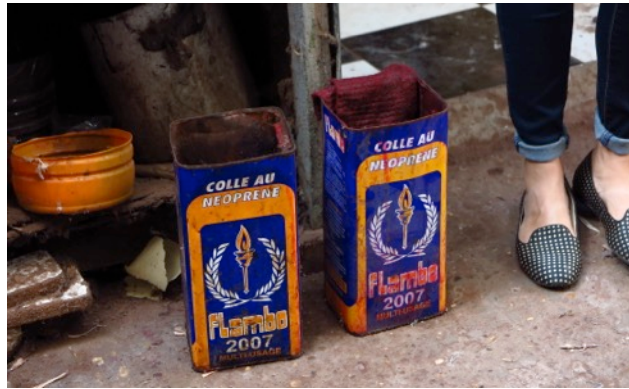
Figure 36 Coloring Vats in foundouk Ben Aissa

Despite how much of the production process each resident can perform, there are still some organization issues that slow down the process. For example, the leather that has already been cut is colored on the first floor must be carried up to the 3rd floor to dry, taking time away from that person. An alternate approach to this method would be to move the coloring vats to the 3rd floor, which will save them the time that it takes to carry the leather upstairs. It will also help the flow of the building as they can bring it down just one level to get it cut and pressed.

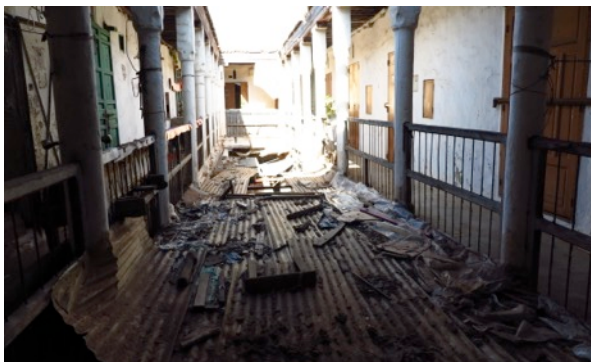
Figure 37 First Floor roof of Ben Aissa

These issues exist in all three of the foundouks that we are working with, and if they are not addressed they will eventually lead to the deterioration of the foundouks to “Ruined” state. (Appendix A)

As a result of this, a few years ago there was a large concrete cover built. It was erected in the front of the foundouk where the plastic roof was leaking, but now it is starting to break. In order to fix this, our suggestion is to completely remove both

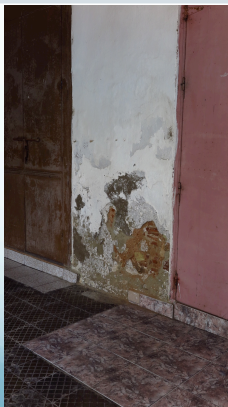
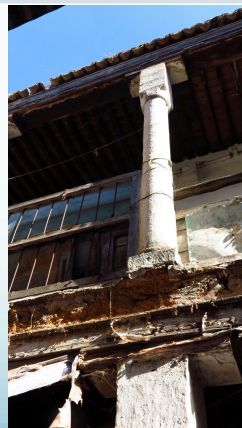
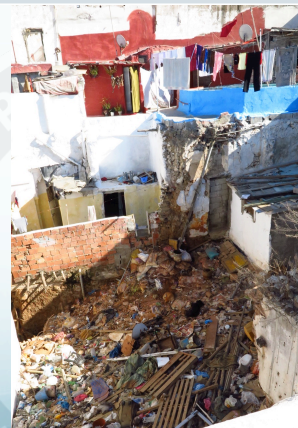
Physical State

<u>Jdilda</u>	<u>Al Khayyatene</u>	<u>Ben Aissa</u>
Livable/Renovated	Dilapidated	Ruined/Collapsed

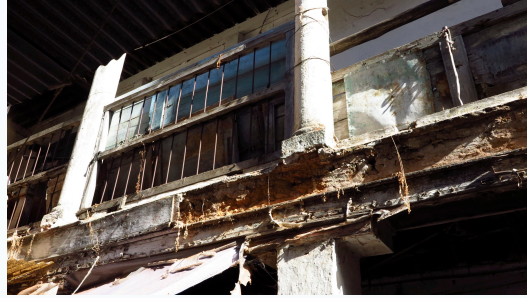
- Cosmetic Issues

- Chipped paint
- Broken tiles
- Broken railings
- Destroyed stairs
- Damaged wood

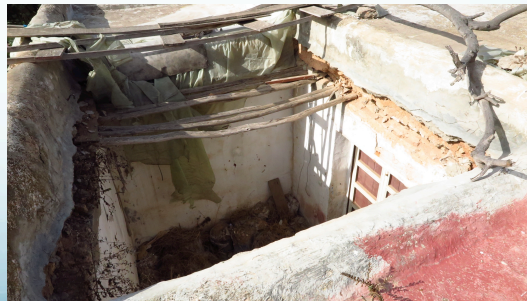
- Major Flaws

- Collapsed rooms/walls
- Unusable utilities
- Poorly reinforced roofs
- Water damaged floors

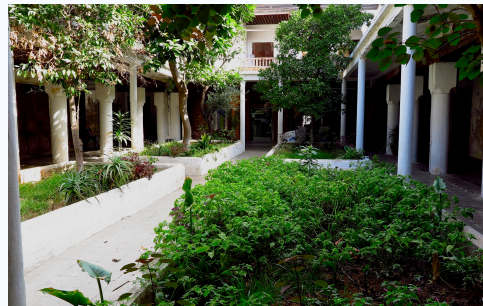
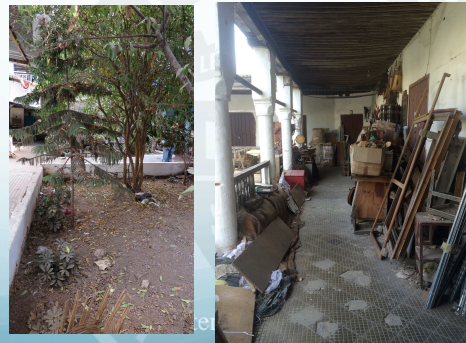
Organizational Issues Observed in All Foundouks

- Poor waste management
- Badly maintained flowerbeds
- Personal items not contained
- Broken areas used for trash disposal

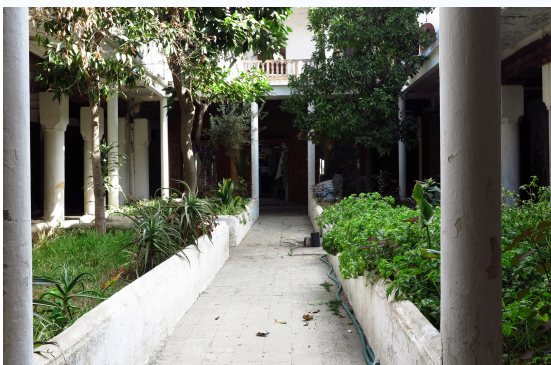
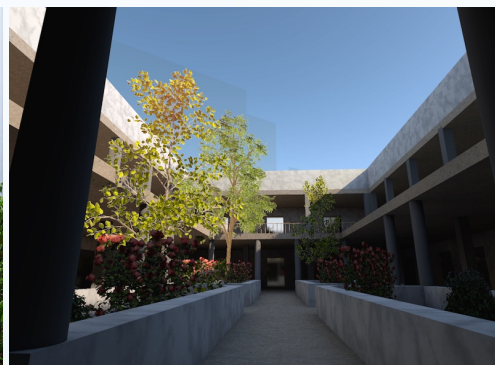
Courtyard Renovation

Before

After

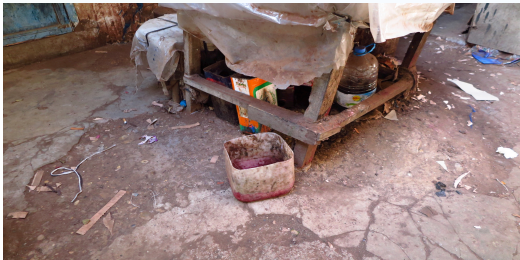
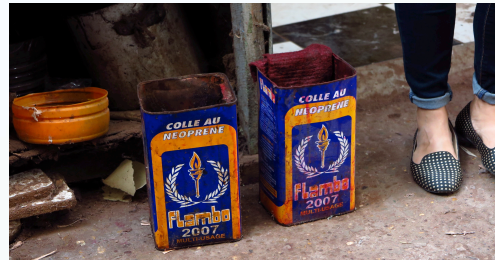
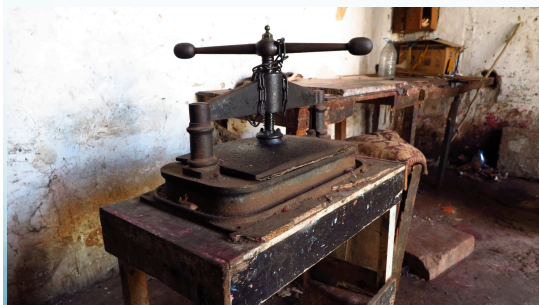
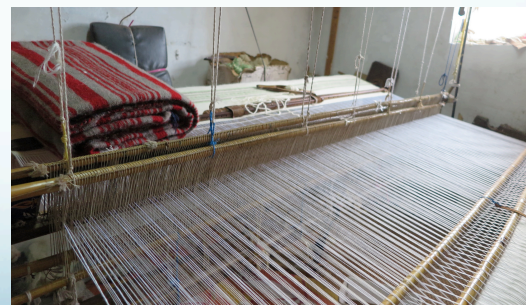
Renovations

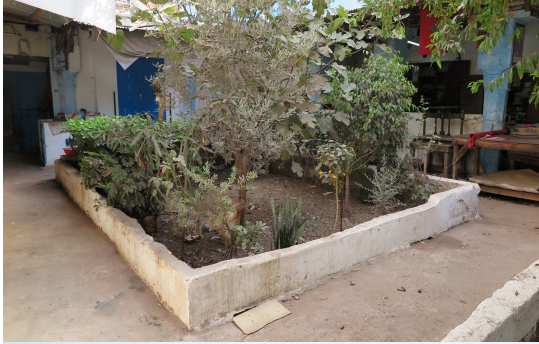
Before

Renovations

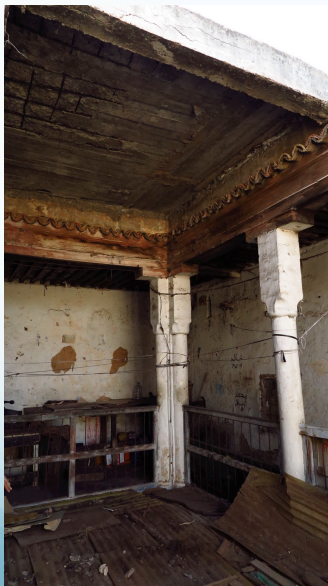
Before

Renovations
