Evaluating the Initial Service Line Inventory and Replacement Plan Processes

A Major Qualifying Project
Submitted to the Faculty of
Worcester Polytechnic Institute
In partial fulfillment of the requirements for the
Degree of Bachelor of Science in
Environmental Engineering and Civil Engineering.

March 1, 2024

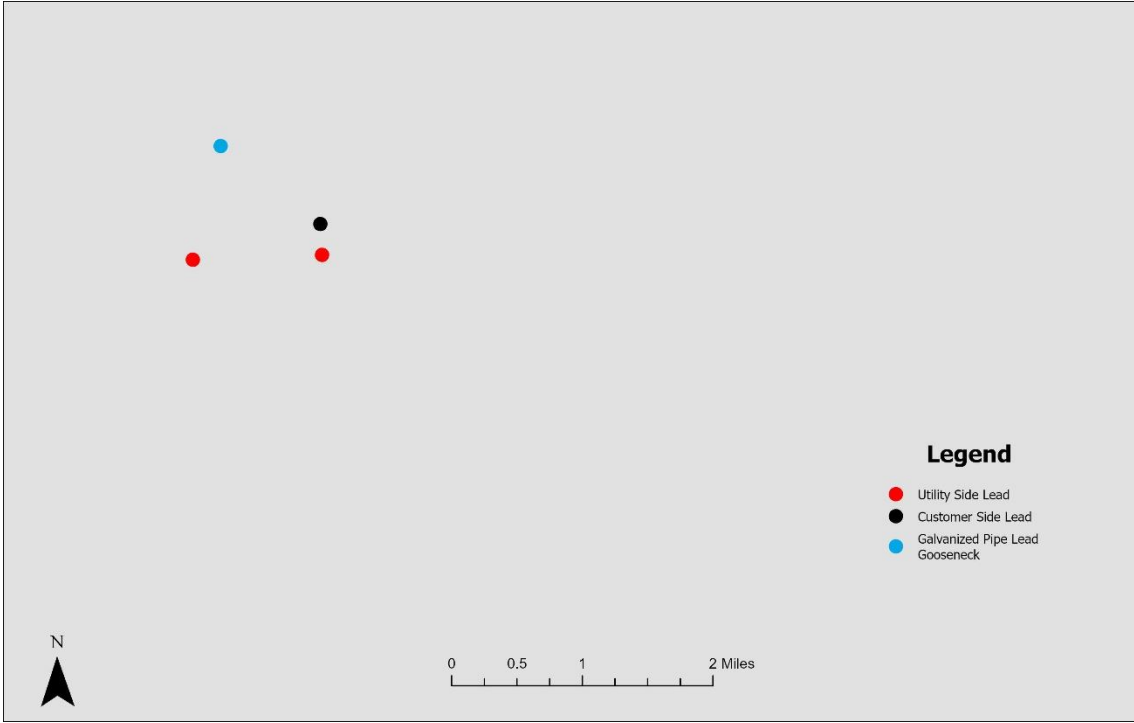
Figure 14. Locations where the use of lead service lines or connectors has been confirmed

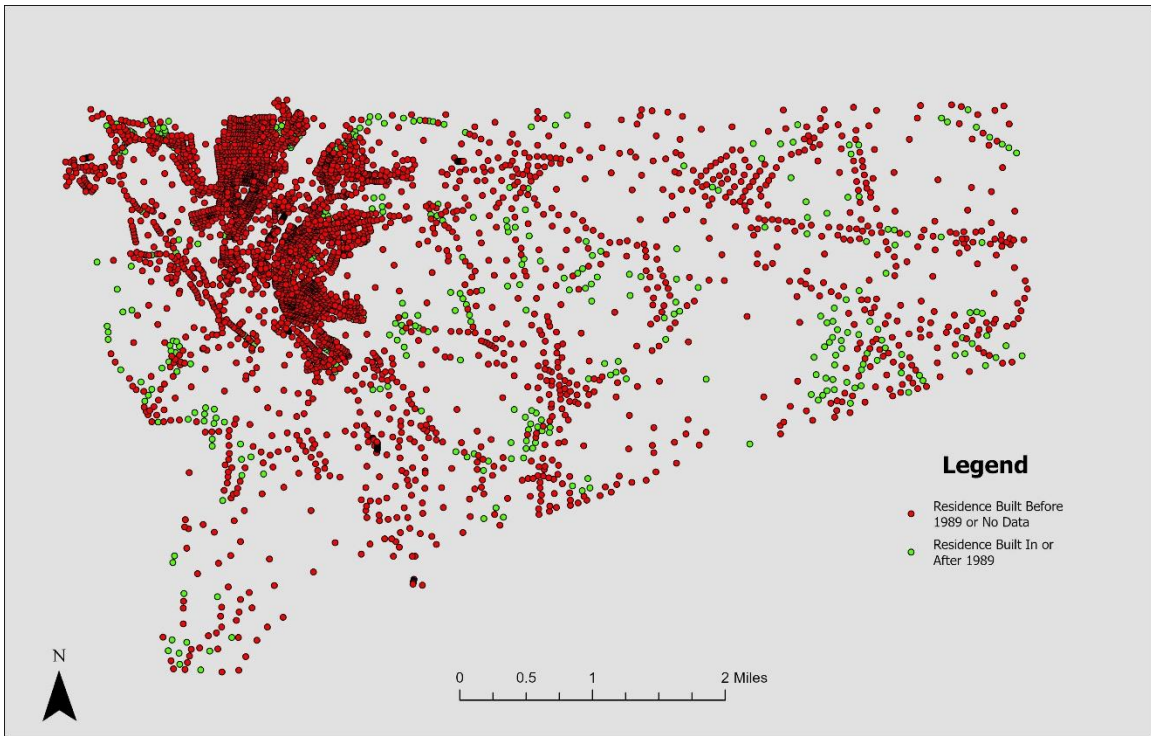
Figure 15. Residences by year of construction

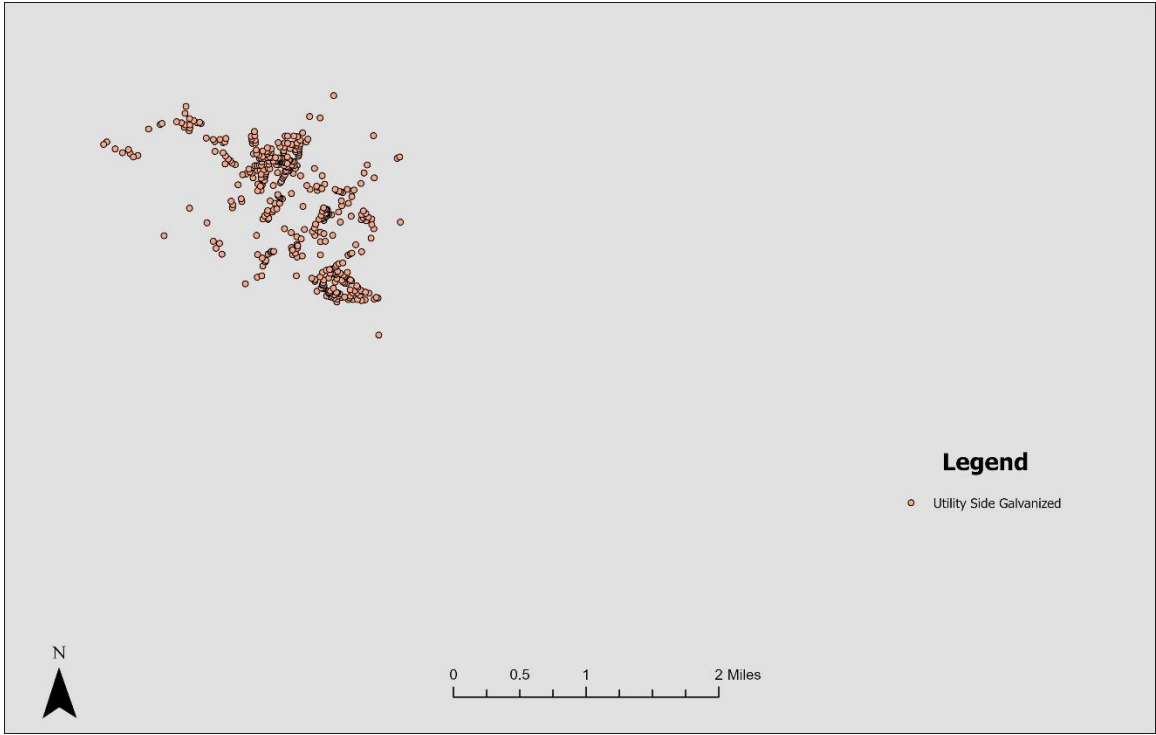
Figure 17. Locations where the utility side of a service line has been confirmed as galvanized

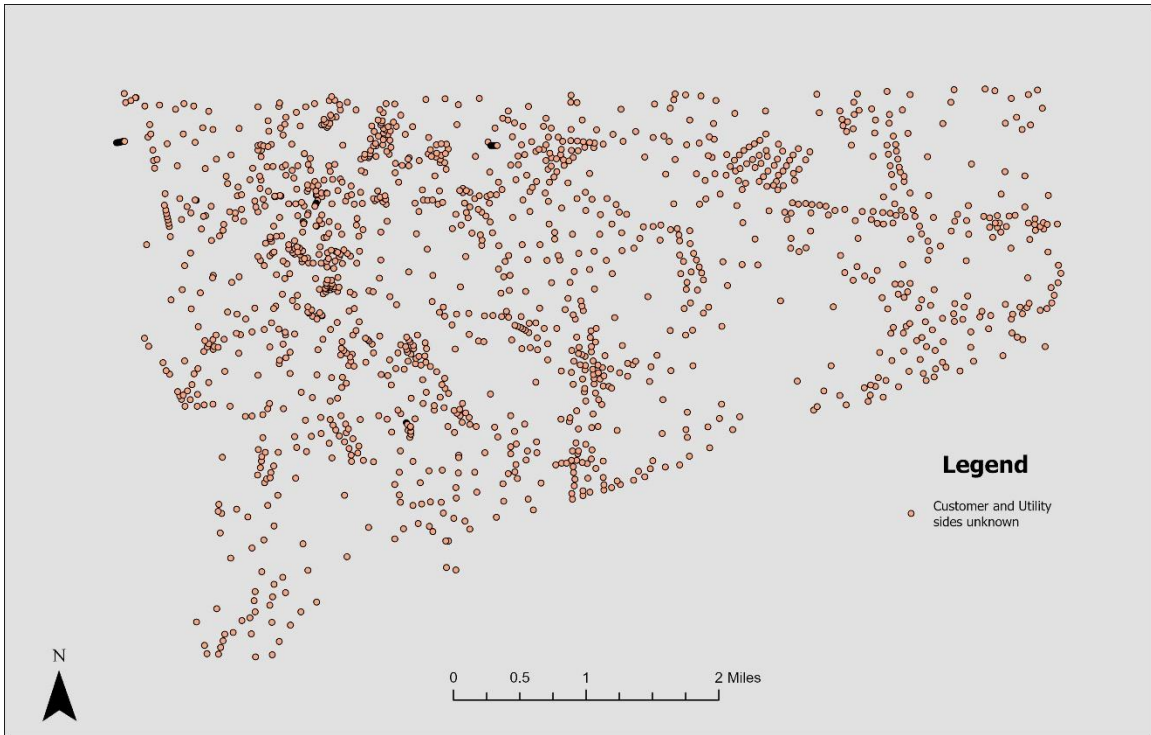
Figure 26. Locations where the customer and utility side service line material are both unknown
