**DESIGN GUIDELINES FOR THE USE OF CURBS AND CURB/GUARDRAIL
COMBINATIONS ALONG HIGH-SPEED ROADWAYS**

A Dissertation

WORCESTER POLYTECHNIC INSTITUTE

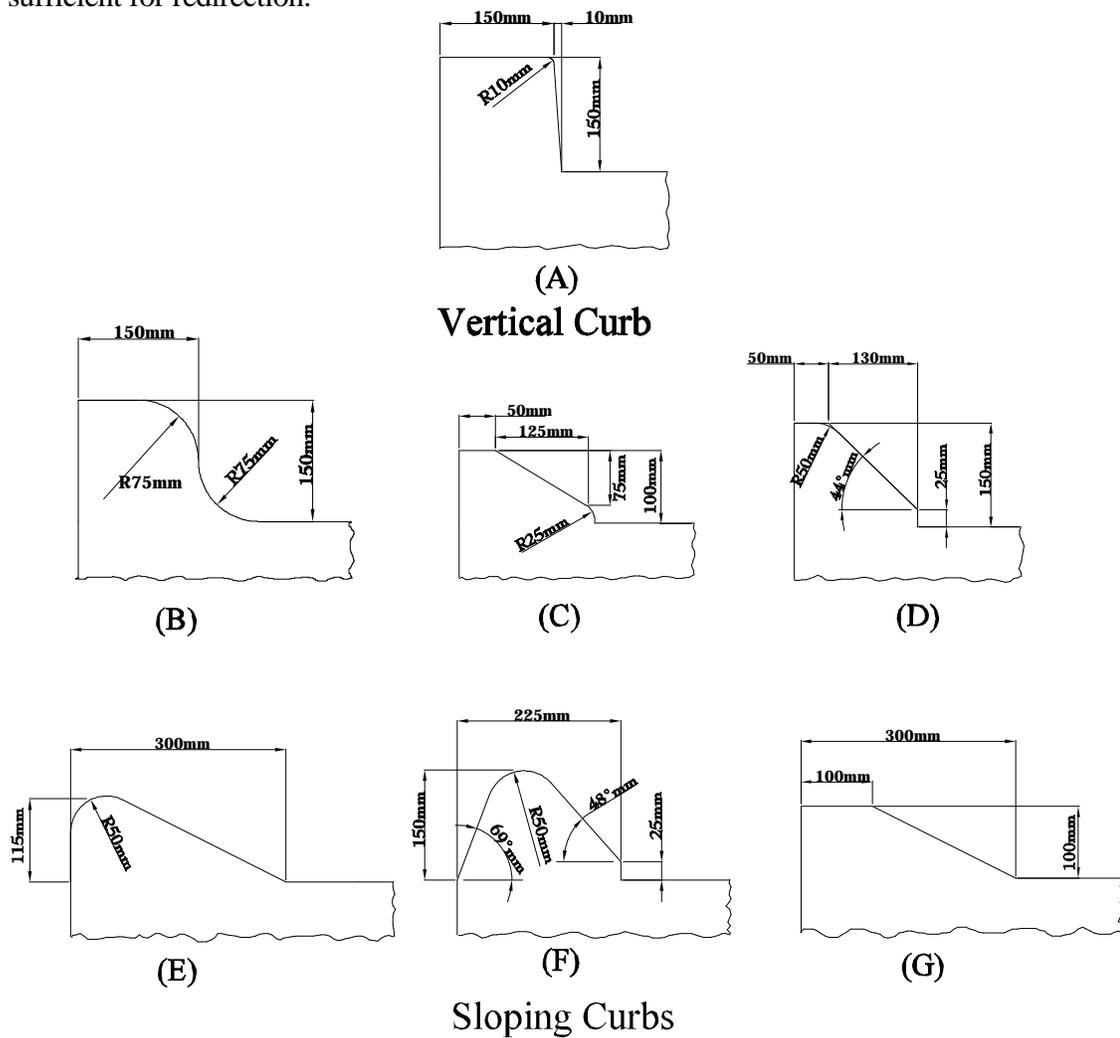
Figure 1.1: Typical AASHTO Highway Curbs (1)

Sloping curbs, as illustrated in Figure 1.1, have a sloped face and are configured such that a vehicle can ride up and over the curb. These curbs are designed so that they do not significantly redirect a vehicle. They are usually used in situations where redirecting a possibly damaged and out-of-control vehicle back into the traffic stream is undesirable. Sloping curbs are often used primarily for drainage purposes but are also used on median islands and along shoulders of higher speed roadways for delineation and other reasons. Sloping curbs provide drainage control while also allowing vehicles access to the roadside in emergency situations.

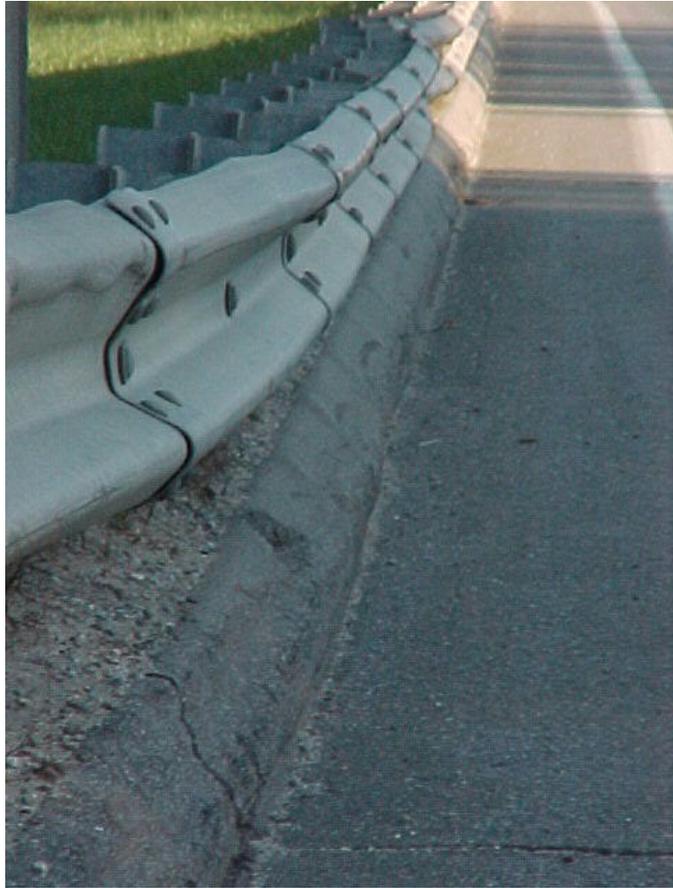
Figure 1.2: Sloping curb installed flush with a strong-post w-beam guardrail on a 90 km/hr two-lane rural roadway in Maine.

Another similar situation occurs on roadways where a guardrail is needed to shield a steep roadside slope as shown in Figure 1.2. Figure 1.2 shows a 100-mm high sloped face asphalt curb installed just in front of the posts of a G4(1S) W-beam guardrail. The site is

a 90 km/hr rural two-lane roadway in Maine. The curb is placed at this site to provide drainage away from the steep side slope behind the guardrail and thereby prevents erosion. The erosion would likely weaken the edge of the road, erode the soil from around the guardrail posts and cause slope stability problems. The curb is therefore necessary for proper drainage. Likewise, the guardrail is necessary for shielding errant motorists from the steep embankment. In such a

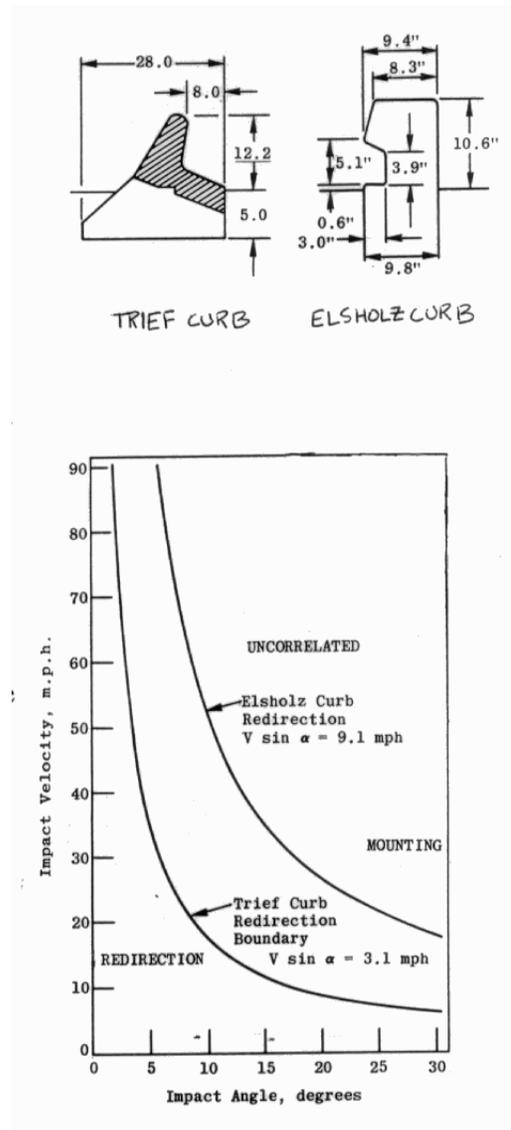
Figure 2.1: Curb performance characteristics of the Trief and Elsholz curbs (10)

Most analytical work regarding vehicle impact into curbs have been concerned with either redirection capabilities of vertical face curbs or their potential to cause rollover. If the impact speed and angle are plotted on a graph and different symbols used to denote redirection and mounting, then a curve like Figure 2.1 can be developed. Figure 2.1 shows the characteristics of two particular experimental curbs, the Trief and Elsholz curbs. (10)(11) The line describes the boundary between redirective behavior and mounting behavior. Combinations of impact speed and angle falling to the left of the curve would result in redirection, and those falling to the right would result in mounting the curb.

where V is the impact velocity and α is the impact angle. In essence, this expression indicates that a given curb will redirect the vehicle when the lateral component of the impact velocity is less than some characteristic value. Dunlap found that the characteristic lateral component of velocity for the Trief curb was 5 km/hr and for the Elsholz curb was 14.6 km/hr; thus, the Elsholz curb was more effective at redirecting vehicles than the Trief curb.(12)

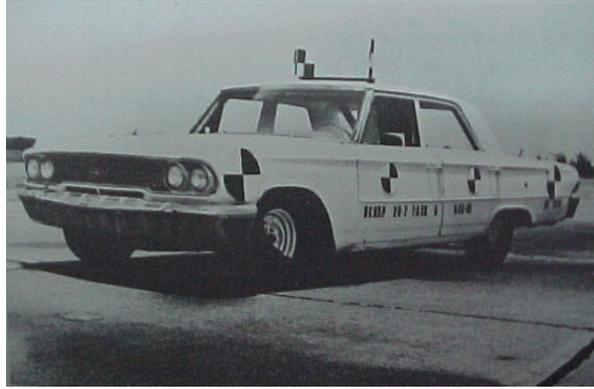
Figure 2.2: Vehicle used in Olsen *et al* study (22)

The test vehicle used in their study was a 1963 Ford four-door sedan with heavy-duty suspension. The vehicle's mass was 1905 kg, and the center of gravity of the vehicle was 610 mm above ground. The test vehicle is shown in Figure 2.2. Olsen *et al.* found that AASHTO types B, D and G curbs, which are sloping curbs 150 mm or less in height, provide no redirection for a large passenger vehicle, such as a 1900-kg sedan, traveling at speeds greater than 72 km/hr at encroachment angles greater than 5 degrees. They also

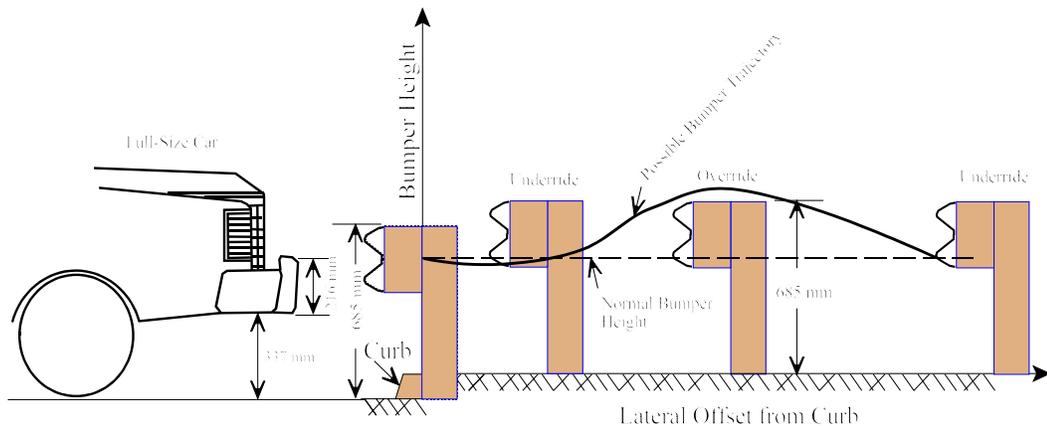
Figure 2.3: Possible trajectory of vehicle bumper relative to typical guardrail height

found that type B and D curbs can produce, under certain speed and encroachment angles, vehicle ramping high enough to allow the bumper height to equal or exceed the height of a typical guardrail, as illustrated in Figure 2.3.

Curbs that are 150 mm high and set in front of a 685-mm w-beam guardrail at a 0.61 m lateral offset may result in the vehicle impacting the guardrail at a point below the lower edge of the rail and cause snagging, as shown in Figure 2.3. During impact with the 150-mm curbs, the bumper would dip down slightly and then began to rise as the vehicle crossed the curb. If the angle of impact is such that the bumper is close to the guardrail before the wheel impacts the curb, then the dipping event would cause the bumper to impact the guardrail just below the w-beam rail. Note that the lower edge of the guardrail is 533 mm above the pavement surface due to the 150 mm elevation of the curb; whereas, the lower edge of the rail is only 381 mm above ground level in normal configuration. An initial dipping motion of the bumper was not evident during impact with the type G curb, and the bumper contacted the guardrail on the face of the w-beam in all impact cases.

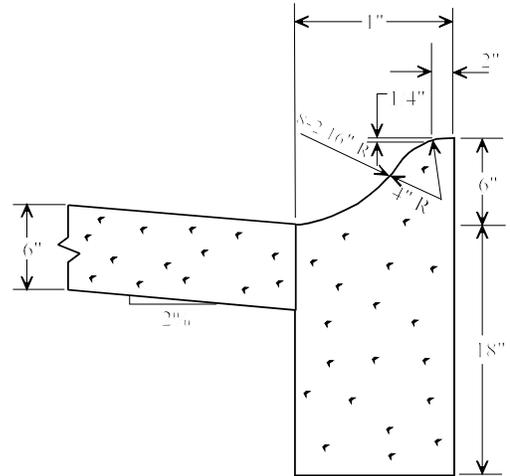
Figure 2.4: AASHTO Type I Curb

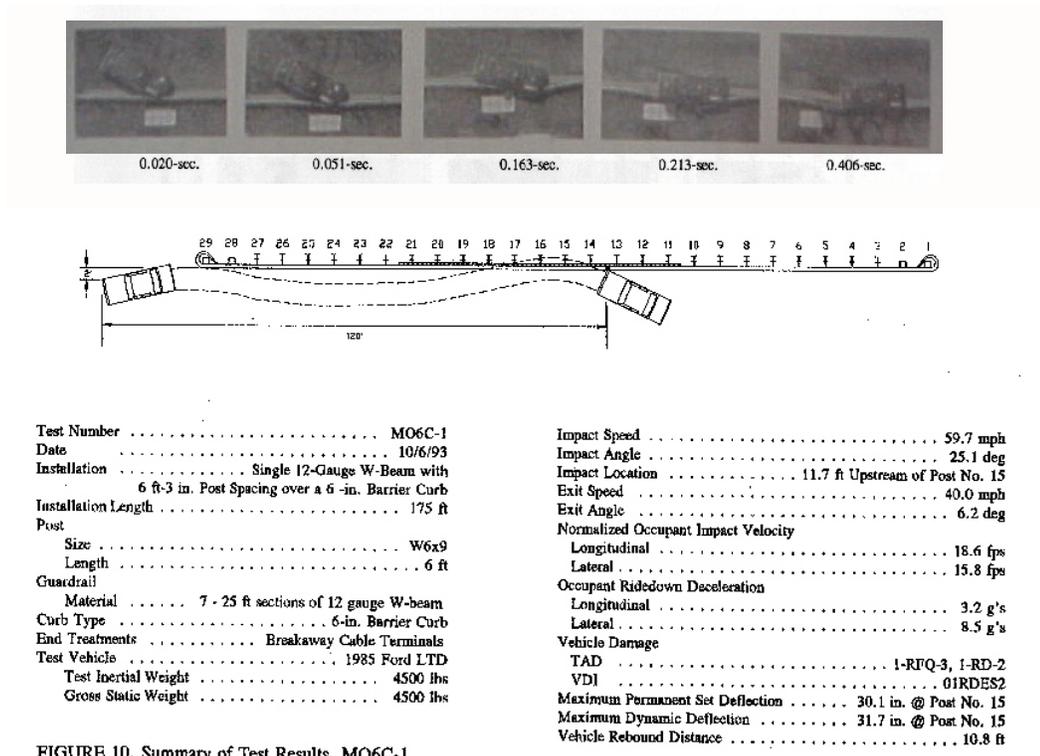
Figure 2.5: Summary of Test Results for MwRSF Test M06C-1 (26)

A study was conducted by Holloway and other researchers at Midwest Roadside Safety Facility at the University of Nebraska-Lincoln that involved a full-scale crash test on Missouri's 150-mm vertical curb placed behind the face of a strong post w-beam guardrail (i.e., G4(1S)). Missouri's 150-mm vertical curb is very similar to the AASHTO type B curb, except that the Missouri vertical curb is on a flat grade and has very little rounding on the top and bottom edge of the curb. The impact conditions for the test was in accordance with NCHRP Report 230 specifications; a 2043-kg test vehicle (1985 Ford LTD) impacted the system at 96 km/hr at 25.1 degrees. The center of gravity of the test vehicle was 597 mm above ground. A summary of test M06C-1 is shown in Figure 2.5.

During the test, the right front tire contacted the curb 20 milliseconds after initial contact with the guardrail, and mounted the curb soon after. The maximum roll angle was negative 14 degrees (the roll angle was away from the system). The vehicle exited the rail at 706 milliseconds at a speed of 64 km/hr and an angle of 6.2-degrees. Vehicle decelerations and trajectory were well within the recommended limits of NCHRP Report 230. As a result of the test, they concluded that the system performed satisfactorily and the Missouri Department of Transportation should continue to use the guardrail-curb system where warranted.

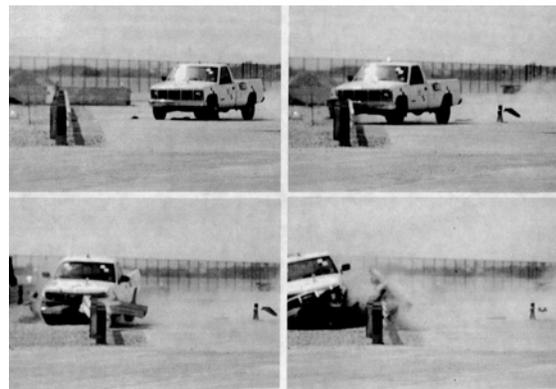
Figure 2.6: Sequential video frames from test NEC-1. (29)

with impact conditions recommended in NCHRP Report 350 test Level 3, which involves a 2,000-kg pickup truck (1991 GMC 2500) impacting at a speed of 100 km/hr at an impact angle of 25 degrees. (2.12) Sequential

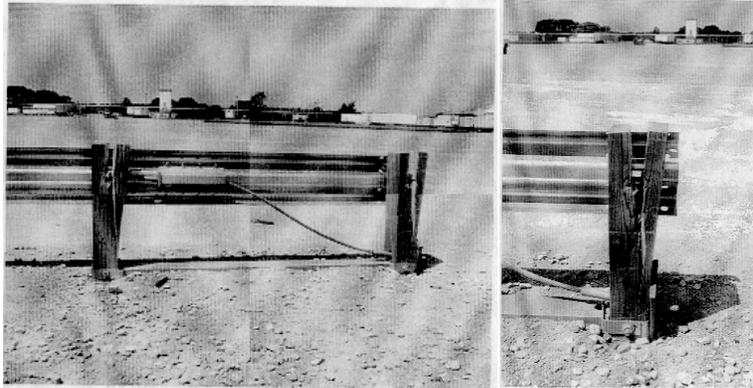
Figure 2.7: Guardrail terminal damage during test NEC-1.
(29)

posts split during the collision, as shown in Figure 2.7, and there was a loss of tension in the w-beam, which resulted in pocketing and rupture of the w-beam rail at a splice connection. The splice failure was attributed to contact and snagging of the post breakout against the w-beam rail splice. The post twisted as it was pushed back in the soil, causing the bottom corner of the breakout to push up against the corner of the w-beam rail splice. This resulted in a tear in the w-beam at the lower downstream bolt location. It was suggested that the guardrail-curb combination could be significantly improved by increasing the capacity of the w-beam rail.

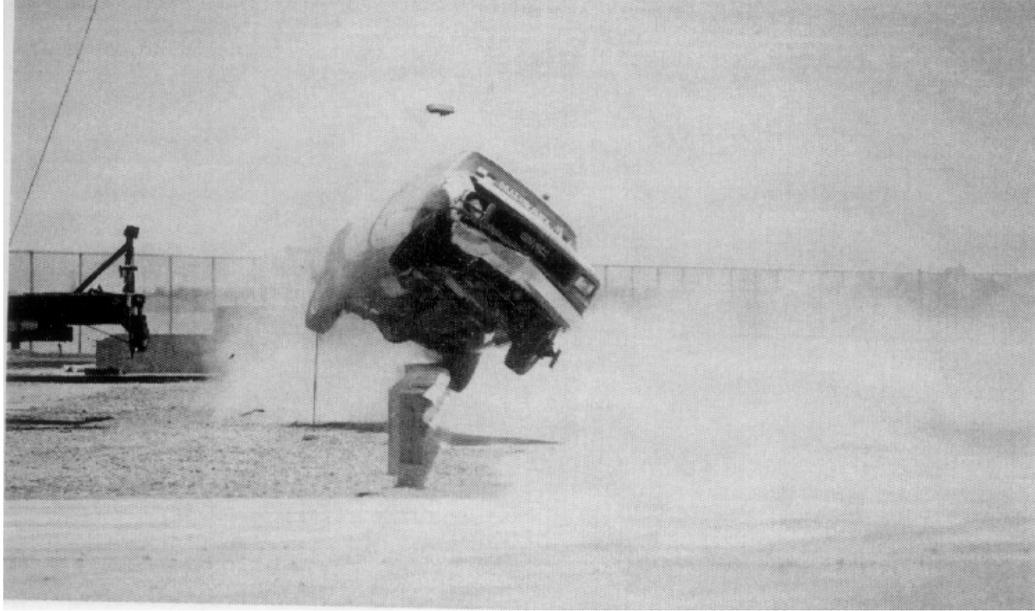
Figure 2.8: NCHRP Report 350 Test 3-11 impact with modified G4(1S) guardrail with nested 12-gauge w-beams and a 102-mm curb under the rail. (30)

The test installation was a modified G4(1S) guardrail with routed wood blockouts. In order to reduce the potential for rupture of the rail, two layers of 12-gauge w-beam were nested over a 26.67-m section of the guardrail. This modification was incorporated based on the results of test NEC-1, conducted in the first phase of the study, in which a splice rupture occurred during impact. The total length of the guardrail was 53.34 m, including an inline breakaway cable terminal located at both ends of the system.

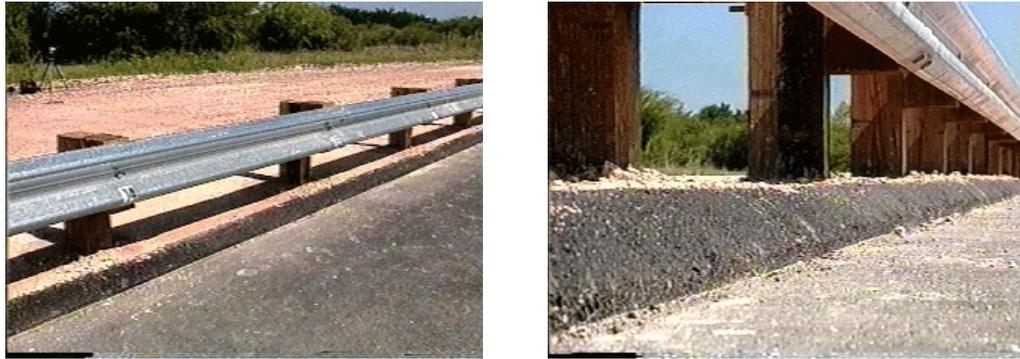
Figure 2.10: Guardrail/curb installation for TTI test 404201-1.(32)

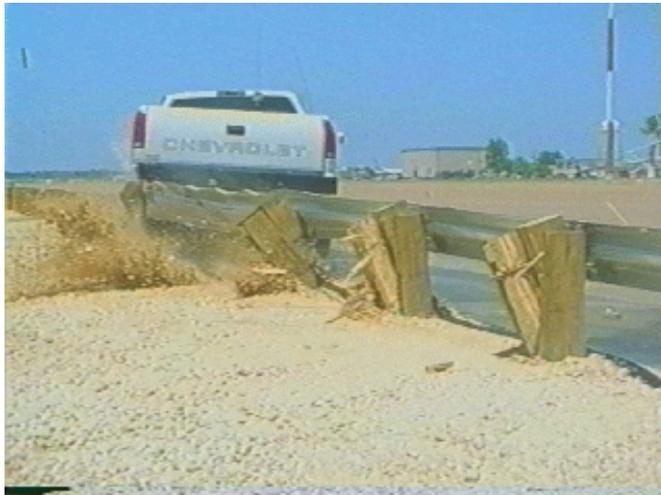
Figure 2.11: Guardrail damage in test TTI 404201-1.
(32)

During the test, there was significant movement of the anchor system as the foundation of the anchor posts moved in excess of 70 mm. The test was successful; however, there was considerable damage to the guardrail system, as shown in Figure 2.11. The extent of damage to the system was much greater than that of previous crash tests on the G4(2W) guardrail system without a curb present.⁽³⁹⁾ From reviewing the film from the crash test and the test report, it is believed that the excessive damage to the system is due, in part, to the use of poor grade posts in the guardrail installation. Many of the posts split vertically during impact along pre-existing splits passing through the bolt hole location in the posts, as shown in Figure 2.12. A summary of Test 404201-1 is shown in Figure 2.13.

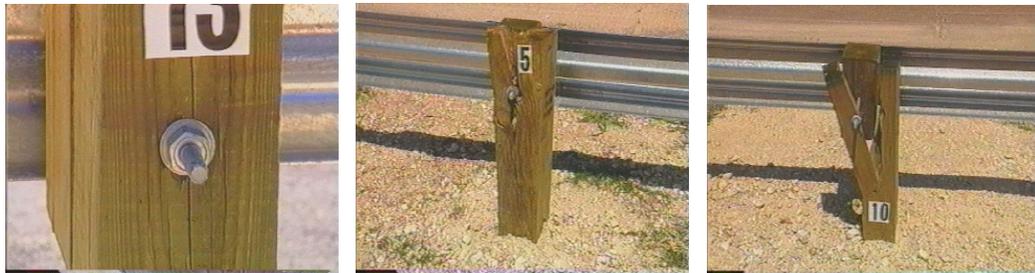
Figure 2.12: Posts split vertically during TTI test 404201-1 along pre-existing splits in posts. (32)

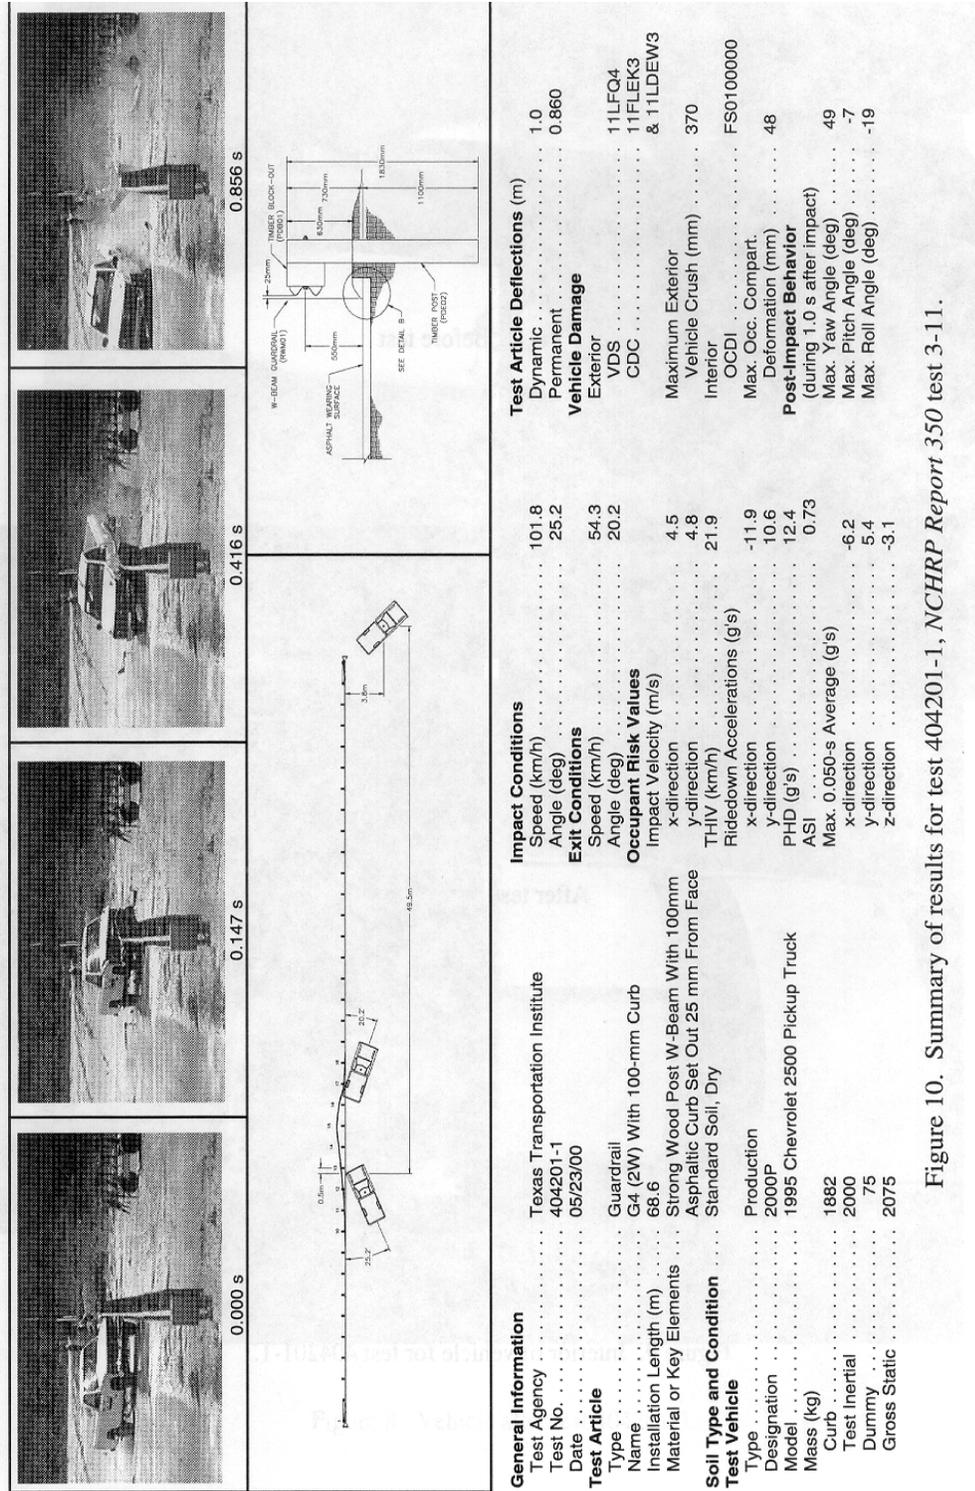
Figure 2.13: Summary of test results of TTI test 404201-1 from Bullard and Menges (32)

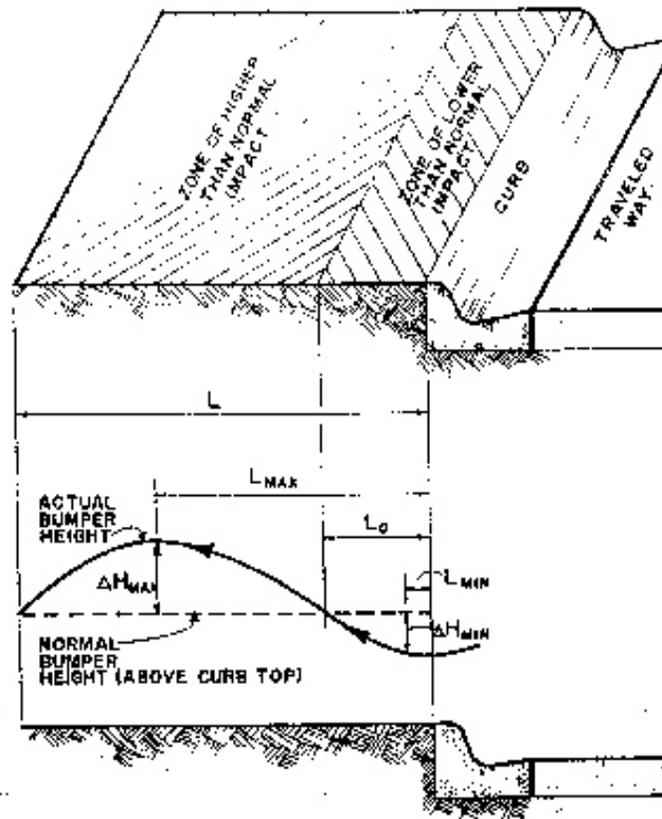
- L = Distance From Top of Curb to the Second Return to Normal Bumper Height
- L_{max} = Distance Measured From Top of Curb to Occurrence of Highest Bumper Height Above Normal
- L_0 = Distance From Top of Curb to the First Return to Normal Bumper Height
- L_{min} = Distance From Top of Curb to the Occurrence of Lowest Bumper Height Below Normal
- ΔH_{min} = Maximum Bumper Height Below Normal Height
- ΔH_{max} = Maximum Bumper Height Above Normal Height

Figure 2.14: Design Parameters for Curb Impacts as Defined by AASHTO (38)
