Life Extension of High Temperature Structural Alloys by Surface Engineering in Gas and Vacuum Carburizing Atmospheres

WORCESTER POLYTECHNIC INSTITUTE

Degree of Doctor of Philosophy

Materials Science and Engineering

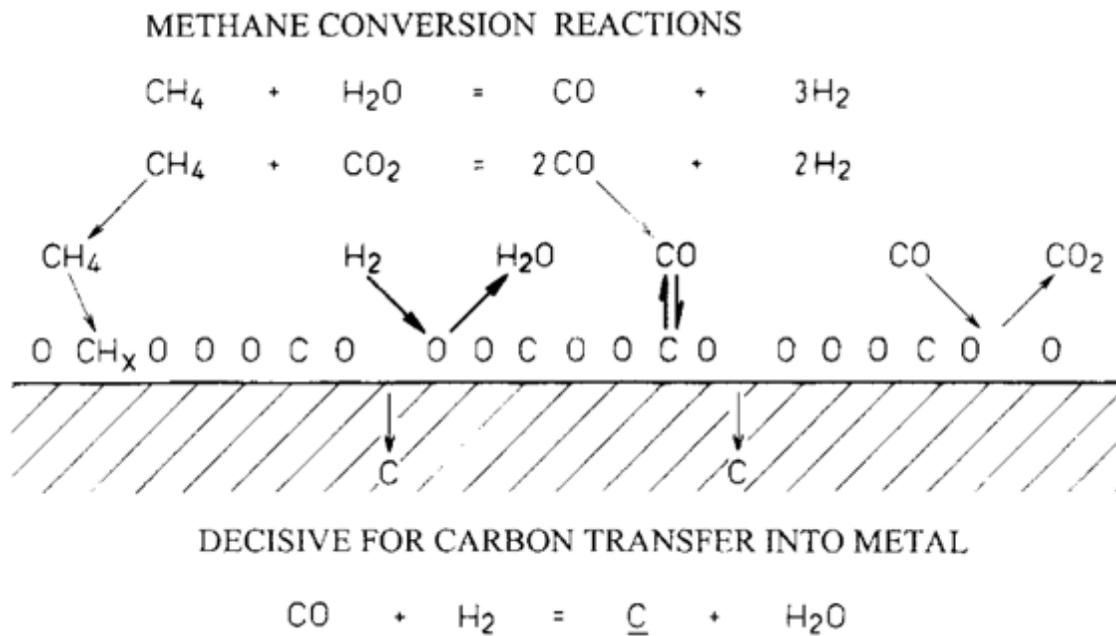
Figure 1. Schematic representation of the partial surface reactions in carburization and metal dusting in a $H_2 - CO - H_2O$ gas mixture [2].

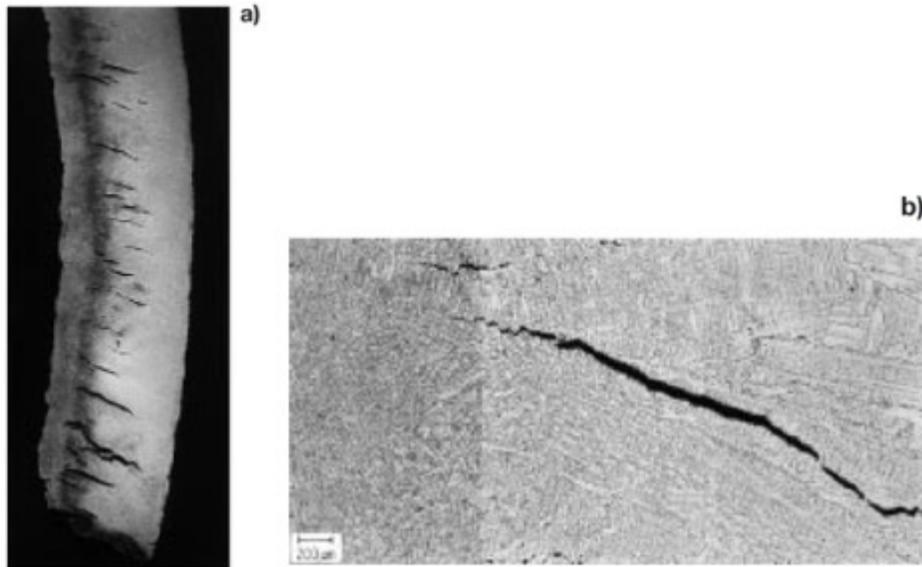
Figure 2, Carburization- section of a carburized tube from an ethylene plant; a) photo of wall section, b) internal carbide and crack formation in the inner wall [2]

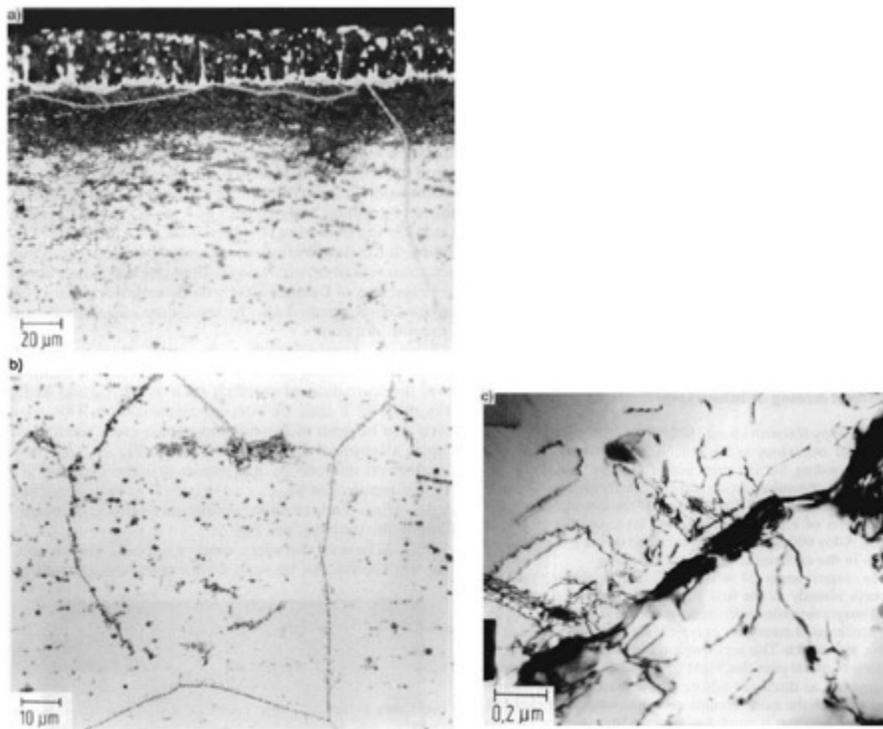
Figure 6. Metallographic cross sections of Inconel 600 after metal dusting attack for 21d at 650°C, a) Optical micrograph showing coke deposit, Cr-depleted zone(white layer) and internal carbide formation; b) internal carbides $M_{23}C_6$ and dislocations created by the internal carbide formation, also shown in c) transmission electron micrograph. [36]

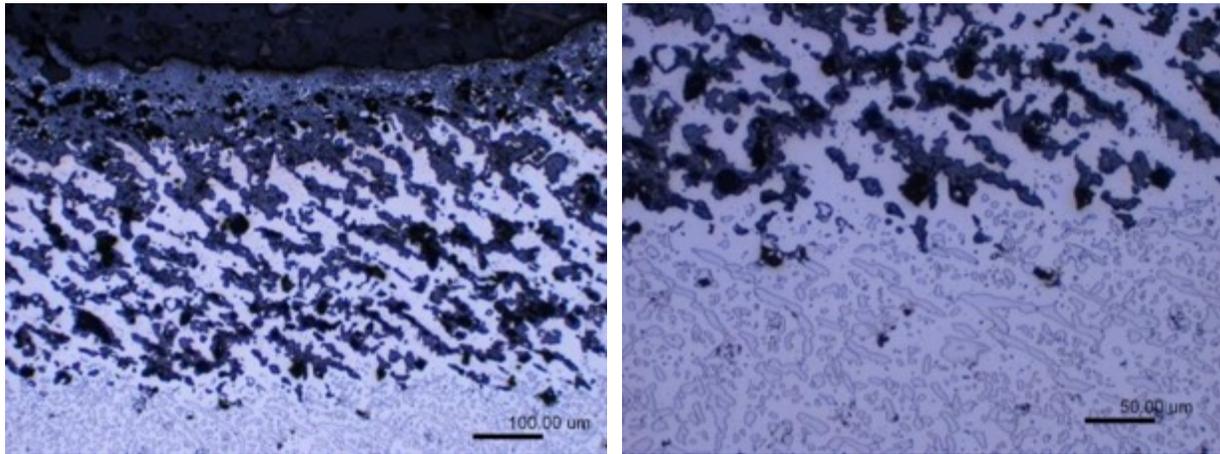
Figure 22. Optical photomicrographs of failed fan blade at the edge (etched with 2%Nital)

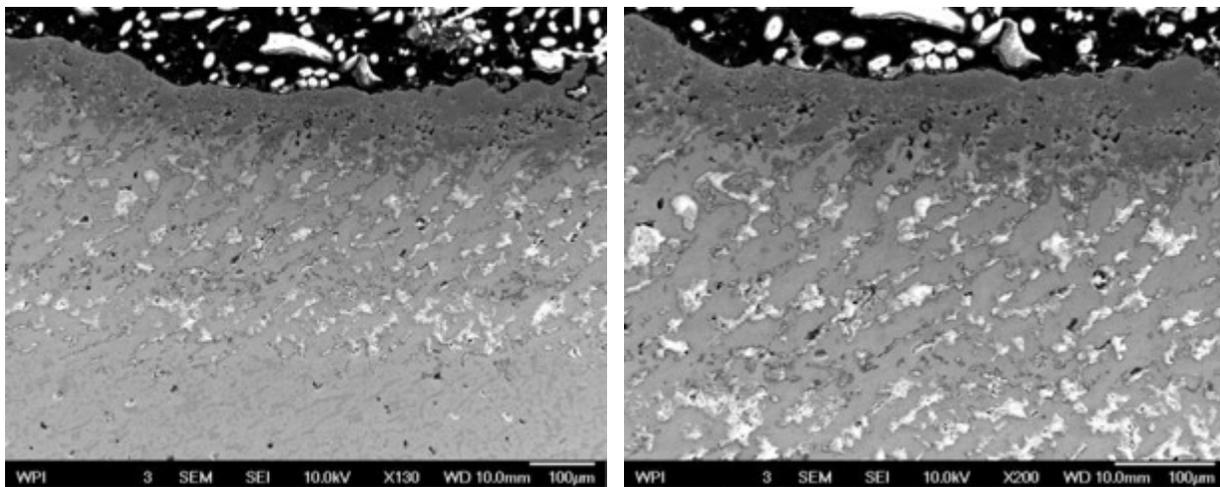
Figure 23. SEM photomicrographs of failed fan blade at the edge (etched with 2%Nital)

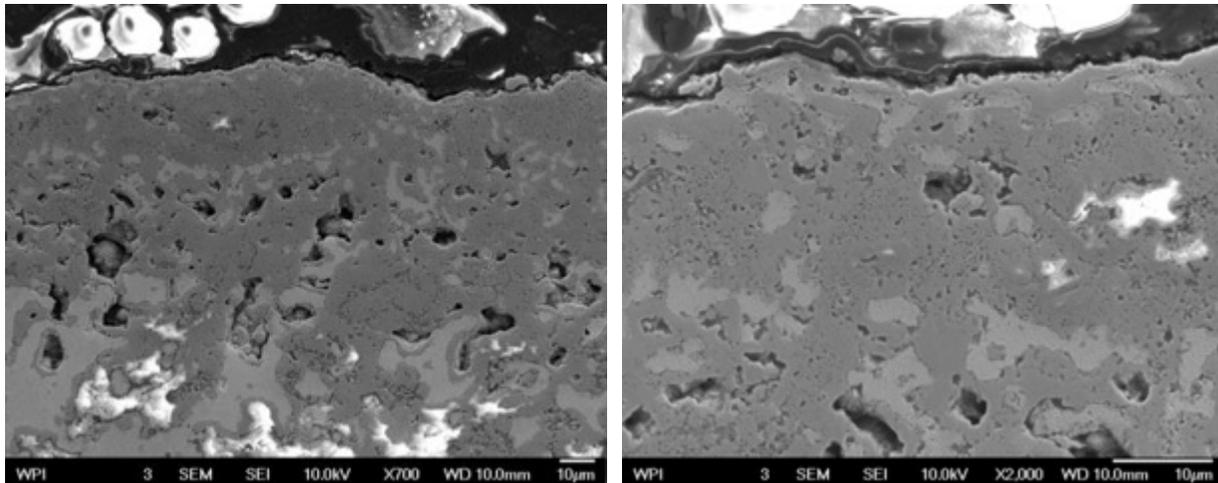
Figure 27. SEM photomicrographs of failed fan blade at the edge (etched with 2%Nital)

Figure 27 shows the cross section SEM photomicrographs of failed fan blade. After one year service in carburizing furnace, the etched structures of RA330 are seen in Figure 27 to have undergone extensive carburization and metal dusting.

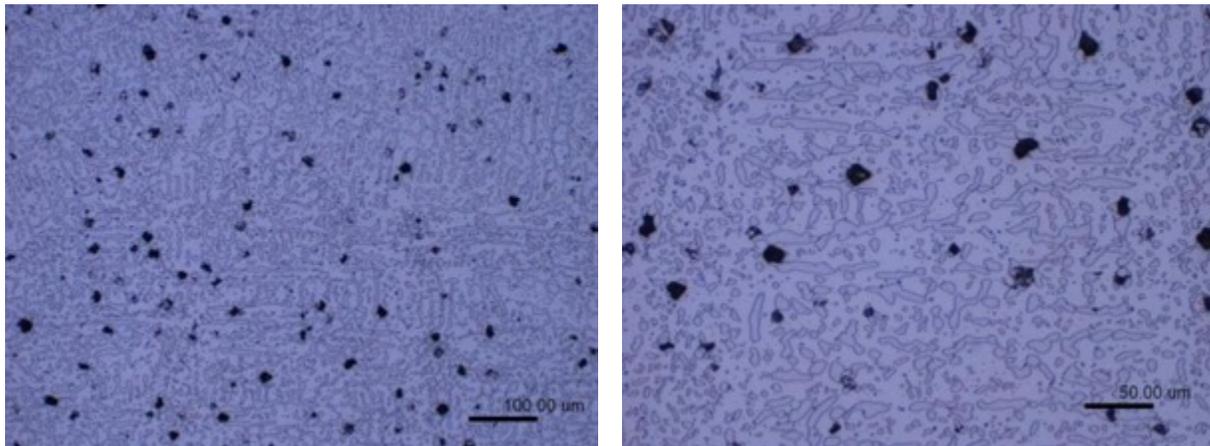
Figure 28. Optical photomicrographs of failed fan blade at the center (etched with 2%Nital)

Figure 28 shows the cross section optical photomicrographs of RA330 fan blade etched with 2% Nital. According to isopleth simulation, the carbon concentration of RA330 is about 0.05% which could possibly form chromium carbides at the grain boundaries. And the XRD and EDS result also verified the simulation assumption.

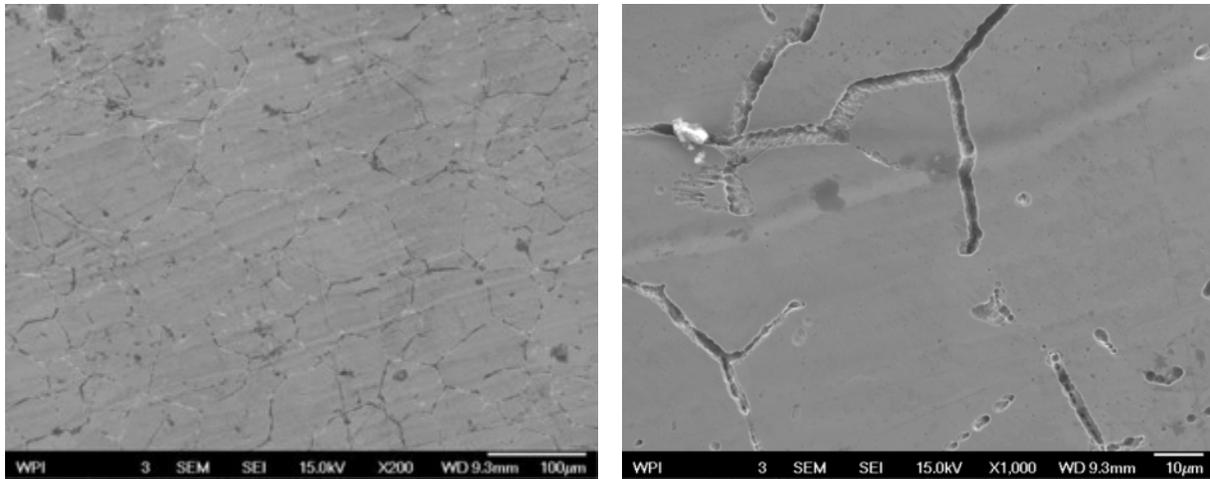
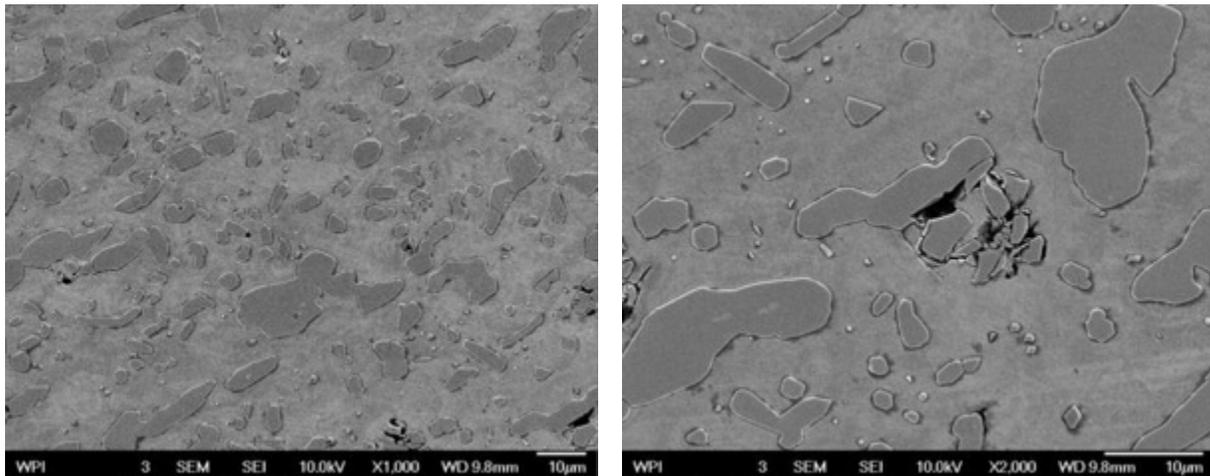
Figure 29. Cross section SEM photomicrographs of unexposed RA 330 (etched with 10%wt oxalic acid)

Figure 30. Cross section SEM photomicrographs of exposed RA 330 (etched with 2%Nital)

Figure 29 and Figure 30 shows the cross section SEM photomicrographs of a new RA330 and a failed RA330. It can be seen that the microstructure of the new RA330 was uniform, a secondary phase forms along the grain boundary, and within the grain (the dark grey phase in the SEM photomicrograph of failed fan blade) after exposure. The carbides precipitated at the core area were of spheroidal morphology, as shown in Figure 31 and Figure 32. The dark grey area was chromium carbides, identified by the EDS. The carbides were also found in the XRD results. In addition, the light grey area was (*Fe, Ni*) austenite.

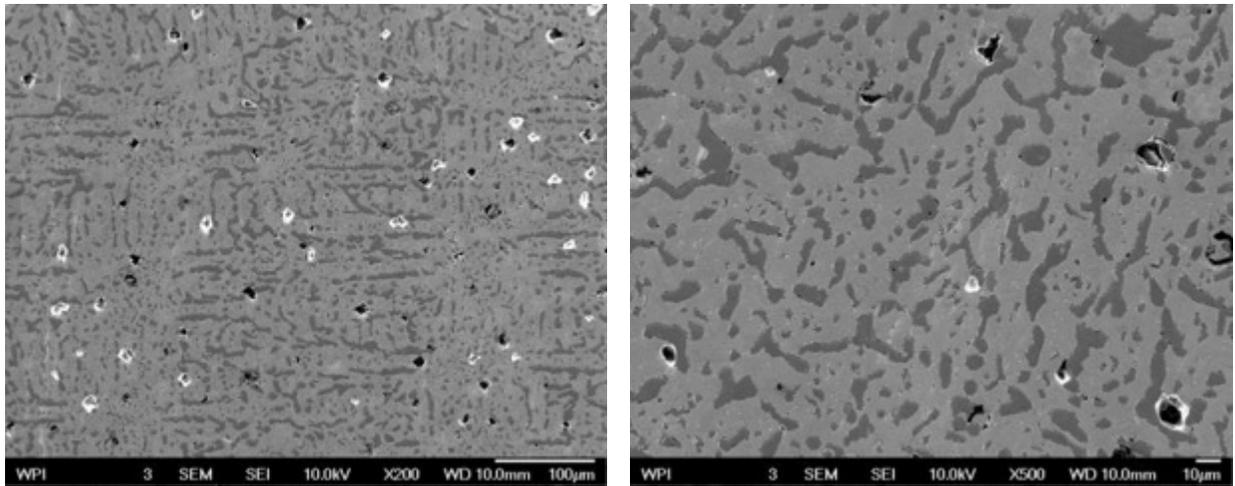
Figure 31. Cross section SEM photomicrographs of exposed RA 330 (etched with 2%Nital)

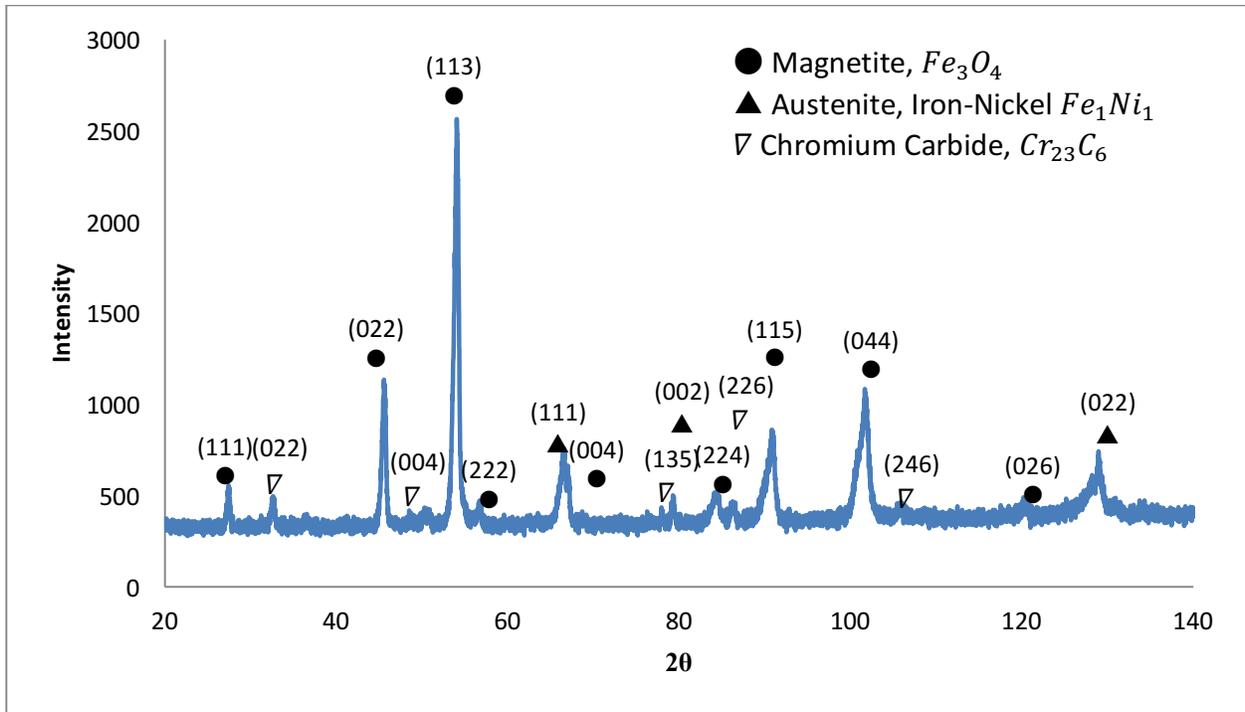
Figure 34. XRD pattern of the surface scan for fan blade (exposed 24 months) (Cu tube)

Combined with EDS, X-ray diffraction was used to identify the phases on the surfaces of the RA330. The main phases of exposed RA330 were iron nickel with face center cubic crystal structure and secondary phase chromium carbides. Magnetite was also detected at the surface of fan blade, shows on Figure 34.

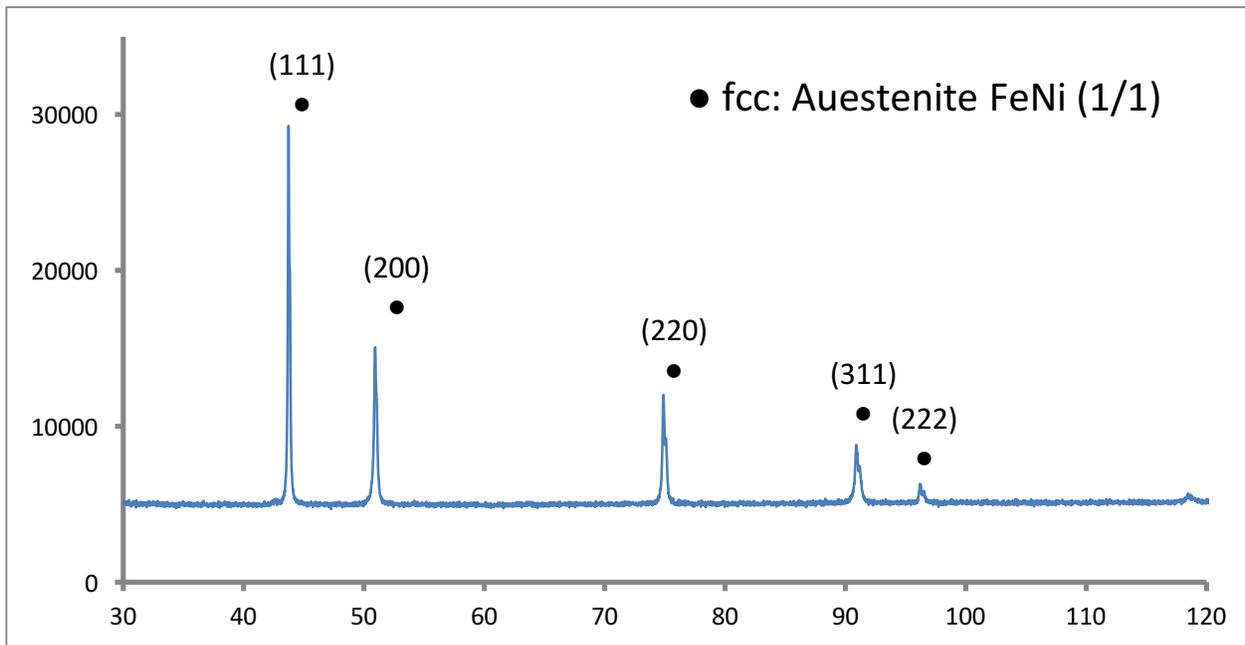
Figure 35. XRD pattern of the surface scan for as fabricated fan blade (Cu tube)

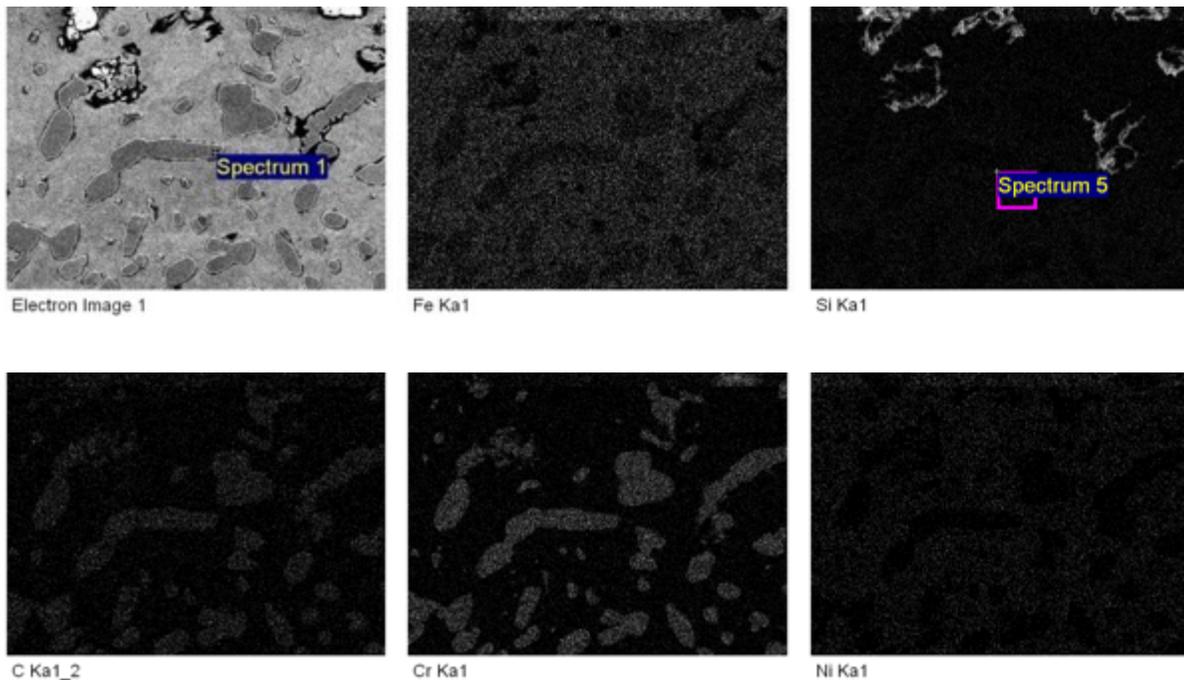
Figure 36. EDS element maps on the cross section of the fan blade

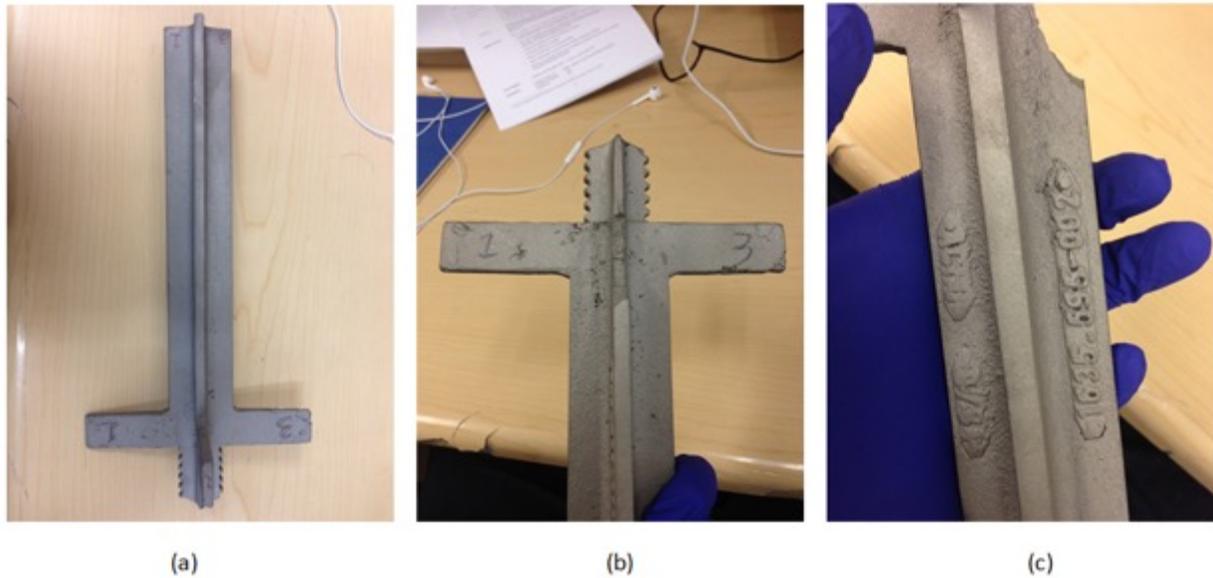
Figure 37: Failed racking pole sample from Sikorsky Aircraft carburizing furnaces. The post was labeled for reference purposes. (a) Normal view of the entire part (b) front view of broken piece (c) close-up side view of broken section.

Thank one of the members of the Center for Heat Treating Excellence, Sikorsky Aircraft, for providing a broken racking pole. Figure 37 shows three different views of the racking pole. The pole was used in vacuum carburizing furnaces at a loosely approximated time of 30 hours per week for 5 to 10 years. The vacuum carburizing operated at 925-1038°C and the endothermic carburizing furnace ran from 815°C to 925°F. The estimated number of heat treating operations is 2000-3000 or 16,000-24,000 hours.

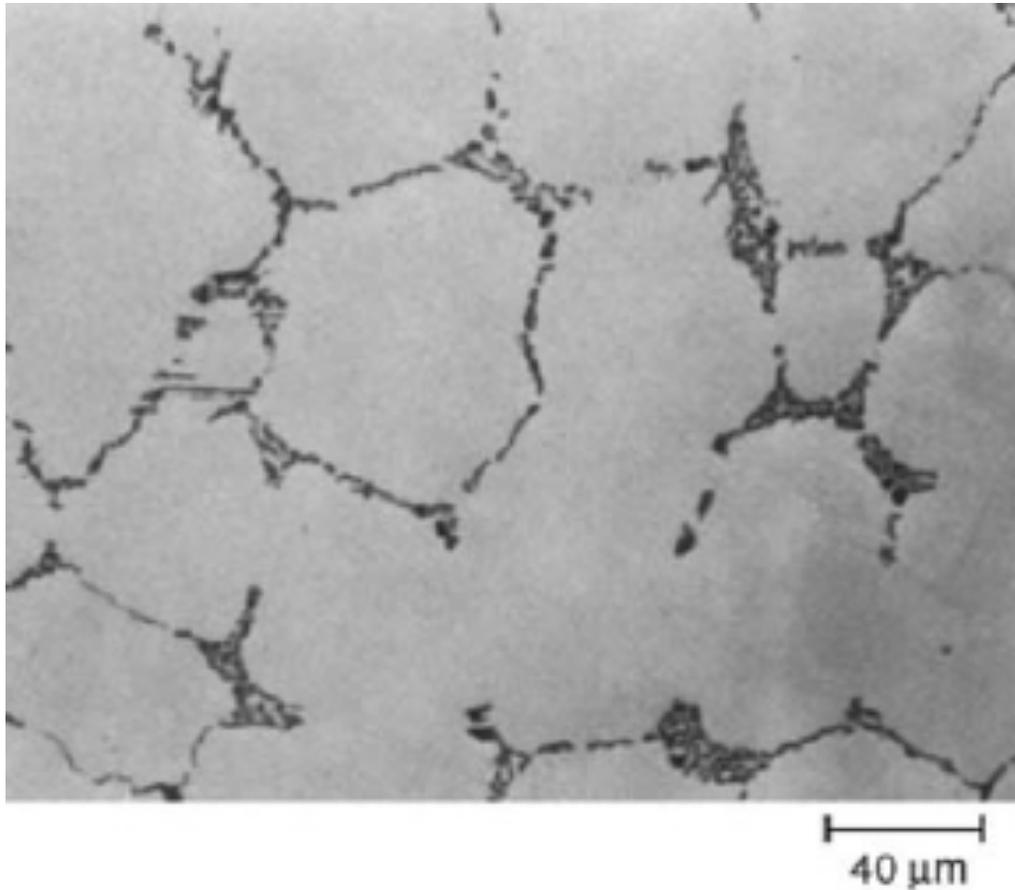
Figure 39: Cast HT-44 microstructure [31].

Microstructures. HT is comprised of an austenitic face-center-cubic matrix with eutectic carbides on the boundaries [31]. The carbides on the grain-boundaries of HT help prevent the creep due to grain sliding, increase hardness, and allow for stress relaxation to occur [31].

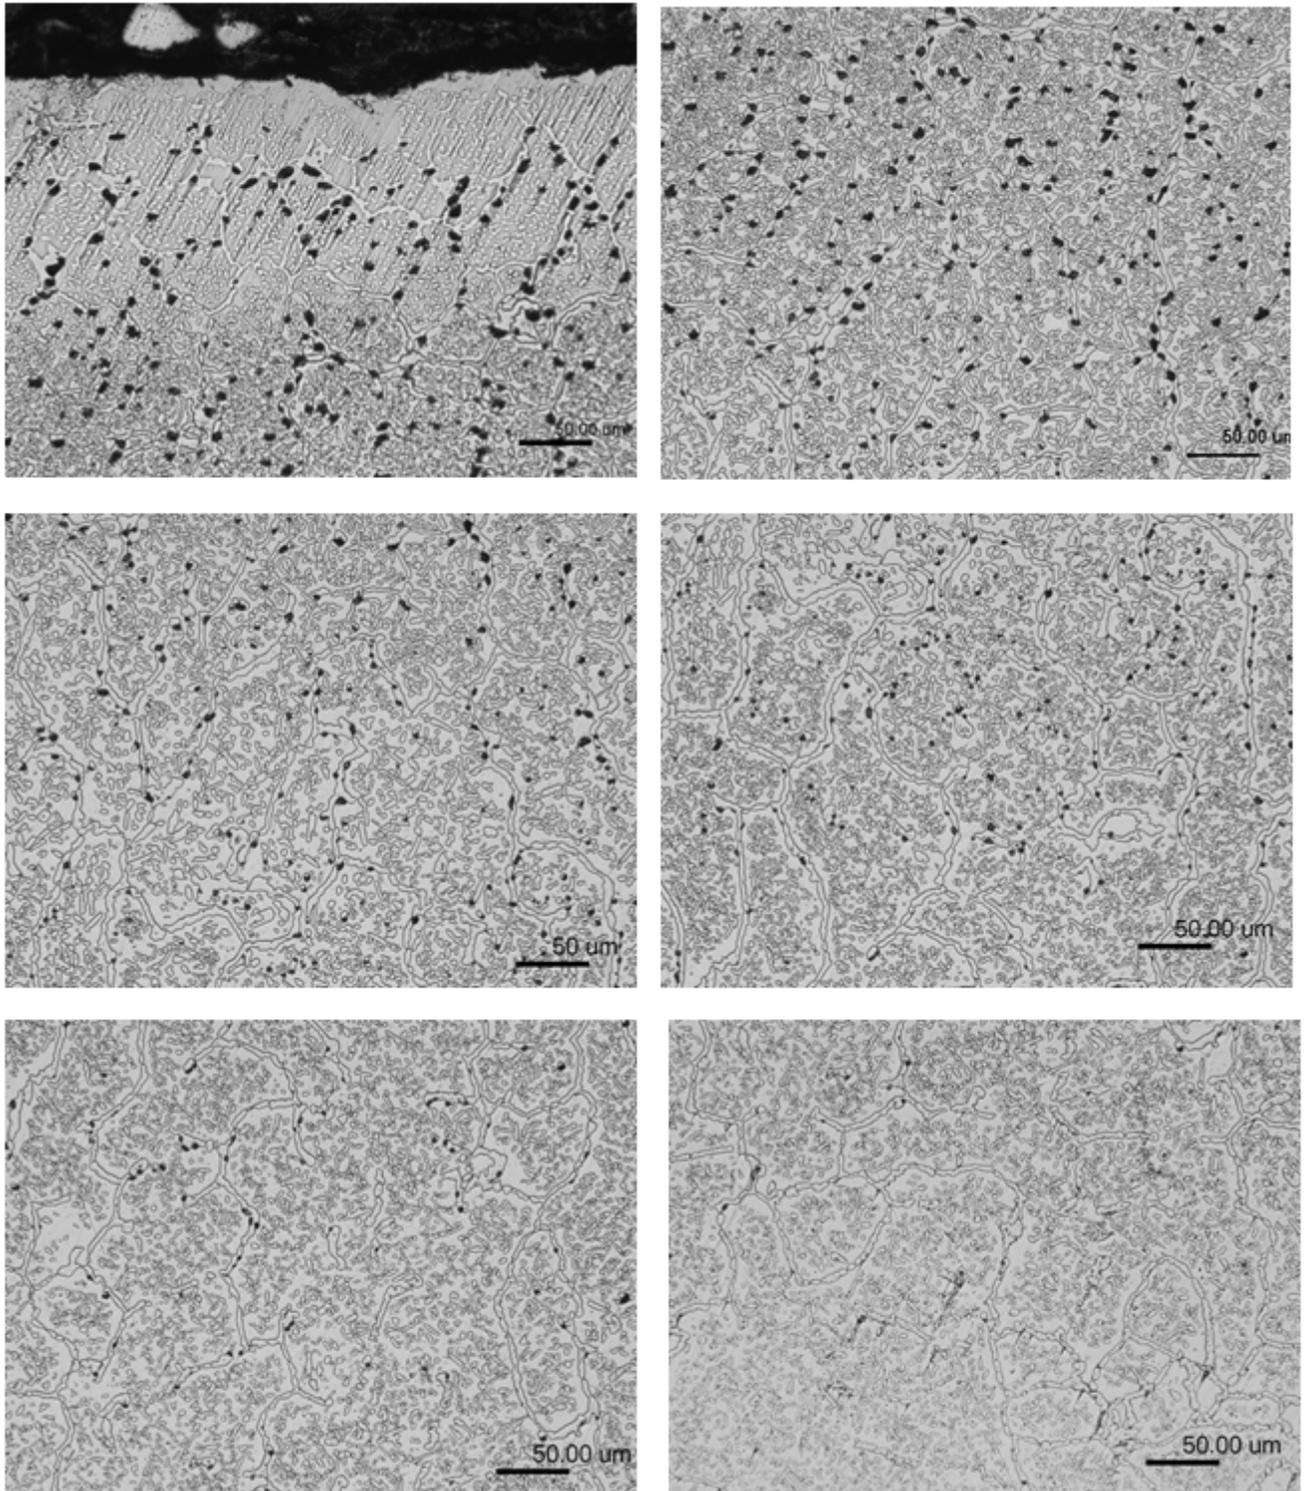
Figure 42: Optical micrographs of sample. Outermost edge (top left) to core (bottom right) of the sample (lower magnification)

Optical micrographs with lower (Figure 42) and higher magnification (Figure 43) were taken from the outward most surface of the part to the interior to observe the microstructure changes from the surface to the core of the pole. It shows that the amount of the black spots decreases from the surface to the core gradually.

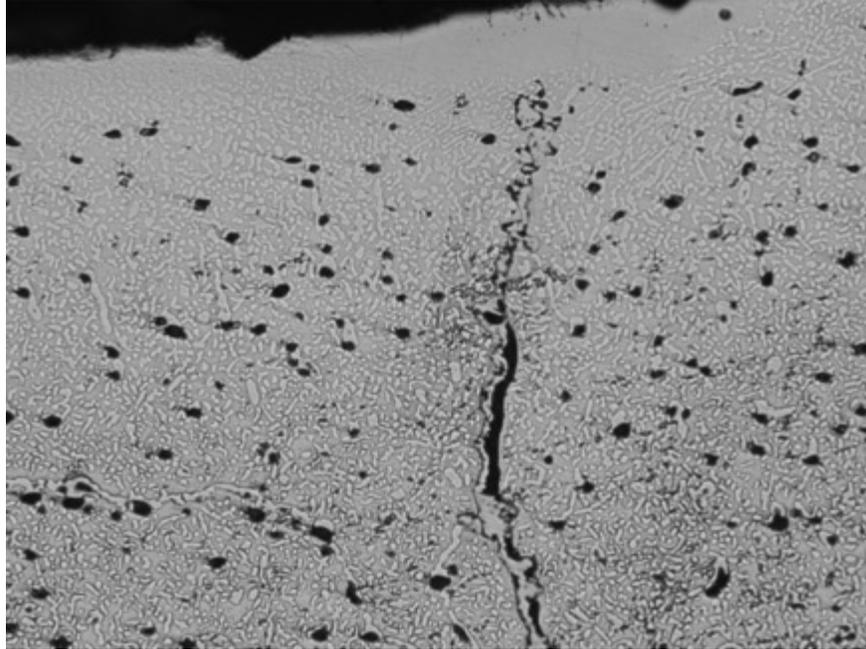
Figure 44: Crack near the surface of the pole

Cracking is evident toward the outer surface of the pole. These defects become fewer and further between as the interior of the part is reached. Figure 44 shows one of the cracks near the surface. Based on the optical observation, it is found the surface microstructure of the pole had been changed after being used in the carburizing furnaces for a long time. And this microstructure change may be related to the failure of the pole. It is thus imperative to investigate the cause of this microstructure evolution to determine the failure mode of the racking pole.

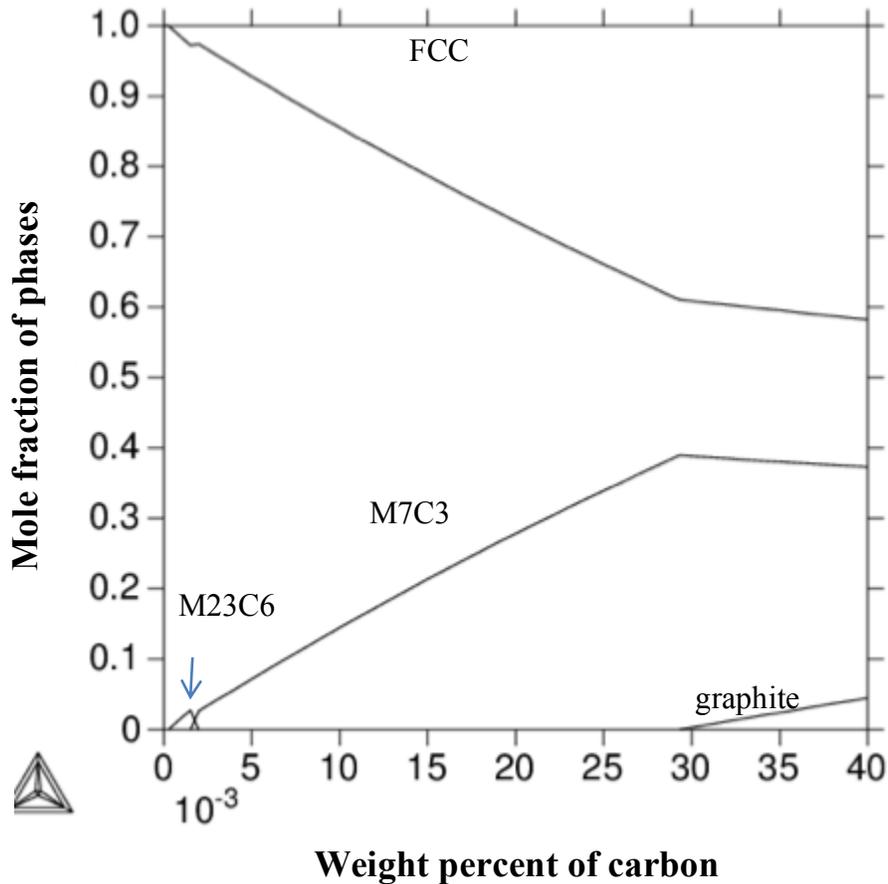
Figure 50: The phase evolution in RA330 with carbon concentration increasing at 1700°F (927°C)

By comparing with the SEM and EDS analysis, it is evident that the chromium carbides increases from the core to the surface with the carbon concentration increasing. At the surface of the pole the carbon concentration is very high and some chromium carbides decompose to form graphite, which is the origin of the cracking. The failure mode of this racking pole is thus determined to be the metal dusting from excess carburizing.

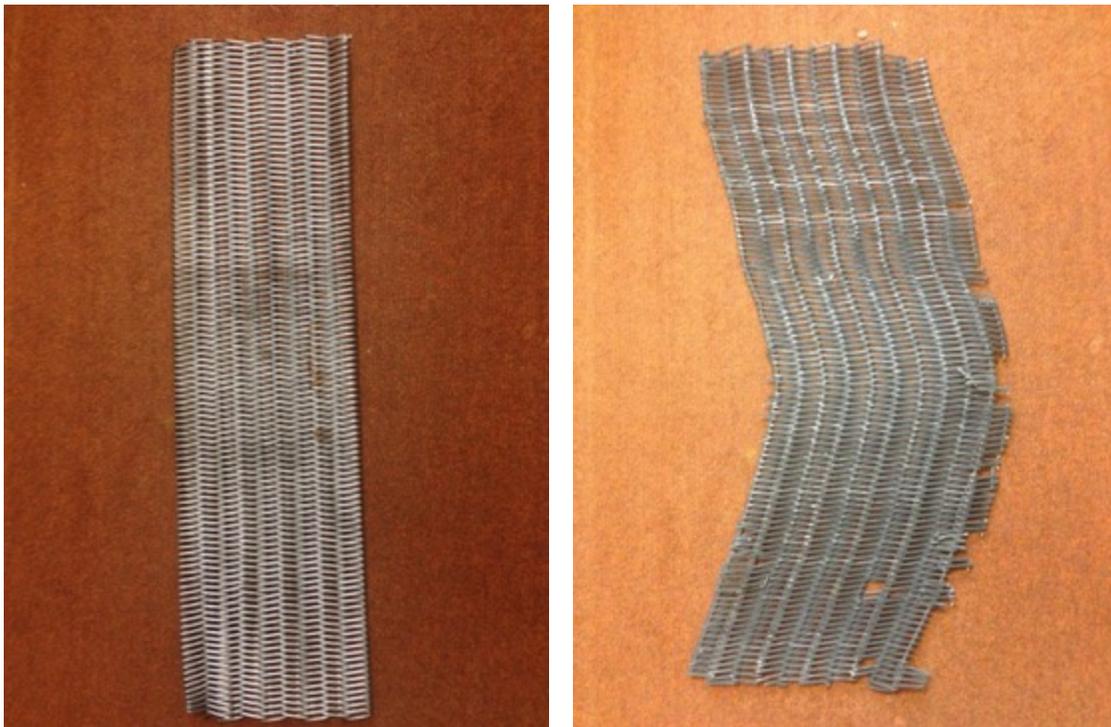
Figure 51. Received new (left) and failed (right) mesh belts from GKN

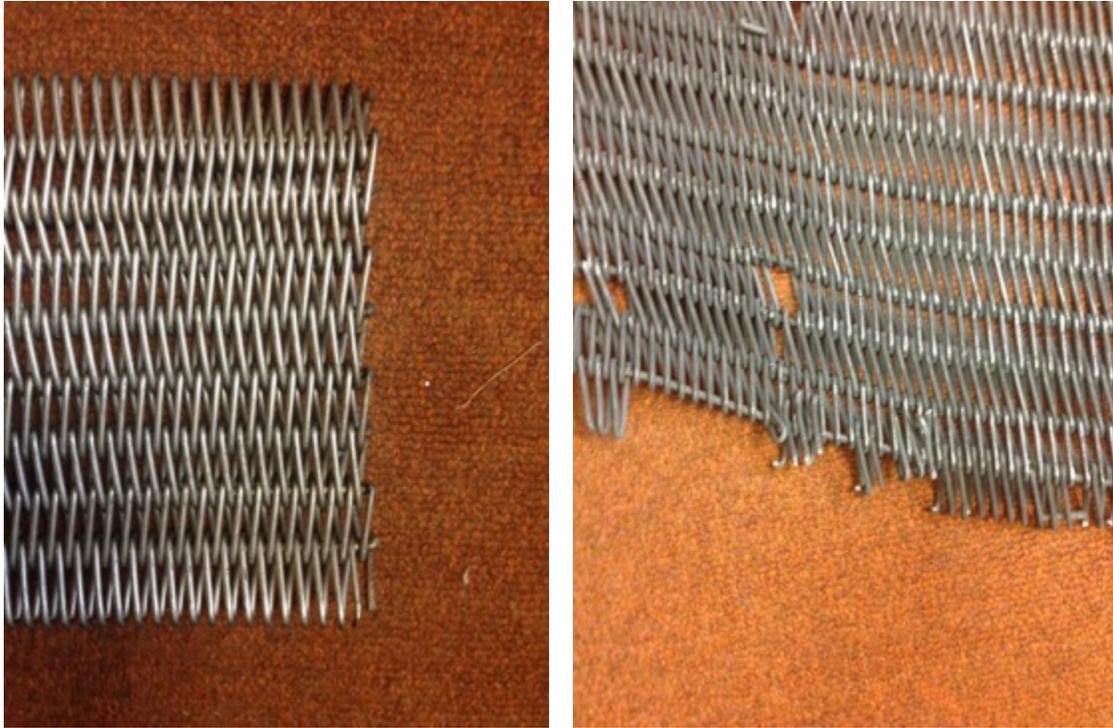
Figure 52. New (left) and failed (right) mesh belts from GKN with a closer look

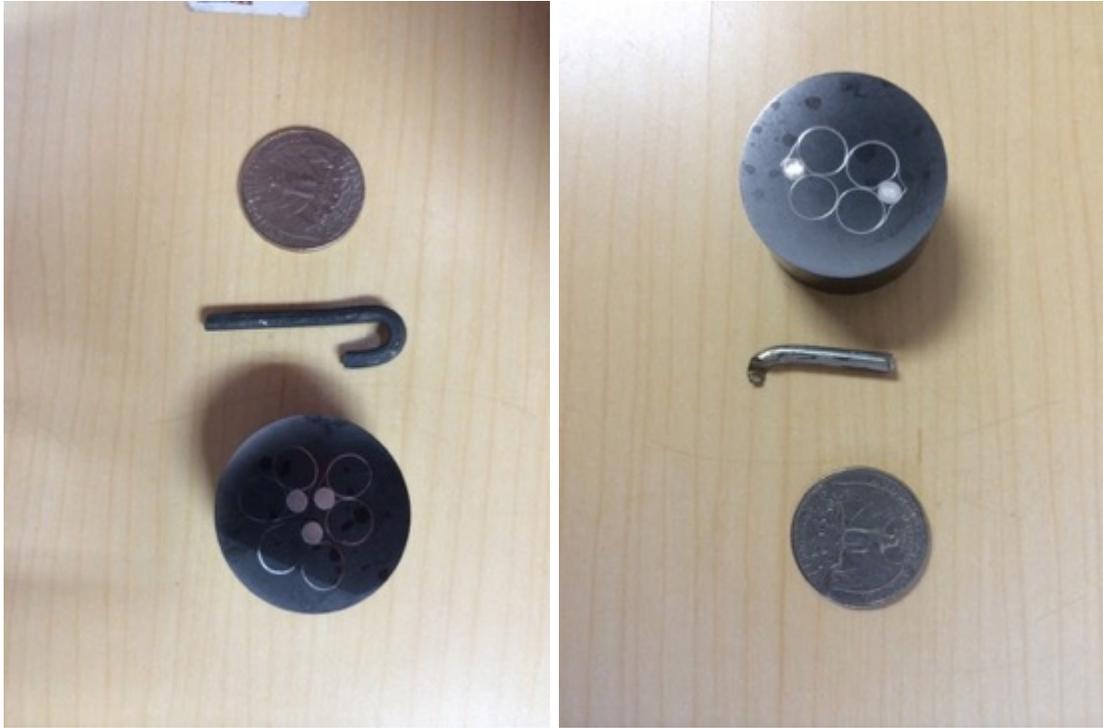
Figure 53. Spirals cut from new (left) and failed (right) mesh belts and mounted in cross section

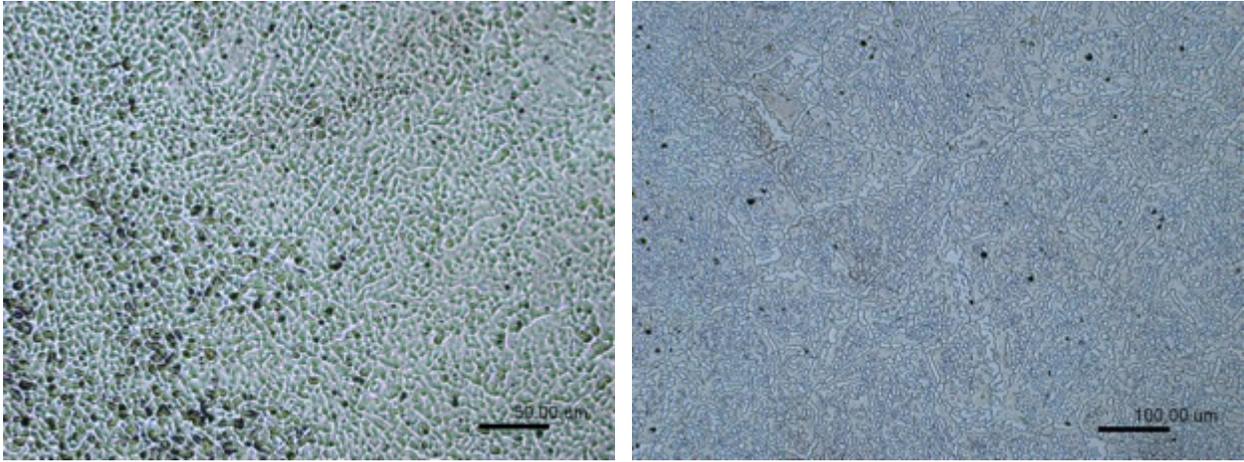
Figure 54. Cross section optical micrographs of spirals from new (left) and failed (right) mesh belts

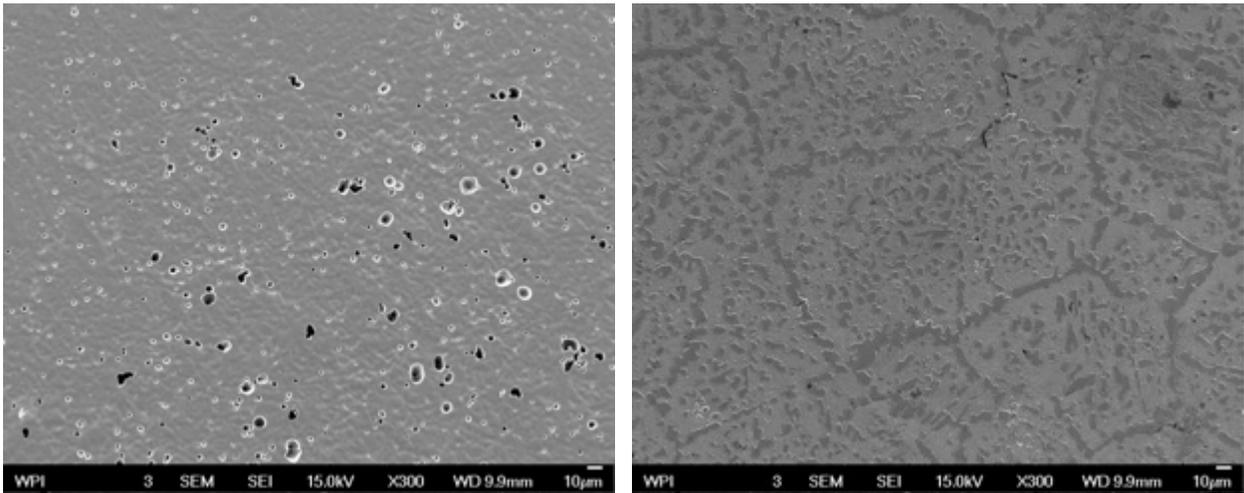
Figure 55. Cross section SEM micrographs of spirals from new (left) and failed (right) mesh belts

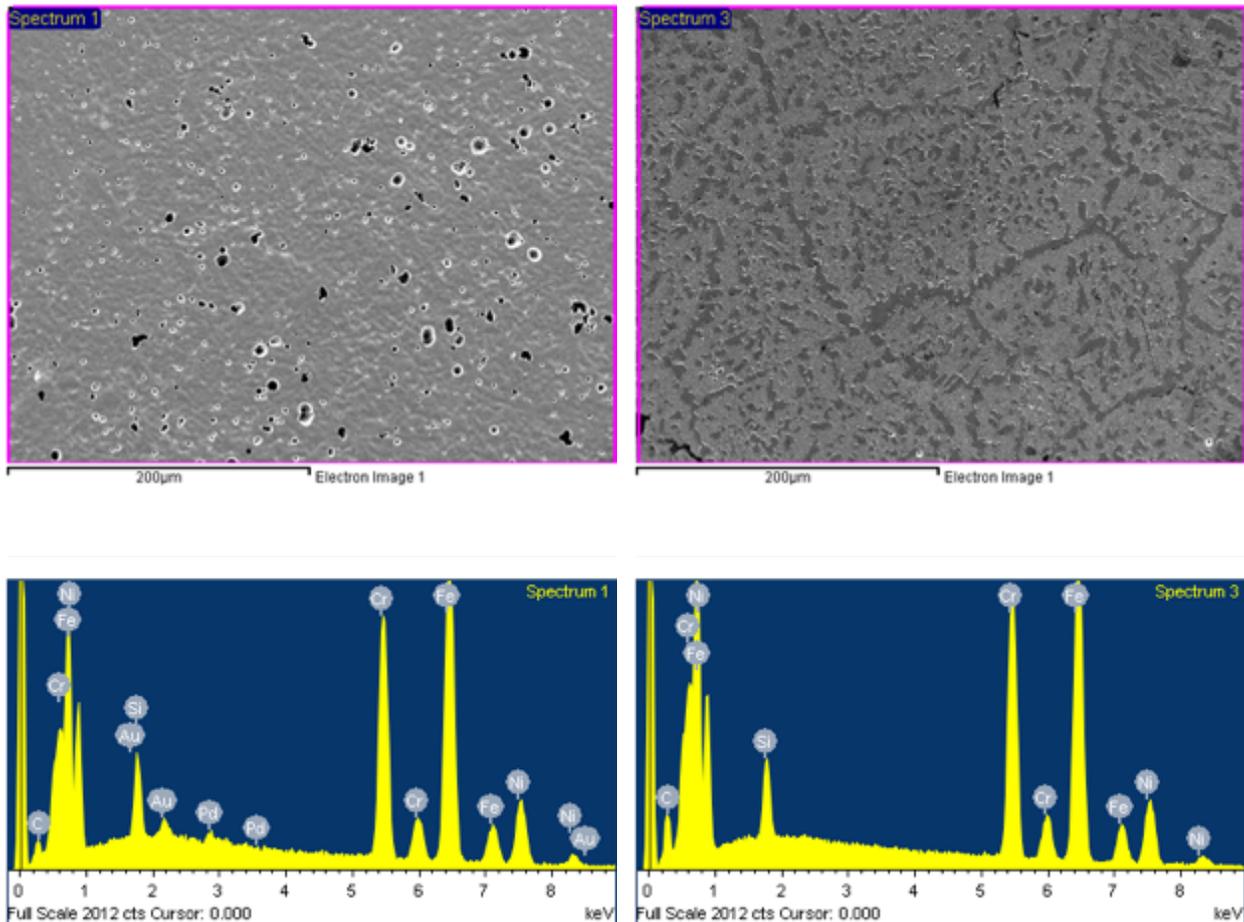
Figure 56. Elemental analysis by EDS on the spirals from new (left) and failed (right) mesh belts

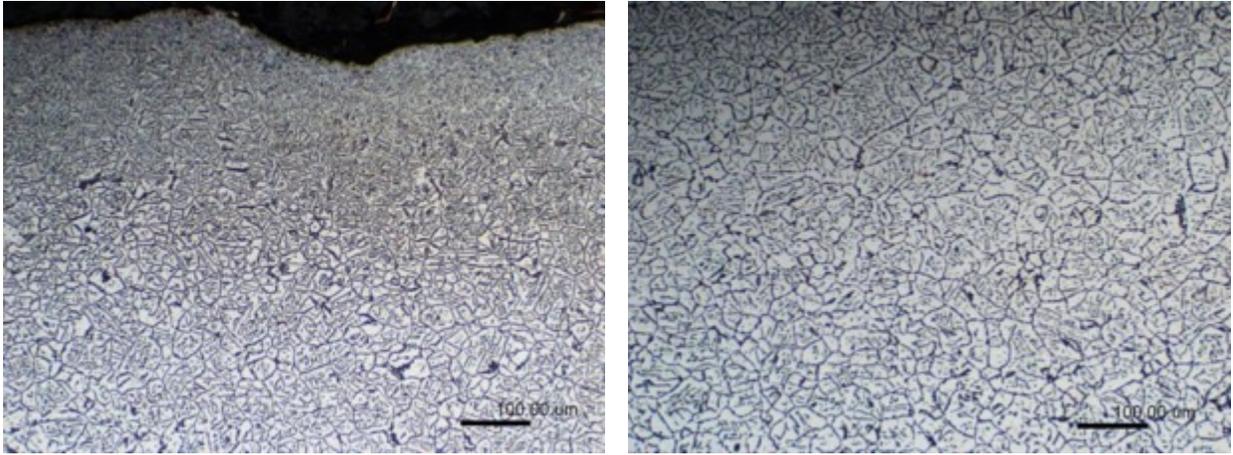
Figure 69. Optical photomicrographs of RA330 raking poles (etched with 10% oxalic acid)

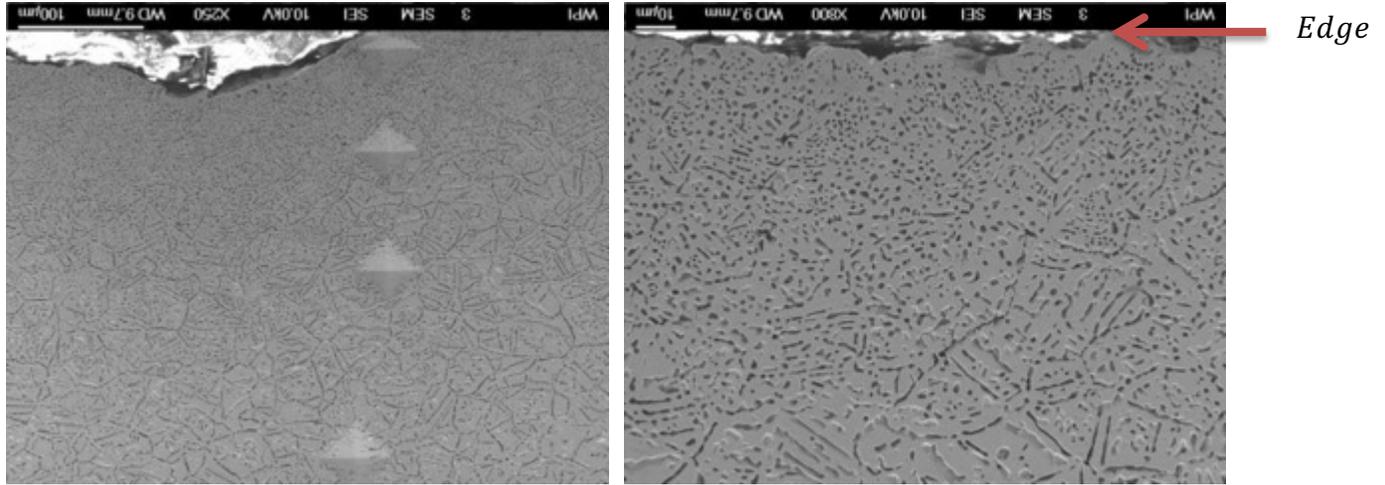
Figure 71. SEM cross section photomicrographs of RA330 at the edge etched with 10% oxalic acid

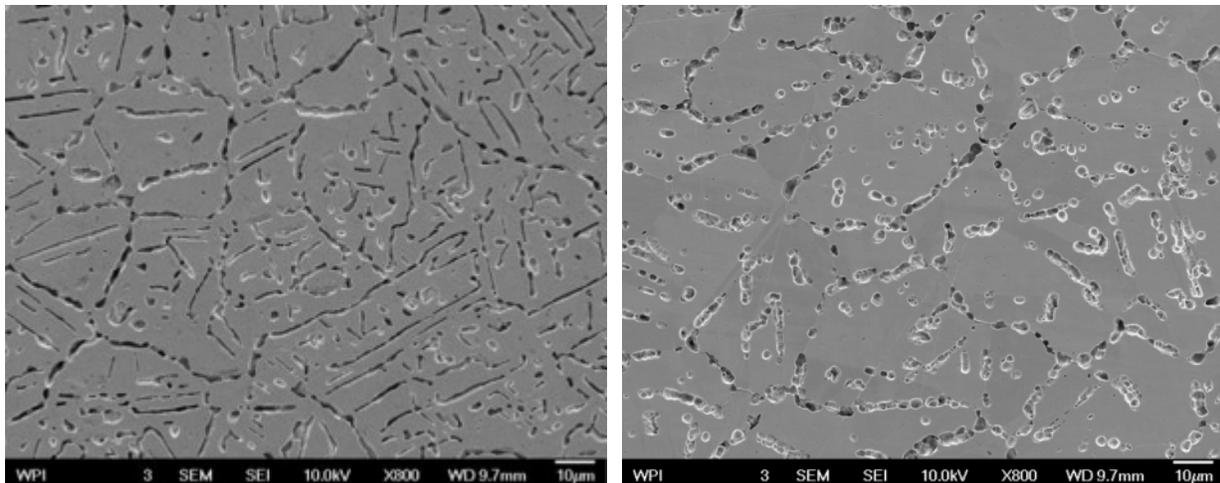
Figure 72. SEM cross section photomicrographs of RA330 at the core etched with 10% oxalic acid

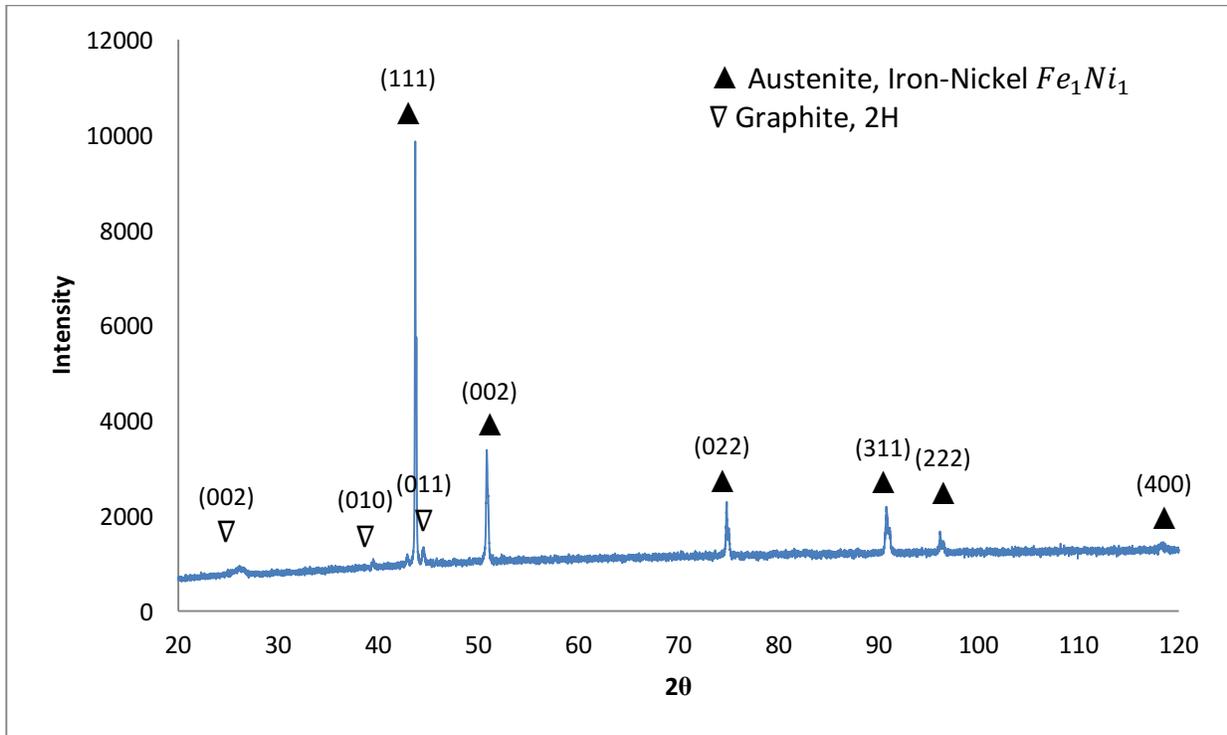
Figure 78. XRD pattern of the surface scan for RA330 racking poles (exposed 6 months) (Cu tube)
