Life Extension of High Temperature Structural Alloys by Surface Engineering in Gas and Vacuum Carburizing Atmospheres

WORCESTER POLYTECHNIC INSTITUTE

Degree of Doctor of Philosophy

Materials Science and Engineering

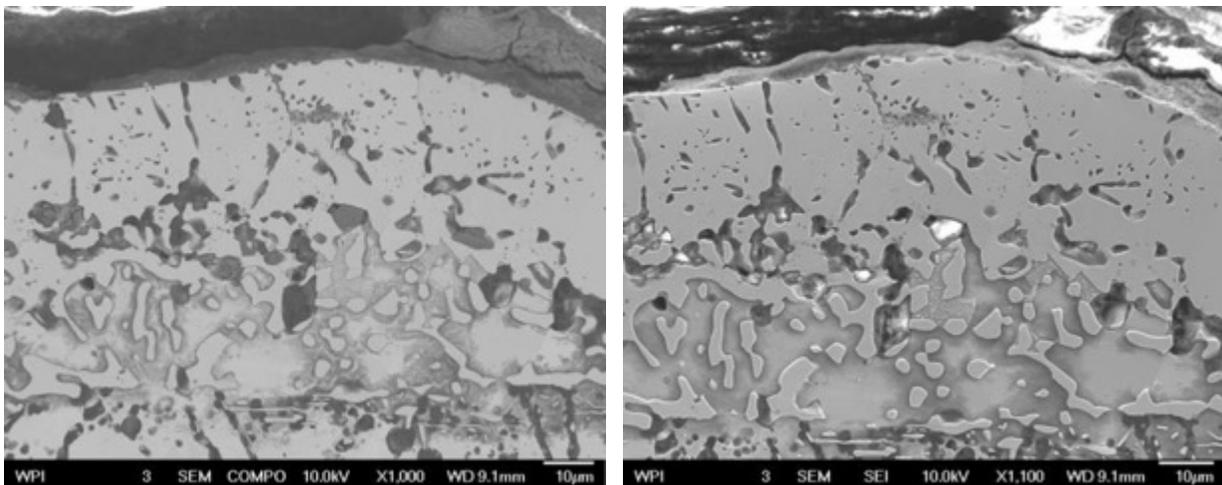
Figure 82. SEM photomicrographs of aluminized RA330 Racking poles Electrochemically etched with 10% oxalic acid for 30s; Backscattered Electron photomicrograph (left); Secondary Electron photomicrograph (right)

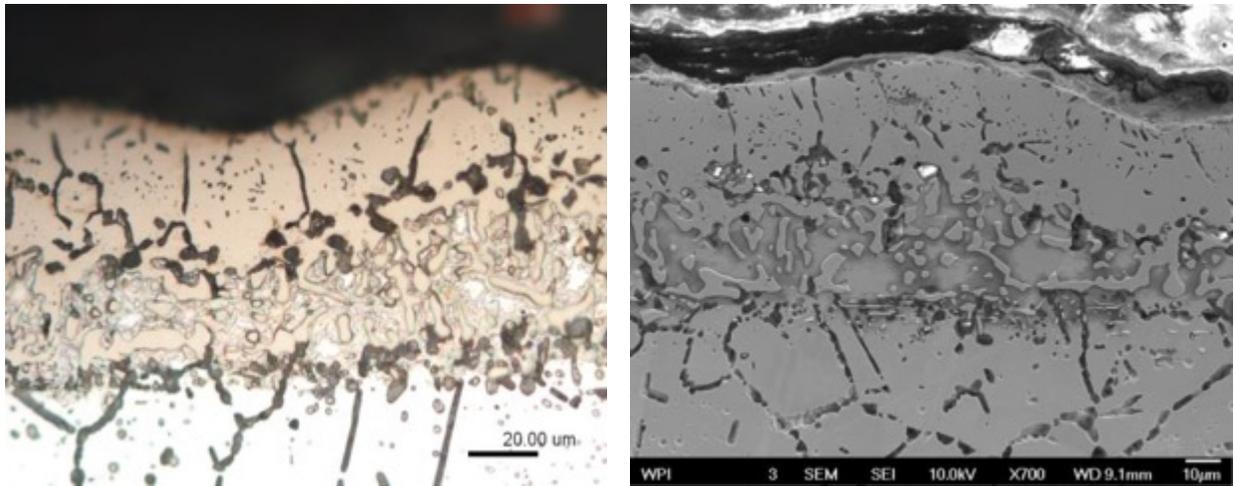
Figure 83. photomicrographs of aluminized RA330 Racking poles Electrochemically etched with 10% oxalic acid for 30s; Optical Photomicrograph (left); Secondary Electron Photomicrograph(right)

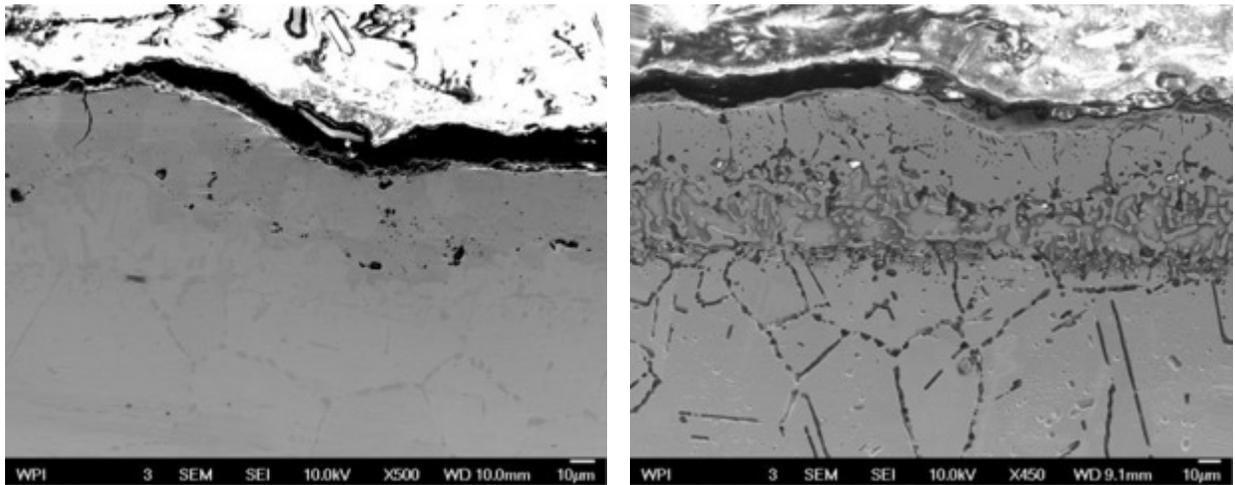
Figure 84. SEM photomicrographs of aluminized RA330 Racking poles; Unetched (left); Electrochemically etched with 10% oxalic acid for 30s (right);

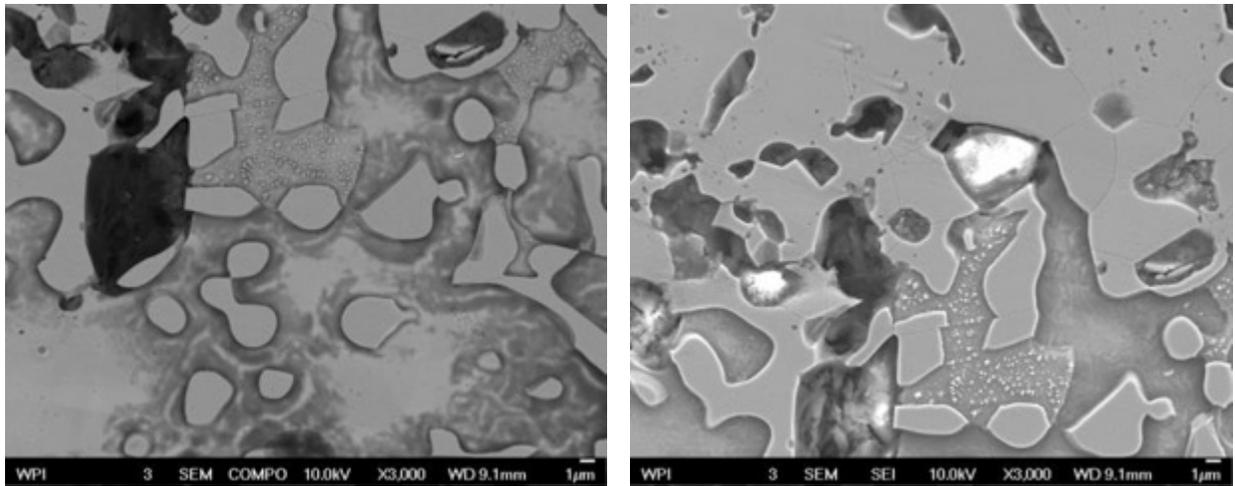
Figure 85. SEM photomicrographs of aluminized RA330 Racking poles Electro-chemically etched with 10% oxalic acid for 30s; Back-scattered electrons photomicrograph (left); Secondary electrons photomicrograph (right)

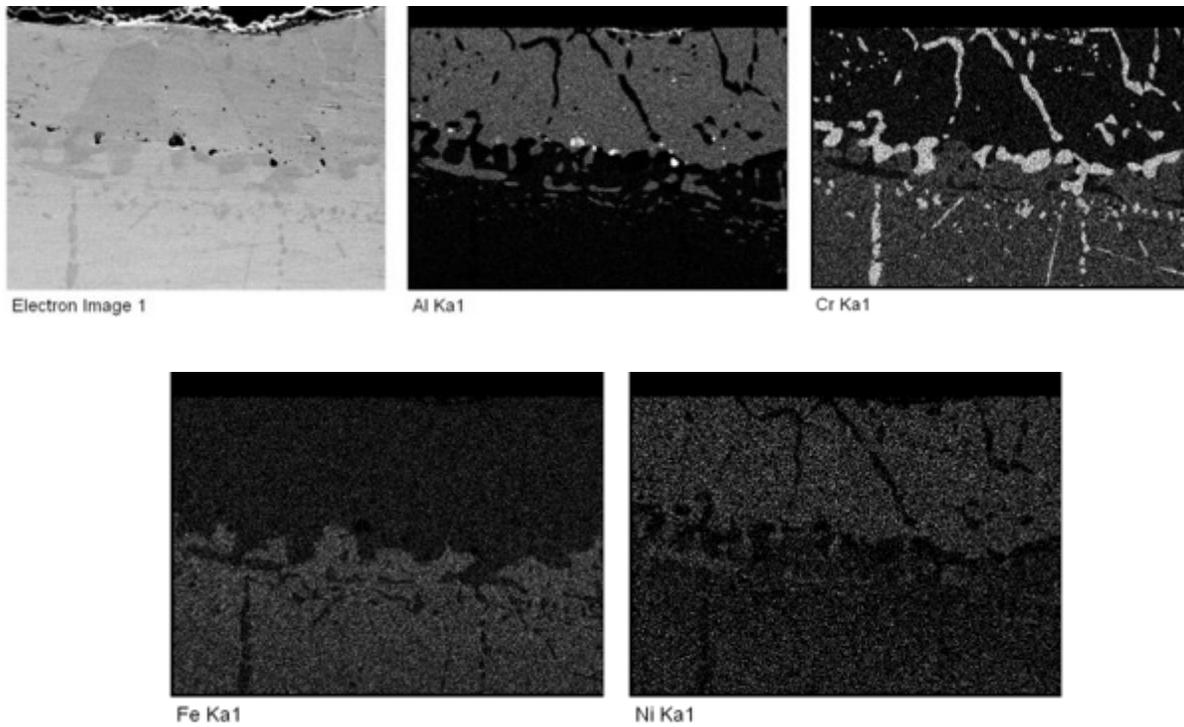
Figure 97. EDS element maps on the cross section of aluminized racking poles

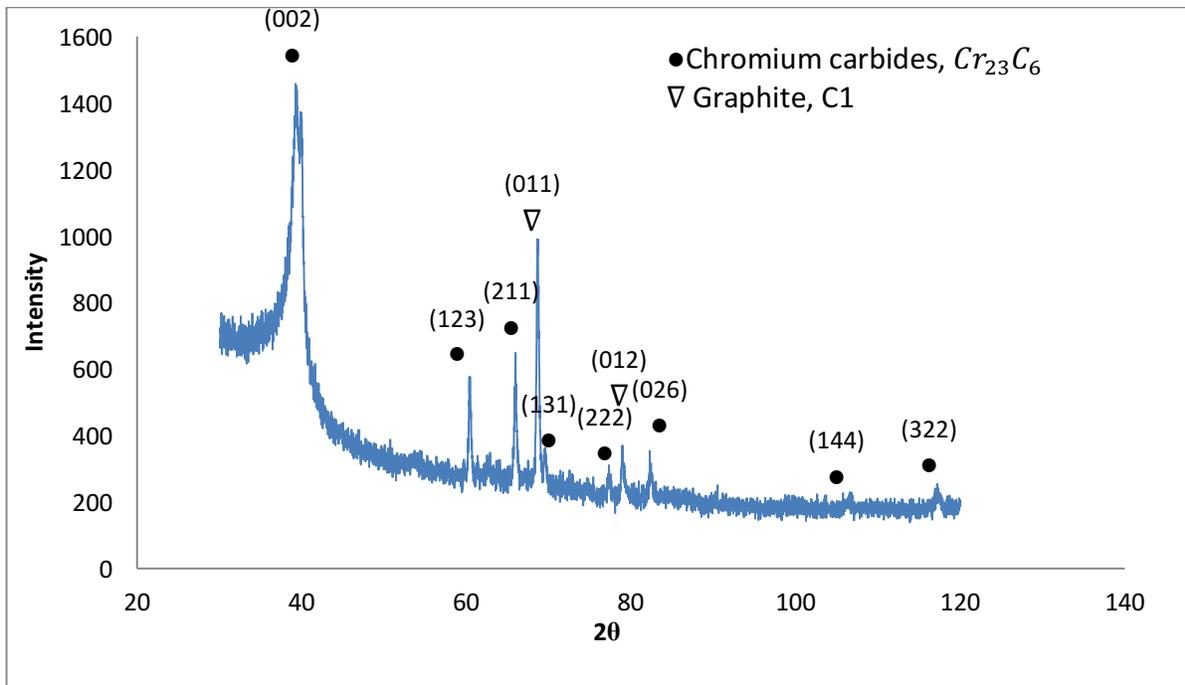
Figure 99. XRD pattern of the inside surface scan for RA330 flake offs (exposed 6 months) (Cr tube)

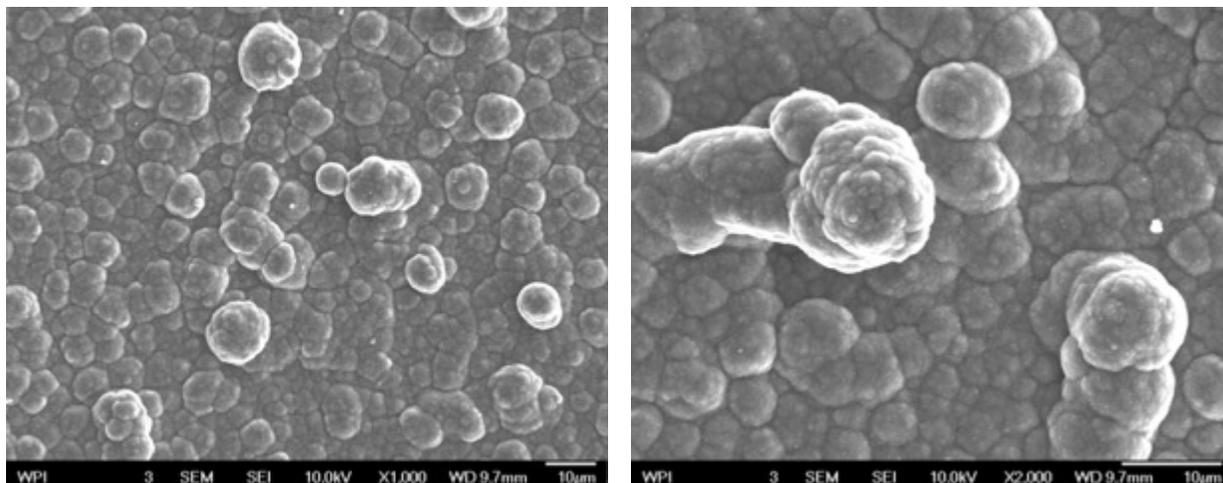
Figure 100. SEM photomicrographs of flake offs removed from racking poles (Outside)

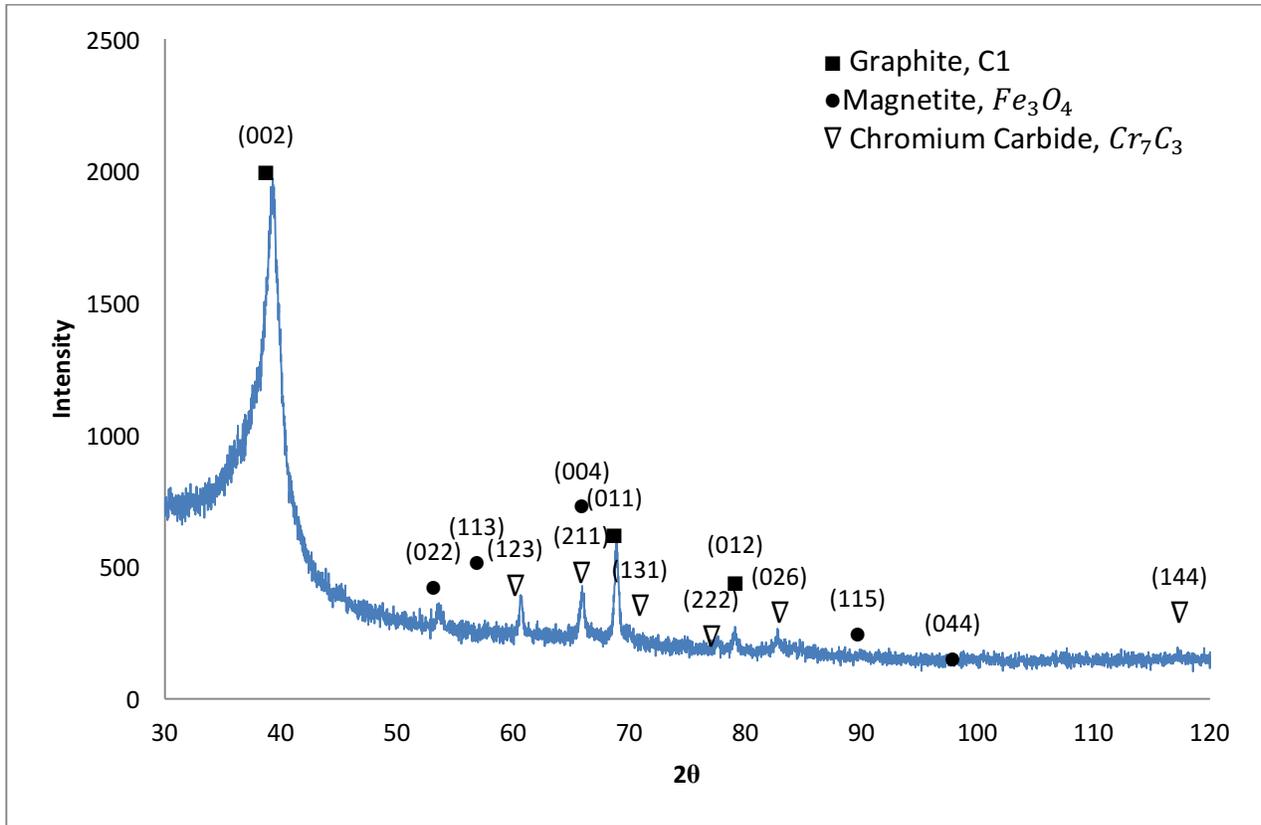
Figure 108. XRD pattern of the inside surface scan for aluminized RA330 flake offs (exposed 6 months) (Cr tube)

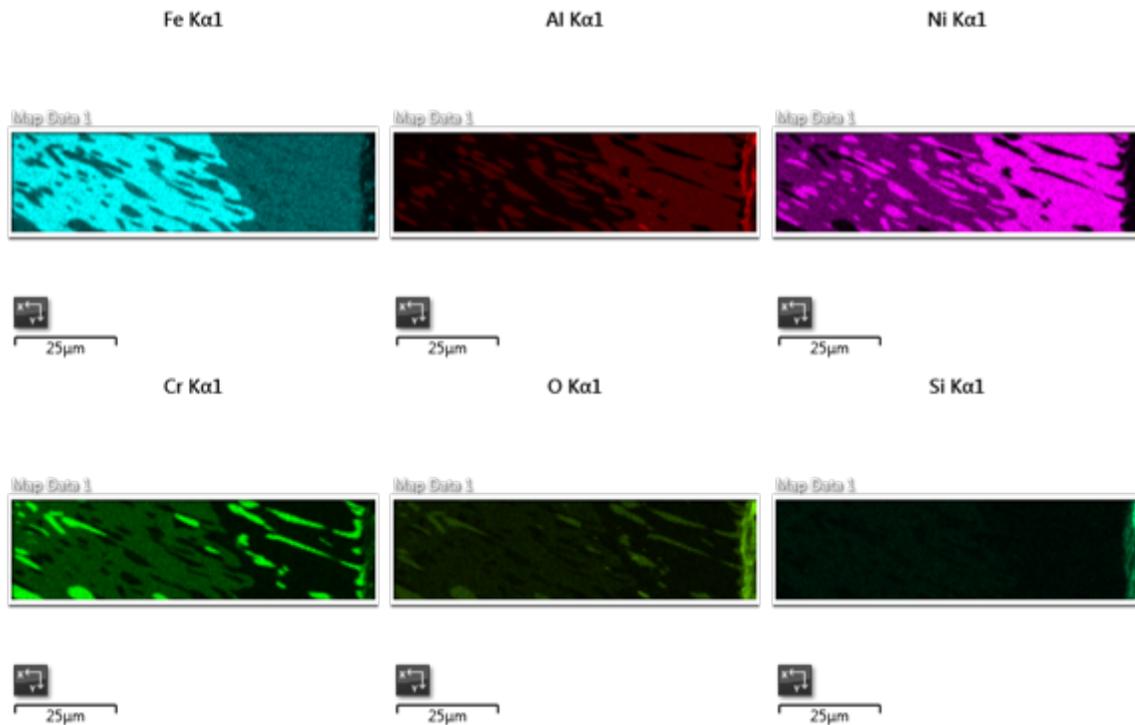
Figure 115: EDS mapping of aluminized racking poles exposed for 3 years

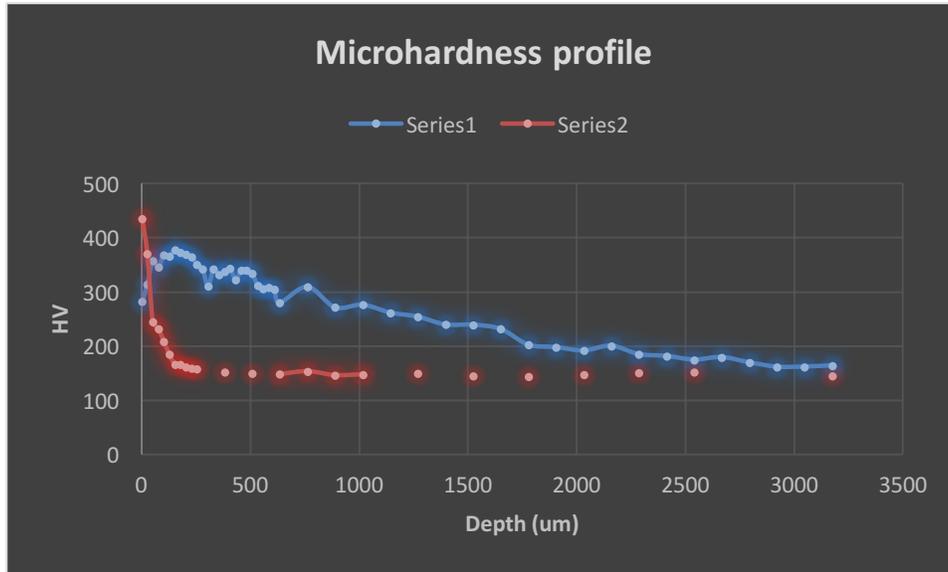
Figure 116: Cross section micro-hardness profiles of as-fabricated RA330 (series1 blue) and Aluminized RA330 (series2 red) exposed for 3 years

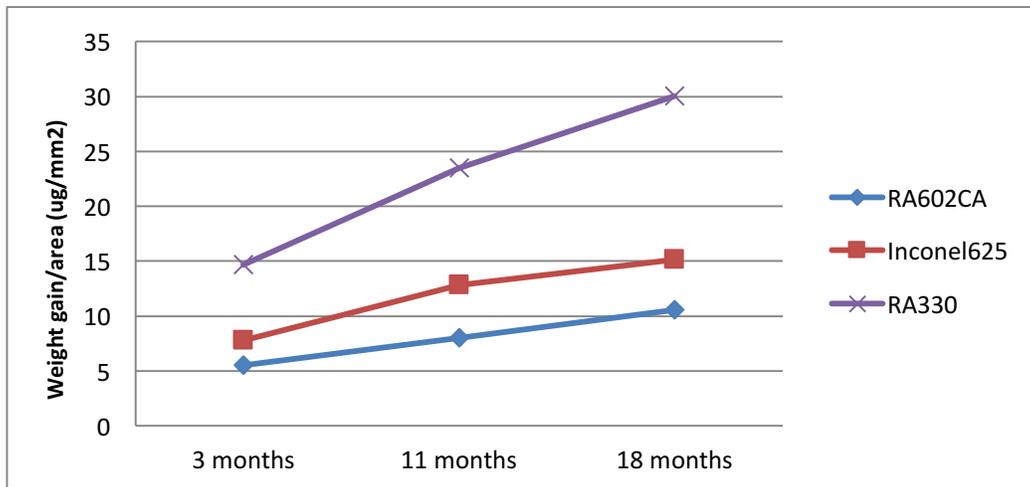
Figure 120. Weight gain per area as a function of time for unaluminized alloys

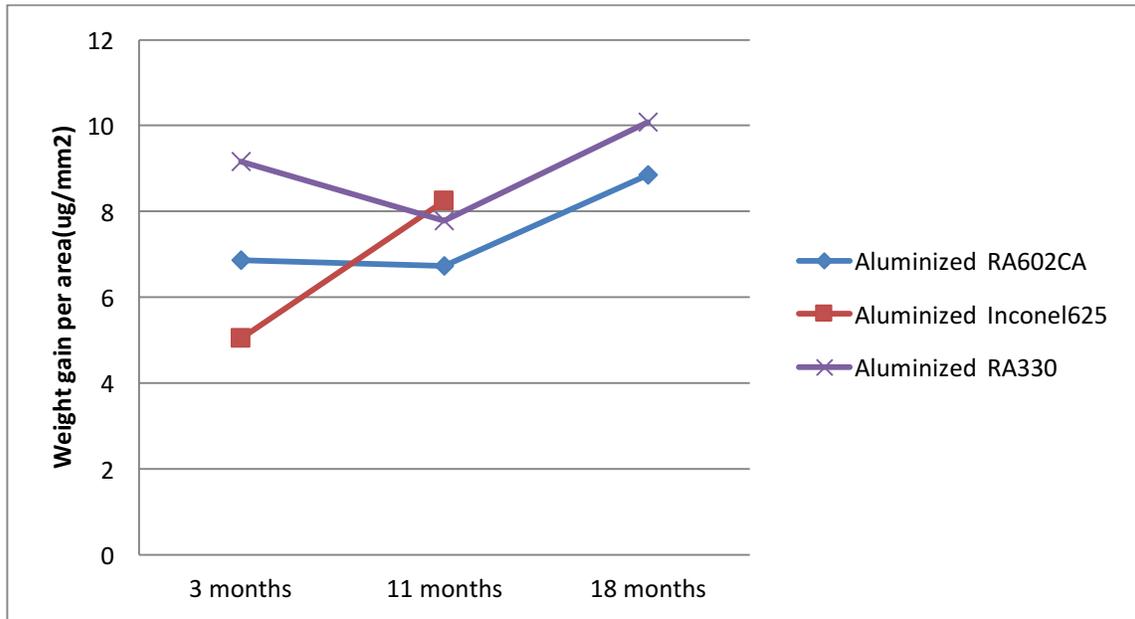
Figure 121. Weight gain per area as a function of time for aluminized alloys

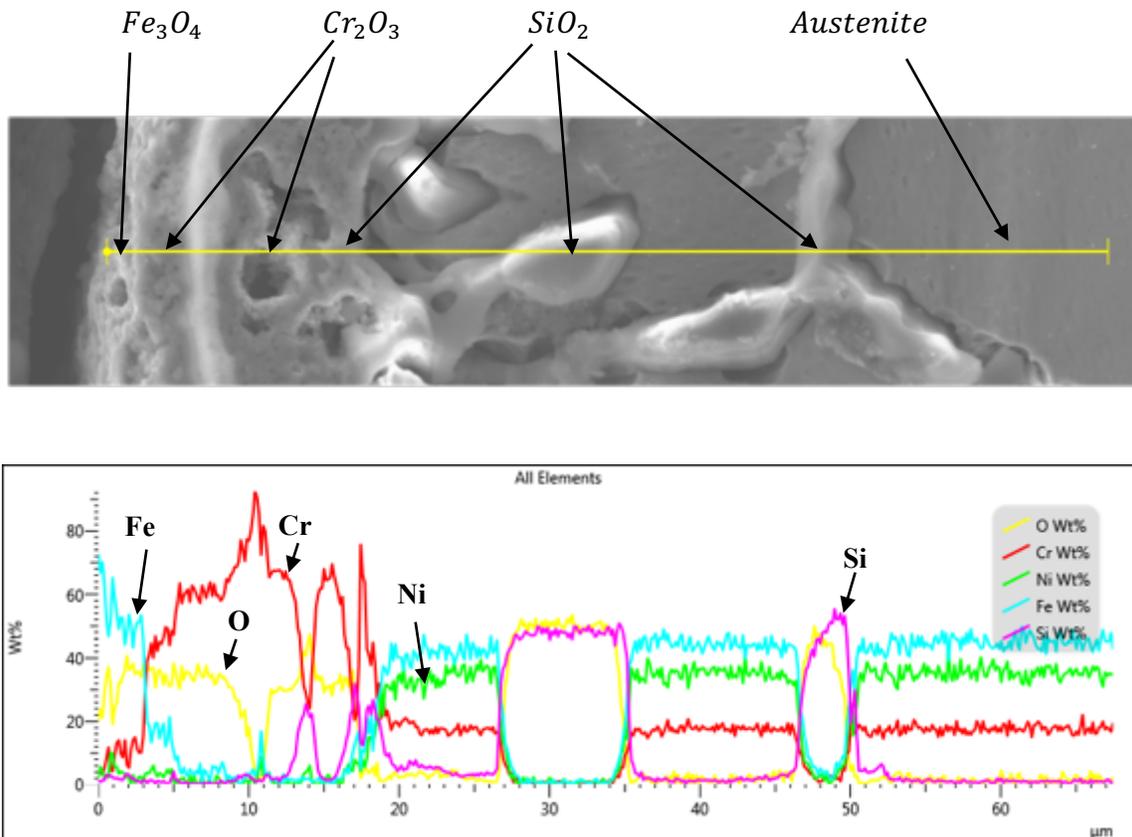
Figure 127. EDS line-scan of RA330 exposed for 12months from surface to the interior

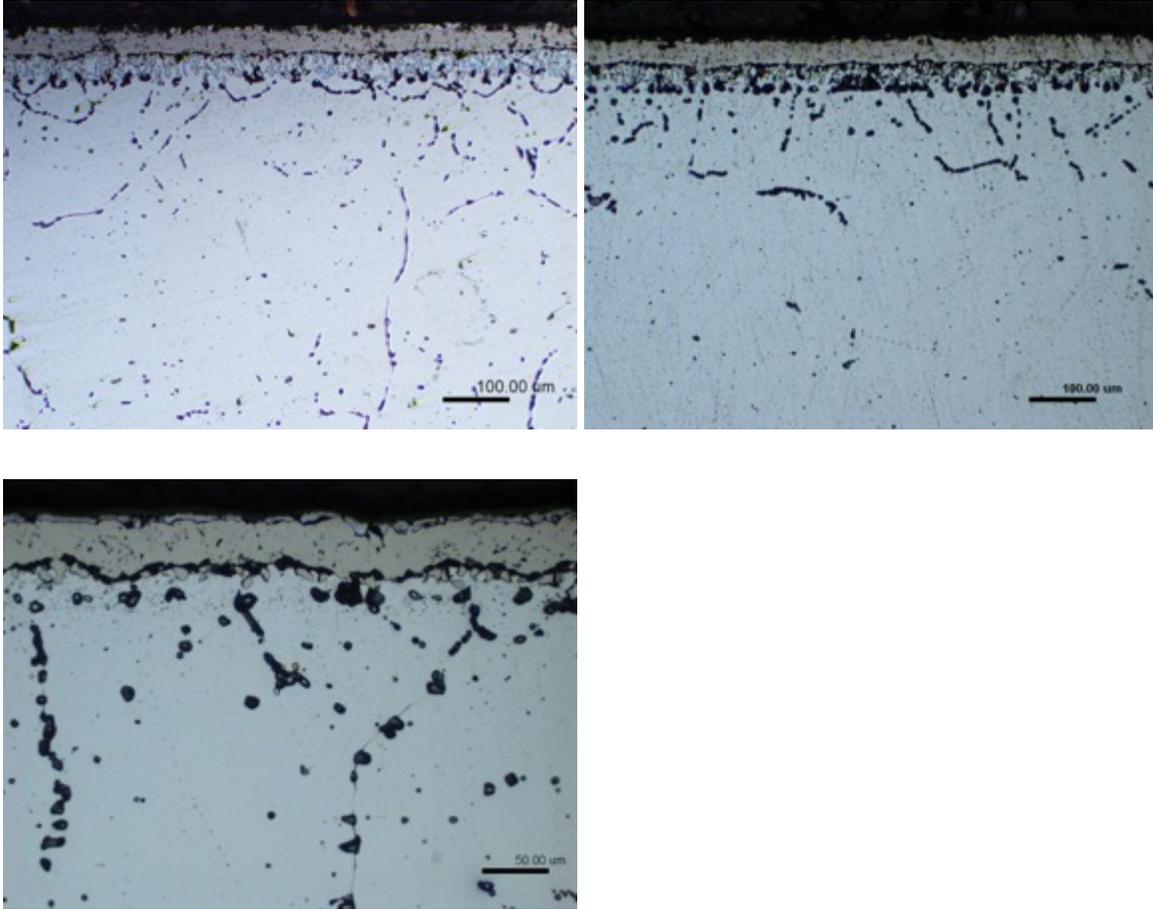
Figure 129: Optical photomicrographs of aluminized RA330, (a) original, (b) exposed for 3 months, (c) exposed for 12 months, (d) exposed for 18 months, (e) exposed for 24 months

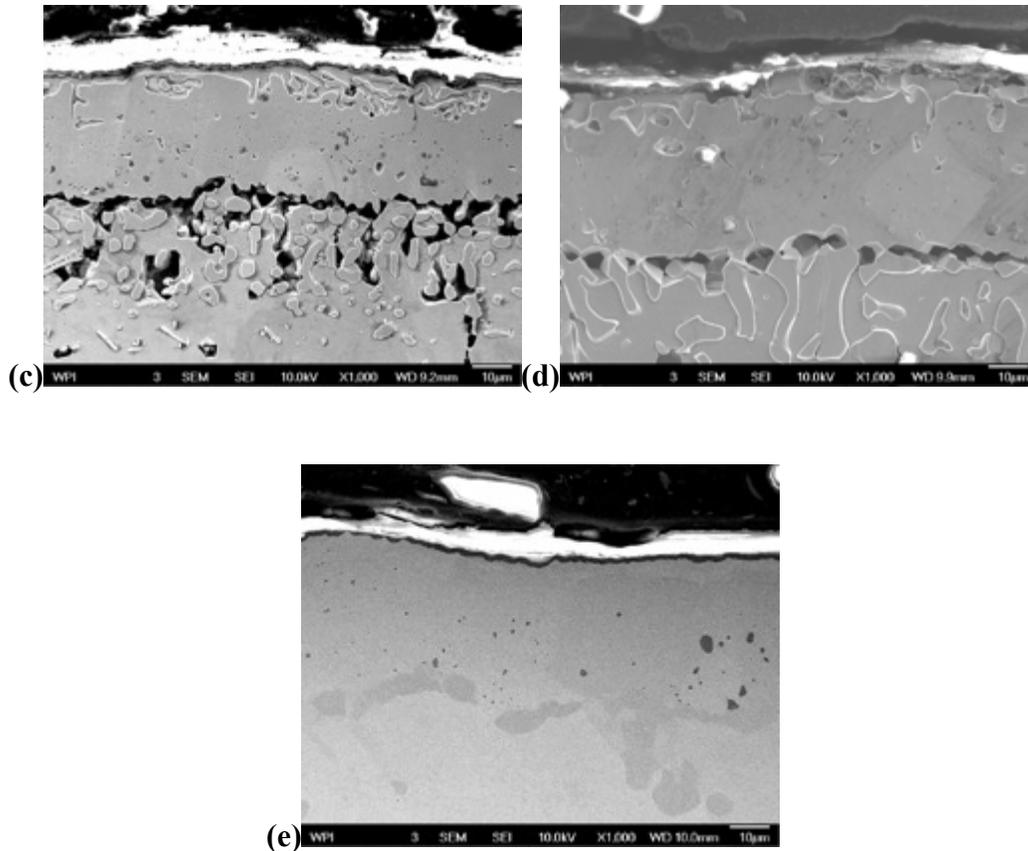
Figure 130: SEM photomicrographs of Aluminized RA330 a) As fabricated aluminized RA330 at edge, b) Electro-chemically etched as fabricated aluminized RA330, c) Electro chemical etched aluminized RA330 exposed for 3 months d) Electro-chemically etched aluminized RA330 exposed for 18 months, e) Polished aluminized RA330 exposed for 24months

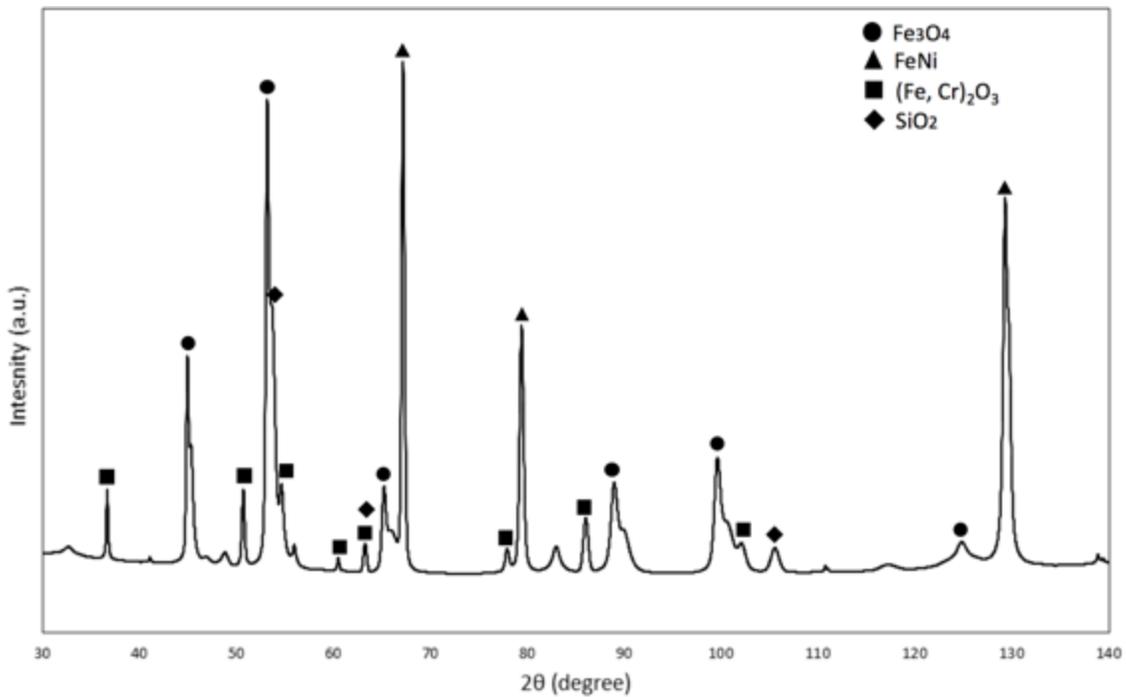
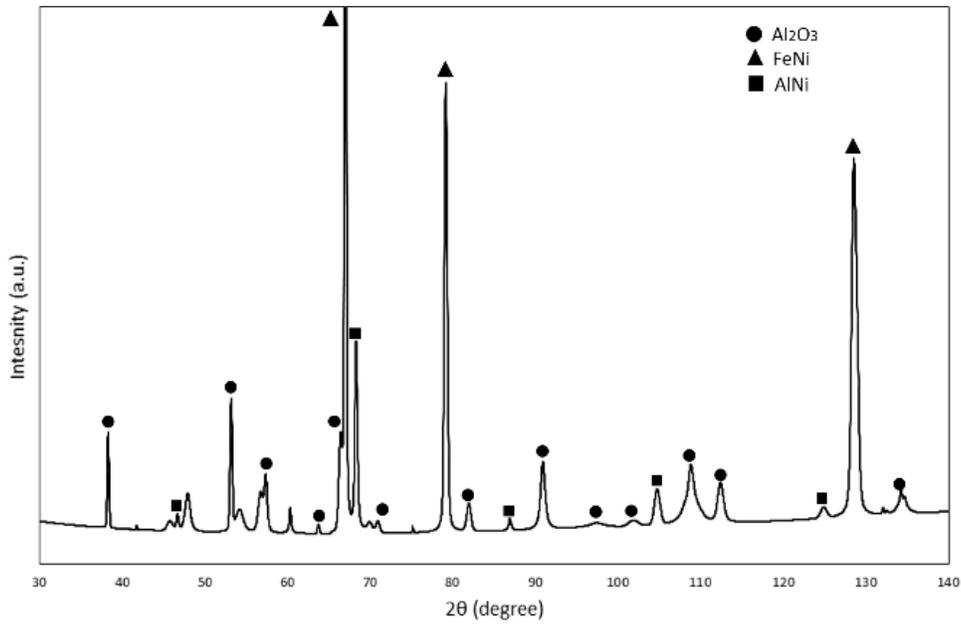
Figure 131: XRD analysis of RA330 (upper) and aluminized RA330 (bottom) exposed for 12 months

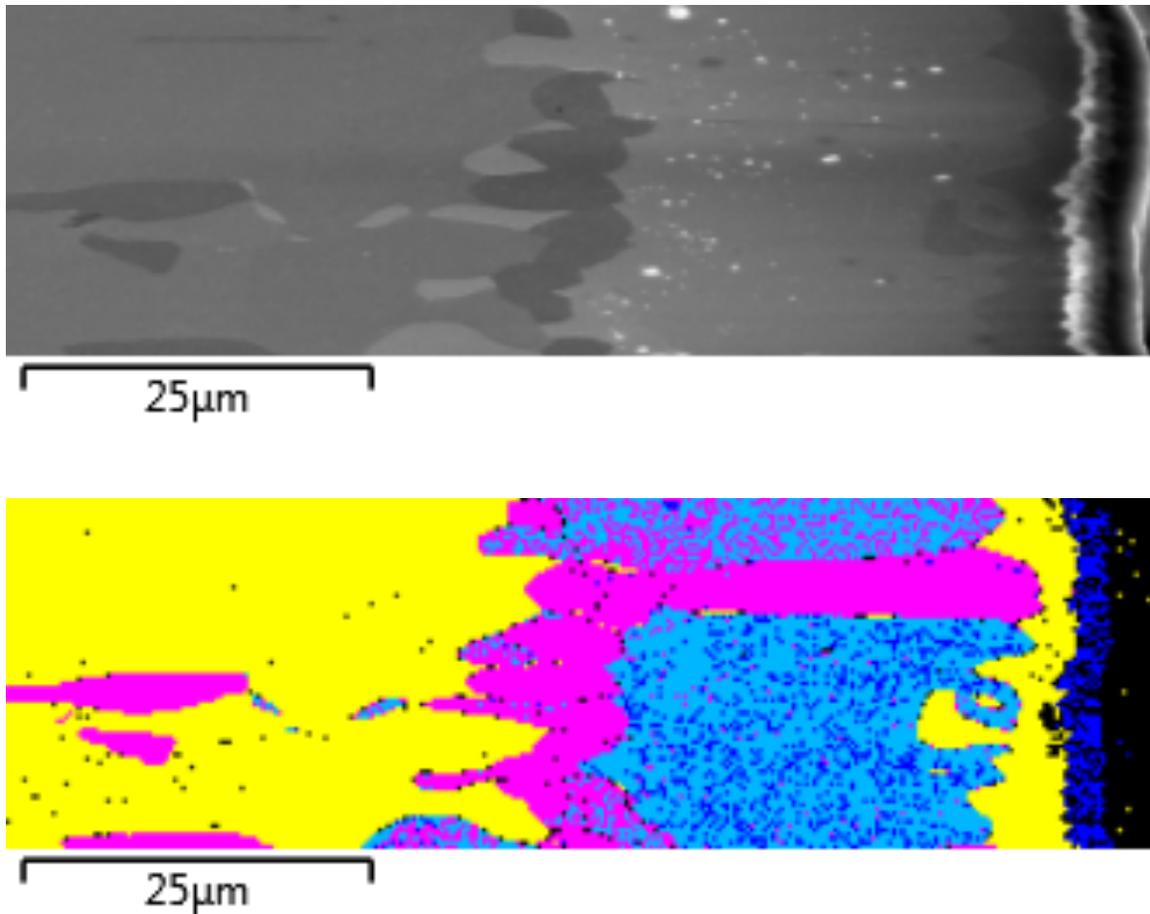
Figure 134: EBSD layered image of Aluminized RA330 exposed for 24 months at edge

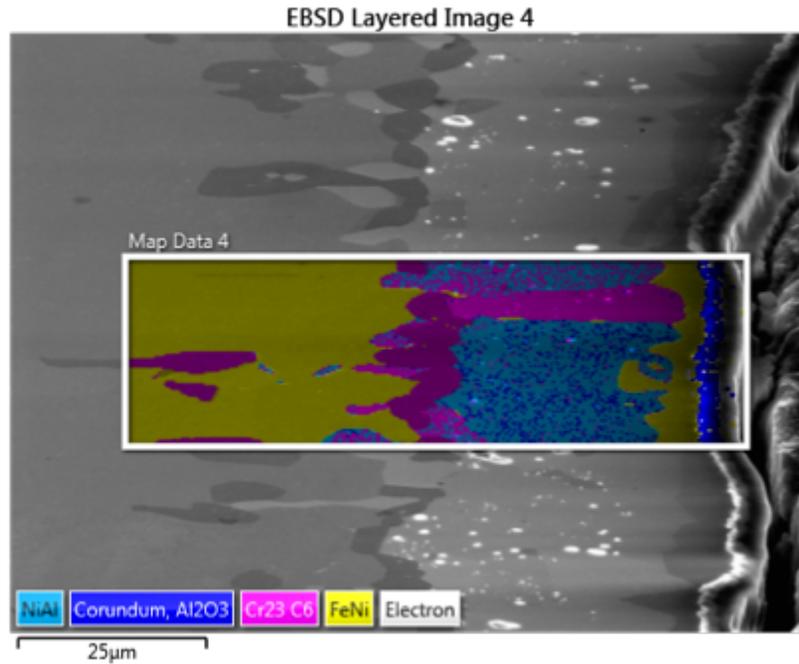
Figure 135. EBSD layered image of Aluminized RA330 exposed for 24 months at edge

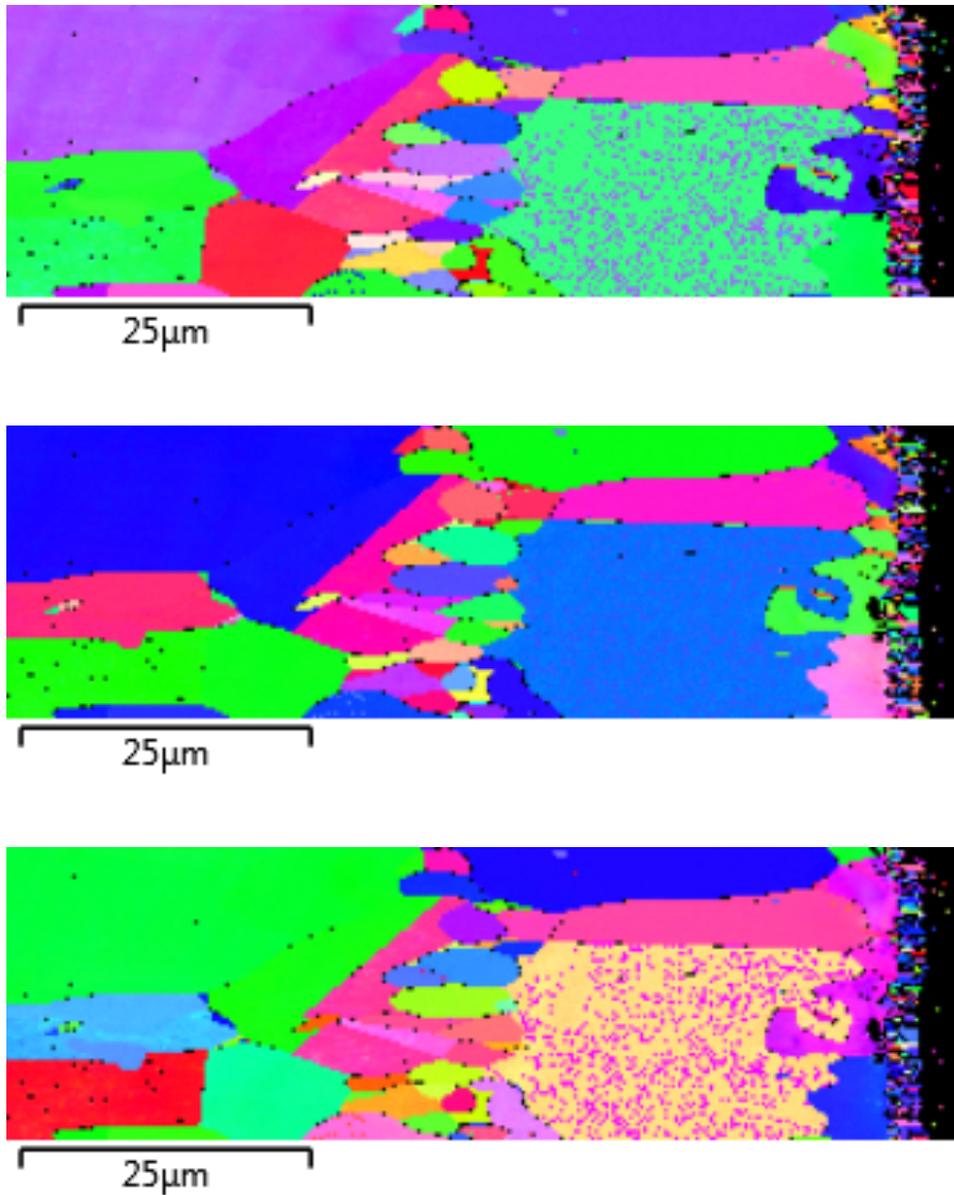
Figure 136: EBSD image of Aluminized RA330 exposed for 24 months at edge with XYZ axis orientations

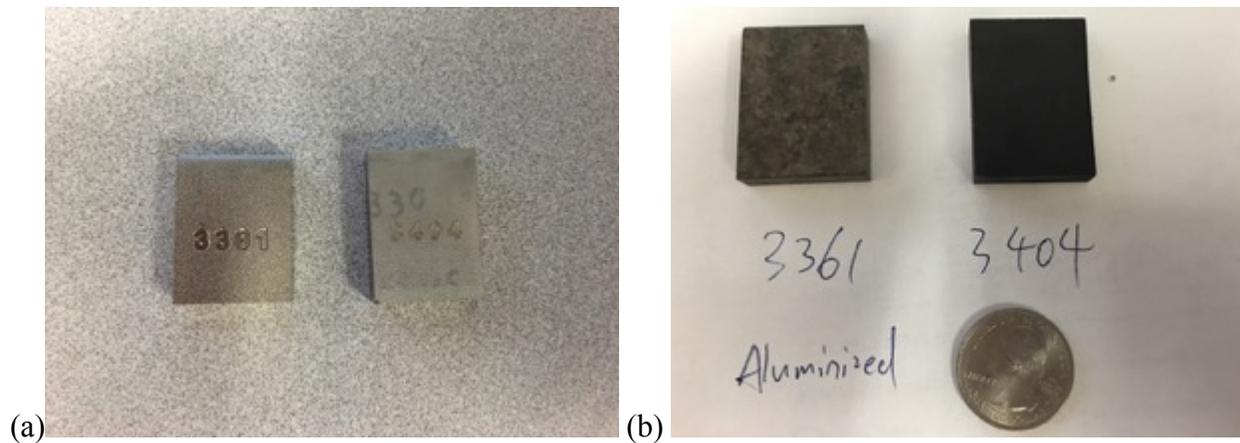
Figure 138: Cyclic oxidation samples aluminized RA330 (left) as-fabricated RA330 (right) before exposure (a) and aluminized RA330 (left) as-fabricated RA330 (right) after exposure (b)

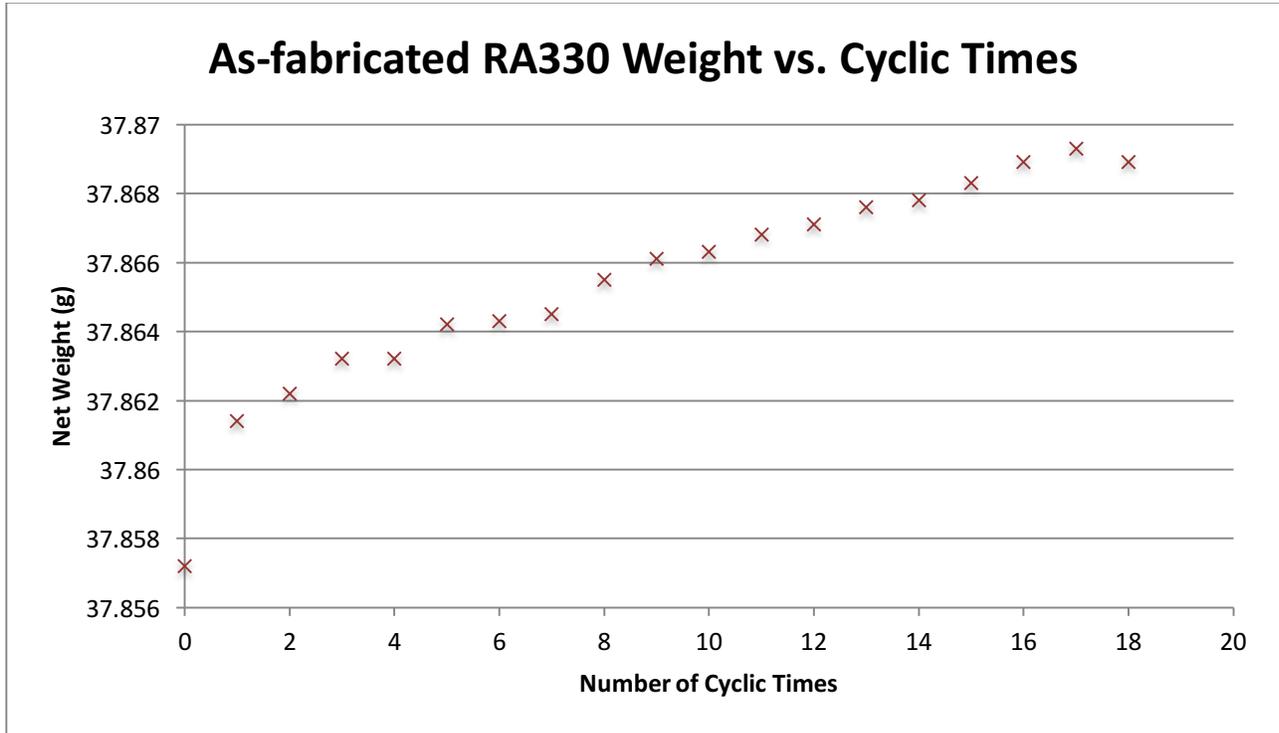
Figure 139: As-fabricated RA330 Weight vs. Cyclic Times

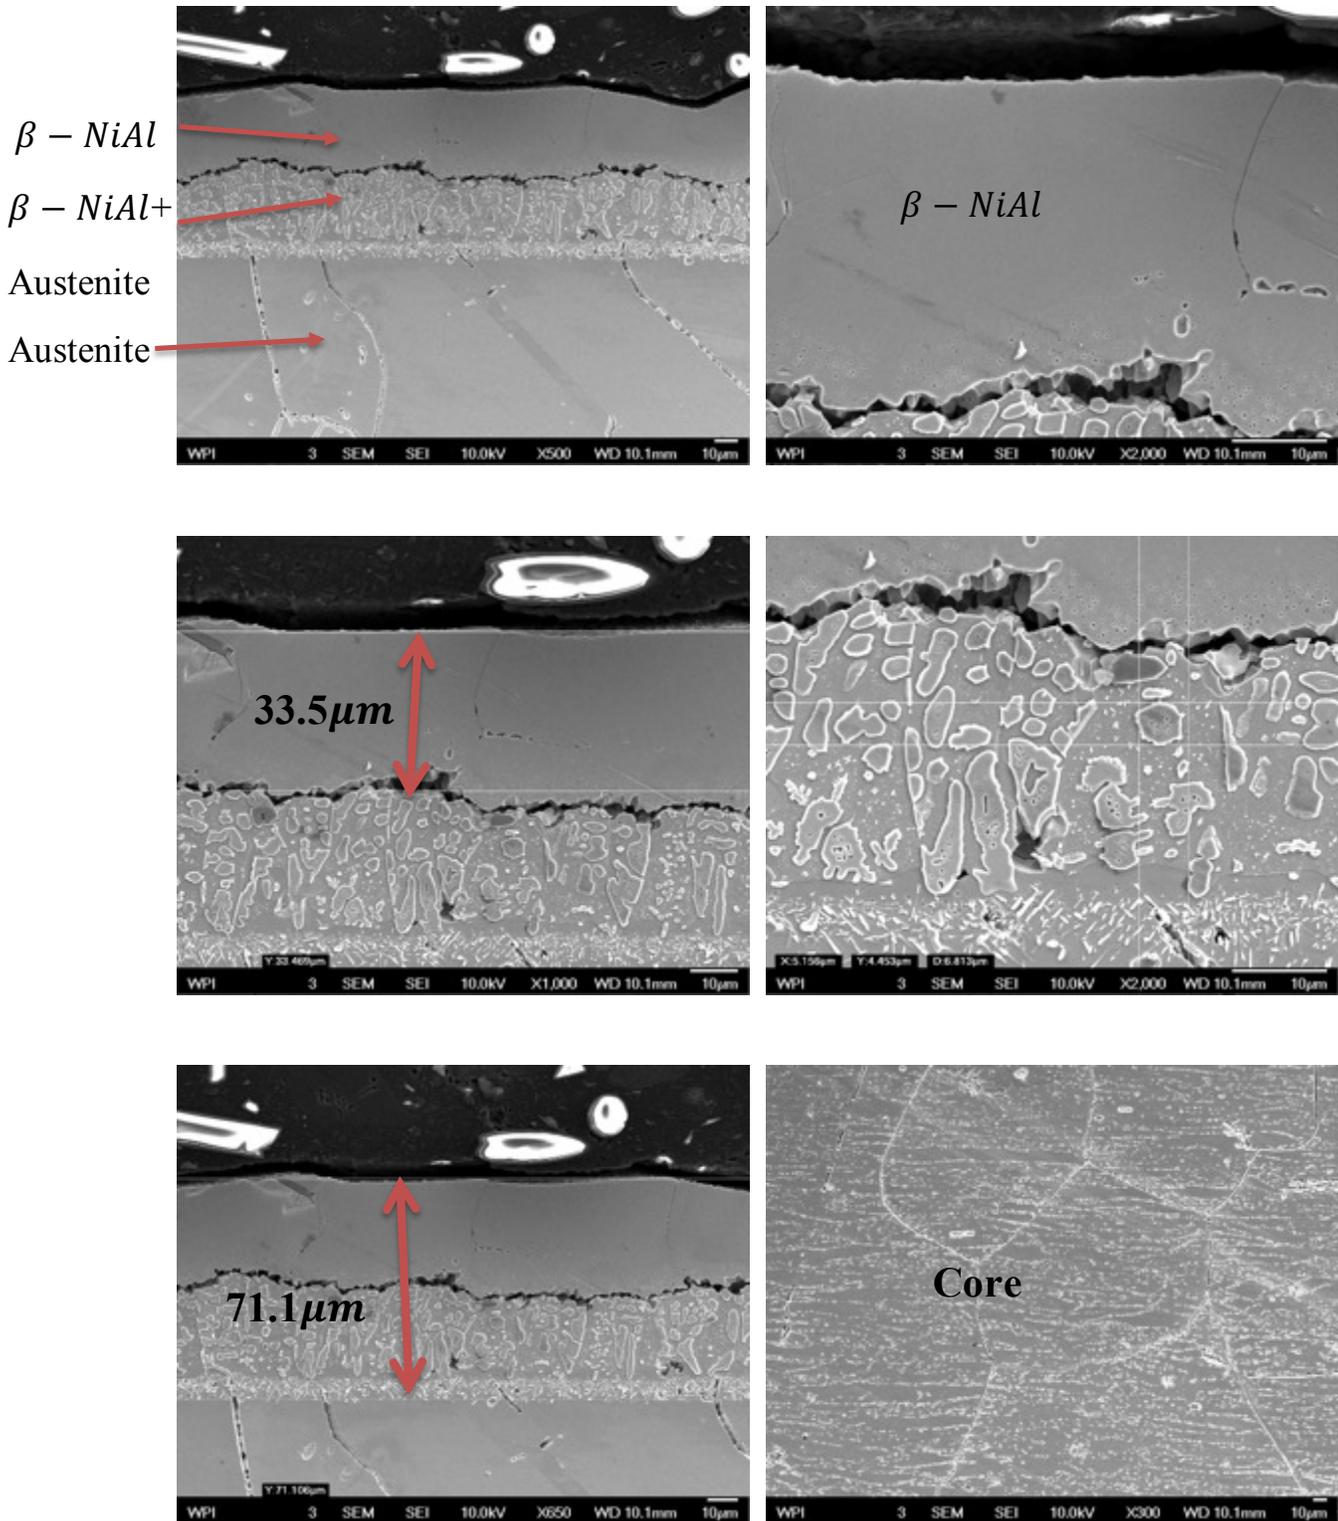
Figure 148: SEM photomicrographs of NaOH dipped aluminized RA330 pre-oxidized for 24h

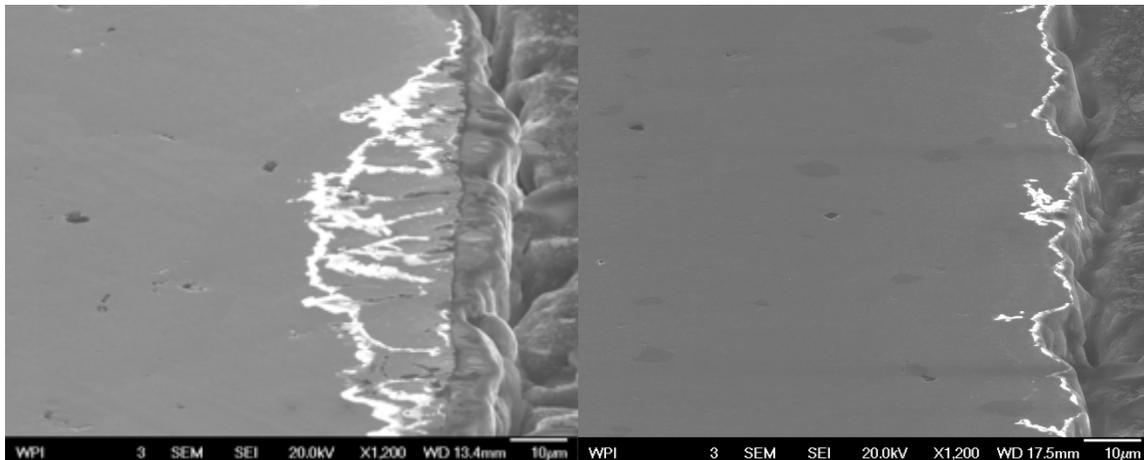
Figure 149: SEM photomicrographs of RA602CA exposed for 18 months(left) and SEM photomicrographs of RA602CA exposed for 24 months (right)

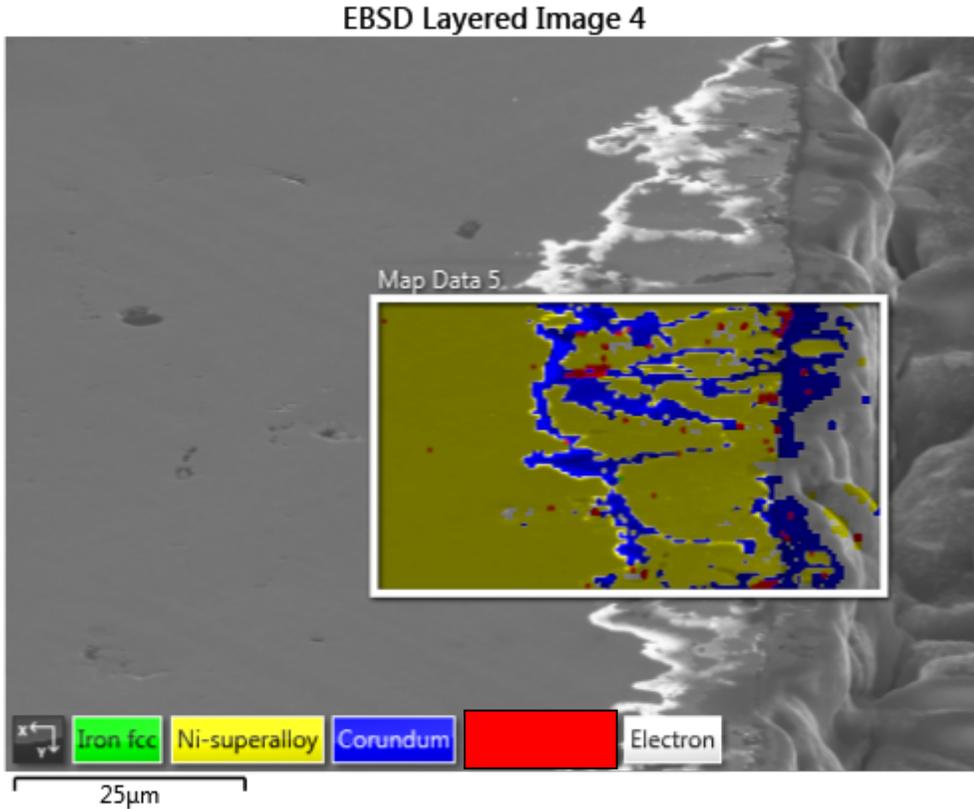
Figure 152: EBSD layered image of RA602CA exposed for 18 months at edge

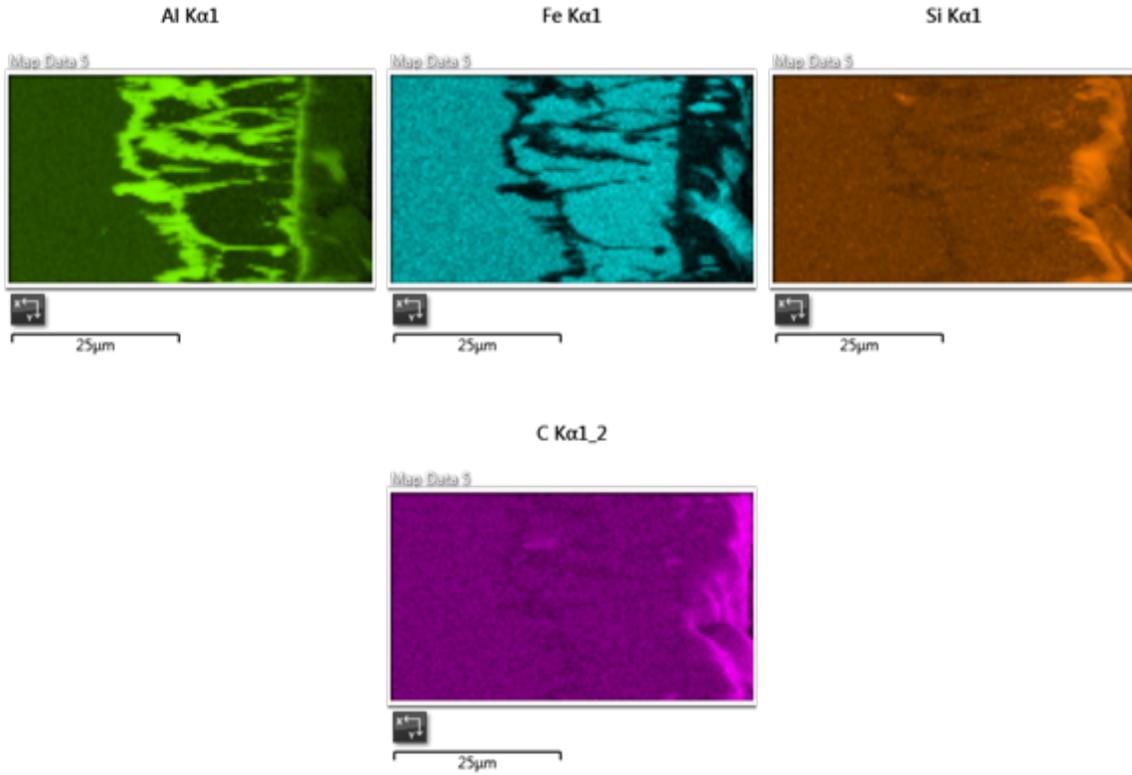
Figure 153: EDS mapping of RA602CA exposed for 18 months

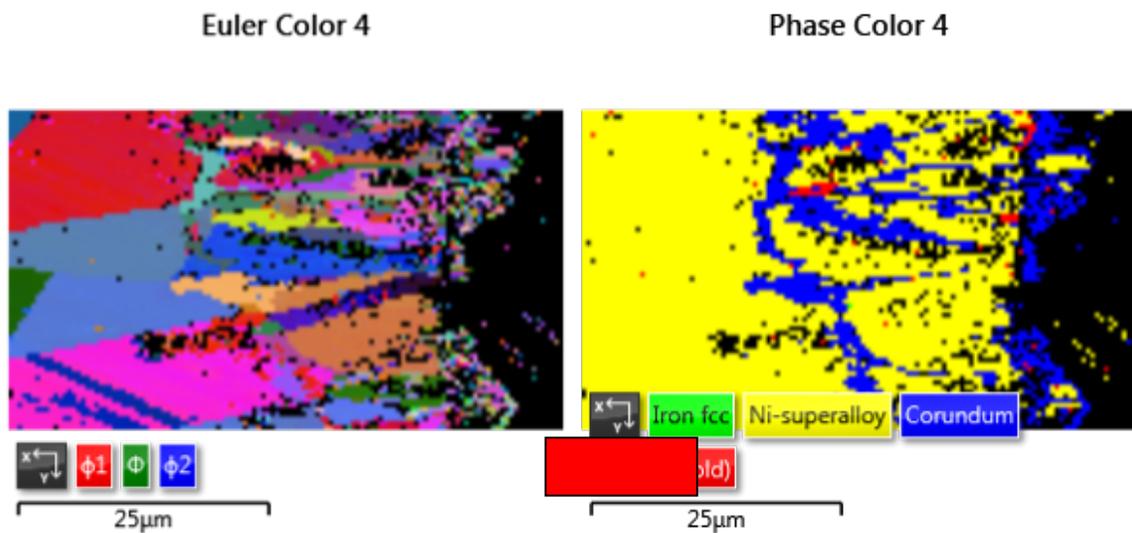
Figure 154: EBSD phase identification of RA602CA exposed for 18 months

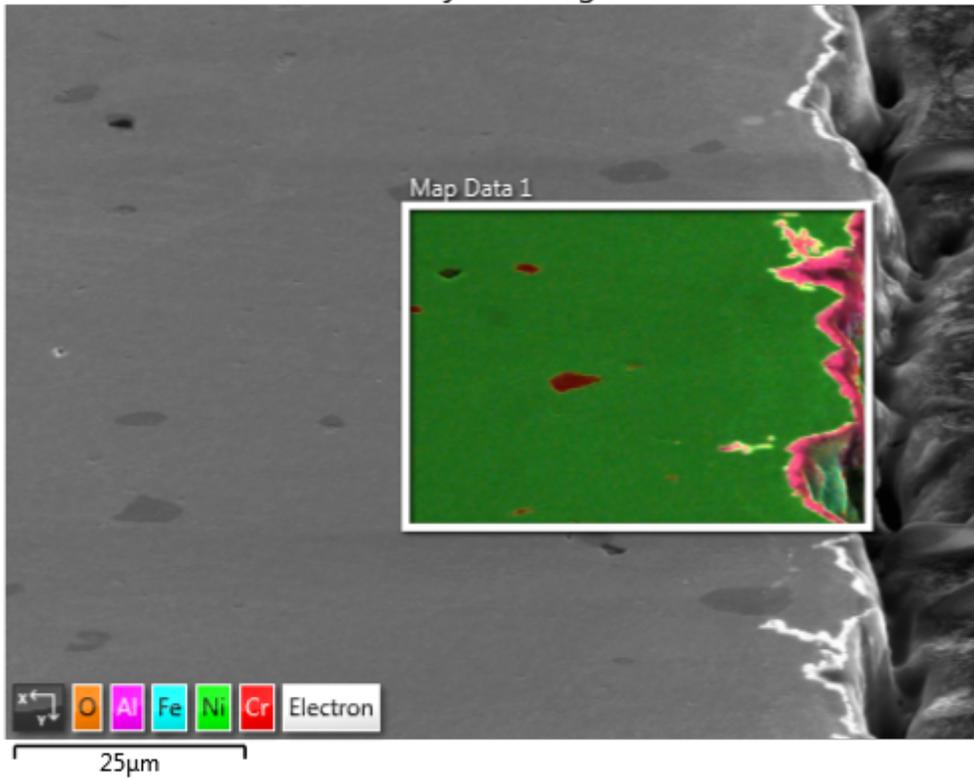
Figure 156: EDS layered image of RA602CA exposed for 24 months
