Life Extension of High Temperature Structural Alloys by Surface Engineering in Gas and Vacuum Carburizing Atmospheres

WORCESTER POLYTECHNIC INSTITUTE

Degree of Doctor of Philosophy

Materials Science and Engineering

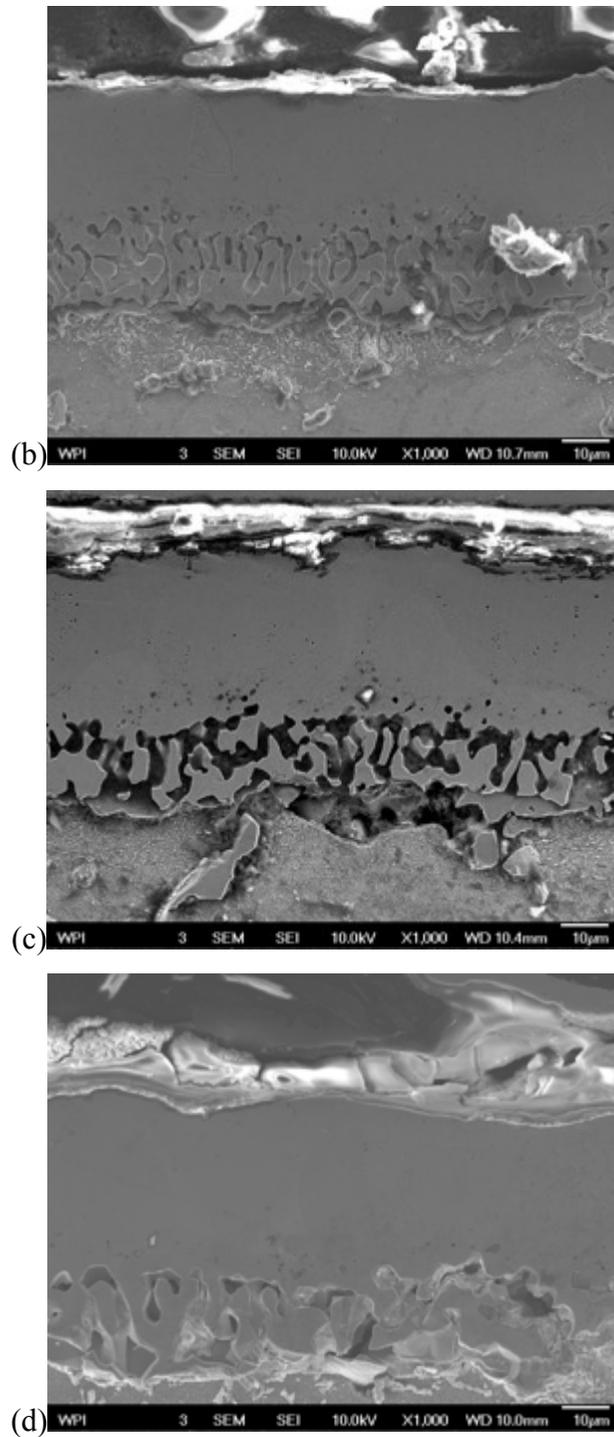
Figure 163: SEM photomicrographs of as fabricated aluminized RA602CA (a), aluminized RA602CA exposed for 3 months (b), aluminized RA602CA exposed for 12 months (c), aluminized RA602CA exposed for 24 months (d)

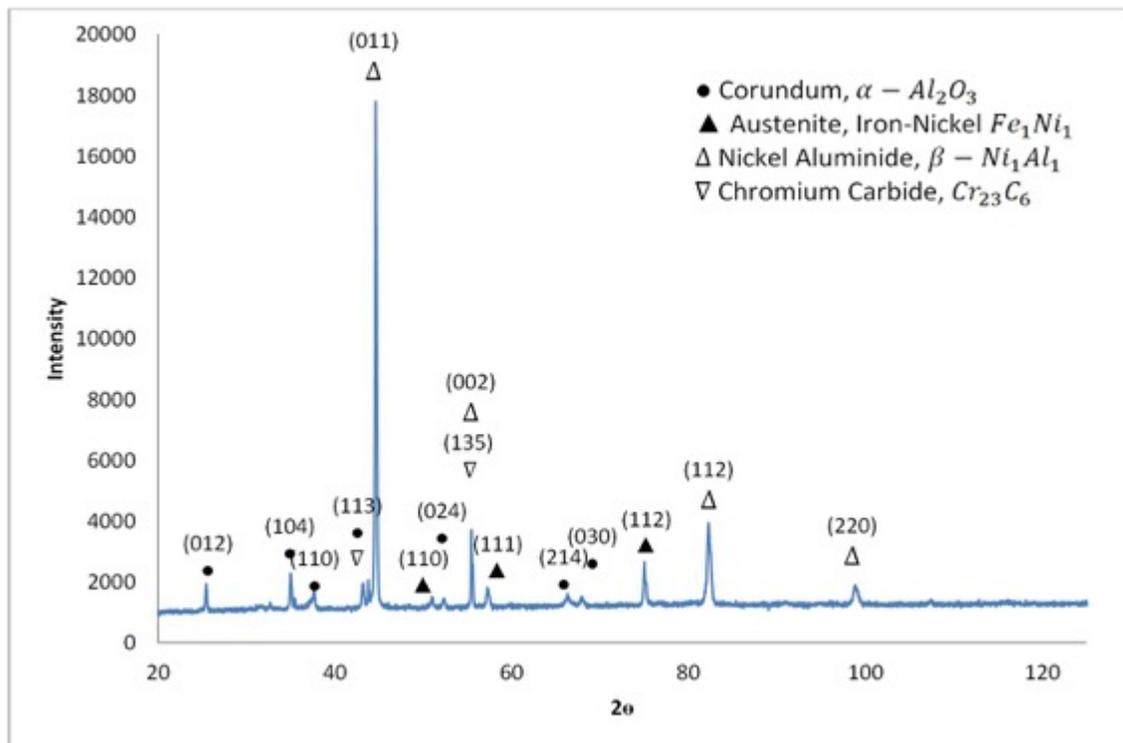
Figure 164. XRD analysis of Aluminized RA602CA exposed for 3 months

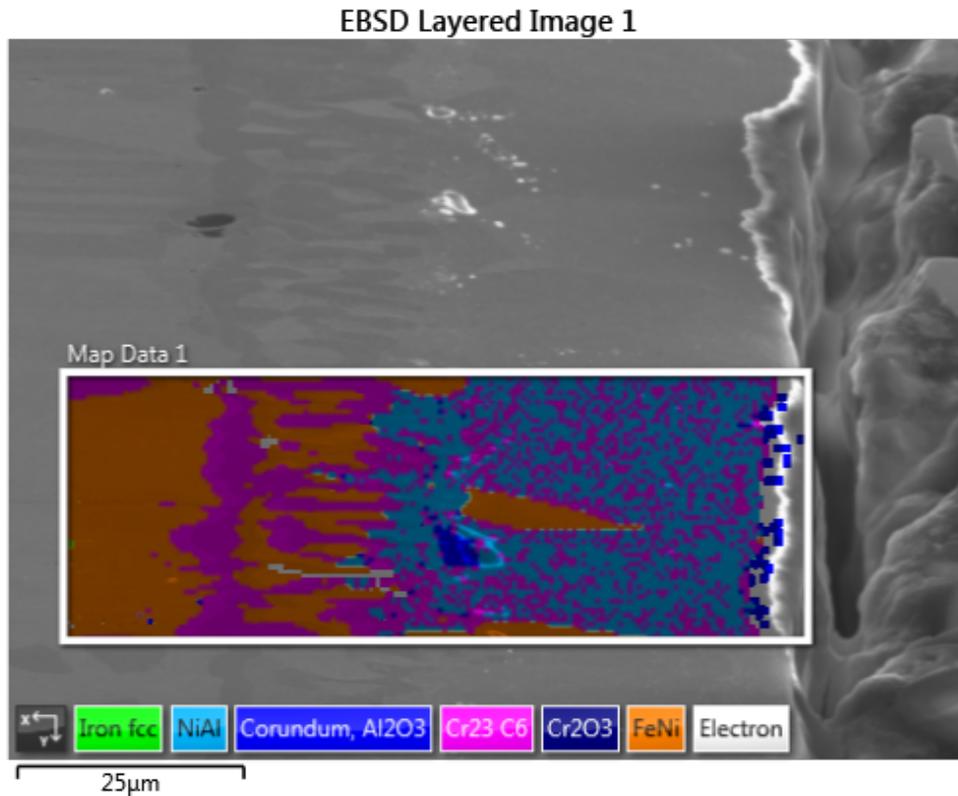
Figure 168: EBSD phase identification of aluminized RA602CA exposed for 18 months

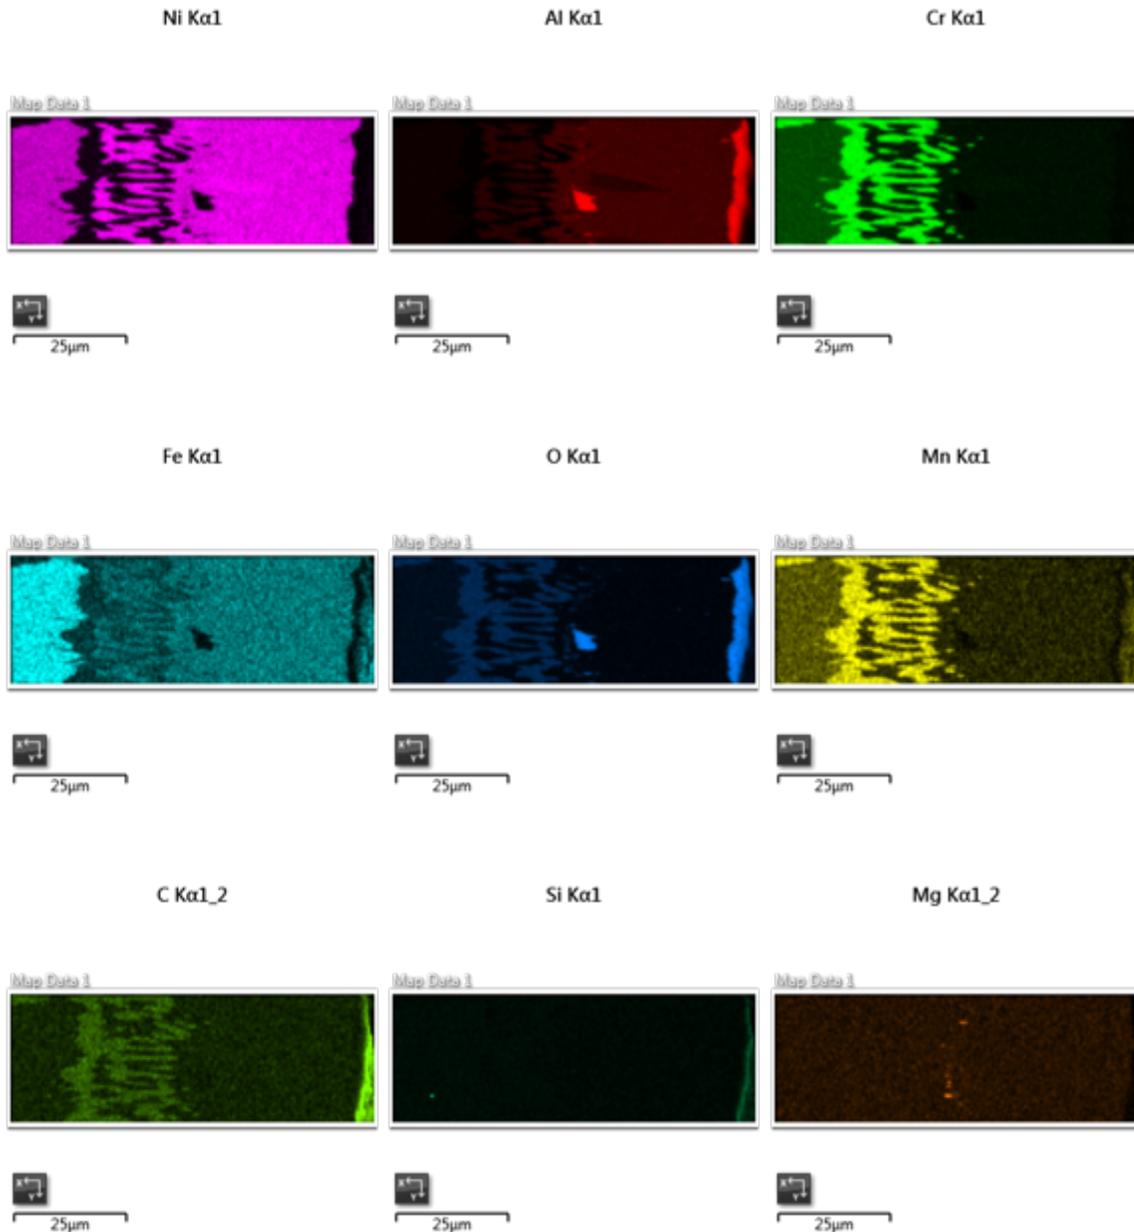
Figure 169: EDS mapping of Aluminized RA602CA exposed for 18 months

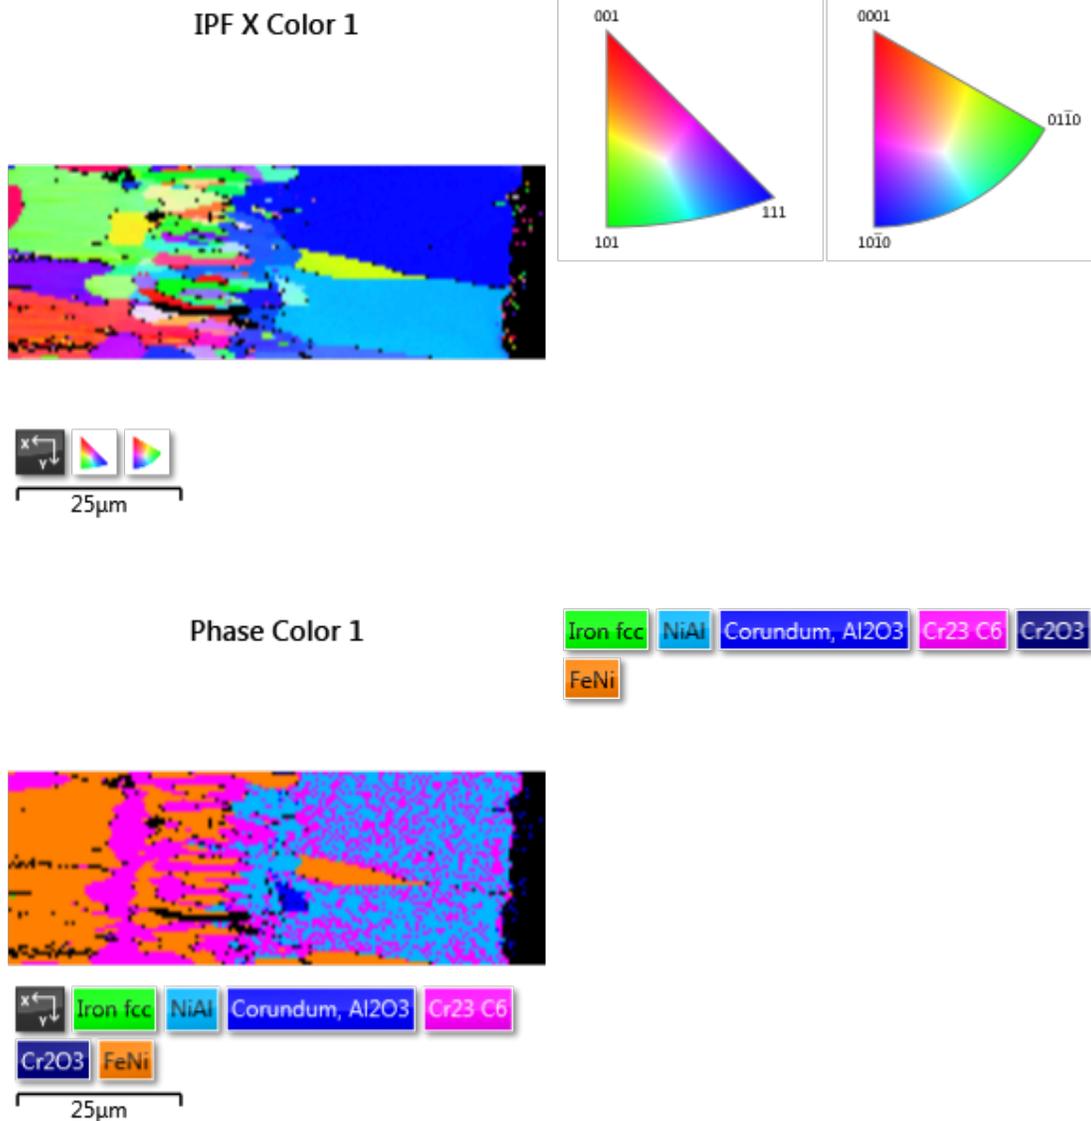
Figure 170: EBSD phase identification of aluminized RA602CA exposed for 18months

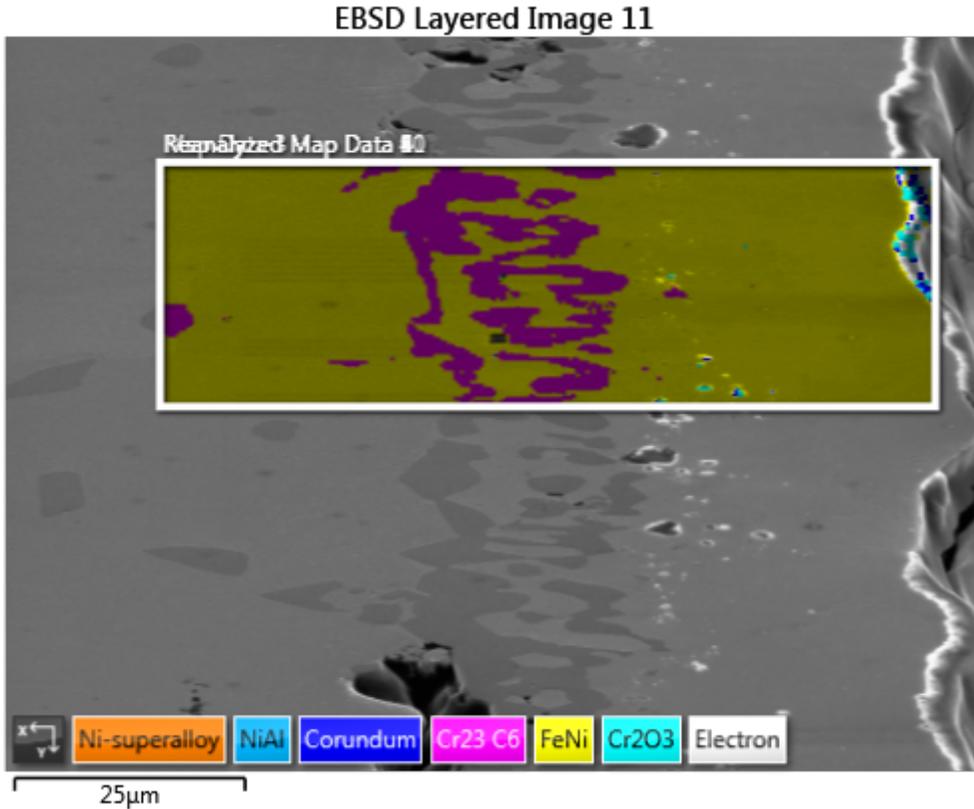
Figure 171: EBSD phase identification of aluminized RA602CA exposed for 24 months
