CAPE TOWN WATER AND SANITATION DESIGN

A Major Qualifying Project Proposal

WORCESTER POLYTECHNIC INSTITUTE

Date: April 23, 2009

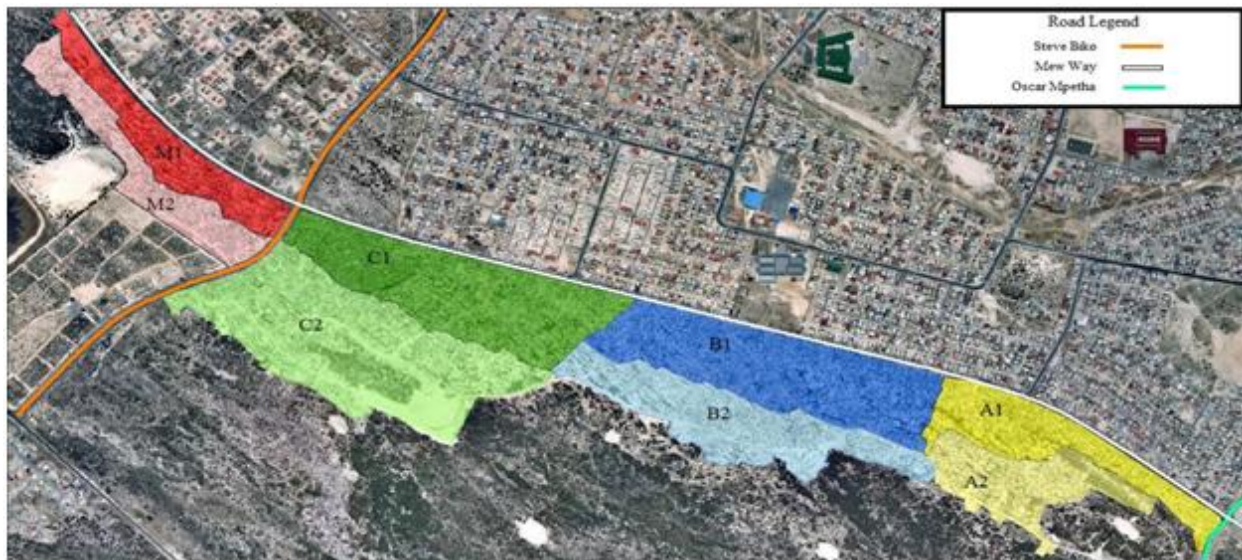
Figure 7: Division of Monwabisi Park Sections (Envisioning Endlovini, 2008)

With an employment rate between 55% and 77%, Monwabisi Park is a particularly impoverished area within Khayelitsha. There are four political sections in Monwabisi Park: A, B, C and M. These sections are further divided into subsections. Figure 7 shows the different sections of Monwabisi Park. There are 5785 shacks in Monwabisi Park, 510 of which are in C Section. “Subsections A1, B1, C1 and M1 have direct access to electricity but have no toilet facilities. Subsections M2, C2, B2, and A2 have no direct access to electricity, but are provided with toilet facilities by the city” (Envisioning Endlovini, 2008).

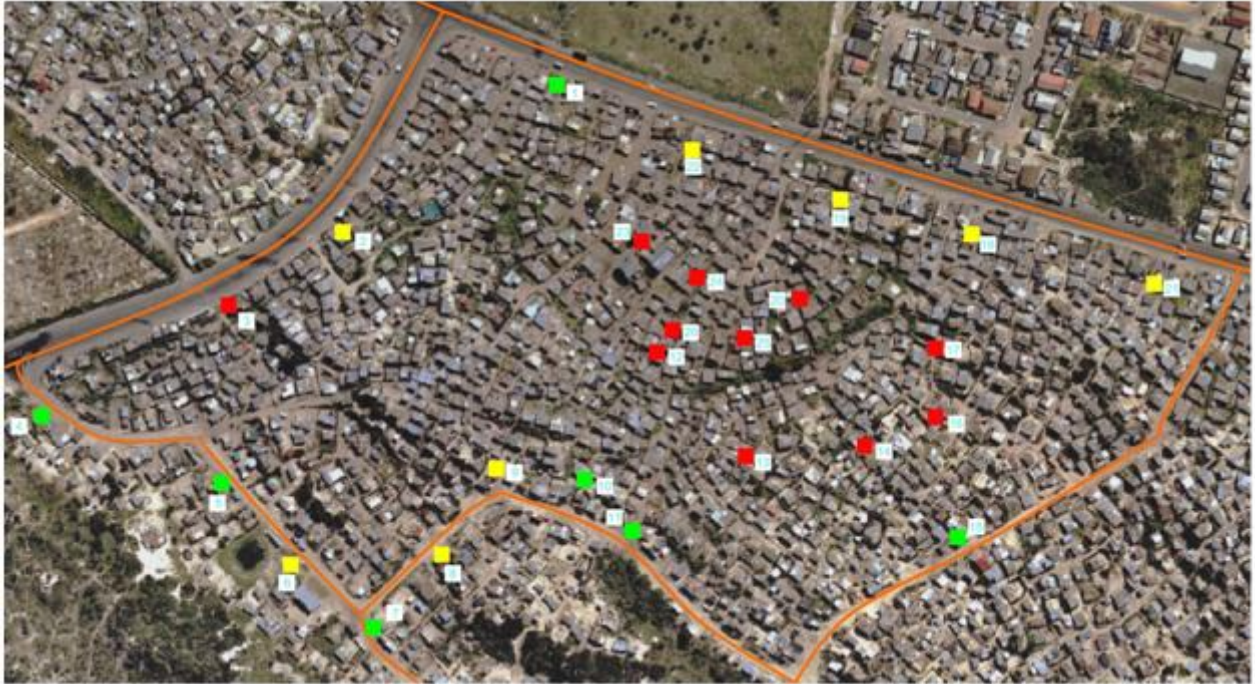
Figure 8: Location and Condition of Water Taps in C Section
(Granfone *et al.*, 2008)

Currently in C Section there are 27 water taps, seven of which are fully functional and eleven that are not functioning. The remaining nine taps possess problems such as missing handles and nozzles, broken piping, and leaks. As shown in Figure 8, the taps in better condition (shown in green) are located along the main roads surrounding C Section, whereas the taps in the center of the settlement are in poor condition (shown in red). The taps along the road are in better physical condition because of their close proximity to pour-flush toilets, which are more frequently maintained by the city. The residents also assist in the maintenance of the taps because without water their toilets do not function (Granfone *et al.*, 2008).

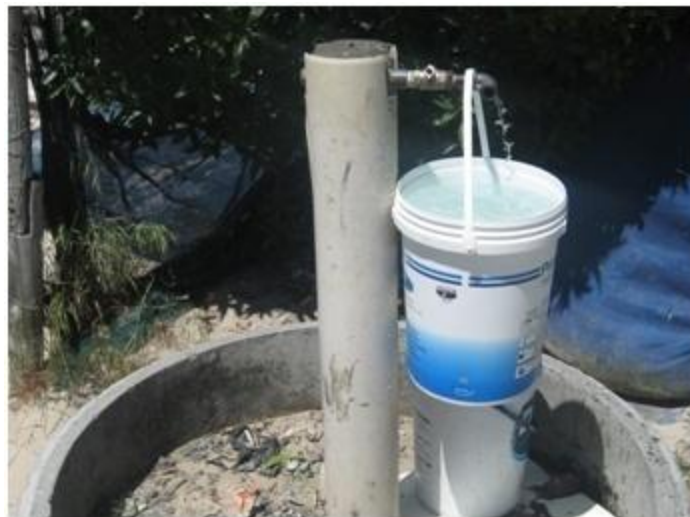
Figure 9: Water Bucket Being Filled in C Section (Granfone *et al.*, 2008)

The water taps are in poor condition for a number of different reasons. Misuse is a major contributor to water tap damage. With many people relying on a small number of taps, there is a physical burden on the structures themselves. For example, the faucets of the taps are at an inconvenient height. Subsequently, people hang their buckets from the nozzle to prevent spilling. When filled with water, the weight of the bucket stresses the piping of the nozzle causing it to bend, break, and leak. Figure 9 shows a bucket hanging from the nozzle of a tap. Residents also fill the cement drainage cylinder around the tap with sand, garbage, and rocks making it a resting place for the bucket. These materials prevent the water from properly draining (Granfone *et al.*, 2008).

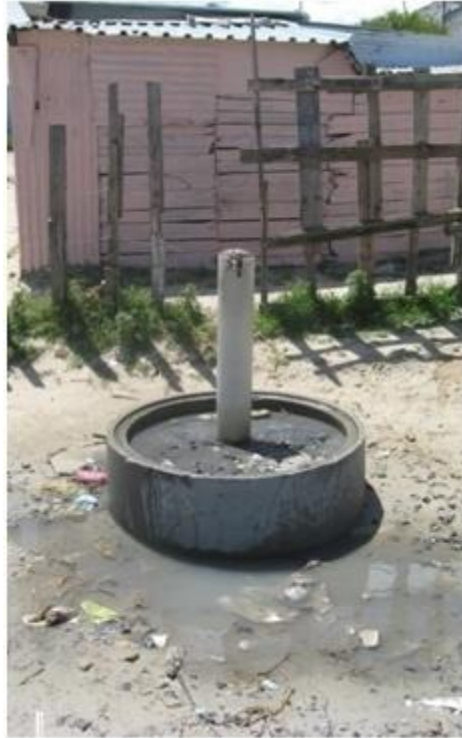
Figure 10: Standing Water at a Water Tap in C Section (Granfone *et al.*, 2008)

Poor drainage is major issue because it results in standing water, which directly affects the health of the community. As mentioned above, the water taps are installed above a cement cylinder intended to aid in proper drainage. The cylinder is filled with stone to allow for more rapid drainage into the ground. However, due to misunderstanding of the residents, these drainage cylinders get clogged with trash, food scraps, and sand. The failure of the drainage cylinder results in standing water in and around the taps, which becomes an area of high contamination as explained in Section 3.3. Additionally, food scraps are left in the cylinders, which attract flies and promote the growth of bacteria (Granfone *et al.*, 2008). Figure 10 is a picture of a tap in C Section surrounded by standing water.

The City of Cape Town attempted to facilitate drainage by installing irrigation systems next to the taps. However, these irrigation systems failed because fats and oils from dishwashing clogged the irrigation pipes.

Residents have also made failed attempts to eliminate standing water in the drainage cylinders. For example, residents have punctured holes in the drainage cylinders allowing water to drain out of the bottom preventing it from pooling at the top. However, this caused the water to flow into one area next to the cylinder, which also had poor drainage and caused erosion. Additionally, the constant overflow wears away the surrounding landscape causing damage to roads (Granfone *et al.*, 2008).

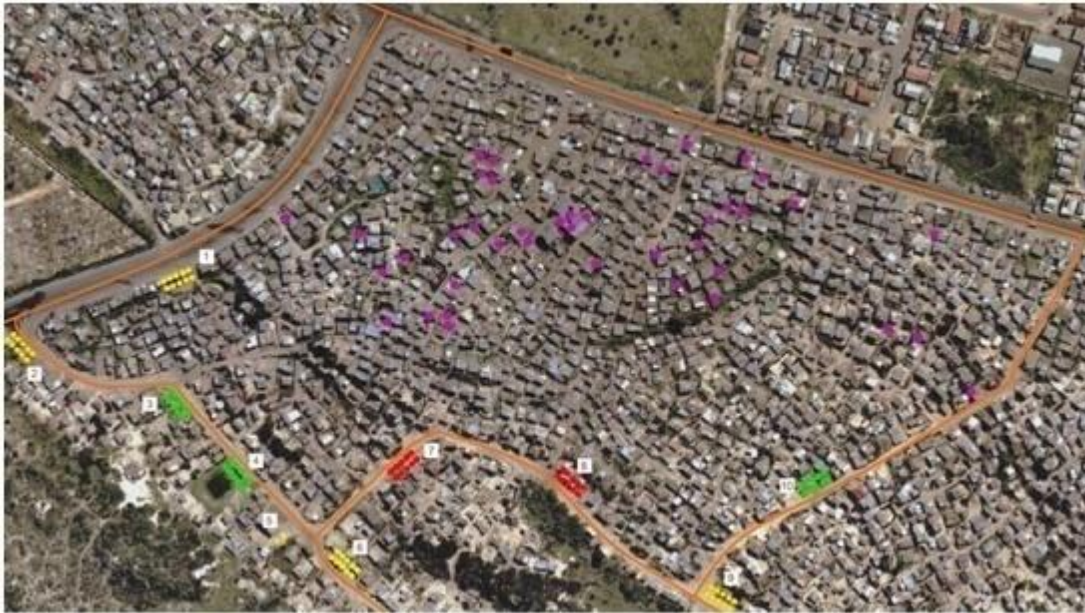
Figure 12: Sanitation Services in C Section (Granfone *et al.*, 2008)

Figure 12 illustrates the distribution of sanitation facilities across C Section in Monwabisi Park. The green markers indicate toilets in good condition, the yellow markers show toilets in fair condition, the red markers indicate pour-flush toilets in poor condition and the purple markers indicate pit latrines.

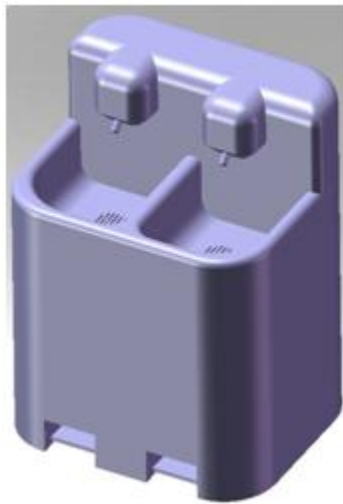
Figure 15: Proposed Hand Washing Station (Granfone *et al.*, 2008)

Public sinks would be part of the facility as well. Granfone *et al.* (2008) recommended the sinks use water primarily from rainwater collection tanks. Although the rainwater collection tanks are unlikely to supply sufficient water for full-time use, the strategy conserves water and reduces the demand on the municipal water system. Public sinks should encourage hand washing, especially if soap is provided. This would hopefully decrease the transmission of disease around the facility. Walking paths would lead people past the sinks as they exit the facility to further encourage hand washing. A sample hand washing station is shown in Figure 15.

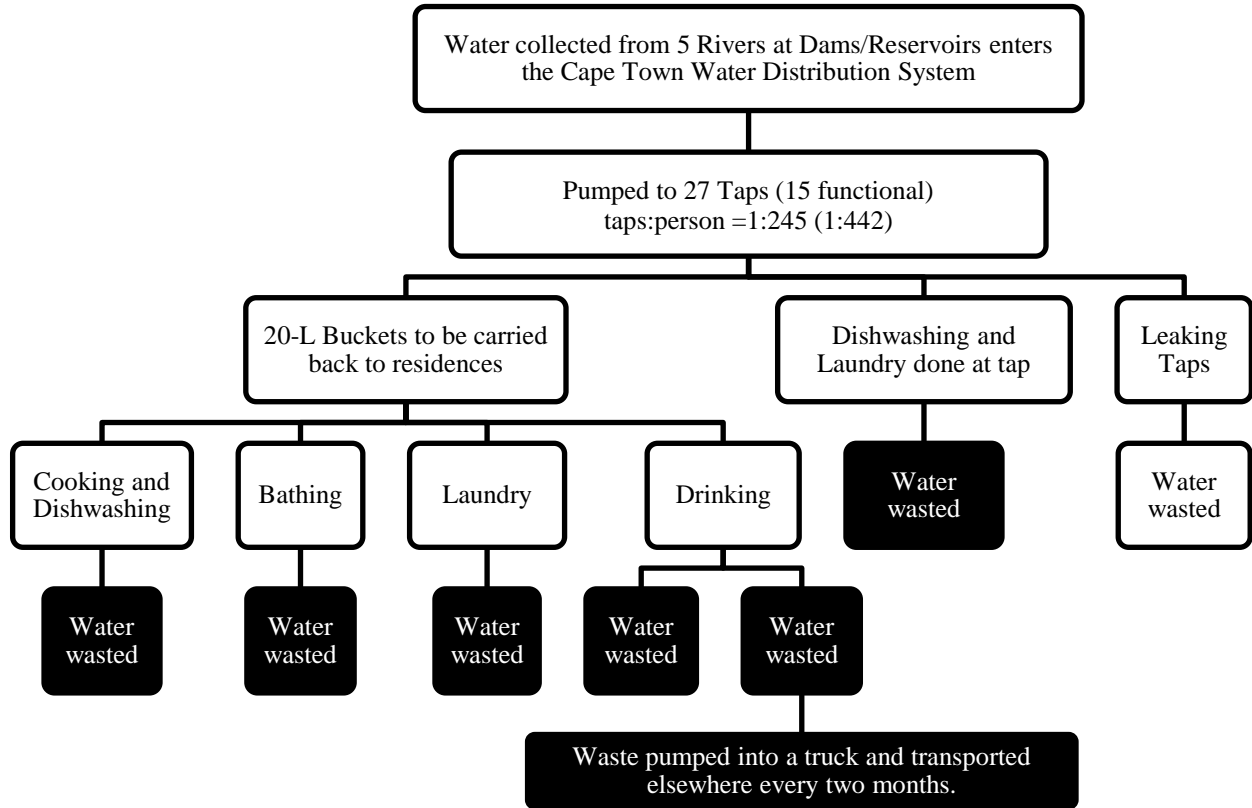
Figure 18: Water Flow through the Community

Figure 18 displays the flow of water from the city distribution system to the home of a Monwabisi Park resident. In this figure, the black boxes represent water that has been used and contaminated. As shown by Figure 18, almost all of the water used by Monwabisi Park residents is wasted after it is used. This dirty water is disposed of in the streets and yards of residents, contributing to the high amounts of standing water that pose potential health risks. Current water use practices provide no means for used water to either be treated or reused.

By comparing Figure 23 and Figure 24 to Figure 18 in Section 3.6, it can be concluded that the facility would greatly decrease the amount of water that is wasted within the community. When water is wasted, it contributes to standing water, thus exposing the residents to public health risks. When water is treated in the facility, it is recycled and reused to water the garden. Additionally, any water that infiltrates through the garden or additional leach field would be naturally treated and thus would not be contaminating groundwater. Most importantly, water would be delivered to the community safely and reliably.

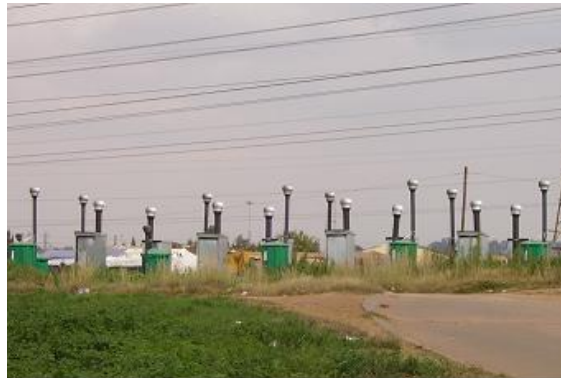
Figure 22: Enviro Loo Toilets at an Informal Settlement (Clean up America, 2009)

The Enviro Loo has already been implemented successfully in many areas across South Africa and around the world. Enviro Loos have been installed at schools, conference centers, national parks, and informal settlements in South Africa. Figure 22 shows multiple Enviro Loos installed in close proximity in another informal settlement in South Africa. They have been installed in the United States at Boy Scout Camps and Golf Courses. Enviro Loo toilets can also be found in France, Australia, Dubai, and Namibia. Each of these case studies reported positive feedback; the Enviro Loo effectively treated the waste (Belzak, 2009).

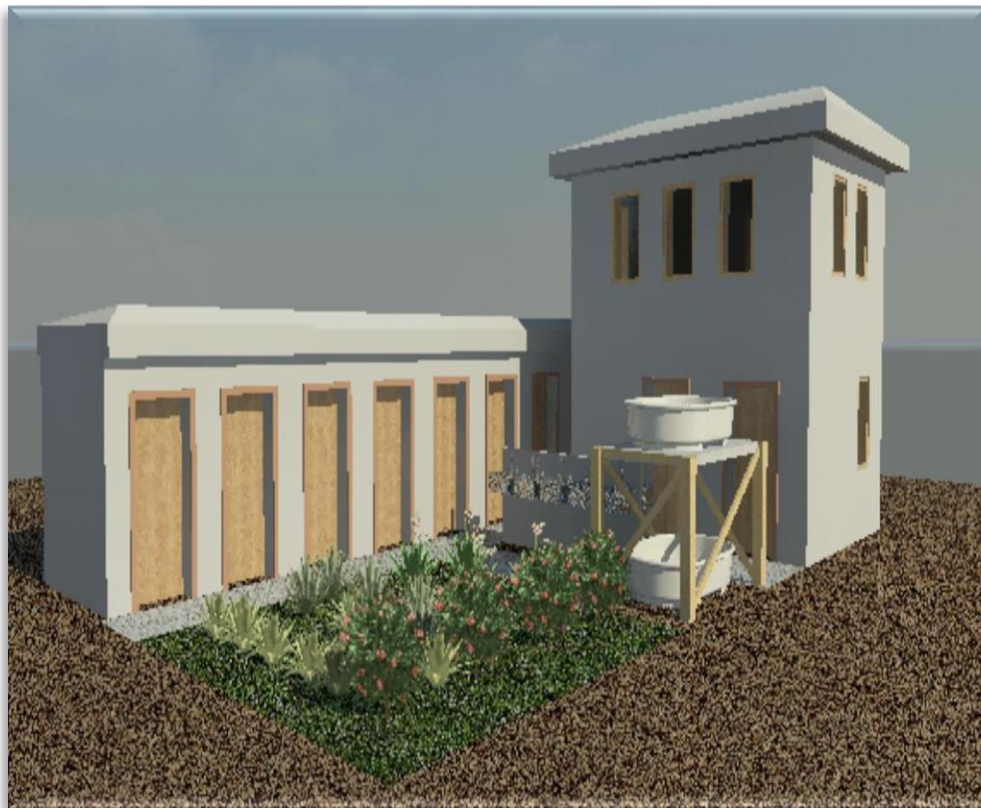
Figure 26: Facility Variation

It is understood that not all areas in C Section would have the same design needs as the Indlovu Center site. One constraint driving the design of any facility is sun exposure. The Enviro Loo toilets should always be placed in the area of the lot that is facing north. Another constraint for the facility is space. Figure 26 shows a 3-dimensional rendering of the facility. Because excess space is unavailable, the facility is compact and thus changes to the design are limited.
