GATEWAY PARK PROJECT: CEMENTITIOUS UNDERLAYMENT & INFORMATION EXCHANGE

A Major Qualifying Project:

Worcester Polytechnic Institute

Date: March 5th, 2007

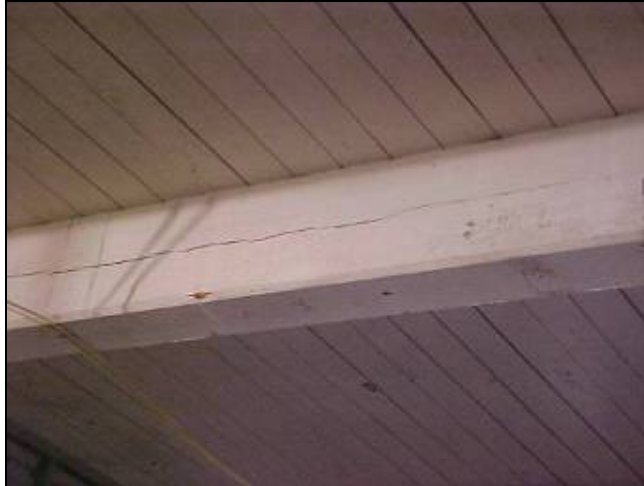
Picture 4: Oak Girder & Southern Yellow Pine Planks

The girders are made of ten by sixteen inch oak timbers, as seen in Picture 4, resting on top of oak columns.

Picture 4 also shows the underside of the 3"x7" full dimensional southern yellow pine planks that are connected to the top of the girders by large nails. These planks are connected together by a tongue and groove joint which are spaced every eight or sixteen feet.

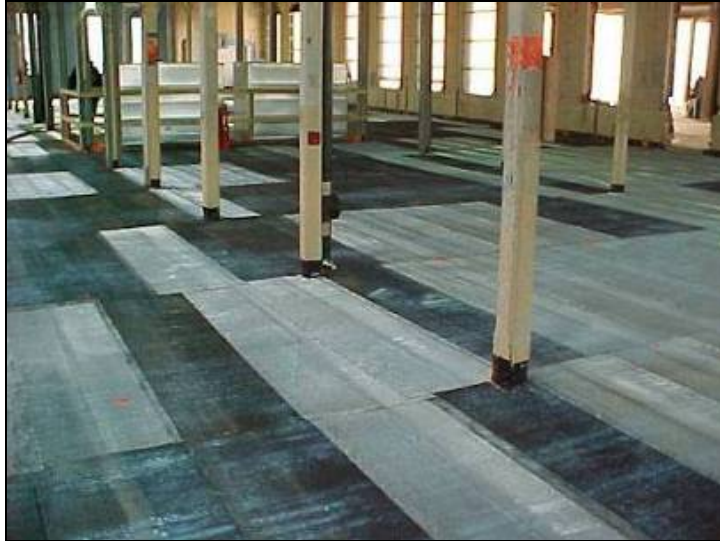
Picture 5: Metal Lath

The renovation process for the floors started by removing as much of the existing oil stains as possible and coating the floors with a water-proofing sealer. After the sealant was dry, 1'x4' sheets of 1.75 lb galvanized metal lath were stapled across the entire floor as seen in Picture 5.

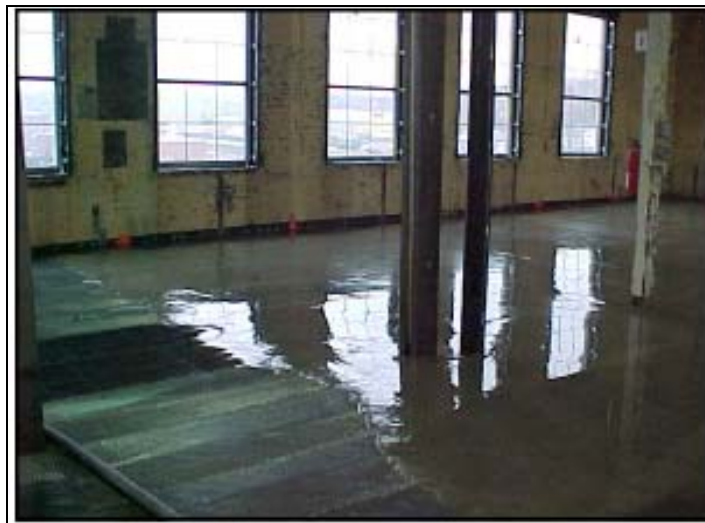
Picture 6: Application of Concrete

Next the concrete was placed starting on February 23rd, 2006 with half of the fourth floor. The concrete for the rest of the floors was placed on February 27th, 2006 and March 9th, 2006. The concrete was a self-leveling Portland based cement underlayment. The particular type of concrete required no extra curing procedures after it was poured due to its self-leveling and curing nature. Reference Picture 6 for application of concrete.

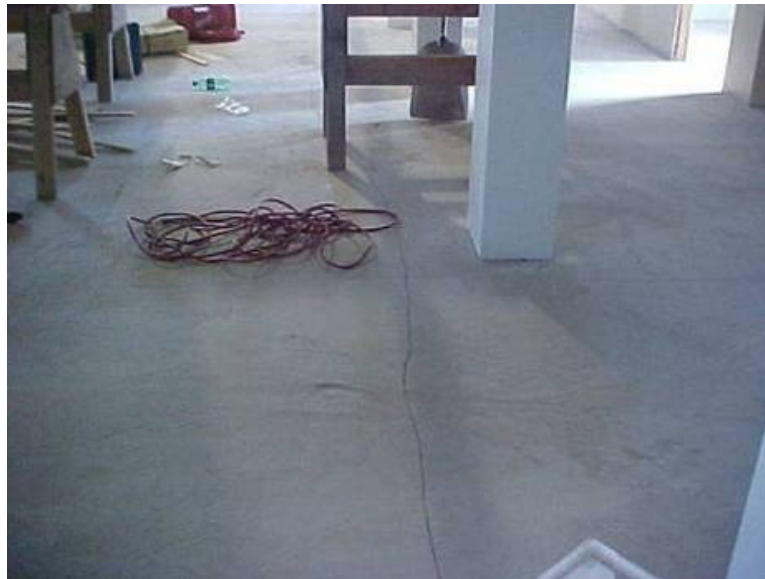
Picture 7: Tension Crack on Fourth Floor

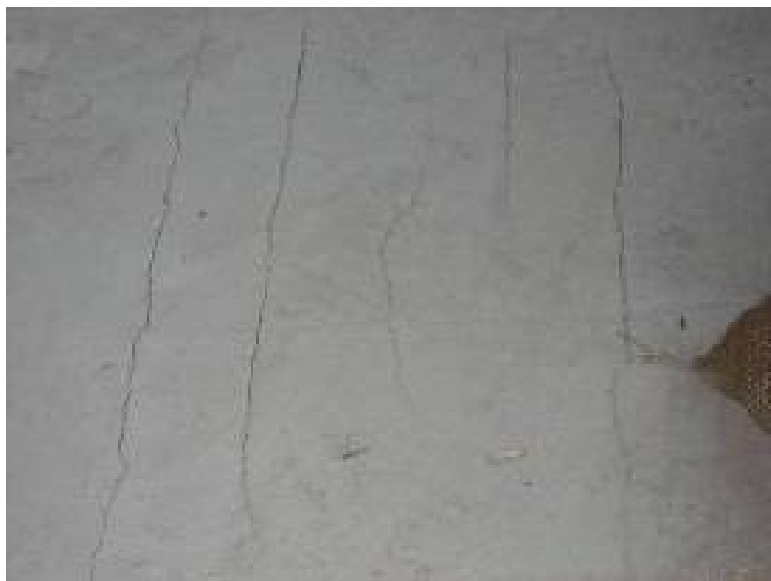
Drying/shrinkage develops about the time the water sheen disappears from the surface of the concrete. Usually these cracks are random, yet straight hairline cracks that extend to the perimeter of the slab (Ropke 71).

Picture 8: Second Floor Shrinkage

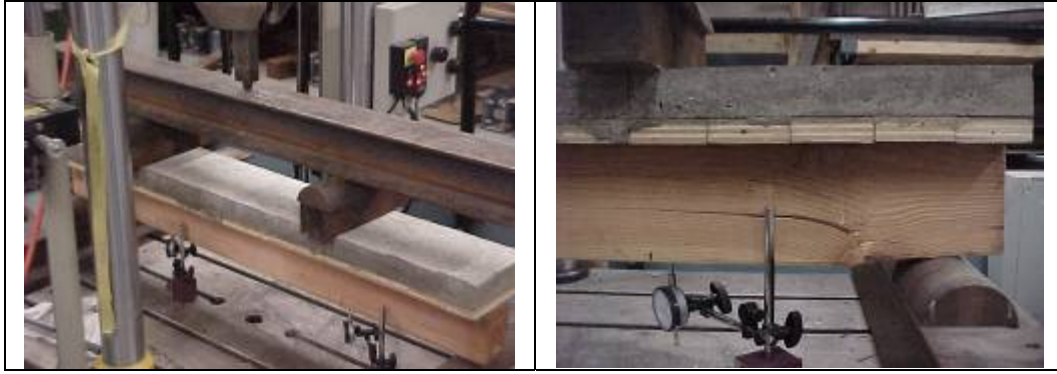
Lab tests were conducted to understand the behavior of timber-concrete designs. The tests consisted of 4-point bend tests of two composite systems based on the calculations as well as a non-composite system, a girder, and a girder-plank combination. Load deflection graphs were created through the use of data from the Instron Machine. In addition to this data, dial gauges were placed under the supports to allow for additional information to be collected for use if needed during the comparisons. Picture 9 shows the composite sections in 4-point bending with the dial gauges placed underneath the load supports.

Picture 9: Testing Photos

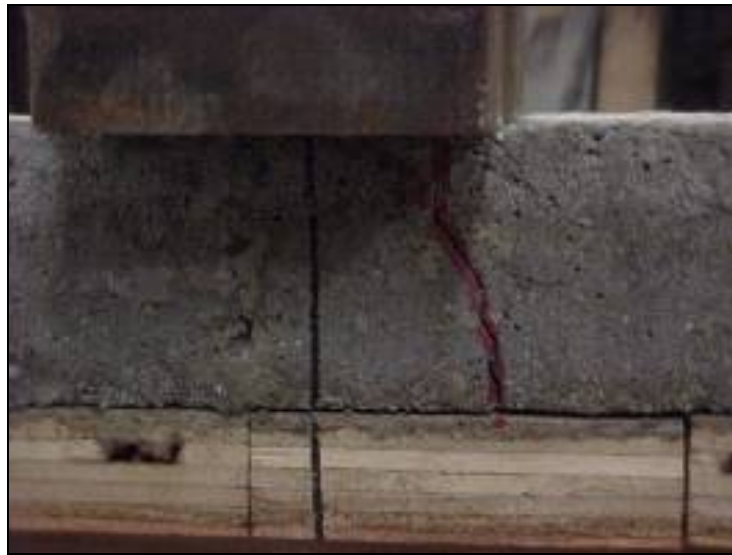
Picture 10: Typical Pattern Cracking

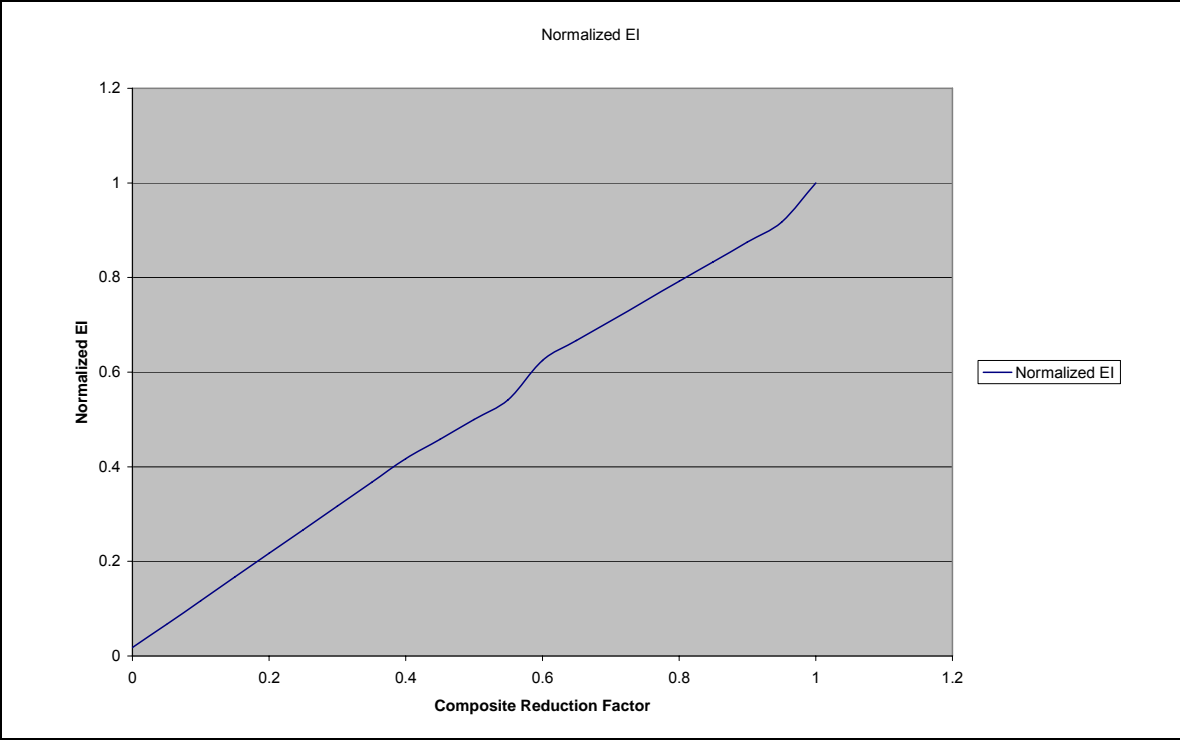
Figure 23 and Figure 24 show the normalized effective EI values for the building. The one-inch spacing connector is approximately five percent composite in comparison to the continuous connector, which is fifty percent composite. These numbers were obtained using the Clouston equations.

Figure 23: Normalized Graph for BTC

Figure 24: Close-up of Normalized Data for BTC

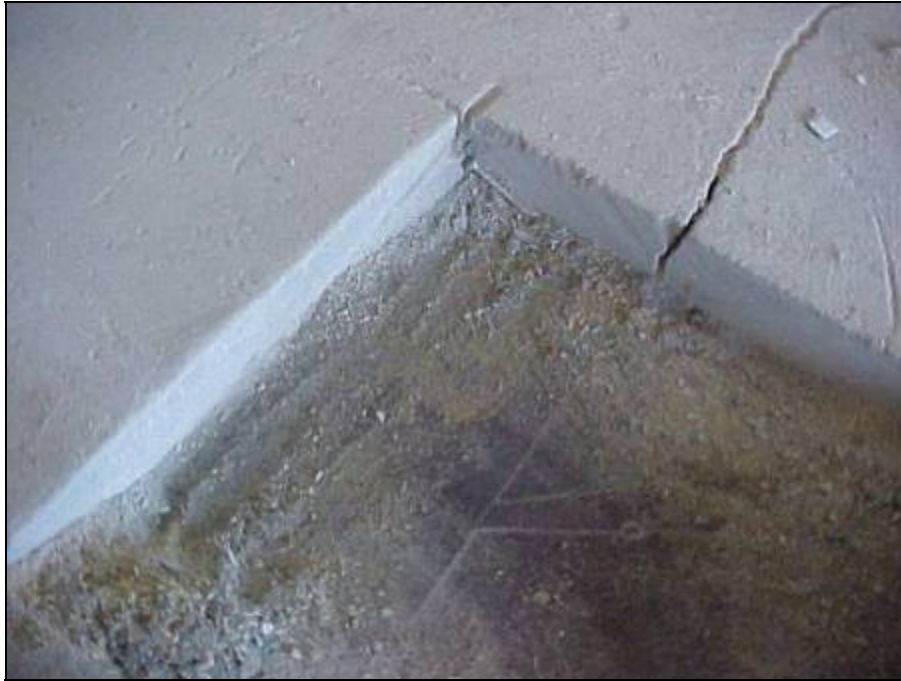
Picture 11: Tension Crack and Wood Floor
