Promoting Access for Those with Disabilities to the Outdoors on Nantucket: Assessment and Communication

An Interactive Qualifying Project
submitted to the Faculty of
WORCESTER POLYTECHNIC INSTITUTE
in partial fulfillment of the requirements for the
degree of Bachelor of Science

Date:
14 December 2016

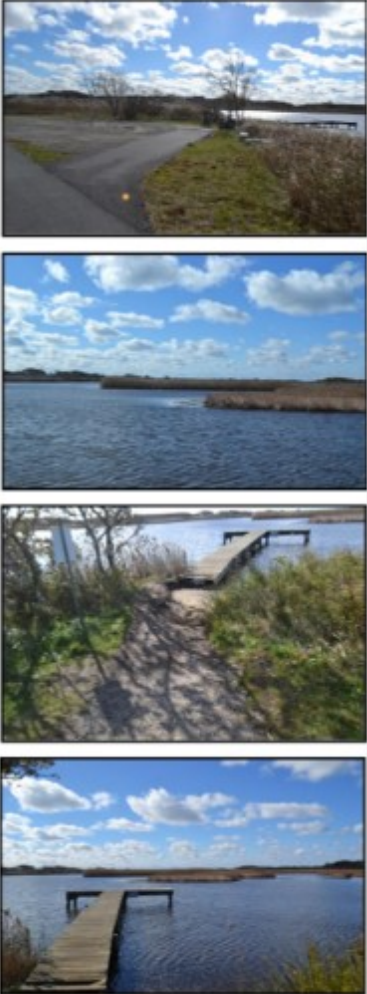
Site Name	Crabbing Spot 1

Owner	Federal, Linda Loring	
Type of Location	View and Bench	
Region	West	
Sub-Region	Madaket	
Current Accessible Elements	<input type="checkbox"/> Handicapped Parking <input type="checkbox"/> Handicapped Bathrooms <input type="checkbox"/> Ramps <input checked="" type="checkbox"/> Boardwalks <input checked="" type="checkbox"/> Benches <input checked="" type="checkbox"/> Signage <input type="checkbox"/> Sensory Elements	
Current Inaccessible Elements	<input type="checkbox"/> Rolling terrain <input type="checkbox"/> Cross-sloping terrain <input type="checkbox"/> Loose sand <input checked="" type="checkbox"/> Wetlands <input checked="" type="checkbox"/> Roots, rocks, sticks, sand <input type="checkbox"/> Poison Ivy, Ticks <input type="checkbox"/> Hunting area in fall	
Parts of Location Are Accessible to	<ul style="list-style-type: none"> • Wheelchair User • Adventurous Wheelchair • Cane • Short Distances • Blind with Assistance

Short Term Recommendations	<ul style="list-style-type: none"> • Pave the parking lot • Add spot for wheelchair next to the bench • Level the path 	
Long Term Recommendations	<ul style="list-style-type: none"> • Add benches up and down the bike path • Redo the dock to be ADA compliant

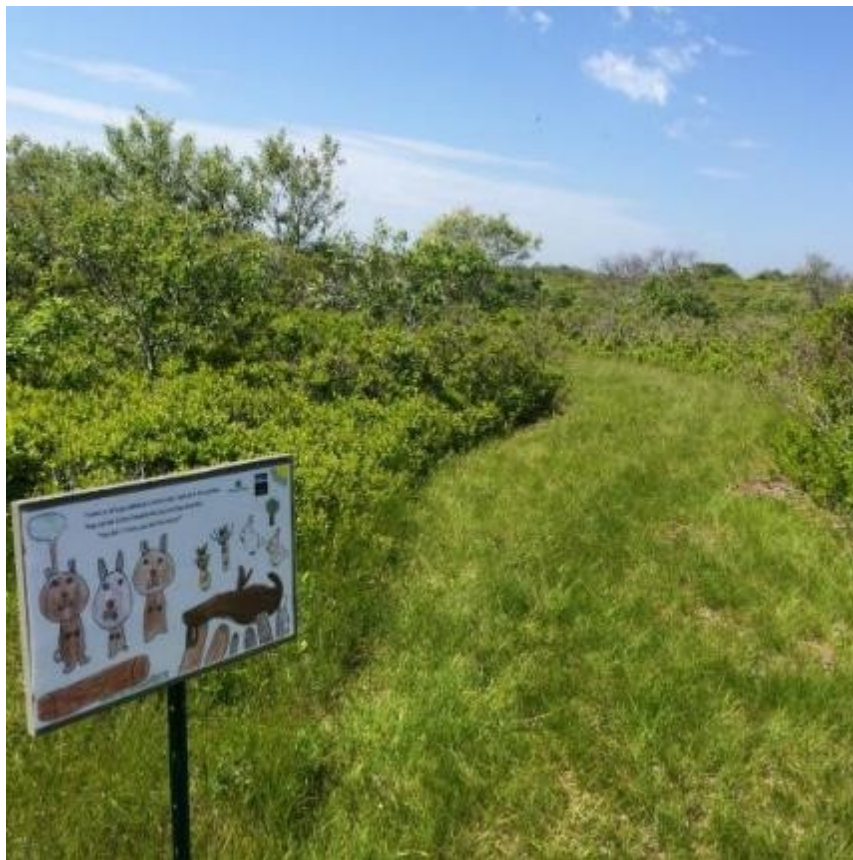
Figure 13: Linda Loring Trail (Edwards, 2016)

Two of the locations included accommodations for people with sensory or cognitive disabilities. For example, the Linda Loring Foundation, as seen in Figure 13, has posts along the trail that collectively tell a story which is something an individual with hearing impairments can easily utilize.

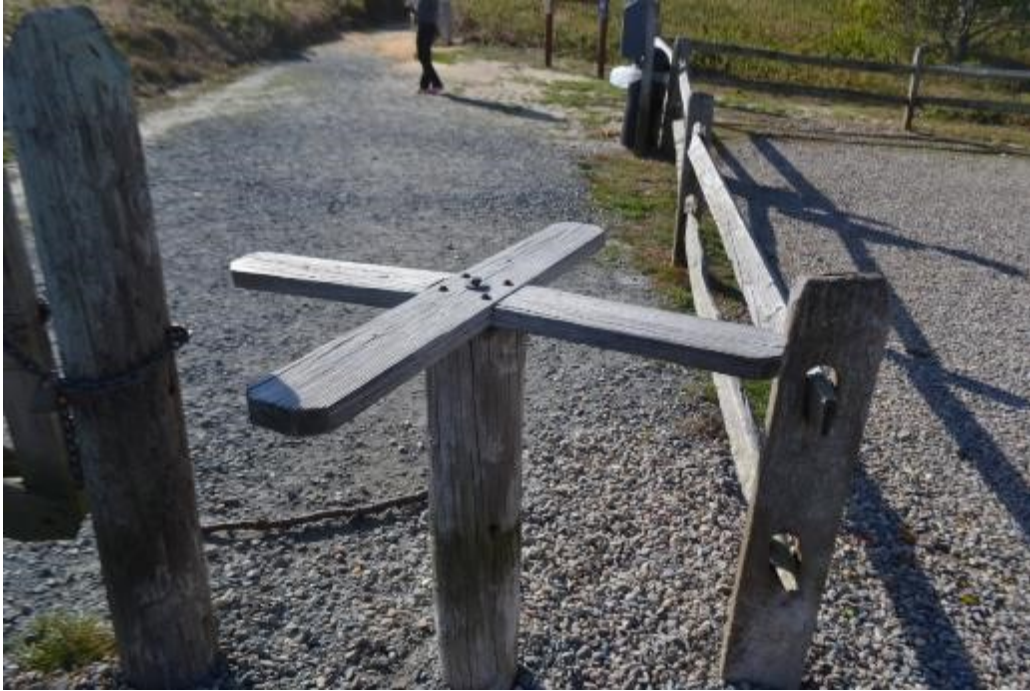
Figure 14: Turnstile at Sanford Farm

Lastly, two of the properties we visited had posts or gates obstructing the entrances. Below, Figure 14 demonstrates the turnstile at the entrance of Sanford Farm that makes it difficult for those with mobility assisting equipment to get through.

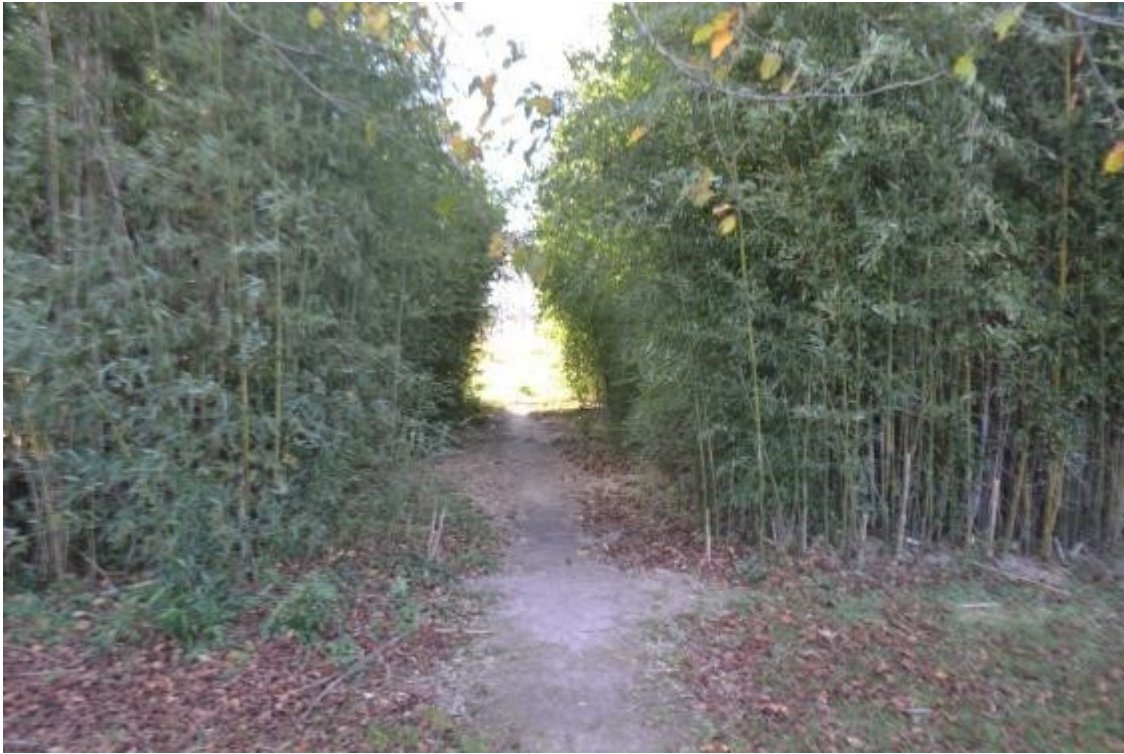
Figure 15: Bamboo Forest

- Parking lot surface is level
- Trail surface is mostly level
 - Periodic ruts in trail
- Trail width meets ABA standards
- Picnic table present
- No accommodations for sensory or cognitive disabilities

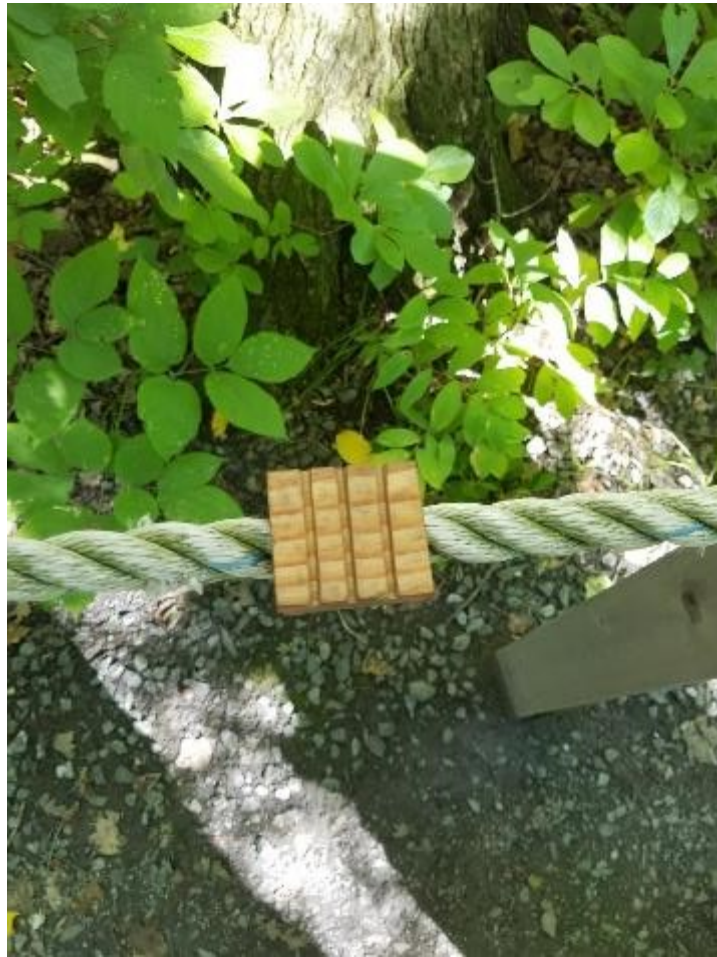
Figure 17: Notification Bead on Post and Rope Guidance System

A long term recommendation applicable to 4 out of the 11 locations is to implement a post and rope guided system. For example, the Linda Loring Foundation could be improved with a post-and-rope system installed along the side of the trail. This is a valuable resource for those with sensory impairments, because this allows them to self-guide themselves through the conservation area. The posts can be used to demonstrate interesting features at the location such as sensory elements like feeling the different types of tree bark and stopping to listen for a specific bird call. The ropes can have beads or markers on them to alert someone that there is a post with text or a sensory feature coming up. Figure 17, below, shows a post and rope system on a property of the Massachusetts Audubon Society.

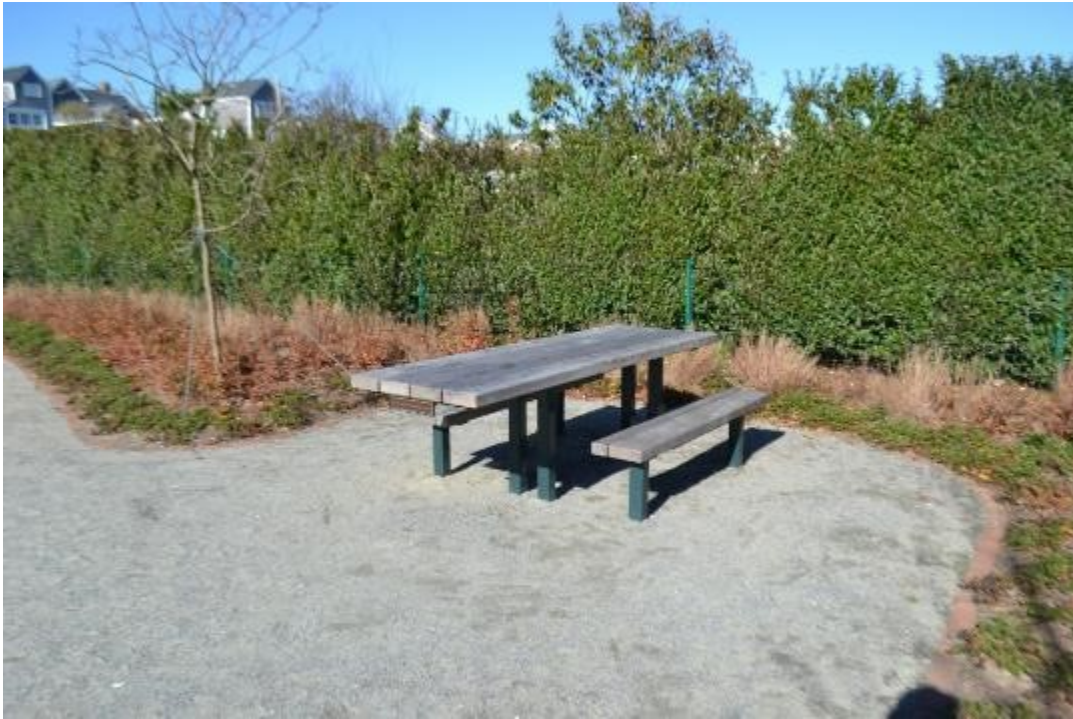
Figure 18: Wheelchair Accessible Picnic Table

In addition, at the top of the hill we would recommend adding a wheelchair accessible picnic table. These do not cost much more than a normal picnic table and only require a small level area around the end and an overhang so that one can be rolled up to the table or a table similar to the one shown in Figure 18. This would allow someone in a wheelchair to enjoy a meal with their friends or family at the same table.

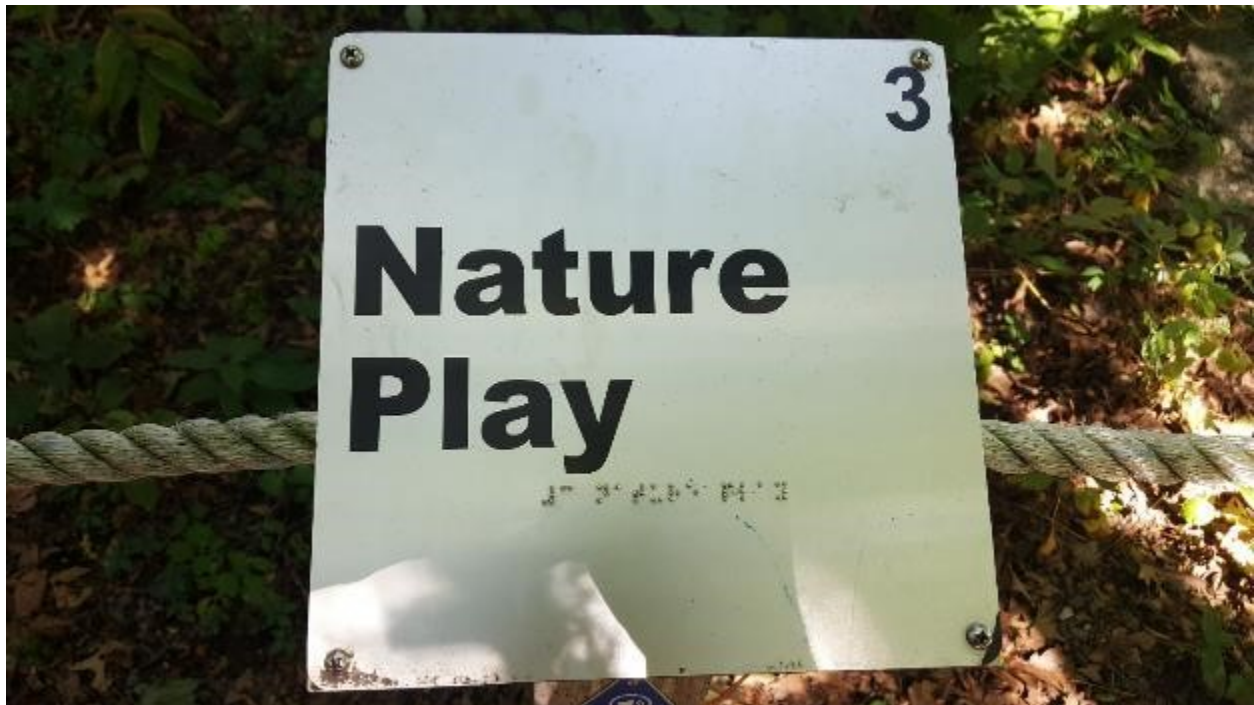
Figure 19: Broad Meadow Brook Sign

To help people with visual and hearing impairments we would recommend placing some signs in the bamboo grove and at the top of the hill that give a bit of information about the history of the grove, the surrounding area, and the flora and fauna of the property. The signs should include Braille text of the same information. Figure 19, below, is an example of a sign at Broad Meadow Brook in Worcester, MA—a property owned by the Massachusetts Audubon Society.

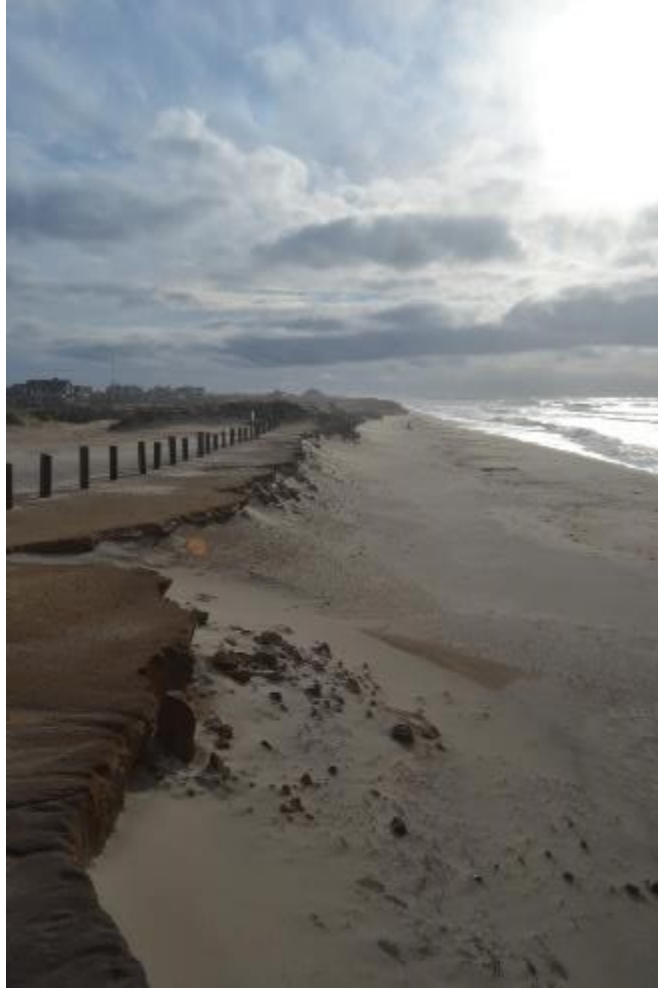
Figure 20: Erosion at Cisco Beach

Most of the beaches assessed consisted of loose sand with fine grains. The south shore of the island especially had finer sand. For example, Cisco and Nobadeer Beach had finer sand than at Madaket Beach. This was significant to determine because it indicated how easy it is for the tide to create shelves in the sand at some beaches in comparison to others (Pilkey, n.d.). The nature of the surf also contributes to this phenomenon. The heavier, or more rough the surf, the bigger we found the shelves to be. The surf on the northern shore seemed to be the calmest while the surf on the south and southeastern shores of the island was very heavy.

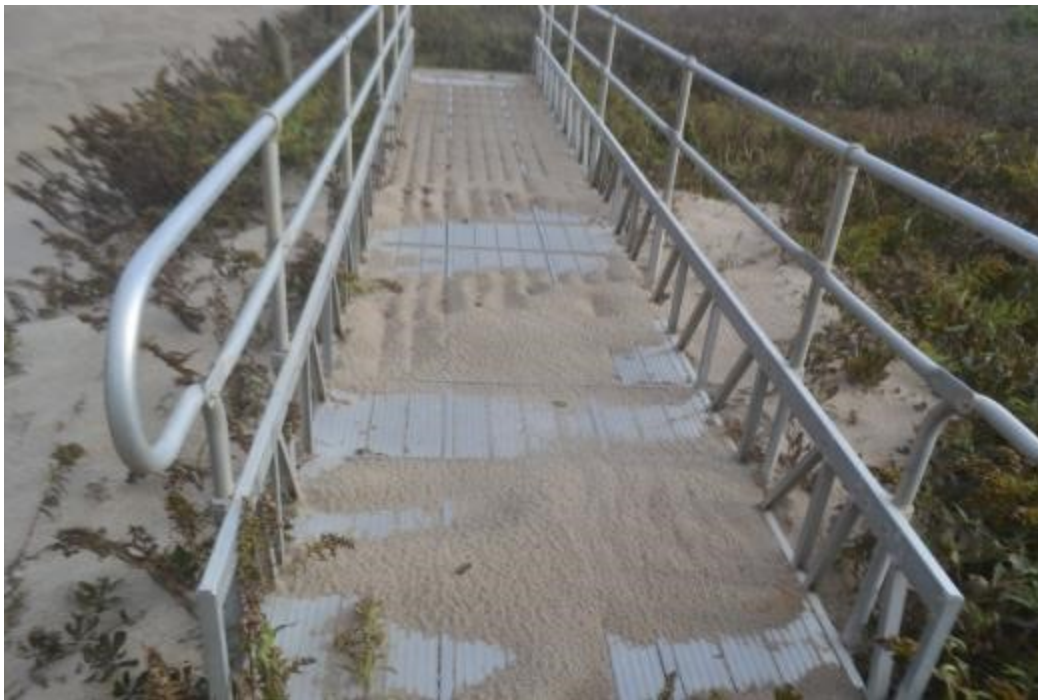
Figure 21: Ramp at Dionis Beach

Tucked behind the bathroom building we found another metal ramp with treads (Figure 21). It is unclear where this metal ramp is placed during the summer months. From our observations, we speculate the ramp is placed towards the beachfront on the other side of the dune rather than the beginning of the pathway on the parking lot-side of the dune. Similar to the metal ramps found at other beaches on the island, the measured length of the ramp is 25’ long.

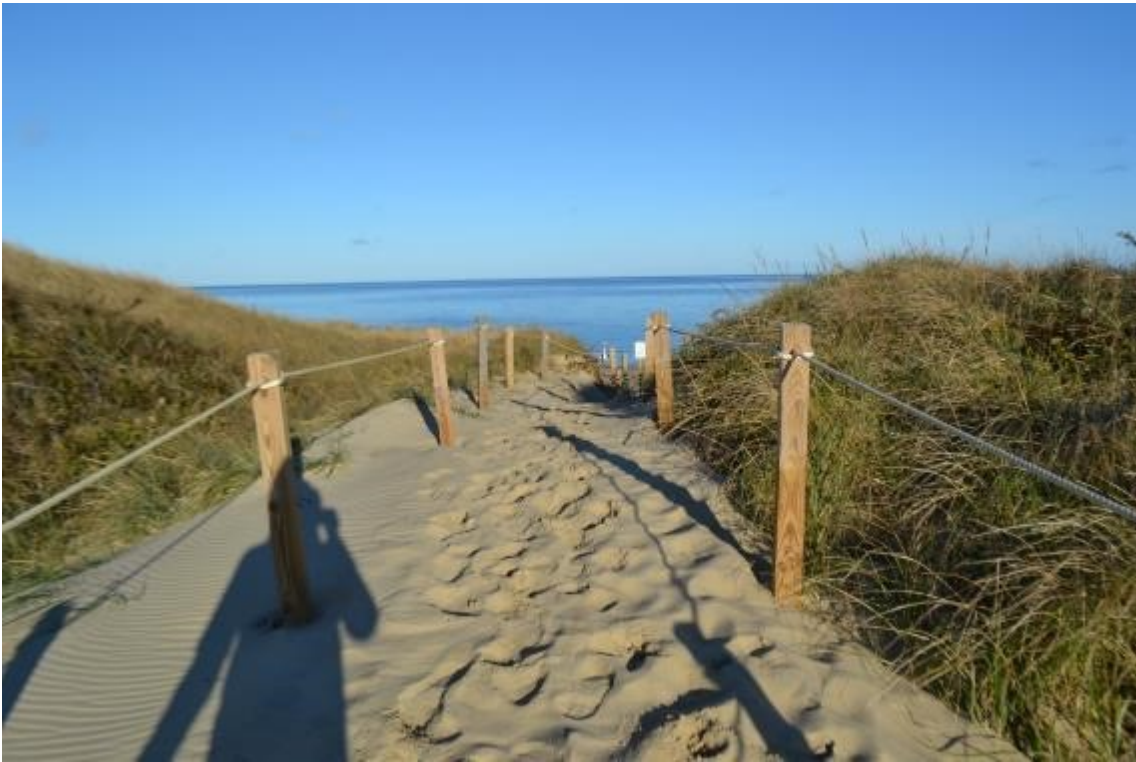
Figure 22: Pathway to Water at Dionis Beach

beach wheelchair) to use the pathway because the equipment does not remain on top of the sand and instead sinks into it.

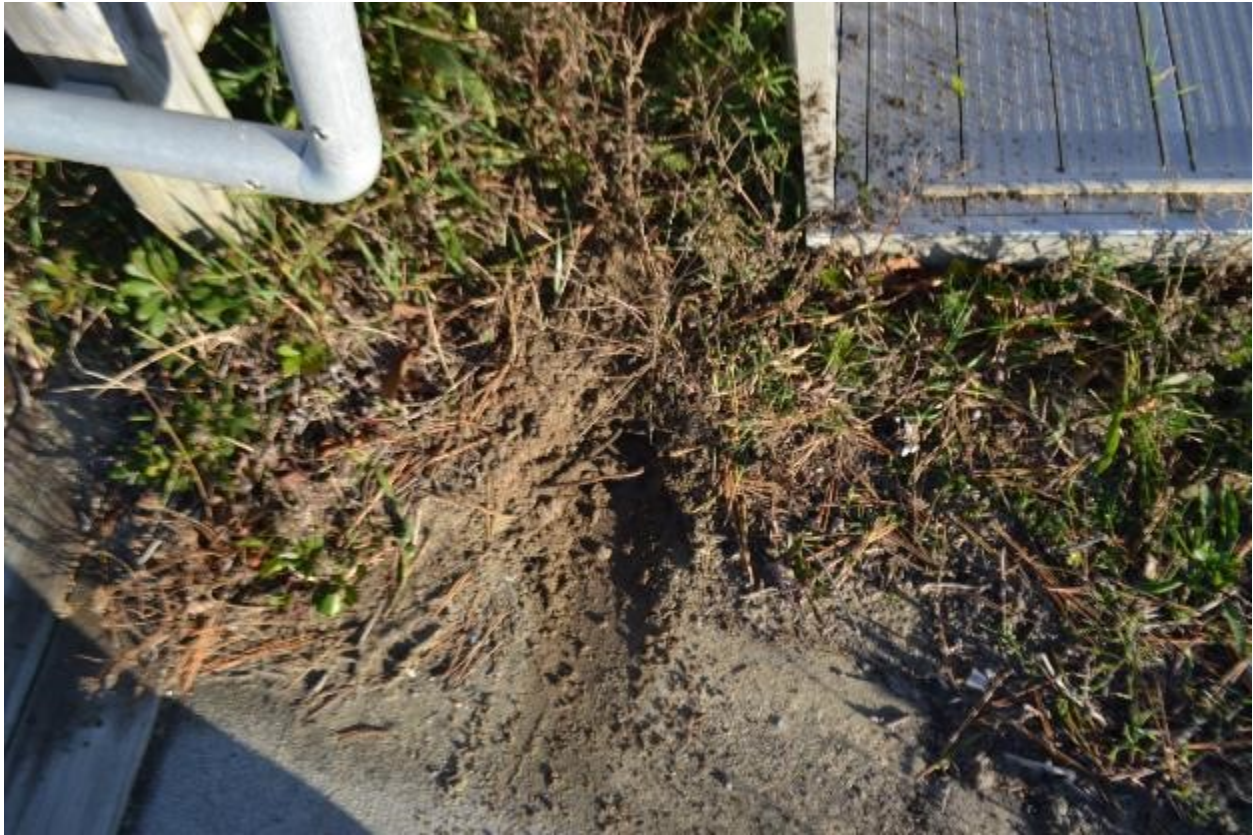
Figure 23: Overgrown Grass Around Bathroom at Dionis Beach

obstructions. We also recommend that additional signage be added around the bathroom building to indicate the presence of bathrooms.

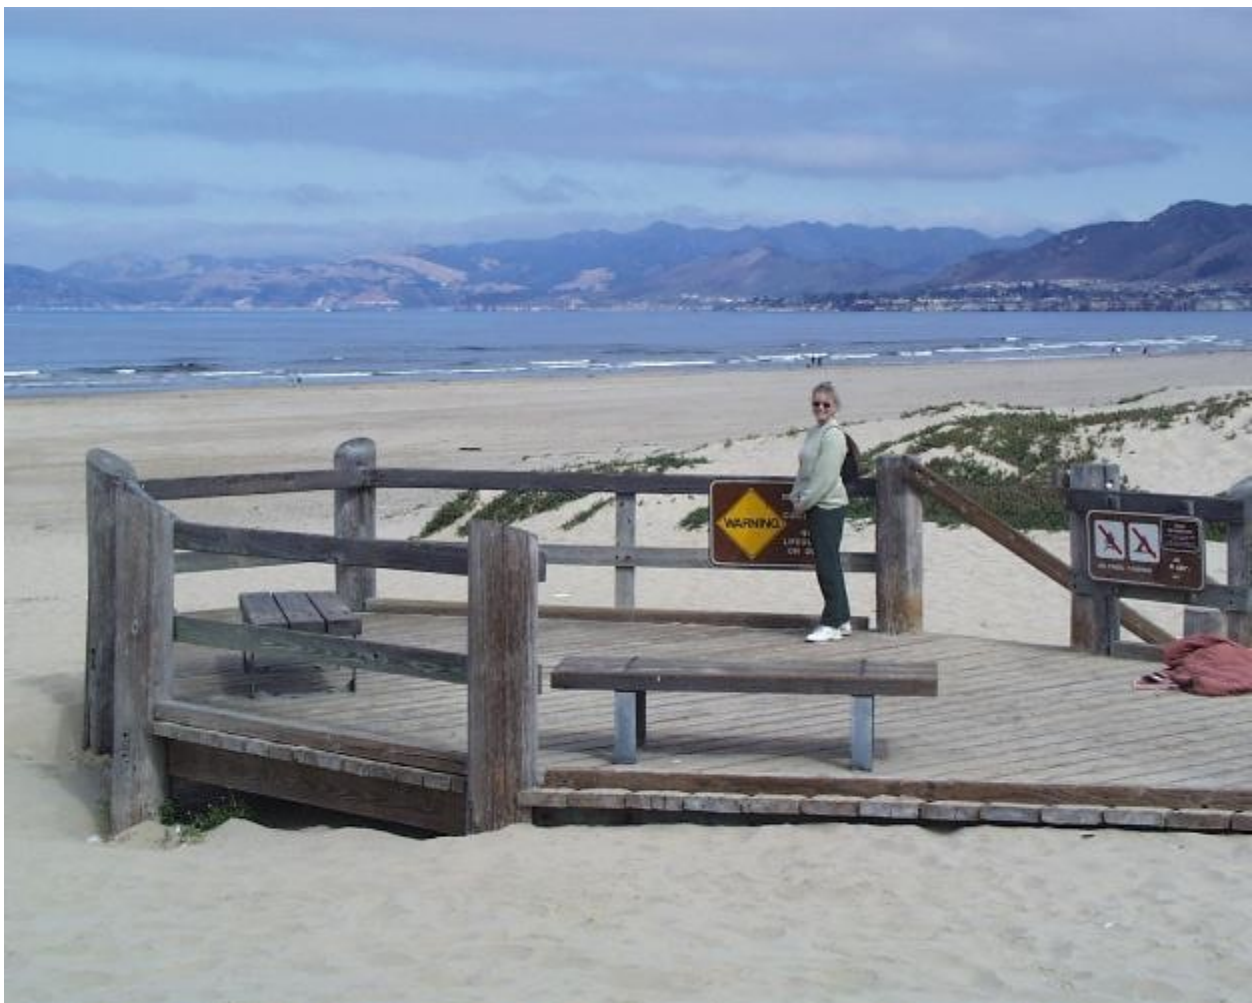
Figure 24: Viewing Platform (Viewing Platform at Pismo Beach, n.d.)

Midway on the beach access route we recommend installing a viewing platform, similar to the one shown in Figure 24, to provide visitors with the option to sit and enjoy the view of Dionis Beach. This addition would be built atop the dune at its crest. The appropriate material, similar to the pathway, would be either wooden planks or metal sheets. It is important to ensure the platform also has curbs around the edge in addition to a handrail. This addition should also include a bench to allow people with ambulatory concerns to rest and view the landscape. Below, in Figure 25, is a diagram which illustrates our recommendations.

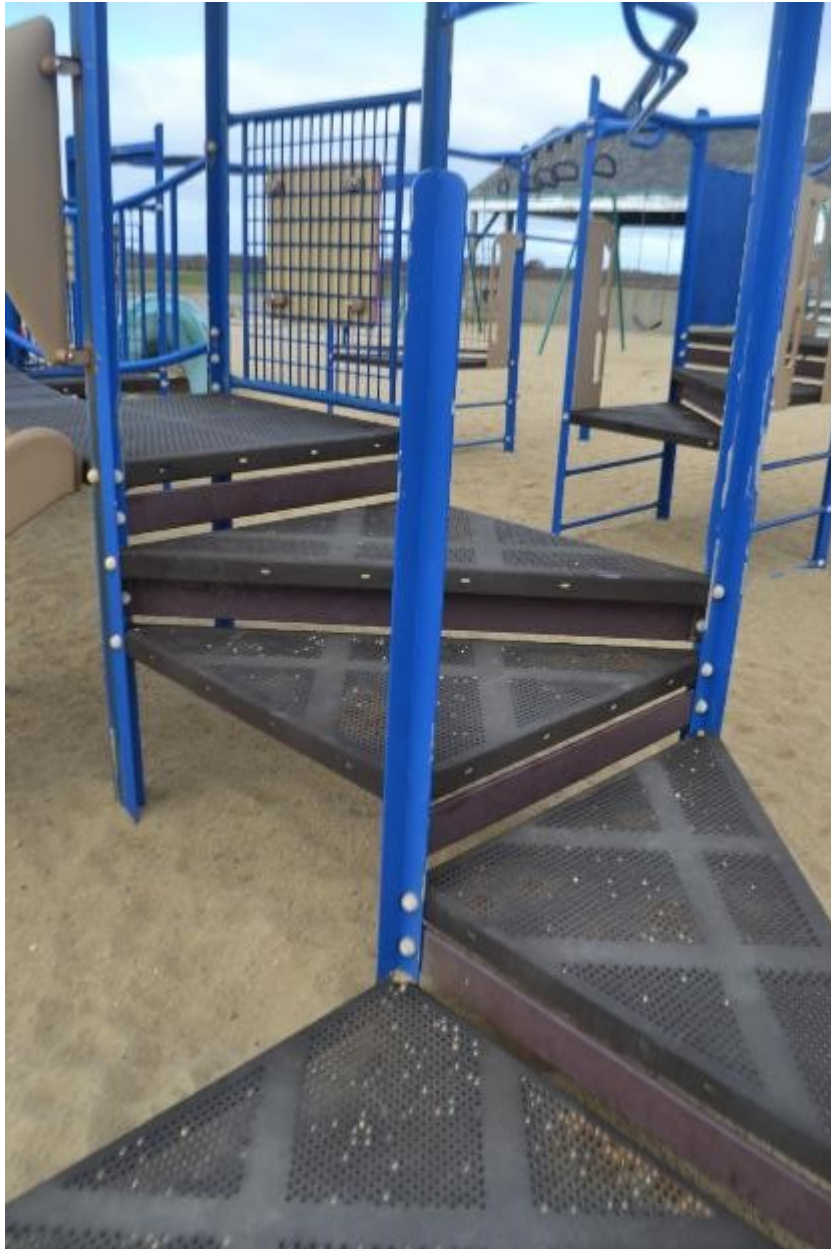
Figure 26: Transfer System on Play Structure at Tom Nevers Playground

Most of the play component measurements are compliant with the standards set by the ADA. The transfer systems (i.e. stairs designed for accessibility) especially have adequate dimensions (Figure 26).

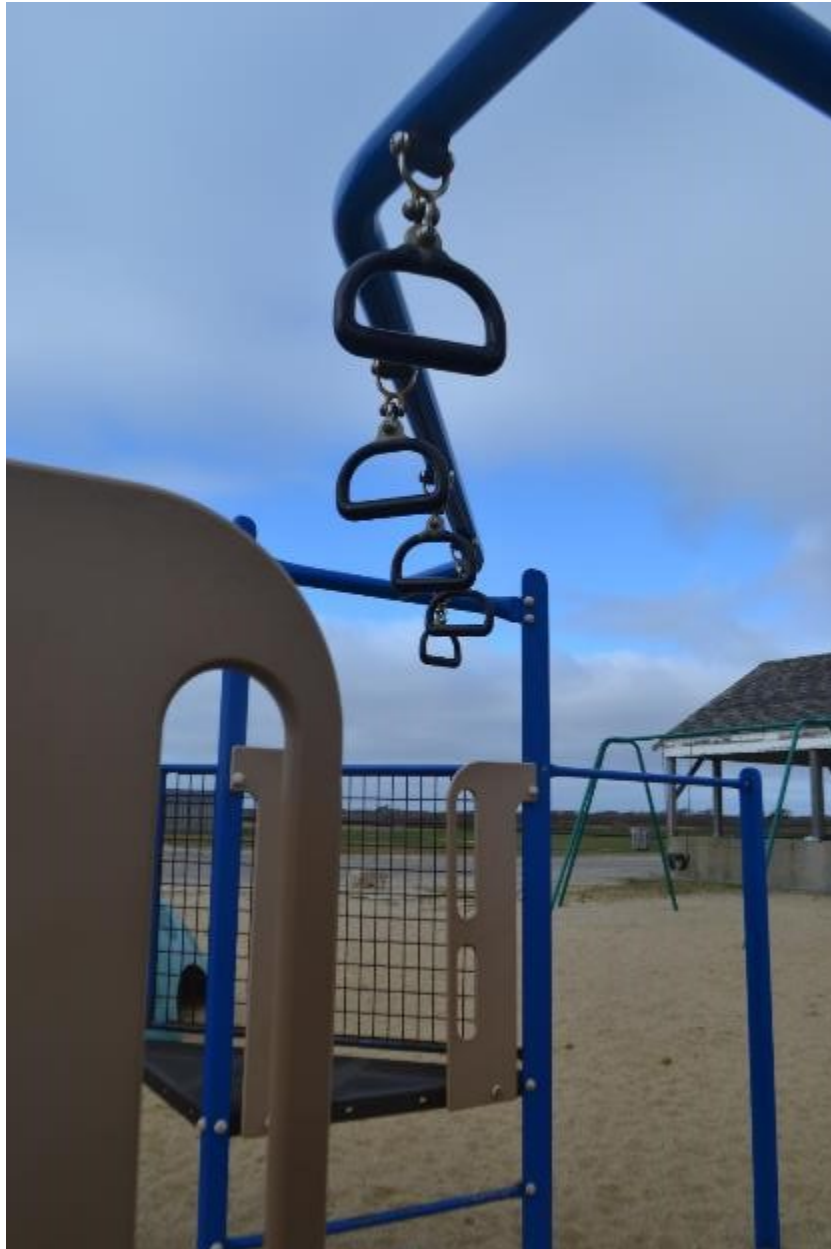
Figure 27: "Monkey Bars" at Tom Nevers Playground

We also note that all five playgrounds had multiple play components that are considered motor play and help exercise children physically. For example, we observed play components such as slides, monkey bars, climbing walls, poles to slide down, and swings. Most of this motor play is not easy or safe for children with disabilities to use. Many of the components are elevated high above the ground and require a lot of strength to use properly as shown by the monkey bars at Tom Nevers Playground in Figure 27 below.

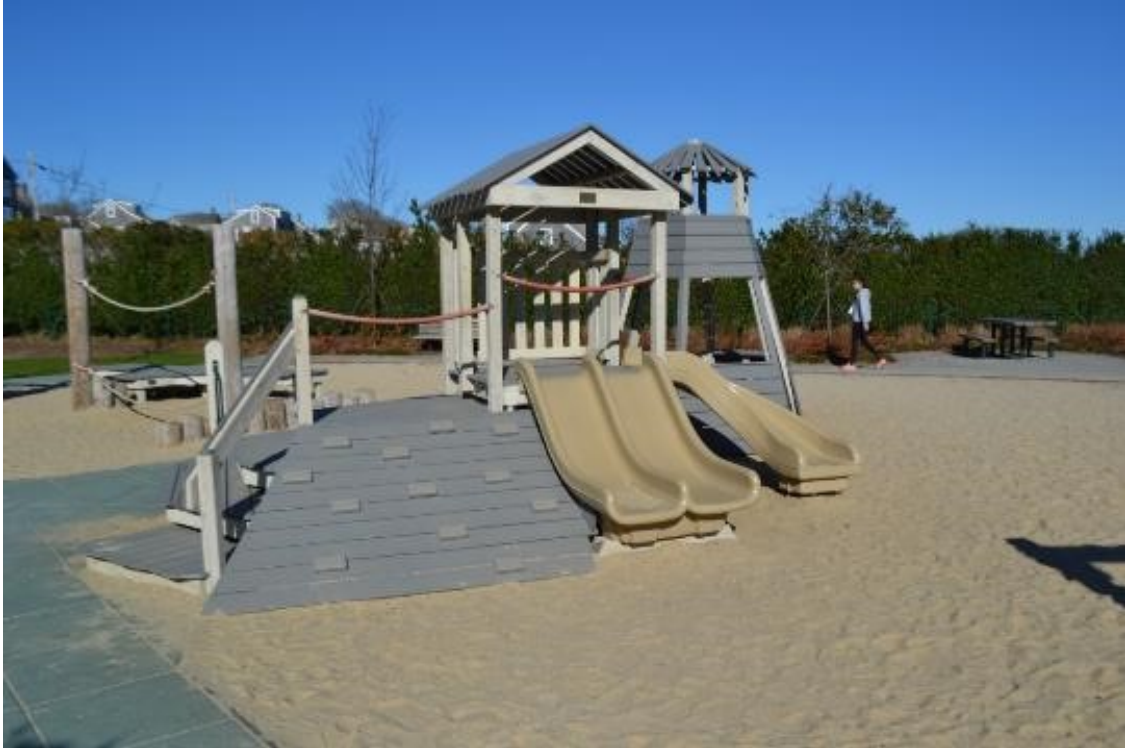
Figure 28: Sconset Playground Rock Wall

Sconset Playground has transfer systems and other motor play components that are easier to use. For example, in one of the play structures there is a short, angled rock wall that leads to the elevated platform in addition to the transfer system as seen in Figure 28. Since Sconset Playground is ADA compliant, it has many other accessible elements which we use as references when assessing and analyzing the other playgrounds.

We recommend adding better transfer systems, safer motor play, and more sensory features to playgrounds. Elements such as the short, angled climbing wall at Sconset Playground (Figure 28 above) or shallow stairs would achieve better transition between the ground and play equipment. In addition to structural improvements, the play components of the playground can be improved. For example, more swings with supporting backs and intended for bigger children, not just small children, would increase the accessibility of that play component. There is also potential for more sensory play components with the public playgrounds we assessed on the island. Features that stimulate the sense of smell, for example, would increase the degree of sensory elements present at the playgrounds. This can be fulfilled, for example, through the planting of different plants. The sense of hearing can be stimulated by installing similar features to the musical components at Winter Park (Figure 36). More advanced elements could include the outlines of species native to the island with buttons next to them that, once pressed, project the sounds the animals regularly make.

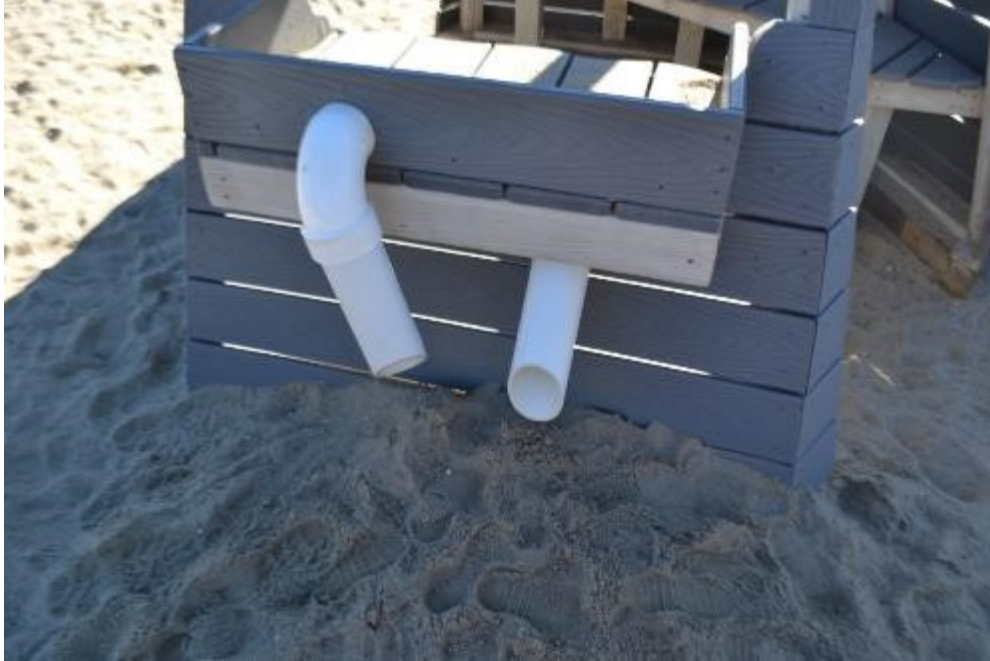
Figure 29: Sensory Element at Sconset Playground

Every playground we assessed has at least one component that exercises the senses. Many of these sensory play components stimulate the sense of touch. For example, Sconset Playground has two pipes located on the wall of the Sankaty Lighthouse structure that are meant to pour sand in and out of, as shown in Figure 29. When children use this element, they experience the feeling of sand running through their fingers.

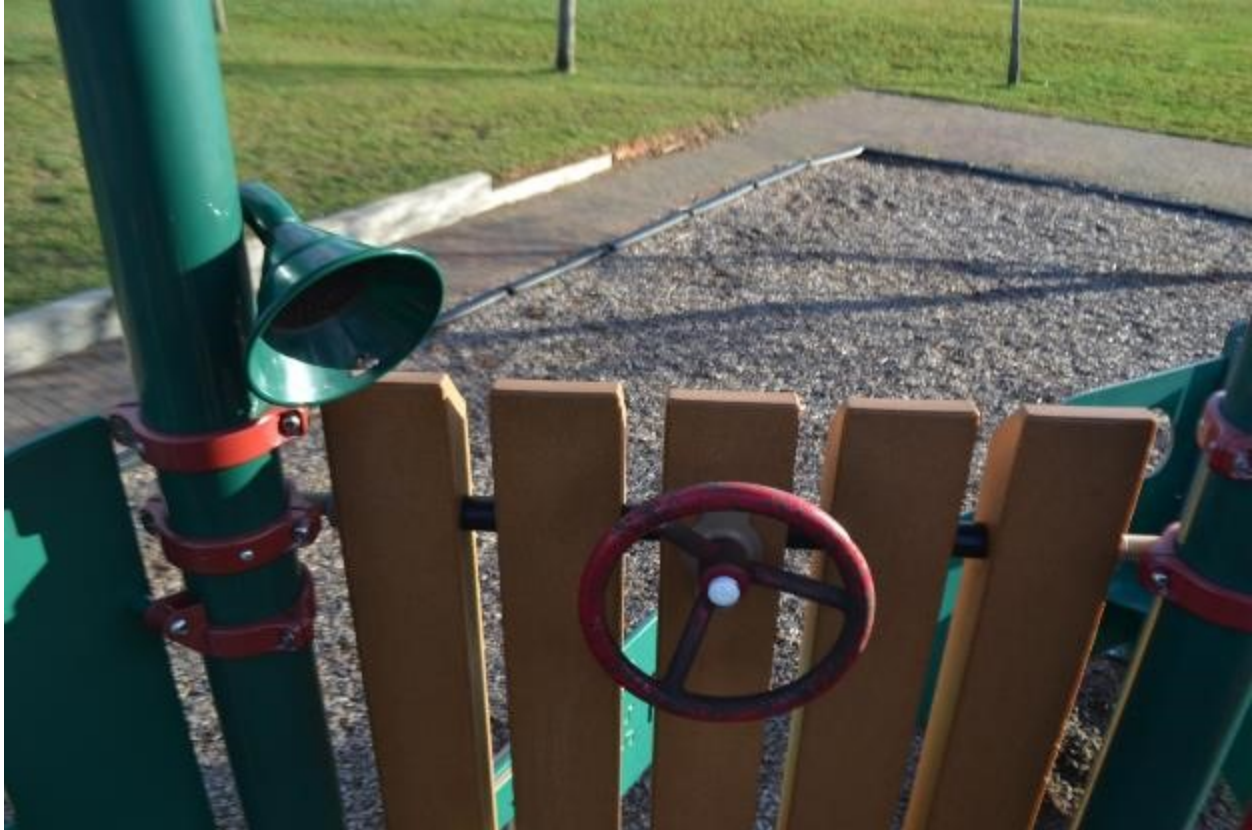
Figure 30: "Talk Tubes" at Winter Park

We also found sensory play components that exercises the sense of hearing. Located at Tom Nevers Playground, there are two telephonic ends resembling speakers on a pipe situated on opposite ends of the play structure. This feature allows children to communicate to one another through speech. We noticed at least one sensory element at each playground. Below in Figure 30, is an example of the “talk tubes” at Winter Park, located just outside of town.

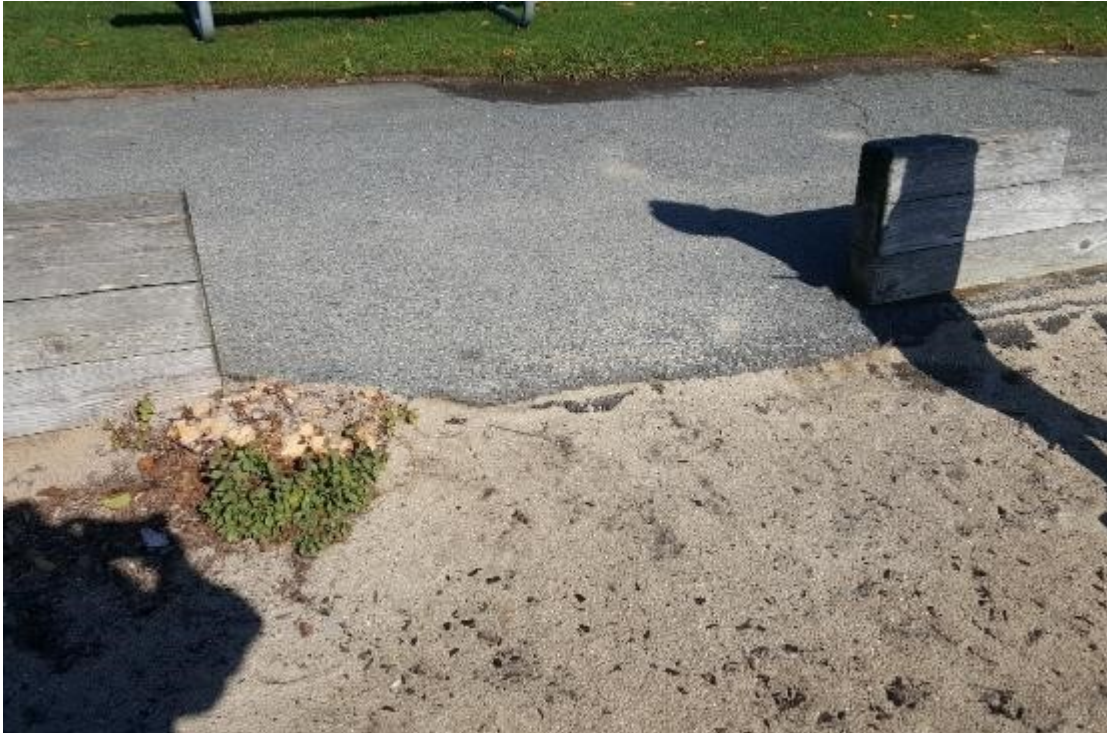
Figure 31: Playground Entrance at Children's Playground

the wooden barrier that is approximately 1.5 ft. tall. Without measuring the entrances, it was evident they were of adequate width to accommodate wheelchairs as shown in Figure 31. The entrances were approximately 5 ft. in width.

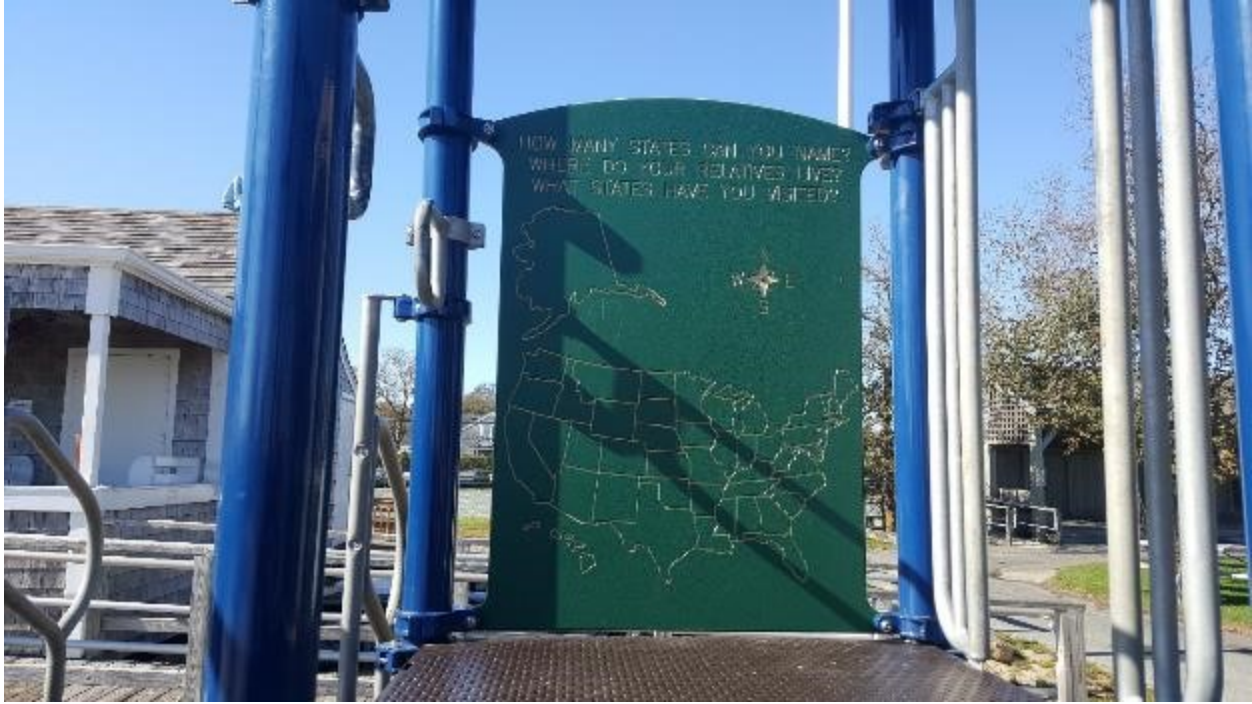
Figure 32: Sensory Element at Children's Playground

The smaller play structure has one sensory play component. It consists of the outline of the United States embossed into a plastic sign bolted to the top landing of the structure as shown in Figure 32.

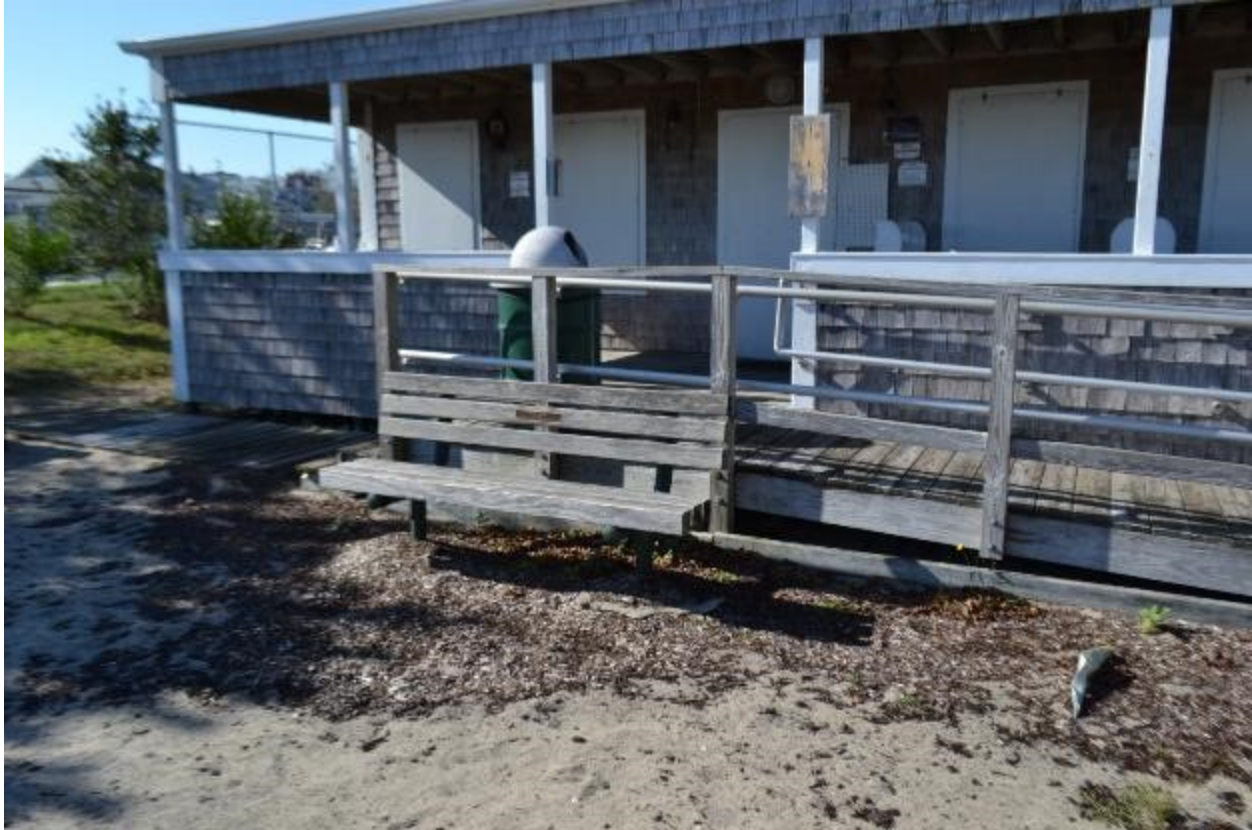
Figure 33: Bench at Children's Playground

Close to the small structure and around the perimeter of the playground are two benches. There are two sides of the playground that have benches (one is shown in Figure 33 below).

Behind one of the benches, and adjacent to the play area, is a building with bathrooms and a café (also shown in Figure 33 above) with ramps leading to both. The ramp providing access to the bathrooms met most standards but not all. The cross slope, rise, and length of the ramp were all within the requirements to meet standards with measurements of 0 degrees, 25.5 ft., and 25” respectively, but the running slope, top rail height from the surface of the ramp, and the clear length of the landing area did not meet standards. The quantitative data we received for those parameters were 5 degrees, 33.5”, and 46.5” wide by 50” long, respectively.

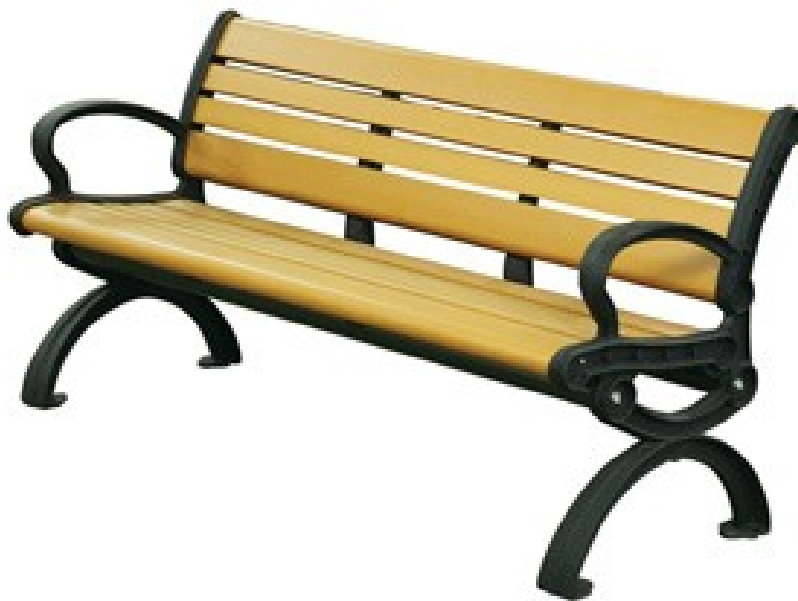
Figure 34: Proposed Bench for Installation (Bench, n.d.)

We recommend the installation of benches and/or picnic tables similar to the bench found in Figure 34 below. Even though some of the other assessed playgrounds already have benches, some of them have the potential for more, or better quality benches. For example, the benches found at playgrounds frequently do not have arm rests. If the user has a disability of some sort and, for example, has difficult getting up and down, the arm rest would be helpful to provide more support in the process of standing up and sitting down.

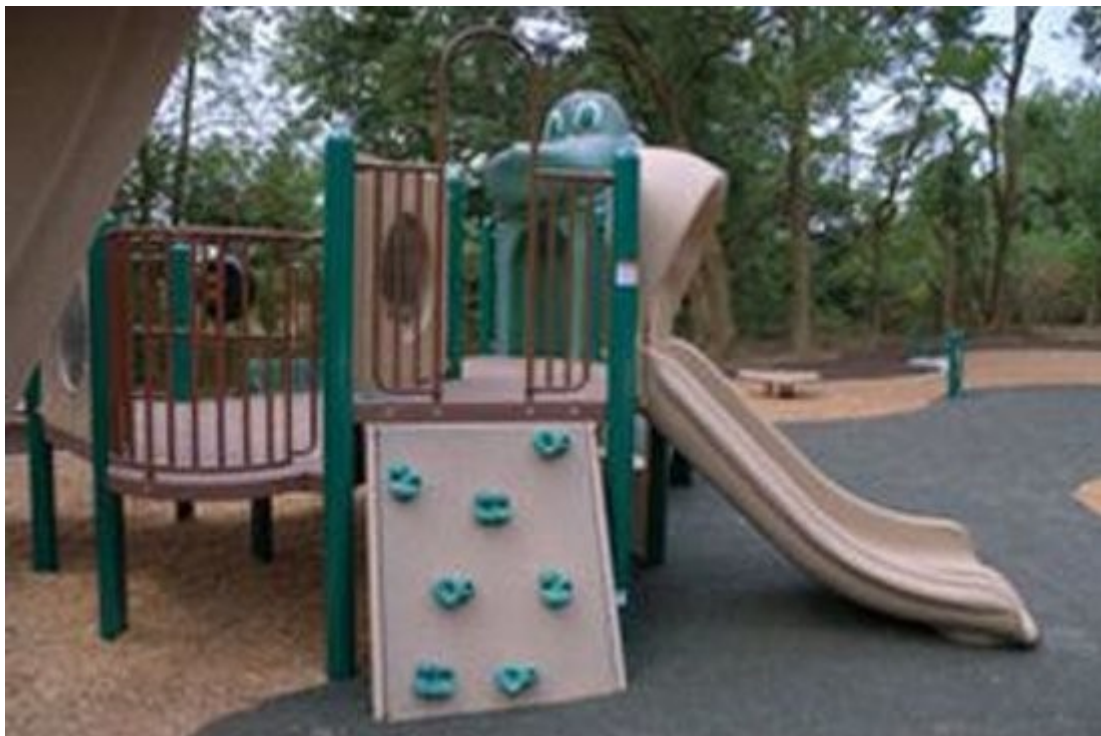
Figure 38: Can-Do Playground Climbing Structure (TripAdvisor, n.d.)

We also recommend that more transfer systems and sensory play be implemented. For example, installing a ramp with a climbing wall on the opposite side of the current transfer system on the large play structure would increase access for a child with ambulatory concerns. If handles are included at an appropriate level, a child in a wheelchair would be able to grab them and use their upper arm strength to pull themselves up onto the platform. Figure 38 shows an example of this climbing wall at the Can-Do Playground in Wilmington, Delaware. For more information about the Wilmington Can-Do Playground, see the case study in Appendix A.3.1.

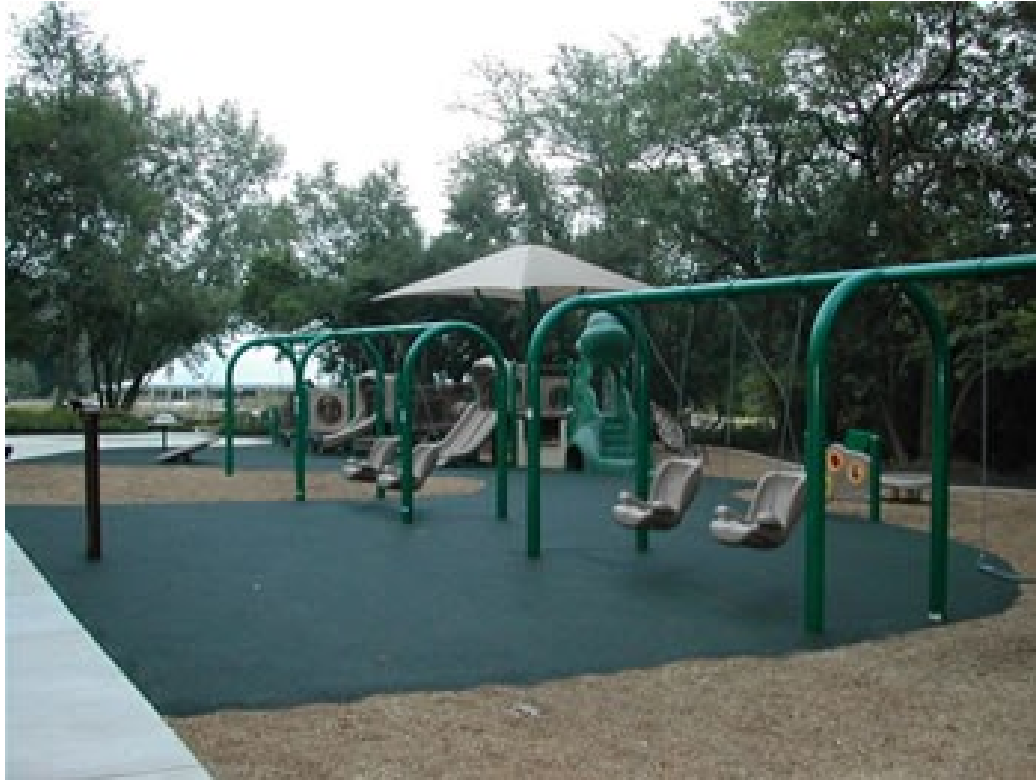
Figure 39: Accessible Swings with Supportive Backs (National Center on Health, Physical Activity and Disability, 2007)

Children’s Playground would be improved by adding additional swings that have supportive back rests. These swings would allow children would do not have back strength to stay upright and still experience the swings. Figure 39 demonstrates the support of the swings at Can-Do Playground.
