Promoting Access for Those with Disabilities to the Outdoors on Nantucket: Assessment and Communication

An Interactive Qualifying Project
submitted to the Faculty of
WORCESTER POLYTECHNIC INSTITUTE
in partial fulfillment of the requirements for the
degree of Bachelor of Science

Date:
14 December 2016

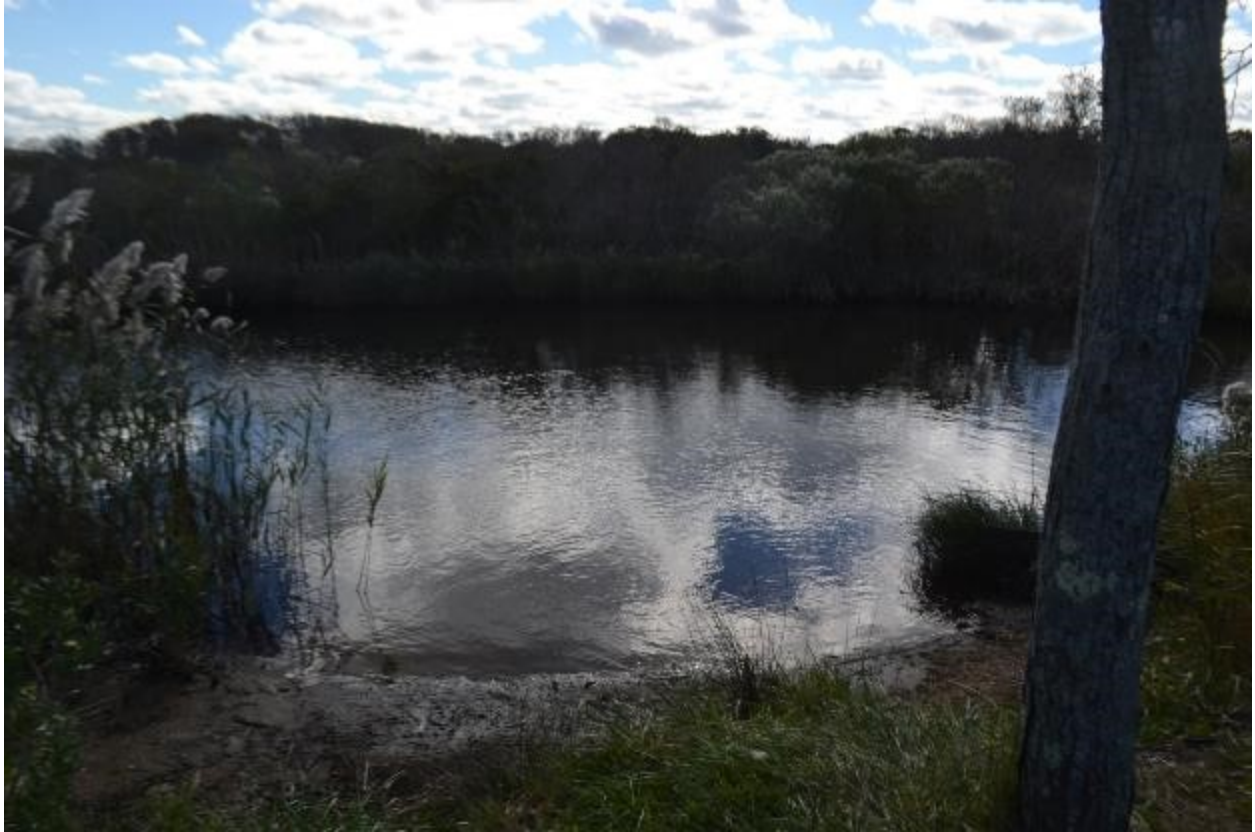
Figure 40: Crabbing Location Water Exposure

Another common finding was if there was a trail or path, it was often very uneven and consisted of dirt or grass. The ruts and dips in the path make travelling over it very difficult for people with mobility disabilities. We found the two crabbing locations on Madaket Road are near the water’s edge and lack any barriers preventing visitors from falling in. Figure 40 below shows the water exposure along the side of one of the crabbing locations.

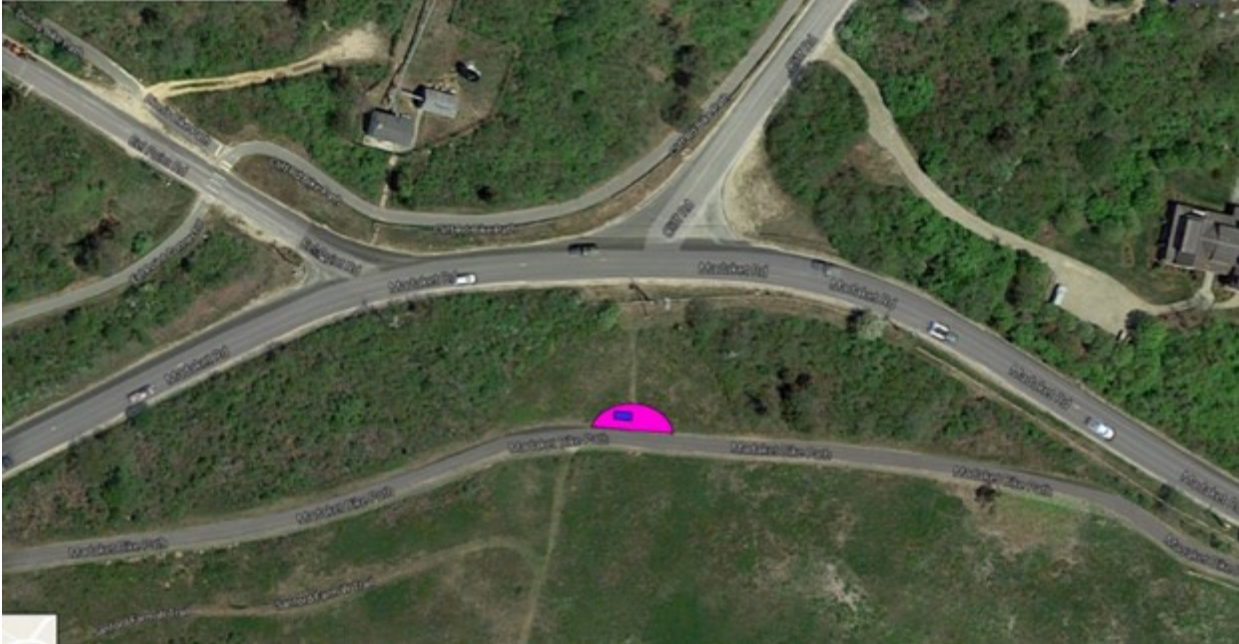
Figure 42: Possible Bench Location

- There is a scenic view of the sanctuary
- Paved bike path leading to area
- Flat surface at possible location

Located off the Madaket Road bike path is an excellent spot to install an accessible bench (Figure 42) to allow those with disabilities to take in a beautiful view. This location is about 800 feet down the bike path from the Sanford Farm parking lot, and since the bike path is paved, those with mobility disabilities would easily be able to visit the bench. The area also has a flat surface so installing a bench would not require flattening of the land.

We recommend installing a bench at the location shown above in Figure 42. The paved bike path and bench would provide a short fully accessible walk with a resting spot at the end with a view for people to enjoy. There should be enough clear area of accessible material (like pavement) next to the bench so someone in a wheelchair and sit next to it as well. The bench should also include a supportive back and armrests for those who would have difficulty standing up.

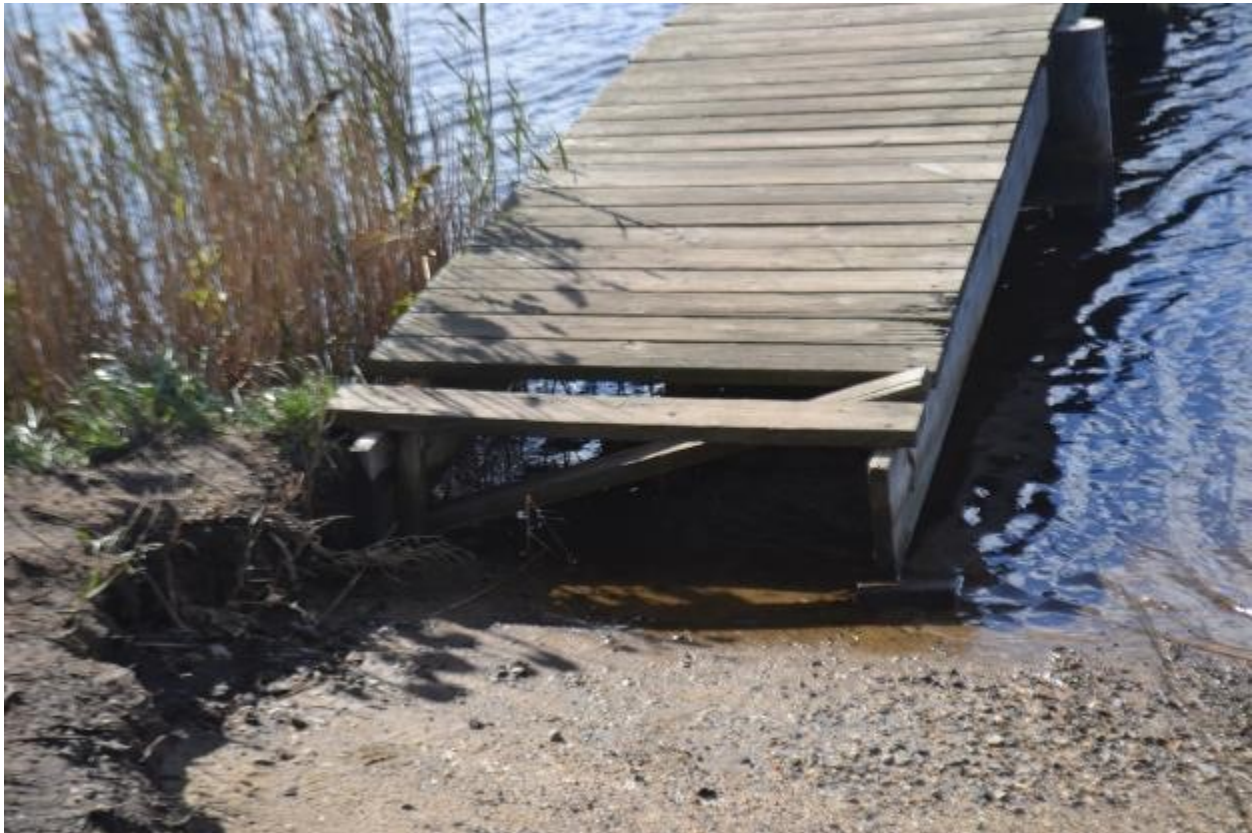
Figure 46: Dock at 1st Crabbing Location

- Area of parking lot has room for 5 to 6 cars
- There is a bench overlooking pond
- Path is not in good condition
- Dock has fallen into disrepair

We also recommend repairing or replacing the dock. The broken planks and 6 inch rise up to the dock platform are shown in Figure 46. Ideally, completely replacing the dock with one that is wider and with handrails and curbs would improve its accessibility by the highest degree.

We also recommend repairing the deep ruts in the pathway leading to the dock. Resurfacing the path with an accessible surface like stone dust would be ideal.

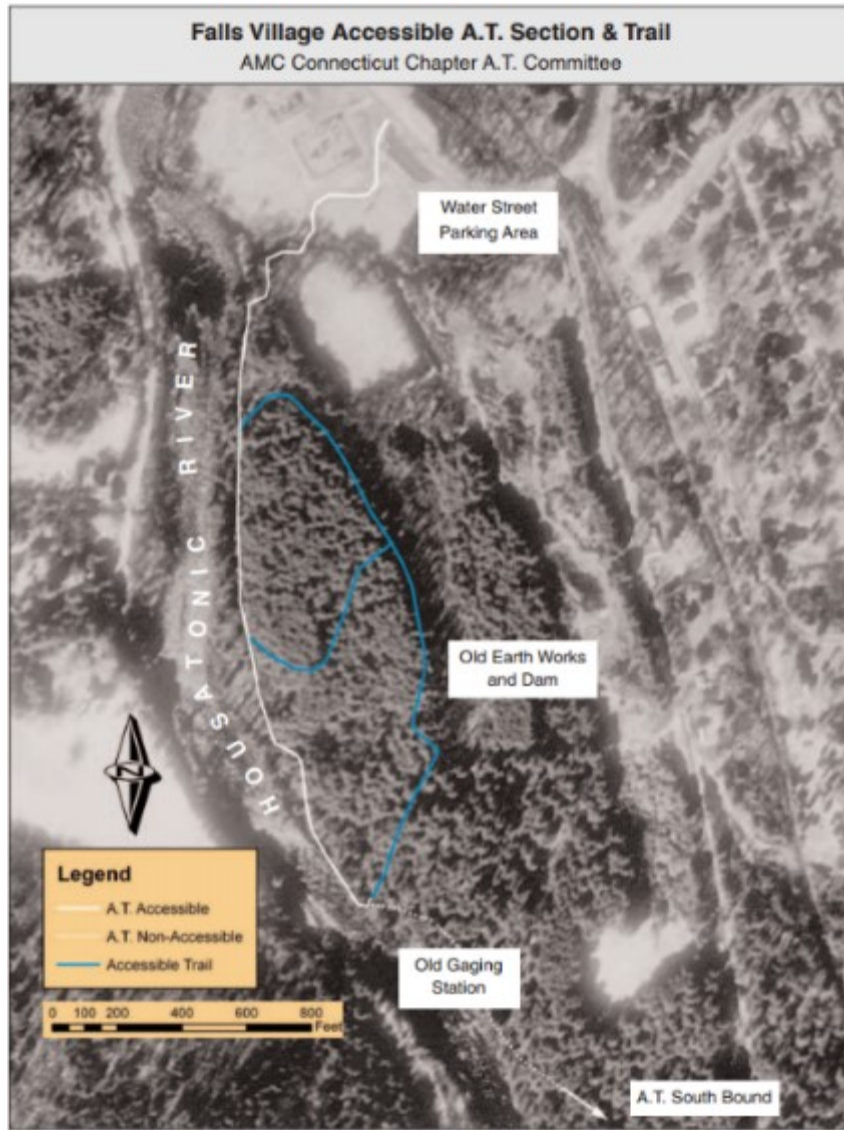
Figure 51: Falls Village Trail Design (*Appalachian Trail Re-Design*, 45)

The club voted to build an accessible trail in Falls Village in order to "create opportunities for accessible and less rugged recreation on the A.T." (Demrow, 41). The A.T. Committee chose Falls Village, because in Connecticut "there are very few locations aside from the Falls Village site with suitable terrain" (Demrow, 41). The trail is next to the Housatonic River and offers extremely gentle grades. The blue lines in Figure 51 illustrate where the accessible trail was built. Northeast Utilities had an "existing interpretive nature trail on the site", and noted that "there is easy access to the trail on paved roads for vehicles importing surfacing material" (Demrow, 41). The report noted that no demographic research was used for decision making.

The National Parks Service (NPS) did an environmental assessment of the site to “ensure that construction would not harm the historic race track or other historic and cultural features at the site” (Demrow, 42). To create the accessible trail, the contractor “laid down geotextile and then spread three quarter-inch gravel 3 inches thick and 3 feet wide for the treadway” (Demrow, 43). He also “imported rip-rap sized stone to build a causeway or turnpike, placed a culvert at the low point, and built the trail on and over a rock” (Demrow, 43). In addition to the trail being made accessible, one bridge was constructed to accessibility standards just as the trail goes into the woods (Demrow, 43).

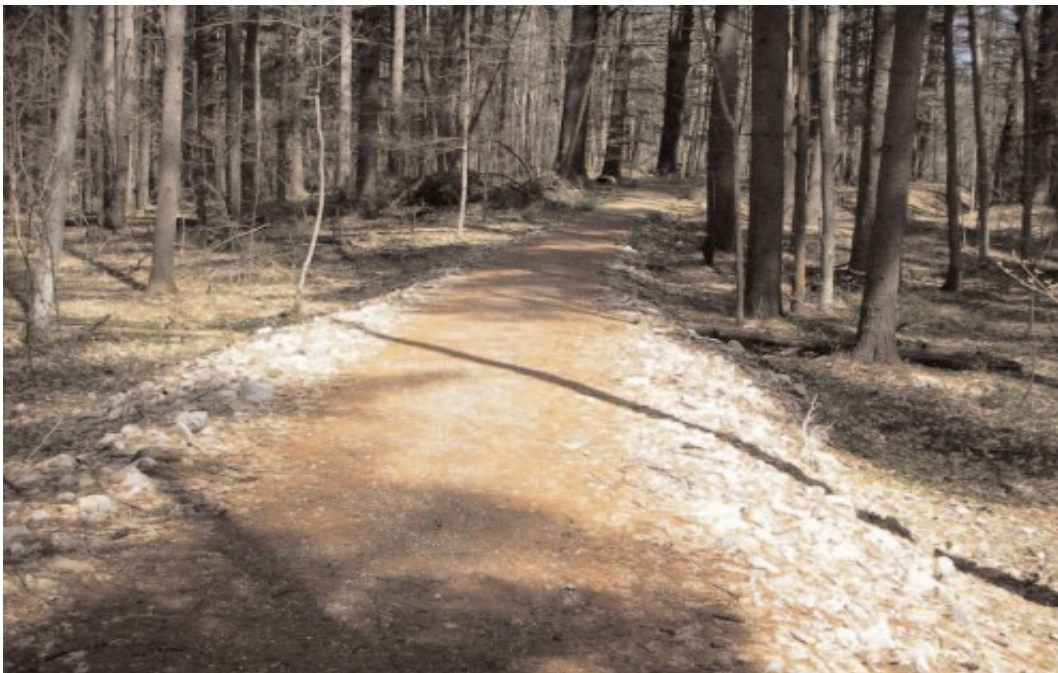
Figure 52: Section of the Falls Village Trail (Appalachian Trail Re-Design, 43)

has washed away, and it does not meet the “firm and stable” criteria. The A.T. Committee is considering removing the sand, then “surfacing the ground with some combination of fabric, stone dust, half inch or less gravel, and a culvert or two” to solve these problems (Demrow, 44). One addition the report mentioned was that a volunteer had make benches to be placed along the trail. However, the benches do not meet accessibility standards, which require a backrest. Also, several of the benches face the river, so there is not sufficient room for a wheelchair to navigate between the bench and where the bank falls away (Demrow, 44). Figure 52 illustrates part of the trail that had to be built up with imported rock to meet accessible grade guidelines.

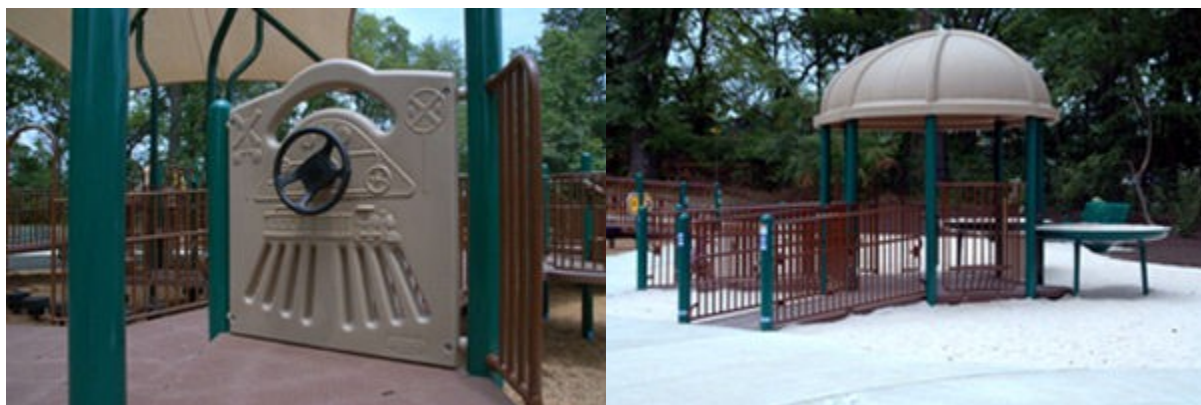
Figure 56 (left): Steering Wheel and Textured Wall for Sensory Play (Can-Do, 2007)

The architects of the Can-Do playground made sure to include all disabilities when designing this playground. For example, there is a textured wall with the designs of the inside and outside of a train, as well as a steering wheel to give children—with and without sight impairments—the imaginative experience of driving the train. Figures 56 and 57 show play surfaces that are vital components to the Can-Do playground. The playground includes mulch and a rubber-synthetic surface for good attenuation—one of the factors that must be considered according to the guidelines set forth by the ADA.

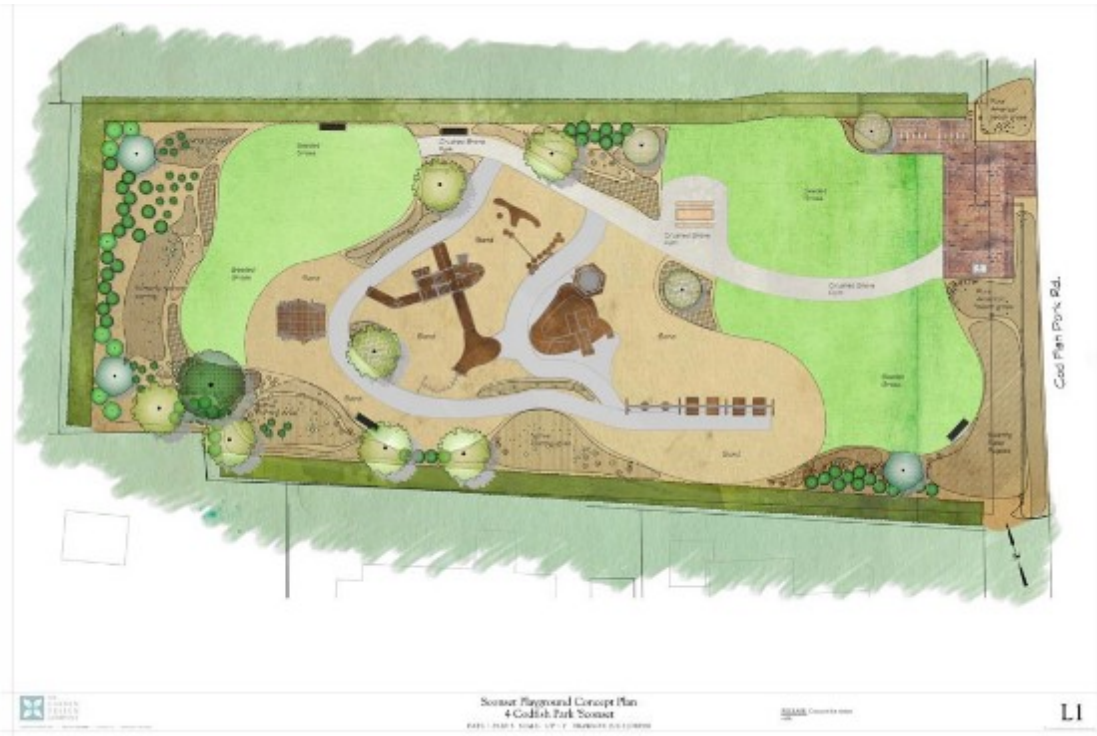
Figure 58: Drawings of the Plans for Sconset Playground (Julie Jordin, 2013)

By the summer of 2013, after the plan was complete, the Land Bank fully approved the design (Community Foundation for Nantucket, 2013). The drawings of the plans are shown in Figure 58.
