Maintaining the Integrity of Structural and Fire Protection  
Systems and Building Documentation in Historic Buildings:

# Washburn Shops Case Study

WORCESTER POLYTECHNIC INSTITUTE

in partial fulfillment of the requirements for the  
Degree of Bachelor of Science  
in Civil Engineering by

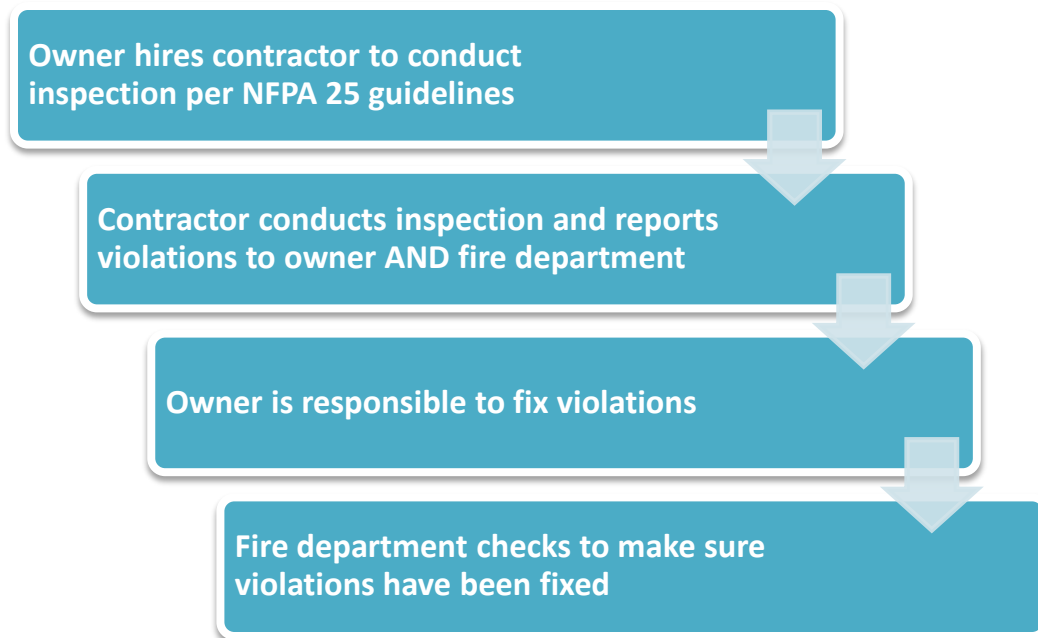
Figure 3: Fire Protection System Inspection Process

Duffy explains that when inspecting an older building, the fire protection system is inspected according to the codes used at that time. The order of inspection process is outlined in Figure 3.

This process shows that the violations of the system are ultimately the responsibility of the owner. The fire department enforces the correction of the violations and sets a time limit upon the owner in which to fix these violations (depending on the severity of the violation).

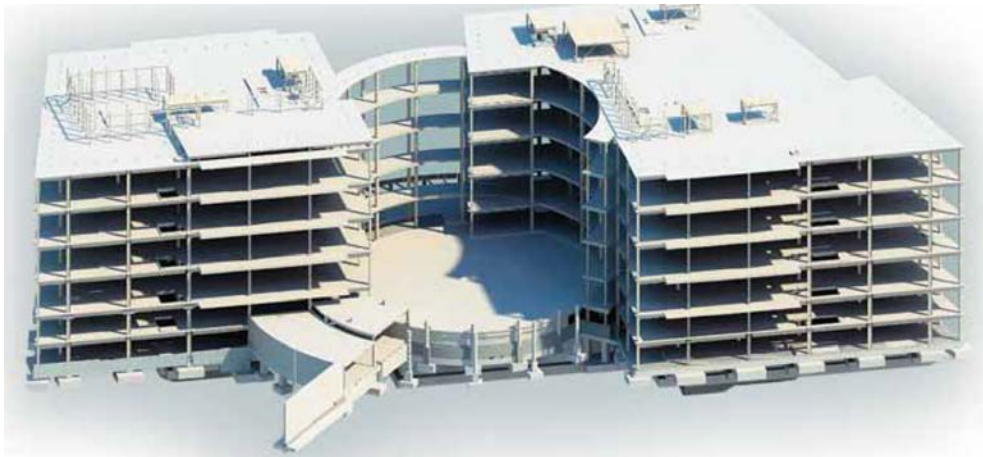
Figure 7: Example of BIM 3D Model (Reid, 2011)

model. “The building information model is a project as well as a process simulation” (Kymmell, 2008). Planning and building a project virtually allows all aspects to be considered and communicated before anything needs to be finalized. “After all, if there is only one opportunity to do it right, it makes a lot of sense to prepare well for that single occasion virtually, and thereby reduce the inherent risks and improve the chances for success and efficiency” (Kymmell, 2008). Figure 7 is an example of a BIM 3D Model.

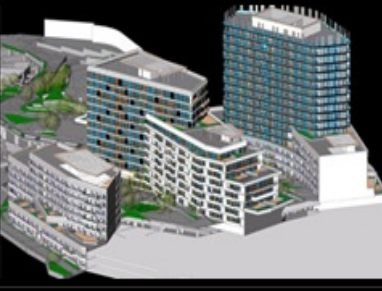
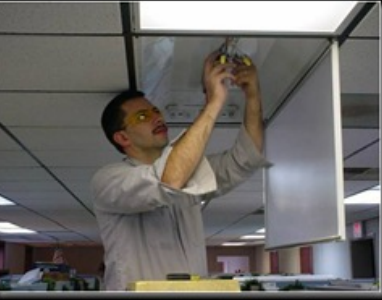
Figure 8: Outline of LOD (Van, 2008)

<p>LOD 200 - Similar to schematic design or design development, the model would consist of "generalized systems or assemblies with approximate quantities, size, shape, location and orientation." Authorized users would include "analysis of selected systems by application of generalized performance criteria."</p>

<p><i>Image courtesy of Mortenson Construction</i></p>	<p>LOD 400 - This level of development is considered to be suitable for fabrication and assembly. The MEA for this LOD is most likely to be the trade contractor or fabricator as it is usually outside the scope of the architect's or engineer's services or would constitute severe risk exposure if such parties are not adequately insured.</p>

<p>LOD 500 - The final level of development represents the project as it has been constructed - the as-built conditions. The model is suitable for maintenance and operations of the facility.</p>

LOD 400 is suitable for fabrication and assembly, and is most likely to be used by specialty trades. The final level, LOD 500, represents the project “as it has been constructed including as-builts”. These models include completed parameters and attributes (Kal-Blue, 2011). Figure 8 displays and describes each level of detail.

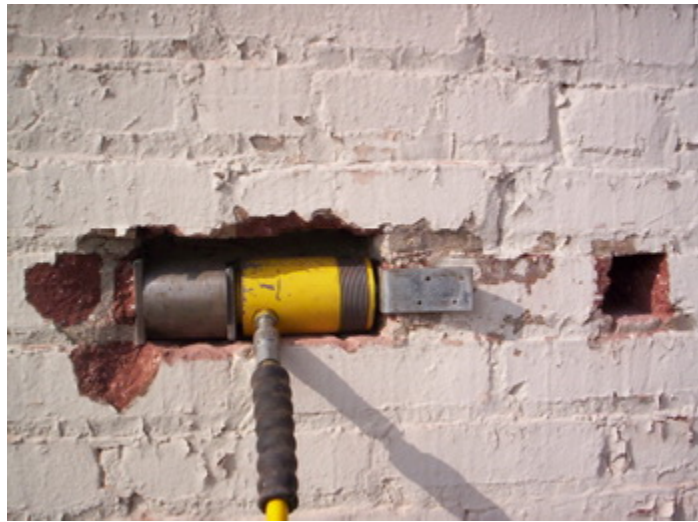
Figure 13. In-place Shear Test

The masonry and the mortar must be tested separately in order to determine code compliance. Section A106.3.3 refers to masonry testing including minimum qualities of mortar and masonry as well as testing procedures and other testing regulations. The *Code* states that the qualities shall be determined by in-place shear tests unless this will cause the masonry unit to fail. In the case that in-place shear tests cannot be used, drilled core tests or hollow unit masonry tests should be used instead (International Code Council, 2007). Figure 13 shows an in-place shear test. Section A106.3.3.5 specifies the minimum quality of mortar; the data from the testing is

$$v_{to} = (V_{test}/A_b) - p_{D+L}$$

If  $v_{to}$  is less than 30 pounds per square inch or 207kPa, then the mortar shall be re-pointed and retested (International Code Council 2007). Section A106.3.3.6 regulates the minimum quality of masonry and states that  $f_{sp}$  shall be a minimum of 50 psi (Cowen, 2011).

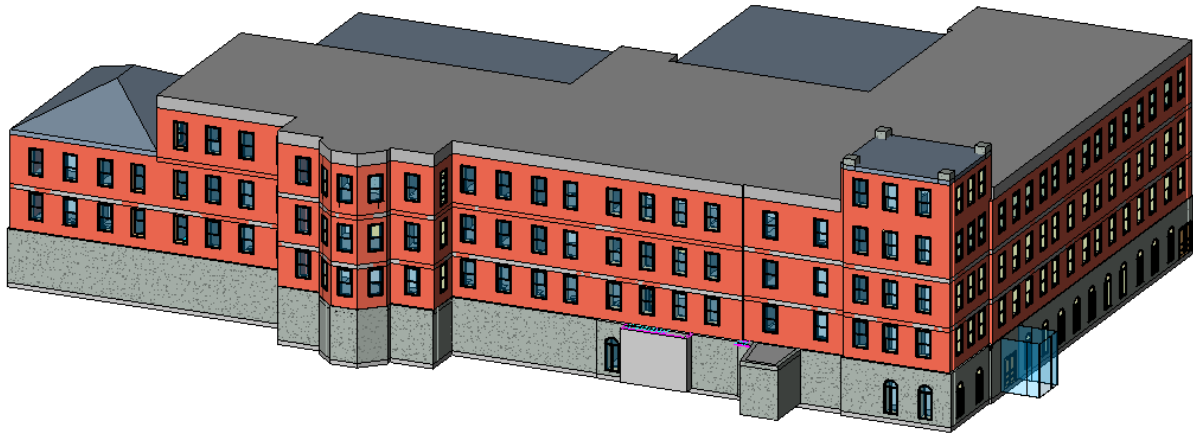
Figure 16: Autodesk Revit Representation of Washburn from WPI Students (Wang, 2010)

The project team was provided with two of the most recent models of Washburn in *Autodesk Revit*. The first, pictured in Figure 16, was created by two WPI students, Mengling Wang and Holian Qu as part of a term project in spring 2010. The 3D model was created from 2D floor plans acquired from WPI Department of Facilities. In creating this model the students focused on space distribution and the floor layouts. Their model did not develop the roof structure on the third floor. The second model the team acquired is in Figure 17 This model was developed by Hoffman Architects during the most recent renovation project. The 3D model displays the structural aspects of Washburn focusing on the original building section.

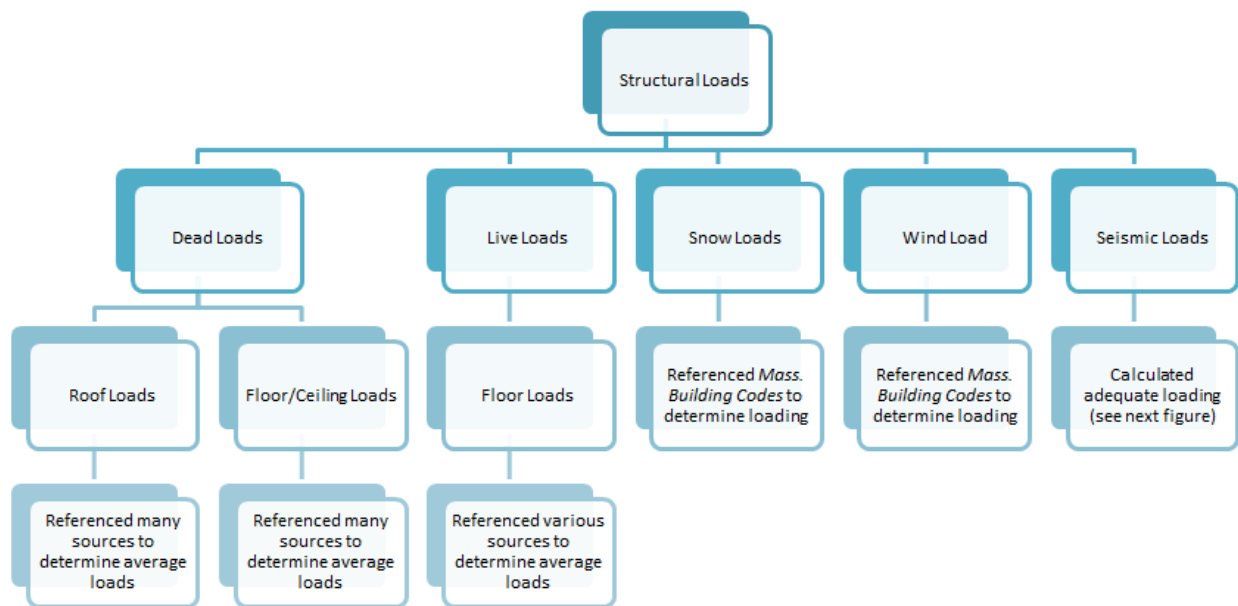
The wind loads were determined by first selecting the appropriate exposure. The exposure was determined to be exposure level B, which refers to suburban areas, towns or city outskirts. Next Worcester was located in Wind load zone 2. The exposure and wind zone were used together with Table 1611.4 of the *Code* to determine the wind pressure loading.

Figure 29: Structural Load Breakdown

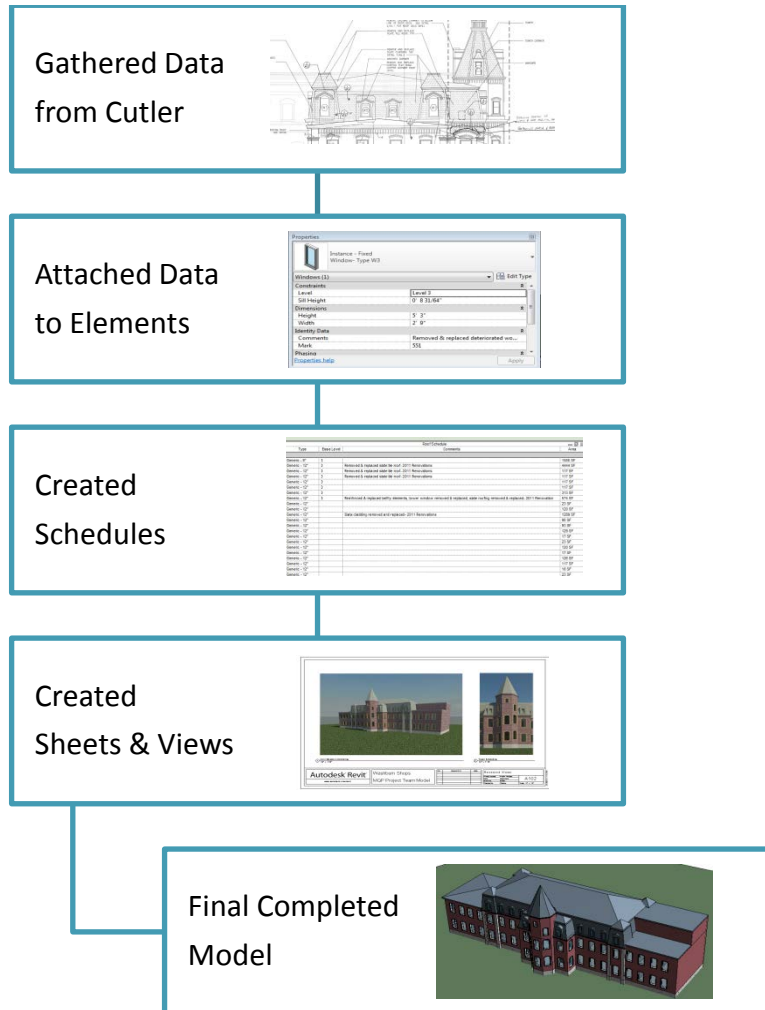
Figure 45: Final Steps to Complete BIM Model

The renovation data was attached to the model to provide another dimension to the depiction of Washburn. For example the work done to a window, removed and replaced trim, was attached to the window item within the model. This was completed in a likewise manner for all the project work. Schedules were also created to view and organize this data within the model. Figure 45 shows the steps taken to complete the model and transform it into a BIM model.

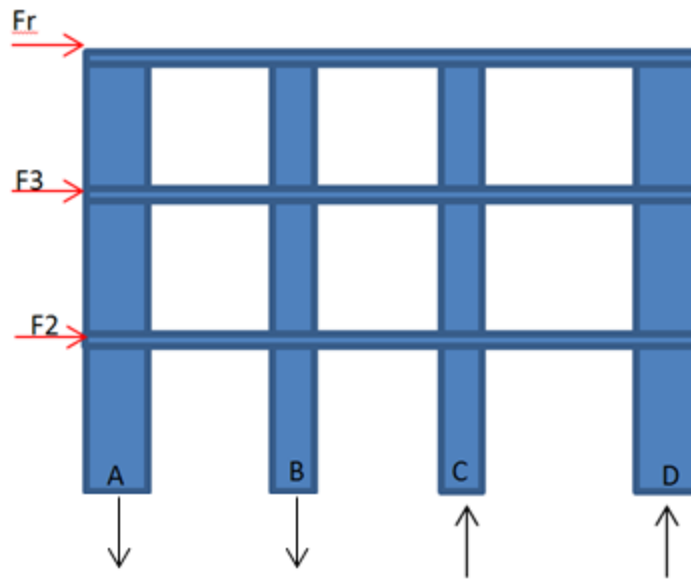
Seismic Loading		
Column	Force (k)	Force (ksi)
<b>A</b>	212.99	204.80
<b>B</b>	96.26	204.80
<b>C</b>	96.26	204.80
<b>D</b>	212.99	204.80

Figure 48: Seismic Loading and Forces

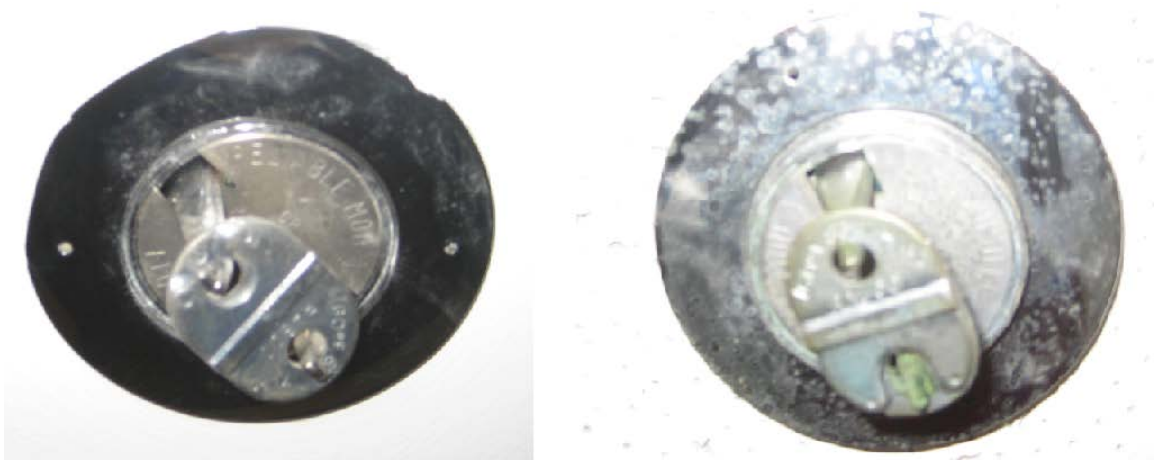
Figure 62: Fusible link askew on left sprinkler compared to right

Figure 62 shows that the sprinkler on the left has a fusible link that is at a different angle than the link for the sprinkler on the right. The sprinkler must have been hit, and no one has noticed

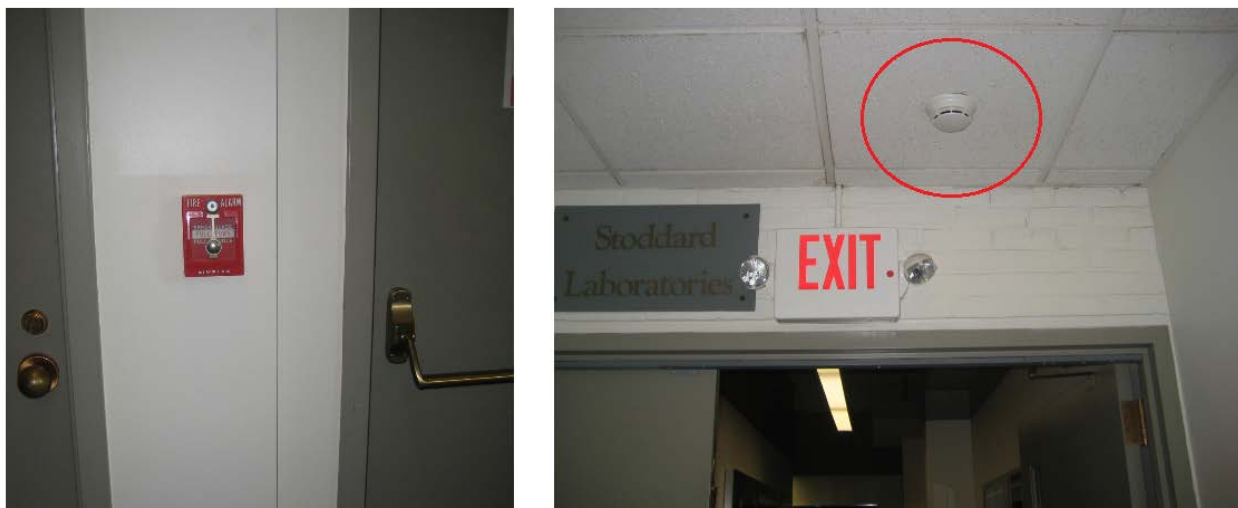
This pull station is seen in Figure 65. The smoke would have eventually reached a smoke alarm at the end of the hallway shown in the far right picture of Figure 64. This detector is also shown in Figure 65.

Figure 65: Manual Pull Station and Smoke Detector used in 2011 Roof Renovation Fire

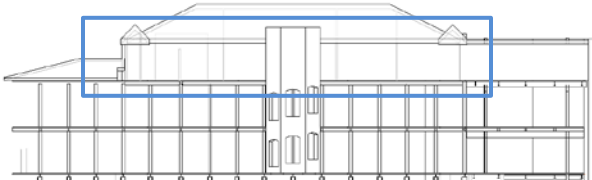
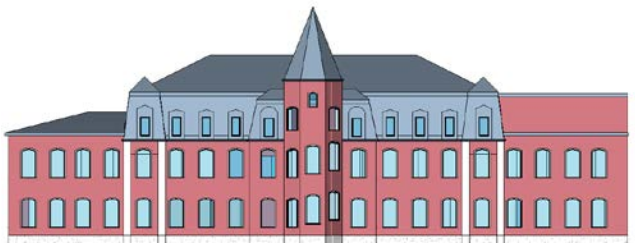
Model missing entire roof structure	Model missing sloped roof and tower	
<b>Corrected Third Floor/Added Dormers</b>

Third floor does not have brick walls	Third floor missing dormers	
<b>Updated/Added Windows</b>

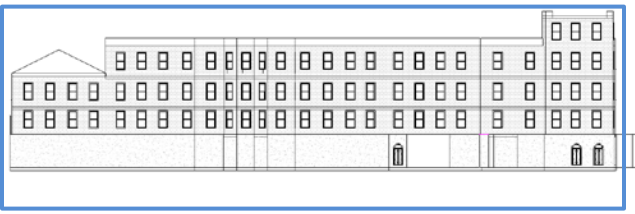
Incorrect size and number of windows	Model missing third floor windows

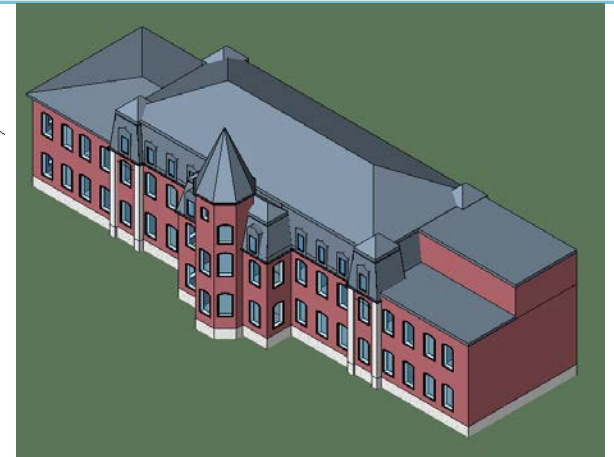
The final model incorporates the roof structure of Washburn along with the addition of the dormers and windows on the third level which neither of the other models displayed. For the final model the project team focused on the core of Washburn, only showing the original building. This section of the building is the highlight of our project and of the most recent renovation work. There is also the most accurate data for this section. The project team did not have the proper documentation to accurately model and display the rest of the building.

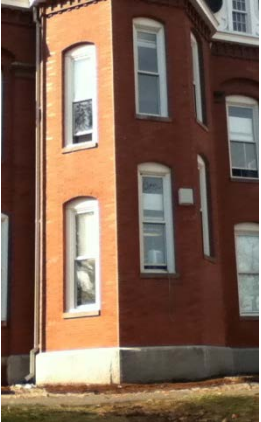
Brick Walls	3 <sup>rd</sup> Floor of Tower	Repointed and added helical anchors every other course

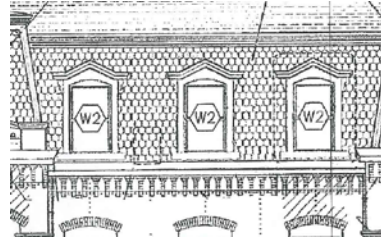
<p>Sheet 1</p>

Mansard Roof	3 <sup>rd</sup> Floor Sloped Mansard	Slate cladding removed and replaced

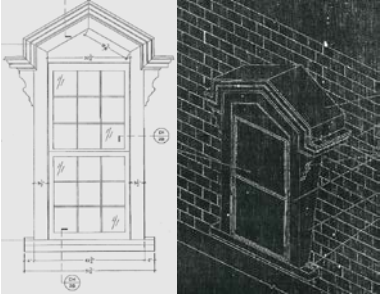
<p data-bbox="1314 545 1415 573">Sheet 2</p>

Element	Location	Renovation Details	Plan Drawing	Images
Windows (Type W1)	3 <sup>rd</sup> Floor Windows (2) on bumped out portions far left and right	Removed and replaced existing sill; Deteriorated wood trim removed and replaced; Dormer window removed and replaced; Sheet metal dormer removed and replaced

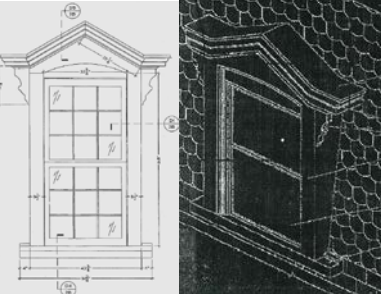
<p data-bbox="1314 927 1415 954">Sheet 2</p>

Windows (Type W2)	3 <sup>rd</sup> Floor Windows (6) on flat face of building	Removed and replaced existing sill; Deteriorated wood trim removed and replaced; Dormer window removed and replaced; Sheet metal dormer removed and replaced

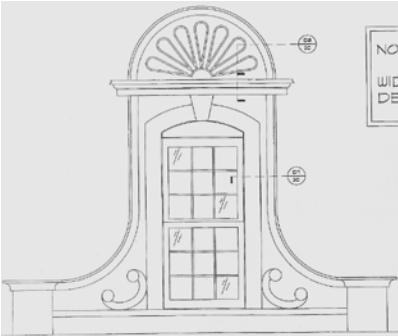
<p data-bbox="1304 1333 1425 1360">Sheet 2A</p>

Windows (Type W3)	3 <sup>rd</sup> Floor Windows (2) left and right of Tower	Removed and replaced deteriorated wood trim, moldings and cresting; Sheet metal dormer removed and replaced

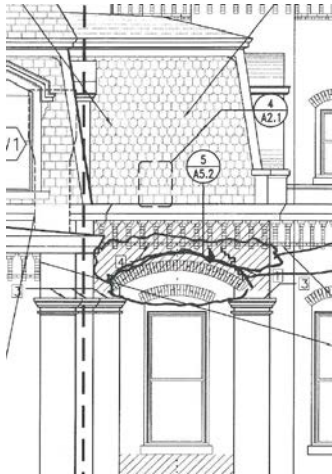
Element	Location	Renovation Details	Plan Drawing	Images
<b>South Elevation</b>				
Arch	2 <sup>nd</sup> Floor Rightmost Window bump out of front façade	Rebuilt arch and replaced flashing above window

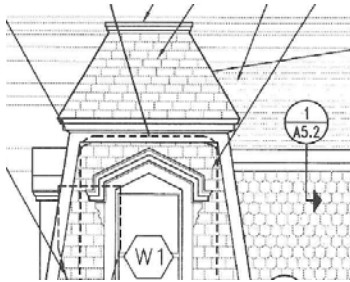
Dormer Roofs	3 <sup>rd</sup> Floor both Dormers	Remove and replace slate tile roof

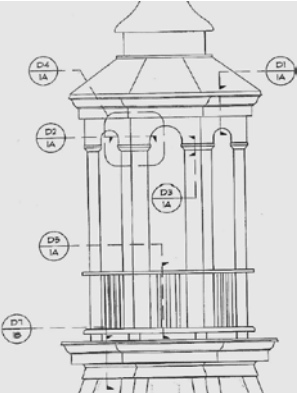
<p data-bbox="1304 1032 1430 1057">Sheet 1A</p>

<b>Tower</b>				
Belfry	Throughout Belfry at Top of Tower	Replaced Spanish cedar woodwork

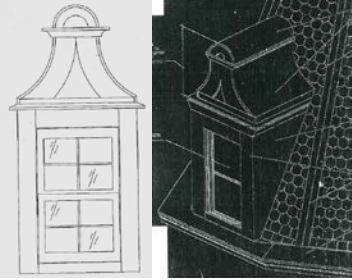
<p data-bbox="1304 529 1423 558">Sheet 2A</p>

Element	Location	Renovation Details	Plan Drawing	Images
Window (Type W4)	Tower Roof	Removed and replaced window in dormer; Cresting removed and replaced; Wood trim removed and replaced; Metal window framing removed and replaced

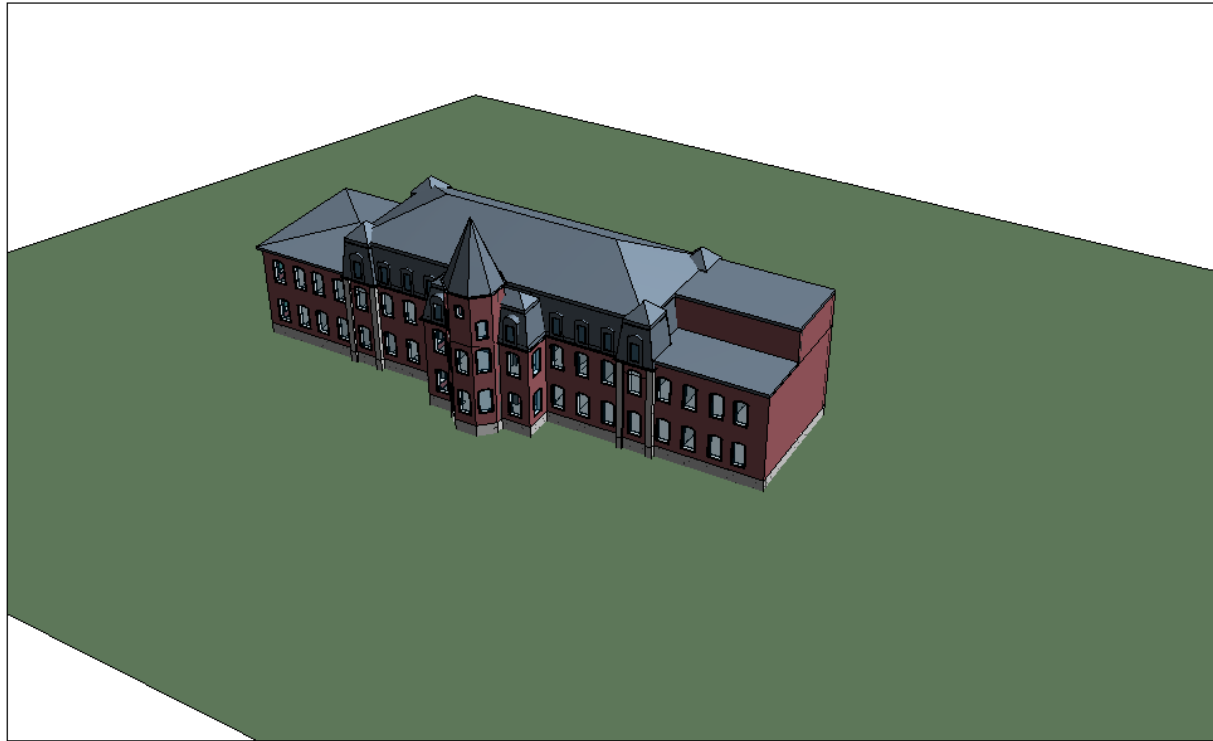
Figure 75: Sheet A101- 3D View

The final product created by the project team to document Washburn is a BIM model in *Autodesk Revit* that has also been converted to a file format *dwf* that is compatible with *Autodesk Design Review*. This format gives access to non-Revit users to the model and its stored information, having a greater ease of use and is a more user friendly program that can be easily downloaded from the Autodesk website. The following are sheets from the model to display the groups work in representing the building (Figure 75-Figure 80).

① 3D View

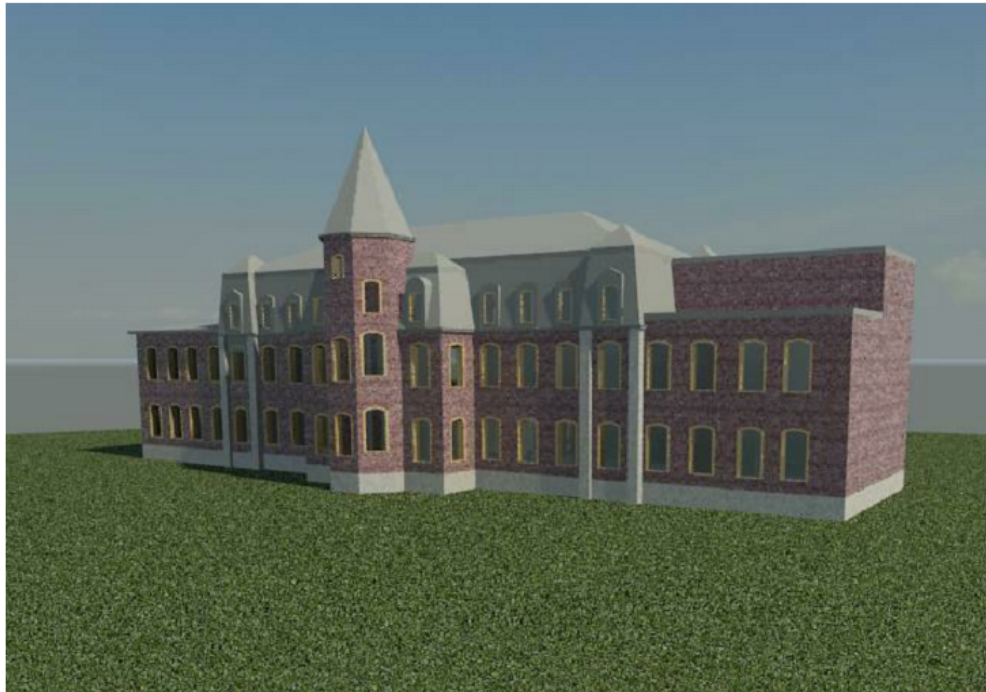
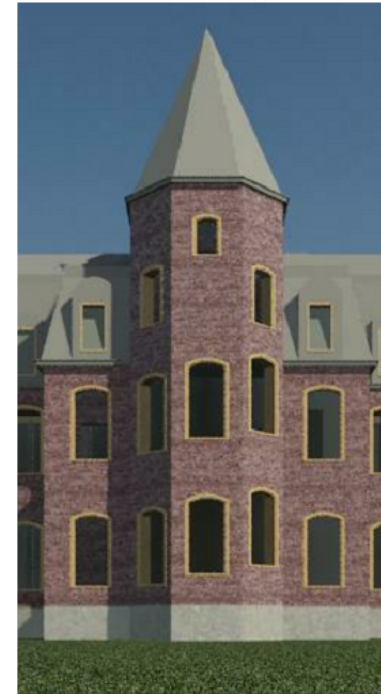
① Front Elevation Rendering  
12" = 1'-0"

② Tower Rendering  
12" = 1'-0"

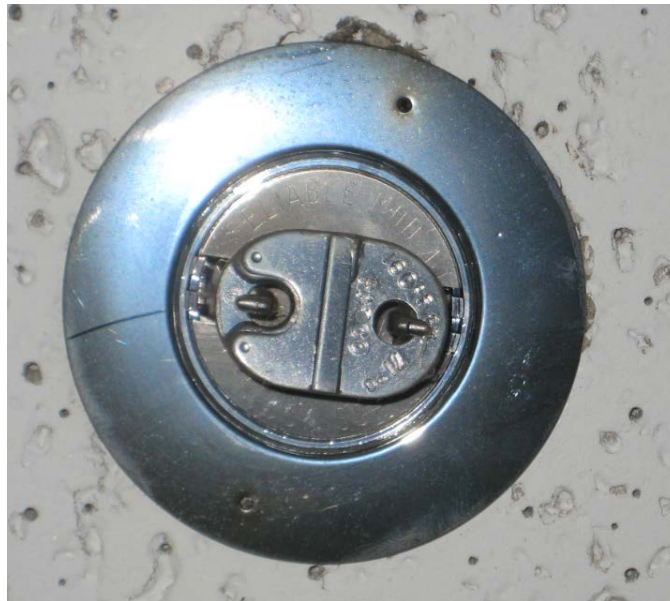
Figure 89: Temperature Rating (item 5)

The sprinklers are rated 160°F and need to be between 135 and 170°F for ordinary rating. This complies with *NFPA 13* 8.3.2.1 and item 5 in Appendix 7.2.

Item #	Element	Code Reference	Code Text	Interpretation	Compliant	Current Conditions
			are met, ordinary- and intermediate-temperature sprinklers shall be used throughout buildings	ducts may need a higher temperature rating but other should be ordinary or intermediate.		suspended ceiling complied. See Figure 89.
6	Area of Coverage	8.5.2.2.2	The maximum area of coverage of any sprinkler shall not exceed 400ft <sup>2</sup>	A sprinkler can protect a maximum of 400 ft <sup>2</sup>	Yes	Inspected sprinklers were closer than necessary
7	Deflector Orientation	8.5.4.2	Deflectors of sprinklers shall be aligned parallel to ceilings, rods, or the incline of stairs.	Deflectors are parallel to surface above sprinklers	Yes	All deflectors inspected were parallel. See Figure 88.
8	Distance from Walls	8.6.3.2.1	The distance from sprinklers to walls shall not exceed one-half of the allowable distance between sprinklers	Sprinklers must be between 4 inches and half of maximum allowable distance	Yes	All sprinklers inspected followed this spacing from wall.

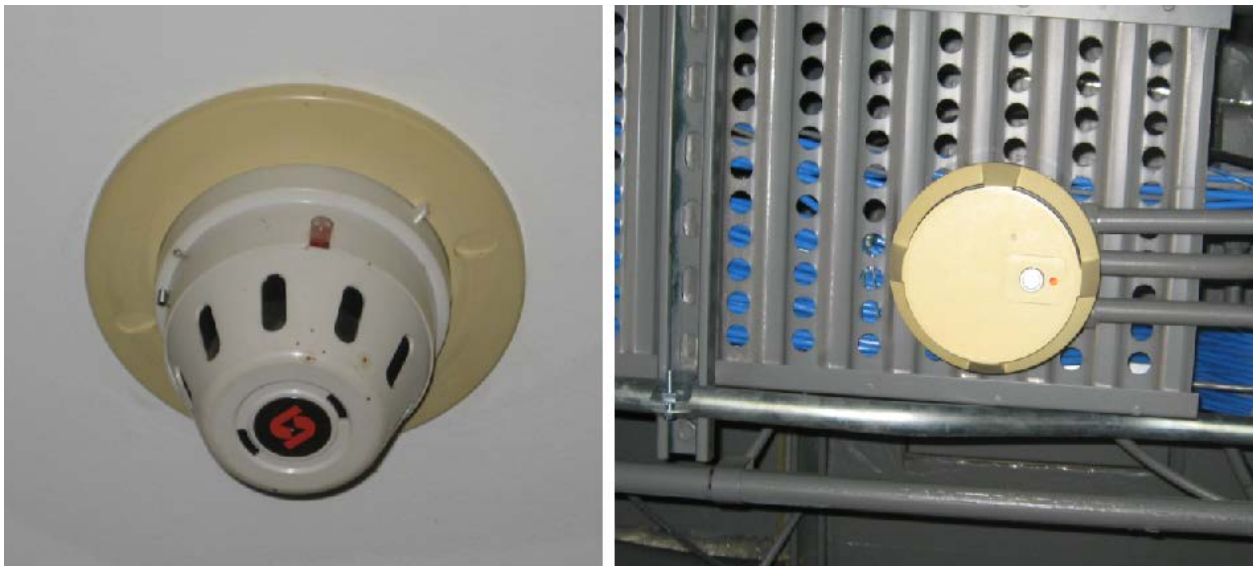
Figure 91: Marked Smoke Detectors (items 18 and 23)

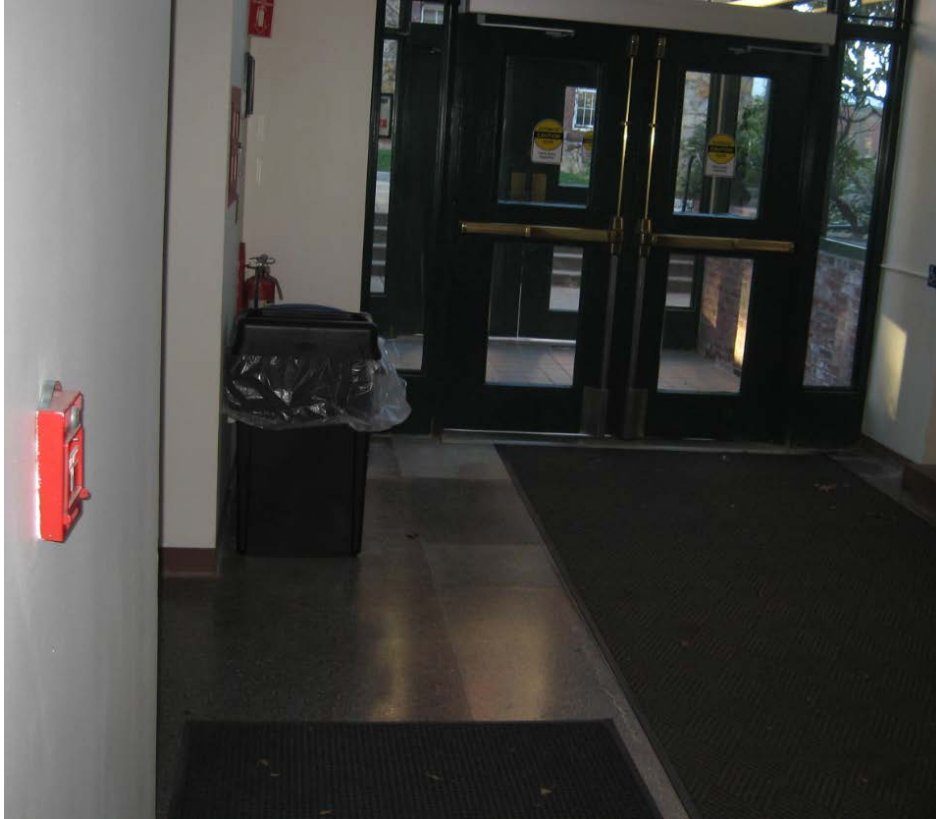
Figure 92: Pull station more than 5 ft from entrance (item 21)

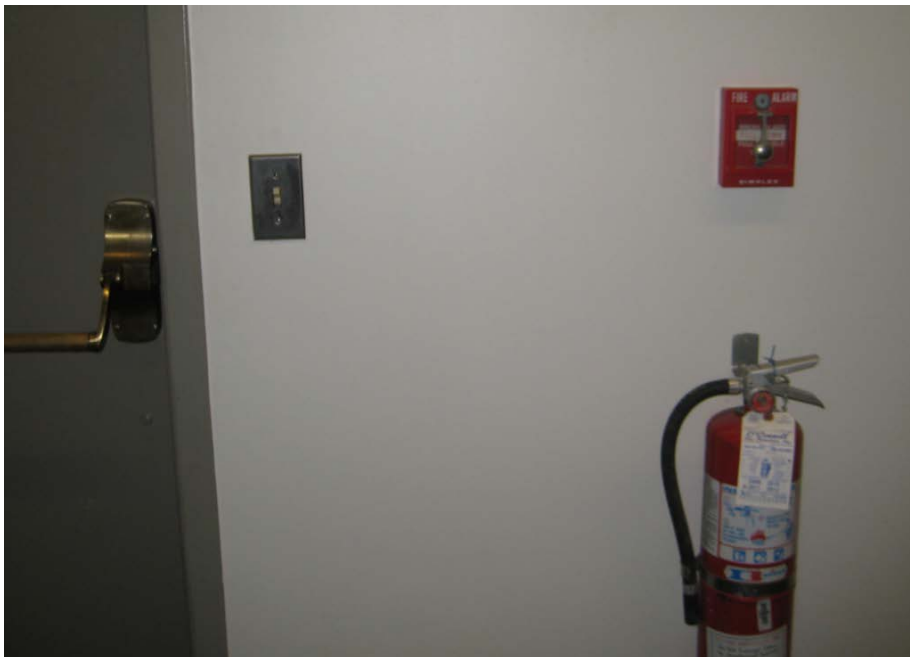
Figure 93: Pull station correct height and distinguishable (items 21 and 22)

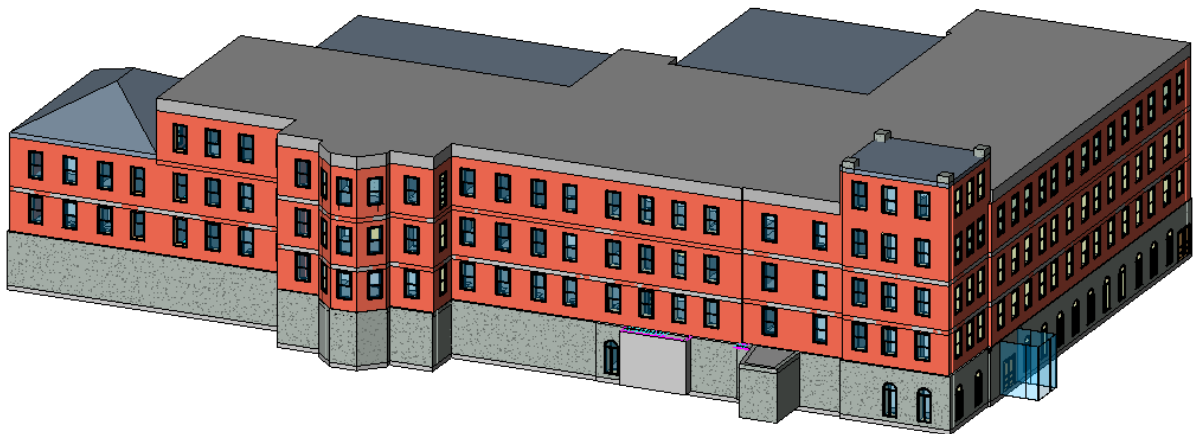
*Washburn shops* was built in the 1800's so it has seen all forms of project documentation. Its original documents were hand drawn representations of the building. They were later compiled to *AutoCAD* and *Autodesk Revit* depictions in order to allow *WPI* to have electronic copies. Figure 11 depicts the *Autodesk Revit* rendition of *Washburn*. The drawings of the building were further elaborated in this software for the preliminary stages of BIM. Figure 12 shows the current BIM Model *WPI* facilities has of *Washburn*.

Figure 12. BIM Representation of Washburn (Wang, 2010)

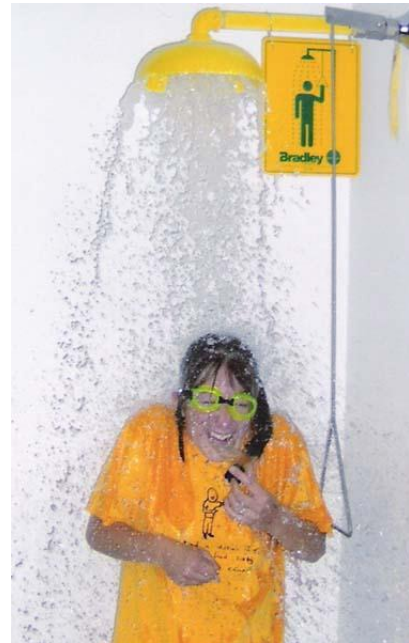
shows an example of an emergency wash system. The codes also state that there should be no obstacles in the direct path to an exit and doors and windows must be kept clear at all times. In addition buildings must be sprinkled throughout when conducting “substantial renovation,” or “when the work performed facilitates the installation of sprinkler” and/or work done on the building affects more than 33% of its gross square footage or the total cost of work is greater than or equal to 33% of the buildings value (Woodworth, 2011).

Figure 19. Emergency Wash System (Board of Fire Prevention Regulations, 2010)

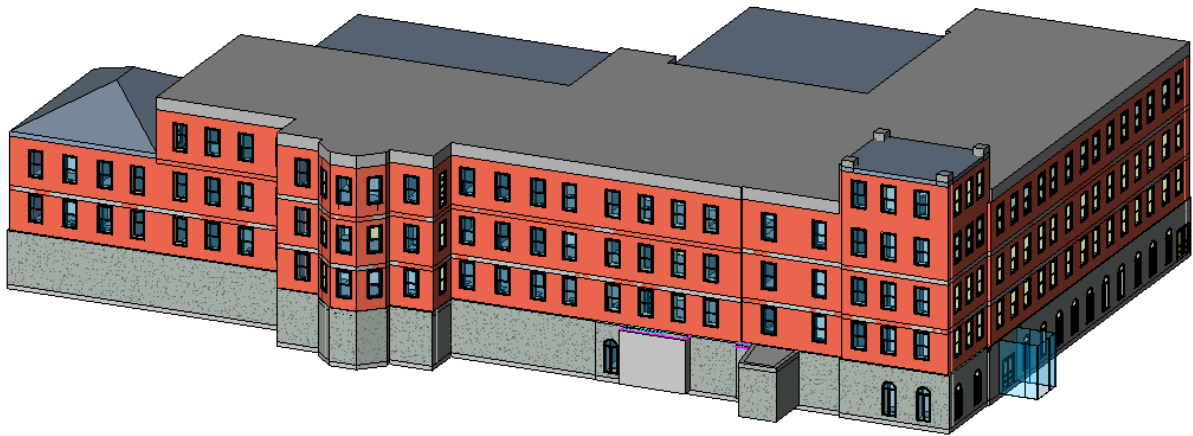
An integral part of this project is the computer-based documentation of Washburn. The team will first investigate the drawings that others have created in the past. These drawings will be reviewed to determine if they are up to date and what inaccuracies exist. WPI Facilities Management has simple architectural and structural drawings, but requires a more detailed and precise capture of the building. Figure 20, Figure 21 and Figure 22 show the drawings that currently exist. These drawings and the three dimensional drawing created from them will be corrected and expanded upon. The roof level of the building will be added and components will be updated to reflect the materials and details of Washburn.

Figure 21. Current 3D Washburn Model

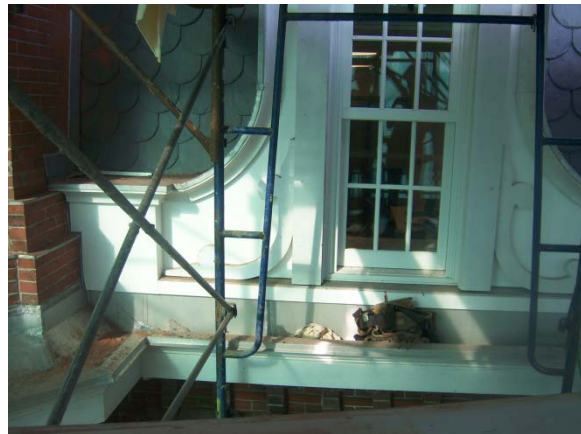
New Window at Roof Level

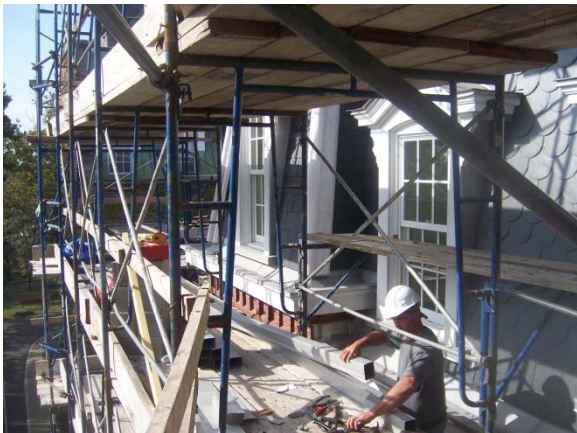
Windows with New Slate

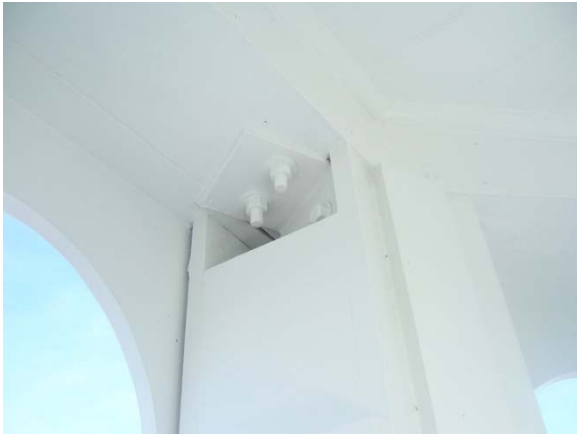
New Exterior Tower Bracket

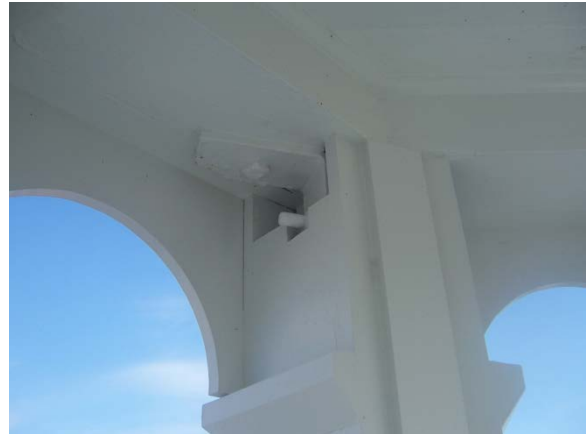
Old Exterior Tower Bracket
