Sackett Harbor Bridge Design

A Project Report for

A Major Qualifying Project
To be submitted to the faculty of
Worcester Polytechnic Institute
In partial fulfillment of the requirements for the
Degree of Bachelor of Science

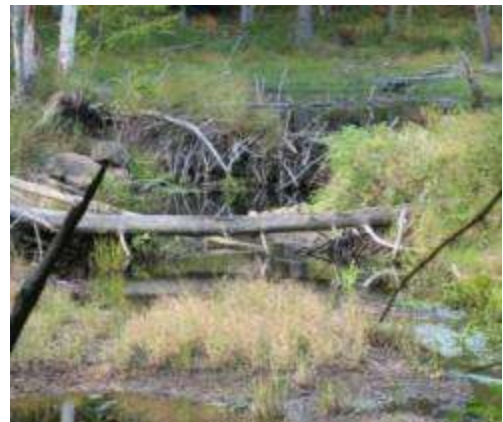
Figure 1: Beaver Activity Upstream of Bridge

The tape measure was also used during this site visit to measure the water level from the bottom of the slump of the bridge. The bridge is currently exhibiting a slump with the lowest point being about 1/3 of the distance from the Northwesterly side. The change in height was measured with the tape measure between the most slumped point and another point that was closer to level with the entirety of the bridge. This will be compared to the values for the water level taken at an earlier time because a noticeable drop in water level has taken place due to beaver activity (Figure 1).

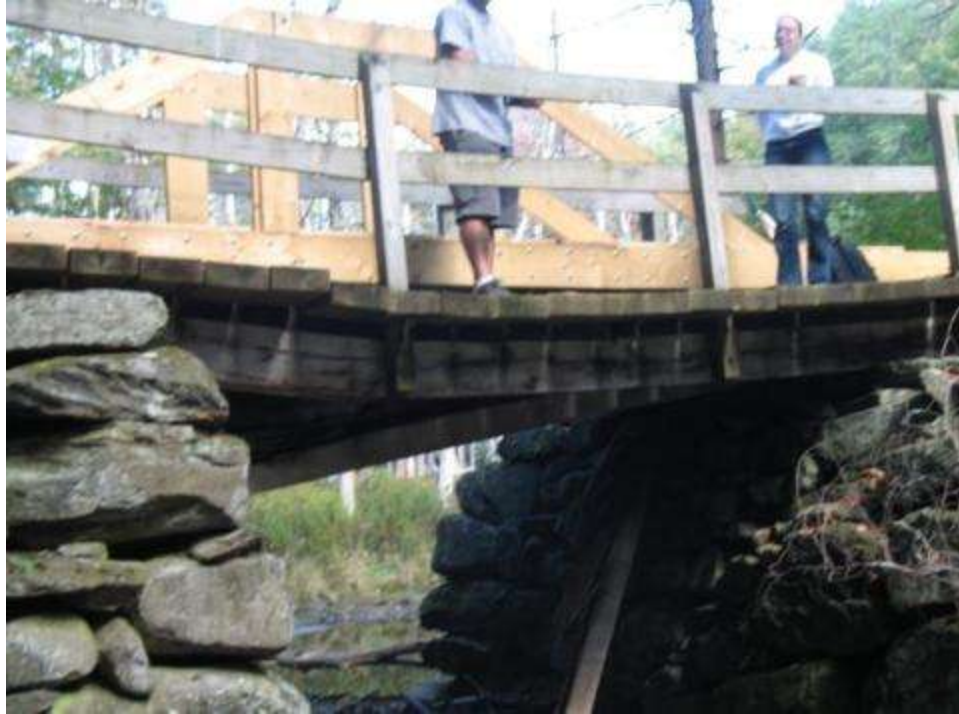
Figure 2: Excessive deflection due to overloading of remaining beams (note presence of temporary structure)

The current structure is a solid-sawn lumber multi-beam bridge. The most important locations for inspection of this type of bridge is the ends of the beams, for shear inspection; lower half of beams, for tension inspection; ends of beam, for horizontal shear crack inspection; and any exposed surface, especially where in contact with water or soils, to look for decay of members. An inspection for shear damage of the ends of the beams showed that none of the beams had failed or begun to fail under this type of shear. No vertical cracks were noticed, most cracks ran horizontally, as will be described in horizontal shear and decay. The next important location of inspection is the center of the span below the center-line of the beam. This location is where the highest tension is found and therefore any failure in tension can be determined here. Inspection found that there was some cracking in this region. Also, excessive deflection or sagging was inspected and turned out to be quite dramatic, as seen in Figure 2. The remaining structural beams are unable to support the bridge's load alone and have begun to sag under the weight.

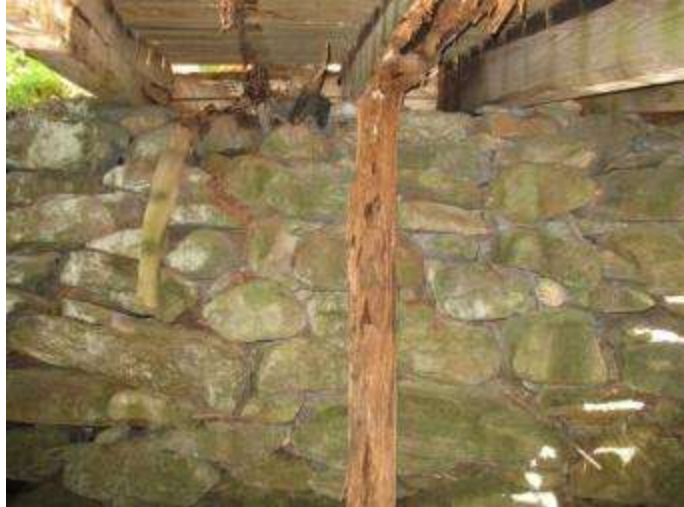
Figure 3: Rotting of entire beam length

An inspection of decay was conducted, although during the entire inspection process it was obvious that decay played a large part in the bridge failure. Most of the failures in the above categories were caused by the weakening of members due to decay. Rotting is most evident where the soil was in contact with the bridge, however, it spanned the entire bridge, with some structural beams rotting to the point of falling off from the decking.

It is recommended that any future design using timber be kept out of contact with soils. Also, diversion of water flow would protect the bridge and abutment from further decay and erosion. An additional protection measure would be to use pressure treated wood, once again, to prevent decay.

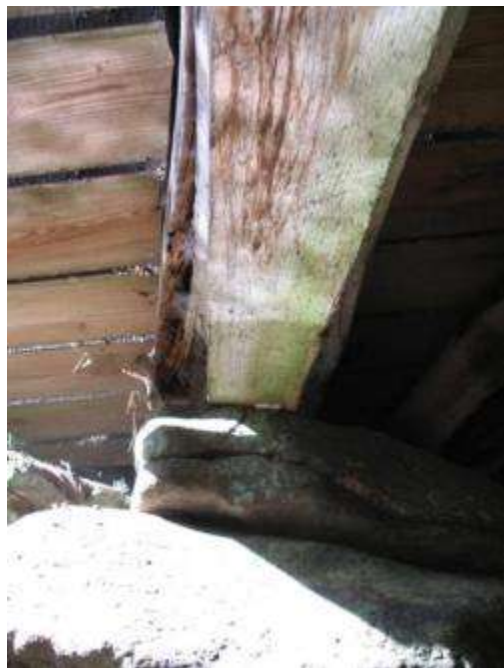
Figure 4: Failure on compression due to decay

As a result of the excessive deterioration, many of the beams failed in *compression* at the point where they rest between the deck and the stone abutment, this was not expected as a mode of failure for the wooden beams.

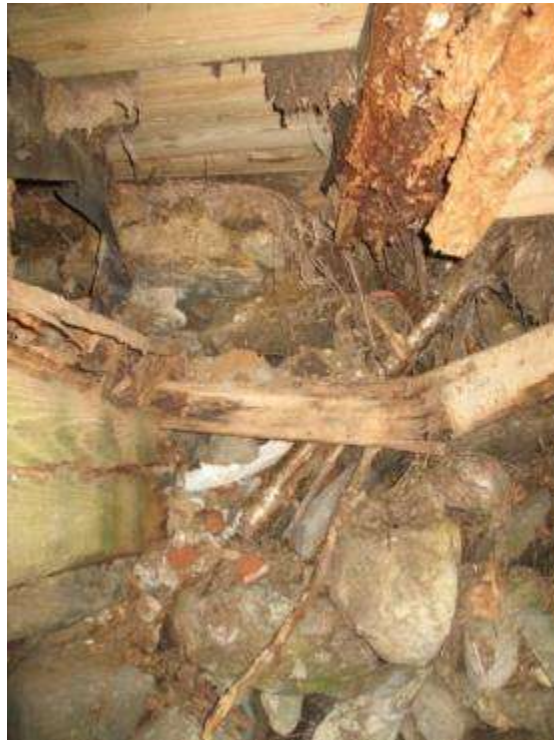
Figure 5: Decay most evident at contact with soil and water

The site of most decay was in the “channel” of the abutment, a low spot in the abutment that channels water from the hill above. In this location most of the support beams had deteriorated completely. Further deterioration was noted where soils came in contact with the beams as shown in Figure 5. It is almost certain that water exposure increased the members’ susceptibility to insect damages and other forms of decay (Baker, 1969). The decay spread through entire beam when water was able to soak up do to prolonged exposure.

Overall, through inspection, the mode of failure was very clear. Failure was caused by excessive decay resulting from contact of the members with the soil and water. Although the remaining two beams have withstood the decay well (due to not being in as much direct contact with soil) they have begun to fail due to excessive loading.

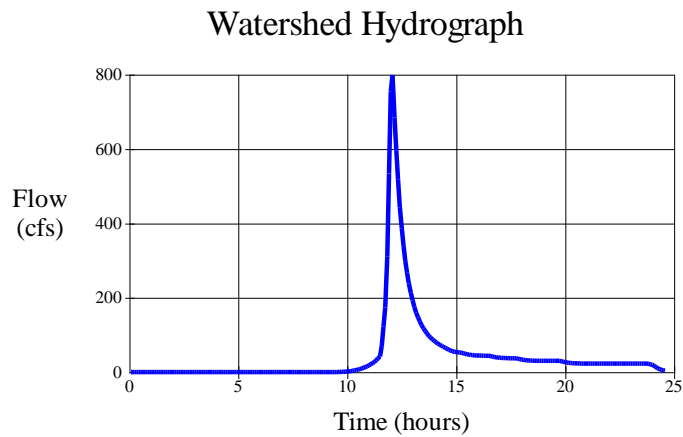
Figure 8: Hydrograph showing flow from 25-yr 24-hr storm event

The flow, in runoff, generated by the occurrence of such an event can be seen in Figure 8. Using the Santa Barbara method, a maximum flow of 799.2 cfs is calculated. The maximum infiltration rate of 0.273 inches per hour was calculated. This data can be used in calculating effects of storm events on scour and sedimentation, as well as predicting runoff velocities and flows in the project area.

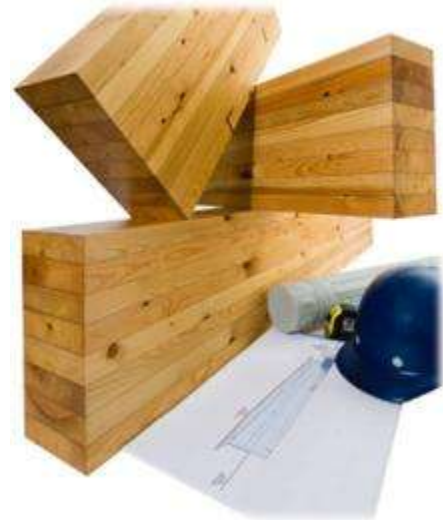
Figure 10: Glulam

Another way that wood members can be used for this purpose is to use glued laminated timber. This is an engineered wood which is made up of multiple layers of wood glued together which allows smaller sized members to be used to support the same loading conditions (Figure 10). For the same thirty foot span as the previous examples four 5"x11" members with a stress rating of 24F-1.8E provides enough support for the applied loading. Although this design alternative provides enough structural support it does not follow the "green" building techniques of the Trustees of Reservations. The glulam members would have to be shipped from a company that is a large distance away. The two closest supplier to Petersham, MA are located in Maine or Ohio which will require a large delivery cost and a large carbon footprint.

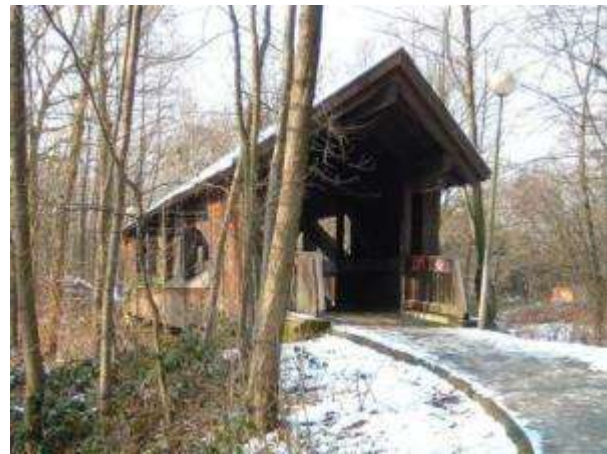
Figure 12: Example of Covered Bridge

One way to increase the lifespan of a wooden bridge is to put a roof on it which reduces the amount of water and other harmful materials that gets on the structure. An example of a covered bridge is shown in Figure 12.

This increases the total weight of the bridge and therefore larger members are needed to support the roofing system. This roof is placed upon a truss design which is tall enough to allow vehicular traffic to pass.

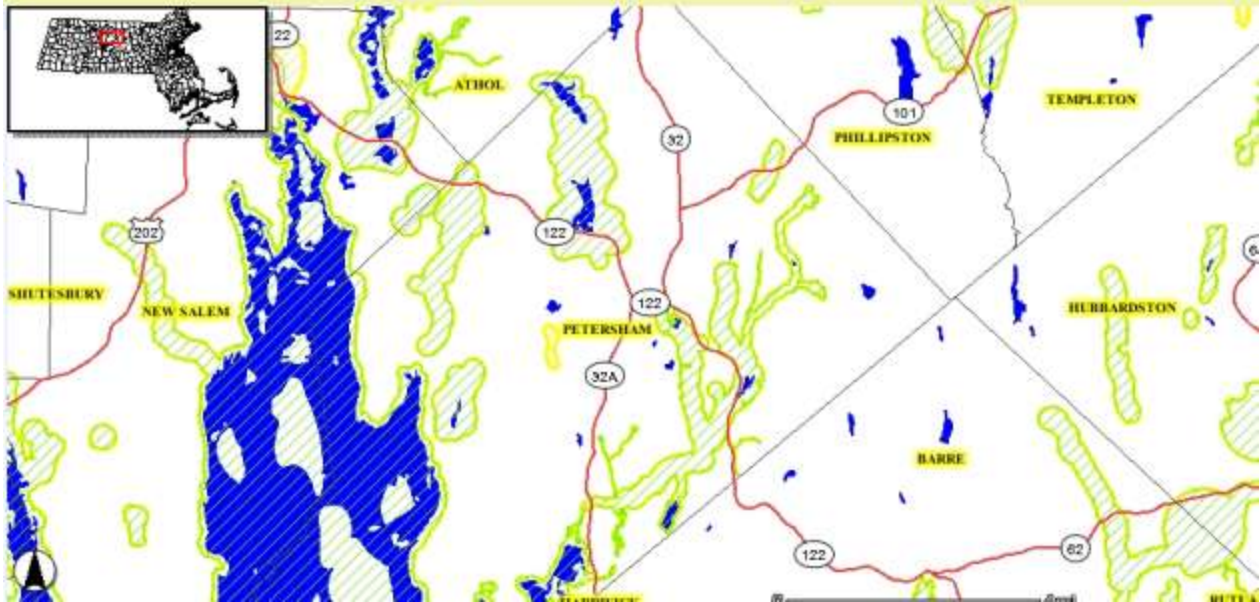
The project area needs to be checked to see if it overlaps an Estimated Habitat of Rare Wildlife. Below is the Habitat Map of State-listed Rare Wetland Wildlife. (Green outline with hatching).
