Goddard Hall Air Audit

A Major Qualifying Project

Worcester Polytechnic Institute

Mechanical Engineering

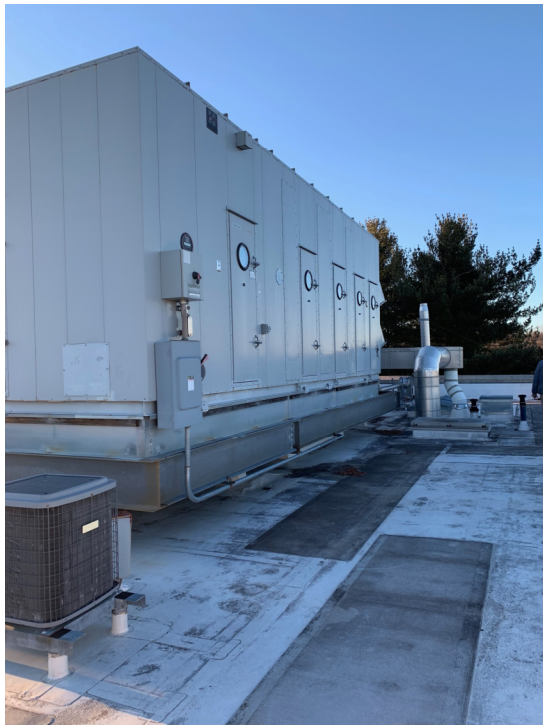
Figure 4. Roof Photo of the new combined overall exhaust system for newer half of the building. (Andrews, 2020)

Half of the building has a combined, new exhaust system. The other half of the building, which is older, has individual exhaust fans for each lab fume hood. Because these systems are so different in design and age, the systems are not compatible. Additionally, the systems are not

balanced in relation to each other, they are not communicating with a centralized controls system and they do not modulate based on need. This results in the building having significantly more exhaust capacity than is needed. For instance, one exhaust fan is running at 1600 CFM, when one typical lab hood only needs between 500 CFM - 700 CFM. This is a large discrepancy in exhaust requirements. Many of the fume hoods are running at drastically different CFMs, despite the building lab sizes, hoods and needs being relatively consistent throughout. Goddard is primarily a teaching laboratory and includes several small individual research labs. There are no highly-toxic contaminants being used regularly in the building, therefore fume hoods ranging with between 500 CFM - 700 CFM are adequate for most needs. Many of the older fume hoods are running well above this, while some of the newer fume hoods are running in this range. This inconsistency is both energy inefficient and contributes heavily to the building's negative pressure issue. Speculating on the energy usage of Goddard Hall, university lab buildings

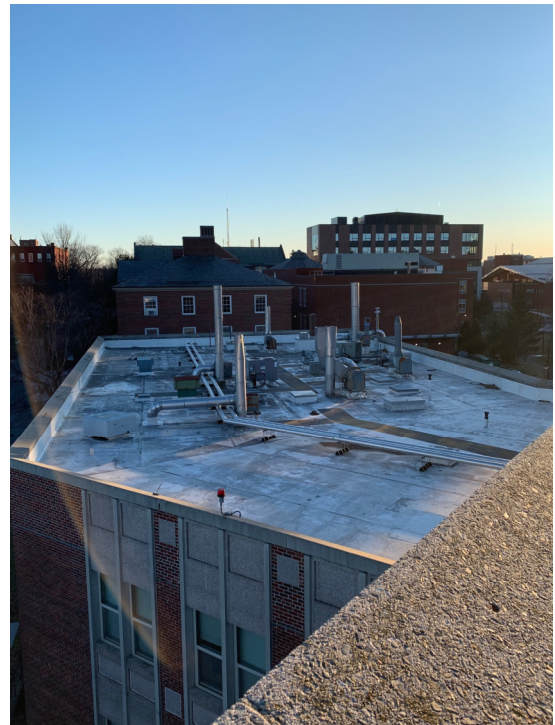
Figure 5. Roof Photo of the older, individual exhaust fans on older half of the building. (Andrews, 2020)

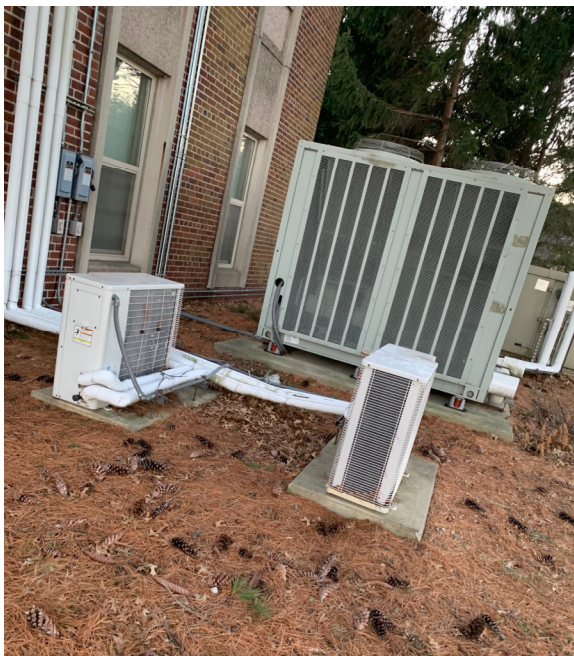
Figure 8. Photo of outdoor Condensing Units. Several different brands are installed at this location (Andrews, 2020).

Another issue that is evident upon walking the building is the various stages of upgrades that have occurred throughout the years. This is obvious on the roof, where the exhaust system for the two halves of the building is completely separate and different. This is also evident behind the building, where there are four separate brands of split system air conditioning units within 50 feet of each other. This demonstrates the “Frankenstein” nature of the building, and

severely impacts efficiency as well as cost. Split systems are designed to work with their own parts and can be incredibly efficient when installed correctly. However, when a building has more than one system, efficiency and comfort are compromised. These units do not communicate with each other and thus do not account for occupancy and load changes. This can result in an uncomfortable and inefficient building. Additionally, as the building has been upgraded, various ducts have been connected, disconnected, and abandoned or reconnected for new purposes. This can be noted when walking through the building and feeling drafts, seeing disconnected and abandoned ducts with the dampers open and

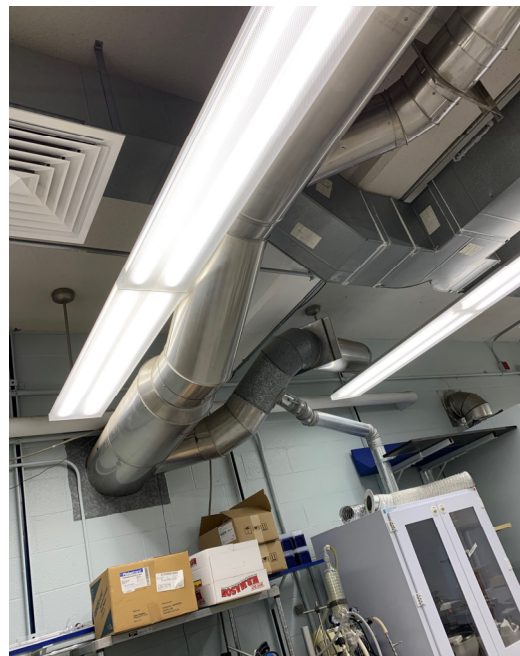
Figure 7. Photo of abandoned ducts in a second-floor research laboratory within Goddard (Andrews, 2020).

when entering rooms that are a significantly different temperature from the adjacent spaces.

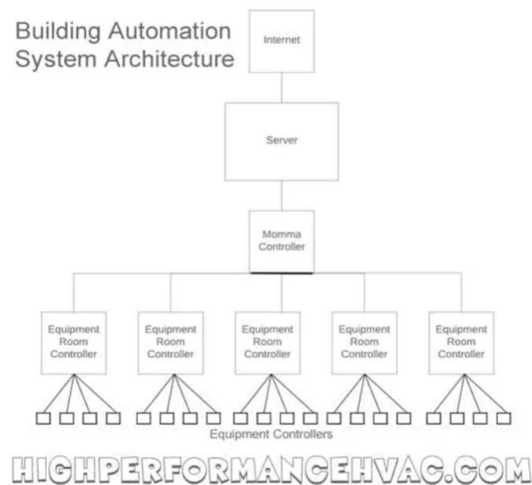
Figure 9. Depiction of communication structure for a BAS (HighperformanceHVAC.com, 2008).

One potential solution to remedy the issues outlined in chapter 5 is the installation of a new overall controls system in the building. One of the major reasons for the issues observed is that there are several different brands of heat pump, fume hoods, terminal boxes and exhaust fans in the building and none of them are communicating with each other or modulating in a way that anticipates air demand and reacts appropriately. While the installation of a new controls system would be costly, due to the controls company needing to engineer the system, obtain information on all of the equipment in the building as well as the demand in each room, and then purchase and install costly controls equipment and thermostats, as well as set up a Building Automation System (BAS), this would result in a huge improvement in the building comfort and energy savings, as well as eventual repayment of the investment, seen below in table 1. A BAS has the added benefits of efficiently controlling the air conditioning, heating and exhaust systems in a way that saves the building owner money. It will also lower building maintenance costs, as it

monitors all energy and HVAC equipment in the building and allows it to work together on a schedule of operation while initiating alarms for equipment that is operating out of normal parameters, or in need of maintenance. Building Automation systems are also capable of load

shedding, which prevents brownouts during days where the grid is hitting peak energy demand, and can alert the building operator to issues and system failures (High Performance HVAC, 2008). Installing a BAS also enables any new HVAC equipment to be tied into it, and relieves Goddard Hall of the issues caused by years of HVAC upgrades that do not communicate. The current market cost for installation of building controls is between \$2.50 and \$7.50 per square foot (Rawal, 2016). As Goddard Hall is a 21,300 square foot building, WPI is looking at a cost of potentially around \$159,750 to install a BAS system and controls for all existing HVAC equipment. Low return on investment typically discourages most building owners from installing a Building Automation System. However, a new controls system has the potential for being a less invasive construction process than an entire new HVAC system. It could very easily be installed in a few months or so during WPI's summer or winter break, which lowers the impact the installation would have on students and faculty research. Possible savings from installing a

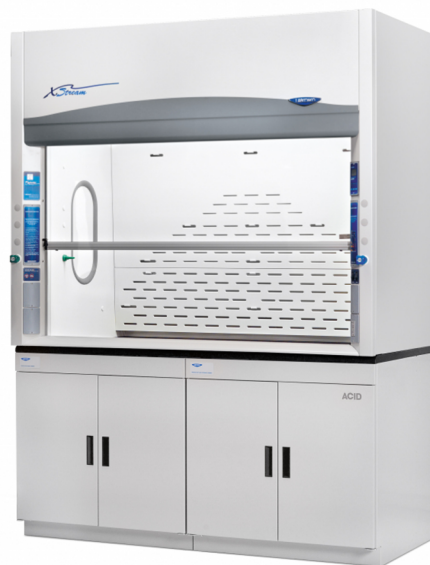
Figure 10. Image of Standard Lab Fume hoods that are replacing older models in Goddard Hall. (Labconco.com, 2020).

Some are totally non-operational and are turned off and used for glassware storage. Others are exhausting much more air than necessary for the type of chemicals and size of hoods that are used in Goddard, and others have been replaced with new energy efficient VAV fume hoods. This wide selection of fume hoods all use different energy amounts, exhaust different amounts of

air and some are not necessary to have anymore. In speaking with WPI facilities, I learned that WPI has been slowly replacing the oldest fume hoods throughout the years in an attempt to minimize the extreme amounts of exhaust air in the building, causing the negative pressurization seen throughout the building. The cost to replace a fume hood is between \$18,000 - \$20,000, which includes the purchase of an equivalent size fume hood, demolition, installation and connection to existing HVAC ductwork, and then individualized safety controls for each fume hood. The return on investment that WPI has seen in doing this is roughly 4-5 years, saving money primarily due to the energy savings, as the new fume hoods are able to vary the amount of airflow they exhaust, as well as using less air than the older models. Another possibility in fume hood replacement is in the “ductless fume hoods” which have been growing in popularity due to their ease of installation and low energy costs. These fume hoods use activated charcoal filters to trap chemicals and then recirculate the filtered air back into the room. The installation of these is significantly easier than a normal ducted fume hood, and they can be great substitutions in buildings like Goddard Hall, which is used for teaching and does not use many highly dangerous chemicals. Ductless fume hoods range from \$2,000 to \$4,000, with charcoal filters costing around \$400 per filter depending on the size of the fume hood. Standard fume hoods like labconco typically cost \$5,000 to \$10,000 depending on size, plus face velocity sensors. Replacing all 77 fume hoods in Goddard Hall with a new high-performance fume hood would cost around \$1,540,000 for the hoods and installation. Replacing every fume hood in Goddard Hall with a ductless fume hood is closer to \$231,000. While the ductless fume hoods are likely not a suitable fume hood substitution for every fume hood in the building, it is very possible to purchase some combination of standard fume hoods and ductless fume hoods, which would still be a significant energy and cost savings solution, as compared to just replacing every fume hood

with an identical, newer, low FPM fume hood. One acceptable method of replacement is one ducted hood per research lab and one ducted fume hood per teaching lab, and the rest would be ductless fume hoods.

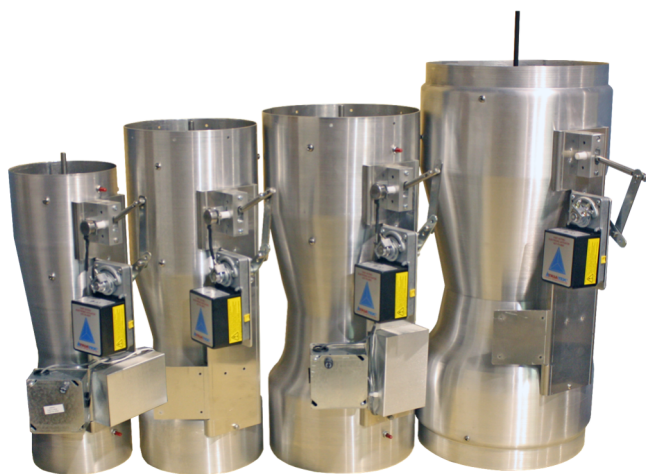
Figure 14. Image of Phoenix Venturi Valve (Phoenixcontrols.com, 2020)

recovery that uses Phoenix Air Valves. Phoenix Air Valves are highly engineered venturi valves that are designed for complex and critical airflow control, like a laboratory building. They are hourglass shaped tubes that contain a moveable cone which regulates flow. Venturi valves can maintain airflow regardless of duct pressure, are capable of operating in constant volume or variable volume, and come with sophisticated controls that allow for modulation based on changing room conditions. These are used in place of traditional Variable Air Volume (VAV) boxes, which a less complicated building such as an office building may use to distribute air, as precise control of airflow, temperature and humidity is less
