Structural Improvement Design for Northern Strand Community Trail Bridge over Saugus River

*A Major Qualifying Project Proposal Submitted to the Faculty of
Worcester Polytechnic Institute
In Partial Fulfillment of the Requirements for the Bachelor of Science Degree
By*

28 February 2019

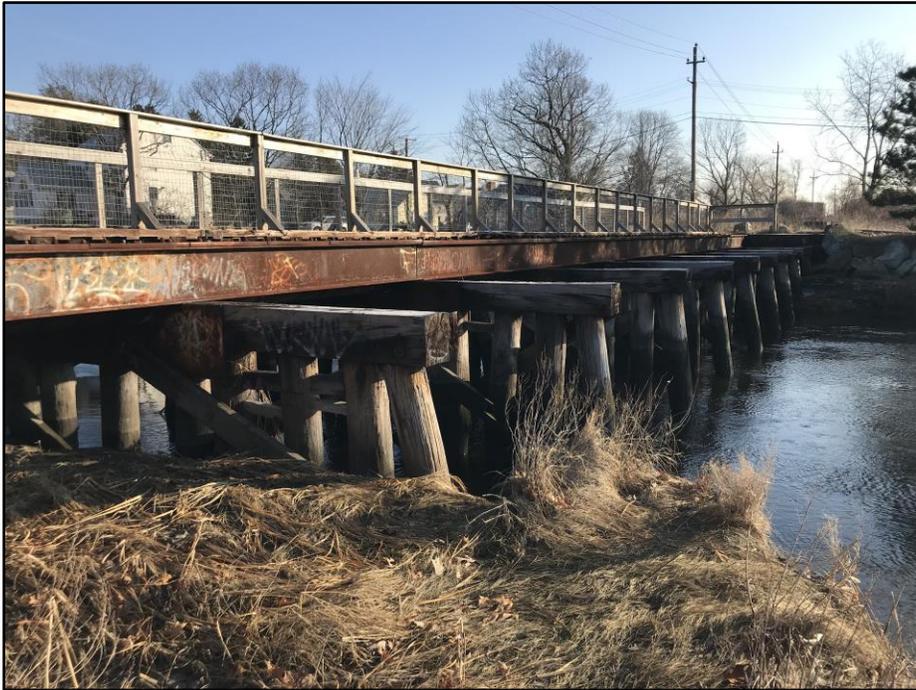
Figure 2: Saugus River Pedestrian Bridge

indicated that the bridge, as seen in Figure 2, is not structurally sound for continued pedestrian use (WAS, 2018).

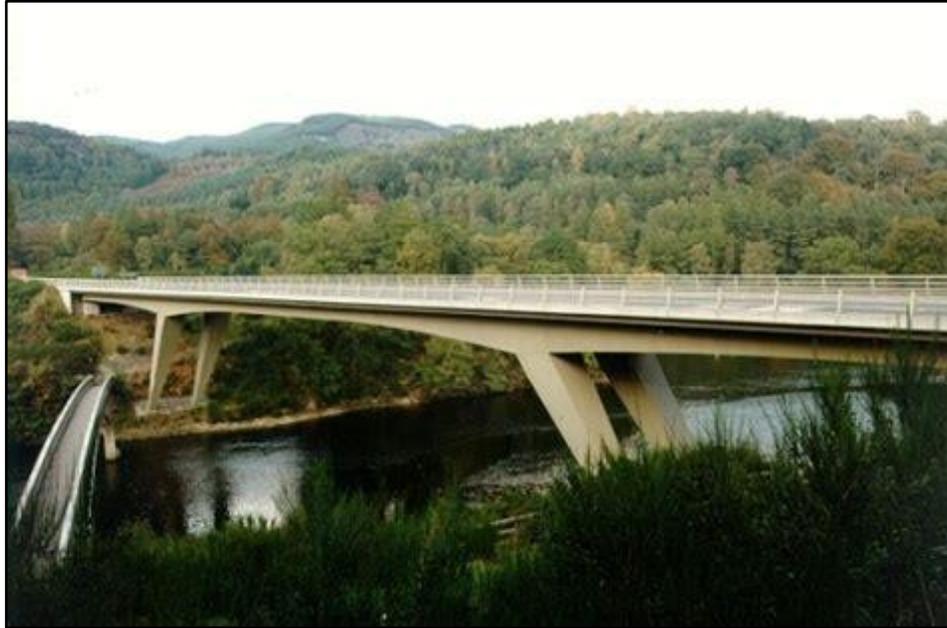
Figure 12: Through-Girder Bridge Example (Steel Construction Information)

With this information, the team researched a through-girder design seen in Figure 12, a common design type for a beam and girder bridge replacement. Two girders are placed near the edge of the deck while shallow floor beams connect the bottom flanges of the girders. This bridge type is excellent for meeting vertical clearance requirements underneath the structure. Yet this bridge is classified as fracture critical and needs to be considered when determining the best replacement structure.

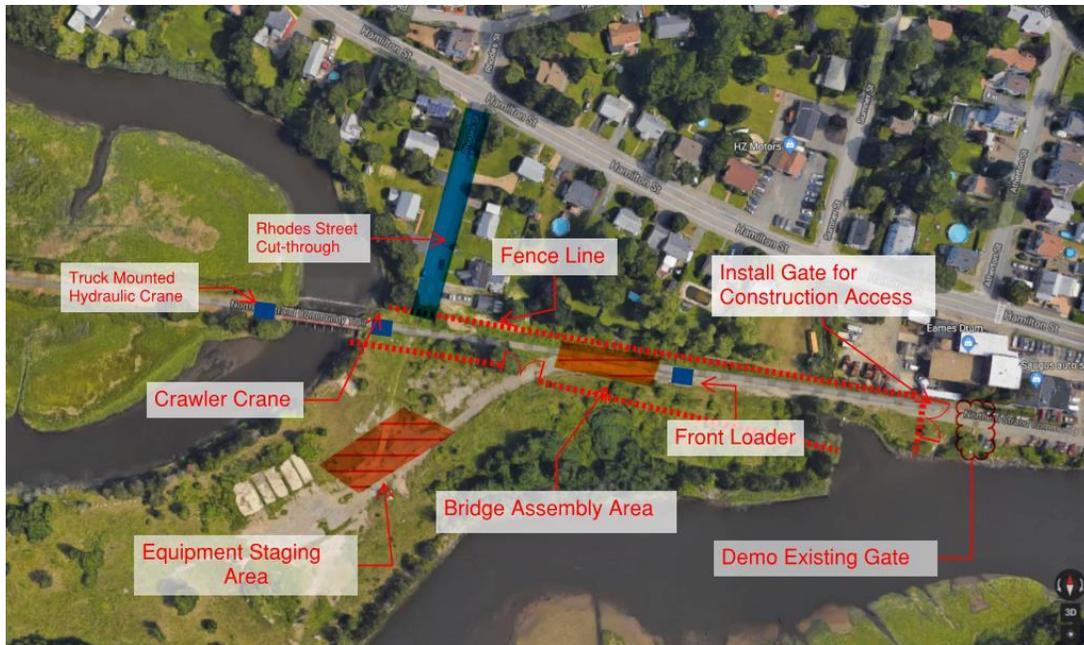
Figure 17: Site Logistics Plan

Once site access is established, equipment will need to be staged for future construction activities. As mentioned in Section “4.2.2 Existing Environmental Conditions,” the most suitable location for construction staging -- the Bacon property -- is contaminated with hazardous materials and requires soil testing to determine the exact location where equipment and material can be staged. As such, the staging area in Figure 17 may not represent most ideal location.

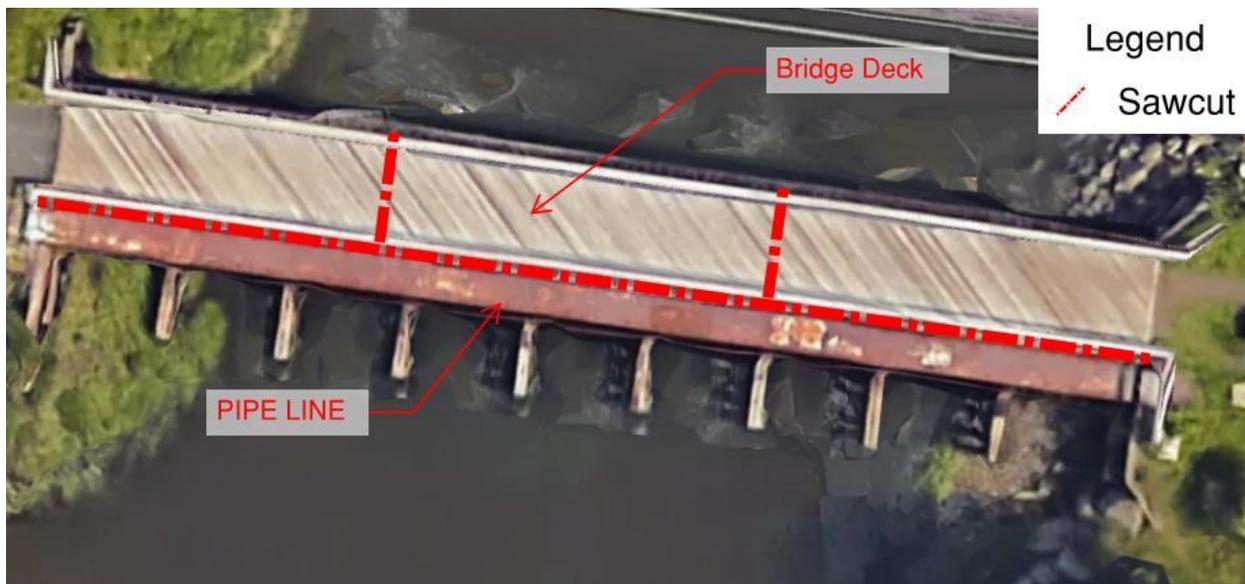
Figure 18: Sawcut Plan

The first task of demolition is to install debris netting underneath the bridge deck to keep material from falling into the river. Once this is in place, crews can sawcut the bents along the bridge length between the pipeline and walking portion of the bridge. Perpendicular cuts can then be made to divide the bridge into sections for hoisting as seen in Figure 18. Before the bridge can be lifted, it will have to be separated from the piles. Cutting the bents from the piles can be done using a properly sized Snorkel™ crane or Genie™ lift, that are equipped with an articulating boom and extendable aerial work platform (AWP). By using an AWP, there will be no need for scaffolding. Hoisting can be accomplished by a truck mounted hydraulic crane, equipped with straps which can be secured to the pile caps. The bridge section can then be lifted and placed in the staging area for disassembly. This process can be repeated for each section of the bridge. By leaving the bridge as intact as possible before hoisting, it will reduce the amount of material falling into the river. This is a critical consideration due to the hazardous nature of the creosote treated wood.

In addition to the deck, there are fifty timber piles supporting the superstructure that will have to be addressed. The complete removal of these members from the riverbed is unlikely; therefore, the team has considered two alternative options. The first alternative involves cutting the piles at the pile caps, reducing them to the necessary height to allow for installation of the new bridge. This option would be relatively inexpensive; however, leaving the existing piles protruding from the river is not aesthetically pleasing. The second alternative is to cut the piles below the mudline and leave the remaining section underneath the riverbed. However, the cost and schedule implications of this process are significant. For this reason, two schedules and cost estimates have been developed for each demolition plan.

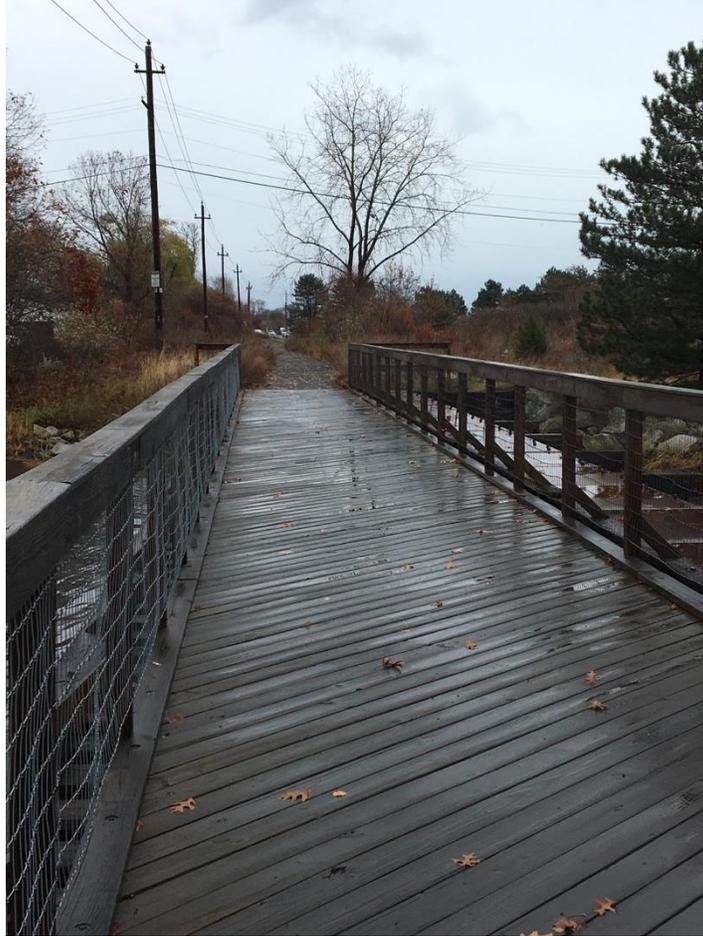
Figure 2: Saugus River Pedestrian Bridge

The communities surrounding the trail are looking to protect the safety of the cyclists and pedestrians that use it. However, the nine-span, 115-foot, bridge over the Saugus River has been proven to be a hazard to trail goers. Preliminary timber pile sampling and testing results indicate that the bridge is not structurally sound for continued pedestrian use (WAS, 2018).

The communities surrounding the trail are looking to protect the safety of the cyclists and pedestrians that use it. However, the nine-span, 115-foot, bridge over the Saugus River has been proven to be a hazard to trail goers. Preliminary timber pile sampling and testing results

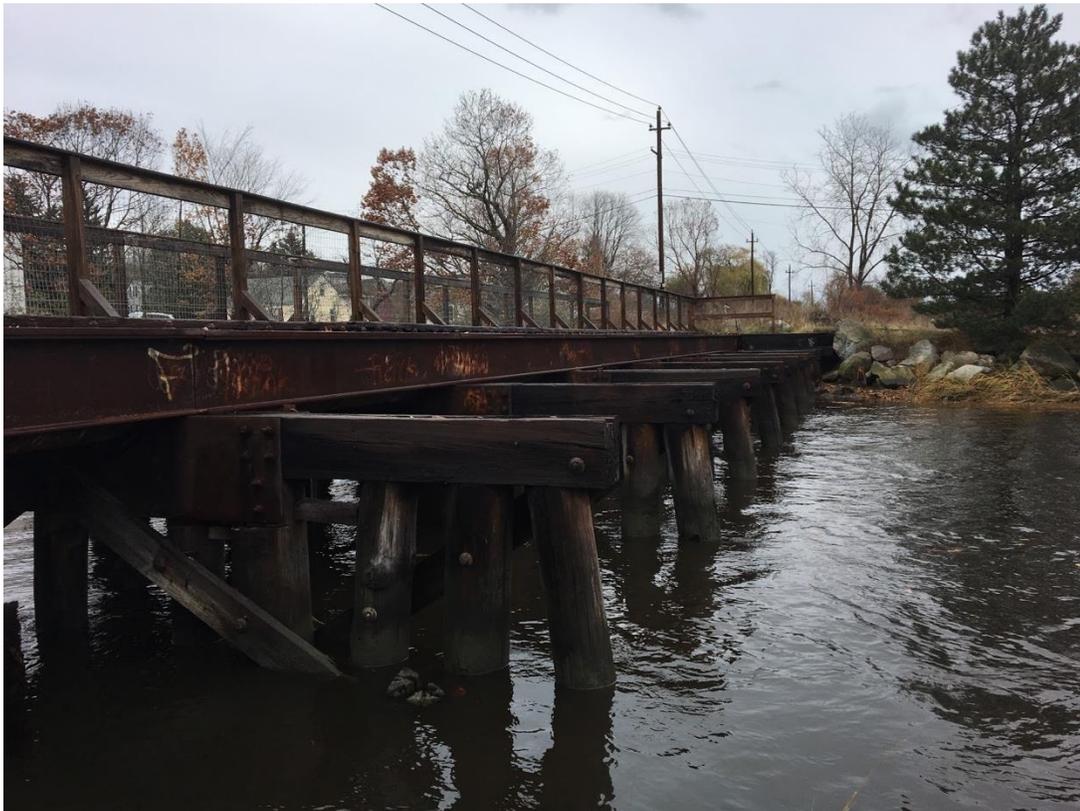
Figure 5: NSCT Bridge over the Saugus River

Additionally, resistographs were created for 70% of the existing timber piles to quantify the amount of deterioration and assess the remaining effective cross sectional area. The results from this testing were extremely variable across the different readings, with an effective cross section ranging between 17% and 92% (Table 1).
