La Plata Nature Refuge

Assessing Land Change

**An Interactive Qualifying Project
Submitted to the Faculty of
WORCESTER POLYTECHNIC INSTITUTE
In partial fulfillment of the requirements for the
degree of Bachelor of Science**

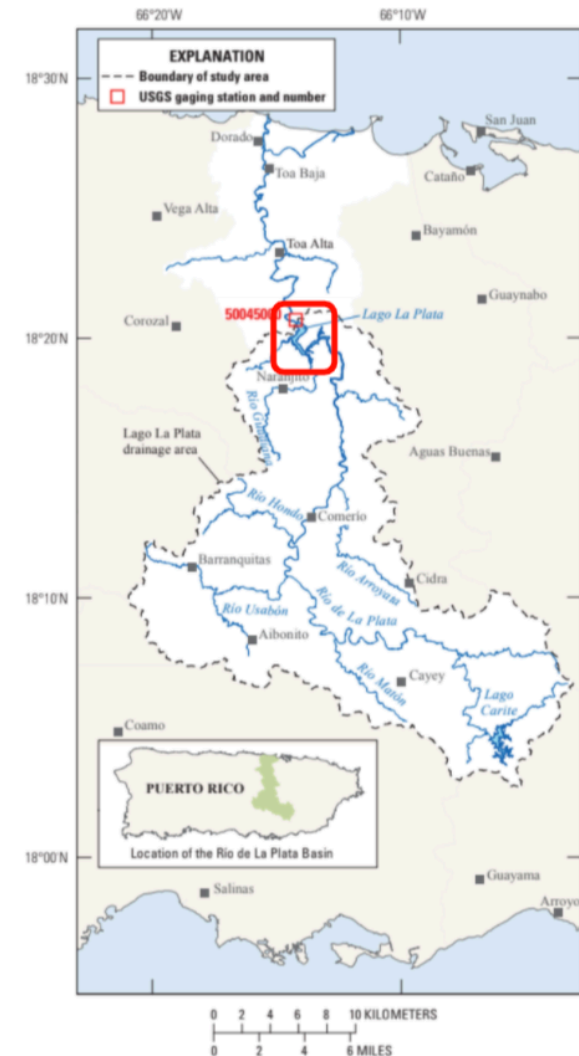
Figure 3. La Plata Watershed.

This image displays the La Plata watershed outlined with the dotted black line. The red box outlines the main focus of the study, La Plata Reservoir and River. (Adapted from Gómez-Fragoso, 2016)

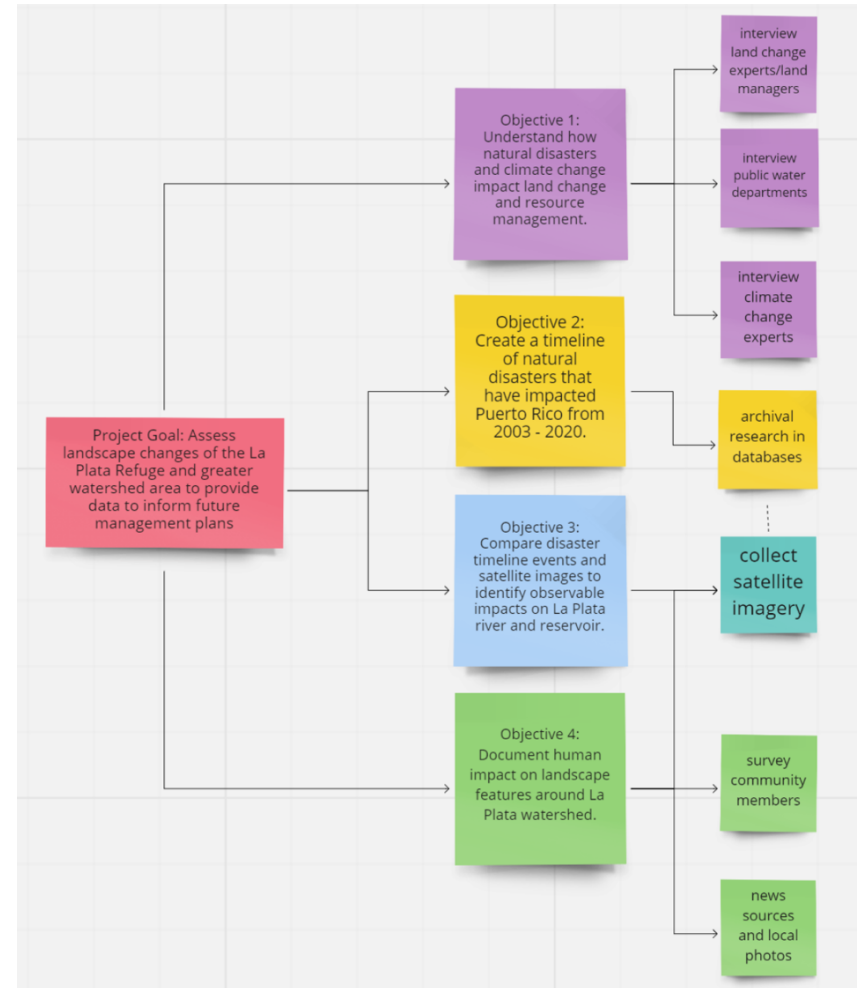
Figure 11. Objectives and Associated Methods.

The figure shows a flow chart from our goal to objectives and then the methods we used to complete them. The arrows show the workflow and connect methods that were used to complete multiple objectives.

The goal of this project is to assess landscape changes of the La Plata Refuge and greater watershed area to provide data to inform future management plans for the DNER. To accomplish this goal, we completed a set of four objectives shown in Figure 11.

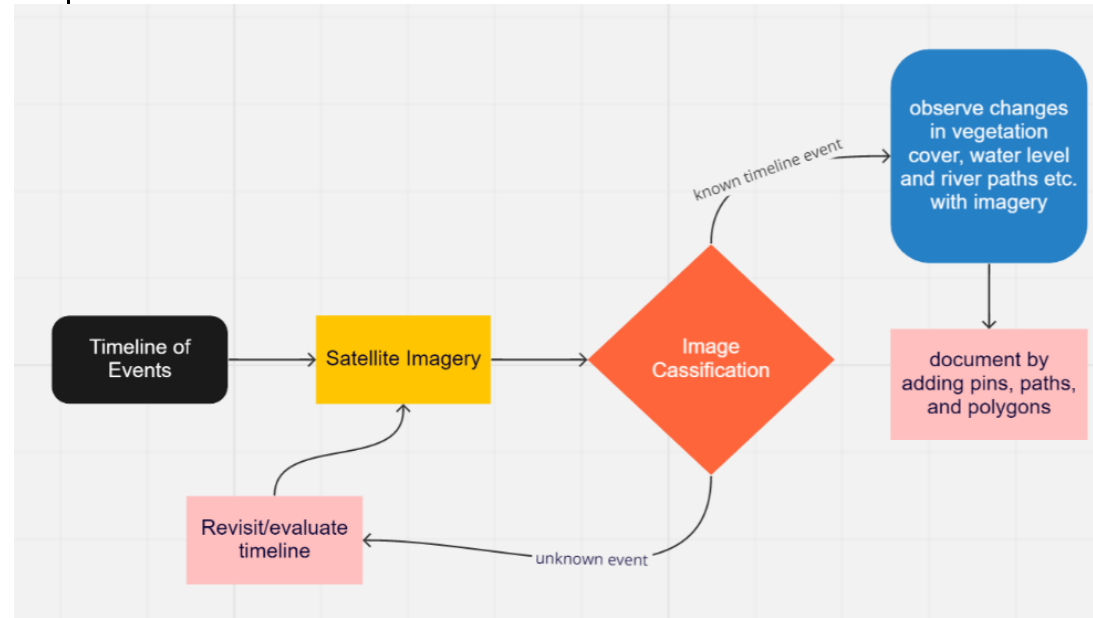
Figure 16. Timeline and Satellite Imagery Process.

We used assessment techniques adapted from Liu et al., 2015 to identify changes through a comparison of satellite images surrounding severe weather events (Figure 16). Next, we created map layers, overlaying paths, and polygons, to outline the riverbanks, and pins, to mark an exact location, onto corresponding satellite imagery to observe changes between time periods. An example of our process is shown in Figure 16.

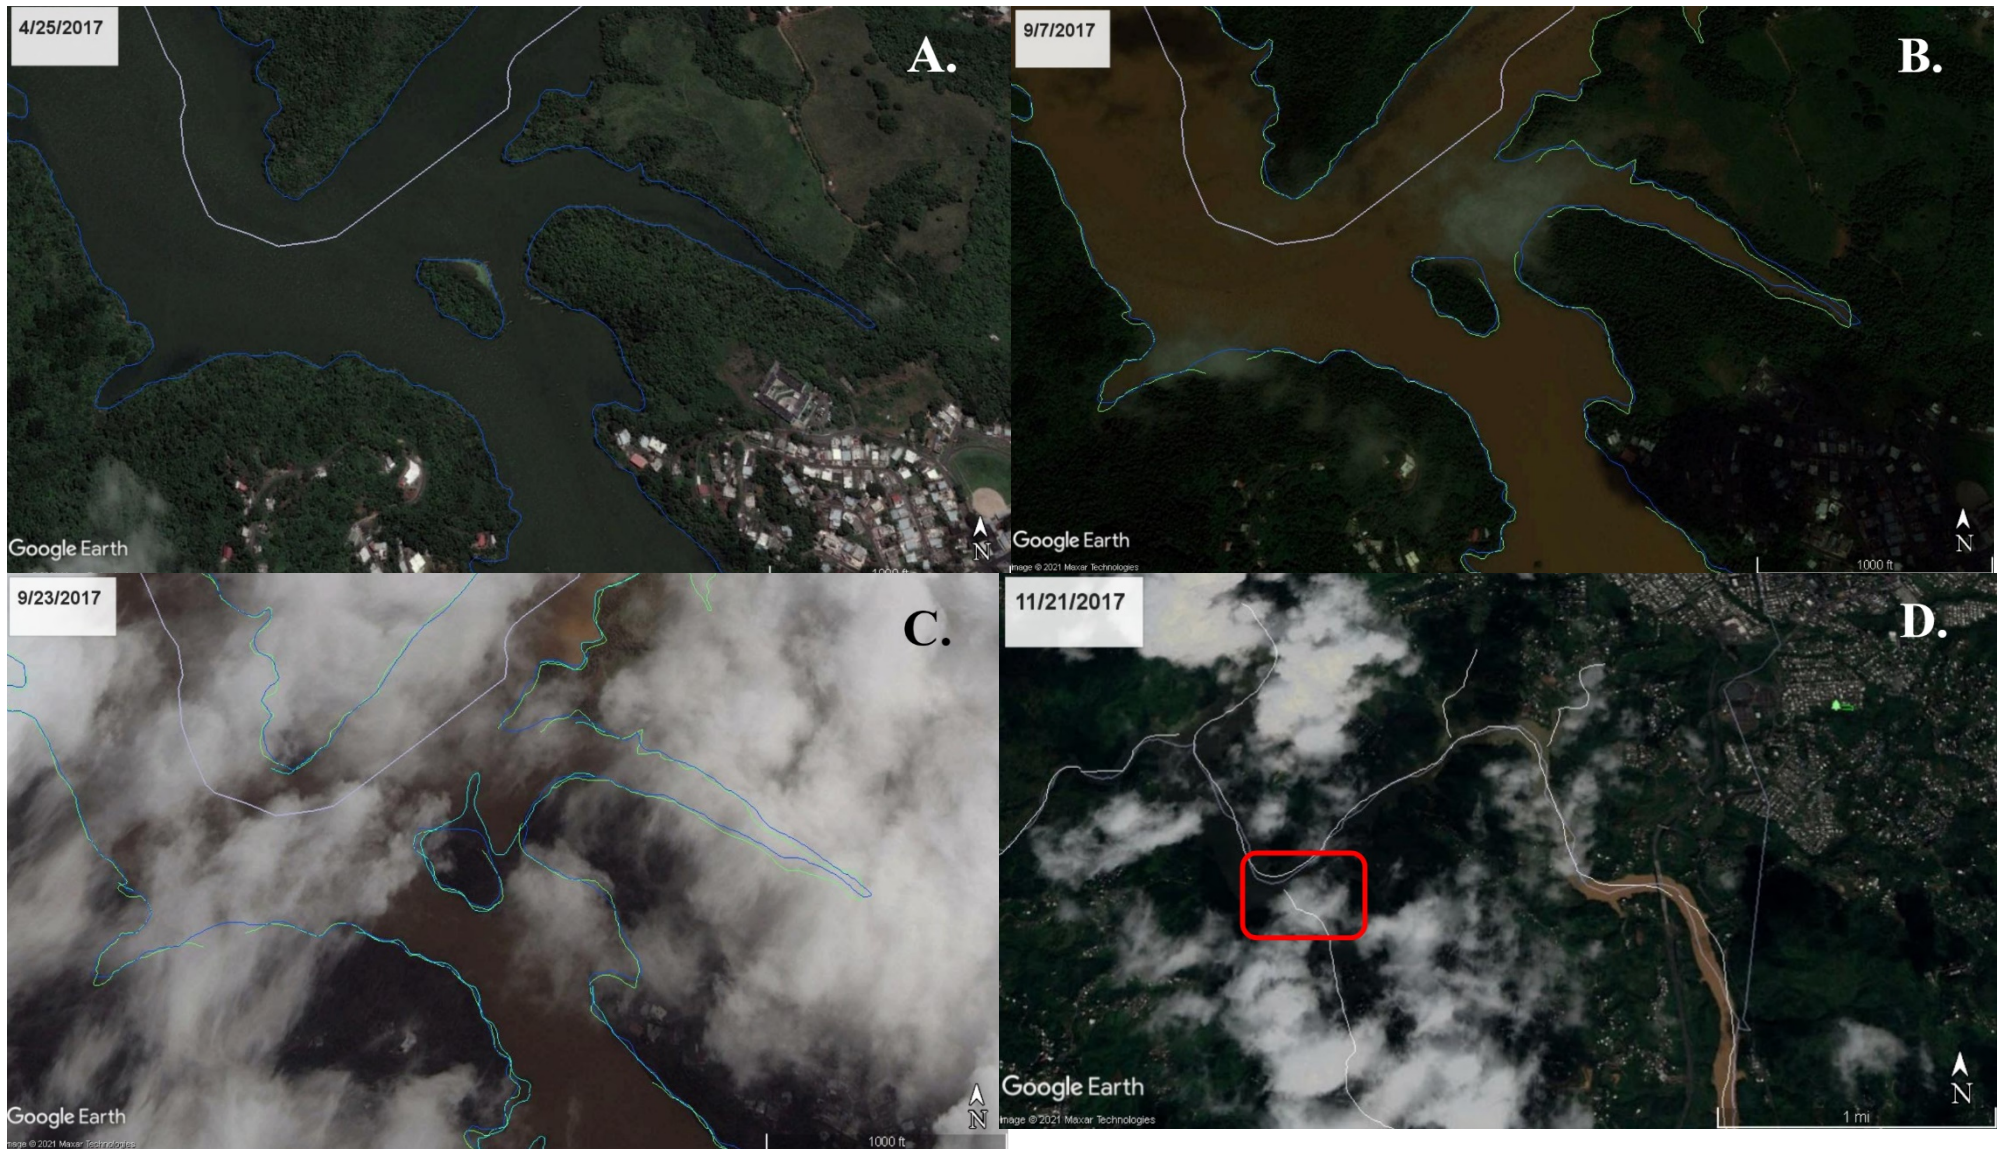
Figure 17(A-D). Sedimentation Before and After Hurricanes Irma and Maria.

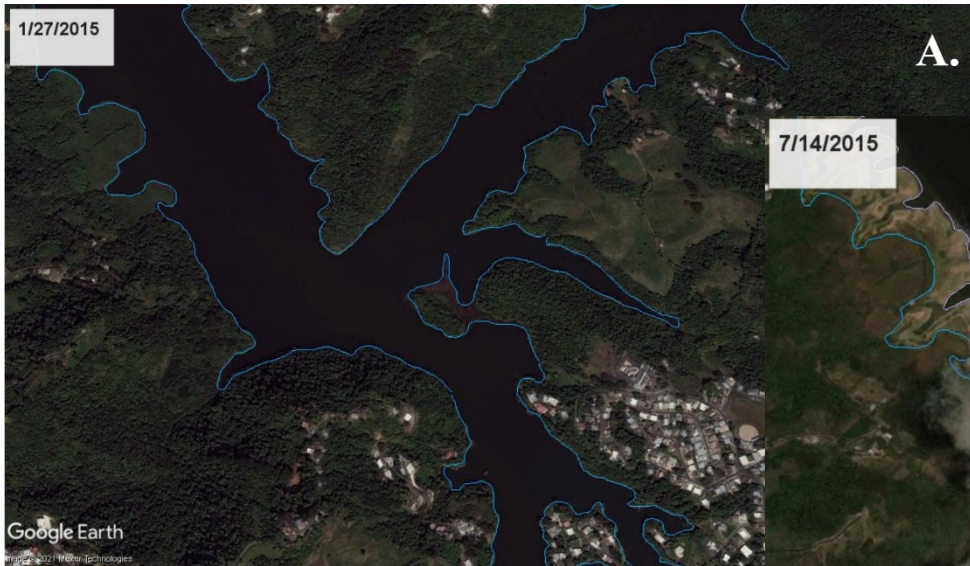
Figure 18(A-C). Water Levels Before and After Extreme Drought (2015).

Our research in images lacks information on numerical values for water level changes. It is valuable to note that the percentage of Puerto Rico still in drought (from our timeline information) drops significantly from that in 2015 which helps to explain why images from La Plata appear to have returned to normal by January 2016 despite the drought in Puerto Rico continuing until November 2016.

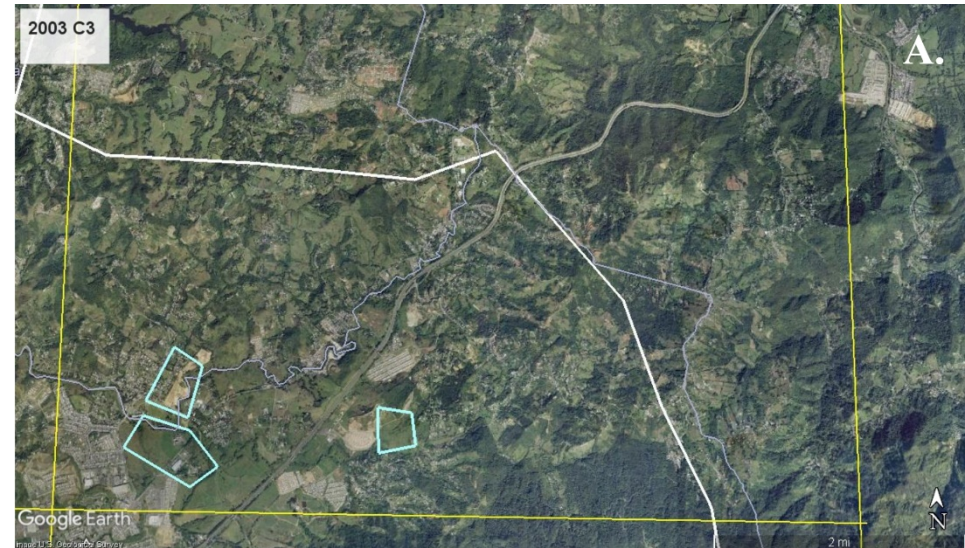
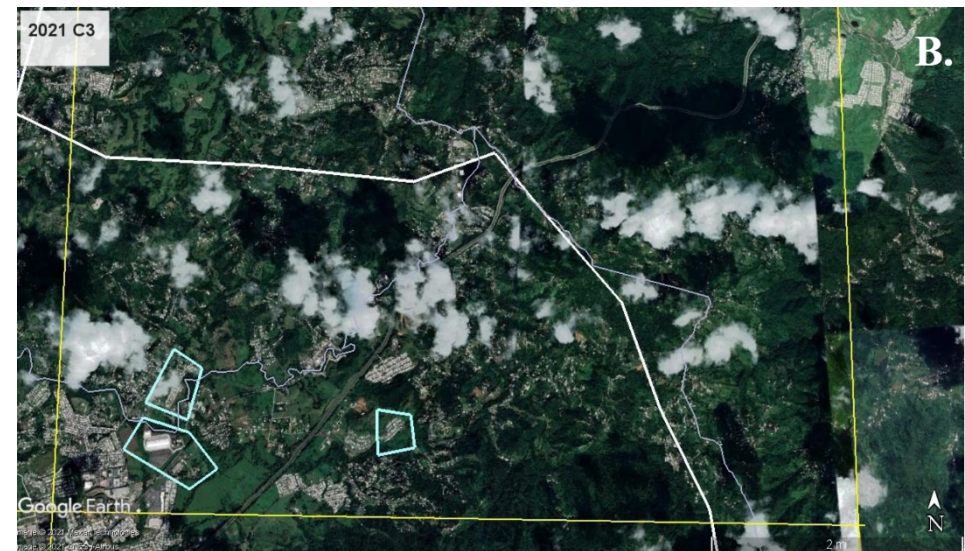
Figure 20(A-B). Section C3 2003 and 2021 side by side.

We compared vegetation density, apparent from visual coloration, and any notable construction in the area. We marked with colored polygons (the bottom left of the image) areas where we observed changes in the grid square.

Within each grid we observed changes by taking an image of one grid section from 2003 and looking at it side by side with the same grid section from 2020. An example of this comparison is shown in Figure 20.

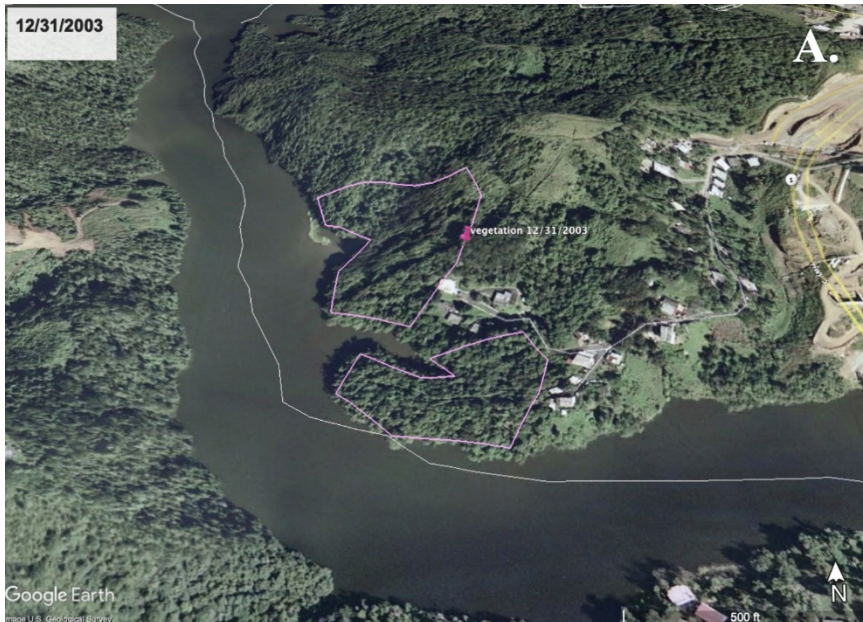
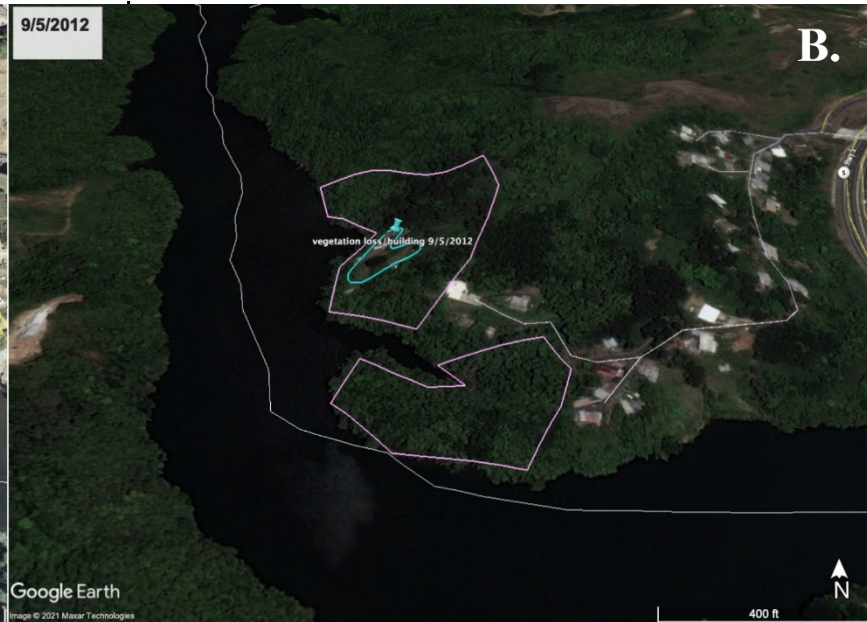
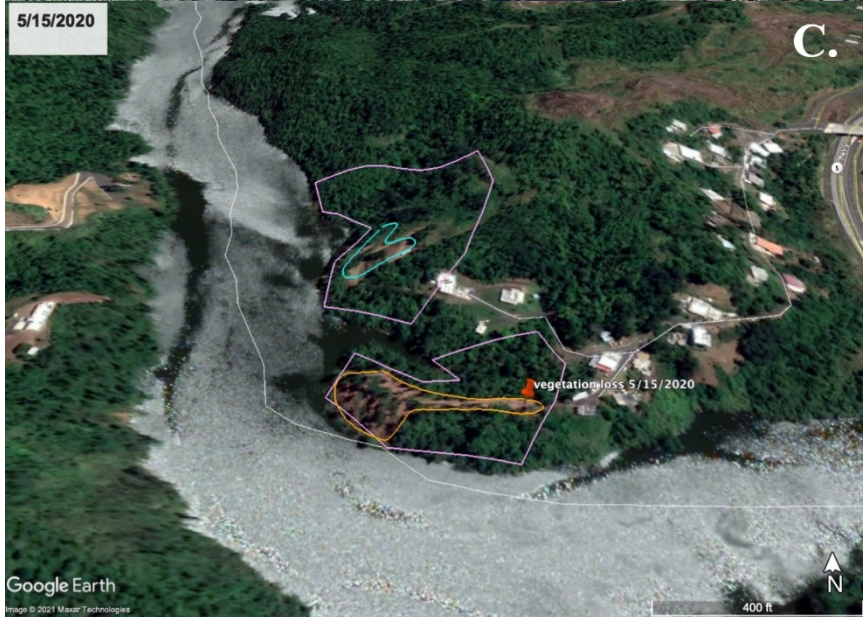
**Figure 22(A-C).
Vegetation in
section A2.**

This coordinate was a point of interest given by the managers of La Plata where they have observed deforestation along the reservoir.

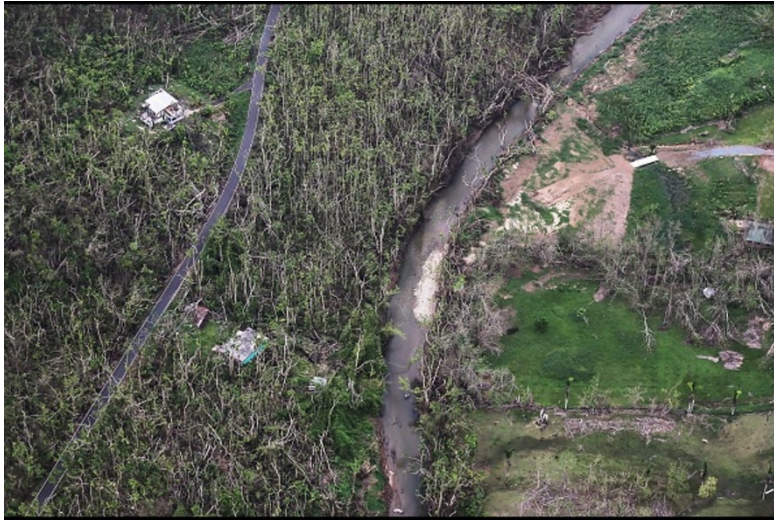
Figure 23. Vegetation loss from Hurricane Maria.

Aerial photo of the damage from Maria. (Adapted from Tama, 2020)

Images from a gallery of photos taken after Hurricane Maria were posted by WAPA.tv but were sourced from several different places. Figures 23-25 show the three different impacts on land from the storm: vegetation loss, sedimentation, and landslides. The images demonstrate one of the limitations of using satellite imagery, which is we can only zoom in so far and in doing so, the image becomes blurry. Figure 26 is an image from the land managers of La Plata Refuge showing what flooding looked like around the reservoir after a hurricane. The exact time of this image is not known; however, we were told flooding generally looks the

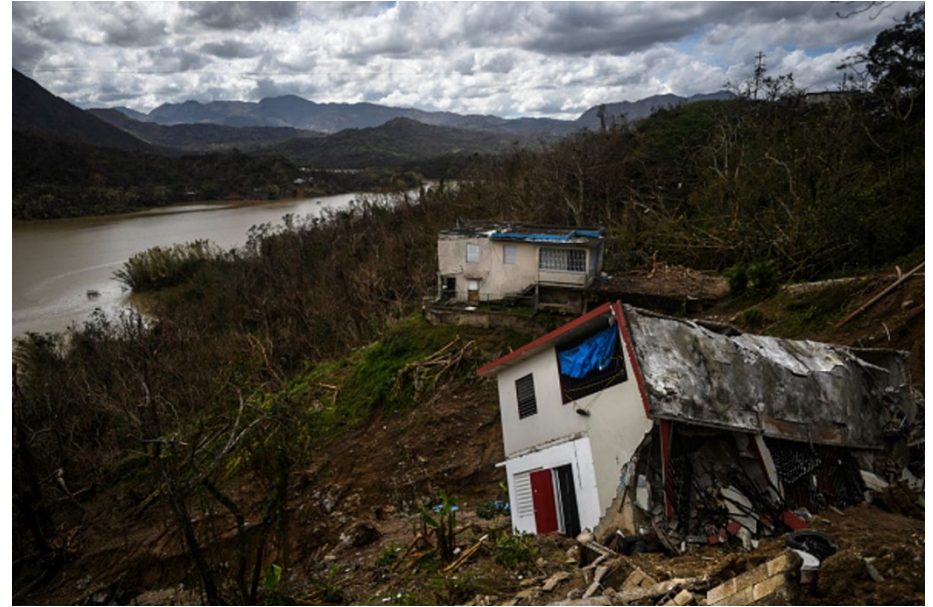
Figure 24. Sedimentation from Hurricane Maria.

La Plata dam on September 25, 2017, 3 days after Hurricane Maria. (Adapted from Raedle,) 2020

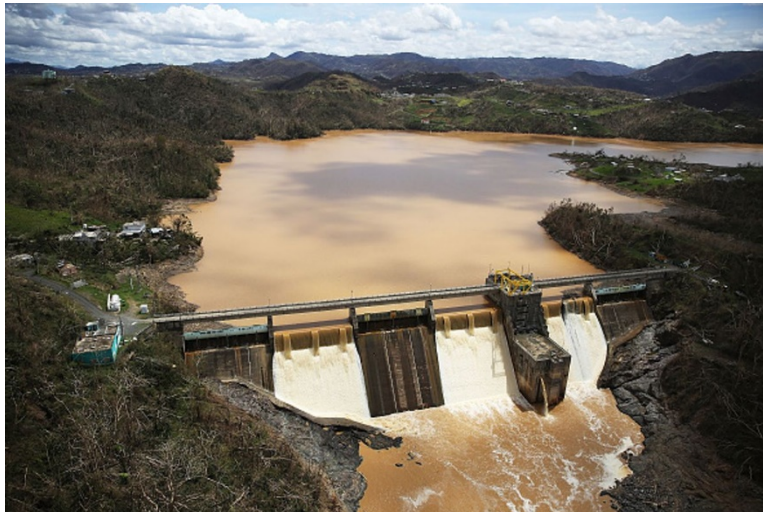
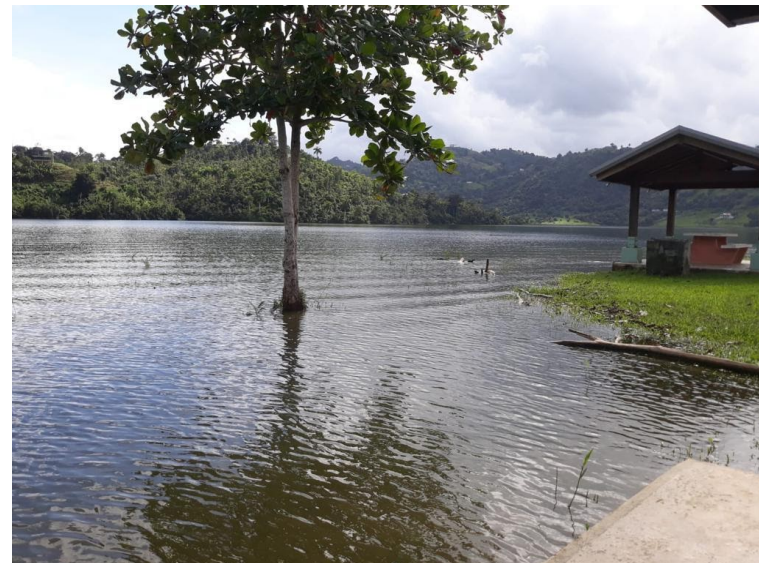
Figure 26. Flooding at La Plata.
(Sr. Rafael A. Rodriguez Santiago)

same each time. This image also is a helpful supplement to satellite imagery because it gives a much more focused view of the reservoir during a flood.
