Redesigning Lincoln Street: Improving Safety, Aesthetics, and Access to Public Transportation

A Major Qualifying Project Proposal
of the A/B Term 2019 site in Worcester, MA,
submitted to the faculty of

WORCESTER POLYTECHNIC INSTITUTE

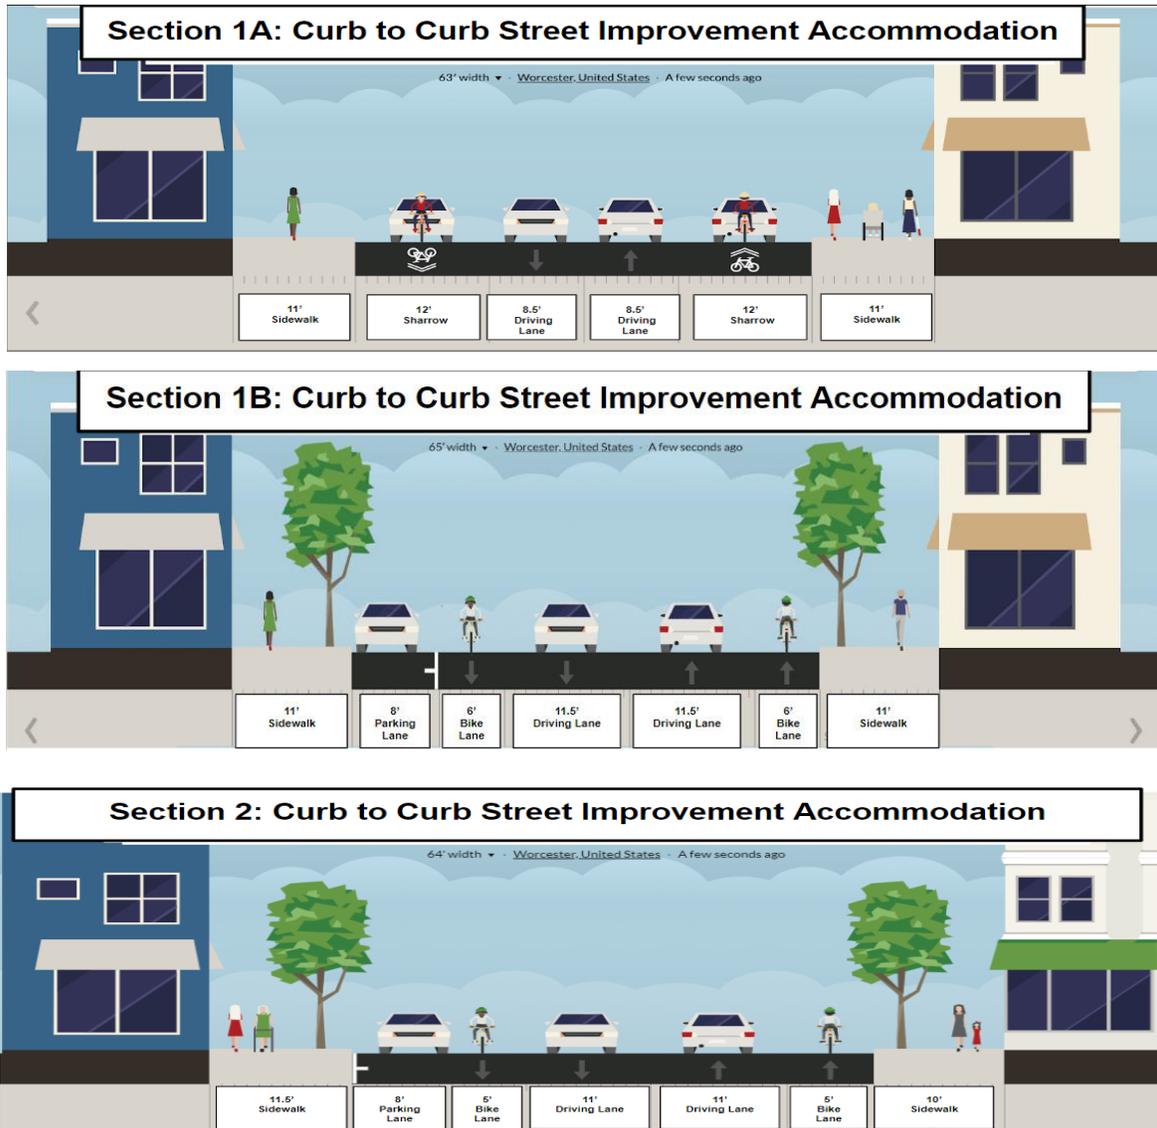
Proposed Curb to Curb Street Improvements for Different Sections of Lincoln Street

other designs which can be viewed in our Preliminary Designs. The cost estimate for the Curb to Curb designs were configured by using MassDOT's weighted bid prices project builder application with a 20% contingency added by our team.

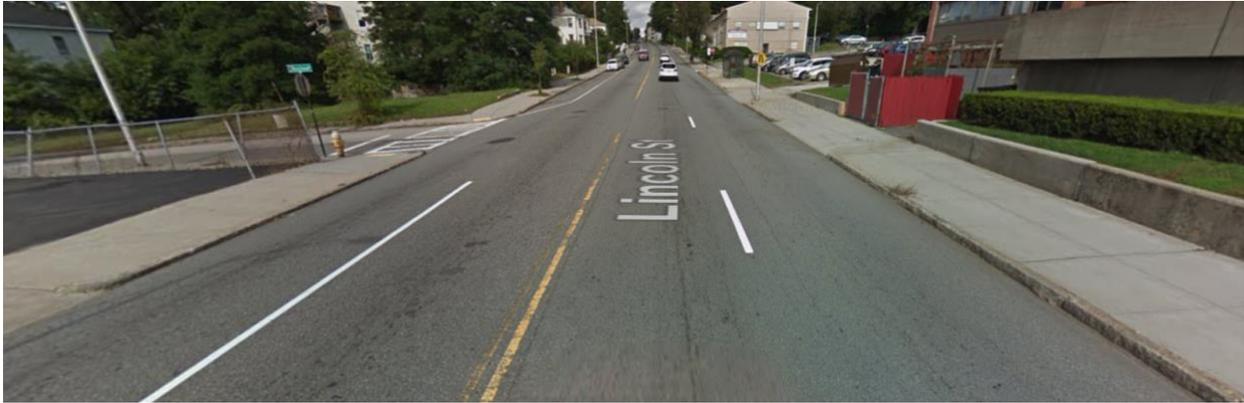
Figure 9: Existing Street View, Section 1A

Below are figures that represent what both parts of Section 1 look like from a cross-sectional standpoint. Figure 9 represents section 1A which consists of 4 total driving lanes, 2 northbound and 2 southbound. Section 1A only lasts about 100 feet in distance and then changes a driving lane to a parking lane on the north and southbound sides of the street. Figure 10 represents the cross-sectional view of section 1B.

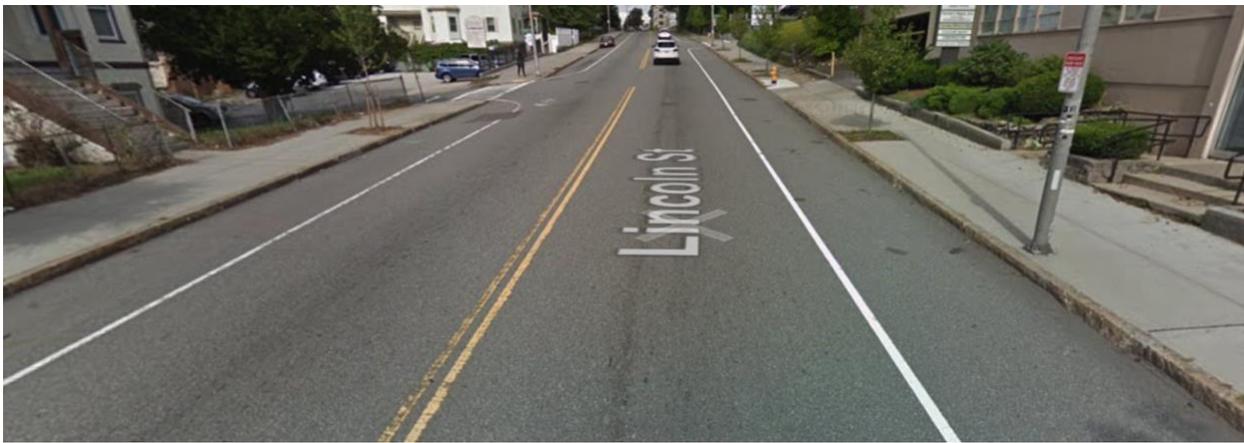
Figure 10: Existing Street View, Section 1B

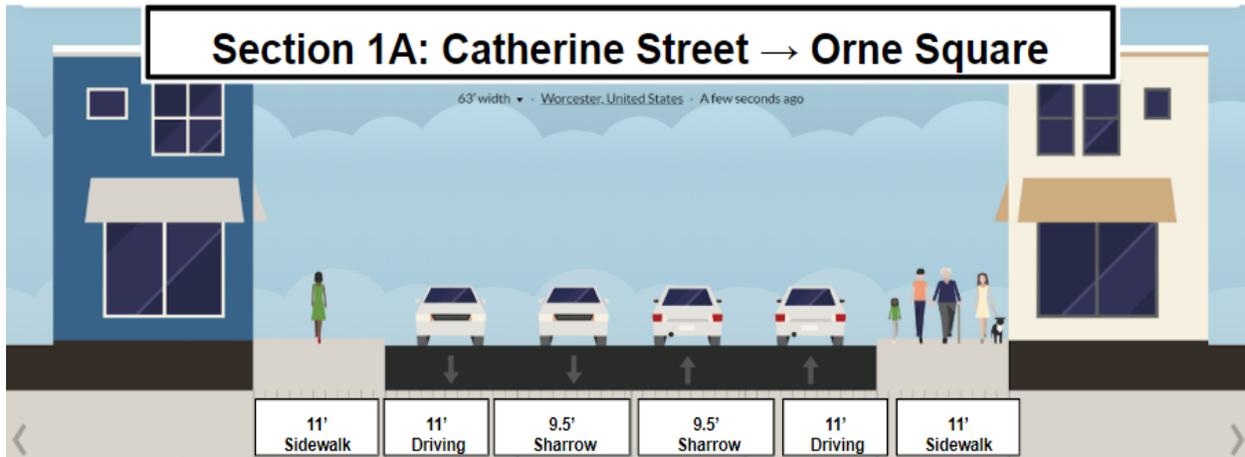
Figure 11: Streetmix View of Existing Conditions, Section 1A

Through several site visits that our team was able to complete throughout the duration of this project, the measurements of both parts of Section 1 were recorded and can be referenced in the site visits in Appendix C. Both Figures 11 and 12 represent the measurements of driving lane widths, parking lane widths, and sidewalk widths for the existing street conditions of Section 1. These views were done in Streetmix because our team believes that this is the best way to display the improvements to the existing designs.

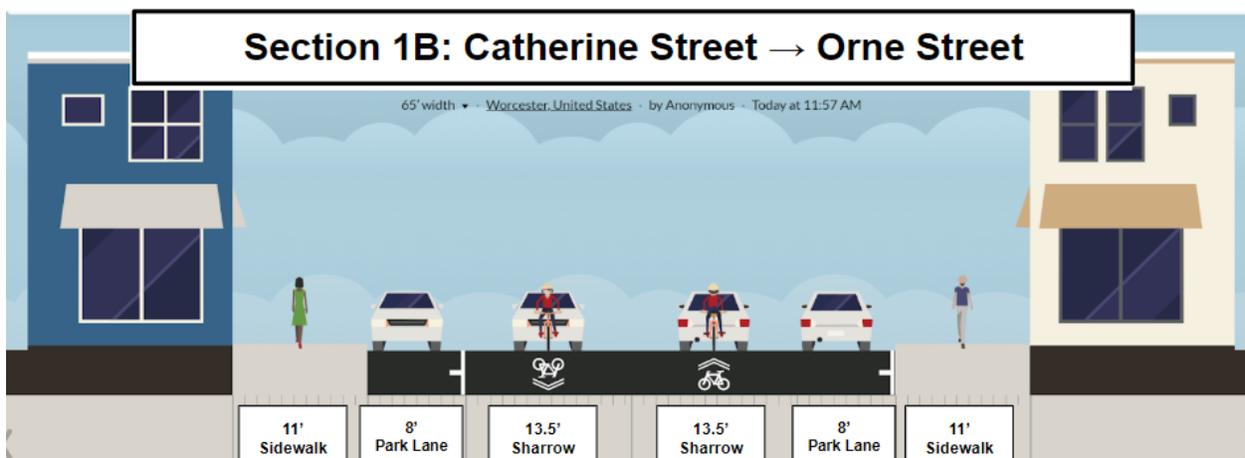
Figure 12: Streetmix View of Existing Conditions, Section 1B

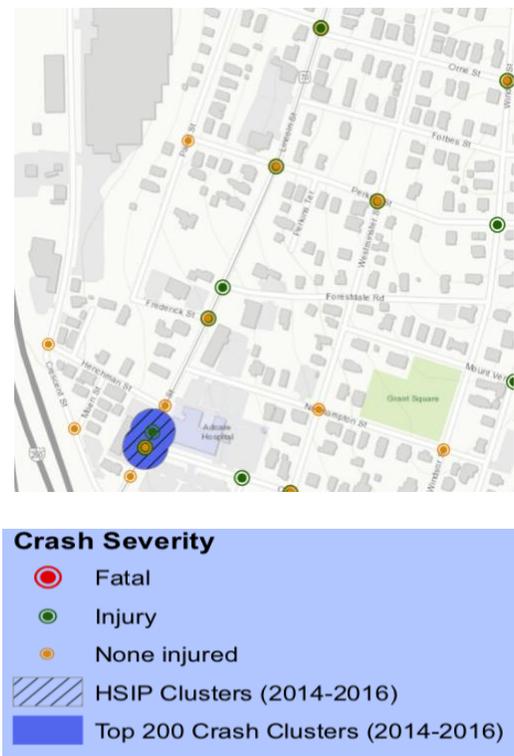
Figure 13: Crash Map of Section 1A-1B from CMRPC

Clusters. An HSIP eligible cluster is one in which the total number of "equivalent property damage only crashes" is within the top 5% in the region. There were HSIP Crash Clusters and a Top 200 Crash Cluster within the years of 2014 through 2016. The Top 200 Crash Clusters are ranked using the Equivalent Property Damage Only (EPDO) crash rates. This cluster is located at the Intersection of Catherine and Lincoln Street. The HSIP Clusters are represented by the blue circles, while the Top 200 Clusters are represented with the cross-hatches. This area was considered a Top 200 Crash Cluster due to the amount of crashes that resulted in either injuries or fatalities. The crashes that result in injury or fatality are weighted significantly higher than those that are only property damage crashes, which in turn is why this area on the map is a Top 200 Crash location.

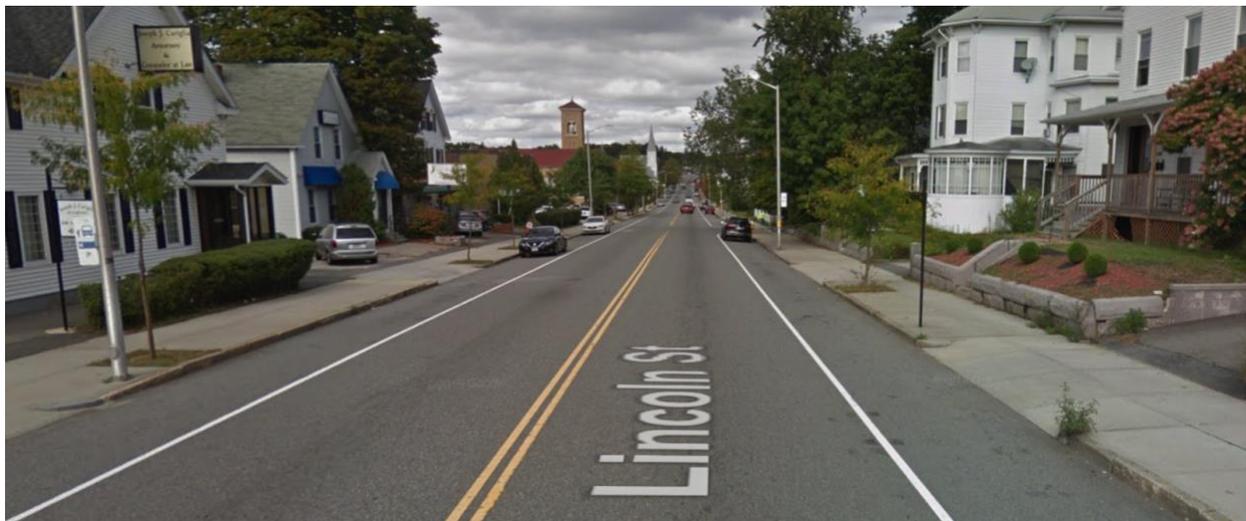
Figure 16: Existing Street View, Section 2

Figure 16 depicts the cross-sectional view for the entire length of the second section within our corridor. This section starts at the intersection of Orne and Lincoln Street and ends at the intersection of Harlow and Lincoln St, which gives a total length of 0.25 miles.

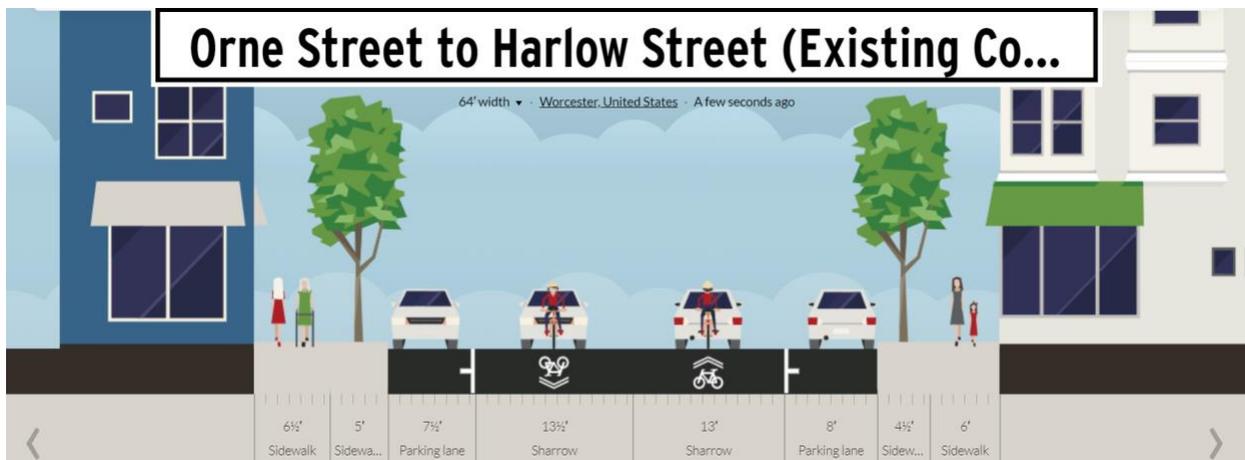
Figure 17: Streetmix View of Existing Conditions, Section 2

Figure 17 provides a visual of the cross-sectional view of Section 2 in the Streetmix software. This software allowed our team to provide the measurements for the specific parts of the street. In the figure the measurements for driving lane width, parking lane widths and sidewalk widths are depicted. In addition, our team was able to represent that both driving lanes have sharrows which are supposed to let drivers know that they must share the lane with bicyclists.

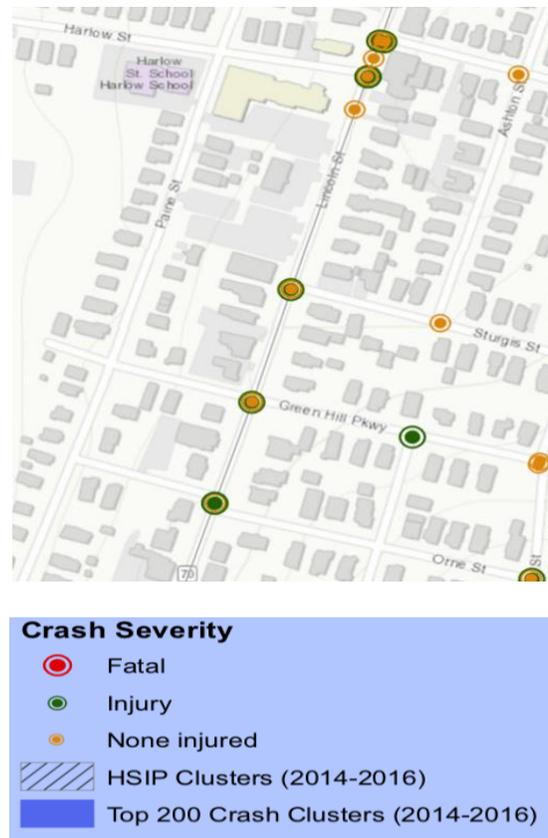
Figure 18 : Crash Map of Section 2 from CMRPC

accessed from the CMRPC allowed our team to analyze the severity and locations of crashes that occurred between vehicles in Section 2 of the corridor. However, multiple crashes occurred in the same spots making it difficult to gain a complete understanding. The number of crashes for each respective category can be seen below in Table 4. The exact locations, times, lighting, etc. can be seen in Appendix D referencing the MassDOT data.

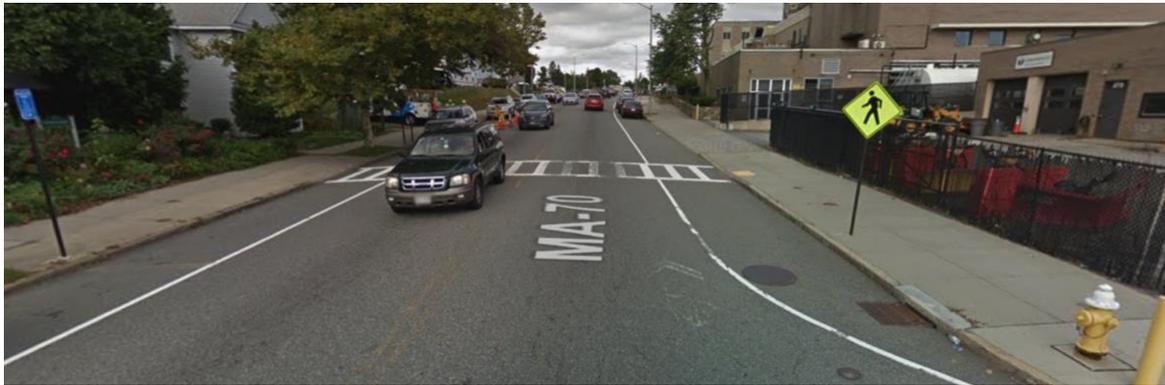
Figure 21: Existing Street View, Section 3

Figure 21 depicts a cross-sectional view of Section 3 within the corridor. This section starts at the intersection of Harlow Street and Lincoln Street and ends at Brittan Square giving a total length of around 0.4 miles.

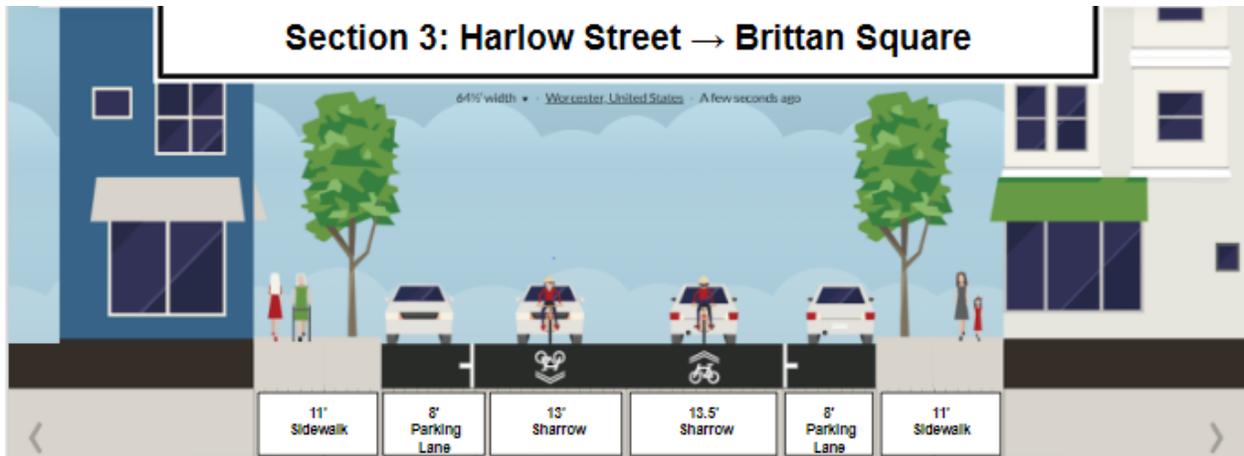
Figure 22: Streetmix View of Existing Conditions, Section 3

Figure 22 provides a visual of what the cross section of section 3 looks like in Streetmix. Set up the same as sections 1 and 2, the Streetmix for Section 3 contains the measurements for driving lane widths, parking lane widths, and sidewalk widths. In addition, our team was able to represent that both driving lanes have sharrows which let drivers know that they are to share the lane with bicyclists.

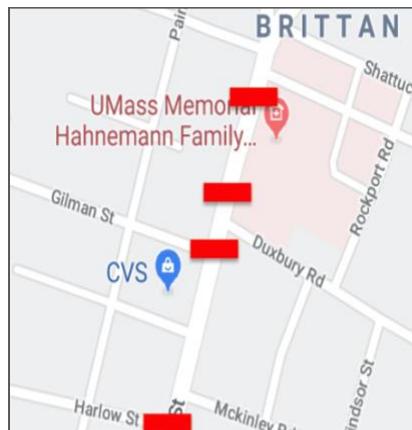
Figure 24: Existing Crosswalk Locations in Section 3

Section 3 of the corridor has four existing crosswalks. The locations of these crosswalks in reference to Lincoln Street can be found in Figure 24. However, these crosswalks are not all located directly next to the bus stops in Section 3, as can be seen in Figure 25. This means pedestrians would need to walk a little further from the bus stop in order to access a crosswalk.

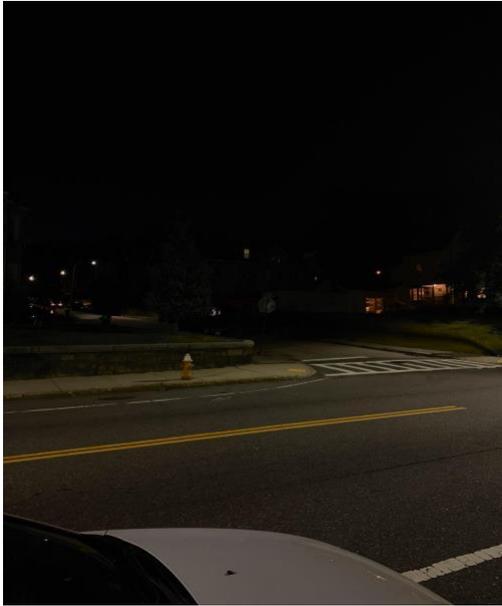
Figure 26: *Street Lighting in Section 3*

The safety of pedestrians is of extreme importance for the Green Hill Neighborhood and everyone who uses the corridor on a regular basis. There are other issues that provide an unsafe environment for the people who access the street. For example, the lighting during the evening hours is poor and limits drivers' and pedestrians' visibility throughout the entire corridor. Our team noticed this during several sight visits. Figures 26 and 27 below show the insufficient lighting that is present in Section 3 and Section 1 of the corridor.

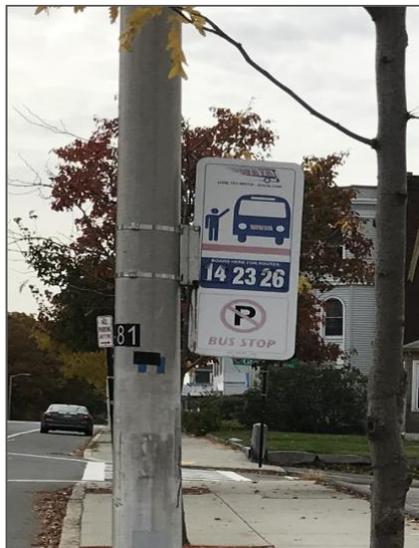
Figure 30: Bus Stop Signage

The problems with the bus stop signs are that they are small, losing stickers, and can be tough to read even when up close to them. This not only makes it difficult for people trying to use the transit system, but for the bus drivers themselves. A new driver that is new to a bus route that travels through Lincoln Street might find it difficult to locate these small and worn-down bus stops. An example of what one of these signs looks like can be seen in Figure 30 below.

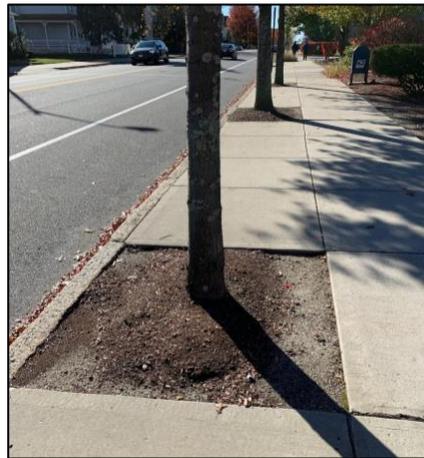
Figure 31: Sidewalk Trees

appeal to the corridor, but because the beds are lower than the sidewalk, a tripping hazard is created. The trees take up sidewalk room and create a hazard which is why we believe these tree beds either need to be addressed for safety or removed. Figure 31 represents the lack of mulch in a tree bed along the corridor.

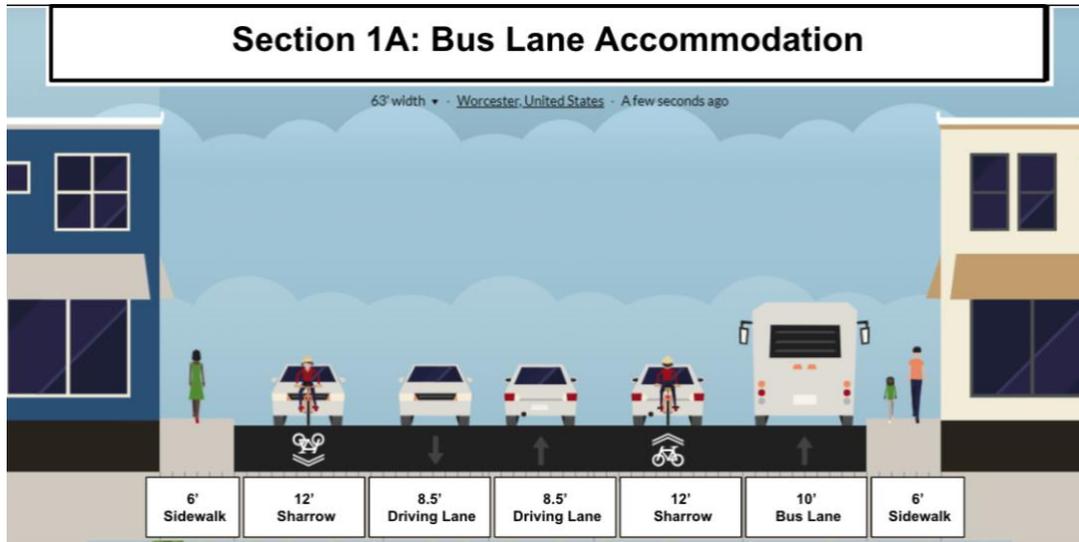
Figure 32: Bus Lane Accommodation, Section 1A

and 2 going southbound. The four designs that include the addition of bus lanes for each section can be seen in Figures 32 through 35.

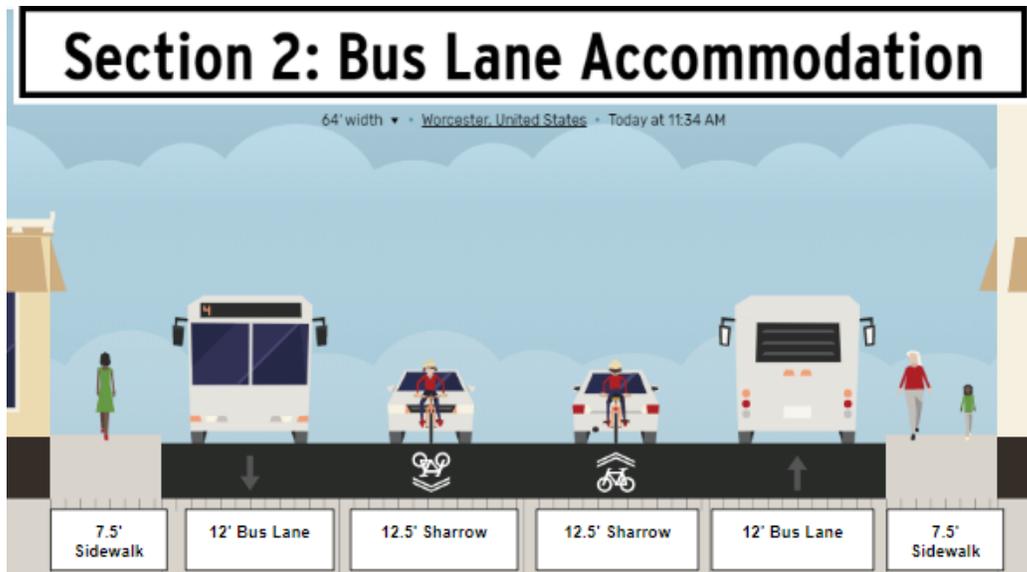
Figure 34: Bus Lane Accommodation, Section 2

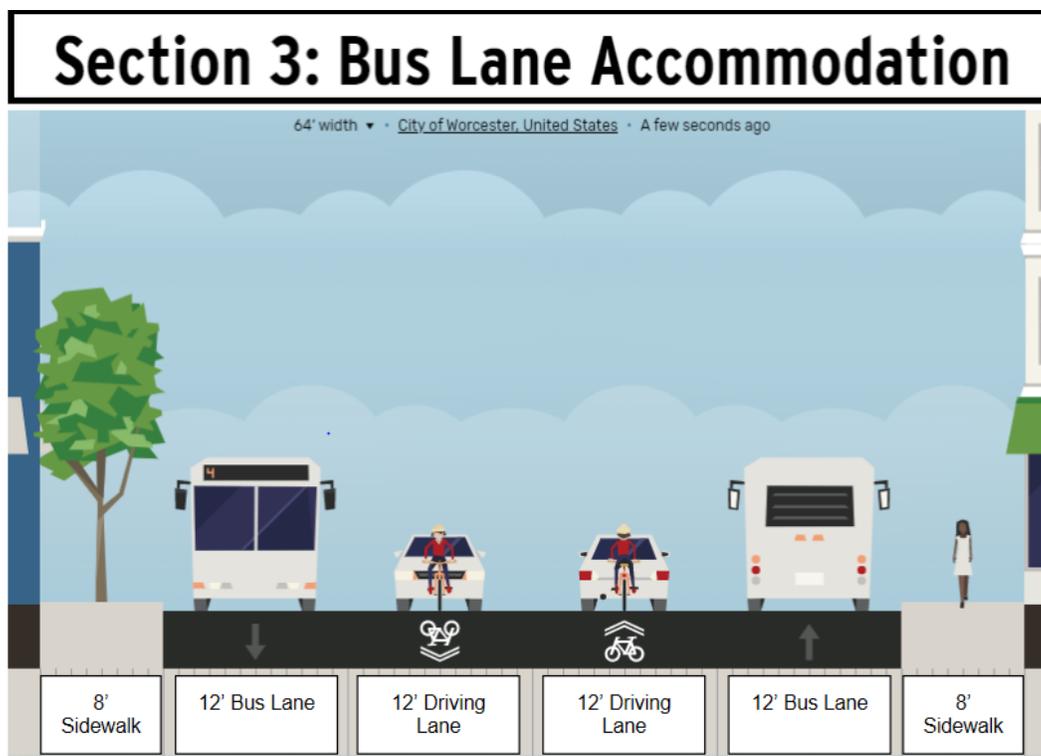
Figure 35: Bus Lane Accommodation, Section 3

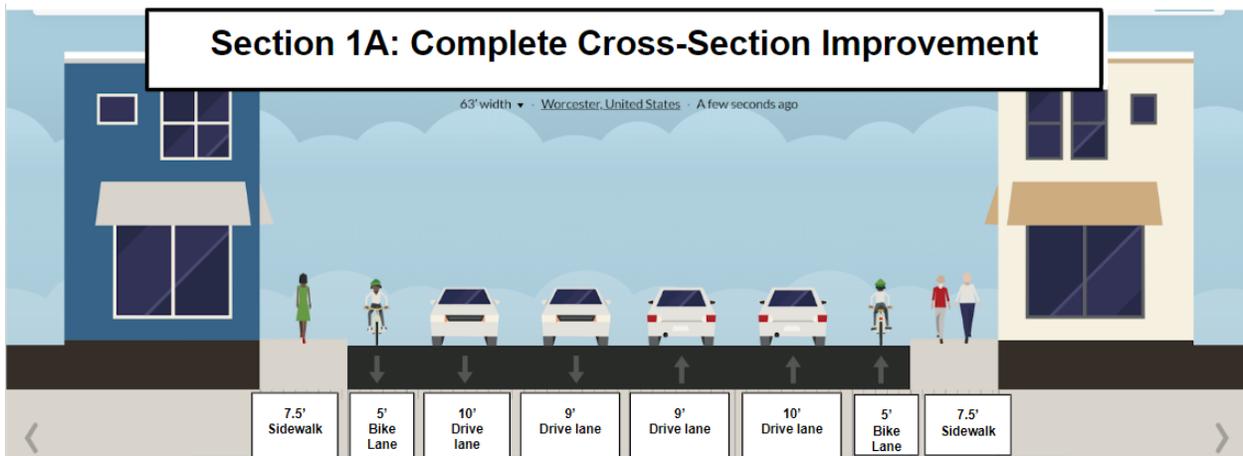
Figure 36: Complete Cross-Section Improvement, Section 1A

The second set of preliminary designs involved changing the dimensions of the corridor by cutting back the sidewalk to accommodate bike lanes and parking lanes in each of the three sections. The complete cross-section improvement designs are shown in Figures 36 through 39.

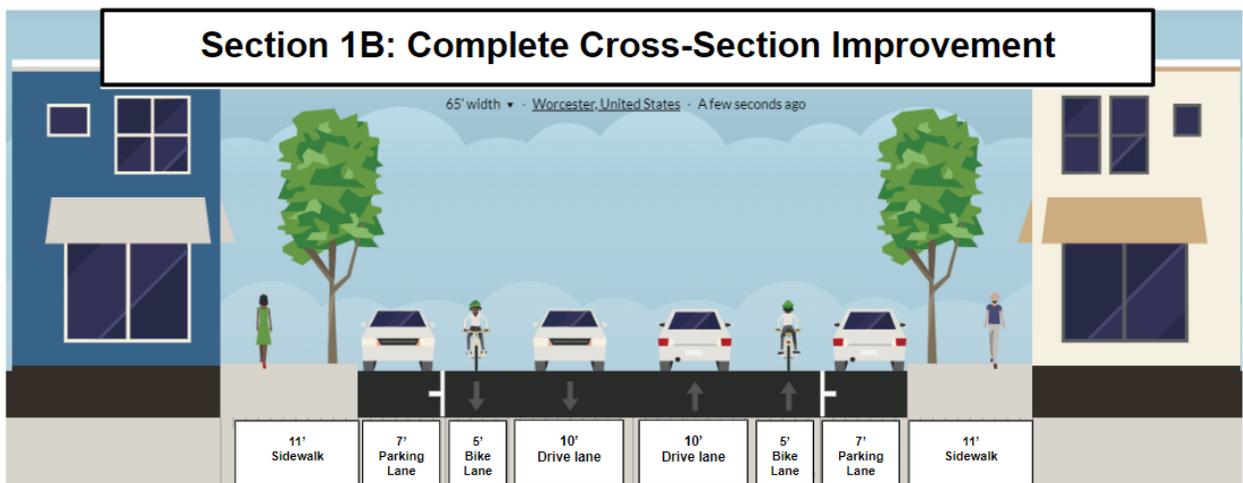
Figure 37: Complete Cross-Section Improvement, Section 1B

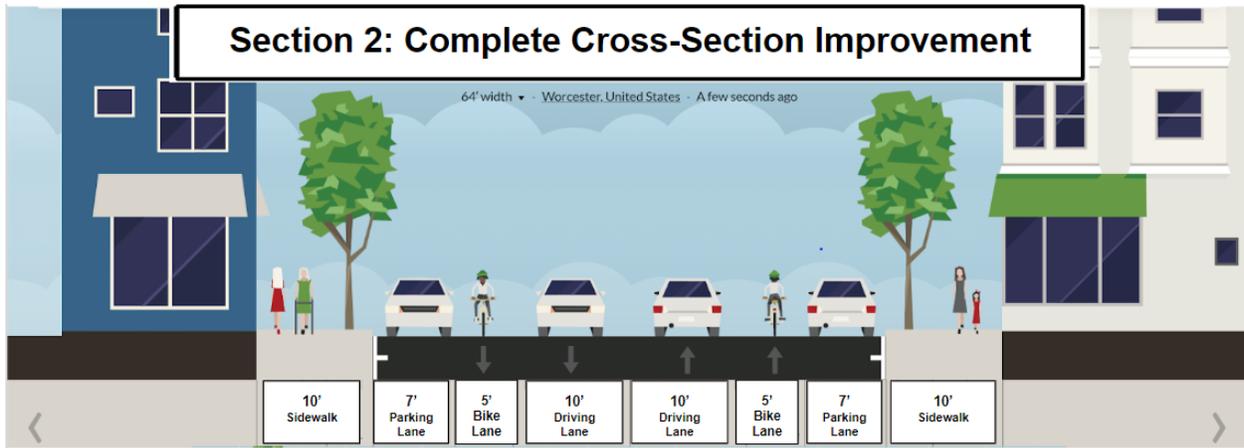
Figure 38: Complete Cross-Section Improvement, Section 2

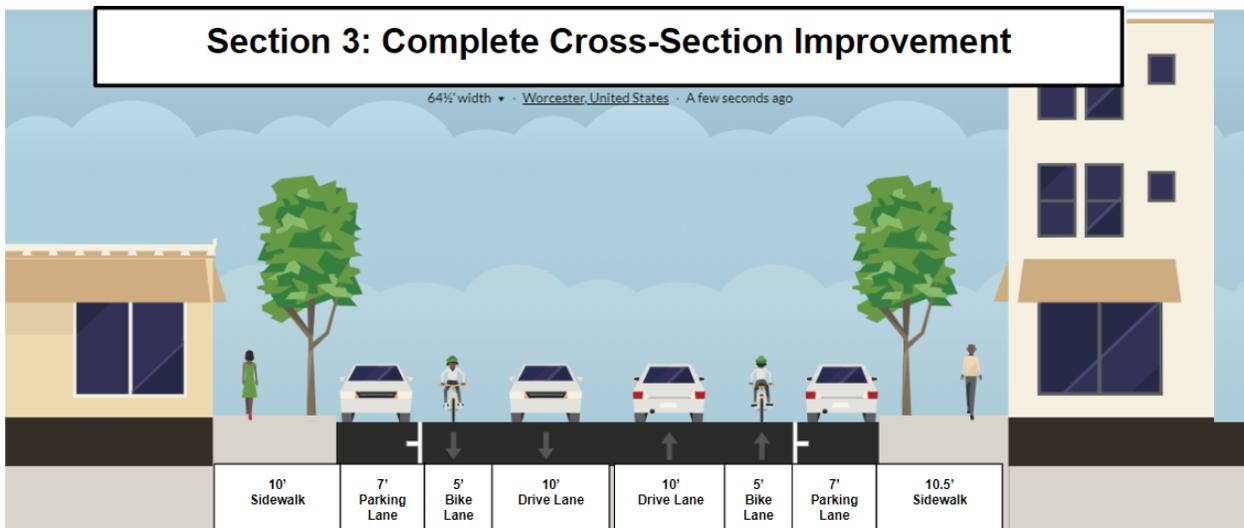
Figure 39: Complete Cross-Section Improvement, Section 3

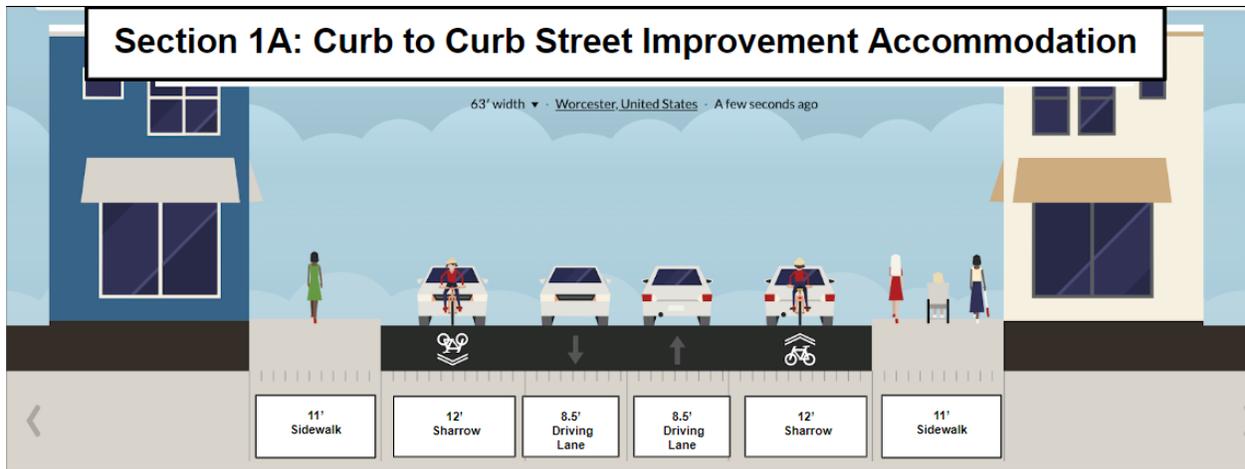
Figure 40: Curb to Curb Street Improvement Accommodation, Section 1A

The third set of preliminary designs include the restructuring of the lane widths to accommodate bike lanes while not changing the sidewalk dimensions. The four designs that keep the sidewalk dimensions intact are shown in Figures 40 through 43.

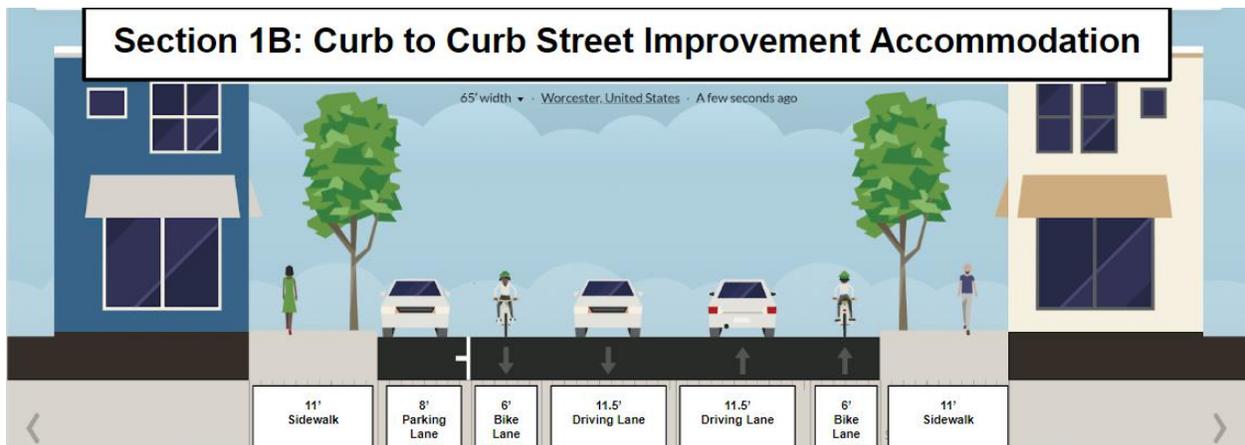
Figure 41: Curb to Curb Street Improvement Accommodation, Section 1B

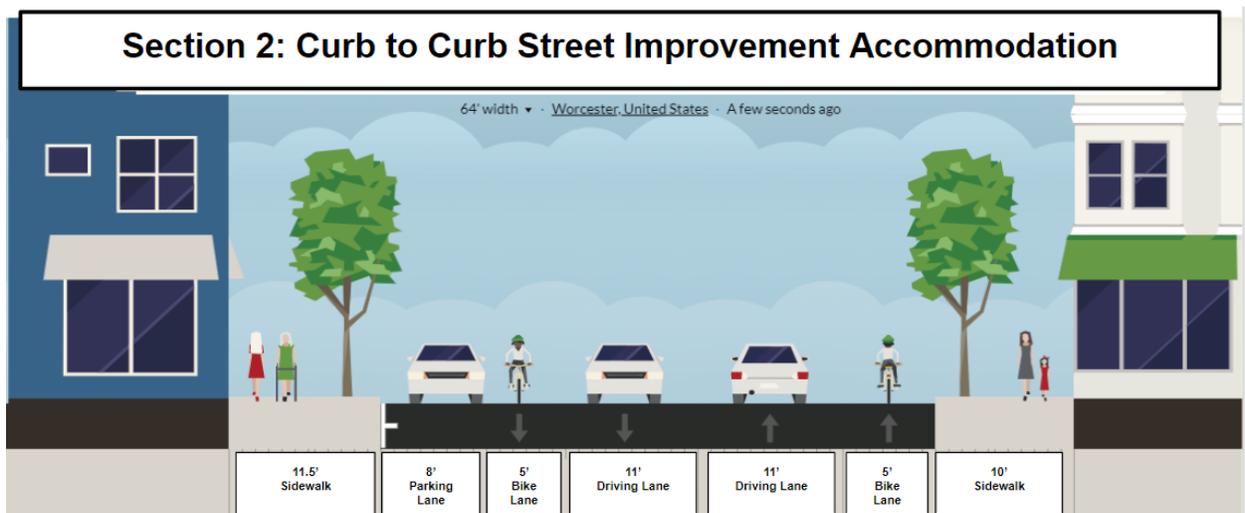
Figure 42: Curb to Curb Street Improvement Accommodation, Section 2

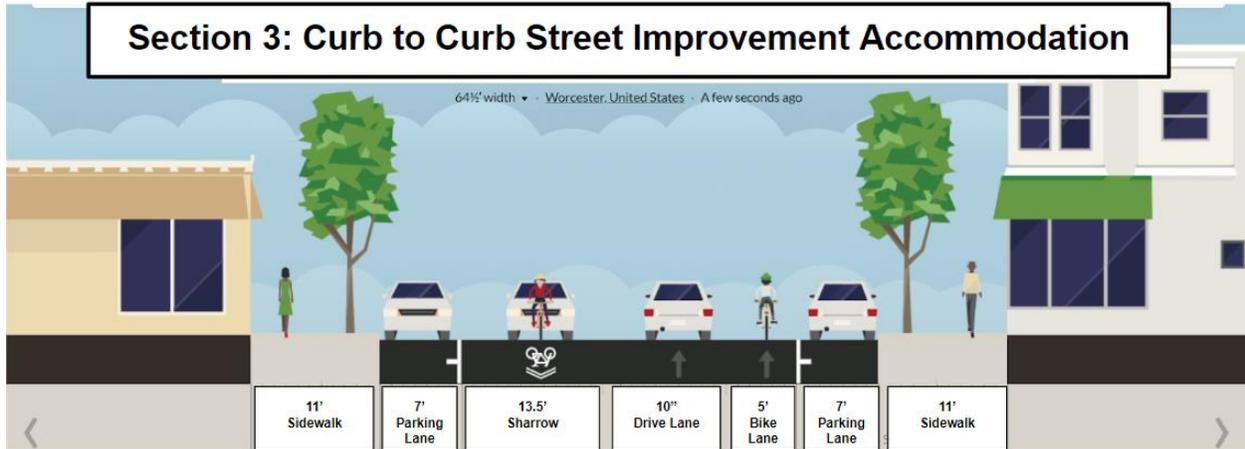
Figure 43: Curb to Curb Street Improvement Accommodation, Section 3

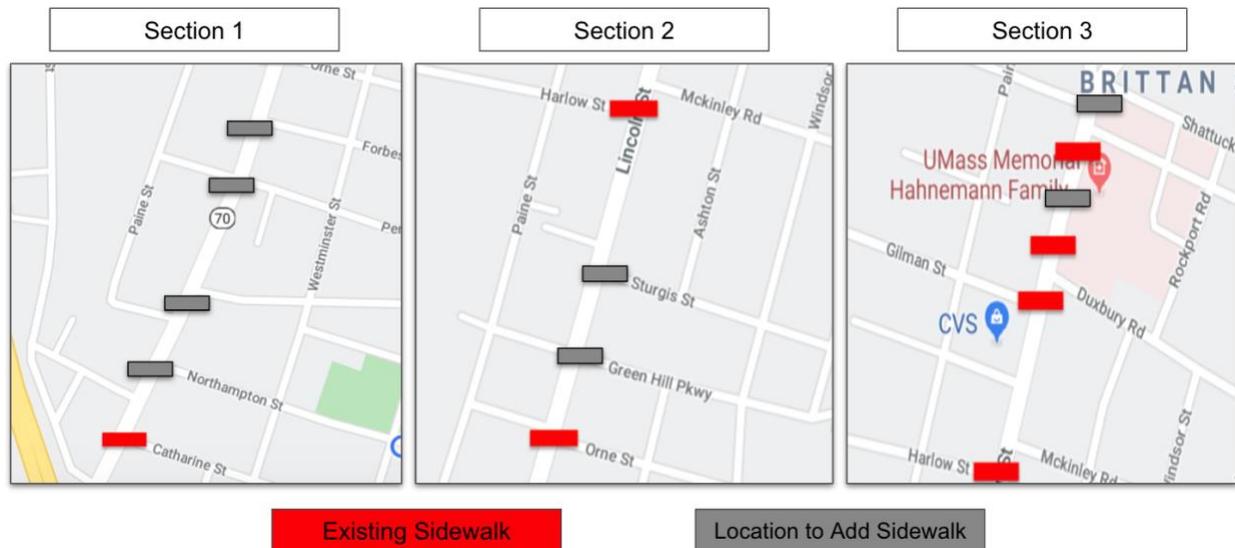
Figure 44: Locations to Add Crosswalks

Each section of the corridor can benefit from an increase in crosswalks as well as flashing crosswalk signs and new bus stop signs. We designed for extra crosswalks to be added near existing bus stop locations. This will help people cross the street near the bus stop they want to get picked up at without having to worry about jaywalking or getting hit by a traveling vehicle. The addition of crosswalks can be seen in Figure 44. The red crosswalks in the images are existing crosswalk locations on Lincoln Street and the gray crosswalks are locations in which our team deemed it necessary to add crosswalks.

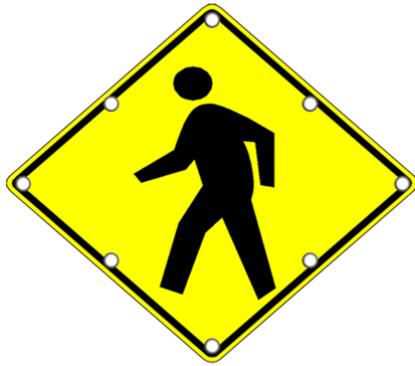
Figure 45: *Manual on Uniform Traffic Control Devices (MUTCD) Crosswalk Sign*

Crosswalk Signs: The team feels that it is necessary to improve the crosswalk signs located at the crosswalks along the corridor. We determined that the number of crosswalk signs needed is 30, with the addition of the crosswalks in the designs we came up with. Figure 45 shows the style of crosswalk signs that we recommend adding to the corridor. The signs would help to improve the safety for pedestrians crossing the street because of their ability to capture the driver's attention by flashing LED lights.

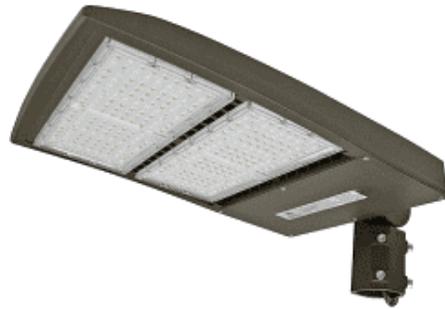
Figure 47: Possible Overhead Street Lighting

lights along the corridor with brighter lights due to the present lighting situation. Improving the lighting by implementing LED street lights, seen in Figure 47 below, will increase visibility at night for all users of the corridor. The height of the lights would not cause a hazard for drivers.

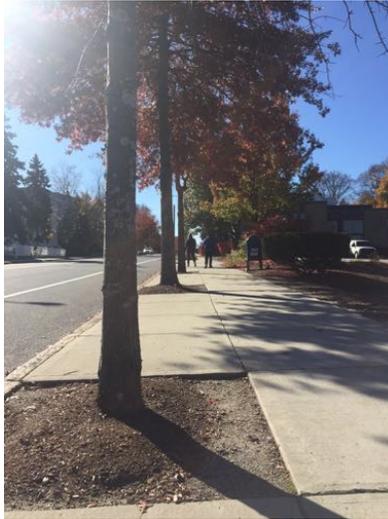
Street trees separate people walking from moving vehicles. Additional mulch could minimize tripping hazard

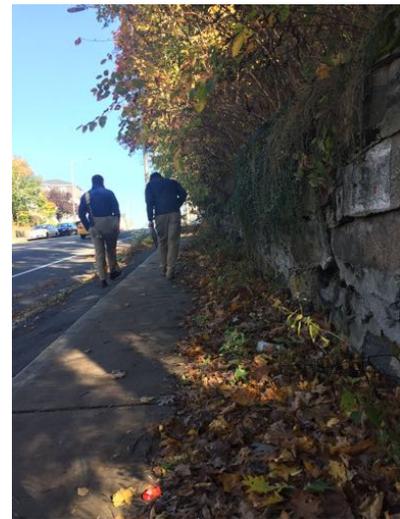
The east side sidewalk of Lincoln Street is uneven in sections and is obstructed by overgrown vegetation and fallen leaves

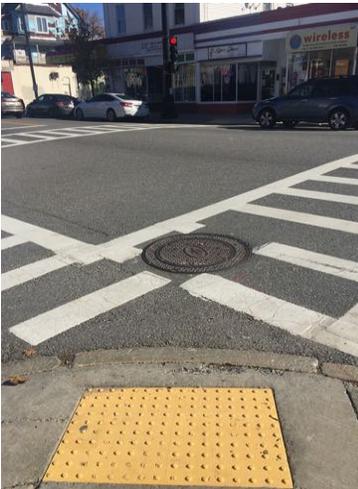
Misaligned tactile warning panel at Harlow Street intersection

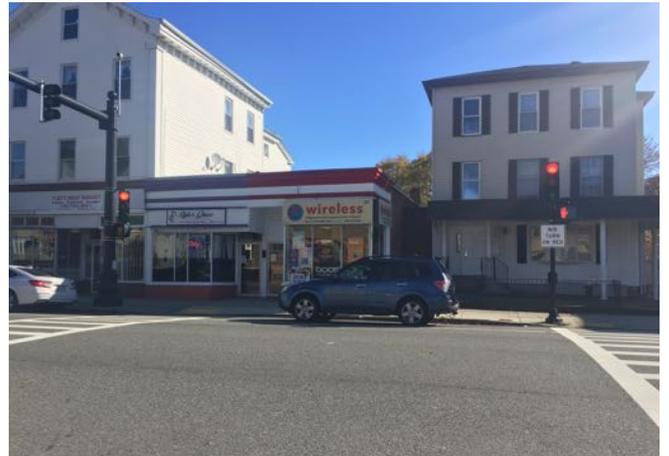
On-street parking within the Harlow Street intersection blocks visibility of pedestrians

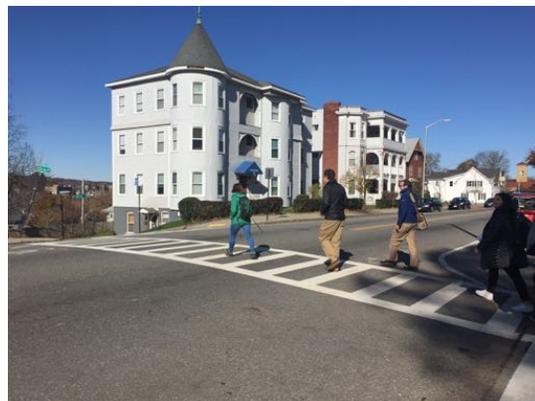
The Orne Street crosswalk lacks elements that make it visible to drivers
