A Study on Biologic Healing in Enzyme Modified Concrete

Professor Nima Rahbar and the Worcester Polytechnic Institute Civil and Environmental Engineering Department in partial fulfillment of the requirements for the Degree of Bachelor of Science
2019-2020

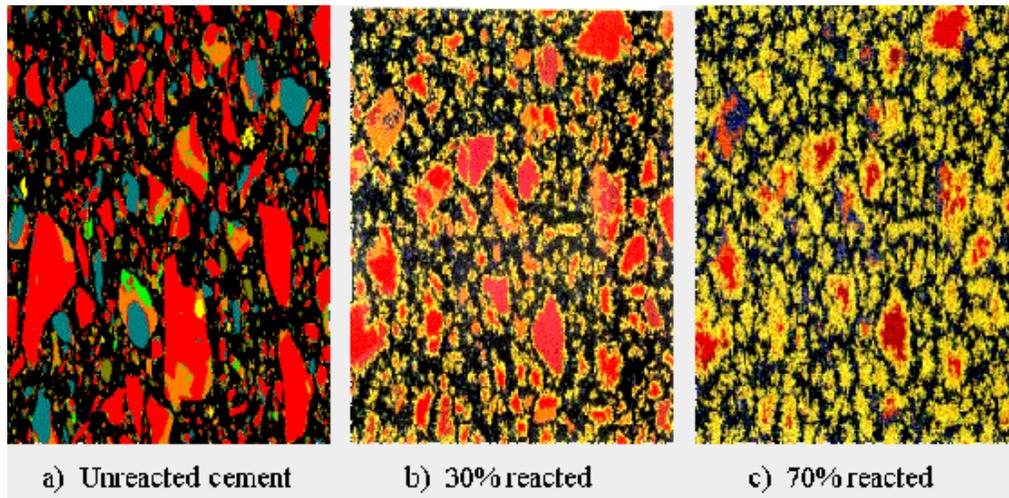
Figure 1: The process of concrete hydration. Water is represented by black, alite is represented by red, belite is represented by blue, and the yellow is C-S-H gel. From left to right, the amount of C-S-H increases and the water filled pores decrease as the hydration process continues, adding to the strength of the concrete (Thomas & Jennings, 2018).

Tricalcium silicate, also called alite, is the most common mineral in portland cement. It is illustrated in Figure 1 in red. Alite is responsible for the initial strength of the hardened concrete. Alite is highly reactive, and it quickly releases calcium and hydroxide ions as well as a significant amount of heat. The reaction causes calcium silicate hydrate gel, or CSH, to begin forming. CSH is illustrated in Figure 1 in yellow and is responsible for binding the particles together. Although CSH is not strong itself, it grows thicker over time, making it harder for the alite to react with water (Monaghan, 2017). Dicalcium silicate, or belite, reacts over a longer period and is responsible for increasing the concrete strength in the long run. It is illustrated in blue in Figure 1.

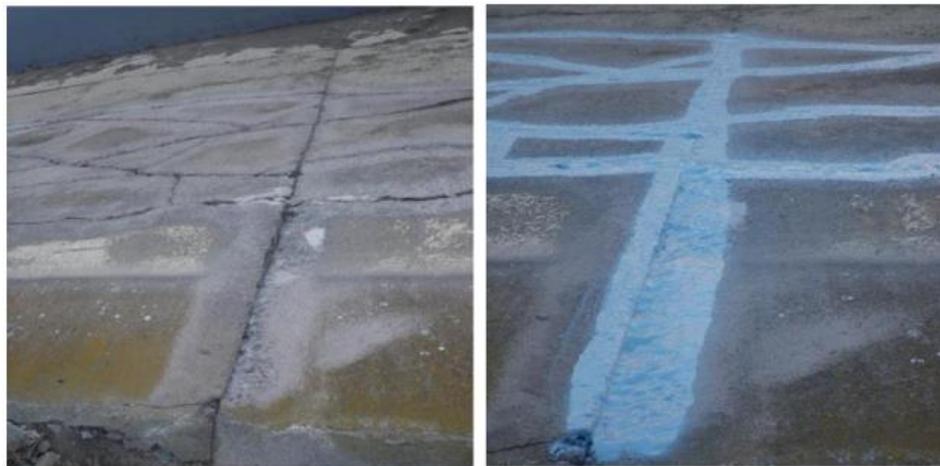
Figure 3: Epoxy crack repair. These types of repair are not always long lasting and often have to be reapplied every few years (von Fay, 2015).

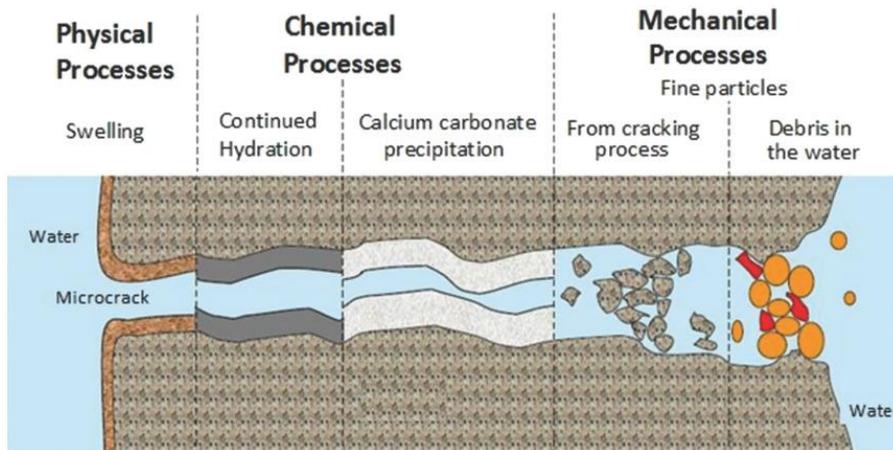
Figure 4: Mechanisms of healing in concrete. Chemical processes are the most common autogenous healing methods. Continued hydration is common in concrete. Carbonation can lead to the precipitation of calcium carbonate, stiffening the cement and filling small cracks. Mechanical and physical processes are less common than chemical (De Belie et al., 2018).

Self-healing in concrete is not a new phenomenon, and has been observed in many concrete specimens. The different mechanisms of autogenous healing are shown in Figure 4. Autogenous healing can occur when unhydrated cement particles are hydrated, or by carbonation of dissolved calcium hydroxide (Seifan et al., 2016). It is a natural process, but it depends on the amount of water and unhydrated cement particles that are present. Autogenous healing is not always an option for healing cracks in concrete because it is dependent on internal conditions and it cannot be regulated. A more promising method of healing concrete is through biomineralization. Some bacteria are able to precipitate minerals such as carbonates and silicates. Calcium carbonate, one of the common minerals in concrete, can be precipitated by bacteria as long as there is a source of calcium (Seifan et al., 2016). In many cases, the calcium carbonate is produced through urea

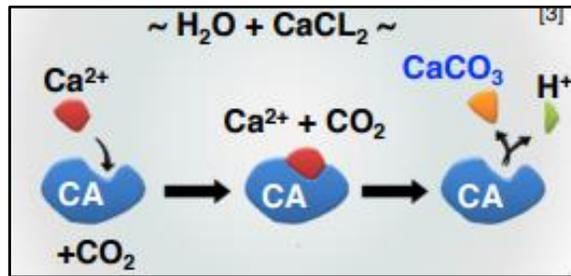
Figure 5: Carbonic anhydrase reaction. CA facilitates the conversion of carbon dioxide to calcium carbonate, as long as there is a sufficient amount of calcium present (Rahbar et al., 2018).

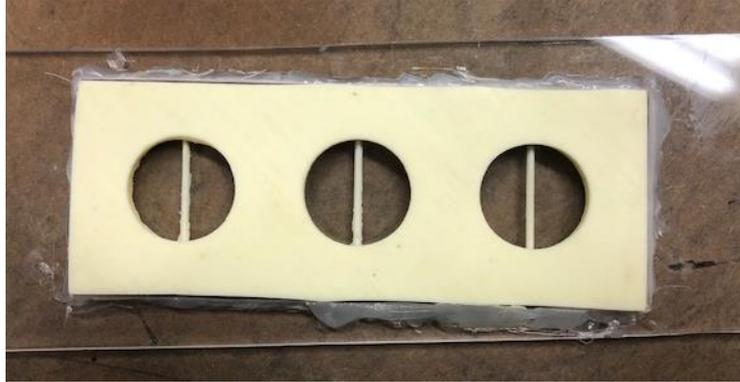
Figure 6: The silicon mold used to make concrete samples with a small v-shaped notch. Samples were used for SEM. Three cylinders were put in each mold for efficiency and ease in demolding.

The samples used in the scanning electron microscope were small cylinders, 25mm in diameter and 5mm in height. The dimensions were chosen because they are the maximum height and width that can be used in the Phenom G1 Scanning Electron Microscope. In order to create the samples, a reverse mold was created using Solidworks and printed using rapid prototyping. A few iterations were printed until the final design was chosen. Ultimately, it was found that having three cylinders in one mold was the easiest to demold the silicone from the plastic. After printing, the mold was placed on a vibrating table and filled with silicone. The mold was left on the vibrating table for 10 minutes. It was then covered with plastic wrap and left to set for 24 hours. After 24 hours, the silicone mold was removed and hot-glued to a small sheet of clean acrylic. The mold was placed atop a piece of acrylic in order to create a smooth top on the sample. A surface with flat topography is easier to observe with SEM, and the acrylic provided a smooth finish on the cylinders. The final mold is shown in Figure 6.

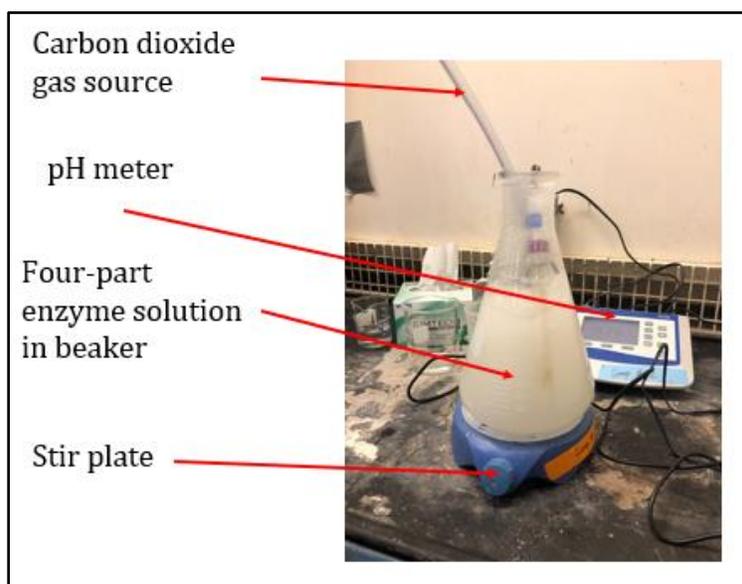
Figure 7: The four-part enzyme mixture for topically applied repairs. The four ingredients are water, calcium chloride, carbon dioxide, and carbonic anhydrase, with tris added to stabilize the pH. A pH meter was used to monitor the pH as it fell to a neutral level. The stir plate kept the mixture homogeneous.

In a large graduated cylinder, 800 mL of deionized water was measured out. A 1000 L Erlenmeyer flask was placed atop a stir plate beneath a fume hood. Half of the deionized water added to the flask. A small bench scale was used to measure 400 mL of $2M\text{CaCl}_2$, or 88.792g. The scale was also used to measure 400 mL of 0.1M tris, or 4.844g. The calcium chloride and tris were added to the flask using a funnel, using a transfer pipette to rinse the measuring dishes. The stir plate was turned on high in order to let the calcium chloride and tris dissolve completely. Once the mixture turned clear, carbon dioxide gas was added. The gas was added to the mixture using a carbon dioxide canister with a hose and nozzle attached. The gas was turned on to a low bubble in the mixture. The last ingredient for the calcium carbonate repair is the enzyme itself. 20 μL of 100 μM carbonic anhydrase was added to the mixture, using a pipette to rinse out the microcentrifuge tubes three times in order to get all the enzyme in the mixture. The four-part mixture is shown in Figure 7.

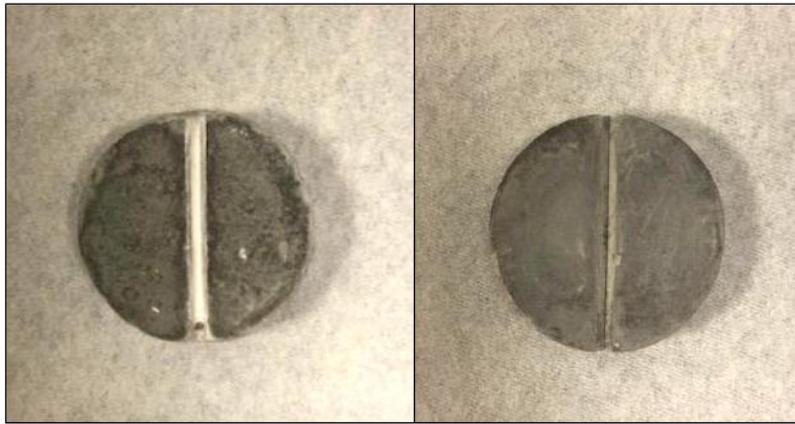
Figure 8: On the left is a repaired sample containing carbonic anhydrase in the concrete mixture (CA-Add). On the right is a control sample containing only water and OPC (Con). The two samples were among those compared using SEM.

falls to 7, the carbon dioxide gas was turned off. After turning off the gas, the flask was removed from the fume hood. Six 50 mL centrifuge tubes were filled with 45 mL of the enzyme mixture. The tubes were placed in a centrifuge for 9 minutes at 5000 rpm. The centrifuge concentrates most of the calcium carbonate at the bottom of the tube. The supernatant on top was poured into a large beaker, leaving about 5-10 mL of supernatant mixed with the concentrated repair. The tube was capped and shaken for 5 seconds and the concentrate was poured into a separate, smaller beaker. The process was repeated for all six centrifuge tubes. The centrifuge tubes were filled again with the mixture from the flask and placed in the centrifuge. The entire process was repeated until the mixture from the flask was entirely depleted. Once the mixture was separated into supernatant and concentrate, about 35 mL of the supernatant was poured over each sample. The samples were covered with parafilm, labeled, and left to sit for 48 hours. The final repaired sample and a non-repaired sample are shown side by side in Figure 8.

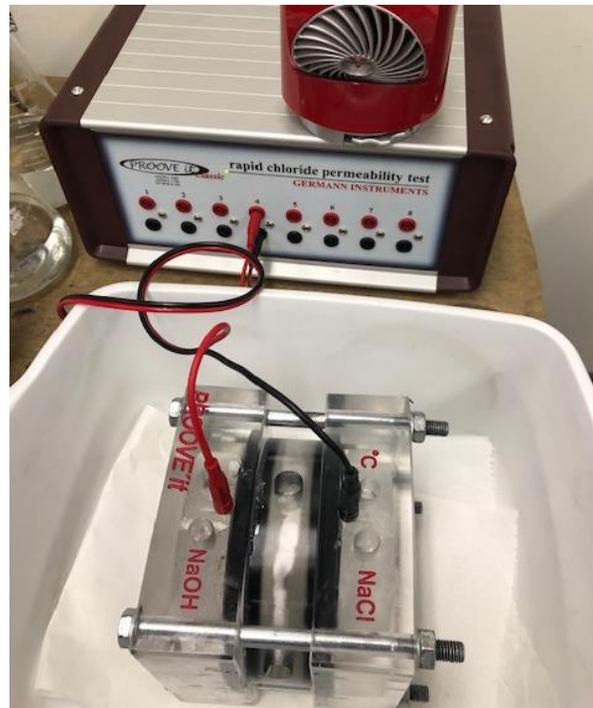
Figure 9: The RCPT test set up using the Proove'it system by Germann Instruments. One side of the apparatus contains 3% Sodium Chloride, and the other side contains 3N Sodium hydroxide. The instrument provides 60V of electricity to push chloride ions into the concrete over 6 hours.

On the day before testing all samples sat in a vacuum chamber for 3 hours. The sample was placed in the bottom of a small vacuum chamber, and the rubber gasket around the chamber was brushed with silicone oil. The chamber was closed, and a vacuum pump was turned on for 3 hours. After 3 hours, degassed water was added to the vacuum and the sample sat for 1 hour in the water vacuum. After 1 hour, one of the nozzles in the chamber was opened and the sample was left to sit and return to ambient pressure for 18 hours. The actual test was performed using the Proove'it system by Germann Instruments. testing apparatus and ran for 6 hours, according to the ASTM standard. The test set up is shown in Figure 9.

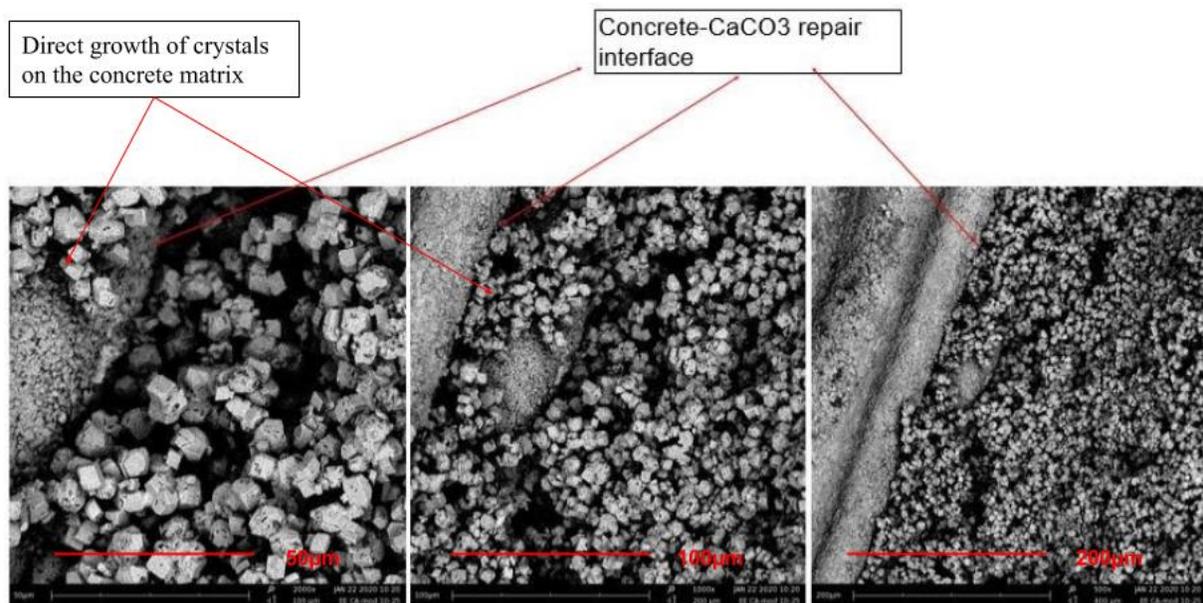
Figure 10: Images of the interface between the repair and the concrete. From left to right the magnification is 2000x, 1000x, and 500x. The crystals are precipitated calcium carbonate. The image shows that there are several gaps in the repair matrix, but the trough is evenly filled.

Control and enzyme modified samples were examined using a Phenom G1 scanning electron microscope. The complete collection of images is shown in Appendix A. Figure 10 shows the interface between the CA-Add concrete substrate and the repair. The crystalline structures are precipitated calcium carbonate from the enzyme repair method. Although the crystal growth is asymmetrical, the size of the crystals is even. The crystals all appear to be in focus in the images, which suggests that the trough is evenly filled. The interface between the concrete and the crystals is clearly distinguished, and there appears to be direct bonding between the concrete and the crystals. The ridged contours in the concrete substrate are from the 3D printed mold.

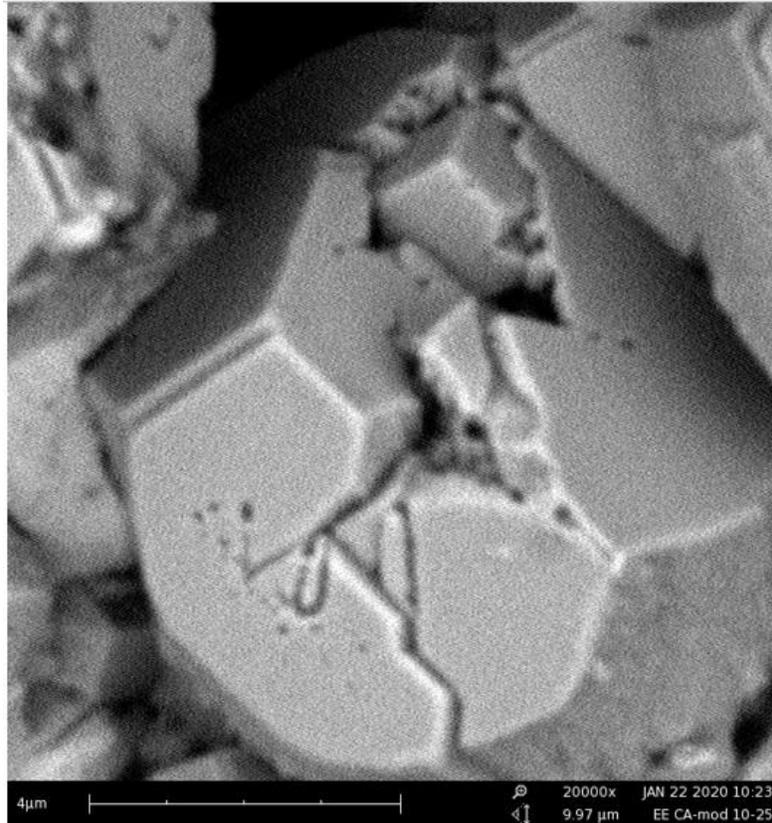
Figure 11: An SEM graphic of a calcium carbonate crystal at 20000x. The crystal has several imperfections and cracks, but it appears to be well bonded to other crystals.

Figure 11 shows a precipitated calcium carbonate crystal at full magnification (20000x). The surface topography is rough, and the crystal contains several cracks, but there is good bonding between neighboring crystals. Not all the calcium carbonate crystals are cracked, but the distribution appears to be random.

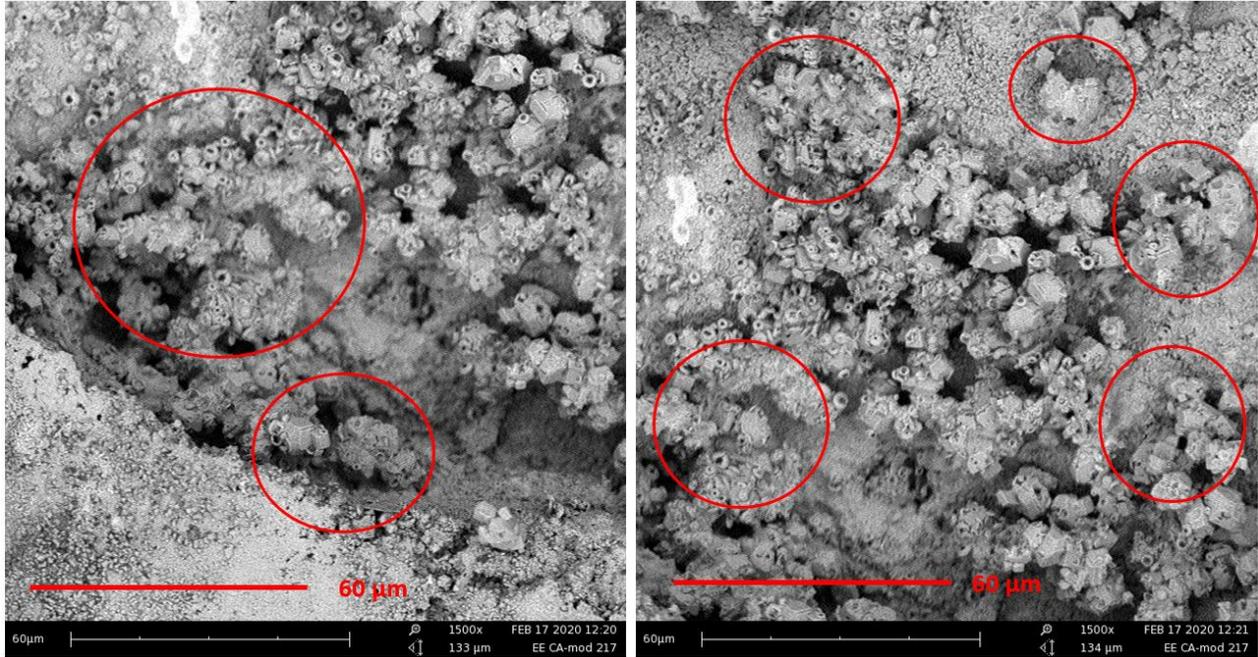
Figure 12: SEM graphic of the repair-concrete interface. The red circles show areas of direct interfacial growth of calcium carbonate crystals onto the concrete matrix. The area pictured is at the edge of the calcium carbonate filled notch. The magnification of the image is 1500x.

There also appears to be interfacial growth of calcium carbonate crystals in the concrete matrix near the boundary of the repair. Figure 12 shows direct interfacial growth of calcium carbonate crystals in the CA-Add concrete. Figures 10 and 12 show the variable crystal adherence onto a CA-Add substrate; each is from identical but separate samples prepared side-by-side in the laboratory. While Figure 10 shows direct crystal growth on the concrete, the crystals in Figure 12 appear to sit in a glue-like substance and grow into the substrate. This suggests that the CA-Add substrate is promoting an advanced bond between the calcium carbonate repair material and the cement matrix, but not in all specimens. The interfacial growth suggests that the addition of carbonic anhydrase to the concrete mix changes the properties of the bond to the repair. However, the variable appearance suggests that further work is needed to obtain consistent repair characteristics.

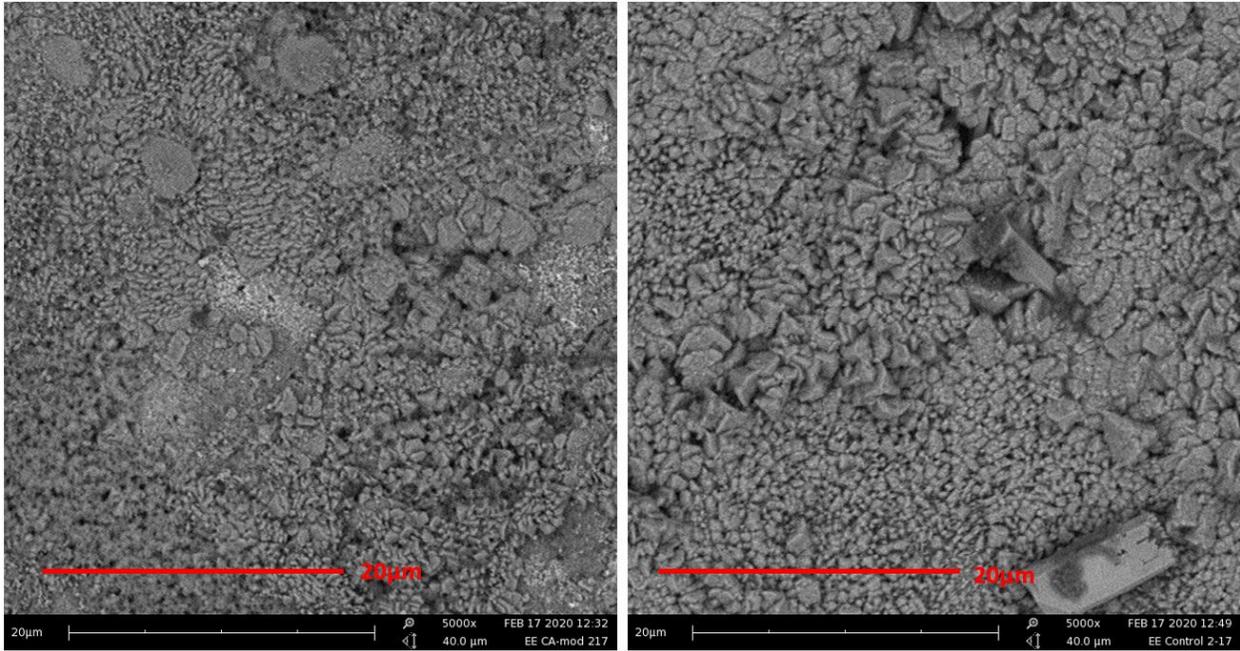
Figure 13: An SEM graphic of the surfaces of CA-Add and control samples respectively. The topographies of the different samples are similar in roughness and homogeneity. The magnification of the image is 5000x.

The surfaces of the control and CA-Add samples were also examined. Away from the notched area, the topographies of the samples were visually similar. There was no crystal growth on the CA-Add samples away from the filled notch. The two samples are compared side-by-side at 5000x magnification in Figure 13.

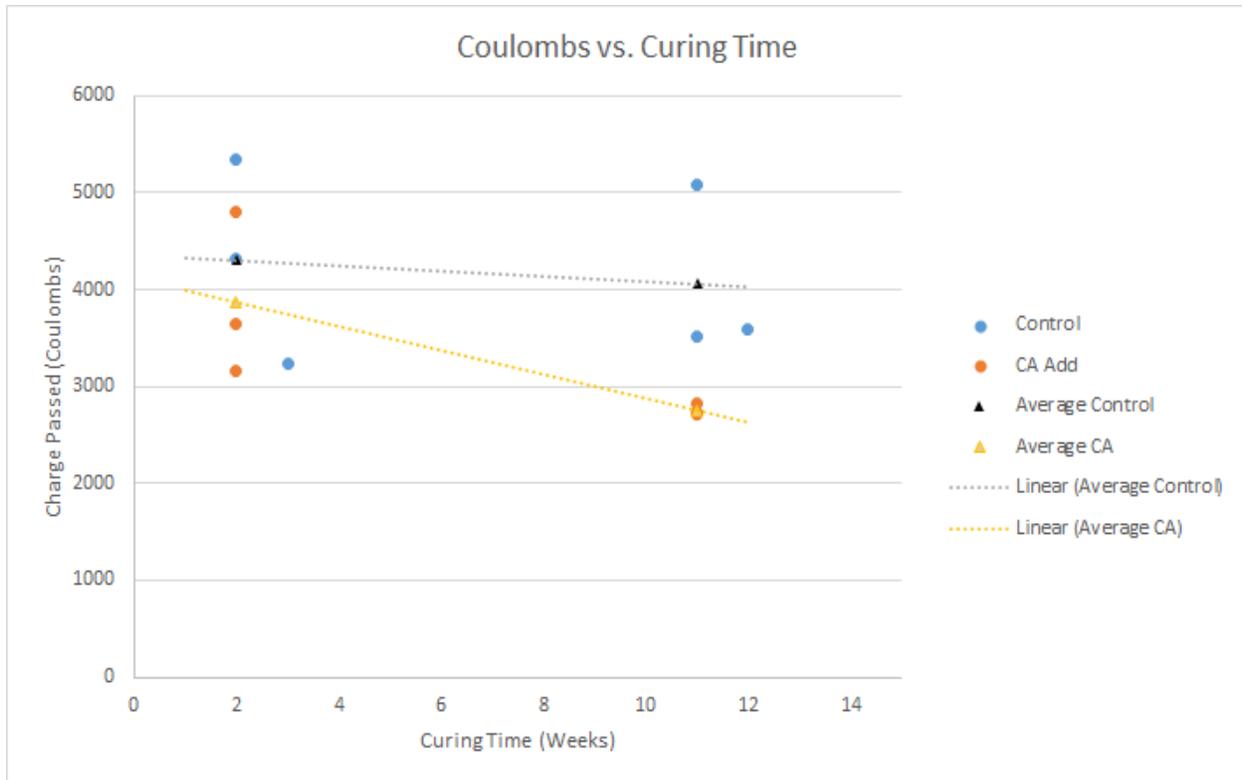
Figure 14: Graphic representation of RCPT results. The permeability of control samples decreased at 36.2 coulombs per week, while the permeability of CA-Add samples decreased at 184.7 coulombs per week.

The RCPT results are represented graphically in Figure 14. The two linear trend lines are between the averages of the two types of samples at two weeks of curing and two months of curing.

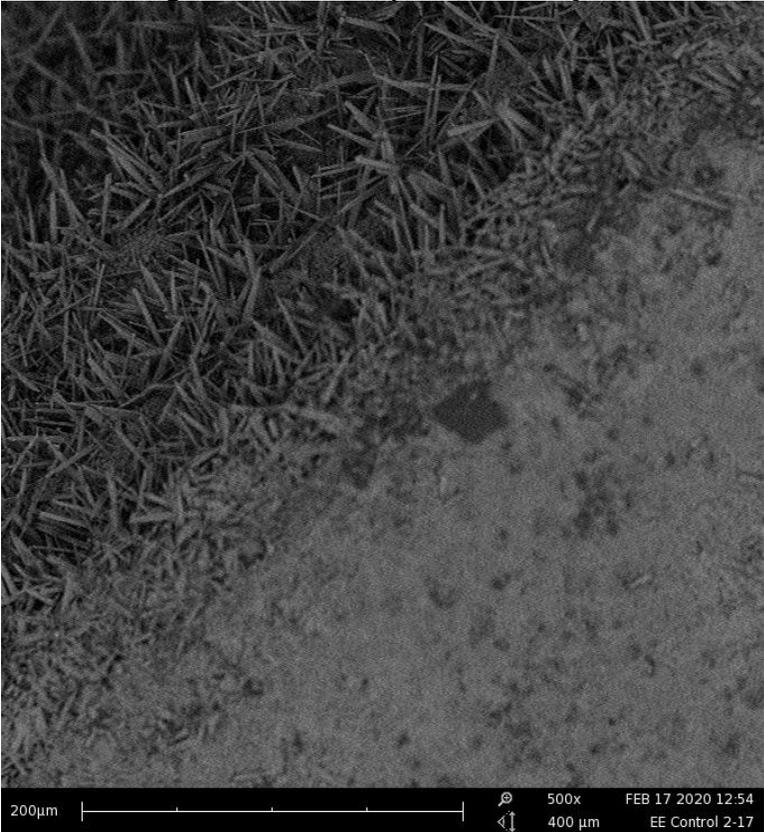
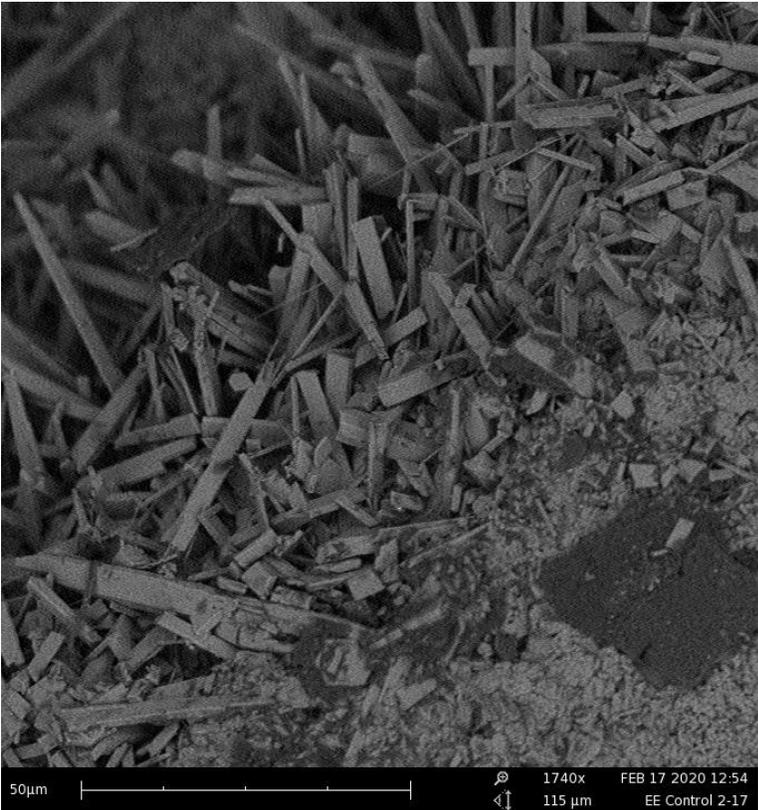
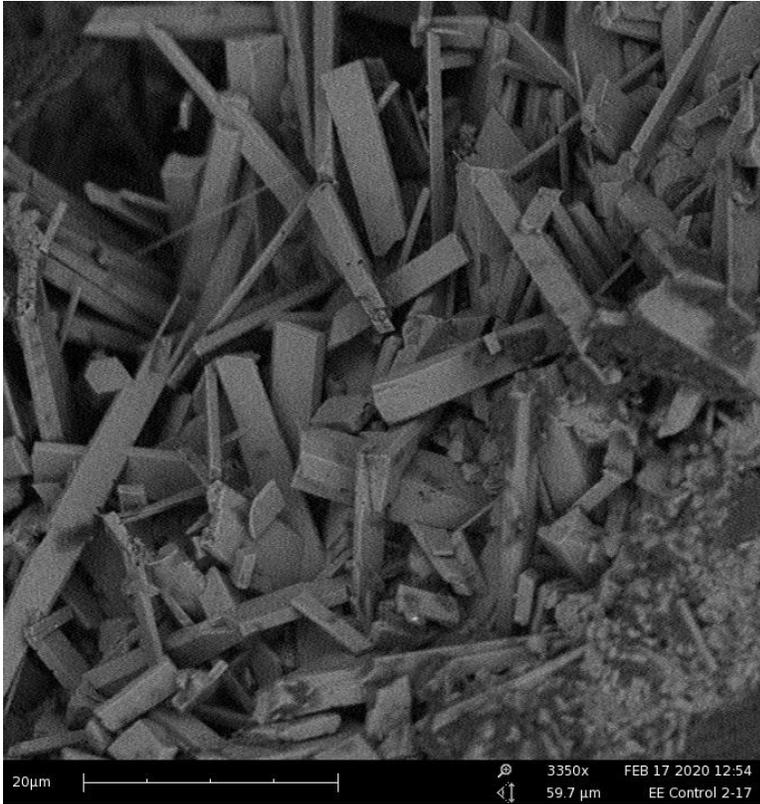
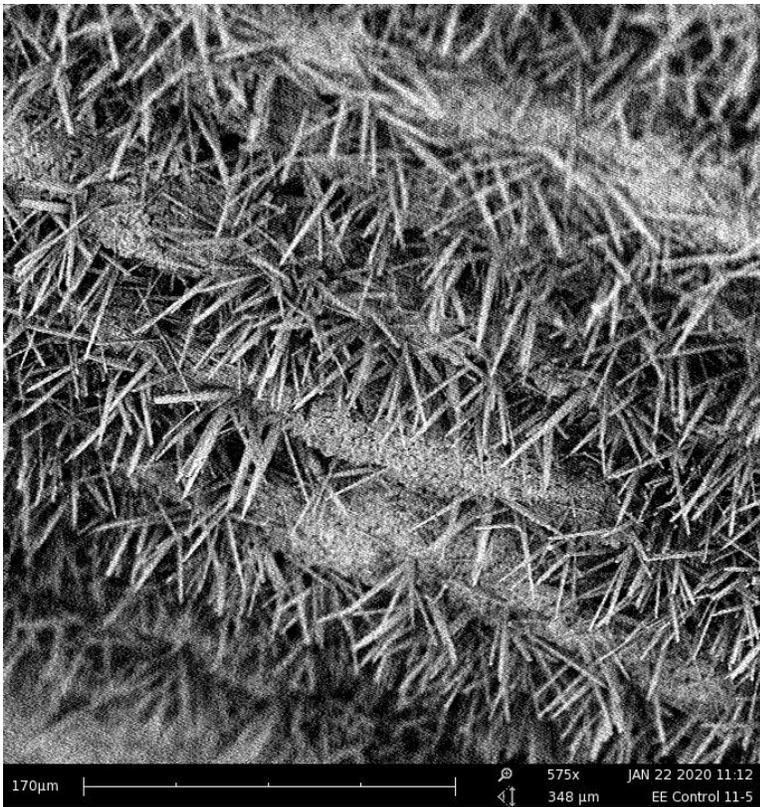
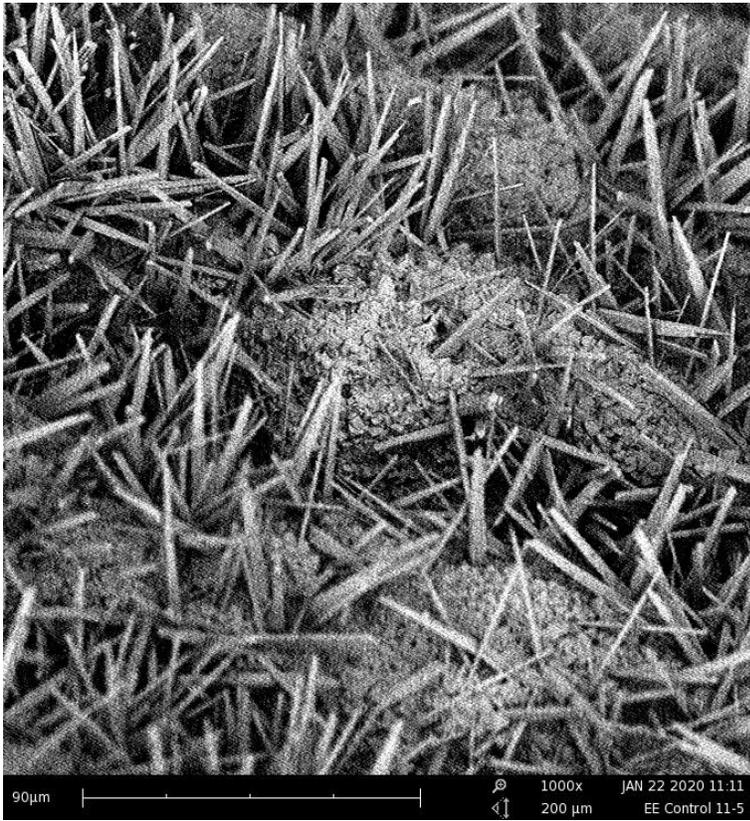
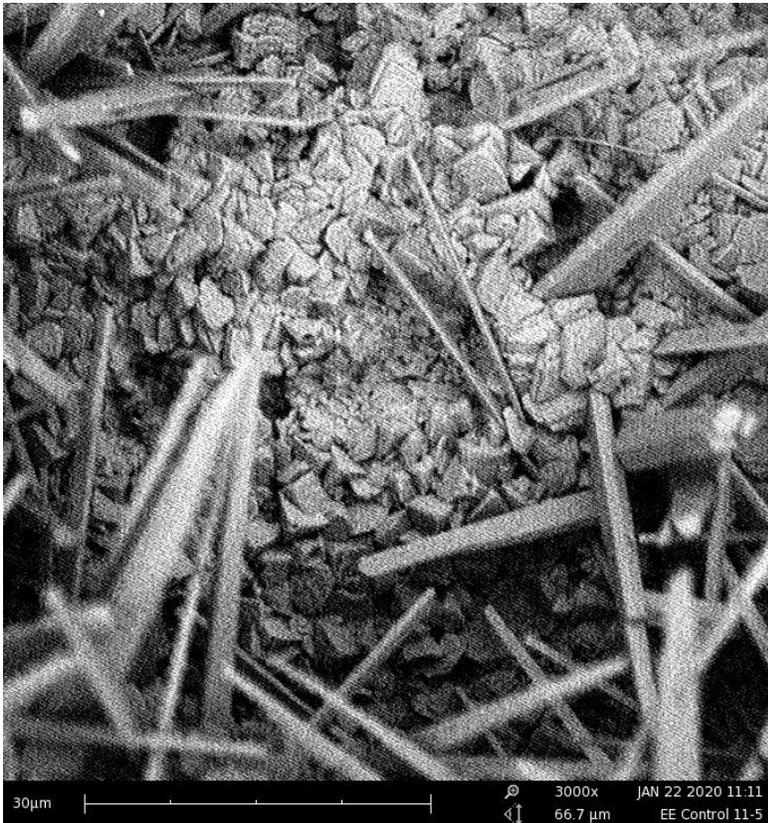
Unfilled trough of control samples (with unhydrated cement crystals):

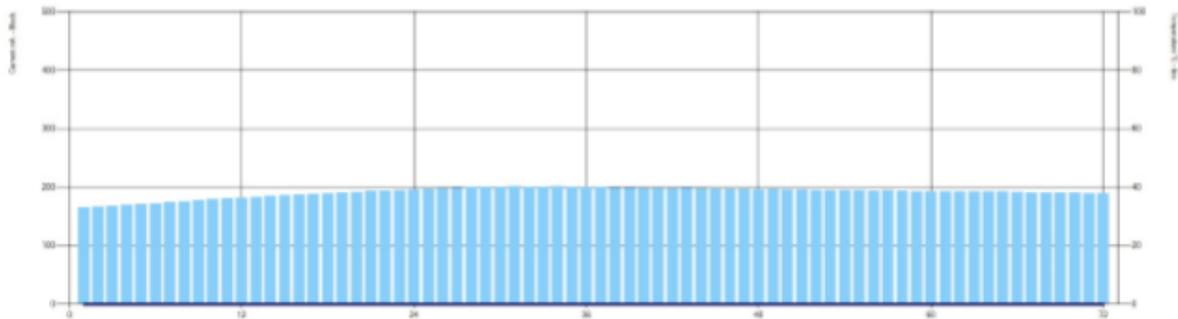
Test report

Voltage Used: 60 V
 Testing Time: 6:00 hours
 Charge Passed (Adjusted): 3581.83 coulomb
 Penetrability Class: Moderate
 Instrument Number: 181624
 Channel Number: 6
 Report Saved: Wednesday, January 29, 2020 2:48 PM
 Testing By: Emma Edwardson
 Reference:
 Sample Diameter: 102 mm
 Sample Length: 50 mm
 Instrument Status: FIN
 System ID: 10074
 Test ID: ejedwardson
