Energy Auditing and Technological Renovation of the Printer's Building for

Davis Publications, Worcester, MA

An Interactive Qualifying Project Report

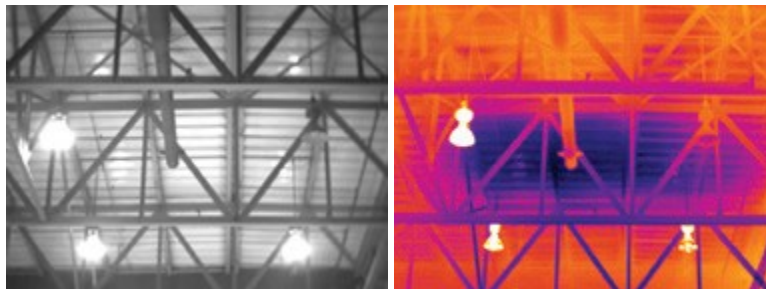
Figure 3. Infrared Imaging Pinpoints Energy Loss (Infrared Thermography, 2008)

An infrared thermal imager analyzes the efficiency of the insulation within a building. Since his device can view infrared waves, which is the wavelength of heat, it can see where heat is being vented to the outside, both across the entire building and in specific areas of the envelope (Everblue 2008). Usually, darker colors mean that those areas are colder, and lighter colors or white means that the area is very warm.

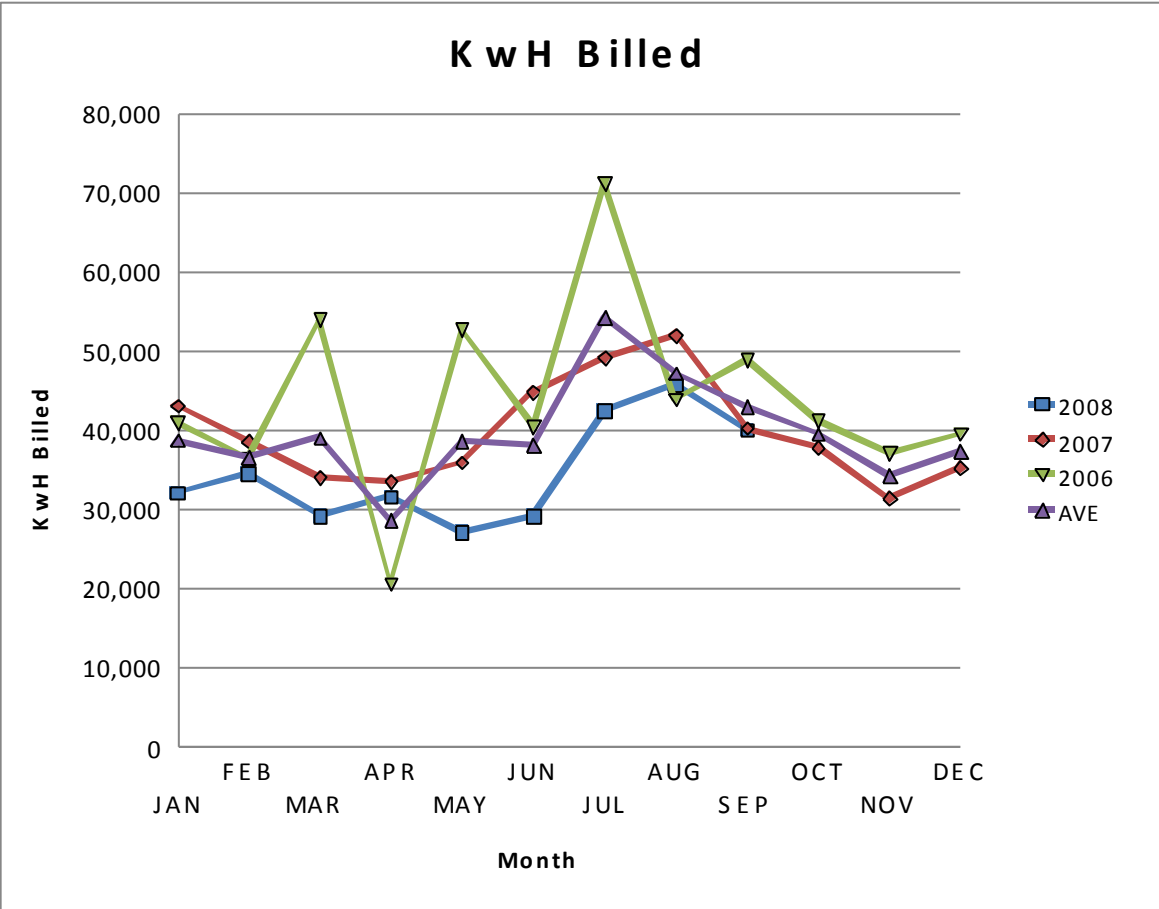
Figure 4. Graph of Kilowatt-Hours Used by the Printer's Building, By Month

The first system that we fully analyzed was the electrical, which was measured in kilowatt-hours. Figure 4 shows what we expected, a large increase in electrical use during the summer months of July and August. During these two months the building averaged an energy use of 93,000 kWh. This is about 1/5 of the average annual energy use of the building, 476,080 kWh. The sudden increase in electrical use during this time is due to the air conditioning units. We conclude this because during the winter, electrical use drops significantly, despite the use of electrical heaters.

Even though there is an increase in electrical use during the summer and decrease during the winter, the total use does not fluctuate a very large amount (max =48000kWh, min=31,000kWh). This high constant electrical draw is due to equipment, which is not influenced by the weather, such as lighting, machinery, and computers.

When we first analyzed the graph, we saw the great spikes in 2006's data (green line), which is probably because the electrical company did not actually measure the meters. Instead, they just estimated the usage within the building. Therefore, this data was used in creating the average (purple line); but we did not spend time analyzing the peaks and valleys of that year.

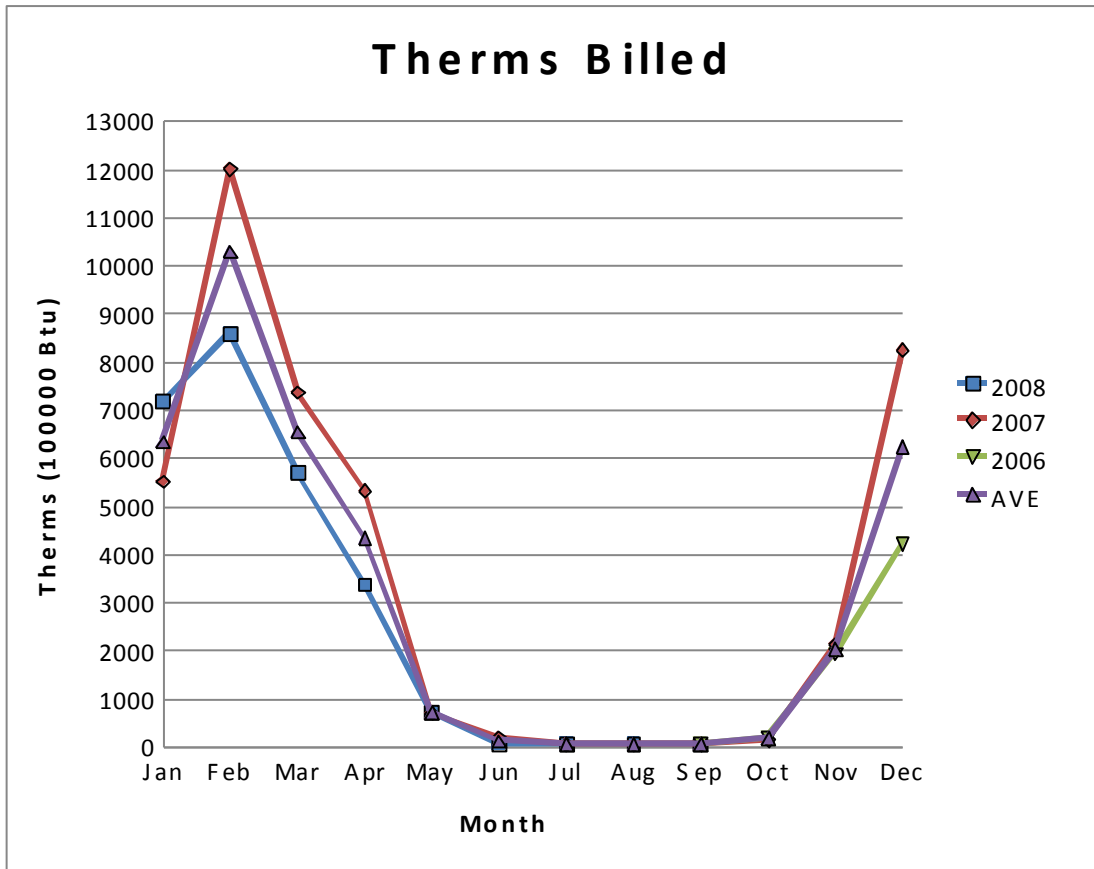
Figure 5. Graph of Energy Usage of Printer's Building, By Month

The other system we analyzed was the gas or main heating system, which is measured by therms billed. As expected, there is a large spike in gas use during the colder months, November to April, as can be seen on Figure 5. These six months account for almost 97% of the total gas

use. Due to increased gas requirements, improvements should be focused on reducing the amount of energy used to heat the building, not the amount used to heat water for other uses, such as hot water for sinks.

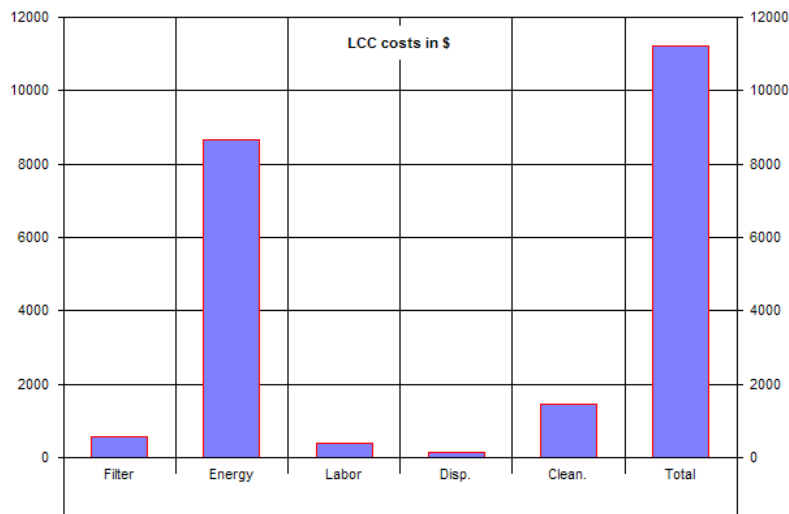
Figure 6. 10-year Cost Analysis of Existing Filters in Carrier 38JB016520

particle-filled filters lead to a reduction in airflow, causing the motor to work harder and use more energy to move air through the system. The type of filter used in the system can affect the efficiency as well; there is higher-efficiency media and construction used in some filters that allow the motor to use less energy to move the same amount of air through the system. We created a life cycle cost analysis based on ten years of use of the same type of filter assuming it is changed twice a year for one of the larger units in the building; this unit was located on the 4th floor and uses 8 filters for the system. The life cycle cost analysis showed us that using the existing filters for the ten year period would cost \$11,207, and is demonstrated in Figure 6.

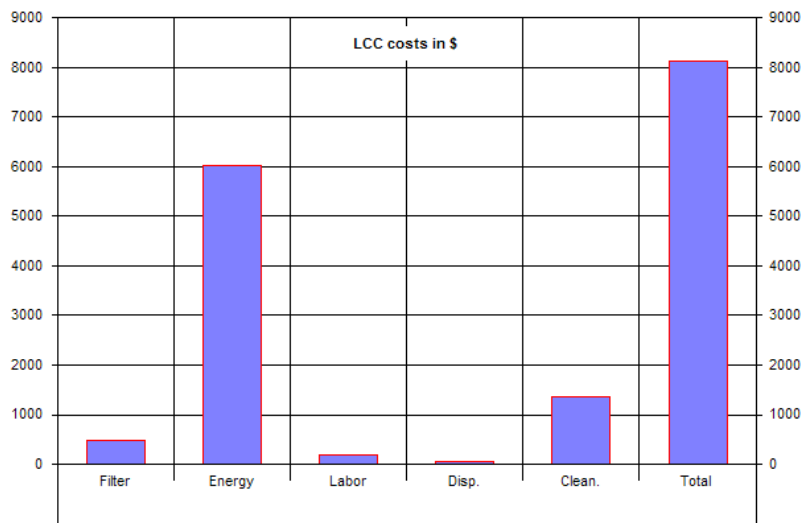
Figure 7. 10-year Cost Analysis of Energy-Efficient Filters in Carrier 38JB016520

Performing the same analysis using energy efficient filters, it was determined that the total life cycle cost would be \$8,134, saving the building \$3,073. This is demonstrated in Figure 7.

The savings netted from changing to energy-efficient filters is approximately \$300 each year for just one of the many units in the building. Making these changes for all of the HVAC equipment within the building could add up to remarkable savings.

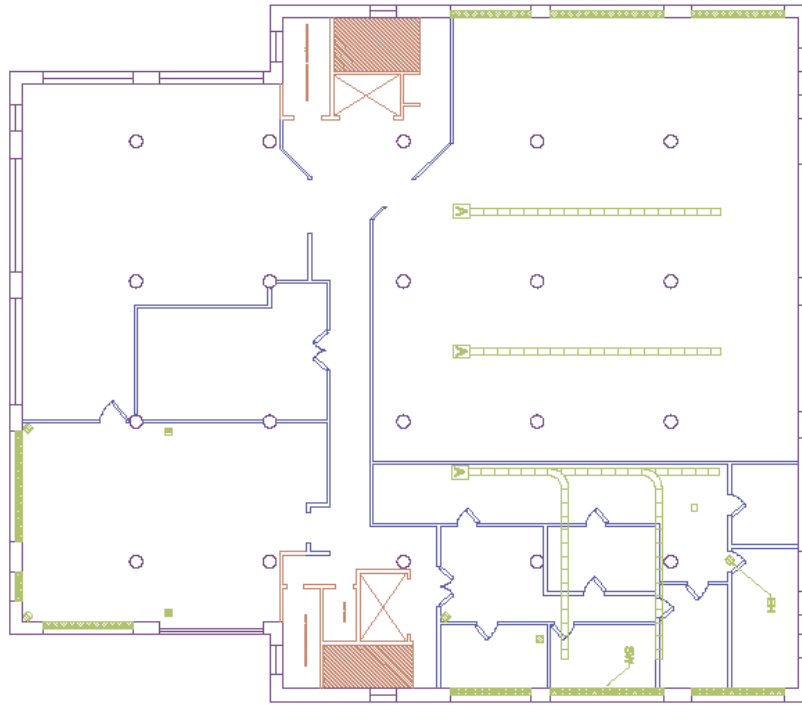
Figure 8. Seventh Floor Plan with HVAC

As part of the audit it was extremely important to map the locations of some of the essential systems in the building, like the HVAC units and ductwork. The only floor plan that could be obtained was those from 1923, and even then, they only displayed the exterior walls of the building. Since no interior floor plans could be found, and since such things could not be determined if they even existed, the group created CAD drawings that served as blueprints of the building. These drawings contain layers, each one containing different information such as HVAC systems, conditioned/unconditioned space, and include a breakdown of the floor space by usage. They also map the location of storm windows within the building, or where the windows have been boarded up (see Figure 8).

These floor plans provide an easy way to calculate the exact percentage of warehouse space versus the percentage of conditioned space. Each floor is drawn separately and has all the offices and rooms represented so that it is easy to calculate the square footage of the conditioned or unconditioned space of the Printer's Building. We input those figures into computer models which analyze a building based on usage types, to determine if the space is efficient or not.

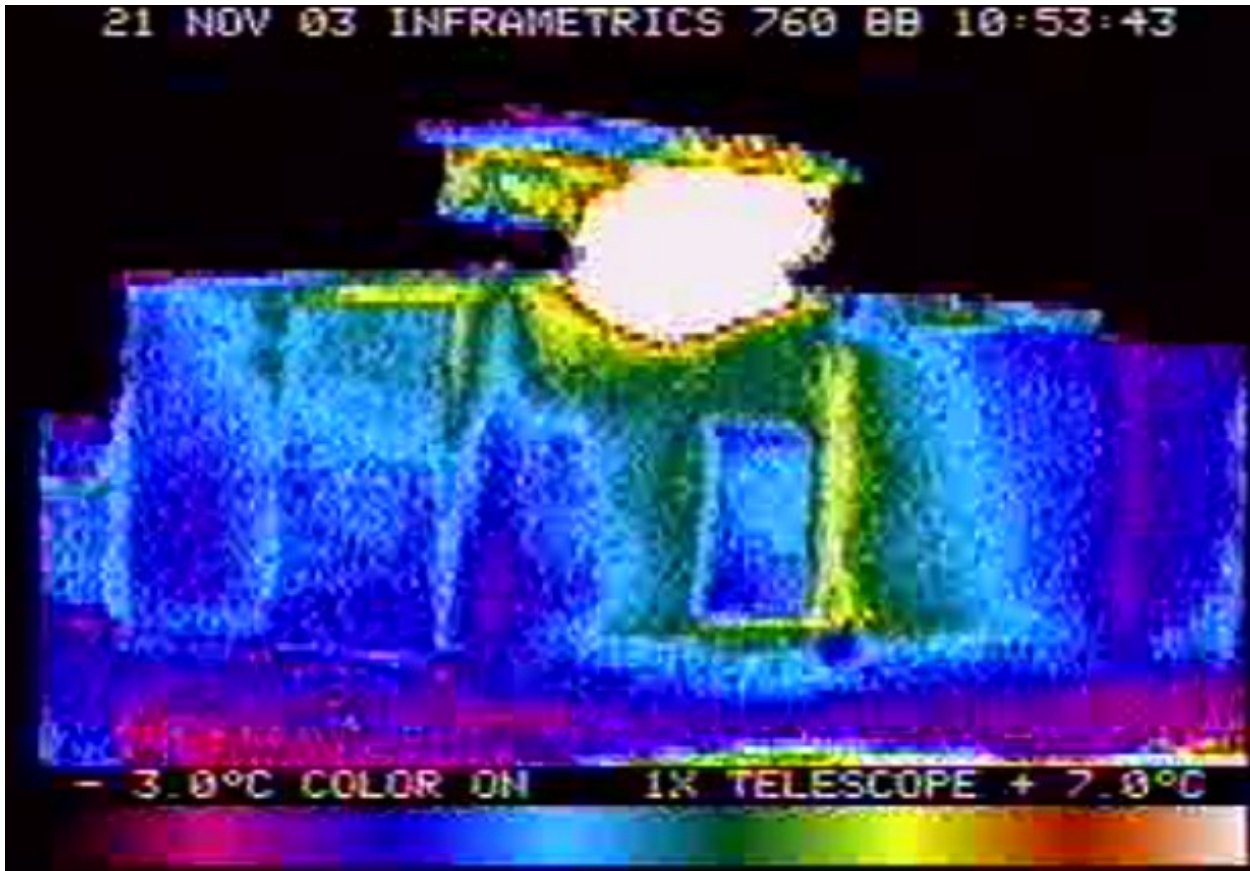
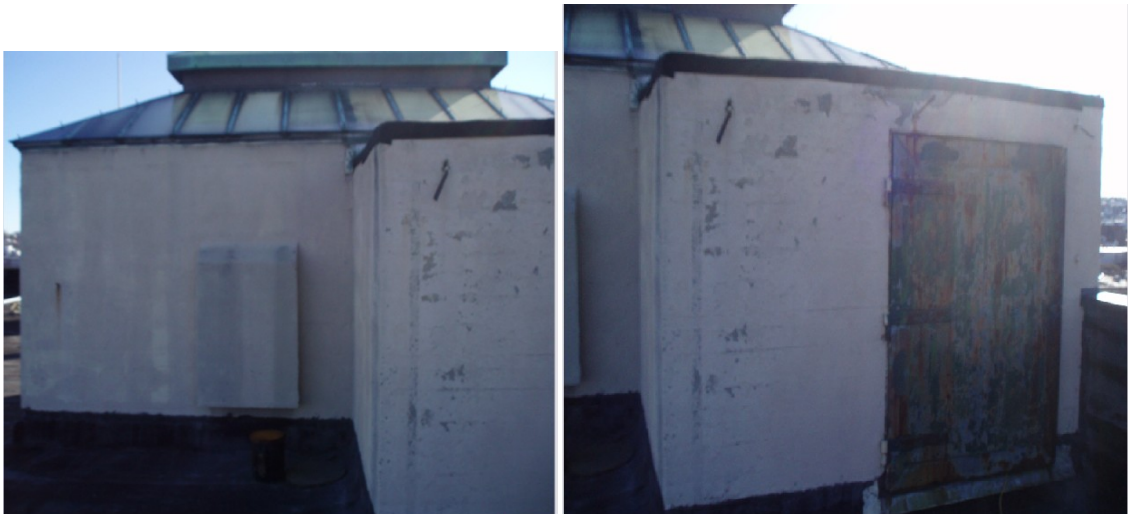
The roof's heat readings were lower than what the group initially anticipated them to be, but were still significant. One area on the roof that lost large amounts of heat was at the top of the elevator shafts.

Figure 10a. Thermal Image of the Service Elevator Shaft

Figures 10b & 10c. Photos of Service Elevator Shaft

Photographs in Figures 10a, 10b and 10c were taken upon the roof of the building, looking at the service elevator shaft. There is no clear picture of 10a, so 10b and 10c are compilations of the elevator shaft from two different angles. The large brighter colored area near the door in Figure 10a shows that a significant amount of heat is escaping, which is also true at the top of the elevator shaft. The sun, heating the glass, could cause the white coloring that appears in Figure 10a. It is a mostly shaded area, however, so we believe it is mainly due to escaping heat.

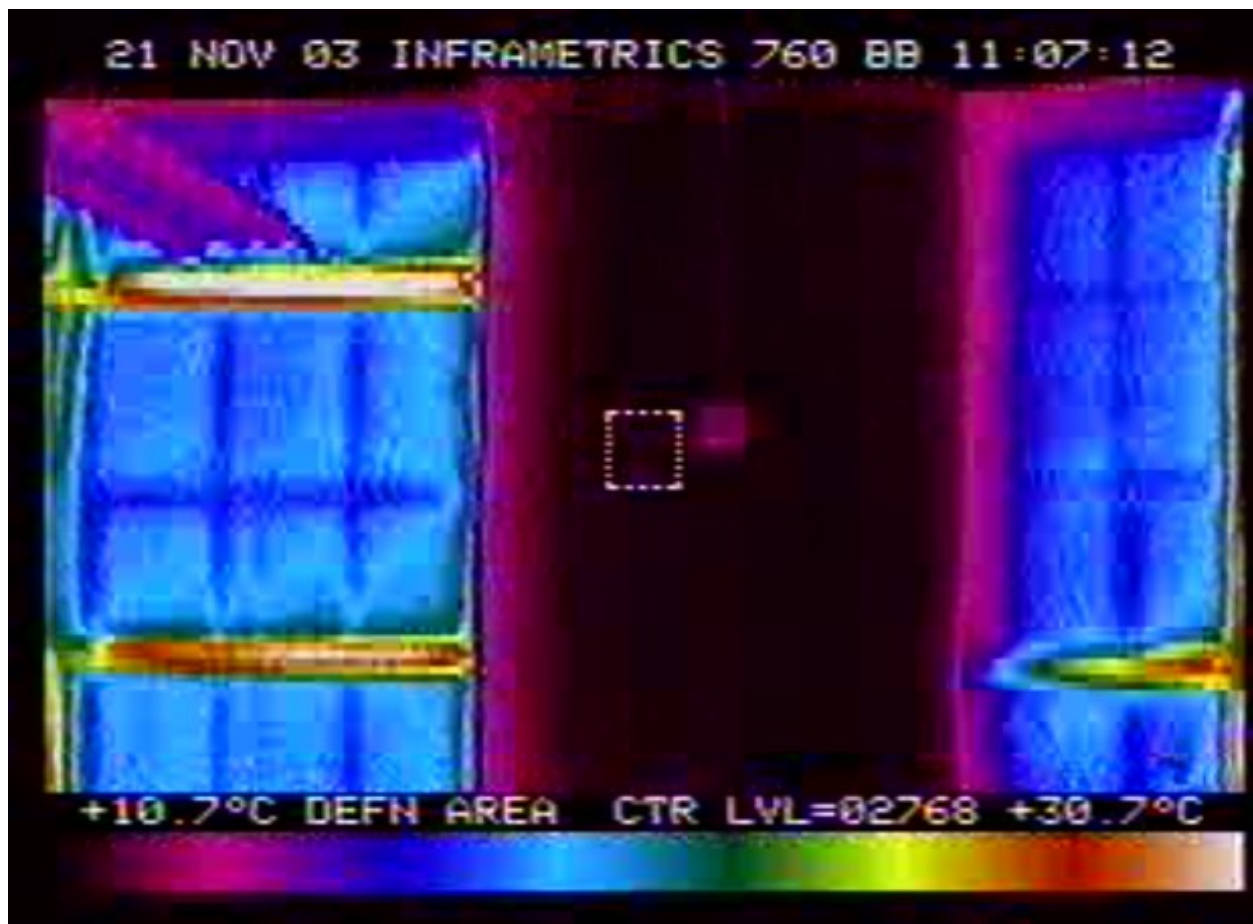
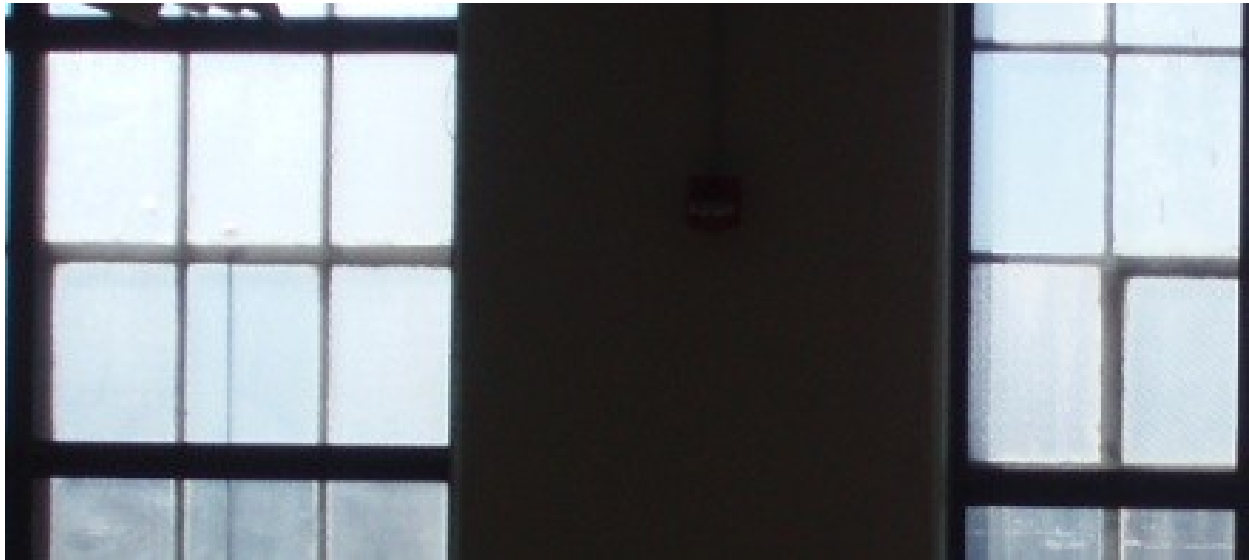
Figure 11a. Seventh Floor Warehouse Thermal Image

Figure 11b. Photograph of Seventh Floor Warehouse

Photographs in Figures 11a and 11b were taken in the 7th floor warehouse, on the south side. These windows featured storm window overlays. The interior temperature was 15 °C. The metal is usually colder than the windows; however, in this case, the metal frames were hotter due to the sun's radiance upon them. This picture also demonstrates how effective the storm windows are, since the thermal energy of the sun is not being easily transmitted (reference Figure 13). Despite the sun, the concrete remained cold, since it was transmitting the outside temperature inwards (and therefore radiating heat outside very fast).

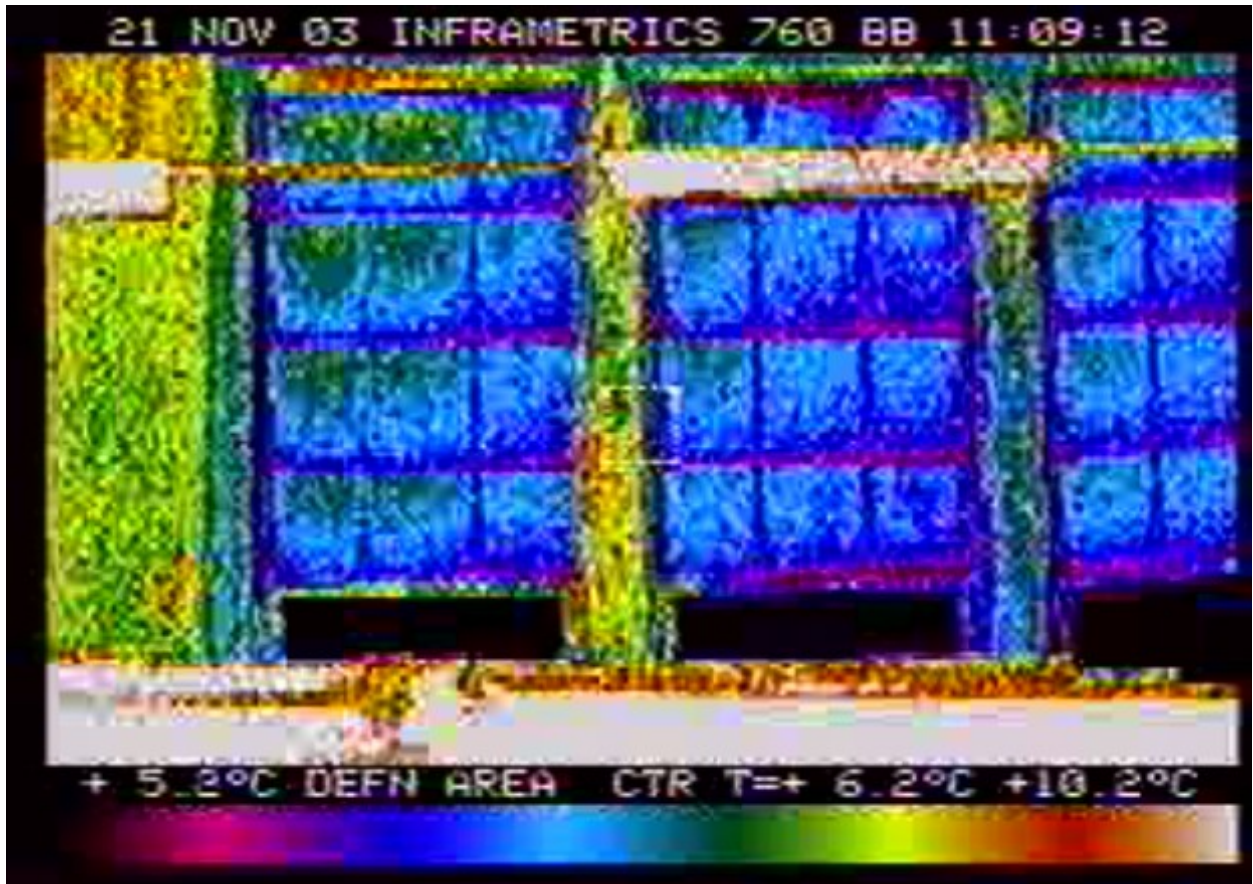
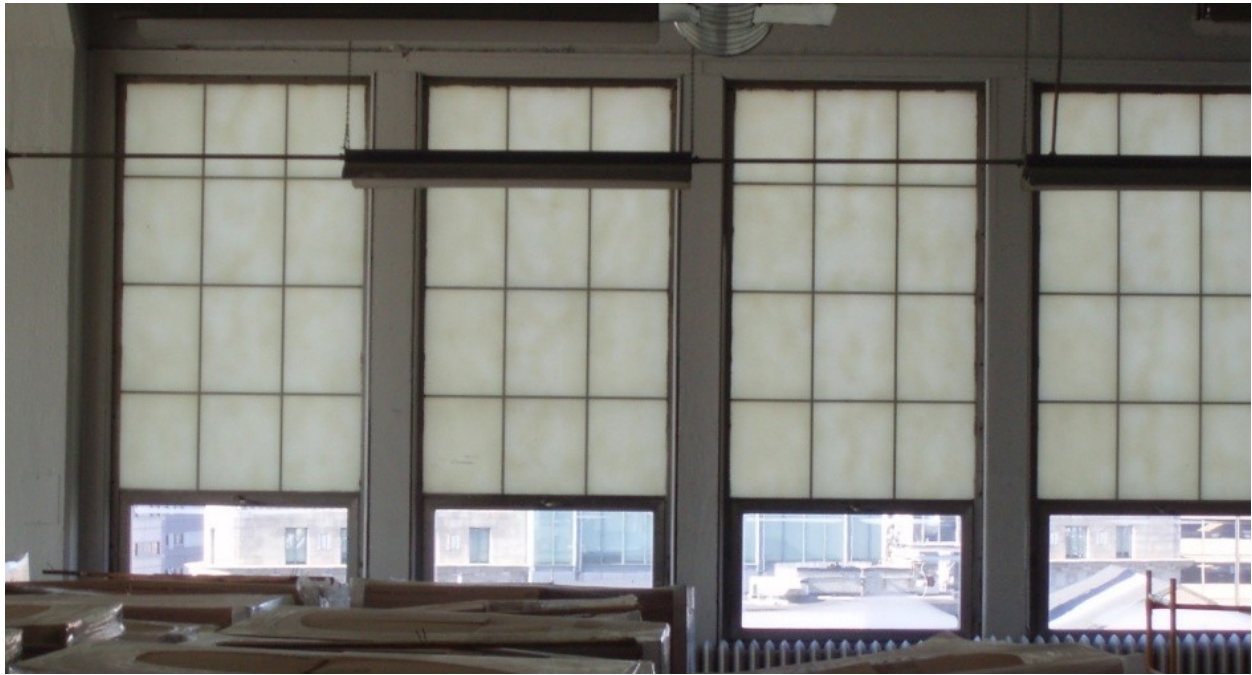
Figure 12a. Glazed Window on Seventh Floor Thermal Image

Figure 12b. Photograph of Glazed Window on Seventh Floor

We also inspected the glazed windows on the 7th floor, as seen in Figure 12, in the same room as the Figure 11. However, these windows were in the shade, which is why they are shown to be much colder, both in the metal frames and the panes themselves. This side would be a top priority for window shades or other treatments. The concrete was about the same temperature as the prior pictures, as expected.

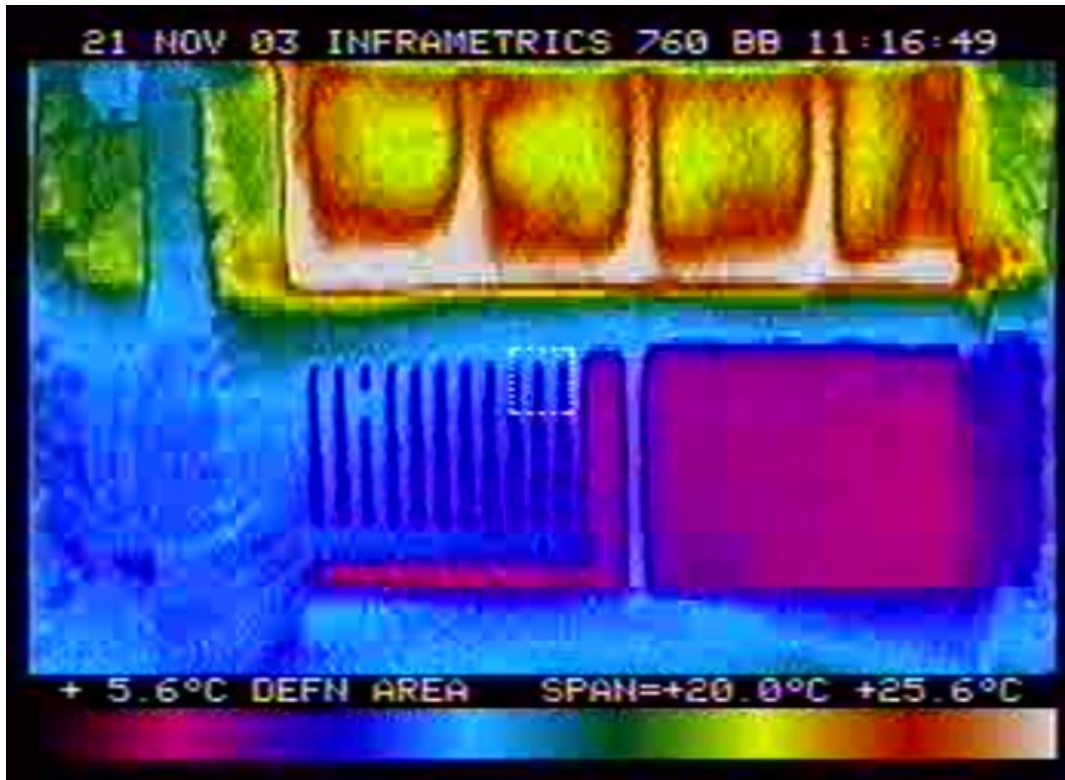
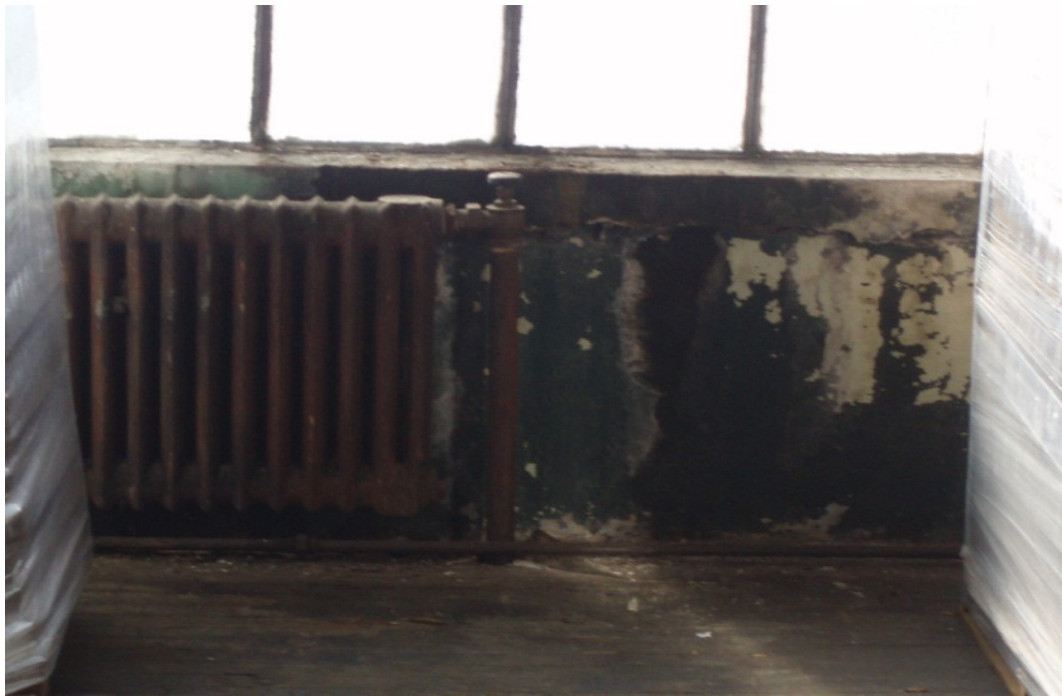
Figure 13a. Thermal Image of Seventh Floor Window without Storm Window

Figure 13b. Photograph, Seventh Floor Window without Storm Window

Like the two preceding figures, Figure 13 was from the 7th floor warehouse, except it was taken on the opposite side of the elevator shaft, within the smaller room. The characteristics of this window are similar to Figure 11 because the sun was also heating these windows. However, they do not have storm windows, which is why they were much warmer. Along with keeping cold air from entering, storm windows can also limit the flow of solar heating.

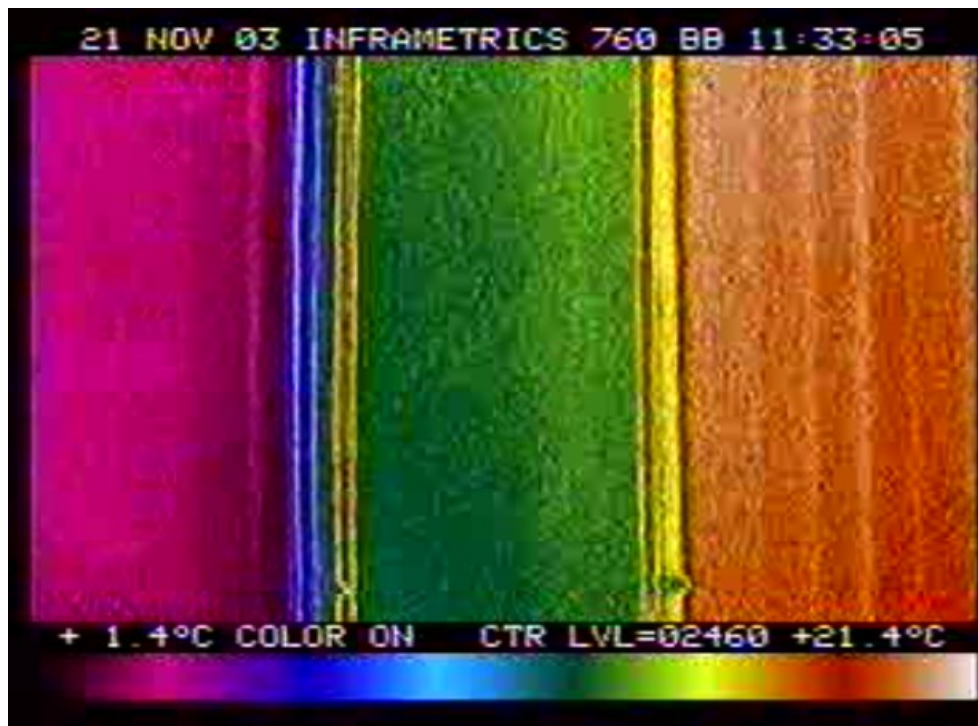
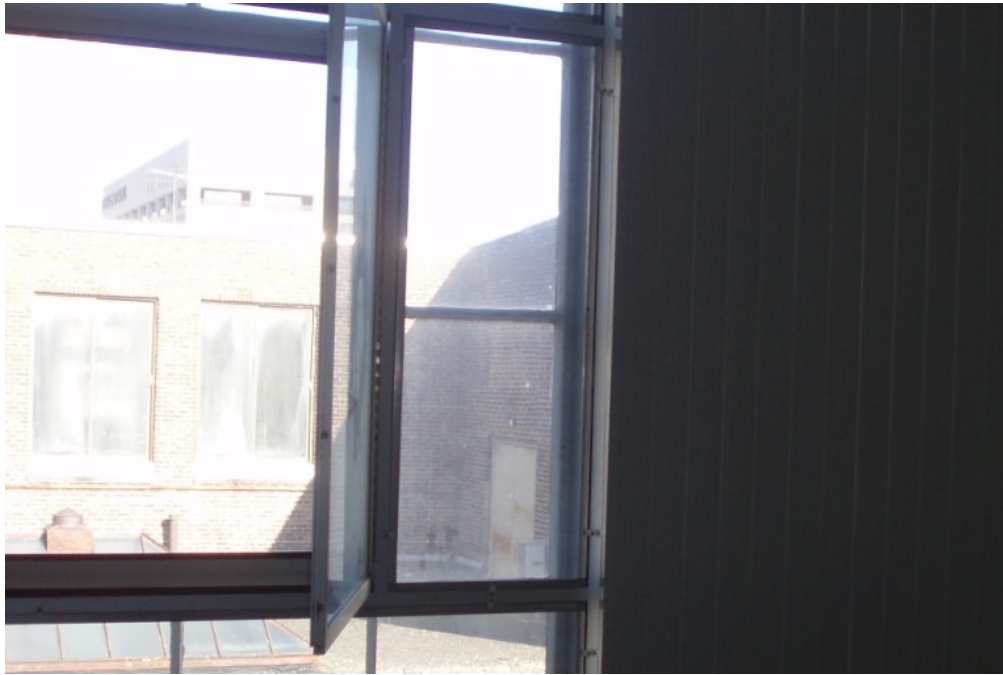
Figure 14a. Thermal Image of Regular Window, Storm Window, and Blinds

Figure 14b. Photograph of Regular Window, Storm Window, and Blinds

Figure 14 was one of the most influential pictures we took. It was taken in Mr. Wade's office, and demonstrates the heat-retaining ability between shades (dark part of photo), storm windows, and regular single-paned windows. The temperature of the room was 21.4 °C, which was almost the exact temperature of the combination shades and storm windows (far right of Figure 14b). This shows that both blinds and storm windows are incredibly effective at retaining heat, as compared to regular windows.

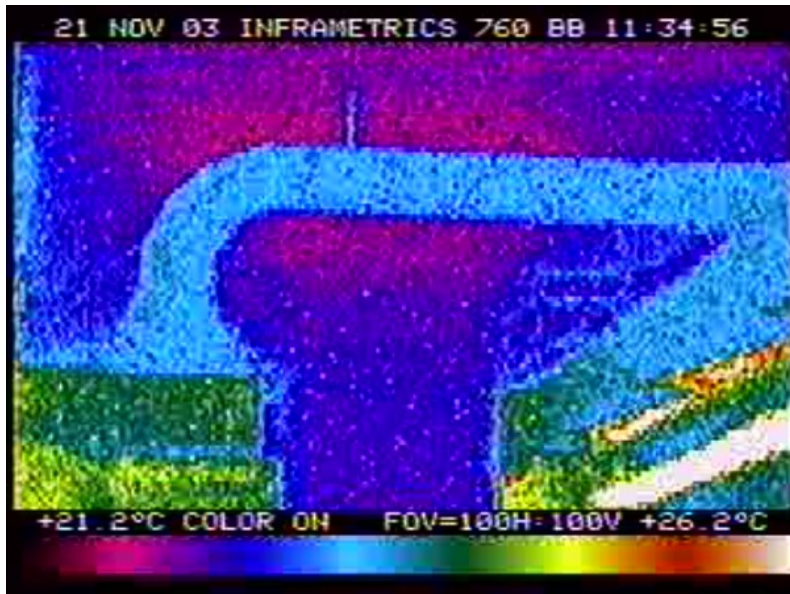
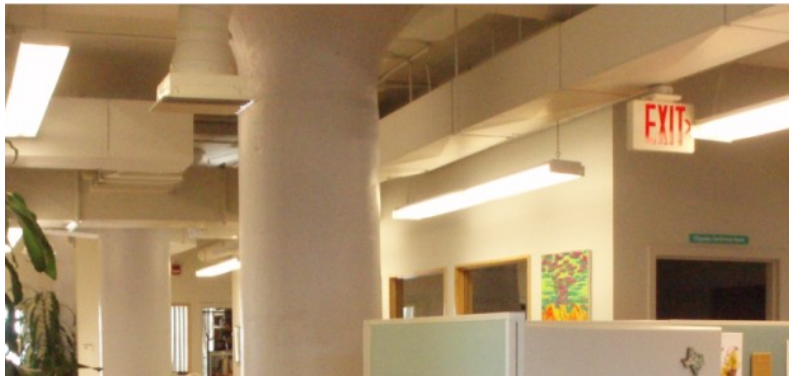
Figure 15a. Thermal Image of Ductwork in Davis Publications

Figure 15b. Photograph of Ductwork in Davis Publications

We took the image in Figure 15 to determine if there was a significant amount of leakage within the HVAC ductwork. These pictures demonstrate that there is very little leakage (since the pipes are so cold although they are moving warm air). This is beneficial because leaking ductwork will greatly reduce the efficiency of HVAC units, and since there is little leakage, we do not have to recommend insulating the ductwork.

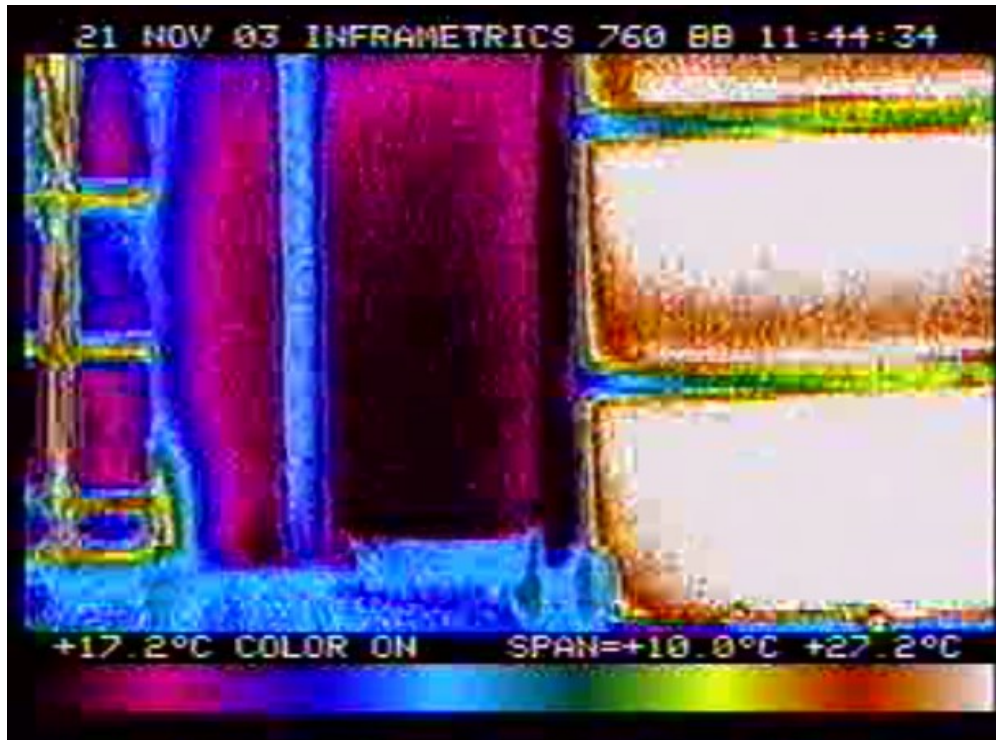
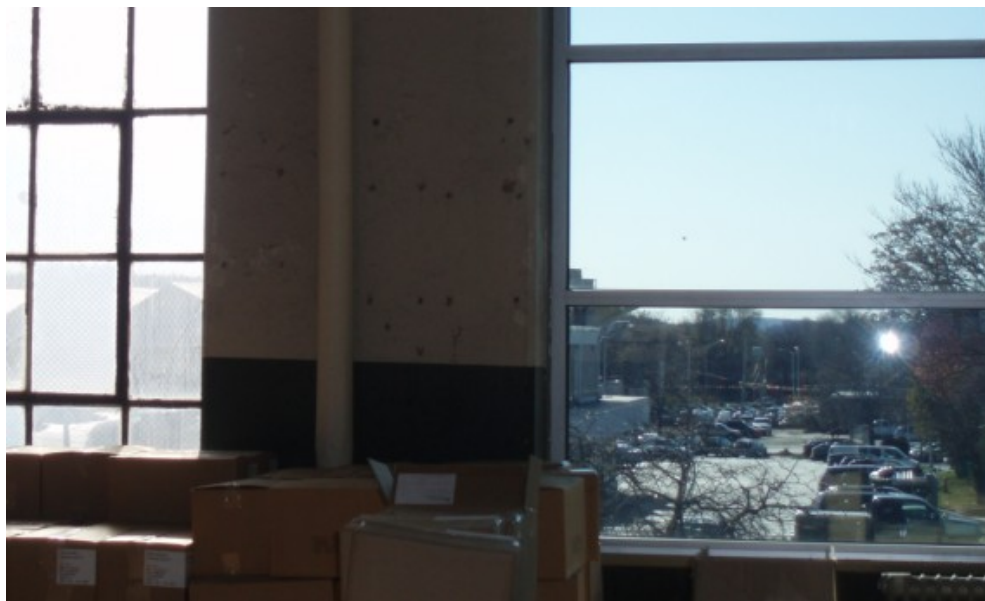
Figure 16a. Thermal Image of Second Floor New Window and Adjacent Old Window

Figure 16b. Photograph of Second Floor New Window and Adjacent Old Window

Figure 16 shows a replacement window, newly installed on the second floor. It is located on the right side of Figures 16a and 16b. The building owner chose this window earlier in the year, to use as a replacement throughout the whole building. Figure 16a demonstrates that the new window retains a significantly larger amount of heat than the old window, and is therefore very efficient. It was warmed throughout the day due to solar glare, and the photo was taken in sunlight, but as the sun receded, it did not lose nearly as much heat to the outside environment as the old window.

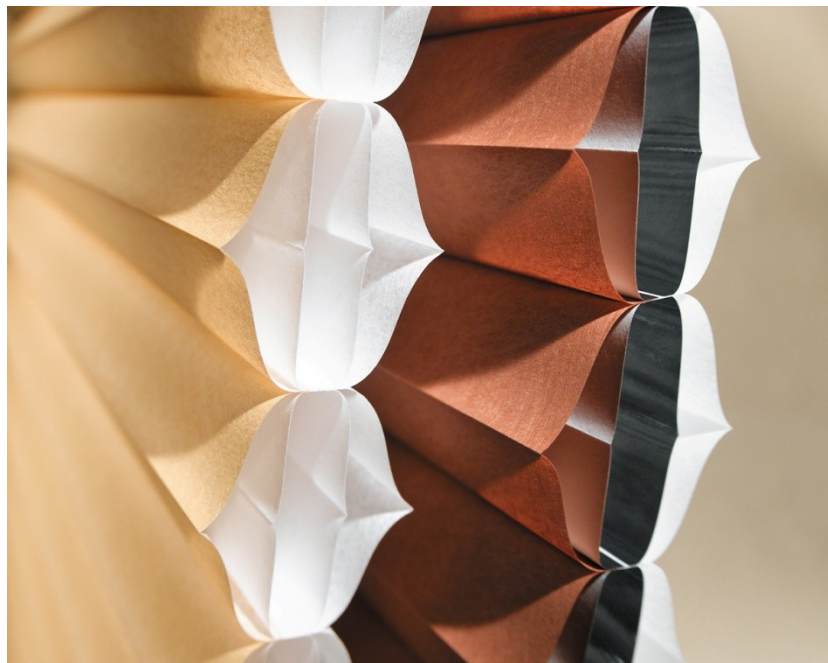
Figure 17. Cell/Honeycomb Shades (Rocky Mountain Shades, 2007)

There is one type of shade, however, that can both insulate the interior and allow natural lighting to enter the building. This type of covering is called a “cell” shade, and it is a simple and cheaper alternative for window insulation. The concept of this blind is that a window-wide “cell” is created when the shade is extended, trapping and controlling airflow between the conditioned interior and the unheated exterior (Blinds, 2008). These cells are similar in concept to a skiing jacket or a bed comforter, where they use a pocket of neutral air that possesses high resistance to energy transference, to insulate from the surrounding environment. These cells can be arrayed both vertically and horizontally, allowing it to cover the entire window, and increase the isolative properties (re. Figure 17) (Blinds, 2008).

Although these shades are not terribly inexpensive, they can be cheaper than even window film, since they are made of basic materials and have an established, streamlined production method. For example, a basic cellular, light-filtering shade can cost around \$215 for a 7'x7' blind (Blinds, 2008). However, an advanced film can cost as much as \$588 for the same area coverage (Conrad, 2008). Another positive is that, while not transparent, they still allow a higher percentage of natural lighting to enter the facility, so that a lesser quantity of electric lights can be used to maintain proper visible conditions. These shades are indeed not as efficient or applicable as a film, but they are more useful within the Printer's Building due to their portability and removability. These coverings can be installed on any older window within the structure, be removed during new window installation, and then be re-installed on the new openings without affecting their operability. They can be utilized when the window is replaced without having to re-cut or re-measure, and that makes them incredibly more cost effective than a window film.

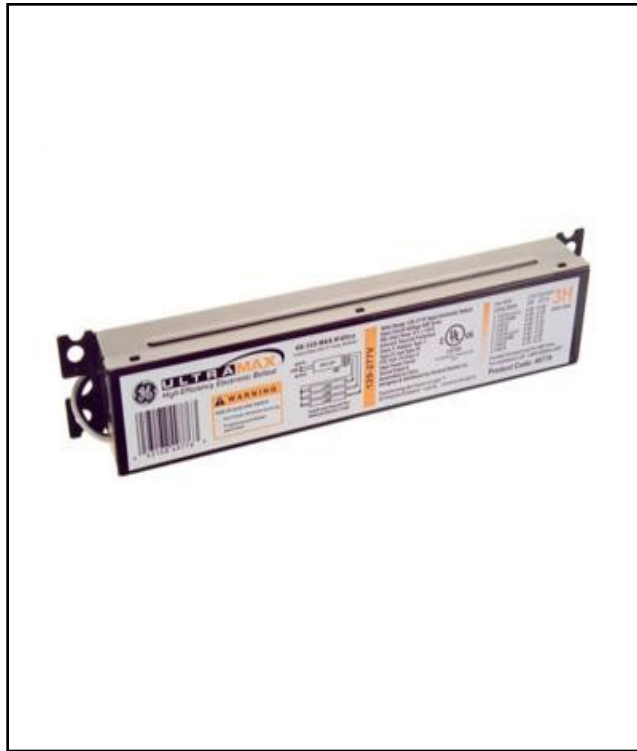
Figure 18. GE UltraMax Ballast (General Electric, 2008)

With hundreds of overhead fluorescent lights with magnetic ballasts throughout the building there is a large opportunity to save money. Newer electronic ballasts for fluorescent lights like GE's high-efficiency UltraMax™ Ballast, shown in Figure 17, are up to 90% more efficient than the antique magnetic ballasts found in the Printer's Building, and 40% more efficient than standard electronic ballast systems (General Electric, 2008). We can see the opportunity for savings by replacing the ballasts for lights that are used frequently in the office or conditioned spaces within the building.

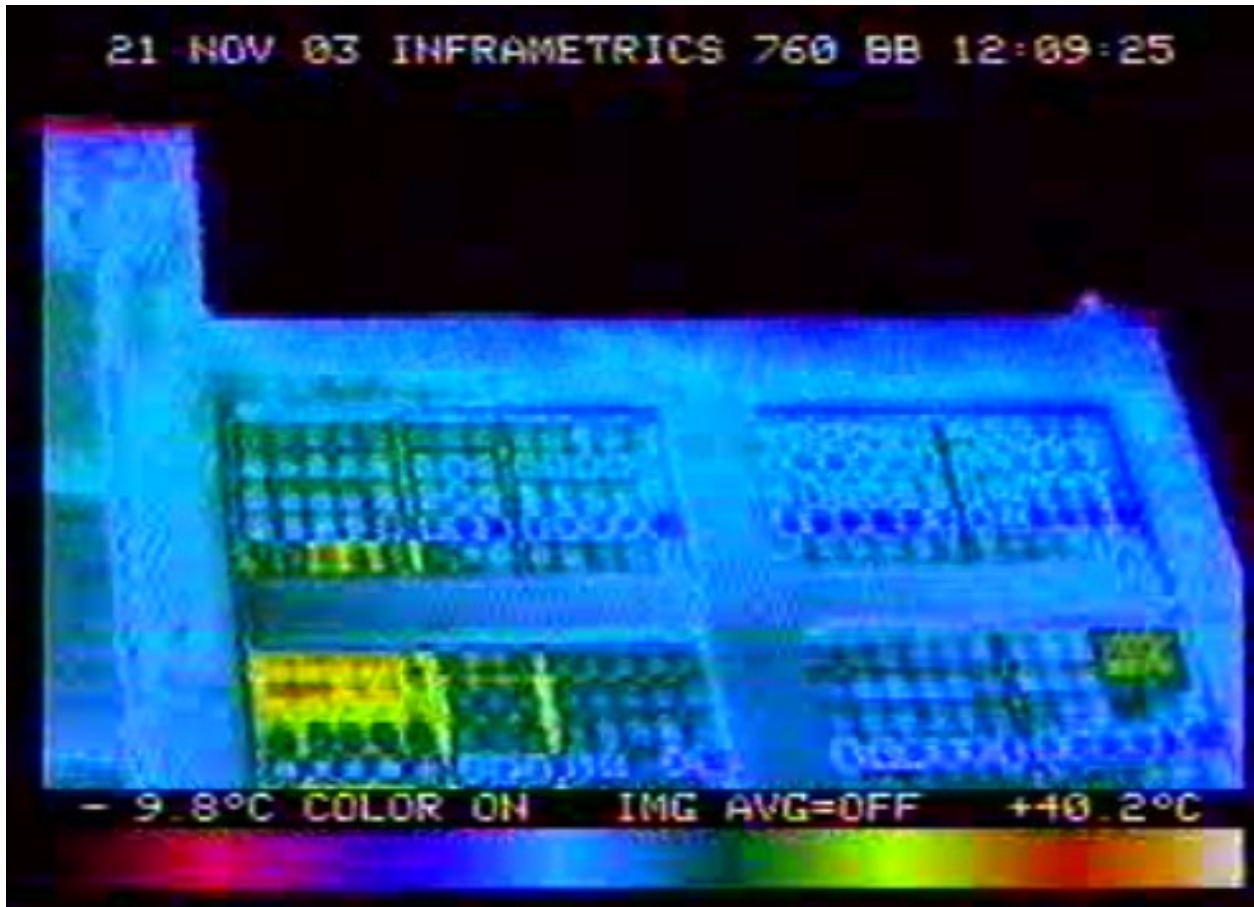
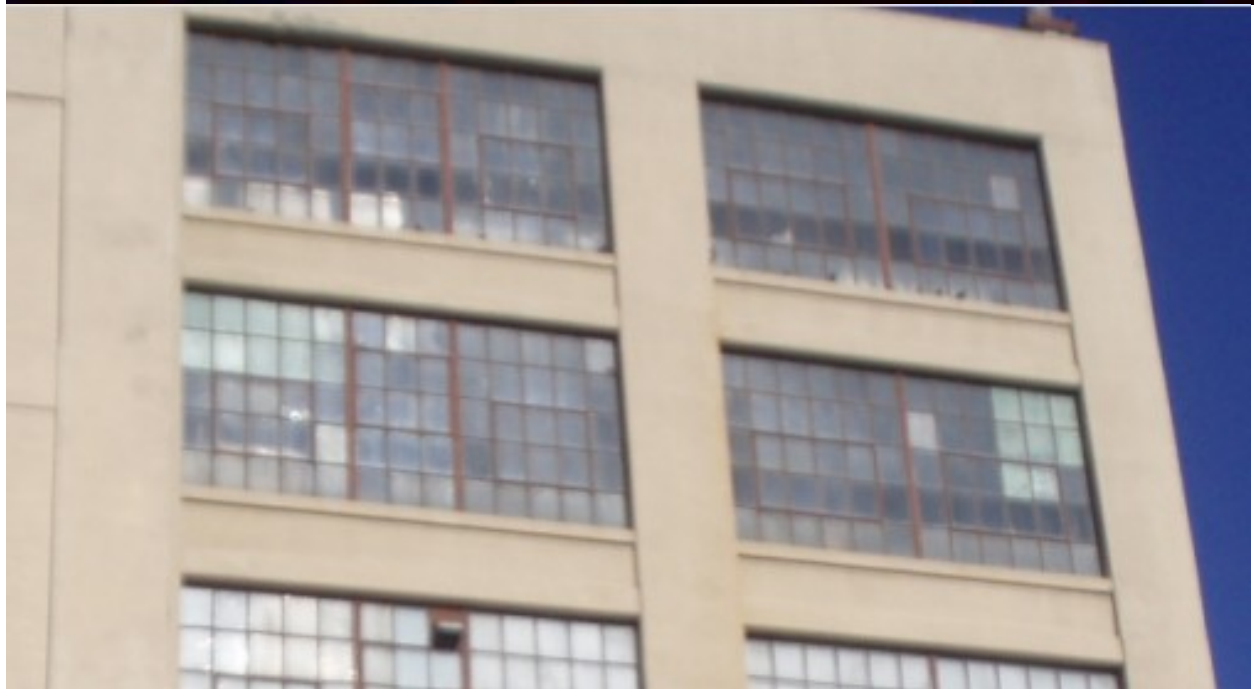
All images contained in this appendix were taken from the south-west outside of the Printer's Building.
