Grand Trunk Trail & Riverlands Revitalization: Trail & Pedestrian Bridge Design

A Technical Memorandum Submitted to the Town of Sturbridge

03.06.2020

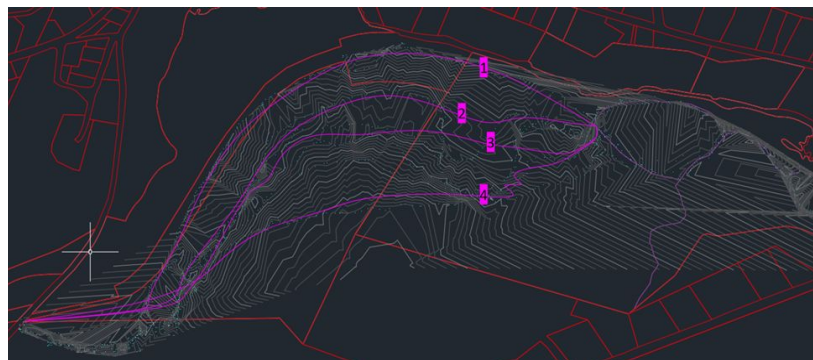
Figure A: Delineation Options

Multiple delineations (shown in Figure A) were created based on the surface in Civil 3D and the contour maps from the Town. Factors that limited alternate trail locations included existing grades, property boundaries, and environmental concerns. Once potential delineations were chosen, site visits verified that the options were free of large obstacles or drainage concerns.

Considering the importance of sustainability and minimizing environmental impact, it was decided that option four would be best, due to having the least interaction with stormwater and wetland areas, as well as providing hikers with a pleasant aesthetic view of the forest.

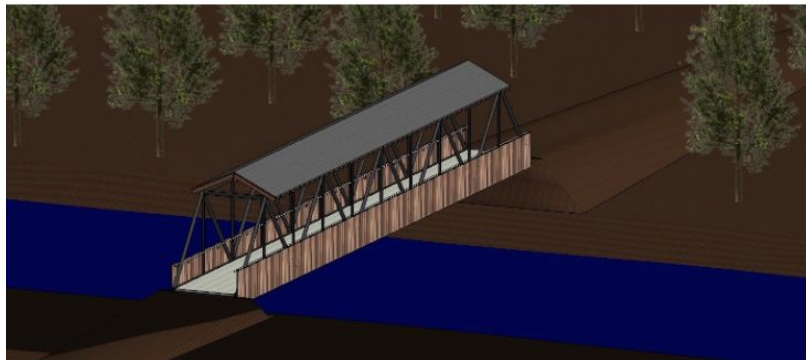
Figure G: Three-Dimensional Rendering of Pedestrian Bridge

The superstructure design consists of a truss on either side of the bridge, concrete deck as a walking surface, floor and roof beams to support the deck and resist horizontal wind loads, a roof truss system to cover the bridge's users, and a wooden siding to maintain the aesthetic of the Town's historic environment. A rendering of this design can be seen in Figure G. The trusses were designed using steel tube sections to resist loads specified in the *LRFD Guide Specifications for the Design of Pedestrian Bridges*. A prestressed, precast deck system is used in the design to carry the pedestrians that will be using the bridge. The deck system will be placed on floor beams that are also designed as steel tube sections, and will carry the load of the deck and pedestrians on the bridge. The floor and roof beams were designed to resist horizontal wind loads and will limit the horizontal deflection of the bridge in extreme wind situations. The roof truss system was designed to resist expected snow loads and will protect the bridge users from the elements. The roof consists of a wooden truss to be placed along the top chords of the bridge and consists of an asphalt shingle finish. The siding along the outside consists of reclaimed barn lumber. The use of reclaimed lumber is beneficial for the environment as it reduces the consumption of new timber and reduces landfill waste, while complementing the historic aesthetic of the Sturbridge area. Connections for the superstructure were also designed to hold together all of its components.
