An Analysis of Cyanobacteria Harmful Algal Blooms in Massachusetts and Methods of Prevention & Event Response

**An Interactive Qualifying Project Report
Submitted to the Faculty of the Worcester Polytechnic Institute
In partial fulfillment of the requirements for the
Degree of Bachelor of Science by:**

Project Advisor: Professor Tuler
Sponsor: Massachusetts Department of Environmental Protection

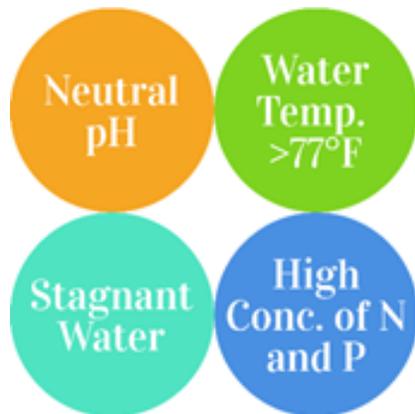
Figure 1. Infographic of Factors Which Contribute to CyanoHAB Development.

The usage of land in the region surrounding a PWS's surface water source is an important factor in CyanoHABs development. If the watershed has large amounts of suburban areas and farmlands, the site is at an increased risk of nutrient loading. In agricultural areas, use of fertilizers containing phosphorous and nitrogen in addition to manure are the main culprit in spurring cyanobacteria blooms (Beaton et al., 2018). Meanwhile in suburban areas, as more land is developed and replaced with impermeable surfaces, runoff can collect debris and pollutants including fertilizers which runoff into water sources.

In addition to land usage, cyanobacteria growth also relies on environmental conditions that are becoming more common due to climate change. The increasing ambient temperatures due to climate change allows water bodies to reach higher water temperatures, especially at the surface (Backet et al., 2013). This condition favors surface bloom-forming cyanobacteria as they are adapted to water temperatures in excess of 25°C or 77°F (Paerl, 2013). Additionally, climate change is also causing an increase in precipitation (IPCC, 2011). Elevated amounts of precipitation can increase the previously mentioned amount of runoff entering the water body from the surrounding areas. When natural filtration does not occur, this runoff can be rich in nitrogen and phosphorus further promoting cyanoHAB development (Paerl, 2013).

Further, environmental characteristics such as neutral pH levels and stagnant water also promote CyanoHAB growth (K. Divris, personal communication, September 2019). Higher residency times, the amount of time that the water stays in the water body, allows nutrients to accumulate and allows the water body to be warmed more easily (G. Zoto, personal communication, September 16, 2019). Certain cyanobacteria species, such as *Anabaena* and *Microcystis*, can exploit these advantages by relocating themselves in the water column to a location with optimal levels of nutrients, temperature, and sunlight (WHO, 2016).

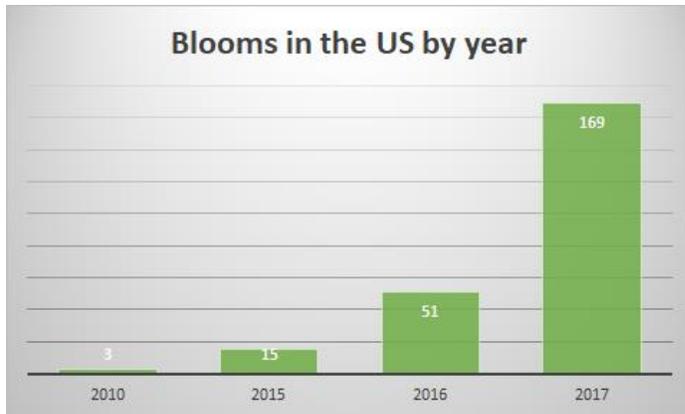
Figure 2. The Number of Reported Cyanobacteria Blooms for Selected Years. Note. From *The Algal Bloom Poisoning U.S. Lakes Tripled in Number Last Year*, New Food Economy

In part due to climate change, land usage, and environmental characteristics, harmful algal bloom reports have significantly increased in frequency during the past decade in the United States (Brown, 2018). As shown in Figure 2, in 2010, there were only 3 total reports, in 2015 there were 15 reports, in 2016 there were 51 reports, and in 2017 their amount was tripled to 169 blooms in the US (Walker & Wathen, 2018). Cyanobacteria most commonly occurs during late summer or early fall, as the conditions are the most amenable to rapid cyanobacterial reproduction.

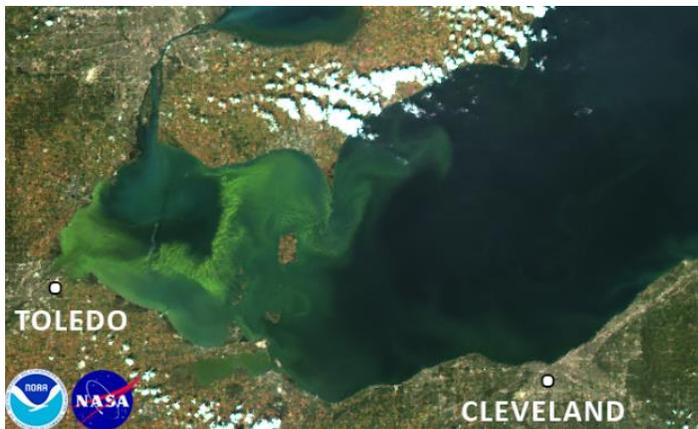
Figure 3. Satellite Image of an Algal Bloom Event in Lake Erie, September 29, 2014. Note. From NOAA

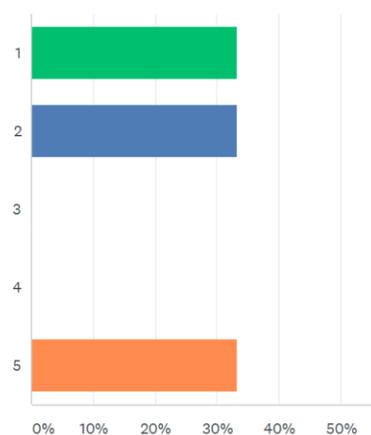
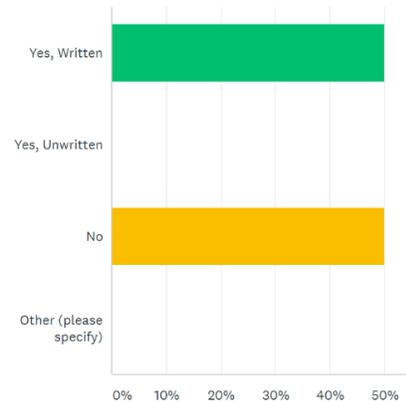
Figure 5. Results from PWS Survey for Questions 1 & 2.

Seen in the left side of Figure 5, only two of the four respondents indicated they are at a level “one” or “two” for concern over cyanobacteria. These two respondents also indicated they have no algal monitoring plan at all. However, PWSs who indicated they are at a “five” for concern, has a written algal monitoring plan in place. Our final respondent preferred not to indicate their concern level but chose to indicate they have a written algal monitoring plan.

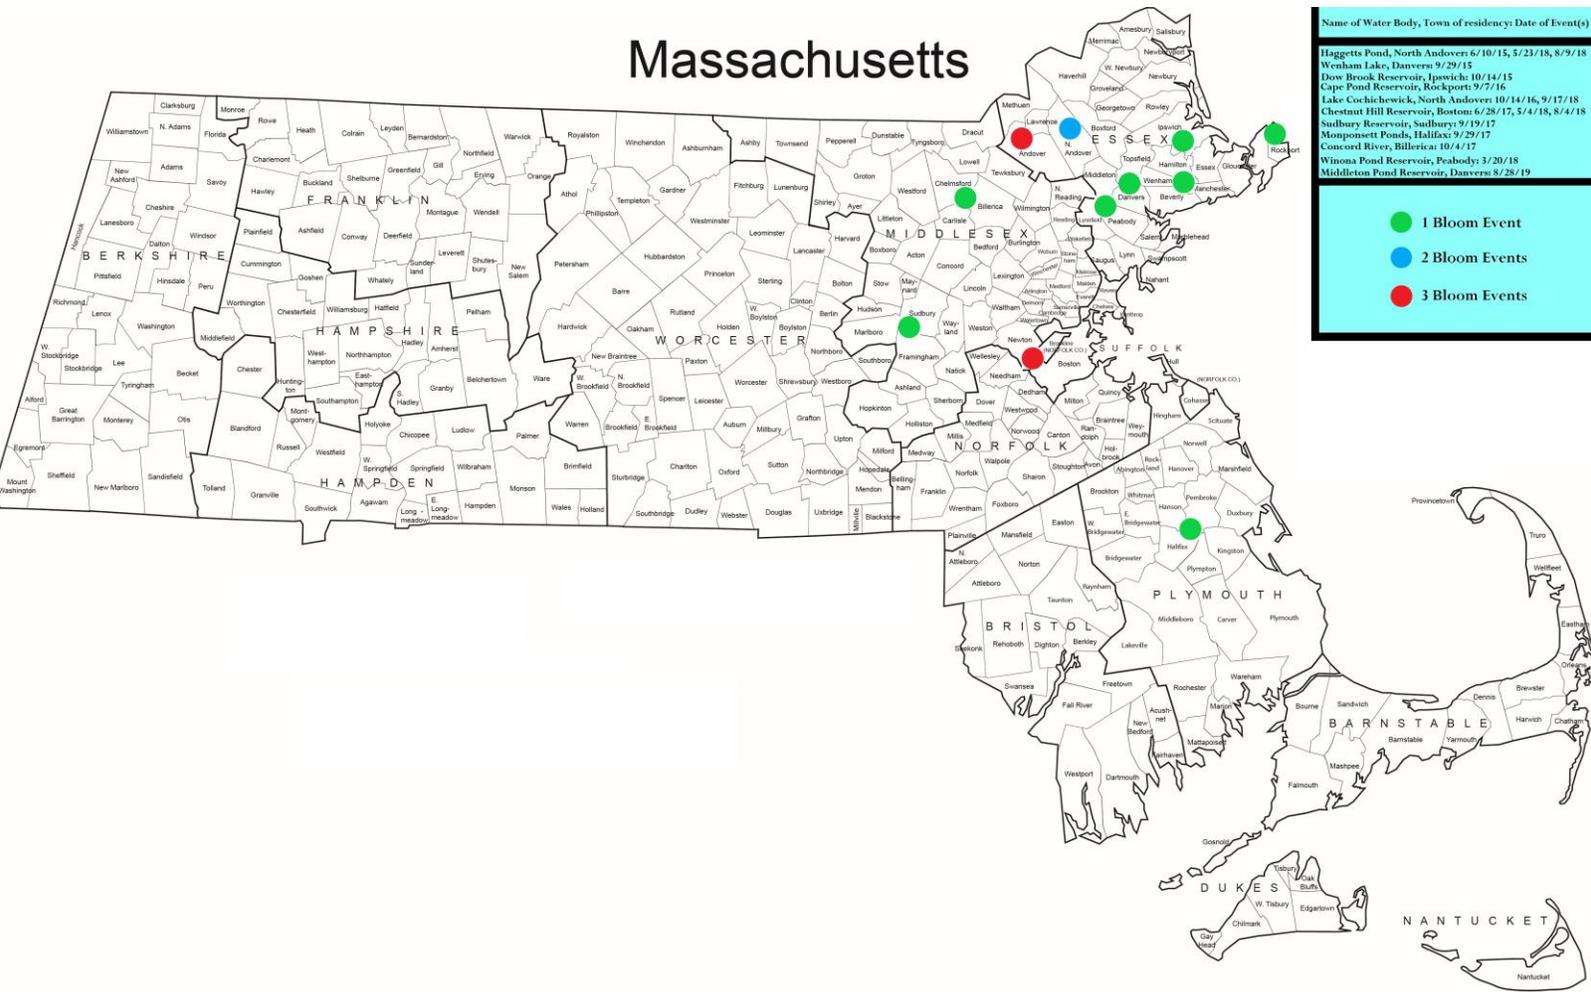
Name of Water Body, Town of residency	Date of Event(s)
Haggets Pond, North Andover	6/10/15, 5/23/18, 8/9/18
Wenham Lake, Danvers	9/29/15
Dow Brook Reservoir, Ipswich	10/14/15
Cape Pond Reservoir, Rockport	9/7/16
Lake Cochichewick, North Andover	10/14/16, 9/17/18
Chestnut Hill Reservoir, Boston	6/28/17, 5/4/18, 8/4/18
Sudbury Reservoir, Sudbury	9/19/17
Momponset Ponds, Halifax	9/29/17
Concord River, Billerica	10/4/17
Winona Pond Reservoir, Peabody	3/20/18
Middleton Pond Reservoir, Danvers	8/28/19

- 1 Bloom Event
- 2 Bloom Events
- 3 Bloom Events

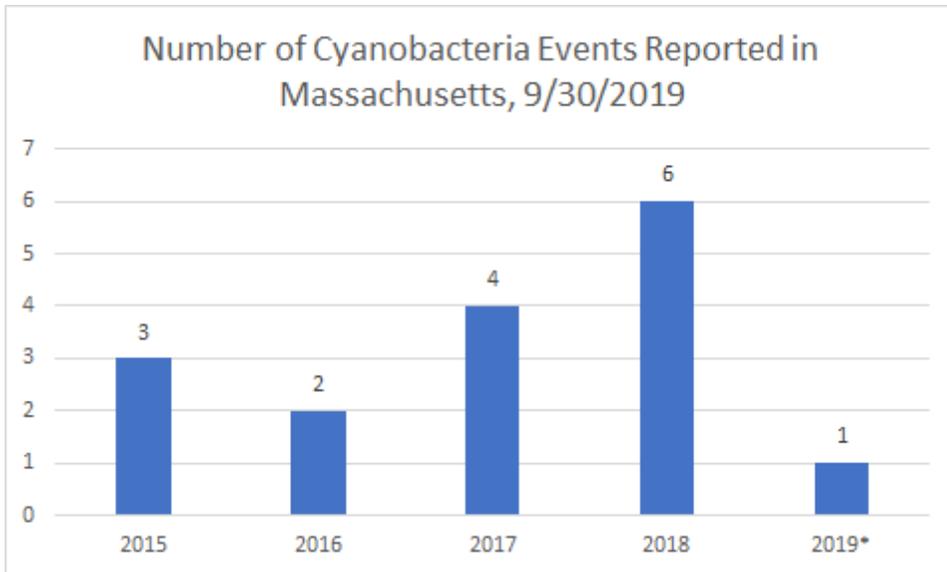
Figure 6. A Chart of Reported Cyanobacteria Events in Massachusetts since 2015

The annual distribution of reported bloom events in drinking water sources in Massachusetts, as seen in Figure 1, does not show any trends that indicate an increase in reports year over year. The statistical variance isn't significant enough, nor are there enough data points to make a claim that they are becoming more frequent in the commonwealth of Massachusetts. This does not support or contrast the common belief that cyanobacteria blooms are becoming more common due to changing environmental factors, as no strong conclusions can be drawn from this data set.
