Self-Healing Coatings for Steel-Reinforced Infrastructure

A Major Qualifying Project
Submitted to the Faculty of
Worcester Polytechnic Institute
in partial fulfillment of the requirements for the
Degree in Bachelor of Science
in
Chemical Engineering
Civil Engineering
By

Date: 3/25/15

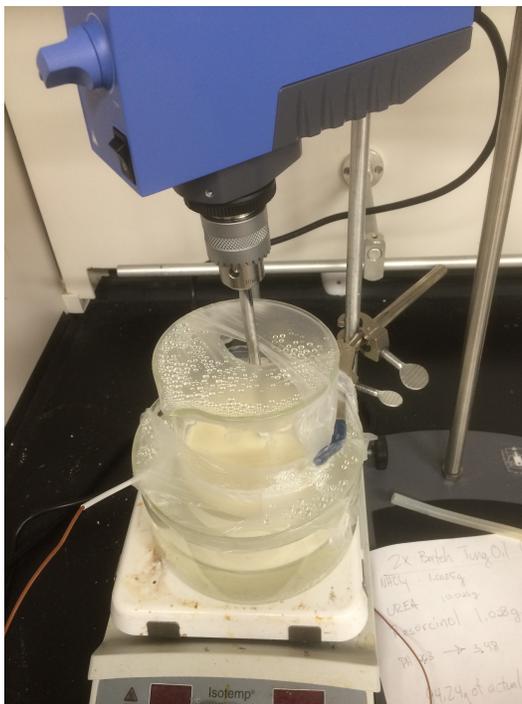
Figure 1: Setup for microcapsule synthesis

At room temperature, 200 mL of deionized water, 25 mL of 2.5 wt.% EMA solution, 0.5 g of resorcinol, 0.5 g of ammonium chloride, and 5 g of urea were mixed fully in a 500 mL beaker. Following this, the pH of the solution was adjusted from 2.7 to 3.5 using dilute sodium hydroxide solution in order to control the morphology of the polymer shells. This solution was placed into a room temperature water bath and kept stirring at 400 rpm as 50 mL of tung oil was slowly added into the solution. The resulting mixture was mechanically stirred at 400 rpm for 10 minutes to form a stabilized emulsion, after which 13 g of 37 wt.% formaldehyde solution was added. The temperature of the solution was raised to 60 °C for 4 hours at 400 rpm to facilitate the polymerization reaction between urea and formaldehyde. The solution was then removed from the oil bath and stirred as it cooled to room temperature over 6 hours. To extract the microcapsules, the mixture was vacuum filtered with coarse filter paper, then washed twice with deionized water and twice with acetone, respectively. Finally, the

microcapsules were air-dried for 48 hours before they could be used. The setup was as shown below.

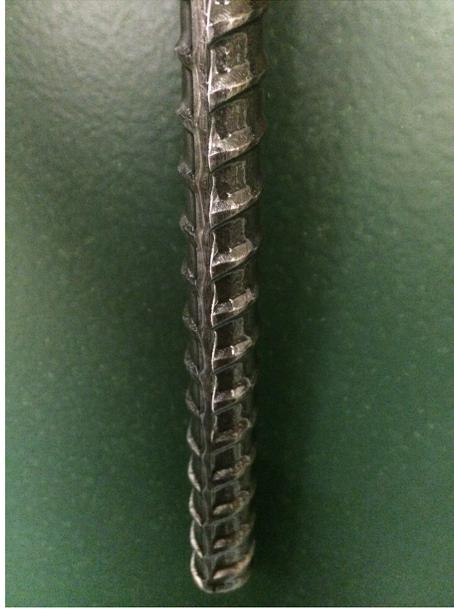
Figure 2: The cut made on rebar coatings

12'' rebar for lollipop samples and 36'' rebar for pullout samples were cleaned and dip-coated. The coatings were then allowed to cure for 72 hours at room temperature before being encased in a concrete sample. Damaged rebar samples were made by using a utility knife to make a 3-inch cut in the unmodified epoxy coating as well as the experimental coatings. This cut was 1-inch from the bottom of the rebar, as shown below.

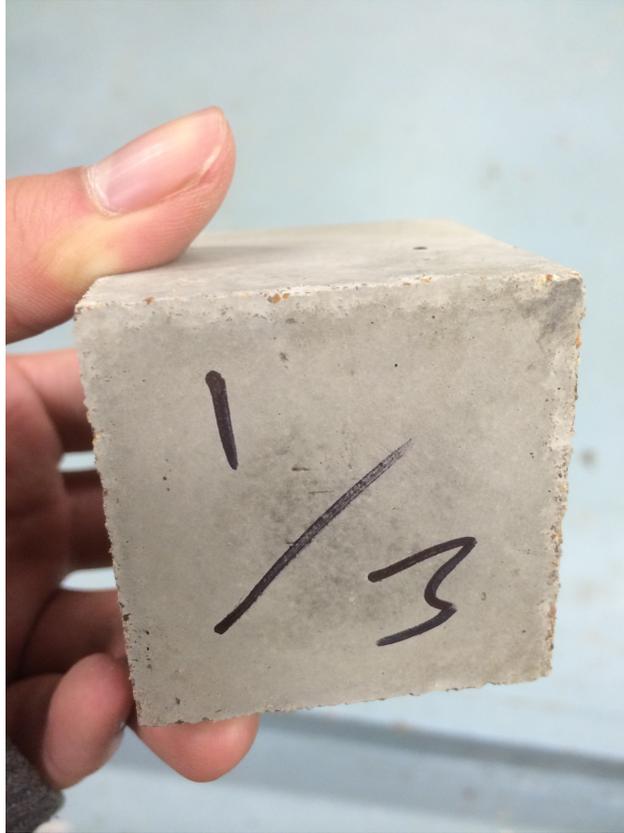
Figure 3: The concrete cube for 1-day testing

Prior to the mix being placed into the cube molds, the molds were assembled and lightly wiped down with WD40 as a release agent to help remove the molds later. The cube molds were then filled 1/3 of the way and rodded 12 times each. They were filled a further 1/3 and rodded 12 times each again before being filled the remaining 1/3 and then being rodded a final 12 times each. This process helps remove air bubbles from the concrete mix. Large air voids could cause samples to have imperfections, which lead to underperformance in testing. The entire mold was then placed into a sealed plastic bag and placed in the curing room. The bag was placed on the sample to keep the relative moisture content in the bag stable for the initial curing period. Twenty-four hours after pouring, the cubes were then demolded and placed back into the curing room without the plastic bag until they had cured for the specified amount of time for testing. One of the samples was shown as below.

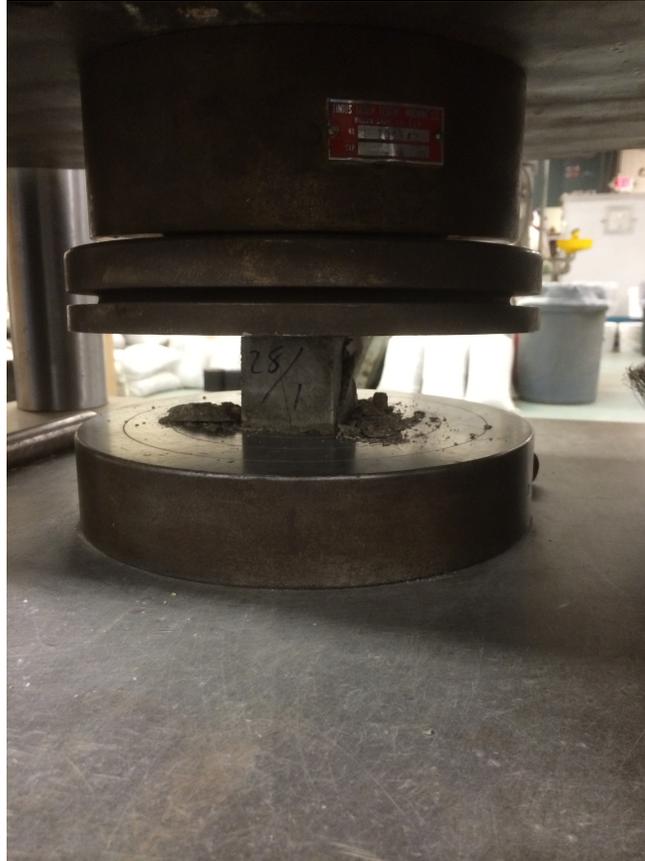
Figure 4: Compression testing for a 28-day concrete cube

Specimens were compressed at a load rate of 2000 pounds per minute until they failed, as shown below. The 3 samples for each cure period were then analyzed to determine whether the strength of the mix was adequate for use in all of our samples.

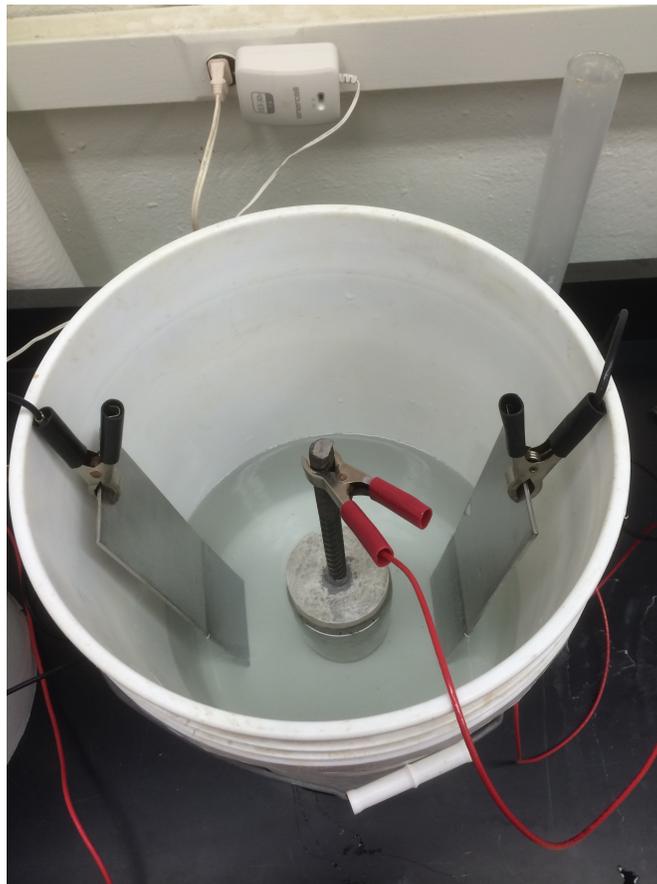
Figure 5: Setup for accelerated corrosion testing

The accelerated corrosion testing was based on the procedure previously used by Ahmad [39]. The 3” diameter by 6” tall cylindrical concrete samples were prepared with rebar partially encased in them. The 1’ long rebar was suspended 0.75” from the bottom of the mold and extended out of the top of the concrete. Sets of the rebar were coated with one of the four coating types being tested: no coating, unmodified epoxy coating, and epoxy coating mixed with 10 wt.% and 20 wt.% of microcapsules containing tung oil. These samples were submerged in a 5 wt.% sodium chloride (Alfa Aesar) solution with

the waterline just below the top of the concrete and the rebar extending upward. Two stainless steel plates were placed in the solution on opposite sides of each sample. 30-volt power supplies were used to apply a current through the system with the stainless steel plates attached to the negative leads and the rebar protruding from the sample attached to the positive lead. A data logging program tracked the current in the circuit at regular intervals, which allowed the determination when the first full crack forms in each sample. A spike in current was observed when a crack was initiated due to significant loss in electrical resistance. The setup was shown as below.

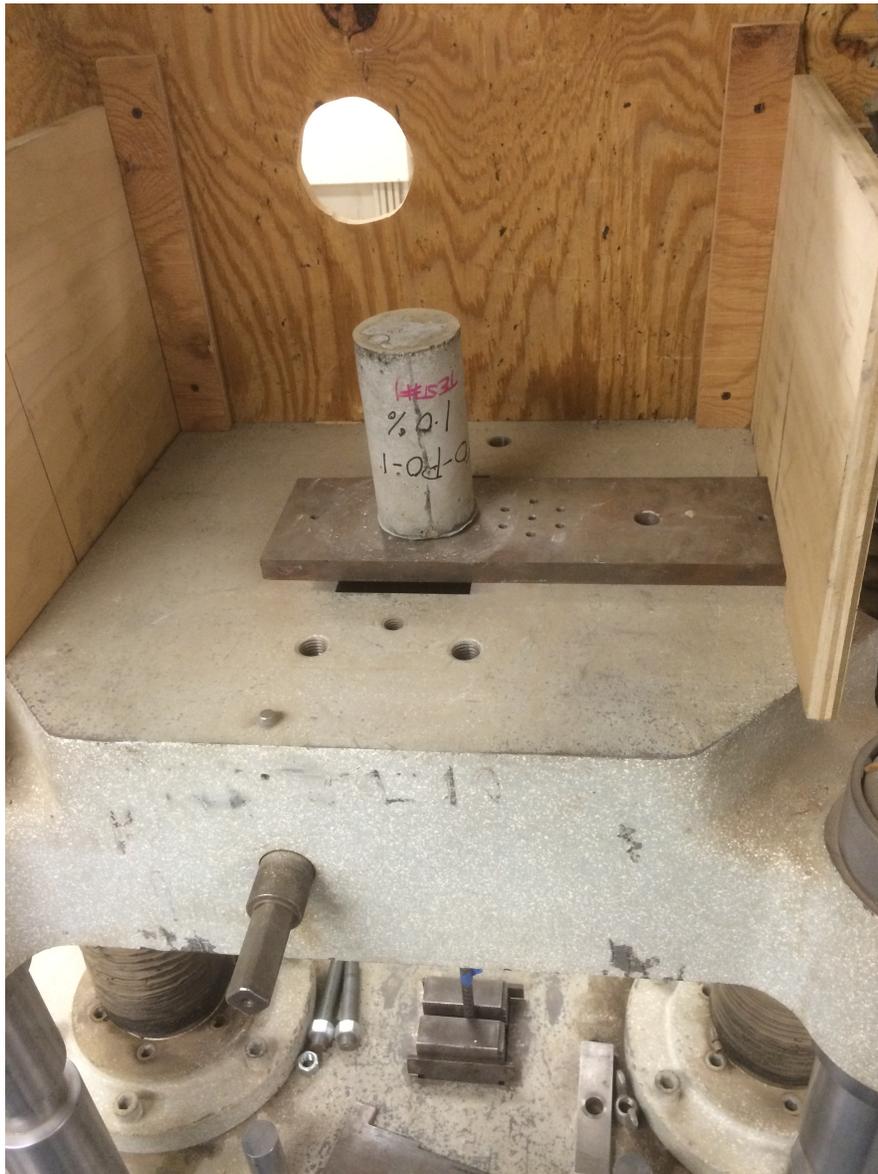
Figure 6: Setup for pullout testing

The pullout testing was conducted based on standard laboratory practices. 3' long pieces of rebar were coated in each type of coating, then encased in 3" diameter by 6" tall

concrete cylinders. After full concrete curing, each cylinder was then placed in the universal testing machine with the rebar clamped and the concrete cylinder braced. The rebar was pulled away from the concrete at a uniform rate of 8000 pounds per minute until it broke from the concrete. The results of this test allowed determination of the effect of adding microcapsules to an epoxy coating on the pullout strength of rebar encased in concrete. The setup for pullout testing was shown as below.

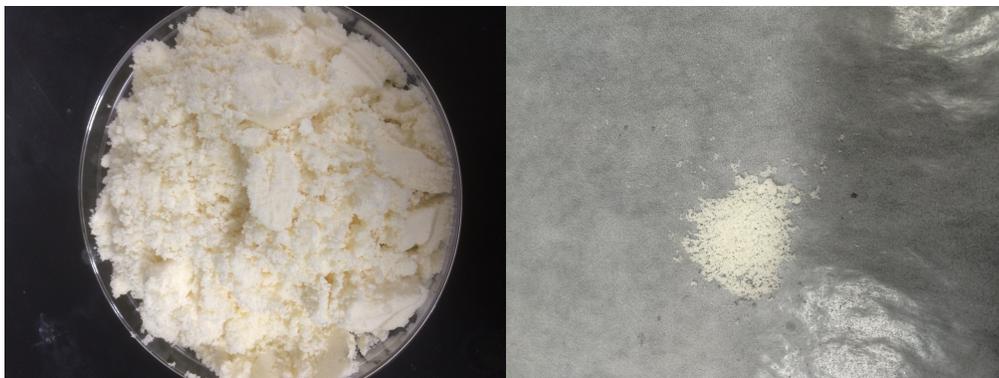
Microcapsules containing tung oil were successfully synthesized. As shown in Figure 7 the product was discrete, slightly yellow particles, the shape of which could be easily observed with the naked eyes. It was also observed that a drop of yellow liquid came out when some of the microcapsules broke.

Figure 7: Appearance of synthesized microcapsules containing tung oil. The images of the whole batch of microcapsules in a Petri dish (left) and some microcapsules (right)

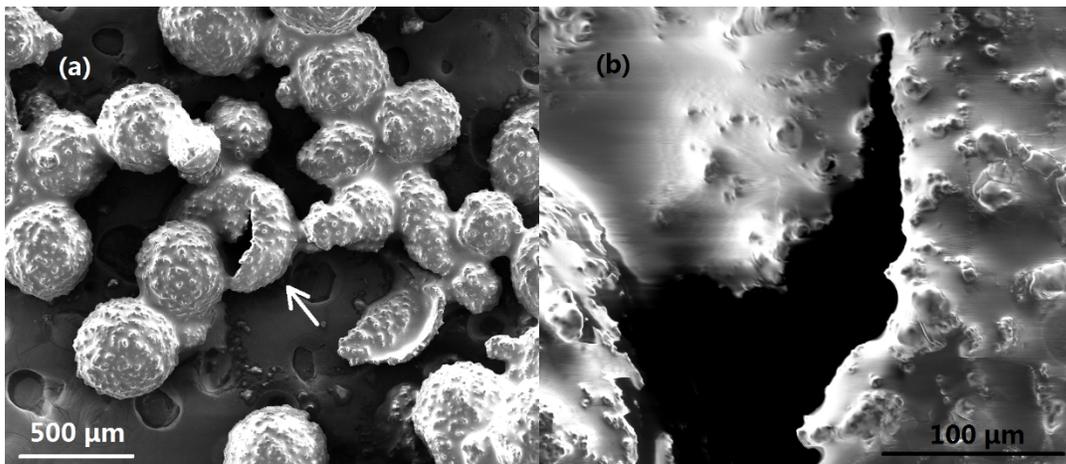
The synthesized microcapsules were imaged by SEM. As shown below in Figure 8, the microcapsules are spherical and have a rough shell, indicating that they will have good adhesion with epoxy coating. The average size of the microcapsules was determined using ImageJ to be around 300 μm . However, the size distribution of microcapsules used for the accelerated corrosion testing was broad and had multiple peaks, as a few batches of microcapsules synthesized at different times were combined, and the size distribution from each batch differed due to the lack of strict quality control during the microcapsules synthesis.

Figure 8: SEM images of (a) synthesized microcapsules containing tung oil; (b) the detail of a crack

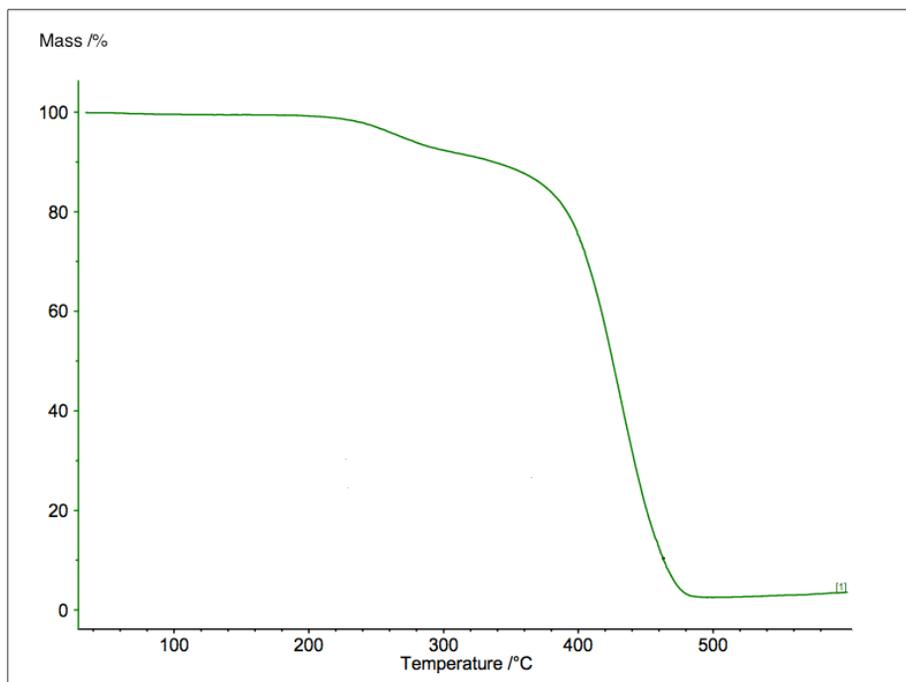
Figure 9: TGA curve of synthesized microcapsules containing tung oil

TGA was conducted for the synthesized microcapsules containing tung oil (Figure 9). The curve demonstrated a slight mass loss starting at 250 $^{\circ}\text{C}$ followed by a significant mass loss at 350 - 480 $^{\circ}\text{C}$, at which the microcapsules ruptured and the tung oil was vaporized. This shows that the synthesized microcapsules have good thermal stability. TGA for broken microcapsules was also conducted and showed the almost exact pattern as the intact sample.

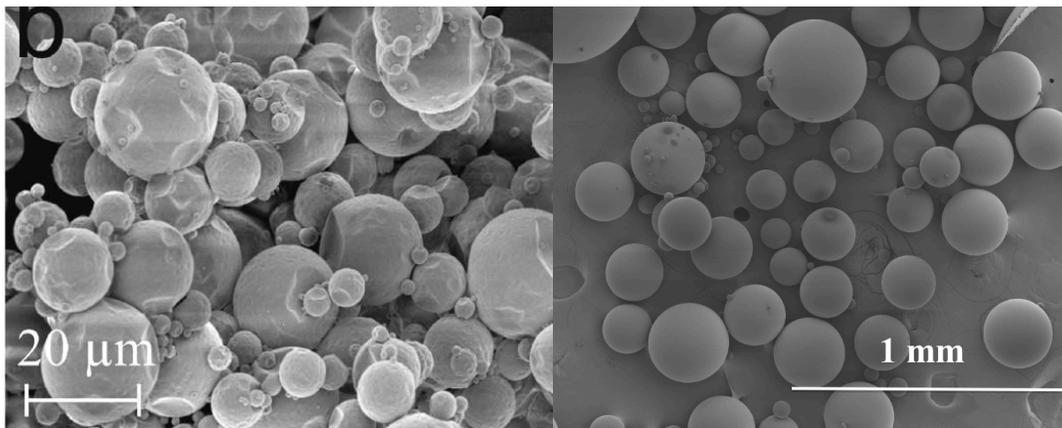
The attempt to encapsulate 2-methylbenzothiazole using the tung oil procedure was not successful. This was concluded immediately upon filtering the solution when no particles were left behind on the filter paper. A possible reason for this unsuccessful encapsulation of 2-methylbenzothiazole was that the healing agent reacted with another chemical used in procedure. This hypothesis is supported by the observation of a white cloud in the emulsion solution upon addition of 2-methylbenzothiazole. Since the formaldehyde has not yet been added, the white cloud could not be poly(urea-formaldehyde). Because the unexpected reaction could not be immediately identified and the overall experiment did not produce 2-methylbenzothiazole microcapsules, this procedure was disregarded.

Figure 10: Encapsulation of 2-methylbenzothiazole by Latnikova *et al.* (left) and encapsulation of 2-methylbenzothiazole by MQP group (right).

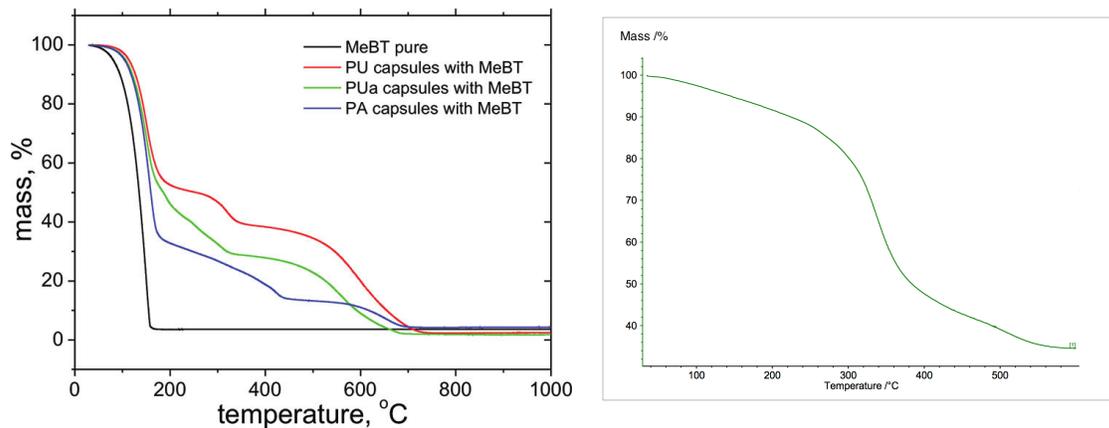
procedure. After performing the experiment, golden spherical particles was obtained. With the naked eye, the particles seemed to look like microcapsules. Thus, SEM images of the particles were obtained as shown in Figure 10. The particles synthesized looked similar to SEM images in the literature shown in Figure 10, signifying there was a chance the particles were in fact microcapsules. To provide evidence of a successful encapsulation, a TGA experiment was performed. As shown in Figure 11, a rapid mass loss of 2-methylbenzothiazole in polyurea shells should occur at around 150 °C according to Latnikova *et al.* [27]. The TGA graph obtained on the experimental 2-methylbenzothiazole microcapsules showed no indication of a rapid mass loss at 150 °C. Therefore, this indirect evidence suggests that there was no encapsulation of 2-methylbenzothiazole in polyurea shells. Furthermore, when crushing the particles with a metal spatula, the substance refused to rupture. Thus, it was concluded that there is no encapsulated 2-methylbenzothiazole in polyurea shells.

Figure 11: TGA graph of 2-methylbenzothiazole microcapsules by Latnikova *et al.* (left) and experimental TGA graph (right)

A possible reason for the failed attempt to encapsulate the healing agent may include the use of a different mixer. The procedure in the literature used a homogenizer at 17000 rpm whereas in this experiment a four impeller mechanical stirrer was used at 400

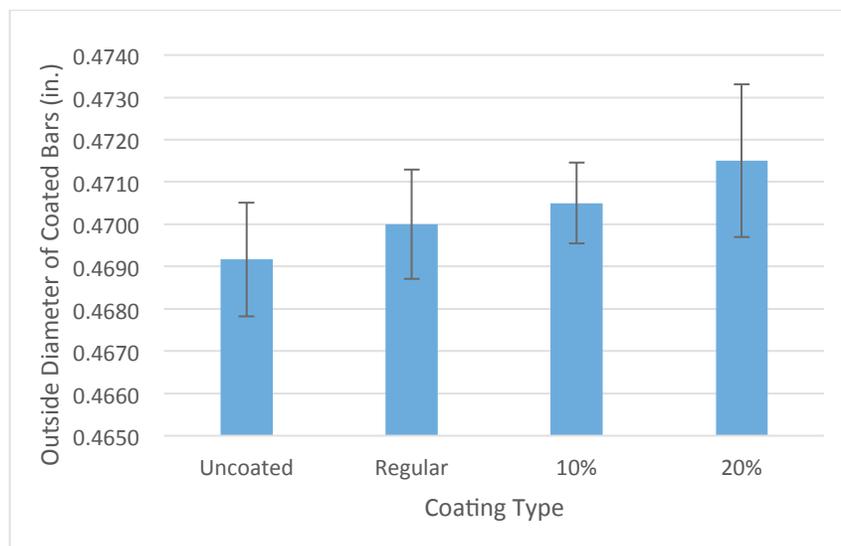
Figure 12: Outside diameter of coated rebars

The relative thickness of the experimental coatings as compared to the unmodified epoxy coating was considered as a potential factor for increased time to break that is unrelated to the self-healing properties of the coatings. Because the coatings are waterproof and nonconductive, increased thickness of the coating would be expected to provide more protection to the steel underneath. In order to determine if the coatings with microcapsules were thicker, several rebars were coated with the same process used in the other tests, but not encased in concrete. After the samples had cured for 72 hours, a caliper was used to measure the thickness of the rebars and coatings. A single-tailed T-test was used on the results (Figure 12) to determine if the thicknesses of the 10 wt.% and 20 wt.% coatings were significantly different from the thickness of the unmodified epoxy coating. With a confidence interval of 95%, the results of the test showed that the experimental coatings were not significantly thicker than the regular coatings.

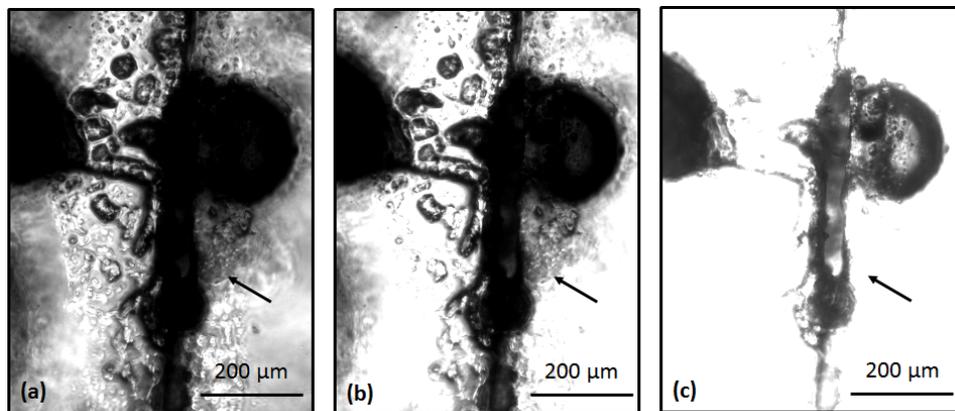
types of epoxy coating: unmodified, 10 wt.% microcapsules, and 20 wt.% microcapsules. The control and experimental samples were cut in a straight line by a brand new box cutter, and the damage was imaged using an inverted transmission optical microscope immediately, two days, five days, and seven days after the samples were cut. As shown below (Figure 13), tung oil bled out of a microcapsule and filled in the cut. This is direct evidence that tung oil is mobile enough to spread out and cover the damage when microcapsules break.

Figure 13: Optical microscope images of tung oil bleeding out of a microcapsule under (a) low, (b) medium, and (c) high exposure (10 wt.%, 5 days after damage)

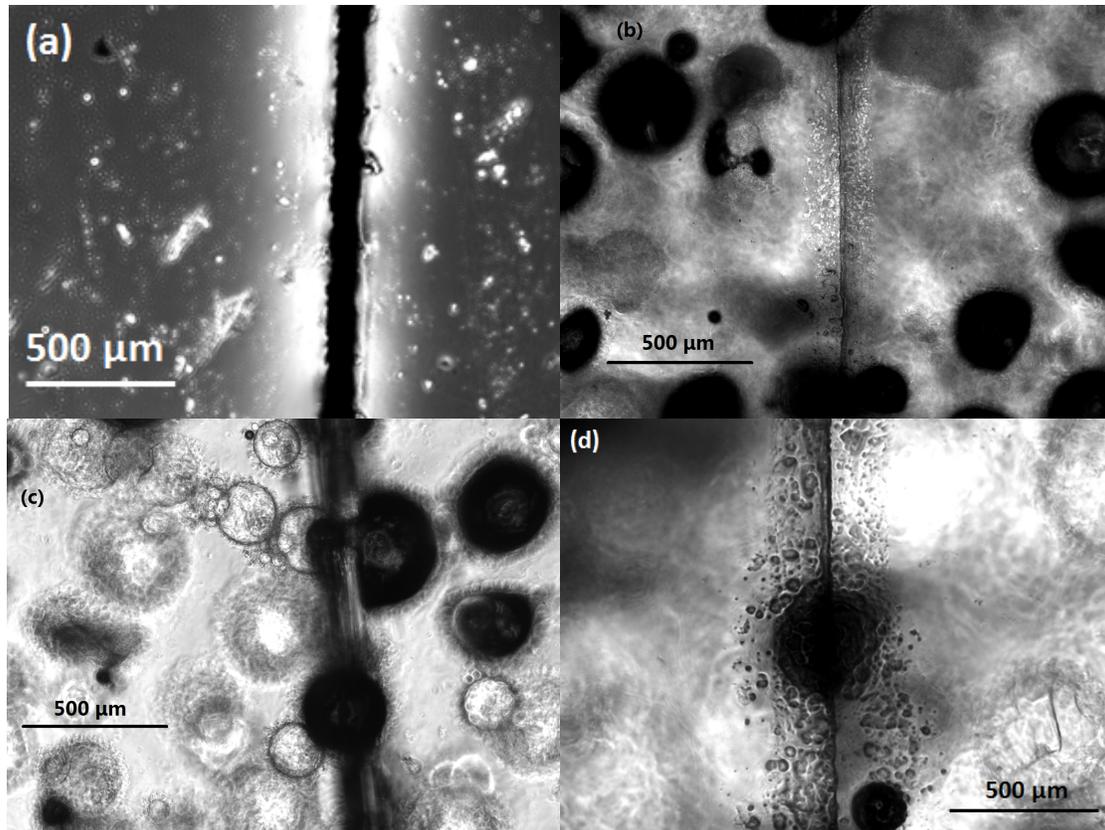
Additionally, there was a newly formed film of oxidized tung oil observed in the vicinity of the damage. Five days after the samples with 10 and 20 wt.% microcapsules were damaged, a band with rough texture was formed all the way along the straight cut. As shown in Figure 14 (b), this band has a very different texture from the original coating. This band resulted from the oxidized tung oil, because it did not exist immediately after the sample was damaged, based on Figure 14 (c). Figure 14 (d) shows a band formed near a cut microcapsule. This band was also observed in the sample two days after being cut, but the band was only formed near broken microcapsules and hadn't completely spread along the cut. This concluded that the synthesized coatings do self-heal and take a few days to repair damage.

Figure 14: Optical microscope images of cuts made on samples. (a) A cut made on unmodified epoxy coating; (b) a cut made after 5 days on the sample with 20 wt.% microcapsules; (c) a cut made immediately on the sample with 20 wt.% microcapsules; (d) a close up image of a microcapsule (5 days)

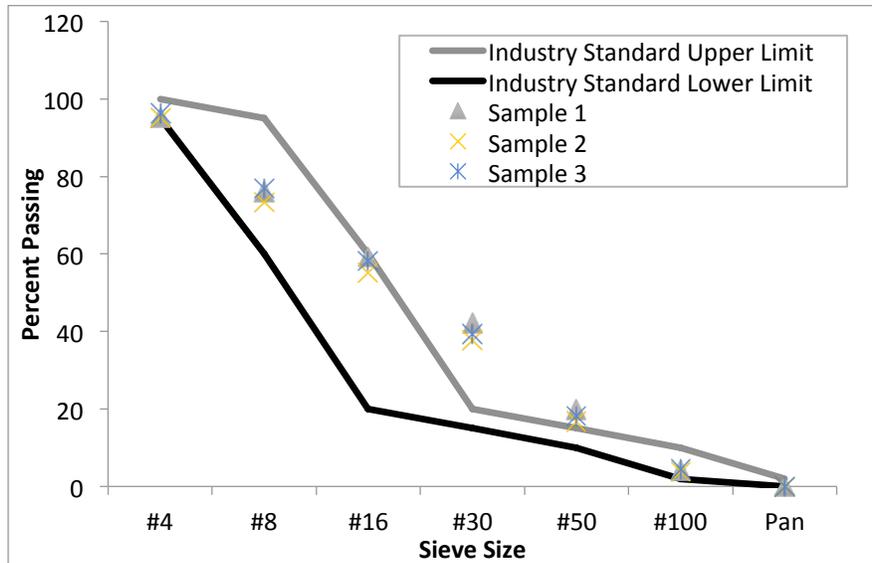
Figure 15: Sieve analysis results of aggregate

A sieve analysis was completed on the fine aggregate used to make the samples. The analysis determined the distribution of particle sizes within the sand used. This test was done for quality control reasons and the results of three separate sieve analyses on the aggregate netted the results shown in the appendix (Figure 33). As shown in Figure 15, the experimental results do not fall between the upper and lower industry standard limits. Even though the aggregate used in the samples for accelerated corrosion testing and pullout testing was not at industry standards, this should not impact analysis of the results significantly because the same aggregate was used throughout the experiments. The relative differences and effects can still be observed.

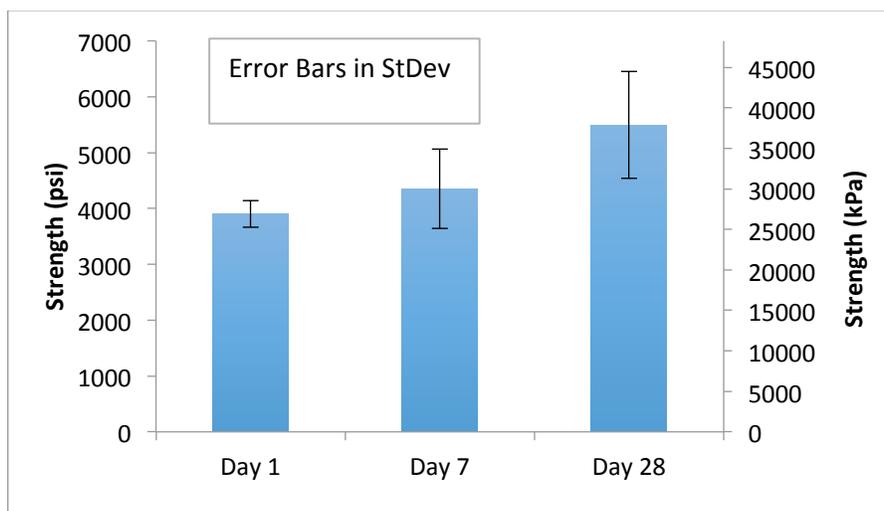
Figure 16: Graph of the peak strengths on various days of the compression tests

Compression testing was performed on several samples as a measure of quality control. The test involved crushing 2” cubes of concrete in the universal testing machine at various days during the curing process. The samples were tested after 1, 7, and 28 days in accordance with industry standard. The results of this testing (Figure 16) showed that the mix design used meets the industry standard 28 day compression strength of approximately 6000 psi.

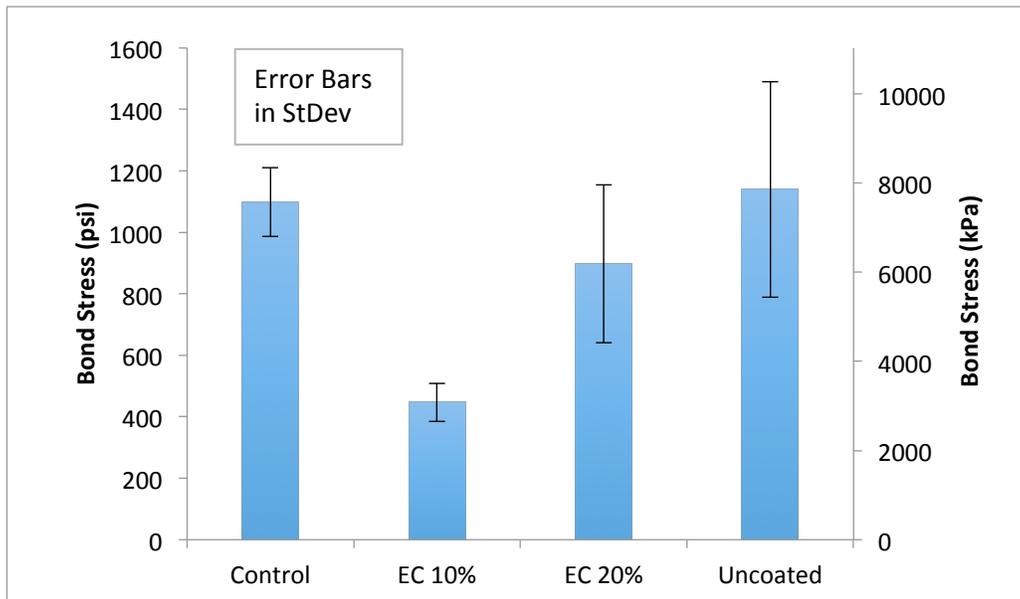
Figure 17: Graph of the peak strengths on various days of the pullout test

The results of the rebar pullout tests (Figure 17) showed only minor differences in the pullout strength for each of the four coating types tested. The peak loads for the samples with no coating, unmodified epoxy coating, and epoxy coating with 20 wt.% microcapsules all showed significantly overlapping standard deviations. The standard deviations of these samples are relatively large, which is due in part to both the sensitive nature of the test and the low number of samples per experimental group. This precludes any absolute determinations on the relative pullout strengths of these samples. However, the 10 wt.% coating does show lower pullout strength. Further testing in the future and a review of the precision of sample creation will likely provide valuable information on this aspect of the coatings. One of the broken samples was shown as Figure 18.

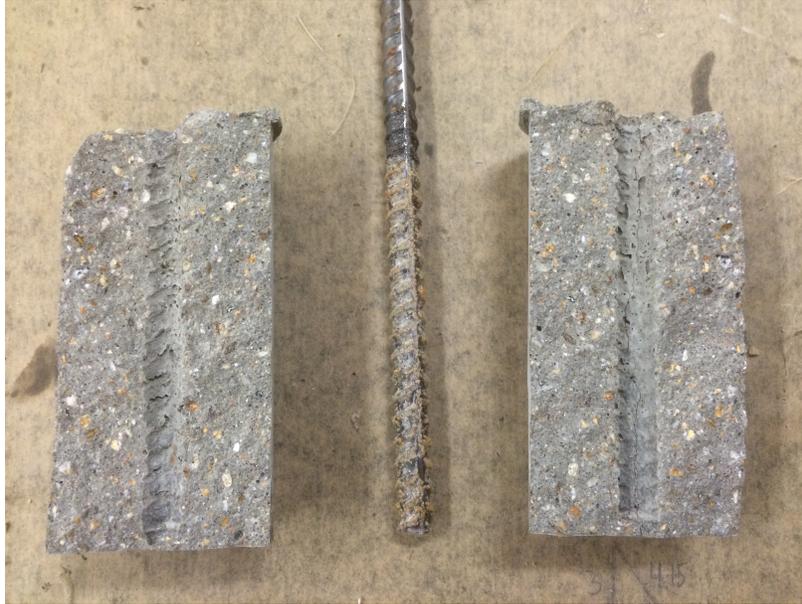
Figure 18: A broken sample by pullout testing coated with self-healing coating with 20 wt.% microcapsules

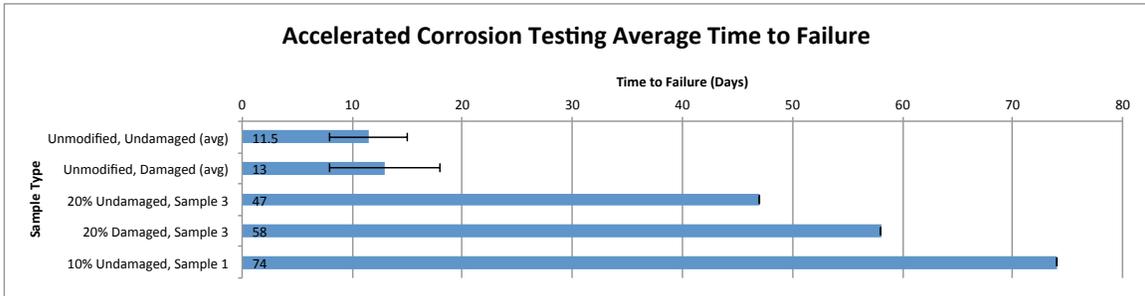
Figure 19: Failure time for accelerated corrosion test

Through the accelerated corrosion testing it was determined that our experimental coating had a substantial and positive effect on inhibiting corrosion. The unmodified epoxy coating lasted an average of 11.5 +/- 3.5 days and the damaged unmodified epoxy coating an average of 13 +/- 5 days, as illustrated in Figure 19 below. The experimental coatings, which included either 10 wt.% or 20% microcapsules by weight, took at least three times longer to break. There were no significant differences in the damaged vs. undamaged samples tested. This could possibly be due to the damage not being large enough to impact the results. As of this writing the experimental coatings have only had 3 failures of the 12 total samples, which occurred at days 47, 58, and 74. The 10 wt.% and 20 wt.% microcapsule coatings tested have not yet had any significant statistical differences between them.

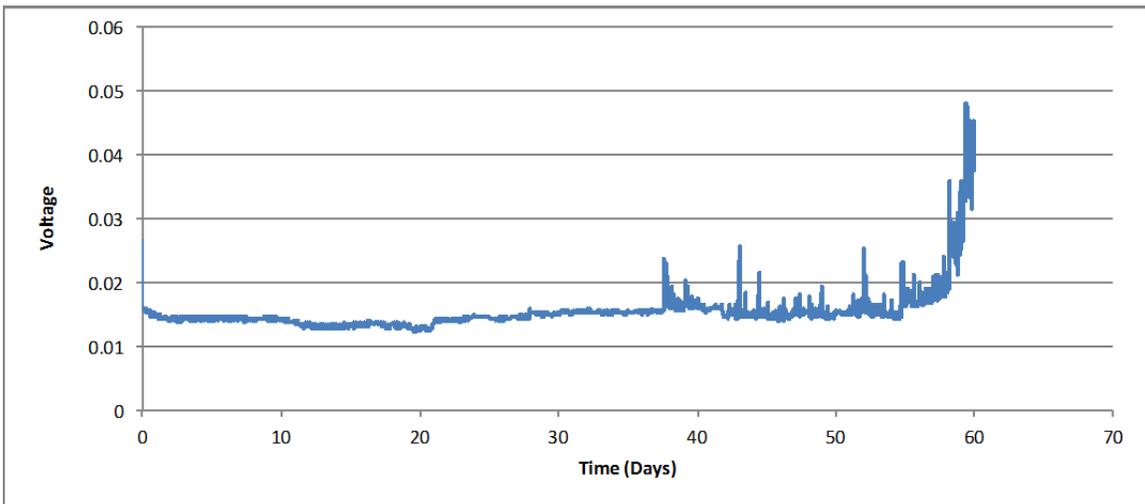
The first experimental sample that failed only showed minor cracking of the concrete, but it was determined to have failed by concrete cracking via the recorded decrease in resistance. The spike in voltage through the sample can be seen in Figure 20 below, peaking at day 60 when the sample was removed from testing due to failure. The minor damage is likely due to the short amount of time between the initial failure and the end of testing for that sample. Once the voltage first spikes, the sample is considered failed. Any data after that is unnecessary, and allowing the samples to continue to degrade for too long runs a risk of burning out the circuit.

Figure 20: Voltage with respect to time for 20 wt.% damaged in accelerated corrosion test

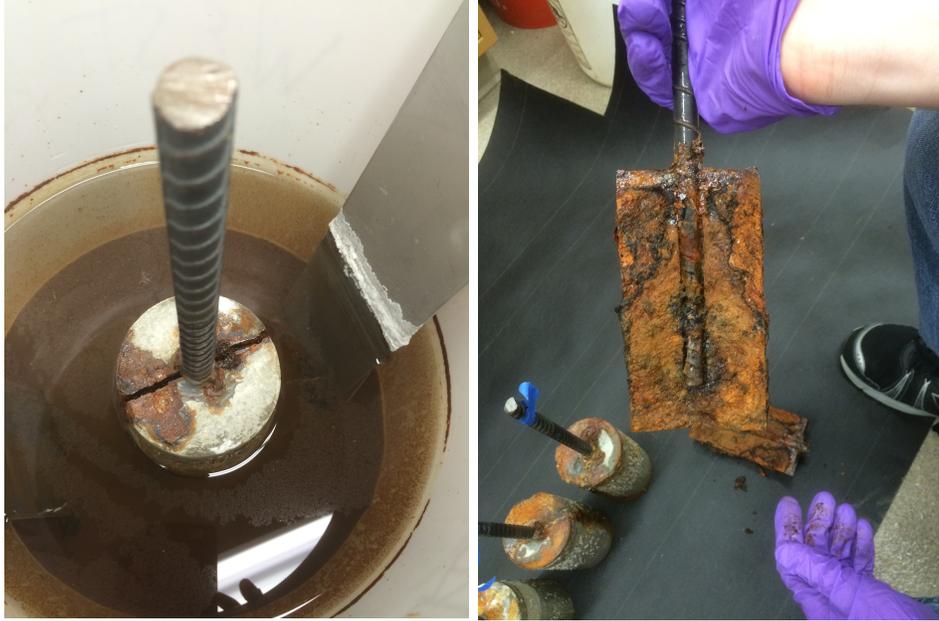
Figure 21: One of the corroded samples for unmodified epoxy coating

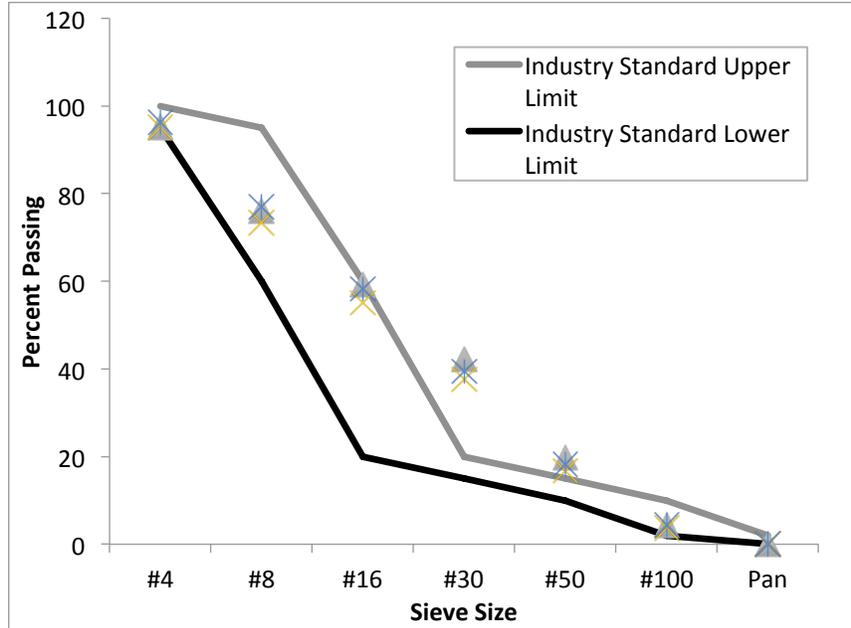
Figure 32: Graduation Chart for comparison of industry standard and experimental aggregate

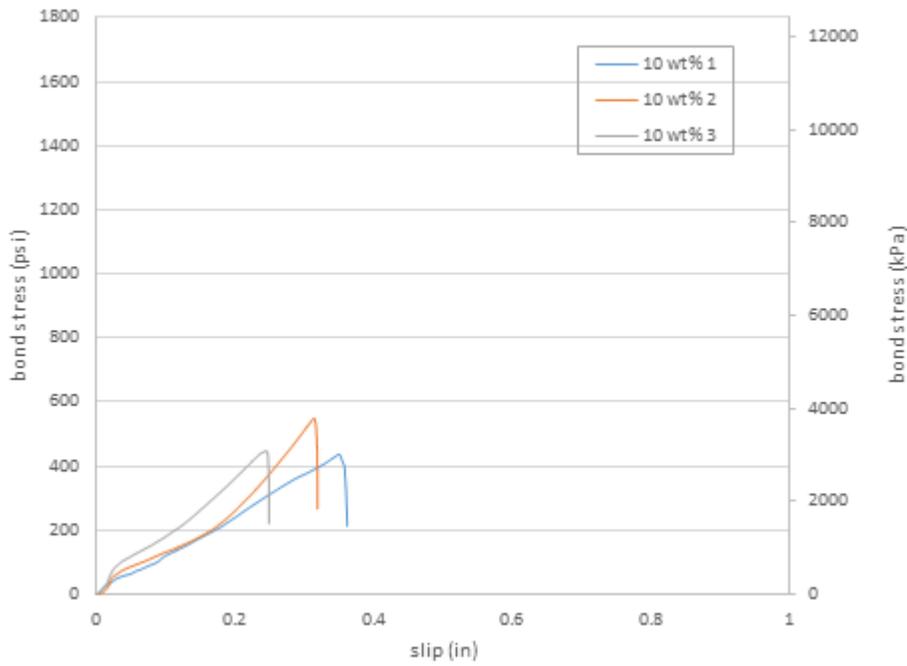
Figure 37: Pullout graphs of the 10 wt.% tung oil EC samples

Note: Sample 10 wt.% 1 had a slip of about 0.24 in at the beginning of test. This was accounted for which is why all the samples started at 0 inches of slip.
