A Pilot Study to Assess the  
Accessibility of Southwest  
Iceland's Hiking Trails

An Interactive Qualifying Project  
Submitted to the Faculty of  
WORCESTER POLYTECHNIC INSTITUTE  
in partial fulfillment of the requirements for the  
Degree of Bachelor of Science

8 October 2019

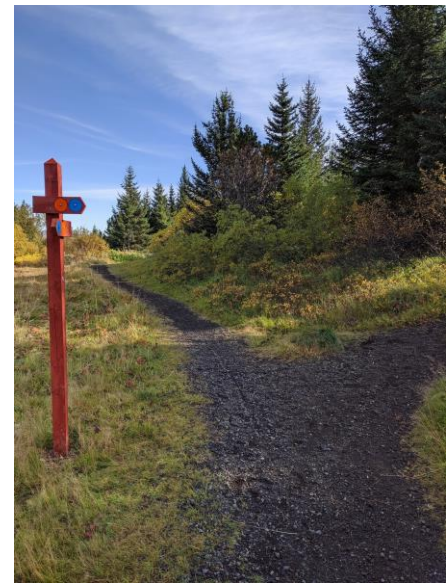
*Figure A. A well-marked trail.*

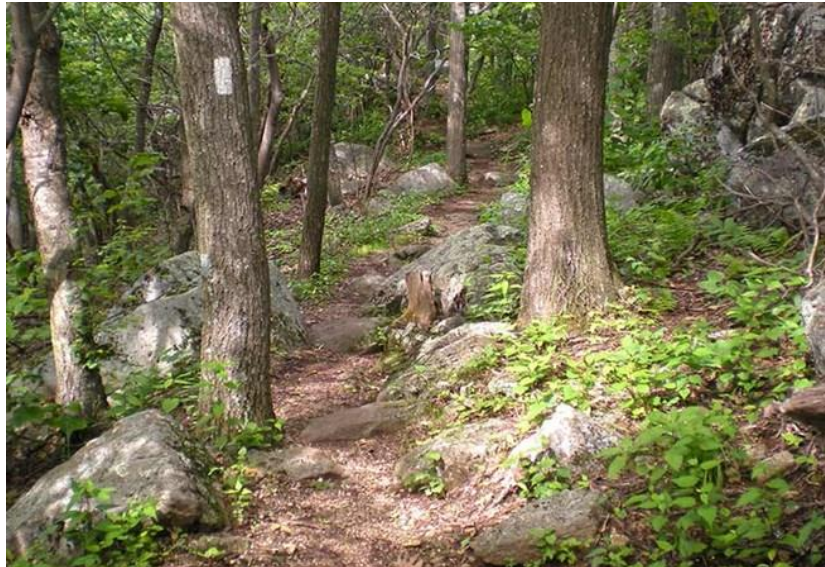
*Figure 3. A white trail marker is clearly visible. (NPS. (2016)).*

For the scope of this project, we will restrict the definition of a trail to be a path through primarily undeveloped and natural land. Trails are typically marked in a recognizable fashion to help hikers stay on the path. **Figure 3** shows a commonly used white “blaze” that marks a hiking trail. Other kinds of trail markers include signposts and cairns (Hodgkins, 2019).

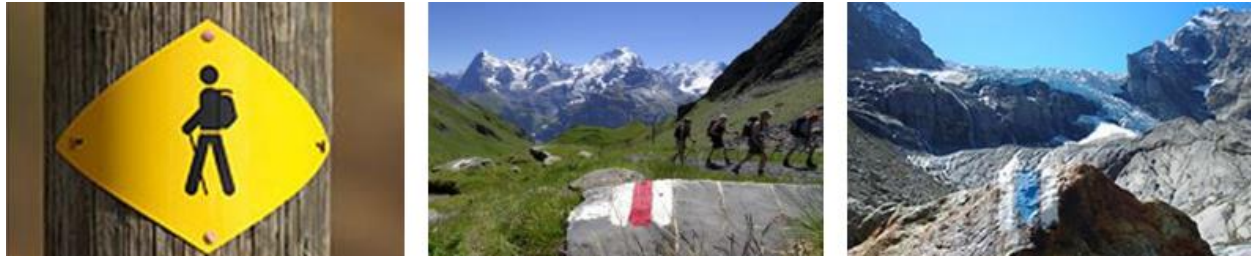
*Figure 6. Trail markers on the Swiss Wanderweg (Trail Signs in the Swiss Alps, n.d.).*

Yellow signs, often in the shape of a diamond, indicate a pedestrian or walking trail, red and white signs or paint marks on trees and rocks tell you that you are on a hiking or mountain trail with more significant elevation gains and losses than a pedestrian trail, and blue signs indicate technical alpine routes and require additional safety equipment (ibid).

As **Figure 6** shows, standardized markings and signage makes it easy for both Swiss and international visitors to understand trail markings and signage. The Swiss trail marking method is successful because there is constant upkeep of the signs. In Switzerland, “each sign and hiking trail is inspected in detail each year” (ibid).

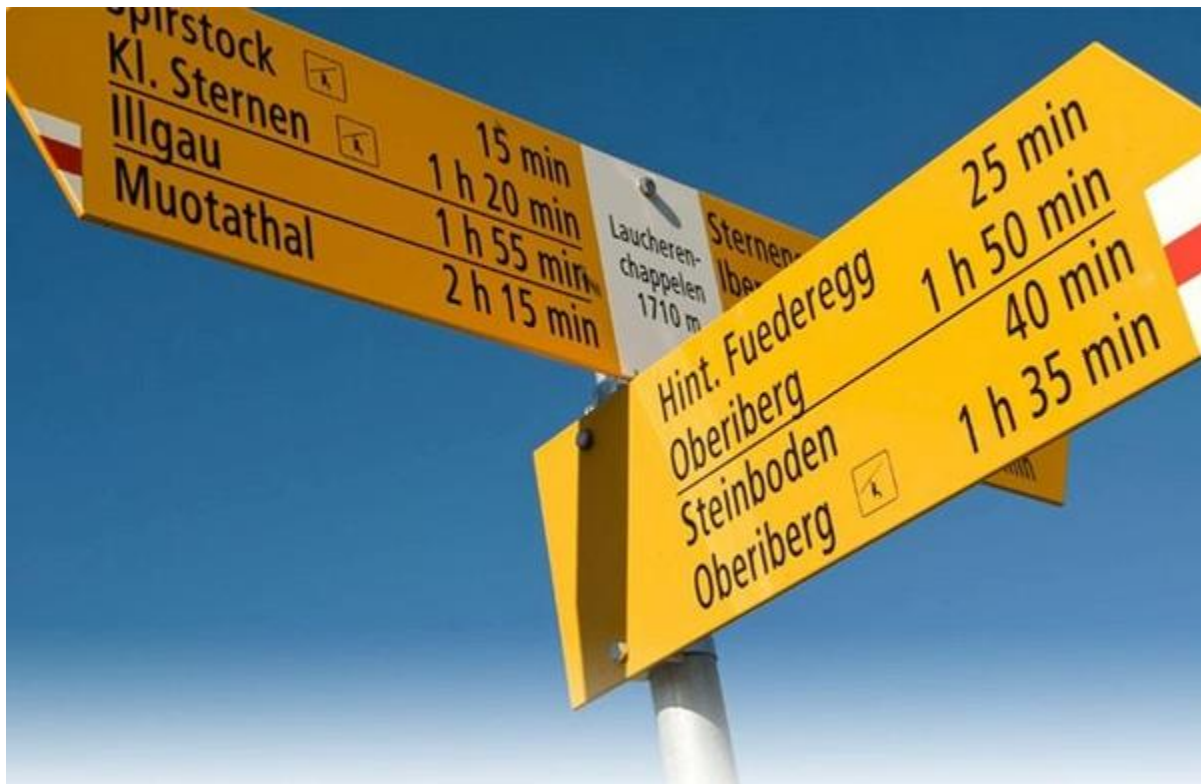
*Figure 7. Swiss Wanderwege signpost (Einsiedeln-Ybrig-Zürichsee. (n.d.)).*

Furthermore, the signs list distance in kilometers as well as hours at an average walking pace, as seen below in **Figure 7**. The inclusion of distance in terms of time makes the trail more accessible to any hiker. These signs are also color coded by difficulty. The colors on the signs correspond to the colors of the markings on the trail they point to.

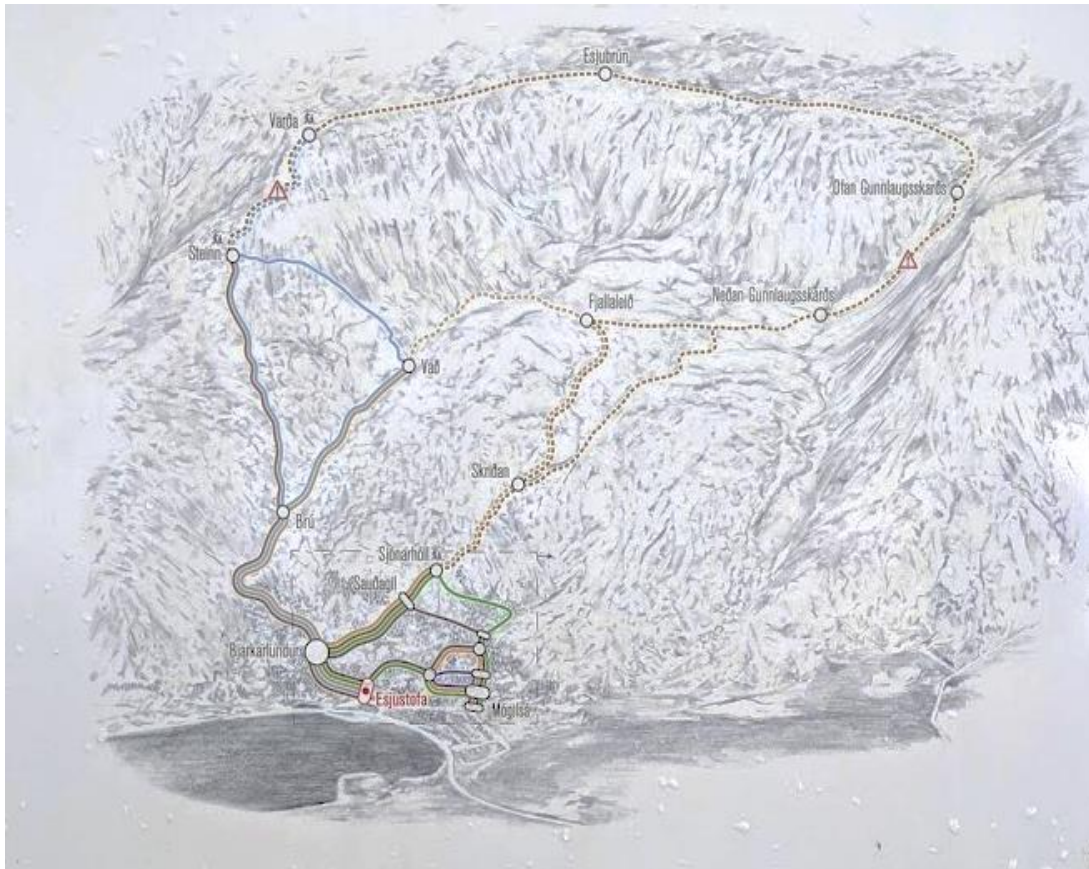
## Fjallaleiðir Mountain Paths

### F1 Steinn - Vörða

At the beginning of our hike, the trails were very well defined and clearly marked. The signs had a smaller map of the mountain with a number showing where we were. The terrain was steep and became progressively rockier the higher up we went. After only half an hour of hiking, we found a fantastic view of Reykjavík.

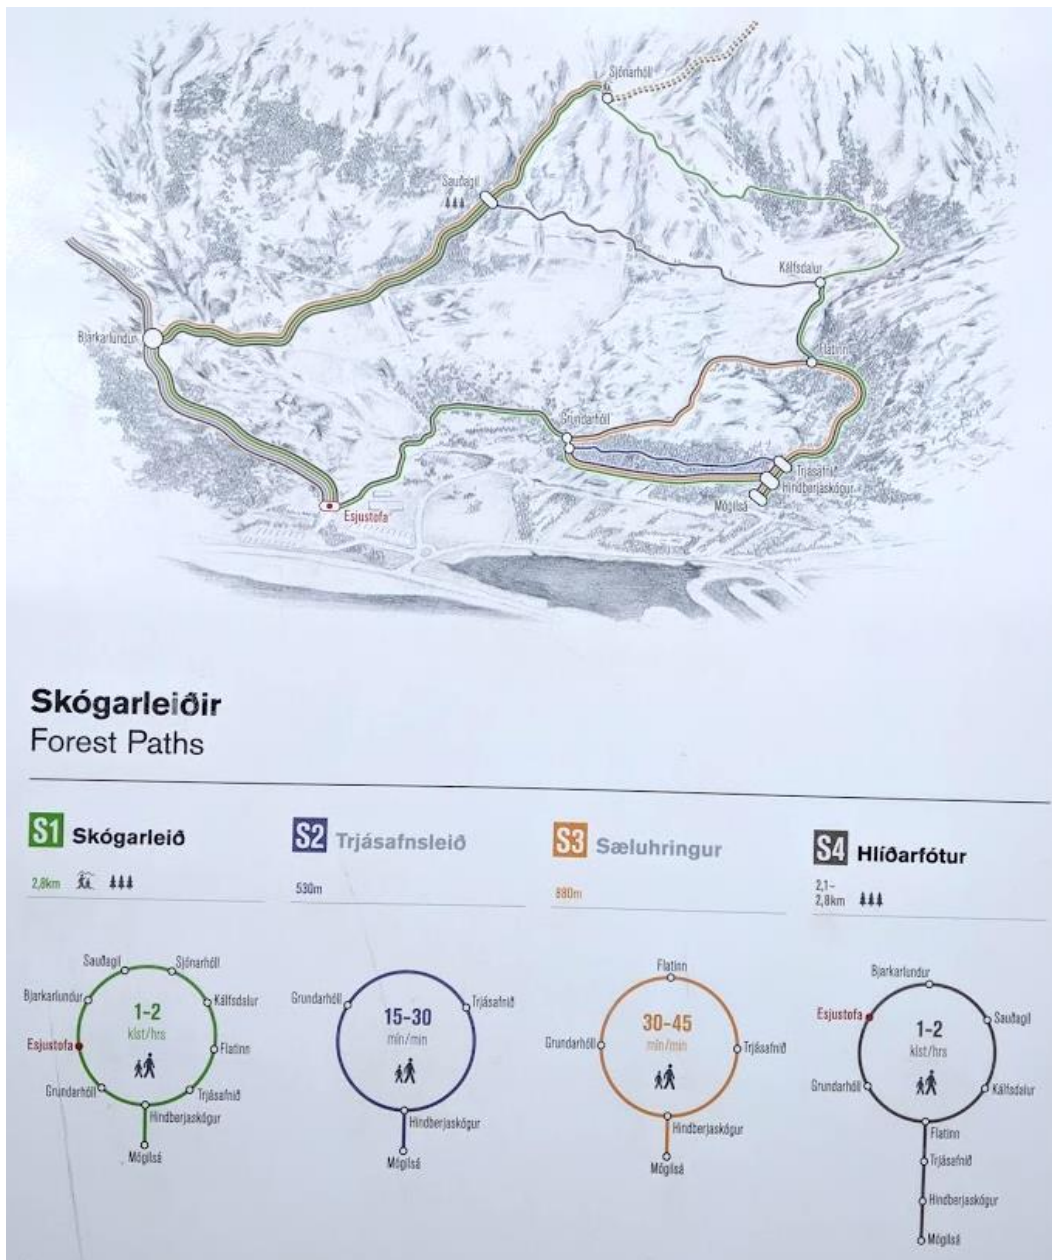
*Figure 8. The map at the base of Mt. Esja.*

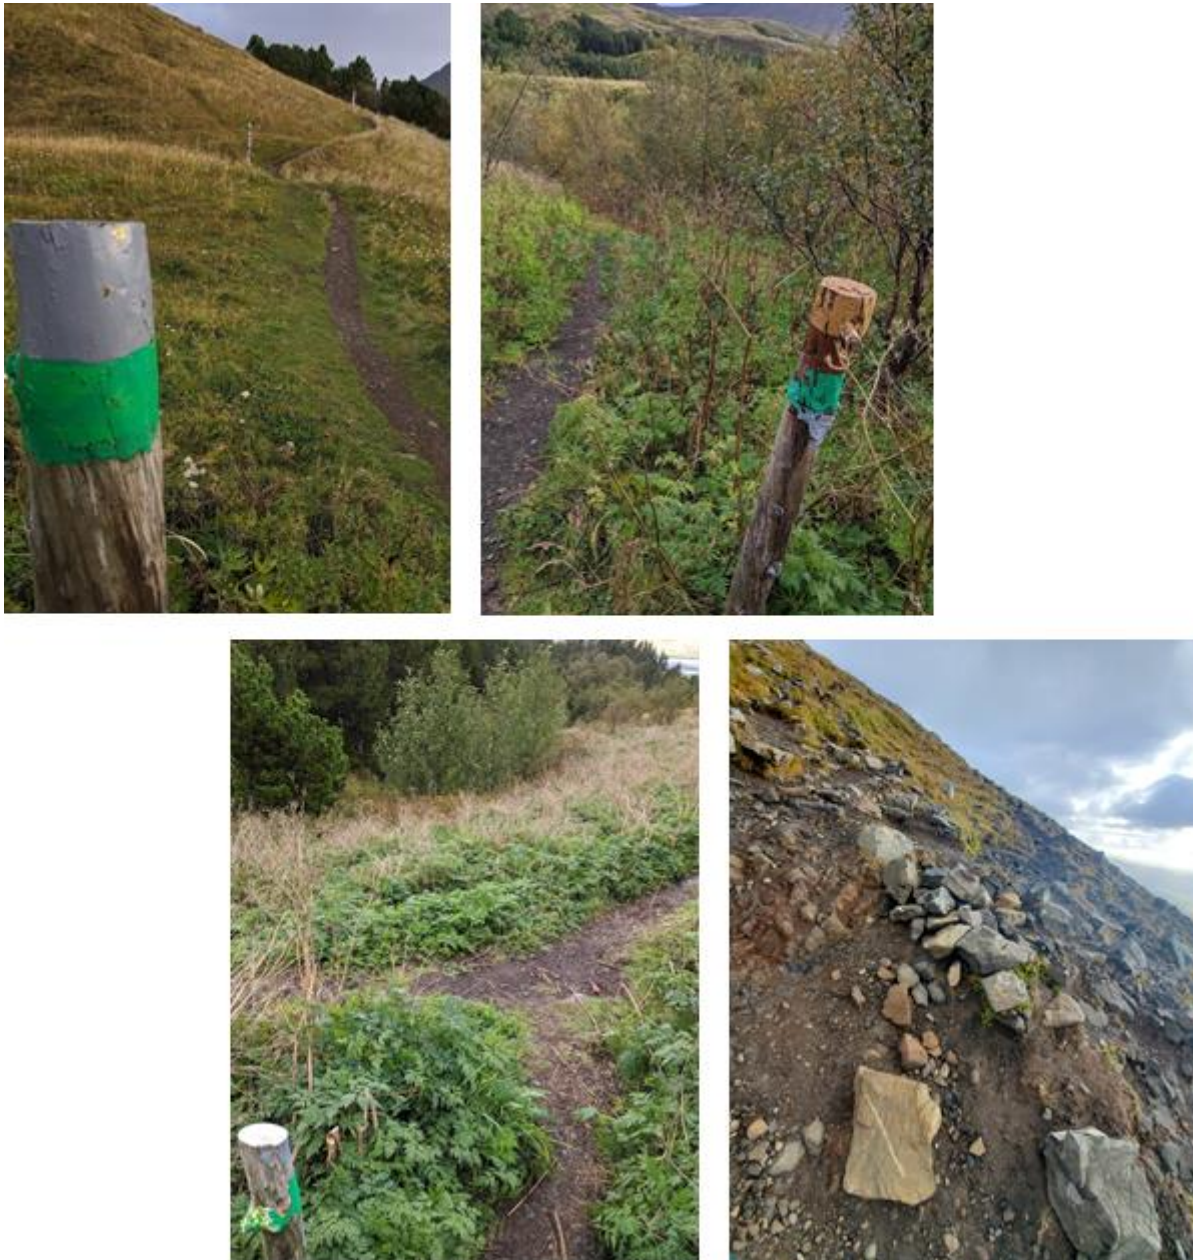
**Figure 9** shows good quality trail markers towards the base of Mt. Esja and the poor quality of

trail markers farther along the trails. The first two pictures show wooden posts displaying bright colors and representing multiple trails. Although these colors were bright to us, one in twelve men and one in two-hundred women experience some form of colorblindness and would not view the colored posts as we did (Johnston, 2019). The second two pictures show a poorly marked crossroads and a thin scratch on a rock serving as a trail marker, respectively.

*Figure 9. Examples of trail markers on Mt. Esja.*

We strongly encourage obvious and bright trail markings at every junction on a trail, indicating which path is primary. We recommend that colors follow a standard, and that all trail markings are consistently in that color. For this method to be effective, the trail markers need to be placed within sight on the trail.

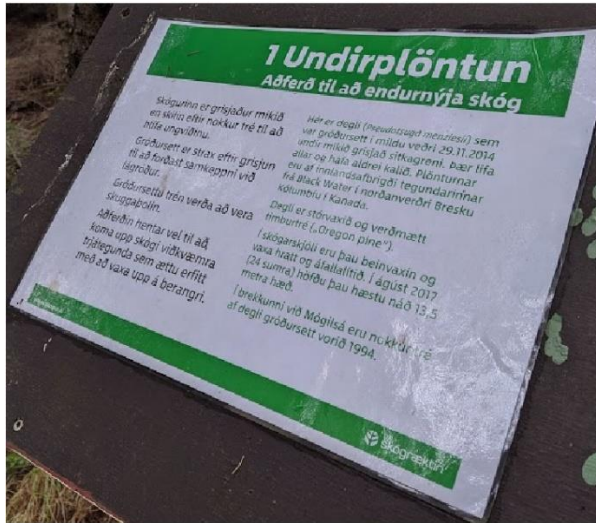
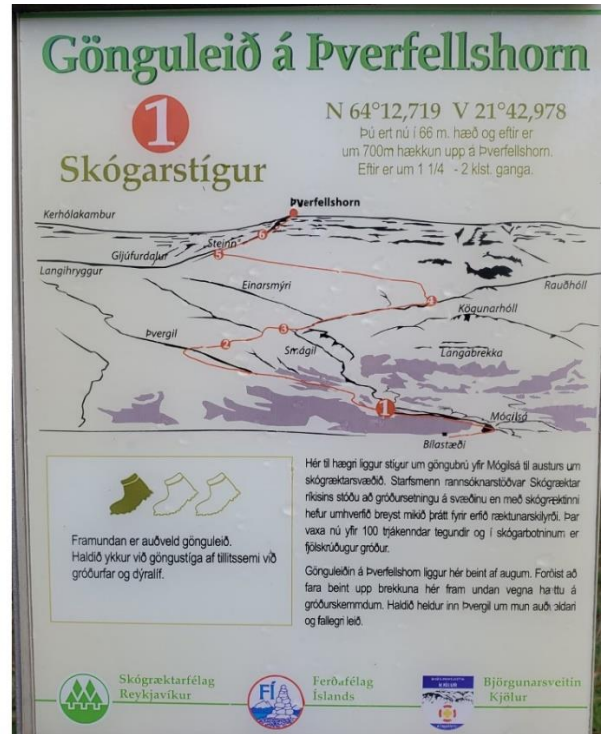
Another challenge presented itself when we looked to trail signs for guidance. None of the signs on the trail were written in a language we could understand. As international tourists, we found it confusing to interpret signs that were written only in Icelandic. **Figure 10** shows two of these

signs that we encountered during our hike. Although the pictures on some signs were slightly helpful, we were unsure if what was written on the signs was important safety, trail marking, historical or another type of information.

Figure 10. Signs along the trails of Mt. Esja.

Signs should be posted in two languages: English and Icelandic. However, signs were frequently written in only Icelandic. We recommend signs be posted in English as well as Icelandic in order to reach the approximately 45% of visitors in Iceland who come from native English-speaking countries (Icelandic Tourist Board, 2018). In addition, it is likely that many more visitors read English at some level of understanding.

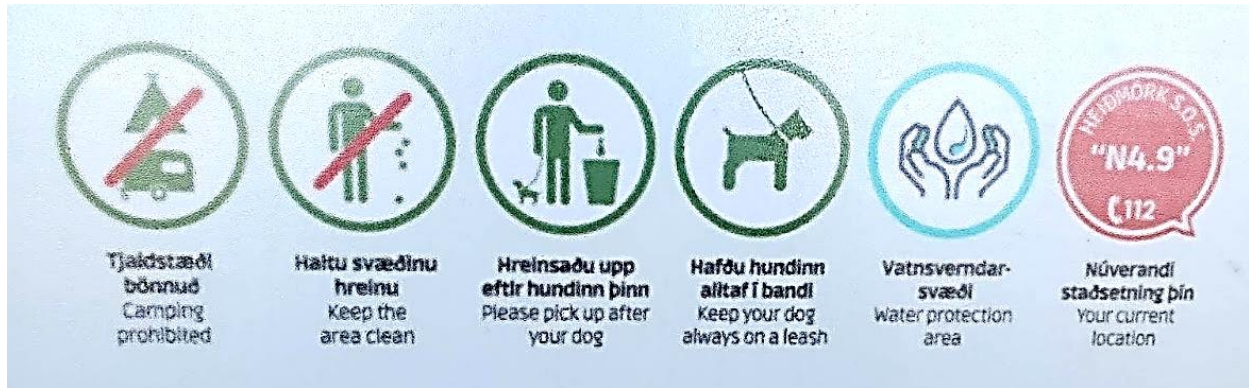
The symbols on the map were simple and universal. Additionally, the labels for each symbol were written in Icelandic and English. The explanations of each symbol are shown in **Figure 12**.

*Figure 12. Legend of symbols in both Icelandic and English at Heiðmörk.*

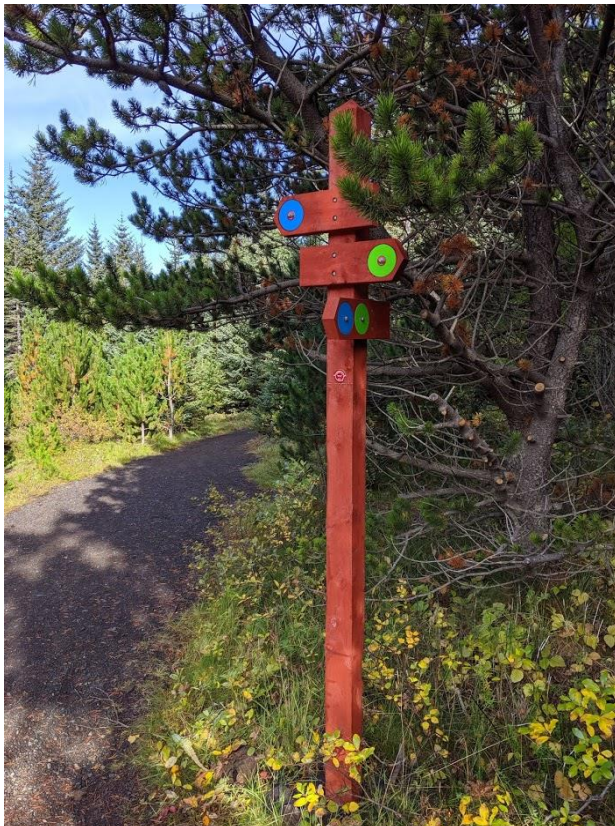
Another observation was how well-marked each trail junction was. **Figure 13** shows a signpost similar to the ones at every trail junction. The trail marking posts were very visible in a bright red color. Again, a person with colorblindness would not have the same experience we did. There were also arrows pointing from the posts that are marked with a particular color corresponding to each trail. This format of trail marking seems very easy to understand, even for international tourists such as ourselves.

*Figure 13. A trail marker showing the divergence of the blue and green trails at Heiðmörk.*

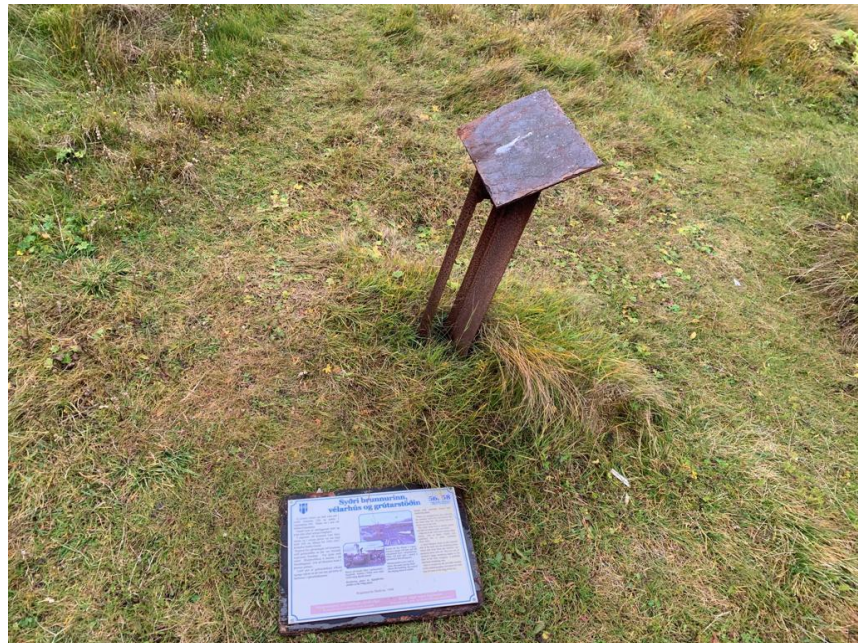
However, once we began hiking the trail, we found the trail's markings and signs poorly kept and unclear. While the path was easy to follow itself, the trail markings often had faded paint and blended in with the surrounding tall grass. This made it more likely to accidentally walk off the trail, which was especially dangerous on the island. One of our team members ventured off the path and repeatedly found that the long grass concealed deep holes in the ground. Many of the signs were also in disrepair, as shown in **Figure 14**. There was also

*Figure 14. Broken sign on Viðey Island.*

We encountered many signs and trail markers in poor condition. The signs and markers have to be able to endure the heavy precipitation that is typical of Iceland. We recommend that trail signs be evaluated on a yearly basis to see if they are still intact and legible.

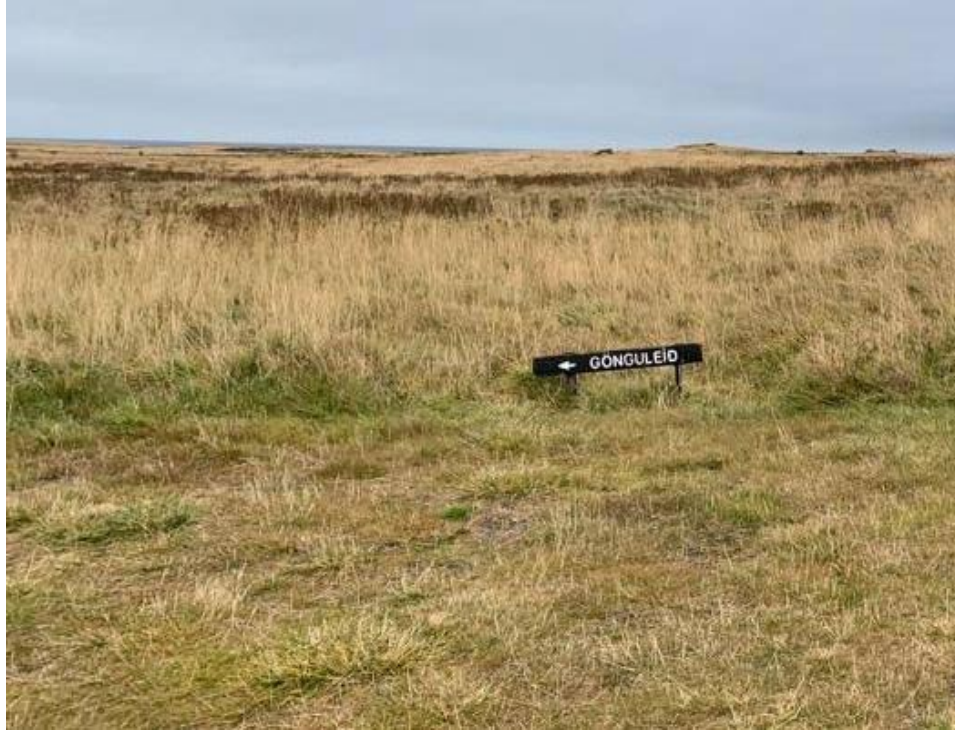
very little signage. As **Figure 15** shows, simple markers with Icelandic names pointed out trails. Even though we encountered several of these signs, they did not exist at every trail junction.

*Figure 15. Trail sign on Viðey Island.*

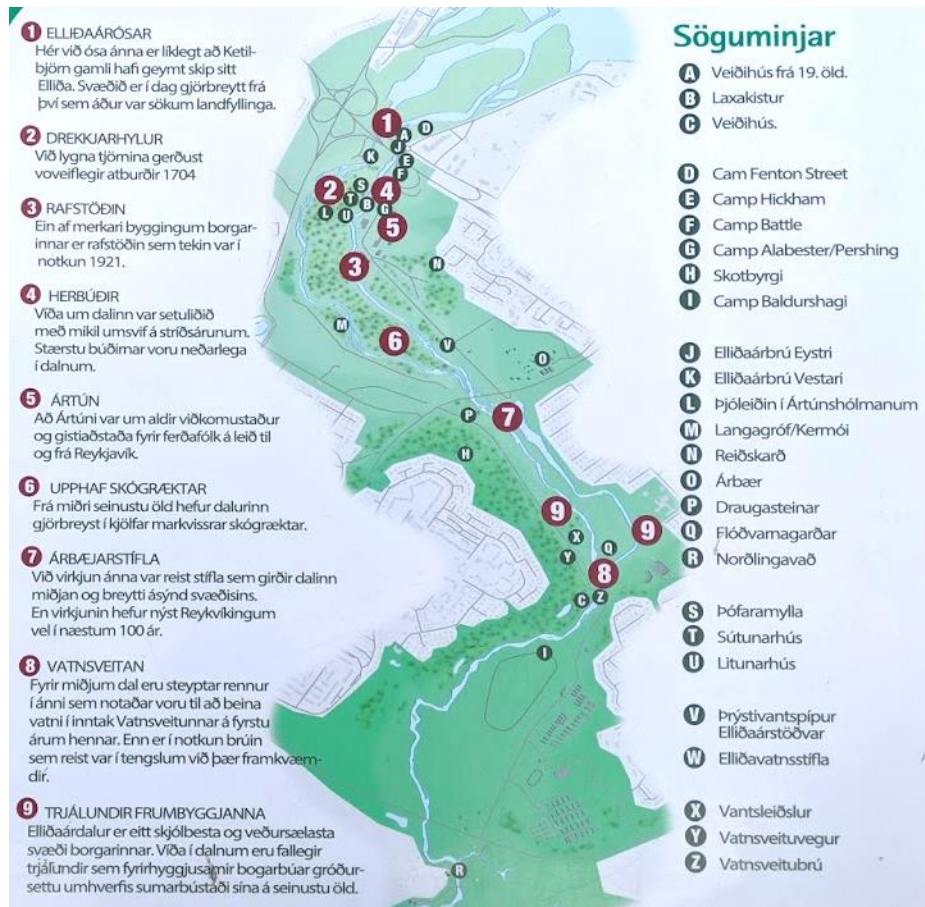
*Figure 16. A map of Elliðaárdalur, entirely in Icelandic.*

As American tourists, we were unable to understand this map. Every point is in Icelandic and we failed to determine even our current position. We began walking and immediately ended up missing a turn into the main area of the island. As is shown by our GPS route in Appendix G, we turned around on the path and walked back towards the island. Quickly we realized there was no danger of getting lost in this area, so markers were not required. However, with English maps or arrows at crossroads like the one shown in **Figure 17**, our group would not have missed the turn and would have taken a different path through the island.

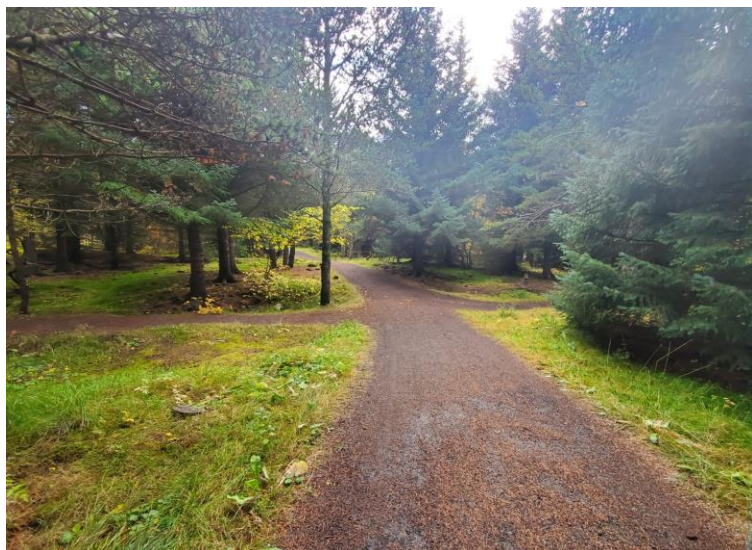
*Figure 17. Crossroads at Elliðaárdalur with no markings.*

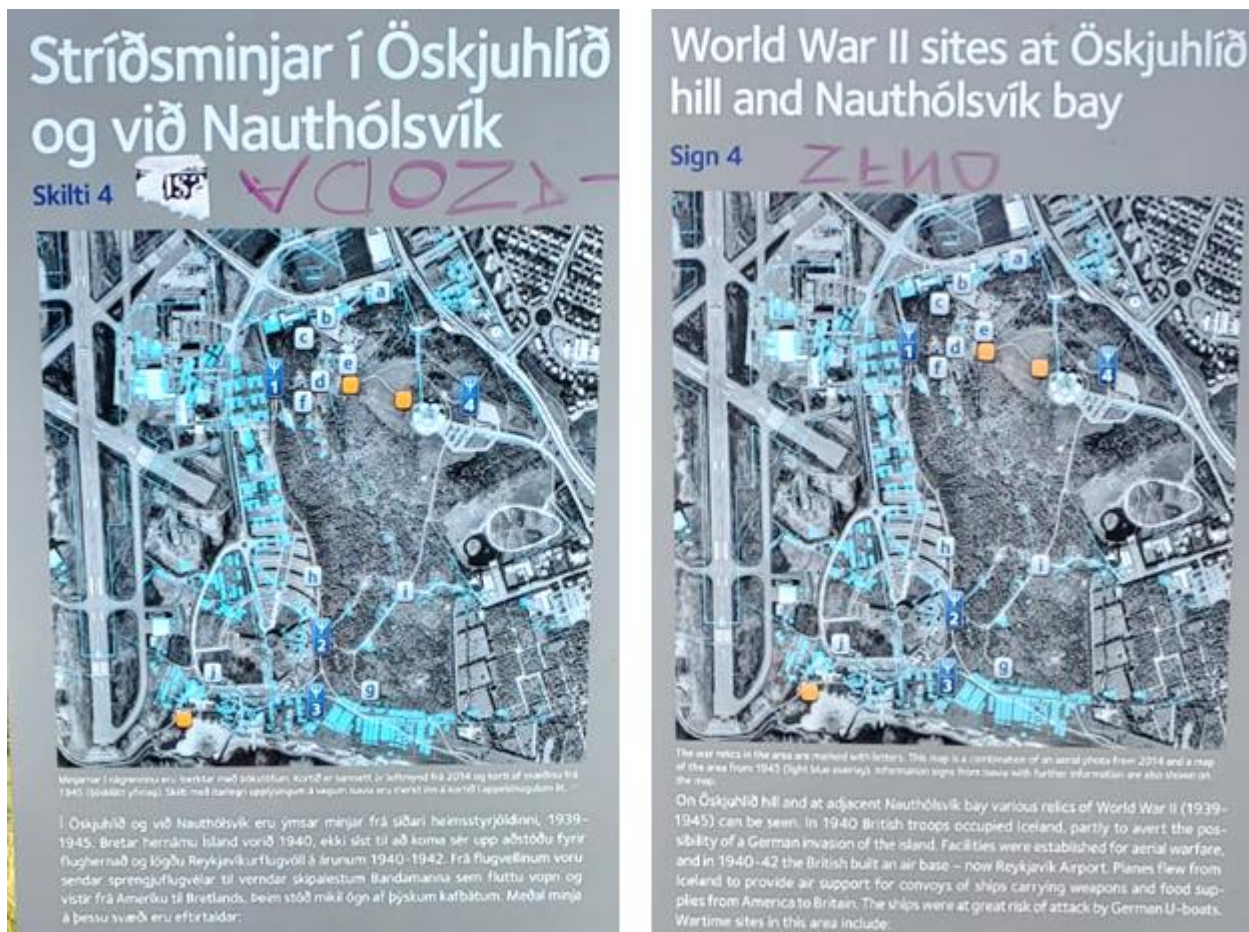
*Figure 18. Icelandic and English signs from Öskjuhlíð.*

The map on this sign was helpful in making a plan for the hike, but a lack of trail markers prevented us from following this plan. We inadvertently traveled south, as can be seen in Appendix H, before realizing and having to turn around. We did not encounter a single trail marker on our entire hike, making it difficult to stay on the path we wanted. The map was difficult to understand. The light blue markings on the map represent historical structures and

paths, but the orange markers were not explained on the sign. While our group found this data interesting, it hindered our understanding of the map.

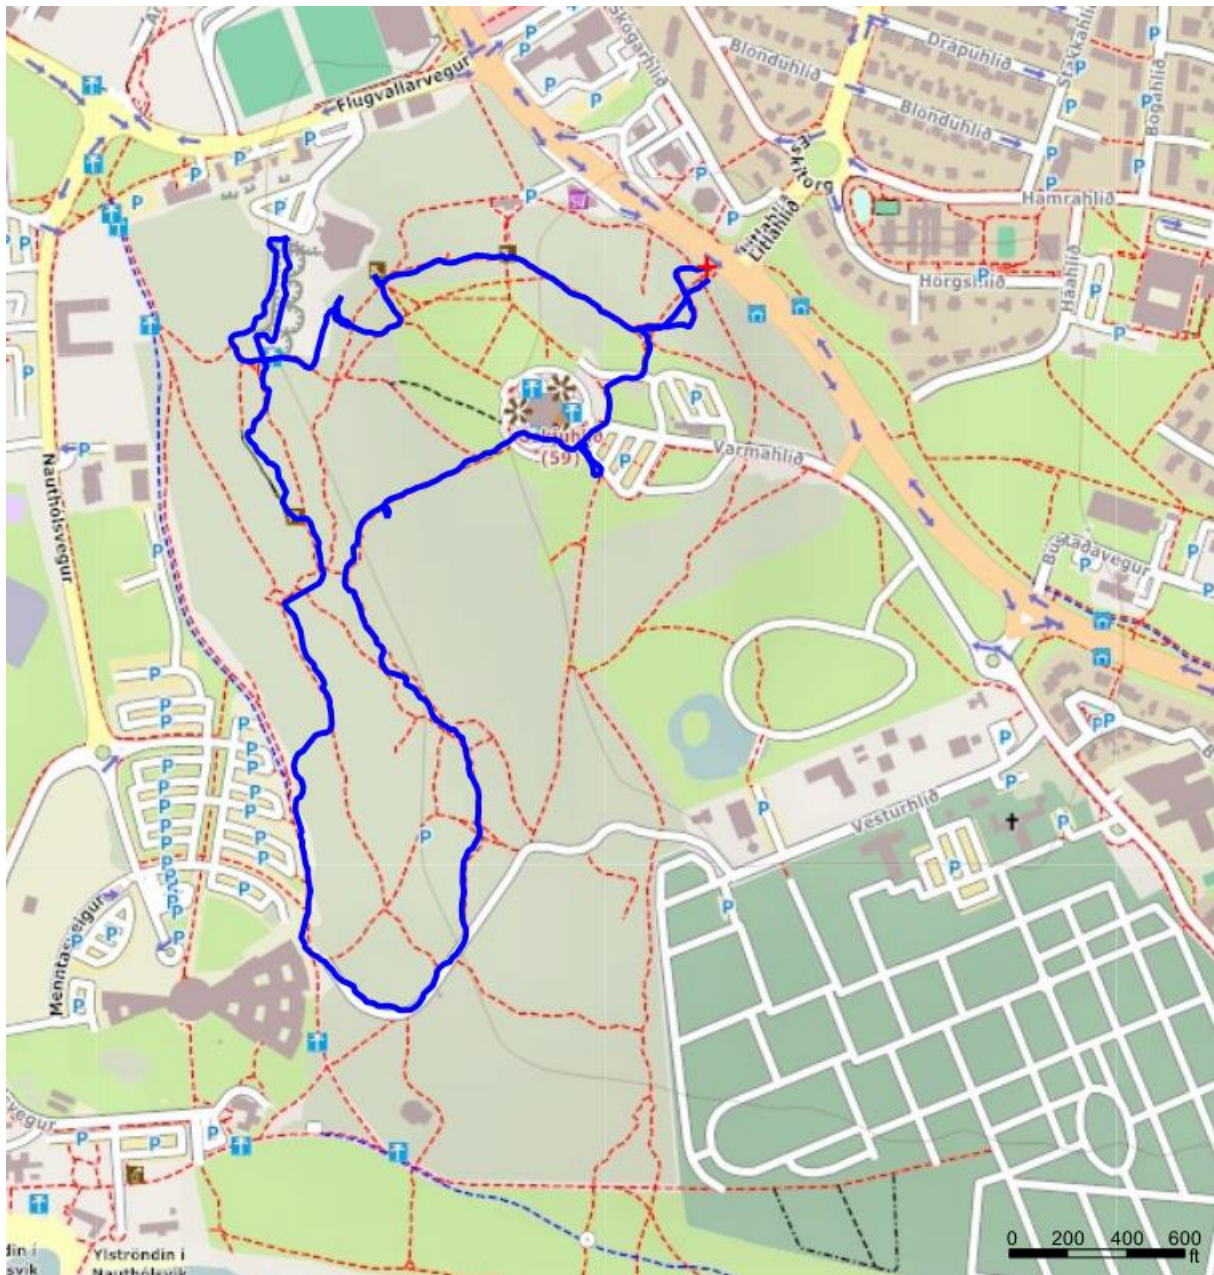
## Appendix H

This map shows the route we traveled through Öskjuhlíð. We had intended to go to the northern section first, but inadvertently ended up hiking south. Once we realized this, we made the wide turn at the bottom of the route and traveled back to the northern part of Öskjuhlíð.
