Project Number: RRHPL00-47

PRODUCTS LIABILITY
An Interactive Qualifying Project
Submitted to the Faculty
of the
WORCESTER POLYTECHNIC INSTITUTE
in partial fulfillment of the requirements for the
Degree of Bachelor of Science

Table of Contents

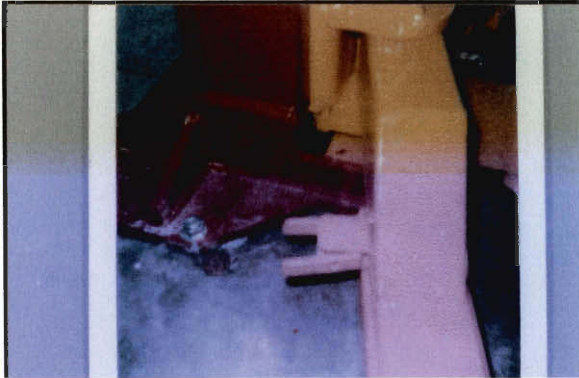
These two pictures show the actual lifting arms of the lift. The pictures also help to show that there were no safety restraints in place. It also shows where the restraints should have been.

The problem that comes about in this case with the ANSI standards is that at the time when the lift was built, 1984, it met the standards that were needed for that time. However, at the time when Mr. Dellea purchased the lift, 1992, it was reconditioned and therefore should have met the new standards that ANSI required. Those standards were that there needed to be safety restraints to prevent the arms from swinging out from underneath the car.

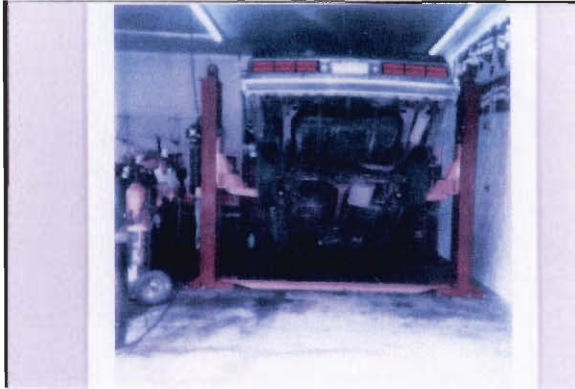
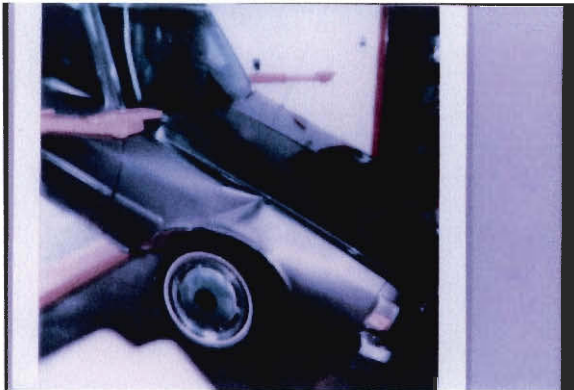
These two pictures show the car after it fell off the lift. The above picture shows how the lifting arm swung out and hit Mr. Dellea from his working position on the left. The bottom picture gives a better picture of how the arms swung out and the damage that was caused due to the lift.

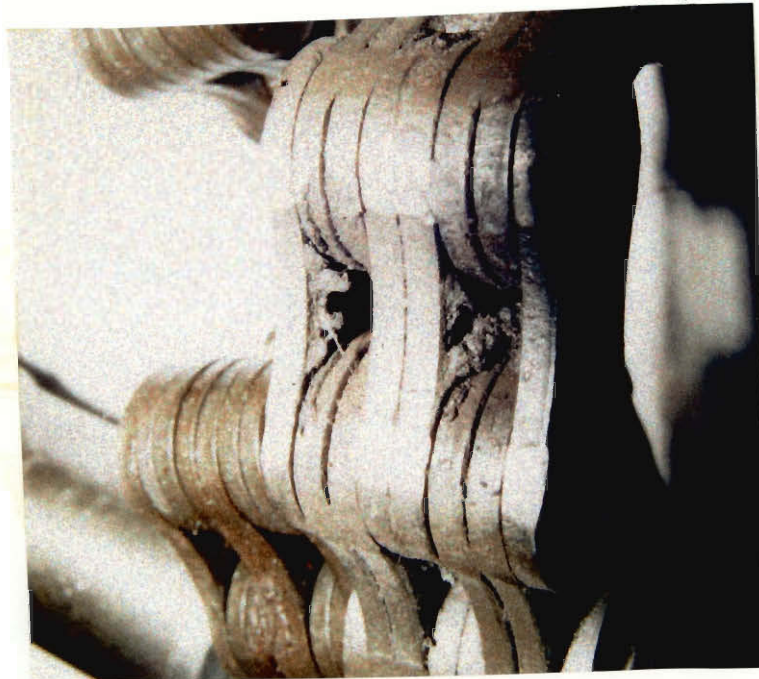
Figure 4:

Figure 4 shows one of the chains, which broke due to the combination of poor lubrication, misalignment and exertion of too great a force. You can see from the picture that some links did not receive proper lubrication. This resulted in a number of stiff links that would not move.

of to repair the machine. He recommended a larger chain size, which had been discussed by the staff of NAPCO previously. And with the larger chain must be installed a larger brush to lubricate.

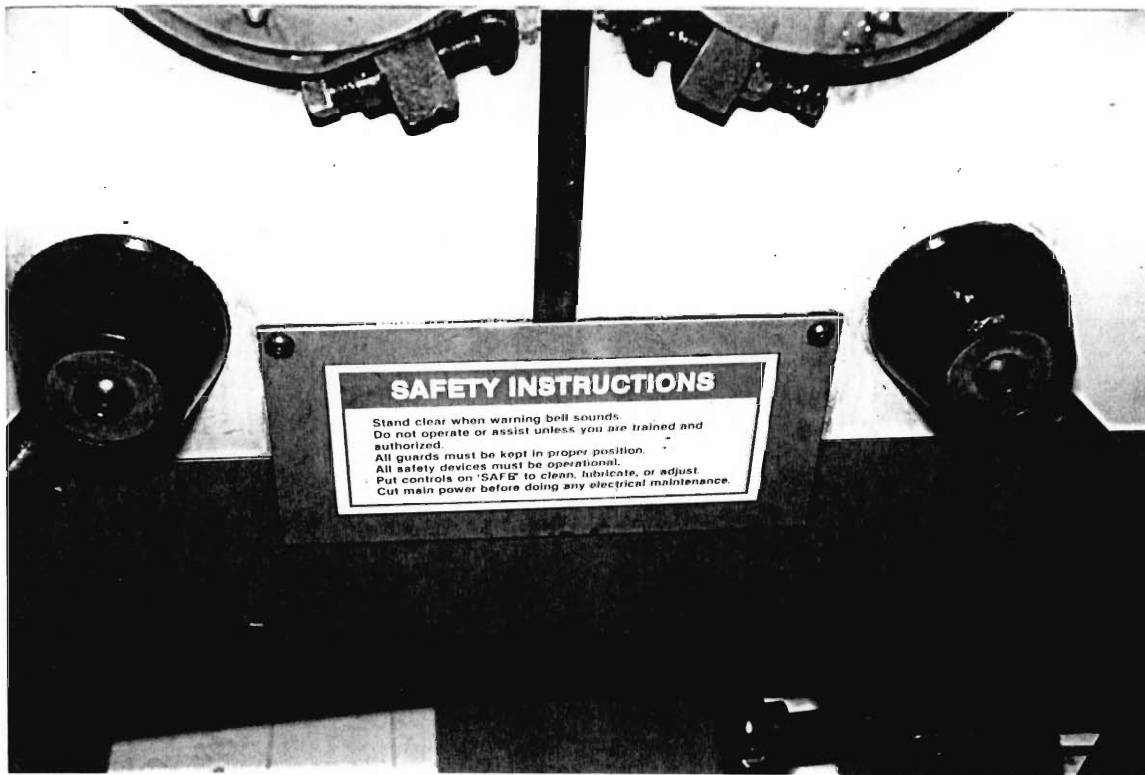
This is a picture of the safety instructions that Mr. Ankenman failed to follow.
