Incorporating cinnamaldehyde into concrete for corrosion mitigation

A Dissertation

Submitted to the Department of Civil and Environmental Engineering

WORCESTER POLYTECHNIC INSTITUTE

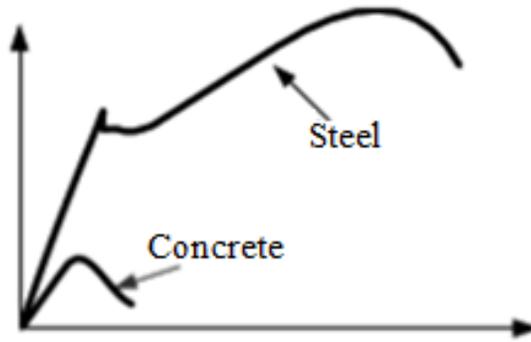
**Figure 1:** Failure behaviors of concrete and steel [15]

Concrete without any reinforcing steel is quasi-brittle and exhibits strain-softening behavior. The steel reinforcement, however, displays ductile behavior and can produce large deformations prior to failure. Thus, the load-displacement responses of these two materials can be observed in Figure 1 (*overleaf*), where the failure behaviors are compared and displays how the steel reinforcement assists with tension; the tension strength of concrete is roughly 1/10 of its compressive strength. The areas under the load-displacement curves also show the toughness of the materials; toughness is described as the material's ability to consume energy. Concrete has a low toughness, close to 1/50 to 1/100 of steel [15].

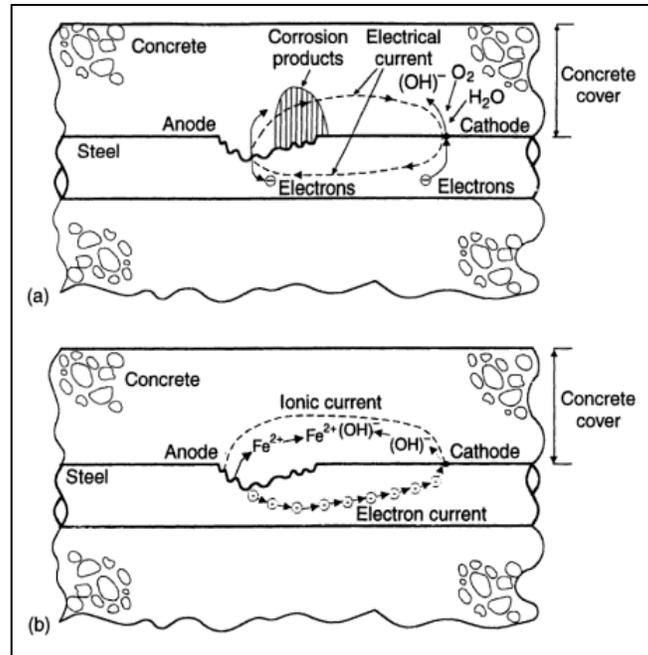
**Figure 2:** Process of corrosion of steel reinforcement in concrete  
 “Bentur, A., N. Berke, and S. Diamond, *Steel corrosion in concrete: fundamentals and civil engineering practice*. 1997: CRC Press.”

Corrosion of the embedded steel in concrete is an electrochemical process where corroded steel is transferred into the pore solution and gives up electrons at the anode as shown in Figure 2 (*overleaf*). Two electrons are given up in the anodic reaction that are consumed along with water and oxygen at the cathode (equations 9 and 10). One way that a reaction can continue and form rust is through ferrous hydroxide turning into ferric hydroxide, which in turn becomes ferric oxide (rust) (equations 11-13) [24, 25].

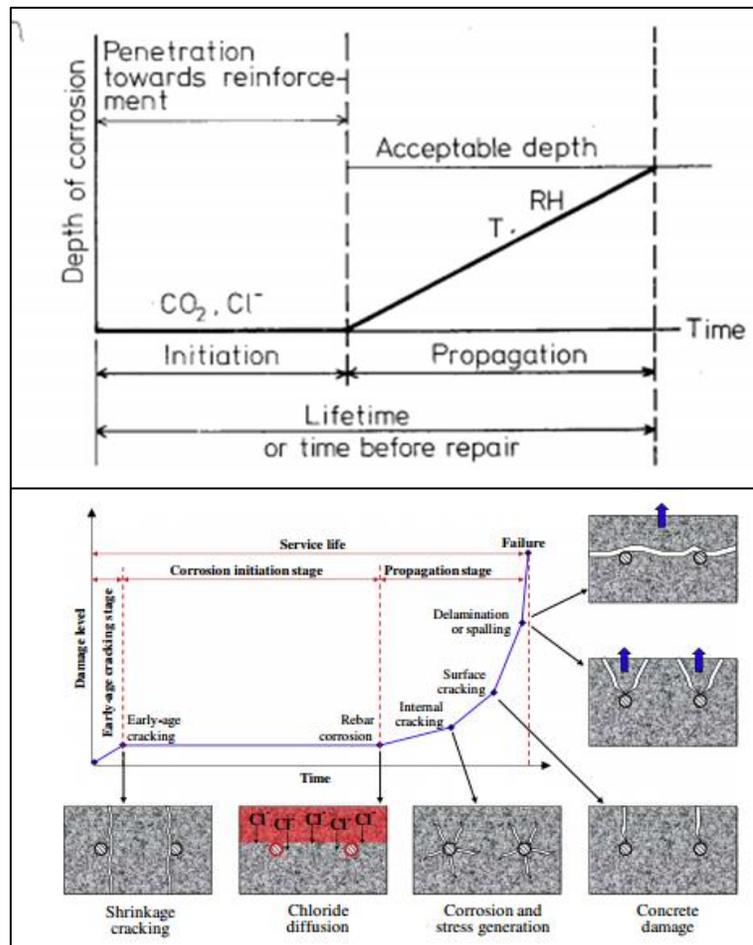
**Figure 3:** (a) Tutti's model of corrosion (*top*) [28] and (b) expanded corrosion model (*bottom*) [29]

loss and therefore create a reduction of its cross-sectional area; this can result in a reduction of the mechanical properties of the steel as well as impact the cosmetics of the structure [20, 21, 24]. The Tutti model describes corrosion of reinforcing steel due to both carbonation and chloride ingress as shown in Figure 3 (a) (*overleaf*). Once CO<sub>2</sub> or chlorides diffuse through the concrete, corrosion is initiated until it reaches its threshold; once the threshold is reached corrosion is propagated and will continuously increase over time [28]. Cusson *et al.* produced a more detailed model of corrosion, based on the Tutti model as shown in Figure 3 (b) (*overleaf*) [29]. This model accounts for premature causes for deterioration such as early-age cracking as well as the gradual processes that lead to a concrete structure’s failure.

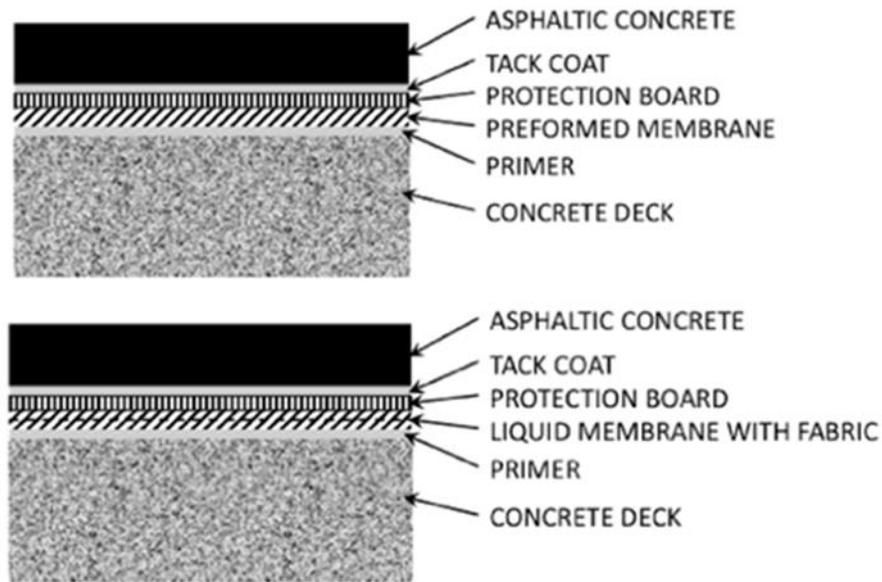
**Figure 5:** A common technique of preformed waterproofing membrane (*top*) as well as liquid membrane (*bottom*). [34].

Waterproofing membranes can be preformed or liquid barriers. Preformed membranes are commonly installed by first placing a primer onto the concrete deck as way to strengthen the bond between the membrane and the deck. Following the primer, the membrane can be laid; many times the membrane is a sheet that can be rolled on top of the deck (and primer) with a self-adhesive back. Some membranes can adhere to the deck by the use of heat (e.g., a hand torch). As for a liquid membrane, it also has a primer placed first as with the preformed membranes. The liquid membrane is then applied through spray or roller and is described as similar to rubberized asphalt, two-component polymer, polyurethane, methyl methacrylate, rubber polymer, polymer-modified asphalt, or rubberized bitumen [34]. Many times, in order to avoid destruction of the membrane during construction, a protection board is used. The material of the protection board can be roofing felt or an asphalt-felt. A finishing bond, known as the tack coat, is placed to create a stronger bond between protection board and the layer of asphalt concrete commonly made of a layer of bituminous material a base course. The asphalt concrete becomes the wearing course [33, 35]. The two waterproofing membranes are illustrated in Figure 5 (*overleaf*).

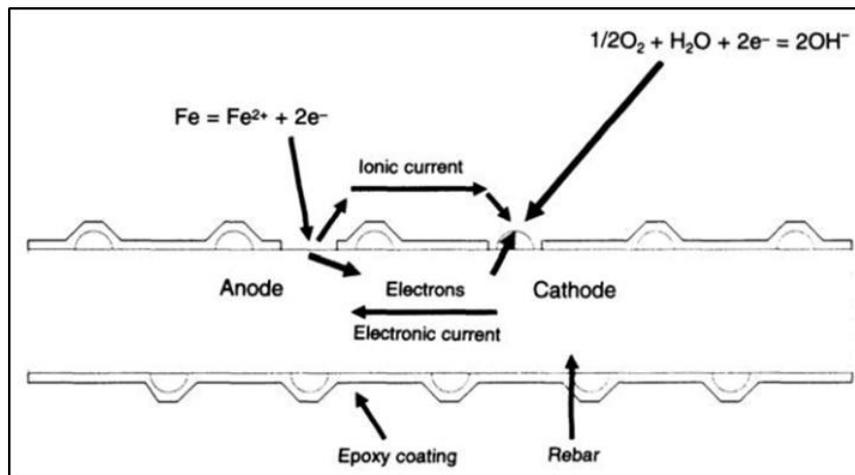
**Figure 6:** Epoxy-coated steel reinforcement undergoing corrosion. Corrosion remains localized [24].

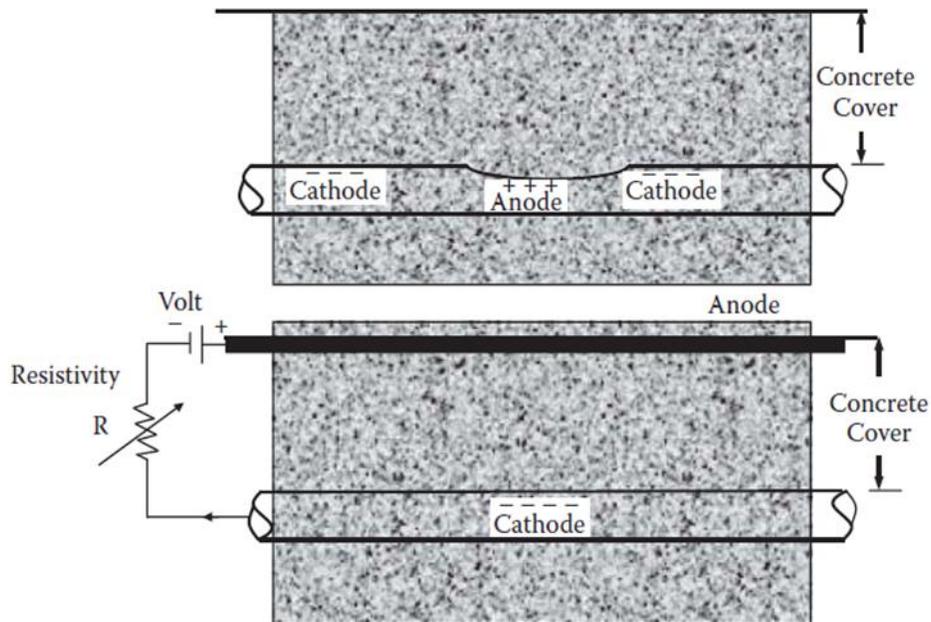
**Figure 7:** Cathodic protection method using sacrificial anode [43]

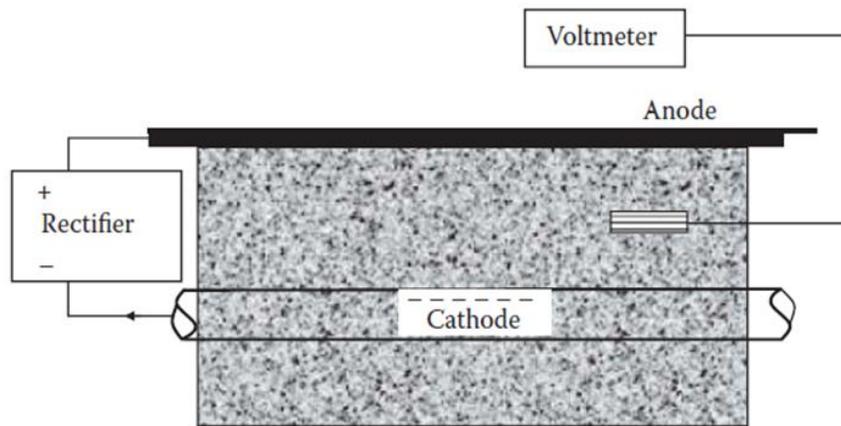
**Figure 8:** Cathodic protection method using an impressed current [43]

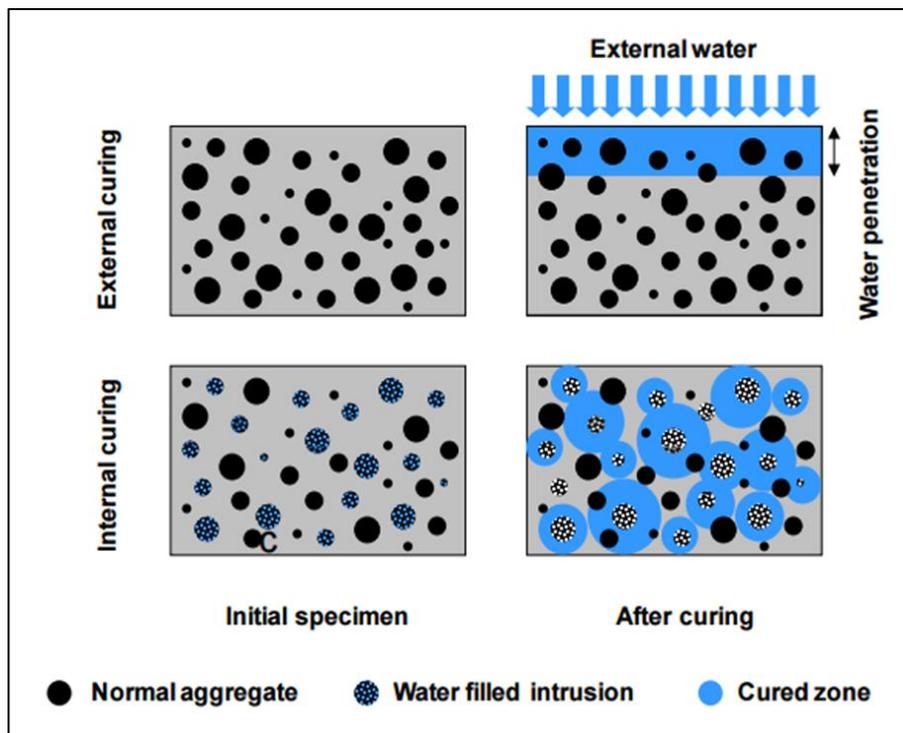
**Figure 9:** Illustration of the use of LWA for internal curing as opposed to the traditional external curing. When concrete is externally cured, water penetrates from the surface and does not hydrate the cement particles within the specimen. However, by including LWA pre-soaked in water, the cement within the specimen can become hydrated and prevent early age cracking [58]

Conventionally, LWA is pre-wet with water and included into a cementitious mix to reduce early age cracking; this can be referred to as *internal curing* as shown in Figure 9. Once the pre-soaked LWA is added to a mix, over time an internal drop in humidity due to cement hydration will occur and cause the liquid absorbed by the LWA to be released [57]. The purpose of internal curing stems from the need to alleviate effects due to cement hydration and chemical shrinkage, which cause early-age cracking (see *Mix design*, section 2.7, below). Chemical shrinkage occurs when the reactants (cement and water) take up more space than the products. After the cement paste is set, it may further shrink due to self-desiccation if it is not exposed to

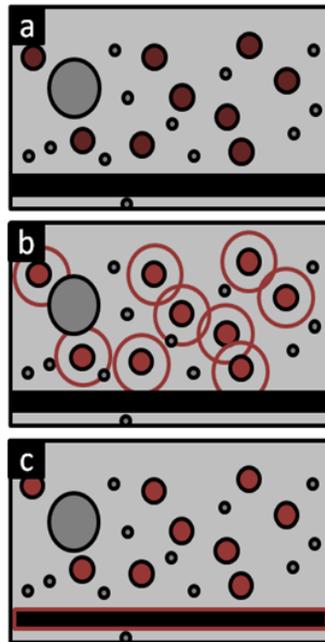
**Figure 10:** Schematic representation of the composite system, CA encapsulated in LWA a) the fresh mix contains cement (light gray), normal aggregate (dark gray spheres), LWA filled with bioactive agent (red), and a piece of rebar (black bar). Because the bioactive agent is 'locked away' it cannot interfere in the development of early age properties. b) After set, water is consumed in hydration reactions, leading to a pressure gradient that forces some bioactive agent to migrate out of the LWA. c) Over time, bioactive agent builds up on the surface of rebar and begins to play a role in corrosion mitigation.

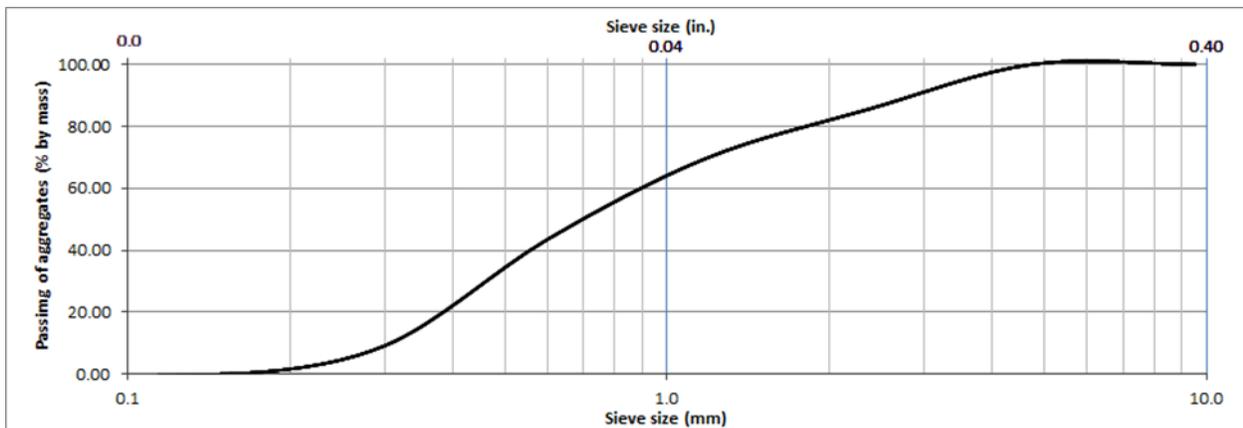
Figure 11: Sieve distribution of sand

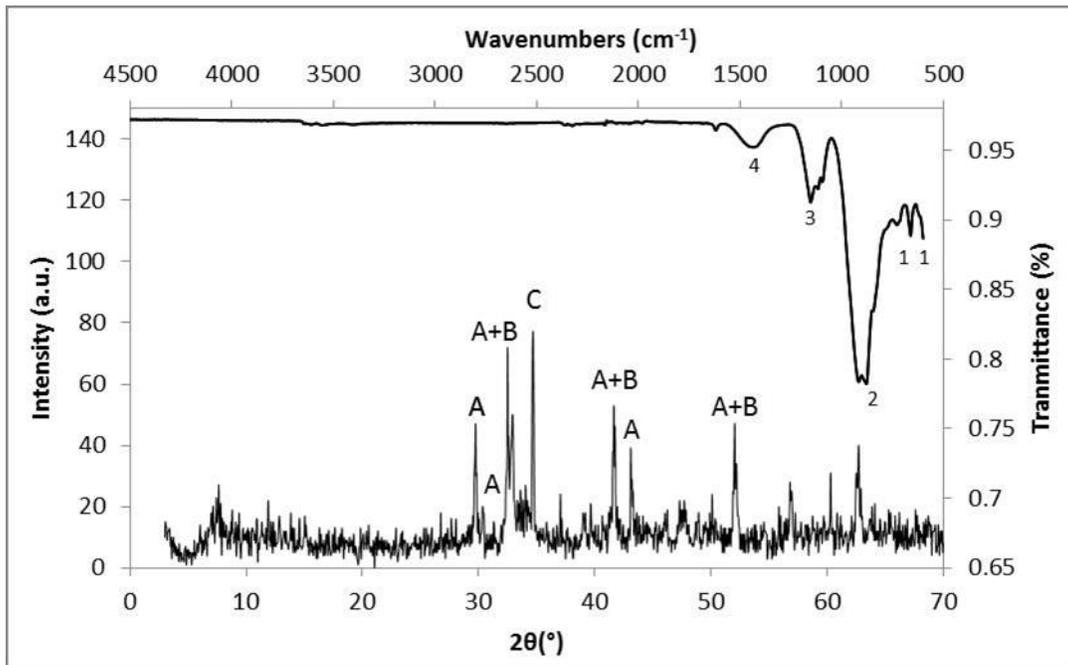
**Figure 13:** XRD (primary axes) and FTIR spectra (secondary axes) of the OPC. A = alite; B = belite; C = celite. Bands at 1 =  $601.8\text{ cm}^{-1}$  and  $663.5\text{ cm}^{-1}$  were due to Si-O vibrations; the band 2 =  $881.5\text{ cm}^{-1}$  was due Si-O, Al-O,  $CO_3^{2-}$  vibrations; the band at 3 =  $1153.4\text{ cm}^{-1}$  was due to S-O vibrations; and the band at 4 =  $1438.9\text{ cm}^{-1}$  was due to  $CO_3^{2-}$ .

All mixes were prepared with commercially available ASTM C150 Type I/II cement. X-ray diffraction (XRD) and Fourier transform infrared spectroscopy (FTIR) were conducted on the as-received ordinary portland cement (OPC) for quality control purposes as illustrated in Figure 13. Alite ( $C_3S$ ), belite ( $C_2S$ ), and celite ( $C_3A$ ) were detected by XRD. Five bands were identified with FTIR. Bands at  $601.8\text{ cm}^{-1}$  and  $663.5\text{ cm}^{-1}$  were due to Si-O vibrations; the band at  $881.5\text{ cm}^{-1}$  was due to Si-O, Al-O,  $CO_3^{2-}$  vibrations; the band at  $1153.4\text{ cm}^{-1}$  was due to S-O vibrations; and the band at  $1438.9\text{ cm}^{-1}$  was due to  $CO_3^{2-}$ . These results are consistent with standard ready-mix OPC.

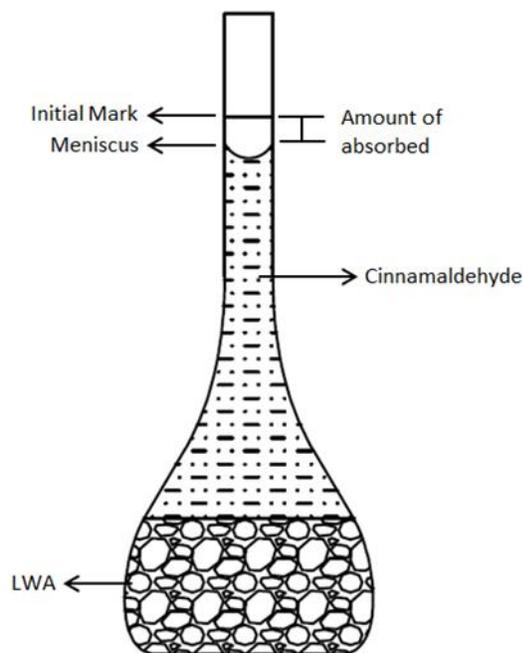
**Figure 15:** Schematic of absorption study of LWA

A similar approach to Castro *et. al* was carried out for this program and is illustrated in Figure 15 (*overleaf*). A 50 ml volumetric flask was filled with ~9.8 g (0.35 oz.) of LWA following the distribution described in section 2.1.2 and water was poured on top to fill the flask up to its meniscus. The same method carried out by Castro *et. al* was used, in which the flask

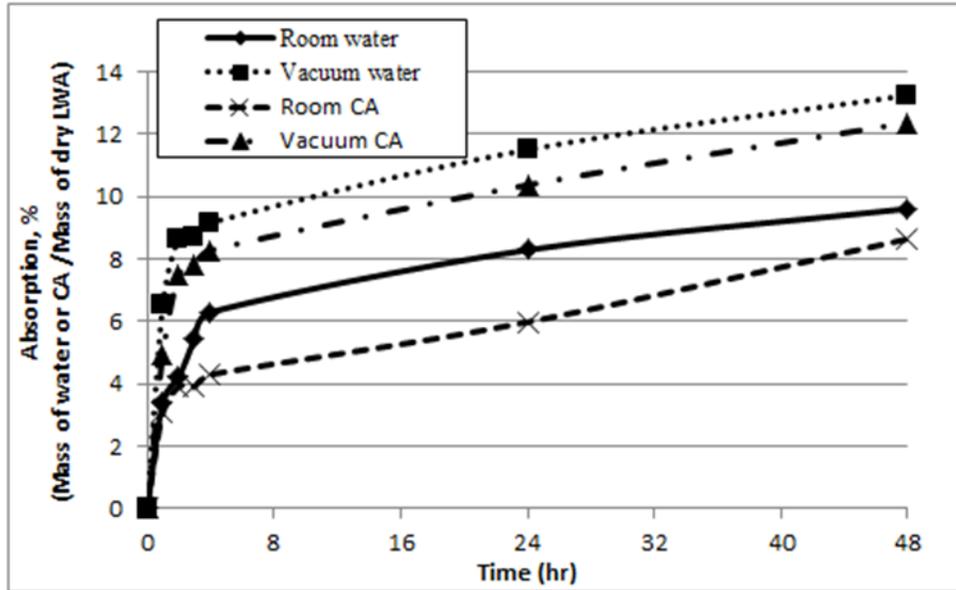
Figure 16: Absorption results

Although the recordings were taken at 0, 1, 2, 3, 4, 24, and 48 h, the time of particular interest was at 24 h since the maximum time for which LWA was soaked in liquid (CA or water)

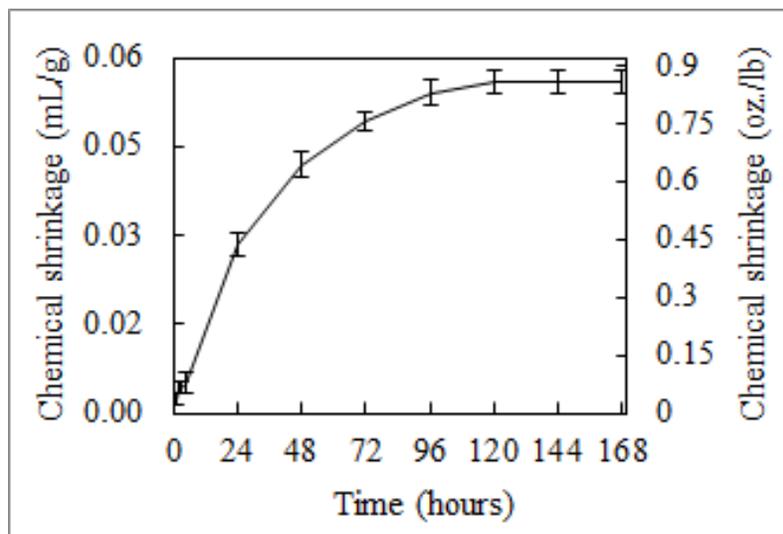
**Figure 17:** Chemical shrinkage of cement paste measured over seven days (168 h).

where  $M_{LWA}$  is the mass of LWA;  $C_f$  is the cement factor;  $CS$  is the chemical shrinkage of the binder (determined using ASTM C1608 [65] – Figure 17);  $\alpha_{max}$  is maximum degree expected for

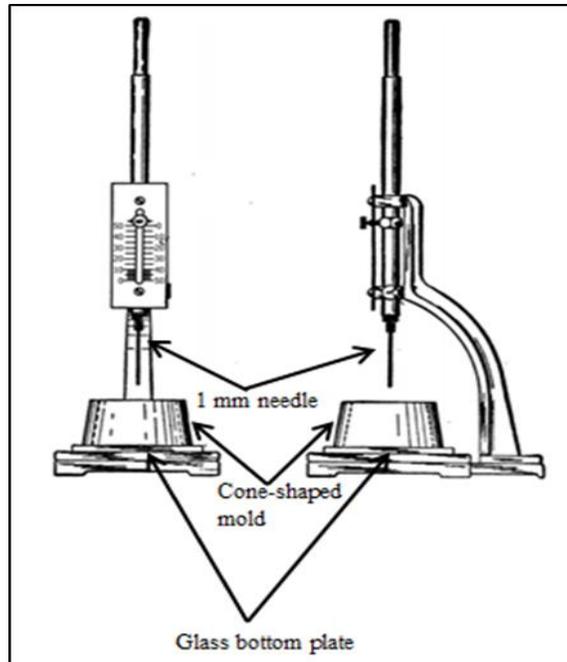
**Figure 18:** Vicat apparatus [69]

Setting time was determined in accordance with ASTM C191 using the Vicat apparatus shown in Figure 18 (*overleaf*) [68]. The Vicat test method uses a 1-mm needle to measure the penetration depth of the needle into the cementitious sample. After mixing the sample, it was immediately placed into a lubricated cone-shaped mold with a glass bottom plate. The sample was then leveled off with a metal spatula to ensure accurate penetration measurements across the top

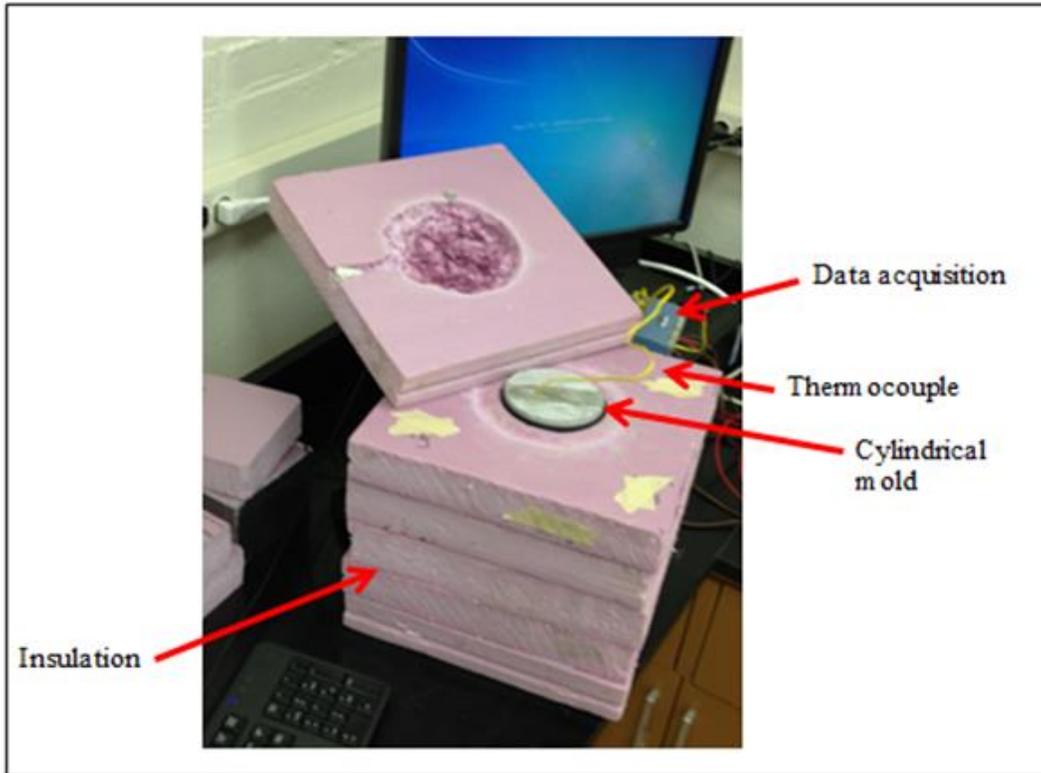
**Figure 19:** Semi-adiabatic calorimetry setup

A similar custom-built setup has been used in previous research when evaluating the temperature rise of phase change materials (PCMs) in mortar [71]. Mortar samples were cast in 2 x 4 in. (47 x 97 mm) cylindrical molds where a type J thermocouple was embedded within the center of the sample and placed inside microporous insulation. This kind of custom-made semi-

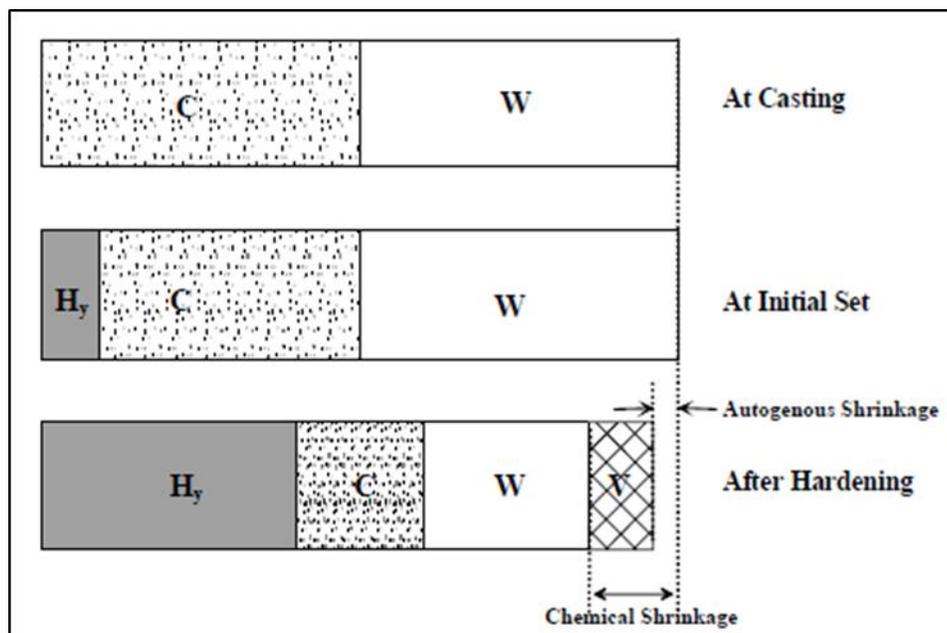
**Figure 20:** Schematic of relationship of chemical and autogenous shrinkage of a cement paste. C = unhydrated cement, W= water, Hy = hydration products, V = void created by hydration [75].

Autogenous shrinkage was measured for the mortar samples according to ASTM C1698 [73]. This test quantifies the bulk strain of a sample. Since chemical shrinkage is due to the hydration of cement particles it results in an ‘internal’ volume reduction. Autogenous shrinkage causes a net deformation to the system and therefore is considered as an ‘external’ volume change. The two forms of shrinkage are compared in Figure 20 [74]. This test was conducted as an indirect

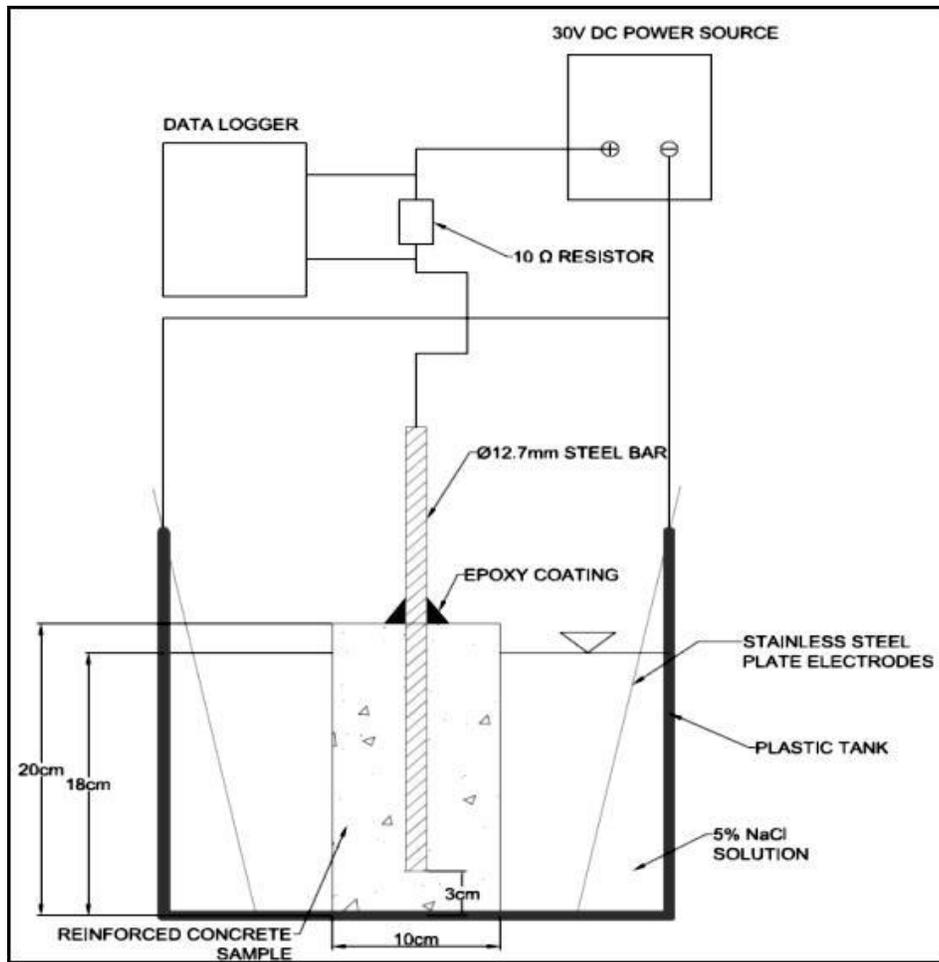
Figure 21: Schematic of accelerated corrosion test (ACT)

Here, three samples were investigated per mix design. Mortar was placed into a 4 x 8 in. (100 x 200 mm) cylinder, and a jig was used to hold a 0.5 in. (12.7 mm) piece of wire-brushed steel rebar in the center. Although wire brushing may not be the ideal pre-treatment of reinforcing steel due to the possibility of residual rust remaining on the steel, it was consistently carried out and therefore reduced the risk of error in the testing process. Epoxy coating was used

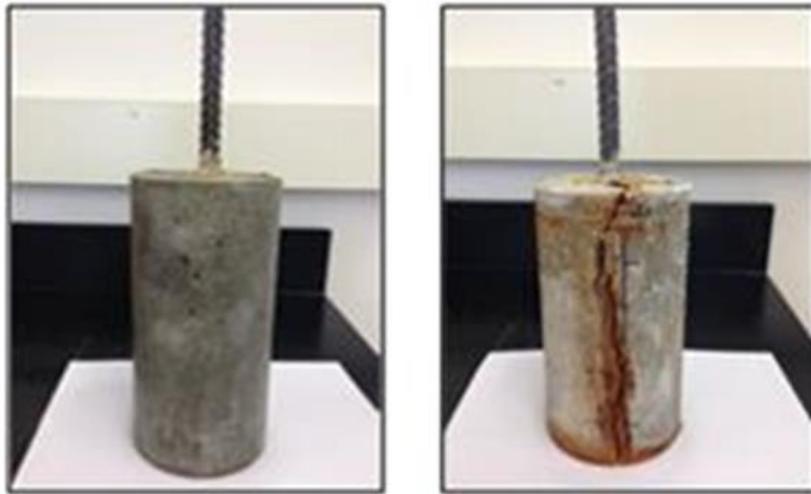
**Figure 22:** Lollipop sample prior to ACT (left); failure of sample after undergoing ACT (right)

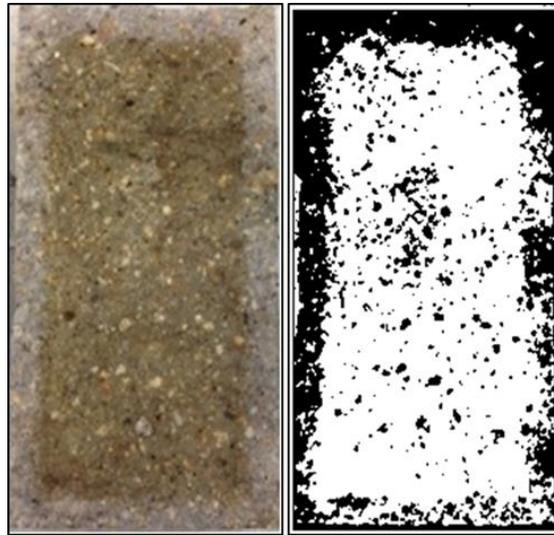
**Figure 24:** Split cylindrical sample after sprayed with silver nitrate. The light gray around sample indicates the depth of chloride ingress (left) and the binarization of the sample using ImageJ where the black indicates chloride ingress (right).

In this research program, mortar (three samples per mix) was placed in 4 x 8 in. (100 x 200 mm) cylinder molds. After 28 d curing, the cylinders were each immersed in a 5 % (by mass) NaCl solution stored in a sealed plastic tank for 3 m. The samples were removed from the solution, split lengthwise, and sprayed with silver nitrate. As seen in Figure 24 (left) the silver

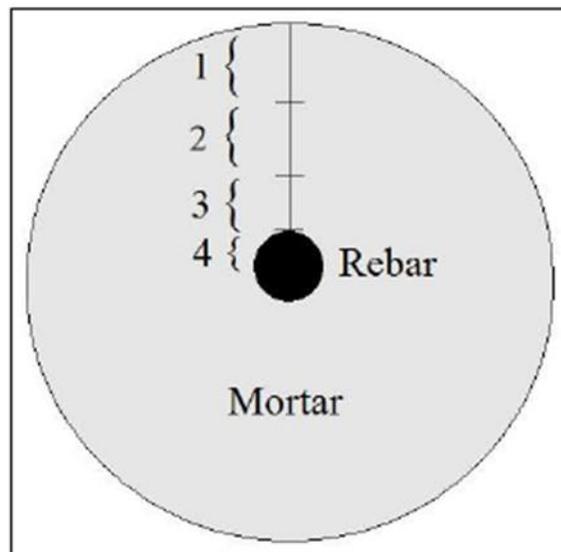
**Figure 25:** A top view of the sample section along with the four depths that were drilled out and tested for chloride content through ion chromatography. (1) is the powdered mortar collected from the depth of surface to ½ in.; (2) is the powdered mortar collected from the depth of ½ in. to 1 ½ in.; (3) is the powdered mortar collected from the depth of 1 ½ in. to 2 in.; (4) is the powdered mortar collected along the length of the mortar-rebar interface.

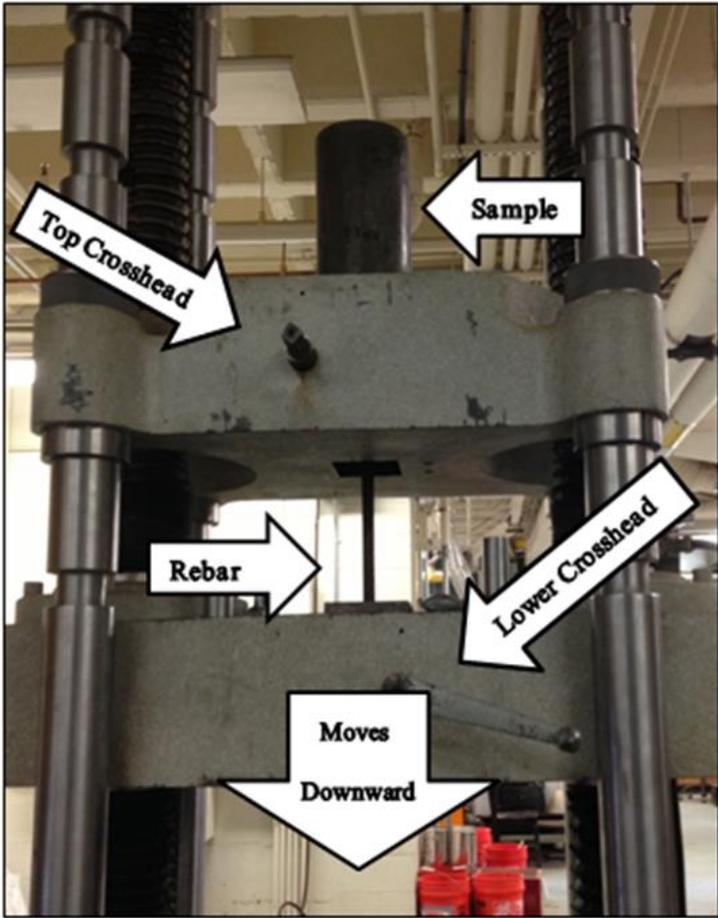
Figure 26: Pullout setup

Samples were prepared by placing mortar into 6 x 12 in. (152.4 x 304.8 mm) cylinders and embedding a 3/4 in. (19.1 mm) wire-brushed rebar of 3 ft. (91.4 cm) length in the center. To ensure perpendicular alignment a jig was made to hold the rebar in place. Once cured for 28 d, the samples (three for each mix) were placed on the top crosshead of a load frame where the rebar ran through the lower crosshead and was secured by jaws as shown in Figure 26. A shim

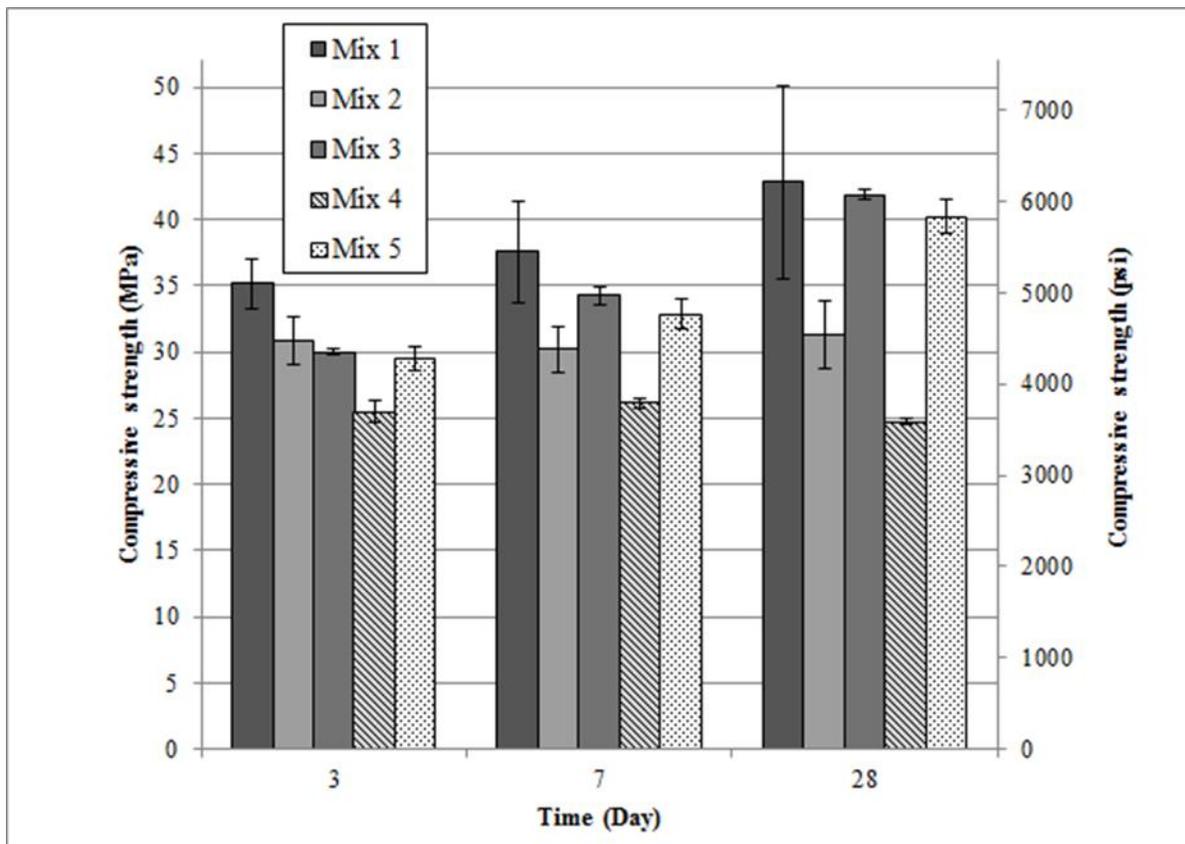
Figure 28: Compressive strength of mortars at days 3, 7, and 28 as tested by ASTM C109

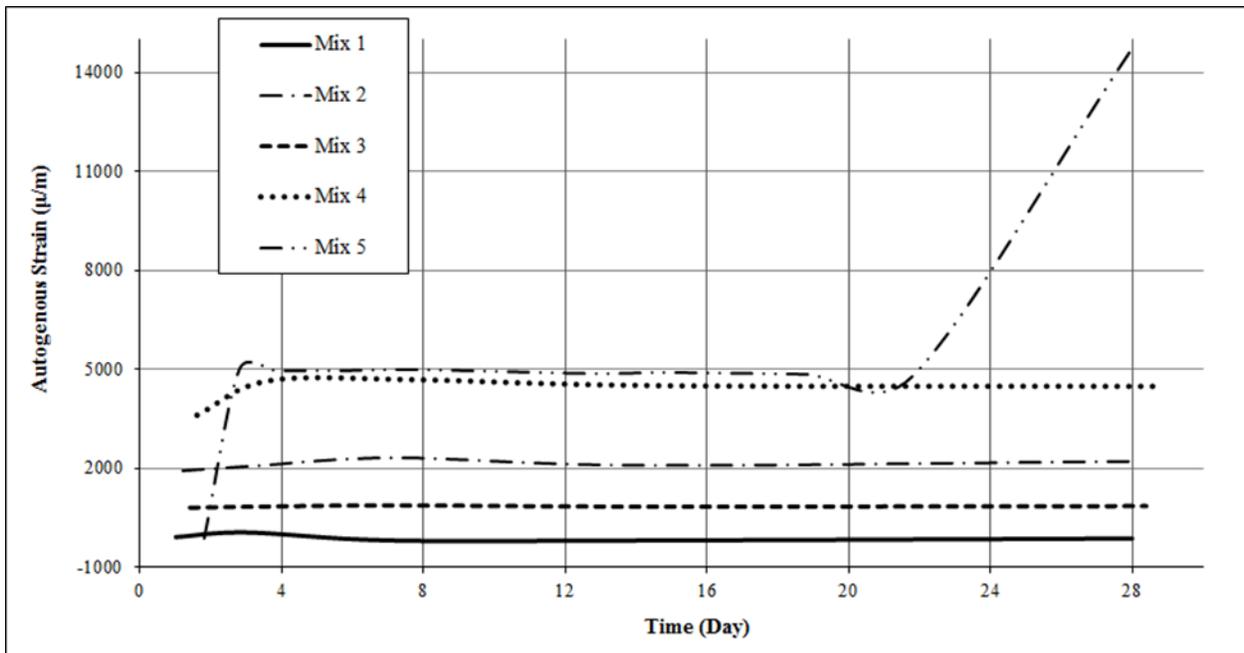
Figure 30: Autogenous strain

Autogenous shrinkage was measured to evaluate if the stored liquids (CA, PCI, or water) were being released from the pores of the LWA. The results are shown in Figure 30. Exhibiting an

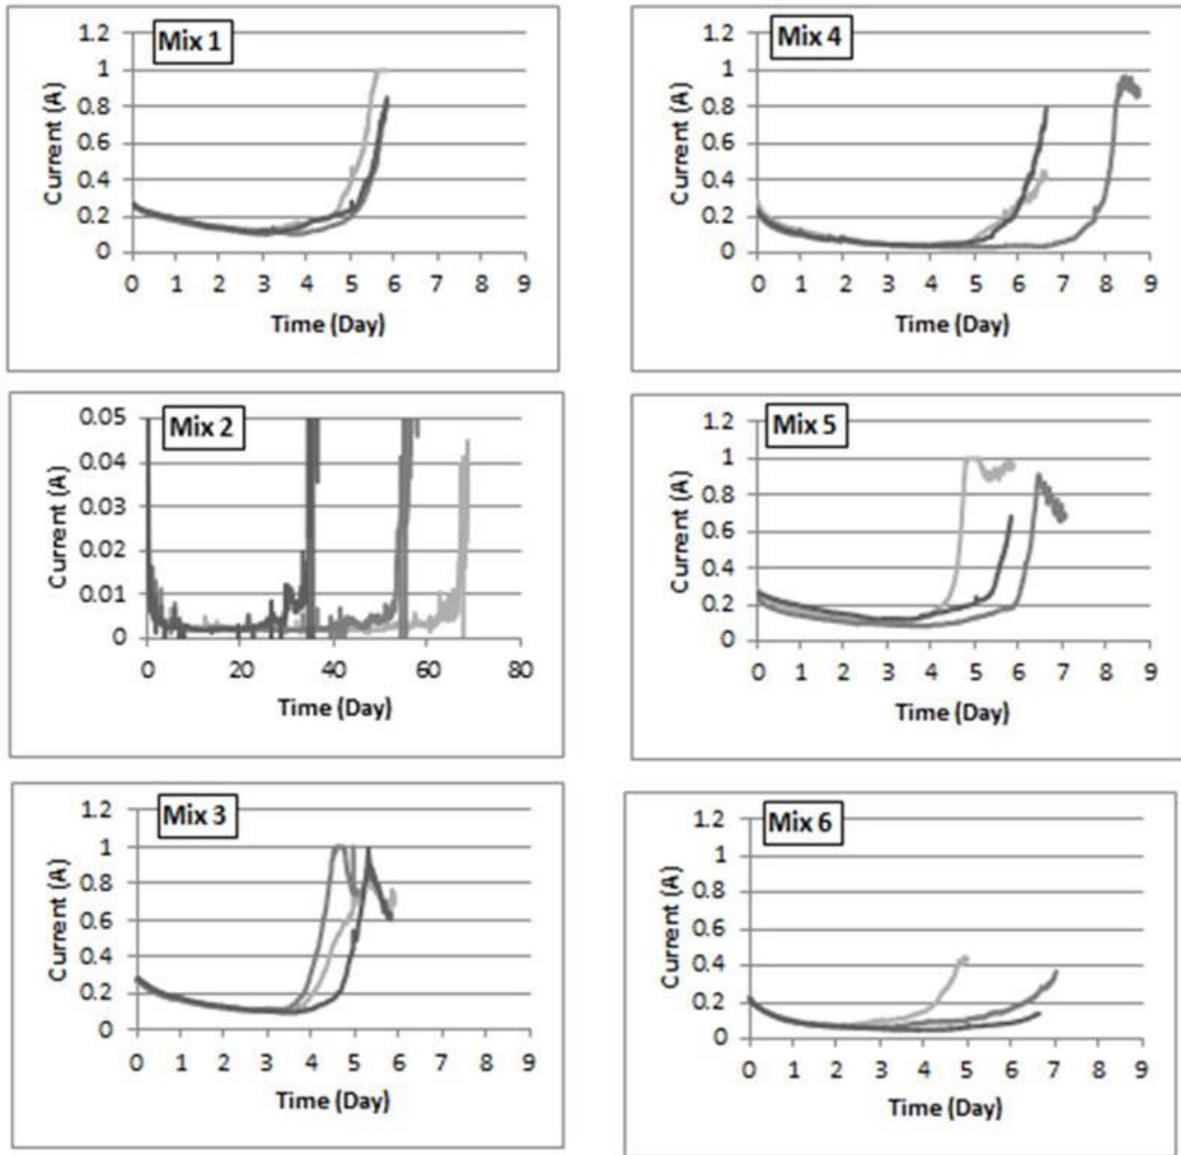
**Figure 31:** Accelerated corrosion test results. N.b.: for Mix 2, the x-axis is larger and the y-axis is smaller

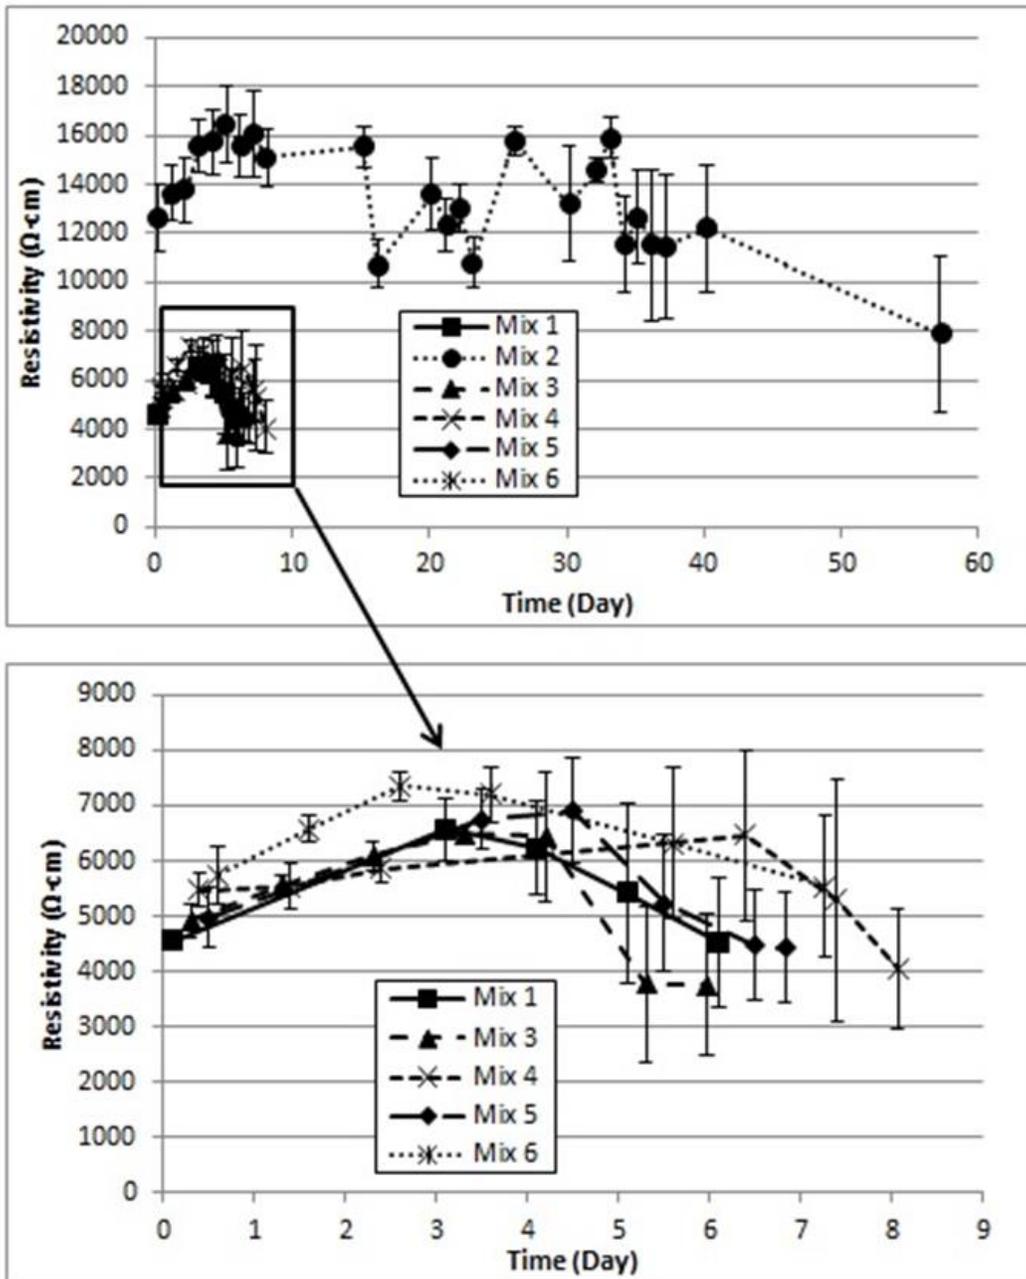
**Figure 32:** Electrical resistivity of lollipop samples as determined by Wenner probe. The electrical resistivity of Mixes 1, 3, 4, and 5 are enlarged in the lower plot.

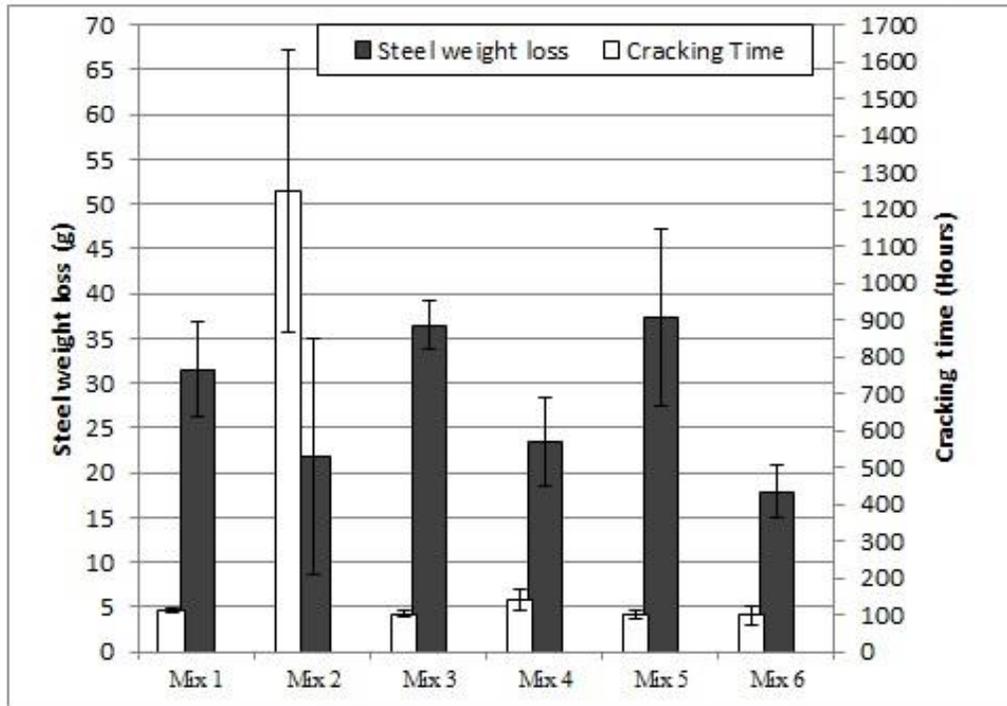
**Figure 33:** Mass loss of reinforcing steel and corresponding cracking time.

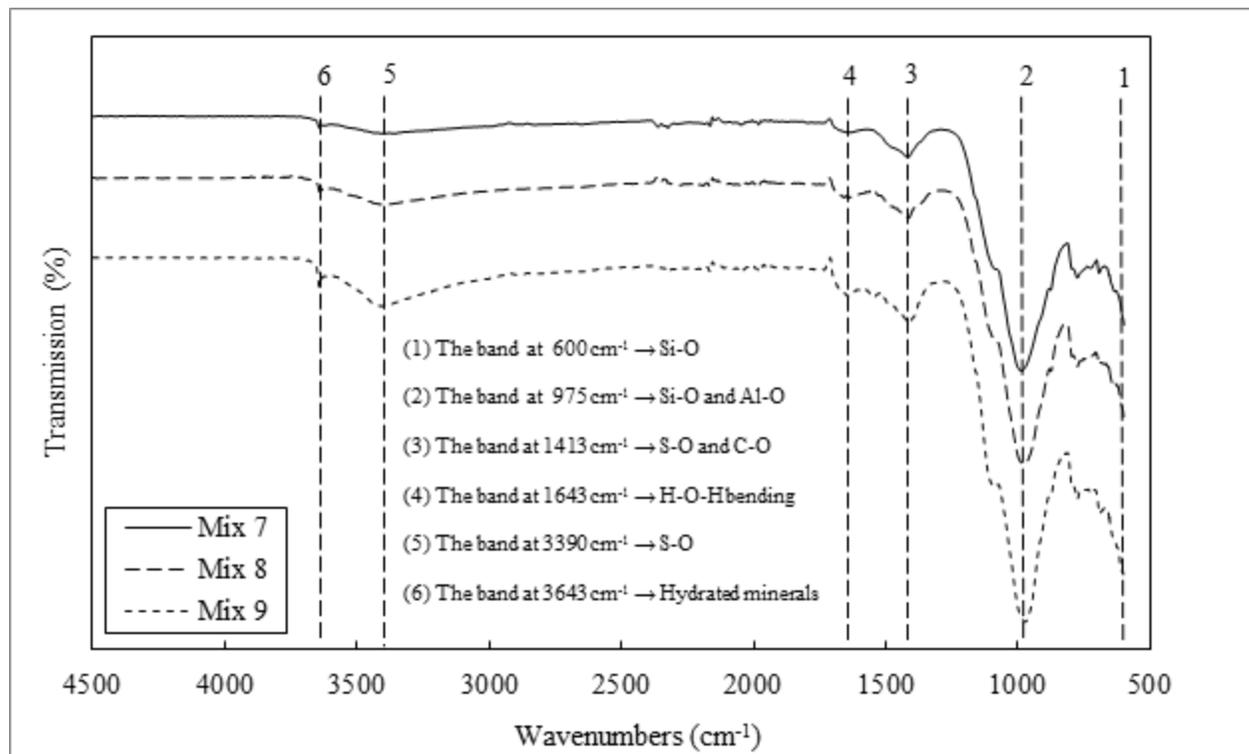
Figure 35: FTIR spectra of the mortars

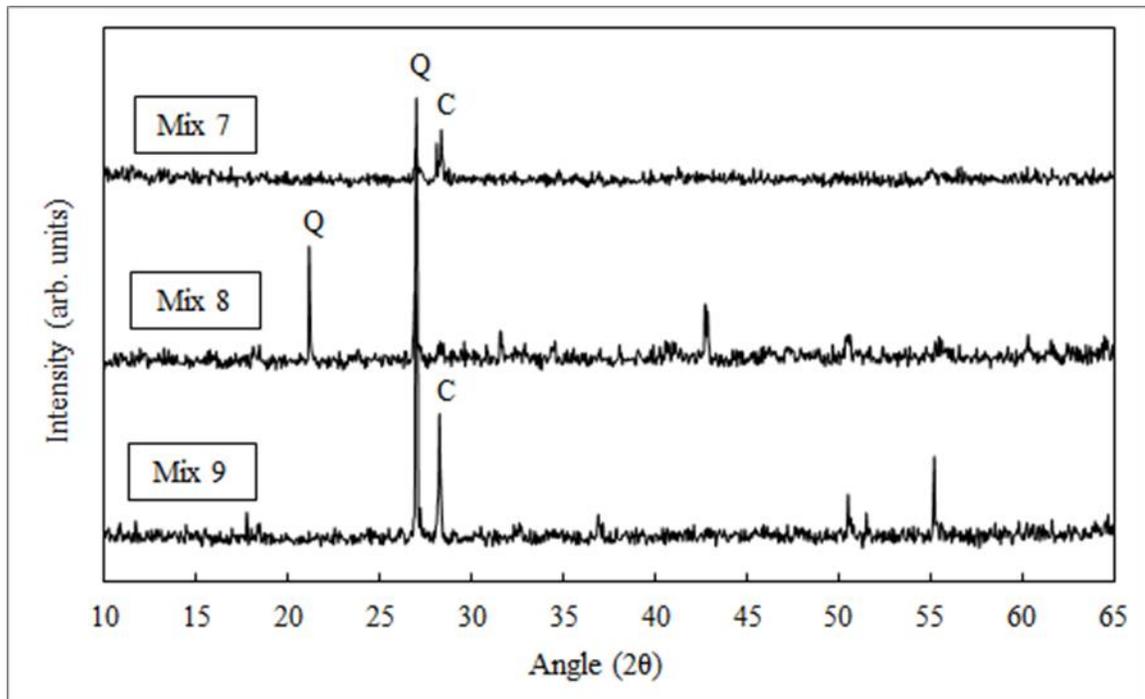
**Figure 36:** XRD diffractograms of mortars. Notes: Q is quartz and C is calcite

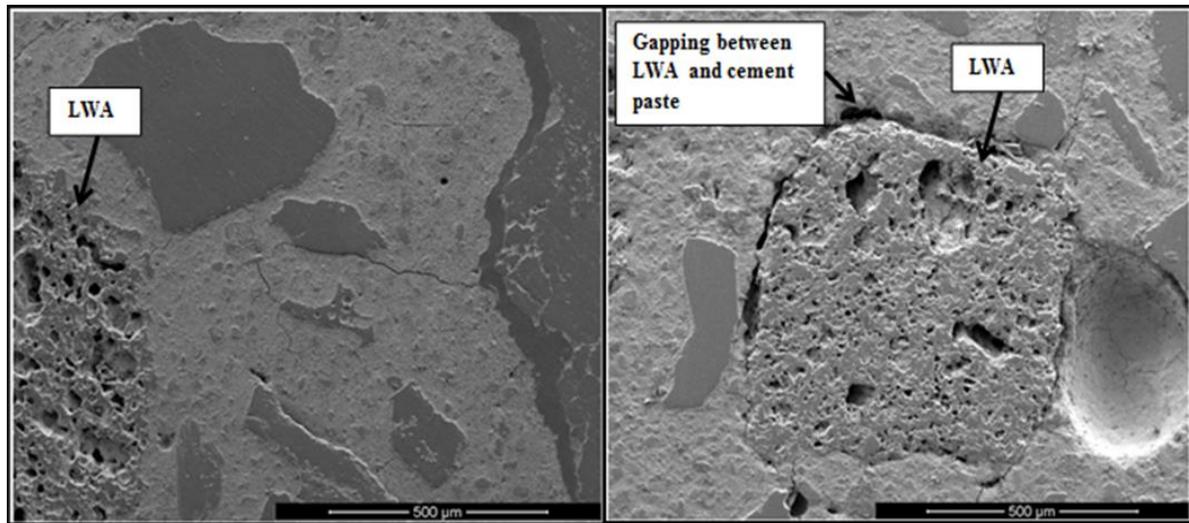
**Figure 38:** SEM image on left is Mix 8. No apparent ITZ is observed around the LWA. The SEM image on the right shows how Mix 3 produces a gapping space between the LWA and the cement paste. This can be a cause of the reduction in

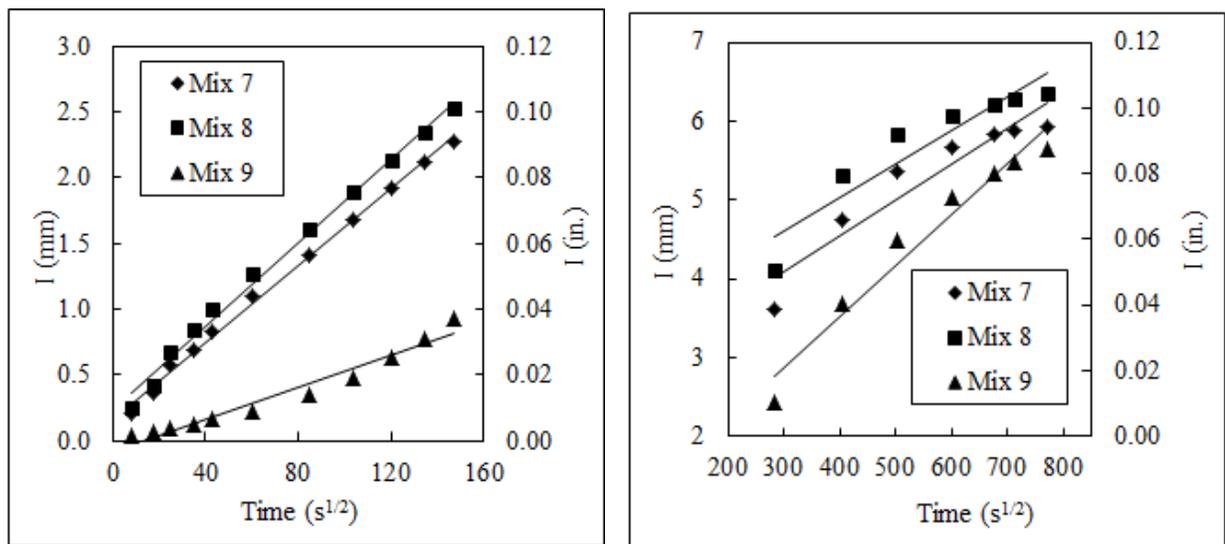
**Figure 39:** Initial rate of water absorption (left) and secondary rate of water absorption (right)
