Incorporating cinnamaldehyde into concrete for corrosion mitigation

A Dissertation

Submitted to the Department of Civil and Environmental Engineering

WORCESTER POLYTECHNIC INSTITUTE

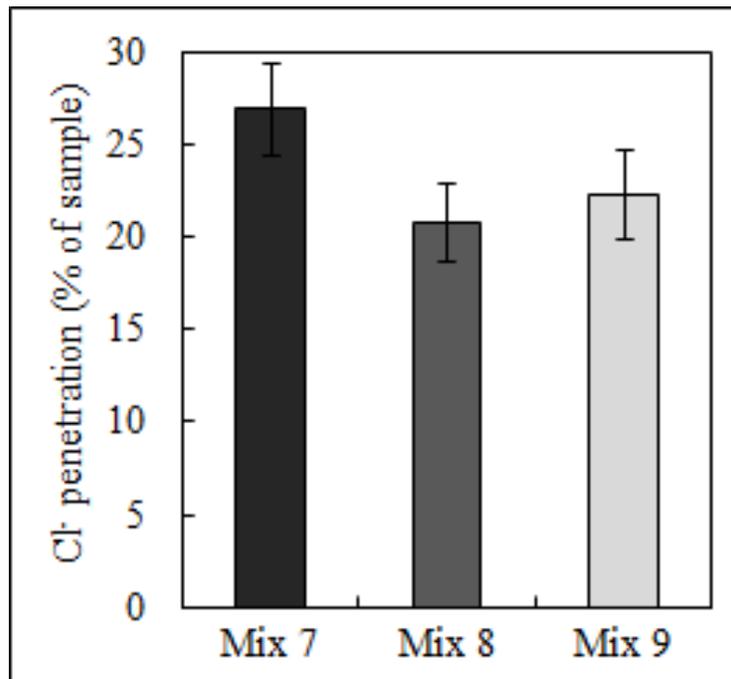
**Figure 40:** Chloride penetration of split cylinders in terms of the percentage of the mortar sample.

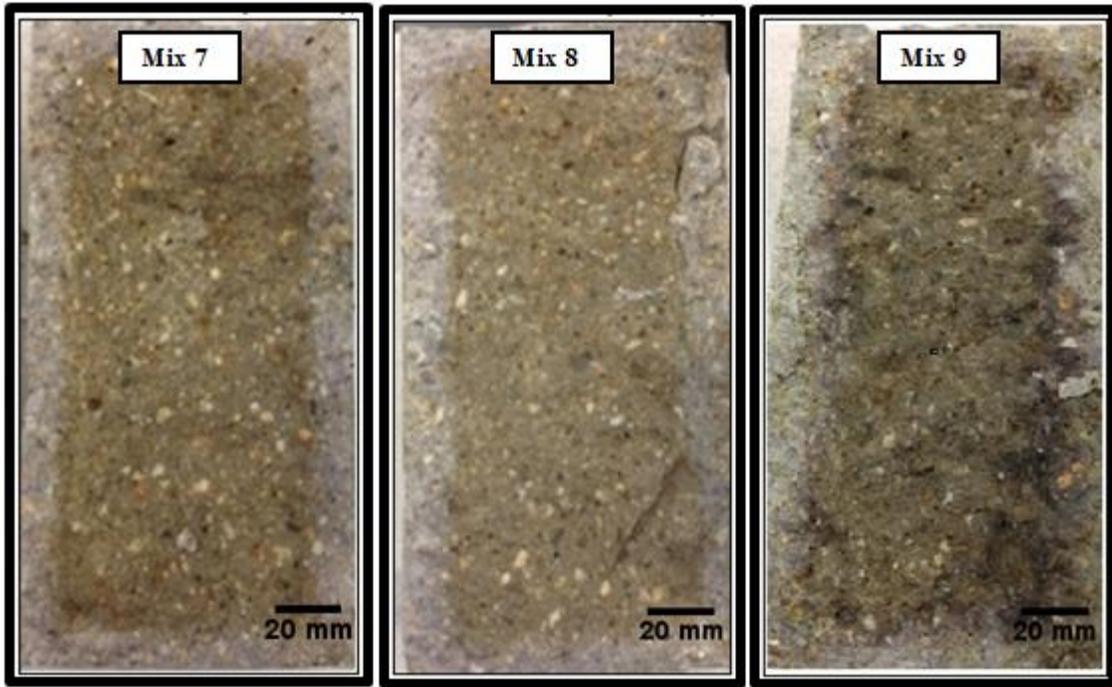
**Figure 41:** Samples of cylinders split lengthwise and sprayed with silver nitrate after exposed to NaCl solution bath for 3 m.

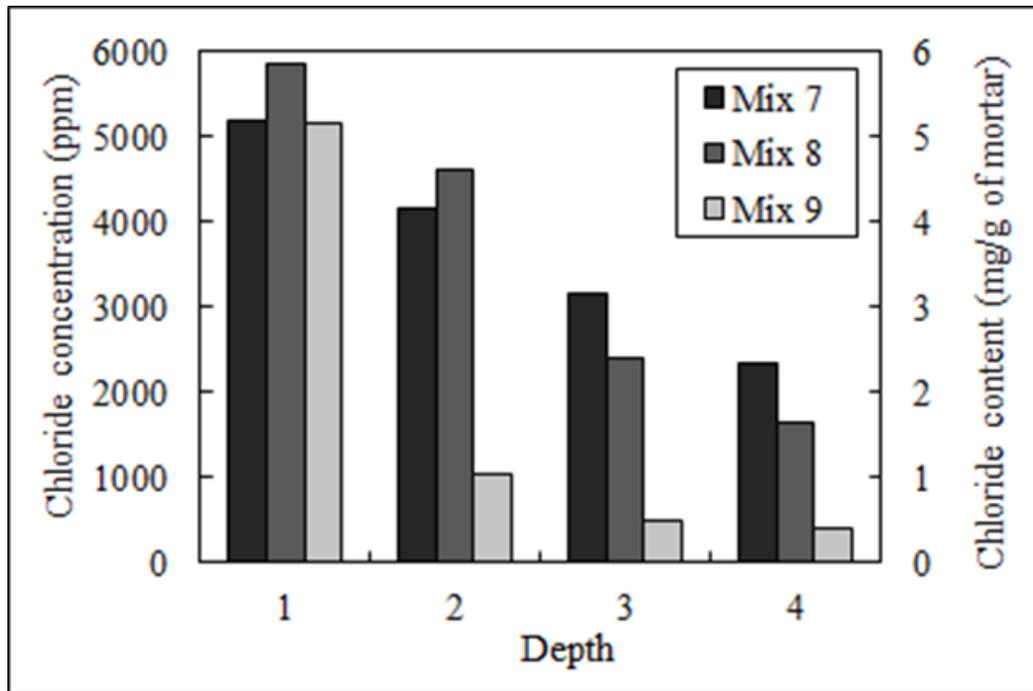
**Figure 42:** Chloride concentration at varying depth within the lollipop sample. The depths refer to Fig. 4 where : (1) is the powdered mortar collected from the depth of surface to ½ in.; (2) is the powdered mortar collected from the depth of ½ in. to 1 ½ in.; (3) is the powdered mortar collected from the depth of 1 ½ in. to 2 in.; (4) is the powdered mortar collected along the length of the mortar-rebar interface. Error bars are excluded for clarity purposes.

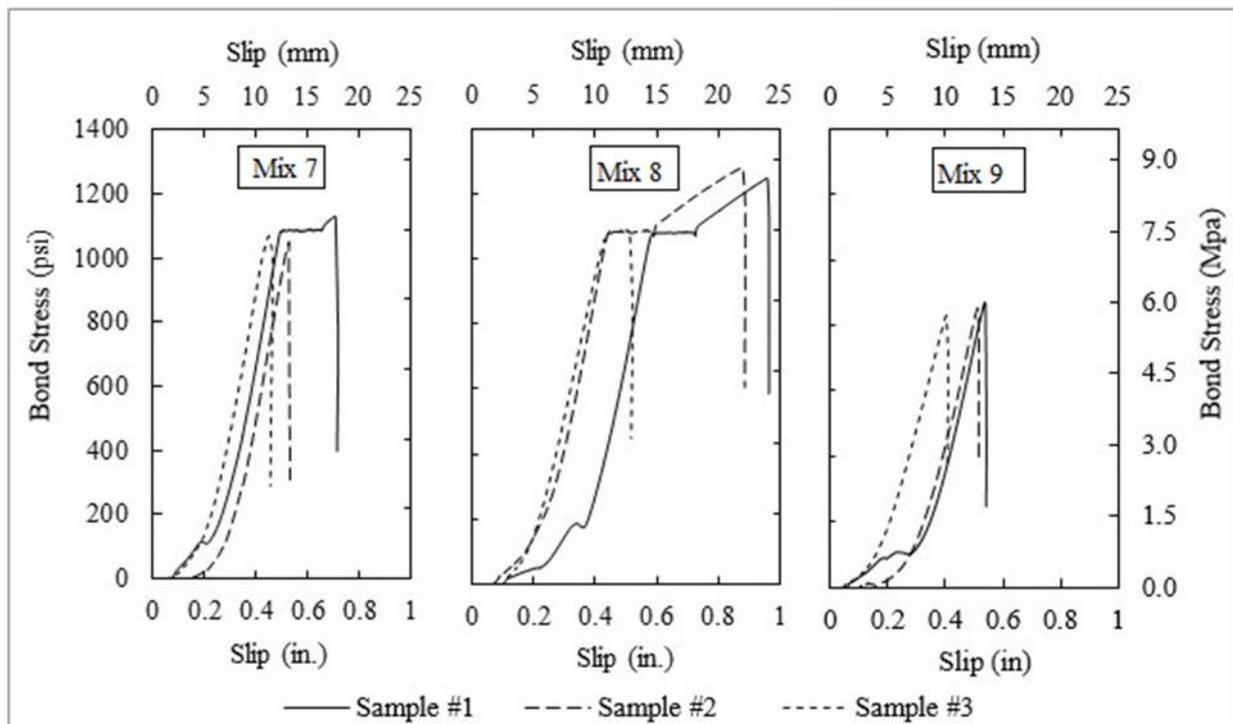
Figure 43: Rebar pullout results plotted as bond stress over slip

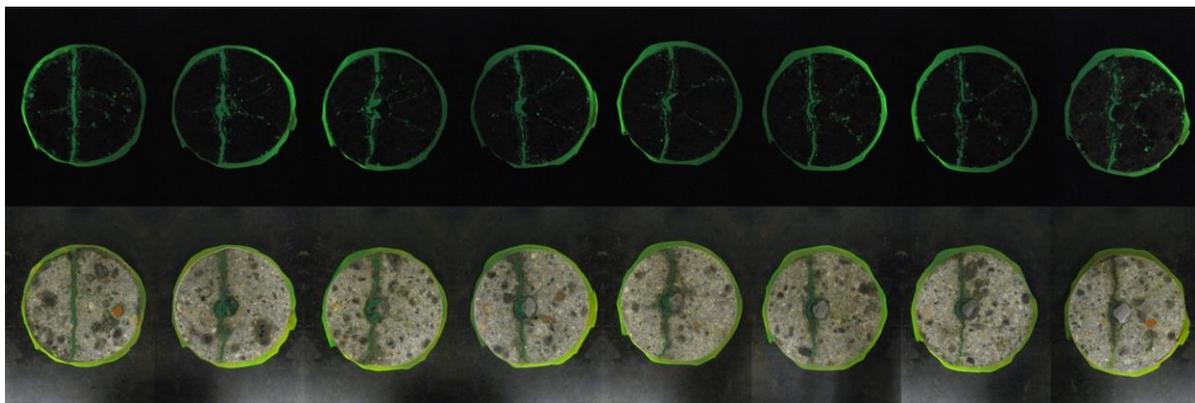
**Figure 46:** Petrographic slide of corroded lollipop sample [117]

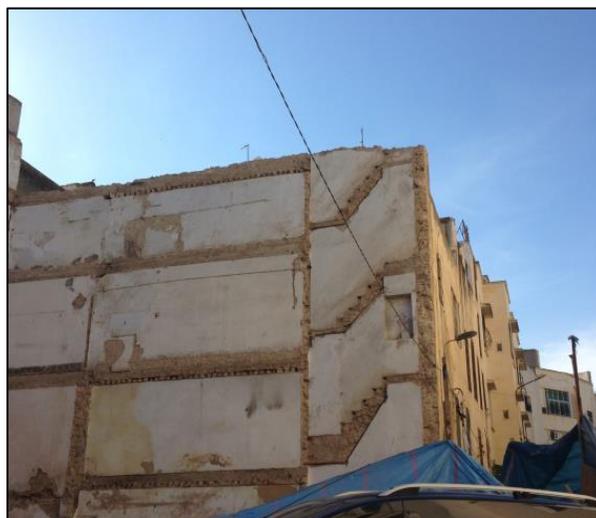
**Figure 48:** A decayed structure in the medina. The entire building has been sheared off

Once Morocco achieved independence (post-colonial period), the *medina* was left as a place with no hope to prosper leading to its decay. An example can be shown in Figure 48 where a structure was left to fall apart. Additionally, the wealthier residents began moving to the Ville Nouvelle, leaving many of the poorer migrants in the *medina*. These migrants would reside in formerly prominent homes (which were many times large) and could not afford the upkeep of these homes. This led to homes initially intended for the use of one family being transformed into multifamily residences. Residences quickly became overpopulated, increased in poor hygiene and in turn was not preserved [121, 122].

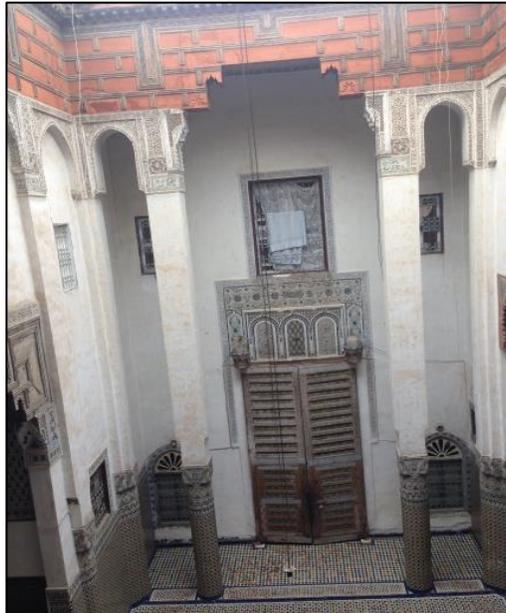
**Figure 50:** Restored *dar* with partial funding from ADER

Figure 50 (a picture of the home prior to the restoration was not available by ADER chose to show this home as an example since it was in poor condition prior to restorations).

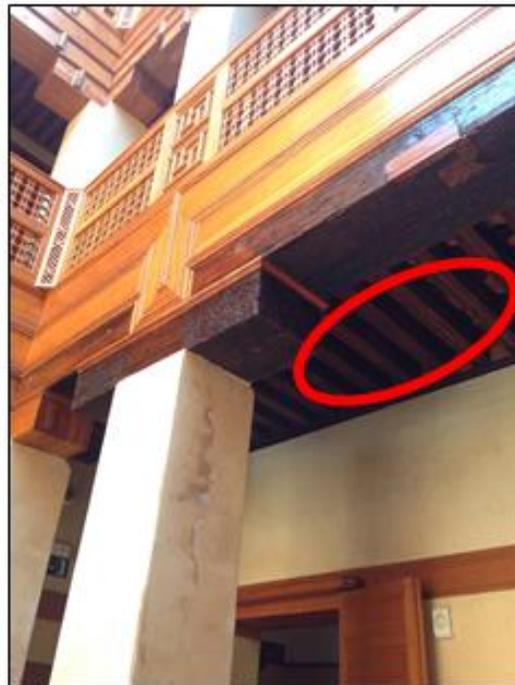
**Figure 51:** Cedar beams (in circle) in a tradition building

The support beams of structures in the Fès *medina* are mainly made of cedar wood shown in

Figure 51. This wood came from the cedar trees of the Rif, Mid Atlas, and High Atlas ranges [137, 138]. The properties of cedar wood are:

- Cedar is resistant to insects and rot.
- Has dimensional stability where it will not expand or contract in size even in weather, humidity, or temperature changes.
- Since cedar is porous it can absorb noise.

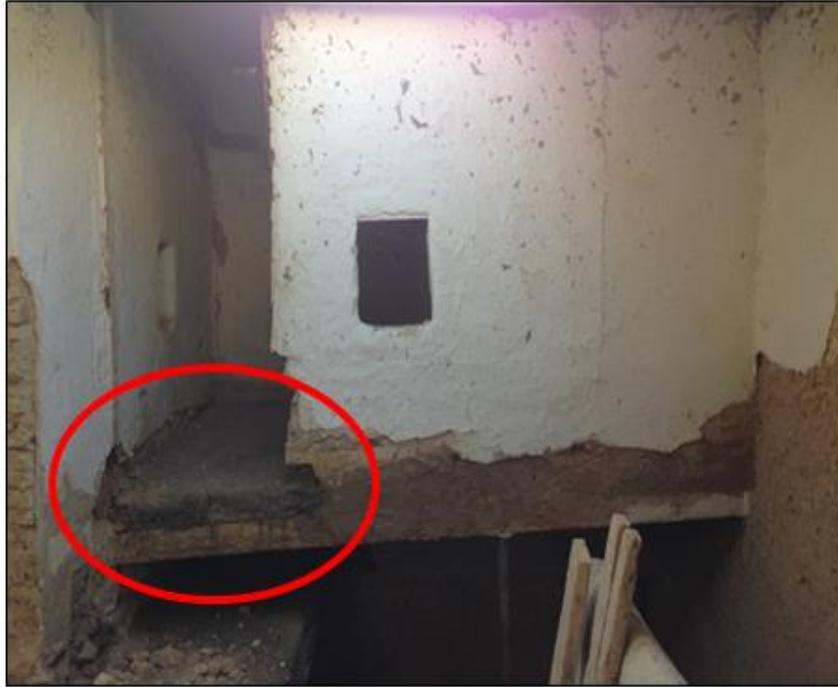
**Figure 52:** Slab using cement for flooring

The use of cement has grown quite popular within the construction sites of the *medina*. Cement has a quicker set time than lime and is less expensive. However, the use of cement can be very destructive to these historic structures if not used correctly. Figure 52 shows the use of cement in an appropriate way. The second floor of a house had a cement slab placed as new flooring. The structure is not impacted or harmed due to the fact that the cementitious flooring does not impact its surrounding materials. The properties that would be beneficial of using lime (such as breathability) are insignificant in this case. Figure 53 (*overleaf*) shows two images of concerning uses of cement. Cementitious mortar is simply ‘slapped’ on the surface of these homes. Using cement in this manner will cause severe problems in the future by producing early failure of the material. Cement is impervious and rigid, and if it begins cracking, large cracks

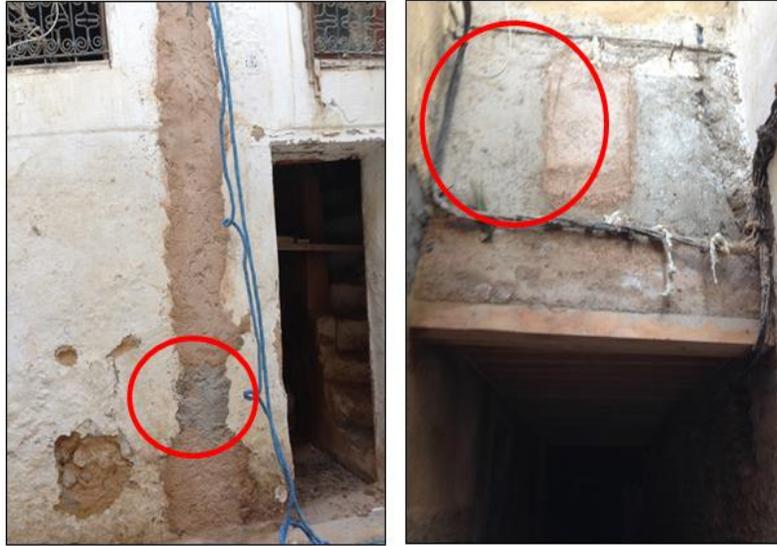
**Figure 53:** Cement mortar mixed inappropriately with traditional lime mix

could occur and progress rapidly. Adding cement to a porous, flexible lime mortar will cause spalling and early deterioration.

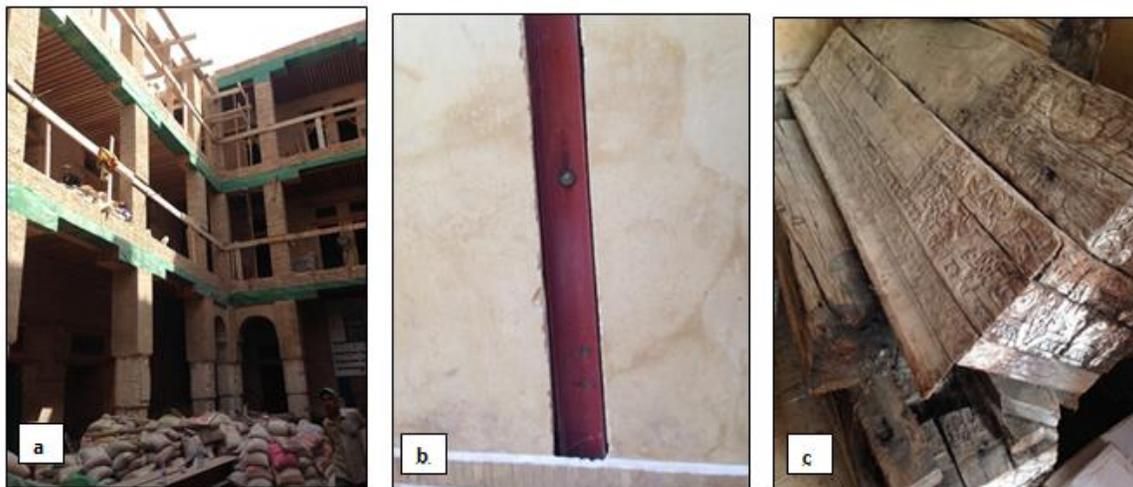
**Figure 54:** a) *Founduk* under restoration; b) C-column put in place for structural purposes; c) The original columns that will be placed in the C-column to keep original look

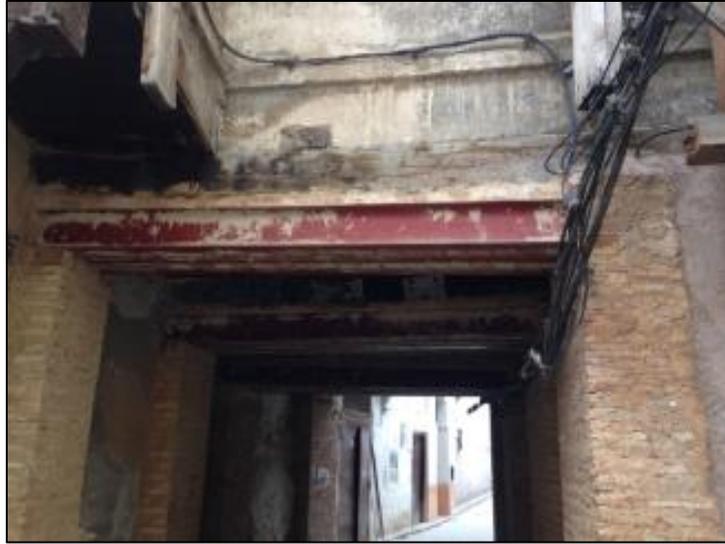
**Figure 55:** Under passage with steel beam exposed

column. This will give the *founduk* its original look but will now be structurally safe. However, in Figure 55, an under passage has been restored (by ADER) but the steel beams are left exposed which becomes aesthetically displeasing and an eyesore.
