# Evaluating Coastal Erosion Structures

December 18<sup>th</sup>, 2014

An Interactive Qualifying Project  
submitted to the Faculty of  
WORCESTER POLYTECHNIC INSTITUTE  
in partial fulfilment of the requirements for the  
degree of Bachelor of Science

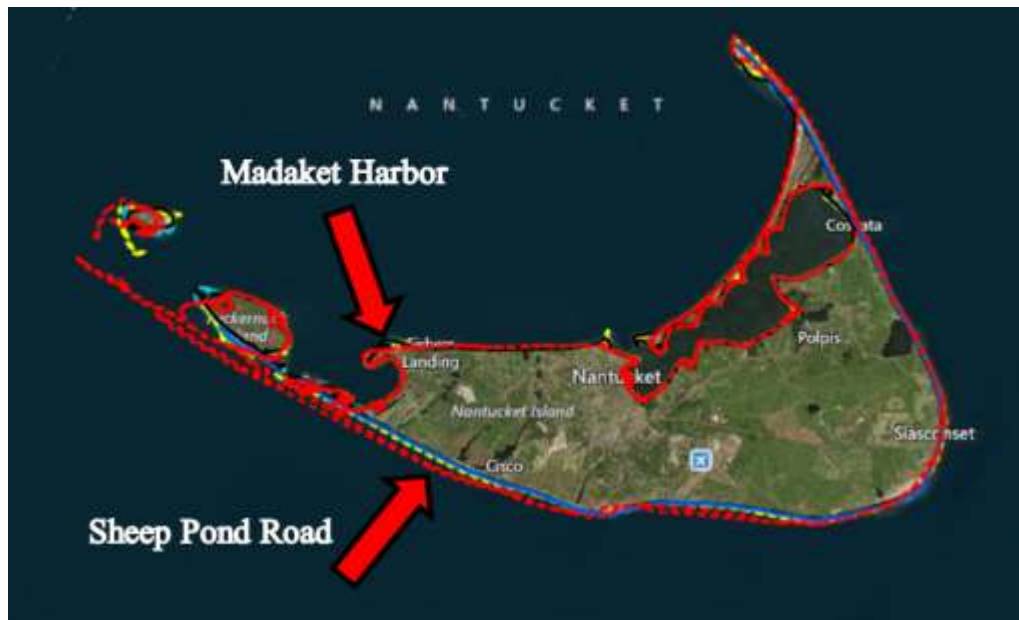
Figure 1: CZM Online Mapping of Nantucket (MORIS, 2014)

Nantucket, an island off the coast of Cape Cod, has some of the highest erosion rates in Massachusetts. It is expected to lose a range anywhere from 2 to 12 feet in a single year (Heinz 2000, 15). Although numerous erosion control structures have been employed by private and public entities, the political, economic, and social issues mean that achieving consensus on appropriate policies and approaches is extremely difficult. Figure 1 below, taken from the Massachusetts Coastal Zone Management mapping system (MORIS), shows the high water marks from the mid 1800's (red dotted lines) to 2009 (black lines) superimposed on an aerial photograph of the coastline of Nantucket in 2012. We highlight two areas (Madaket Harbor and

Sheep Pond Road) that have seen some of the most dramatic changes over the past two hundred years and discuss them in more detail below.

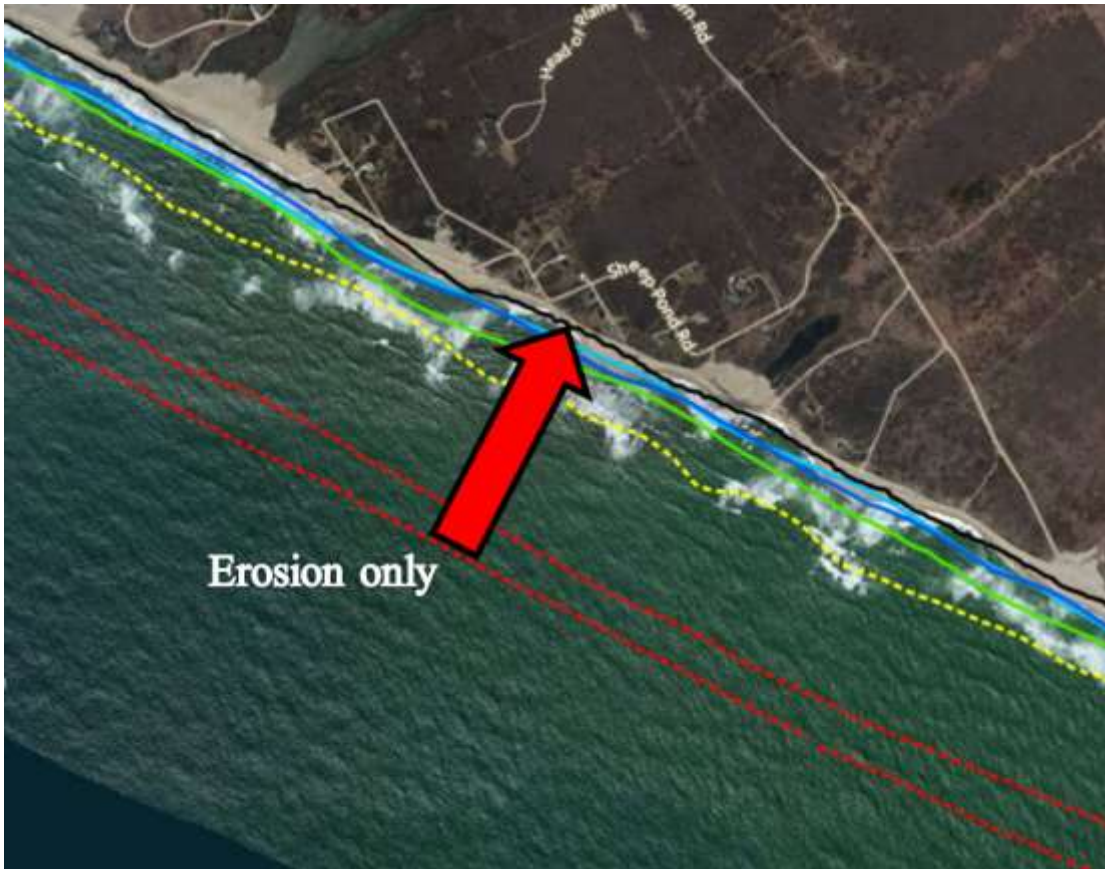
Figure 3: CZM Online Mapping at Sheep Pond Road (MORIS, 2014)

Figure 3 is from the same MORIS data and shows the south coast of the island at Sheep Pond Road. Between 1884 and 2009 the high water mark has receded inland by approximately 1,780 feet, making it one of the most rapidly eroding parts of the coast on the island. Due to its location, the sand that erodes off these beaches is reintroduced back into the ocean with no deposition or accretion to counteract the erosion. The relationship between areas of erosion and deposition is not straightforward. It is not simply a matter of assuming that material eroded from one area is transported to the nearest area of accretion. Depending on the direction of the winds, tides, and currents in relation to the shoreline, especially during a major storm, material may be eroded and deposited in a variety of places over relatively short distances. Much material may even be transported away from the coastline and deposited far off shore.

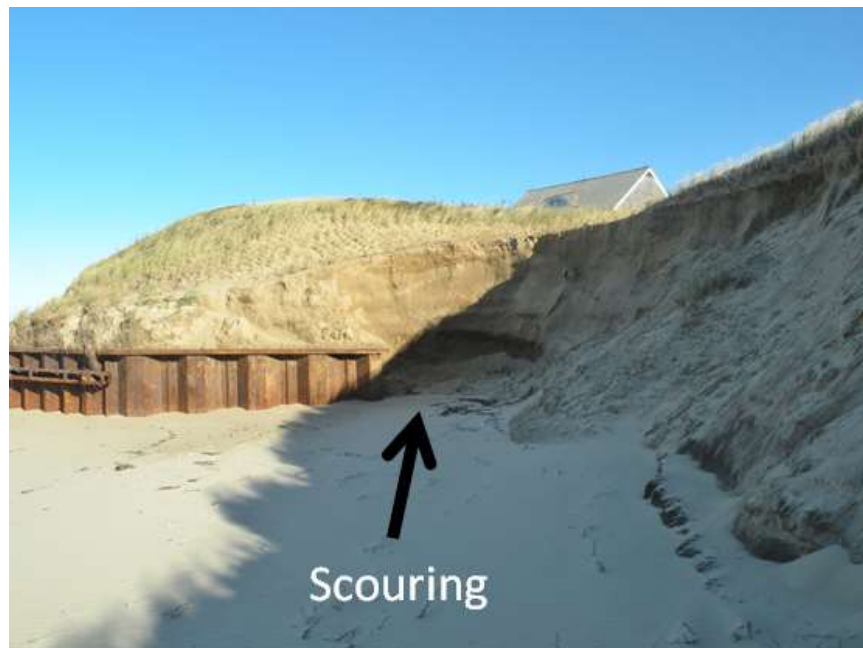
Figure 5: Seawall with Scouring on the Northwest Shore of Nantucket

it, but it is used to prevent the land behind from being washed away (Kraus, 1988). A beach that has been eroding prior to the installation of a seawall will likely continue to erode until the water reaches the armoring (Board, 2014). If a seawall is implemented in such a way that it impedes cross-shore sediment processes then it may stem erosion and cause scouring (i.e., excessive removal of material in a limited area) immediately at the ends of the wall (Kraus, 1988), as shown by the arrow in Figure 4. Seawalls can also have other serious environmental impacts. By changing the water landscape immediately in front of the wall or by erosion of the beach, they can disrupt the habitats of various fish species and shore birds (Board, 2014).

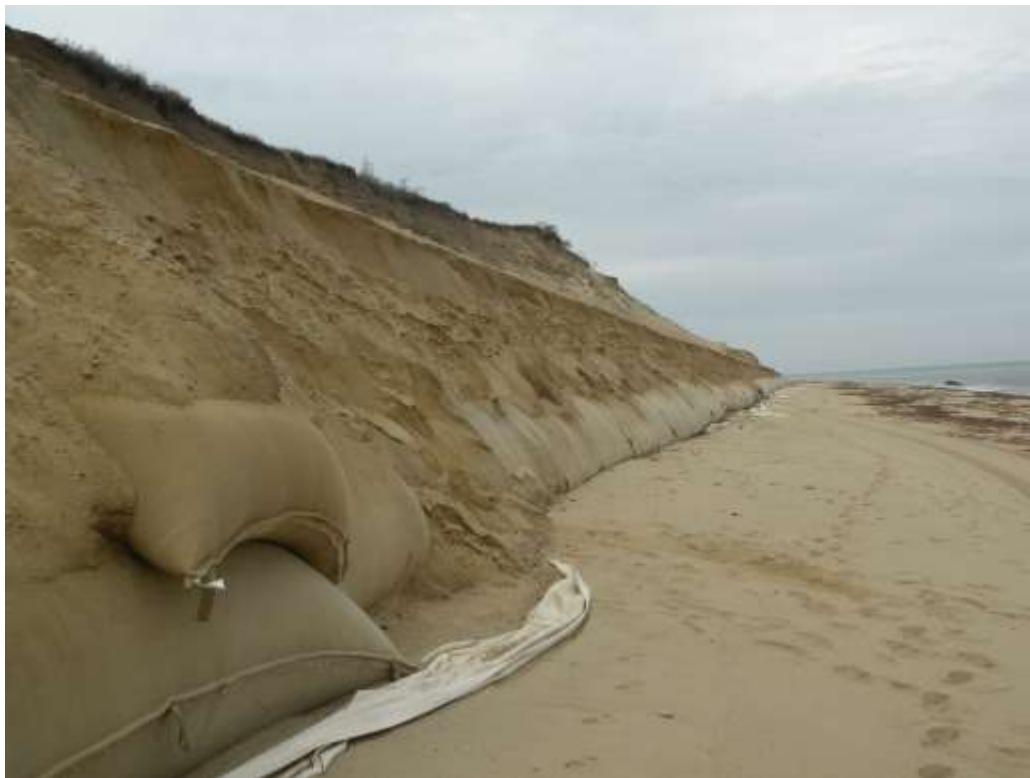
Figure 10: Geotextile Tubes, Siasconset Bluff Nantucket

As experts have learned more about the effectiveness and impacts of different erosion control structures, hybrid structures that combine soft and hard structures have become more common (Erisman, 2014). One example of this is the installation of an oyster reef. An Oyster reef is a bed of oysters joined together to form a solid offshore structure. Oyster reefs diminish wave energy and provide a barrier for sediment erosion while providing a habitat for oysters. The oyster reefs acts very similarly to a low-crested submerged breakwater. It has been shown that these submerged breakwaters help prevent erosion in moderate conditions but do not fare so well in high energy events (Board, 2014). Geotextile structures represent a combination of beach nourishment and seawalls. These structures consist of a permeable fabric that is pressure filled with sand. This creates a tube that can be placed longitudinally to the water line and can be covered in sacrificial sand to enhance visual appeal (Figure 10). While they may prevent erosion in the same fashion as seawalls they can have similar adverse effects on sedimentary dynamics. As sacrificial sand is lost from wave energy, the face of the geotextile tube is exposed and can cause scouring and other detrimental effects (Akson, 2012). Every structure has its advantages and disadvantages, but the quality of the design and implementation of the structure determine its effectiveness in reducing erosion.

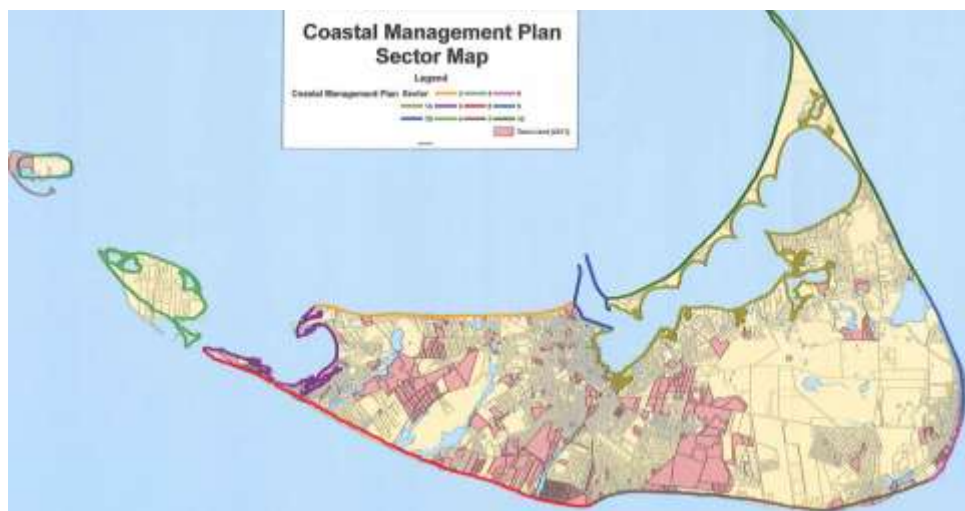
Figure 12: Map of Coastal Management Zones as Laid Out in the Nantucket Coastal Management Plan (Oktay et al)

In March 2012, a committee was formed with the aim of creating a plan on how the island should handle its coastal erosion structures, called the Coastal Management Plan Workgroup. This committee created a coastal management plan which was adopted in 2014. The Management Plan workgroup conducted an inventory of existing municipal properties to determine how the town should manage and protect these facilities. This included an assessment of erosion impacts and potential control measures. The plan also divides the island's coasts into ten sectors, as shown in Figure 12 below. Table 3 lays out the structures identified and any issues noted with the area.

Sector	CES	Issues
<b>Sector 1</b>	Bulkheads, jetties, beach nourishment	Must integrate the Municipal Harbor Plan
<b>Sector 2</b>	Jetties, storm drains, dune stabilization	ACOE to maintain jetties
<b>Sector 3</b>	unknown	Extensive eelgrass beds and significant salt marshes
<b>Sector 4</b>	No structures recommended	Ecologically significant; habitat for piping plovers and roseate terns
<b>Sector 5</b>	No structures recommended	Ecologically significant; habitat for gray seals, beach voles, piping plovers and roseate terns
<b>Sector 6</b>	Beach nourishment, dune stabilization, Jersey barriers	Ames bridge needs to be monitored as well as the sewer beds
<b>Sector 7</b>	Beach nourishment, dune stabilization	Must maintain communication with the Airport
<b>Sector 8</b>	Beach nourishment, dune stabilization, Jersey barriers	Tidal and wave energy should be encouraged
<b>Sector 9</b>	Beach nourishment, dune stabilization, geotubes	Projects should not impede ability to open Sesachacha pond

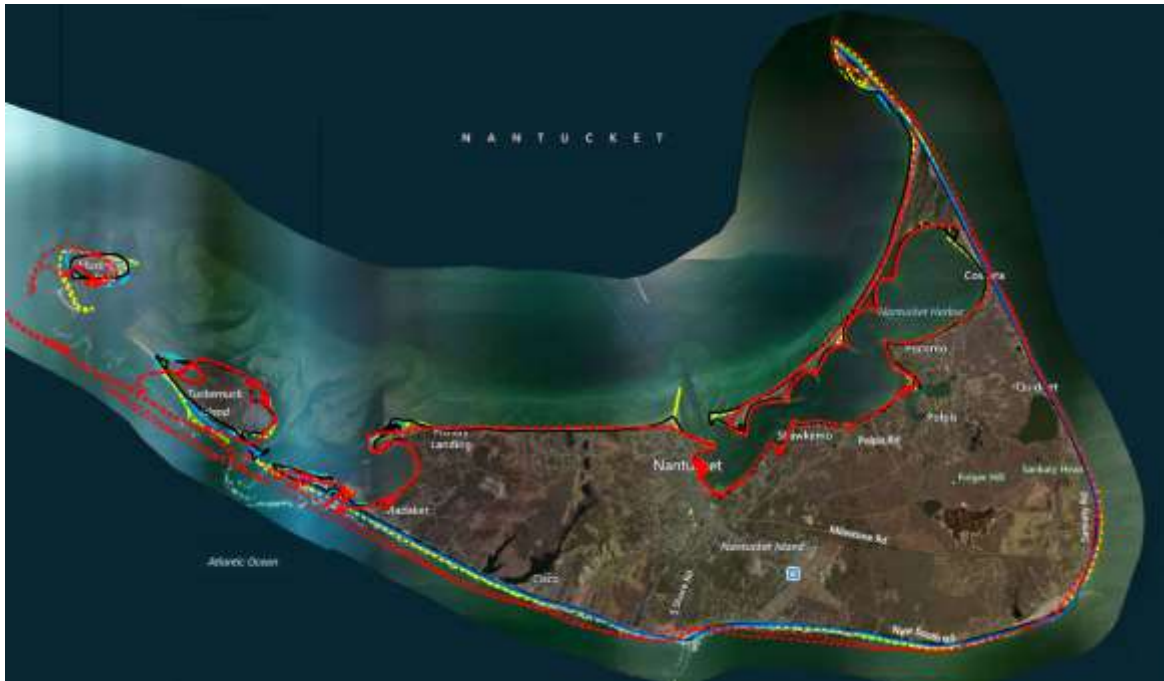
Figure 13: Nantucket High Water Marks 1844-2009 (MORIS, 2014)

In addition to the qualitative assessment of condition and effectiveness in the field, we also analyzed historical data on high water marks from 1884. We attempted to measure effectiveness in two ways: by qualitative assessments conducted in the field and by analysis of high water marks in the MORIS data maintained by the Massachusetts CZM office. By using GIS and Google Earth software to extract time-lapse photos of coastal erosion, it provided a map view of erosion over a period of time from 1998 to 2014. In order to add to the effect and visual representation of the Nantucket GIS map, we also looked at the high water mark map from the Massachusetts state website of CZM data (MORIS) so that we can compare property lines and property information with structure locations and high water marks. Figures 13 and 14 below are images from MORIS and Nantucket GIS respectfully; they included a series of changing high water marks between the years 1884 and 2009 from the MORIS map and individual property lines of Nantucket from the Nantucket GIS map. Using Morris maps allowed the team to assess changes in shoreline around the island due to variations in erosion and deposition.

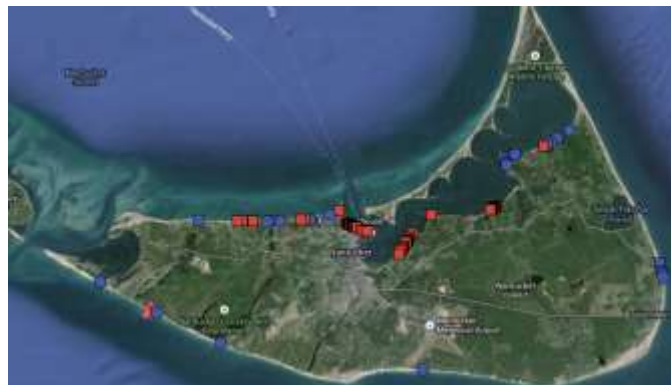
Figure 15: Nantucket Coastal Erosion Structures (Google My Maps, 2014)

The structures are organized in the database by five coastline sections (Northwest Coast, Siasconset Beach, the South Shore, and the Harbor Section) and then ordered numerically by map and parcel number. Figure 15 shows our Google My Maps application. The map shows every structure documented in a specific section and represents that structure based on its type as either a hard structure (red square), soft structure (blue circle), or a structure that has qualities of both a hard and soft structure (blue square).

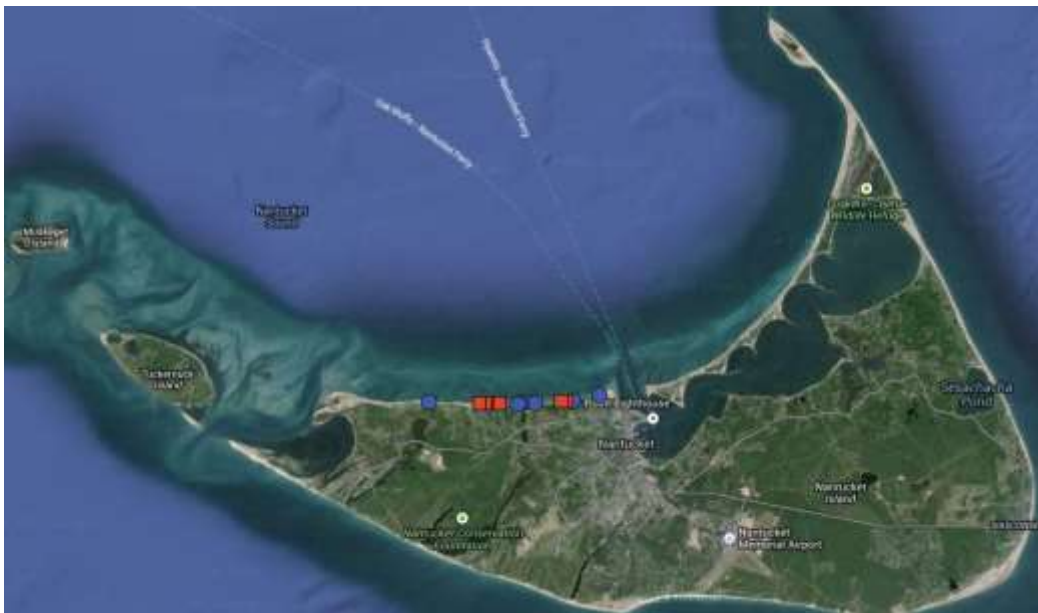
Figure 16: Northwest Section (Google My Maps, 2014)

The northwest section spans from North Point to Bathing Beach Road. Figure 16 was taken from our Google My Maps application. We identified 12 private structures across 23 separate properties in the northwest section. Many of the structures are periodically repaired to maintain their structural integrity since all have been built in the last 40 years. Of these structures half were hard structures and the other half were soft structures. We found the following types of structures: fences, bulkheads, beach grass, groins, plantings, zigzag fences, rock walls, gabion baskets, and sand replenishment efforts (Table 6). We discovered (Table 6) that the majority of structures were structurally stable and 7/12 (58%) were showing signs of visible accretion of sand however 9/12 (75%) structures were showing signs of erosion. Five (42%) structures showed signs of both. Three (25%) structures showed signs of scouring on either edge of the structures.

Structure and Parcel Number(s)	Erosion	Accretion	Scouring	None/New Structure
Dune Fencing and Beach Grass (Soft) 30 44, 30 44.1, 30 45	X	X		
Zigzag Fence and Beach Grass (Soft) 30 22.2	X	X		
Wooden Groins (Hard) 30 93	X	X		
Wooden Groins (Hard) 30 257, 30 257.1, 30 11, 30 10, 30 17	X			
Metal Bulkhead with Wooden Groins (Hard) 31 18.1	X		X	
Wooden Bulkhead (Hard) 31 1	X		X	
Rock Wall with Wooden/Stone Groins (Hard) 31 4	X			
Rock Wall and Sand Fence (Hard) 31 5, 31 7, 31 8, 31 9	X		X	
Sand Fence (Soft) 31 13.3				X
Zigzag Fence (Soft) 31 15.5		X		
Dune Fencing and Beach Grass (Soft) 31 19		X		
Zigzag Fencing, Jute Bags, and Beach Grass (Soft) 32 9, 32 10, 32 11	X	X

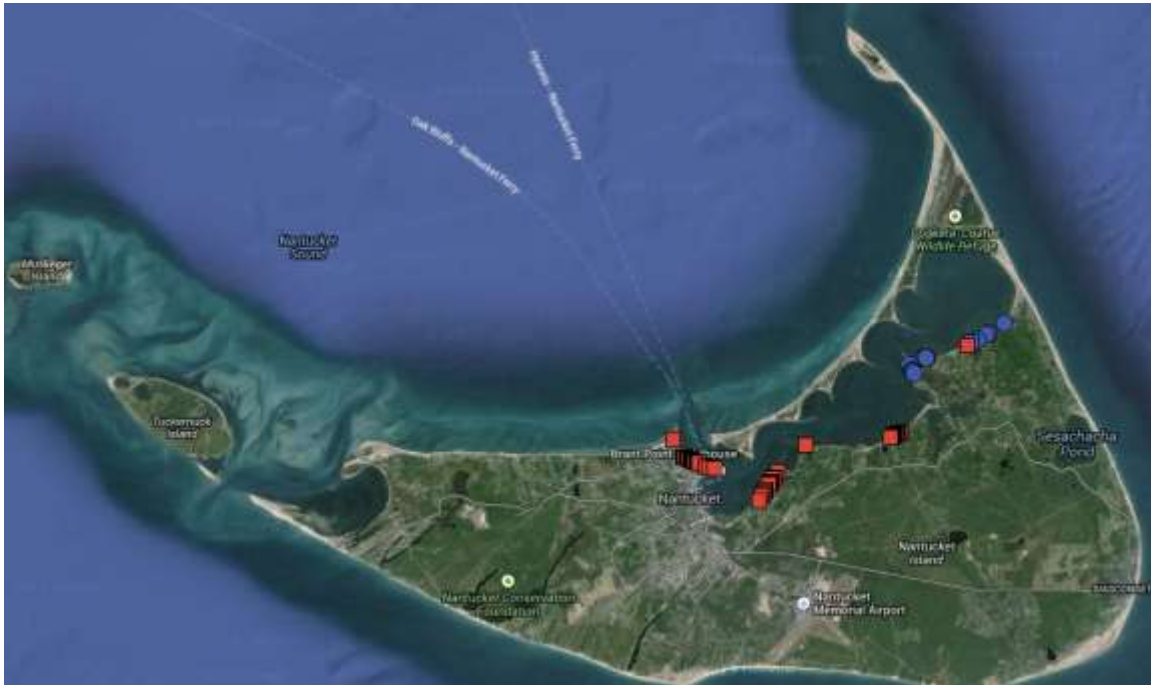
Figure 19: Harbor Section (Google My Maps, 2014)

The harbor section spans from the Brant Point to Wauwinet and was the most densely populated area with 50 private structures across 52 separate properties (Figure 19). Since the harbor section was so densely populated, it had a variety of different types of structures including: sand fences, rock walls, wooden fences, beach grass, jute bags, beach nourishment, zigzag fence, (metal, wooden and concrete) bulkheads, windscreens, rock and wooden groins. These were all private structures with the only public erosion structure being the jetties located at Jetties Beach. As shown in Table 9, 16 (32%) of structures showed signs of visible accretion of sand but 30 (60%)

of structures showed signs of erosion. Five (10%) structures showed signs of both erosion and accretion.

Structure Parcel Number(s)	Erosion	Accretion	Scouring	None/New Structure
Sand Fence (Soft) 11 28				X
Rock Wall (Hard) 14 10.1	X		X	
Wooden Fence, Beach Grass, and Jute Bags (Soft) 14 14	X		X	
Zigzag Fence and Dune Nourishment (Soft) 14 15	X			
Wooden Fence and Dune Nourishment (Soft) 14 17	X		X	
Wooden Fence, Beach Nourishment, Beach Grass, and Jute Bags (Soft) 14 56.2	X		X	
Beach Nourishment and Beach Grass (Soft) 15 9				X
Sand Fencing (Soft) 15 10	X	X		
Sand Fencing (Soft) 15 11	X			
Sand Fencing (Soft) 15 12	X

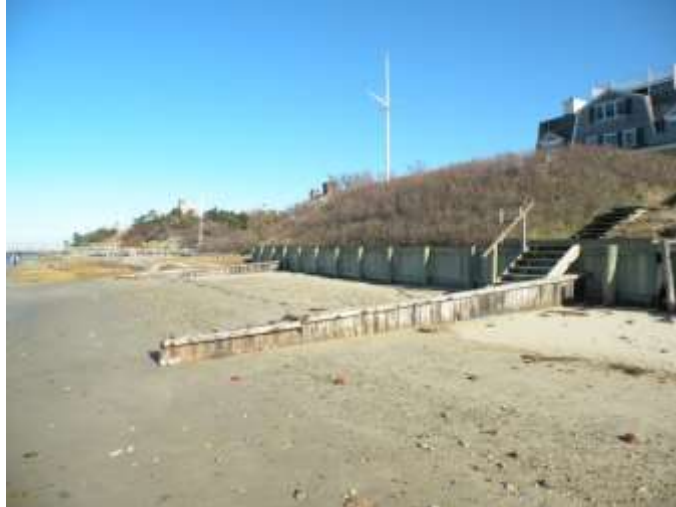
Figure 20: Timber Groins Along Shimmo Pond Road, Nantucket harbor

Sediment collects on the up-drift side of the groin and is eroded on the down-drift side. Groins are often set up in groups called groin fields and on Nantucket we noticed that the groins were typically set up in groin fields in conjunction with a seawall. There were two major types of groins installed on the island; timber groins and rock groins. Figure 20 below shows an example of a pair of timber groins at Shimmo Pond Road and Figure 21 shows an example of a field of rock groins on Quaise Road. In both cases they are joined to a seawall. Location also has an impact of how an effective a groin field works. If wave energy is too high the groins become deteriorated and the sediment is washed away before it can accumulate. Figure 22 shows a close up view on the wear of the rock groins in Figure 21 where they connect with the bulkhead.

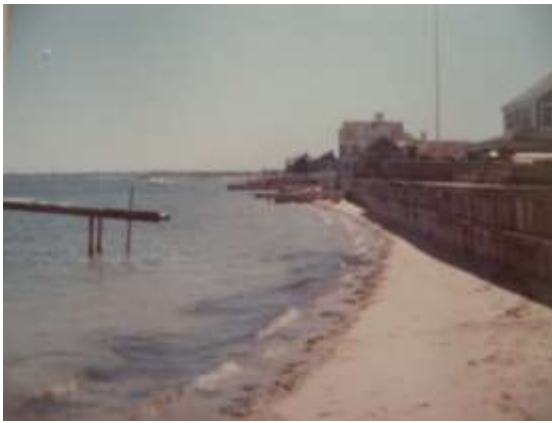
Figure 23: Hulbert Avenue, 1981

While most of the groins we observed had effects of scouring and accretion near the groin itself, one groin field on Hulbert Avenue had a significant impact. The half mile stretch of coastline along Hulbert Avenue just inside the harbor is lined with timber bulkheads and groins that were installed prior to 1978; hence they did not undergo the permitting process. The groins appear to have been successful in trapping sediment and this entire stretch of coast has signs of accretion. Figure 23 below shows a photograph from 1981 that was found in the permit for the wooden bulkhead repair and Figure 24 shows a picture we took in 2014.

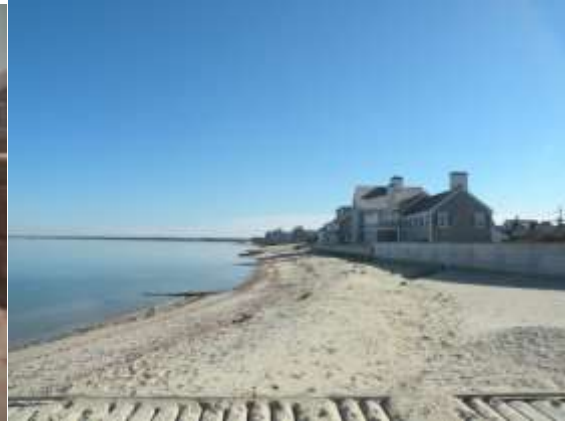
Figure 24: Hulbert Avenue, 2014

When we visited the sites along Hulbert Ave most of the groins are just visible above the sand and many had sand accretion along the bases of the timber bulkheads. The purpose of a groin is to trap sediment from longshore drift and this section appears to be successful since it shows signs of accretion.

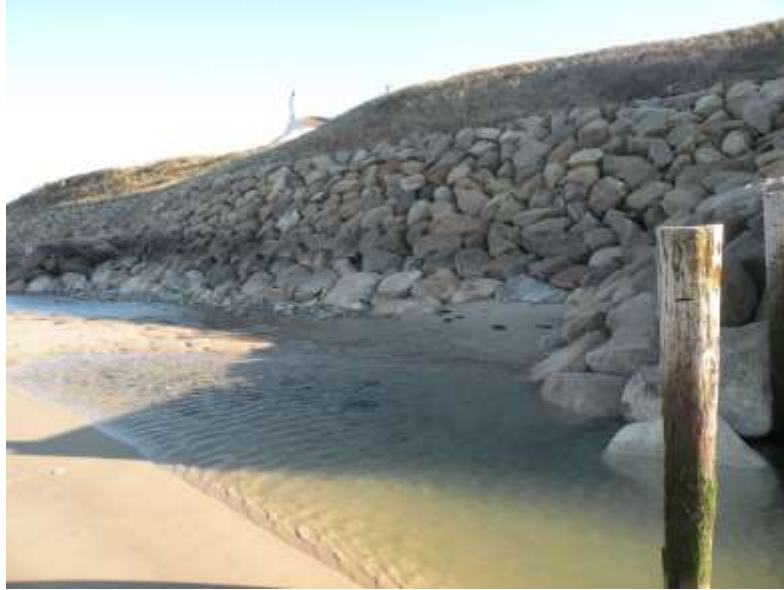
Figure 26: Rock Wall, East Tristram Ave, Nantucket Northwest shore

Some of the largest structures on the island that predate 1978 are located along the northwest shore. These structures consist of large hard armoring and seawalls. There are a total of four seawalls; two large rock walls, a timber bulkhead, and a metal bulkhead. While each of these structures shows signs of success in preventing the land behind it from being washed away, they also show adverse impacts similar to those documented in the research literature. When wave energy hits a shoreline it is absorbed by the dune and as a result sand is released to replenish sand that is lost. When wave energy hits a seawall, the energy has nowhere to go so some of it is deflected downwards into the beach below. This can be seen in Figure 26 along East Tristram Avenue where one of the dilapidated groins is still attached to the rock wall. The energy results in vertical scouring and beach is lost at the base of the seawall. Since the seawall is locked in place there is no source of sand to replenish the sand that was lost. The dark line along the rock wall shows the reach of the recent high water line.

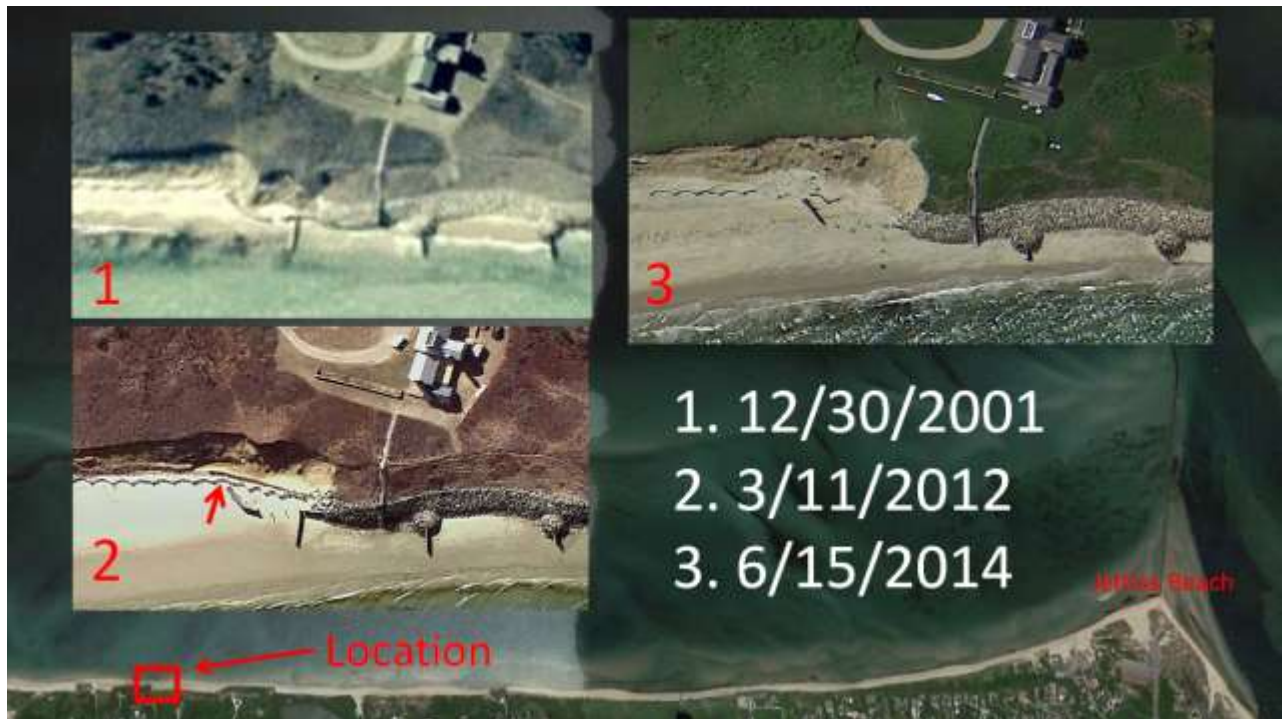
Figure 27: Aerial Photographs, East Tristram Ave, Nantucket Northwest shore (Google, 2014)

Along with vertical scouring, we also observed regular scouring at the four seawalls we visited. The energy that isn't deflected downward is deflected to the side and results in increased energy at the end of the seawalls. The seawall at East Tristram Avenue (Figure 26) has suffered some of the most severe scouring we observed on the island Figure 27 below shows the location of the seawall in relation to Jetties Beach and the inset photos show the extent of scouring over 13 years.

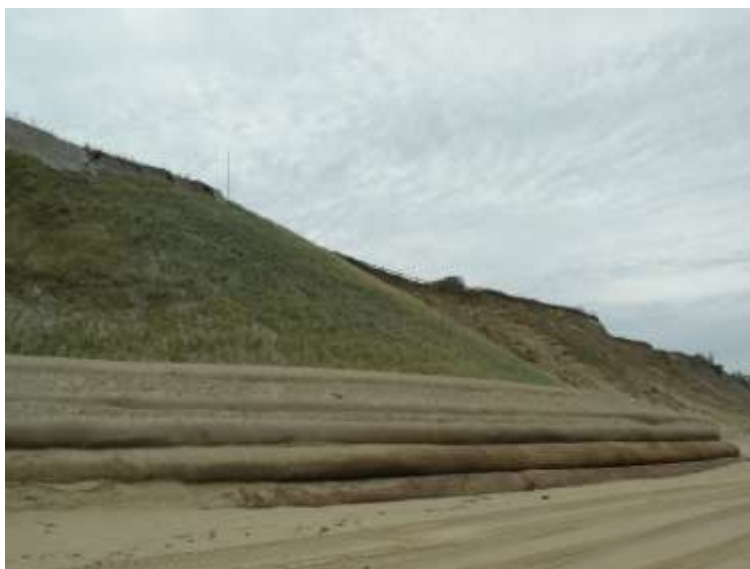
Figure 28: Jute Bags and Beach Grass, Siasconset Bluff Nantucket

After the Town imposed a ban on hard structures there was a shift to the use of soft structures. Hard structures may still be permitted for buildings that predate 1978 if a soft method cannot be proven to be a viable option. Beach grass plantings, sand nourishment, jute bags, and sand fences are now the preferred methods permitted by the Conservation Commission. Soft structures are more versatile and can be adapted to each location. They have less of a dramatic impact on the natural environment and are designed to fail in cases of extreme wave energy. In most cases we saw the use of a jute mesh to stabilize the bank until the beach grass seedlings had a chance to take root and grow and then the use of jute bags or a fence to stabilize the toe of a bluff. Figure 28 shows a section of the Siasconset bluff that was permitted with a soft structure. Along this section the beach grass had a chance to stabilize and grow and the base is supported by rows of jute bags.

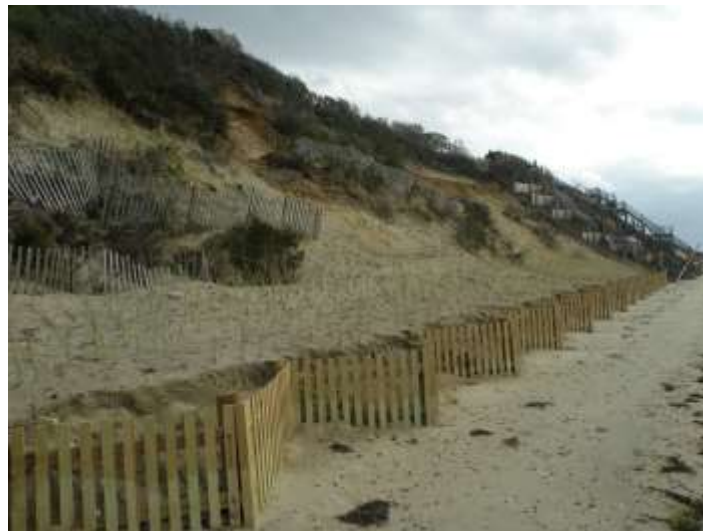
Figure 29: Zig-zag Fence, Beach Nourishment, Beach Grass, Pocomo Road Nantucket

Figure 29 shows the use of a zig-zag wooden fence with sand nourishment behind the fence and beach grass plantings at Pocomo Road. Along the bank of the dune sections of sand drift fence have been used to trap sediment blowing over the dune. Figure 30 shows an example of a linear wooden fence at Coskata with a dune that has a section of well-rooted beach grass plantings. The section of dune was lined with a jute mesh before the seedlings were planted.

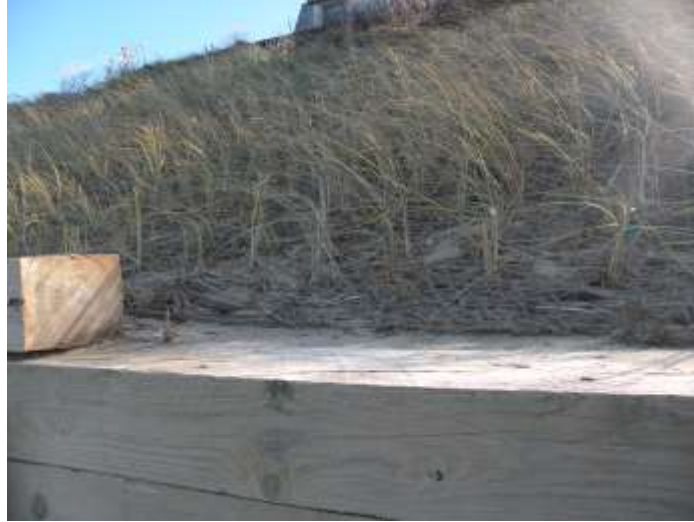
Figure 31: Wooden Bulkhead with Beach Grass and Jute Mesh, Quaise Road Nantucket

Figure 31 below shows an example of jute mesh and beach grass plantings that stabilizes the bank behind a seawall at Quaise Road in the harbor section of Nantucket.

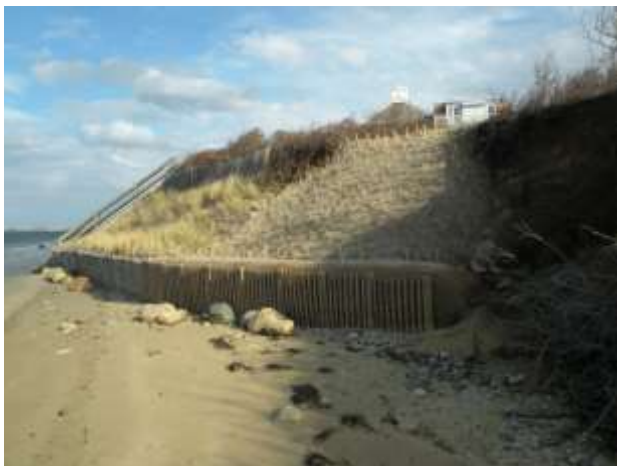
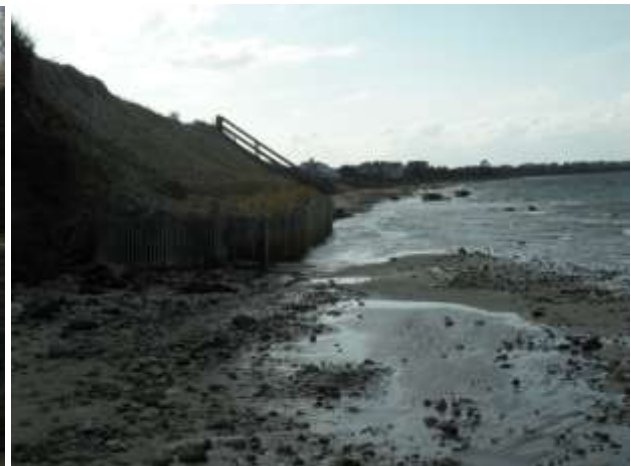
While most structures on the island conform to those described in the research literature, we also found a few structures that were idiosyncratic combinations of approaches to erosion control. One of these structures was located at 11 Laretta Lane. This location was permitted for sand fencing, coir jute bags, sand nourishment, and beach grass plantings. The structure was assembled from materials permitted for a soft structure but it actually functions in a similar way to hard armoring. As seen in Figure 32 the fencing is layered in such a way with the jute bags that it prevents sand from passing through it. As a result, the fence acts as a solid structure like a sea wall and blocks the source of sediment for the beach directly in front. Figure 33 shows the resultant loss of beach in front of the fencing.

Figure 32: Right View of Laretta Lane, Nantucket

Figure 33: Left View of Laretta Lane, Nantucket

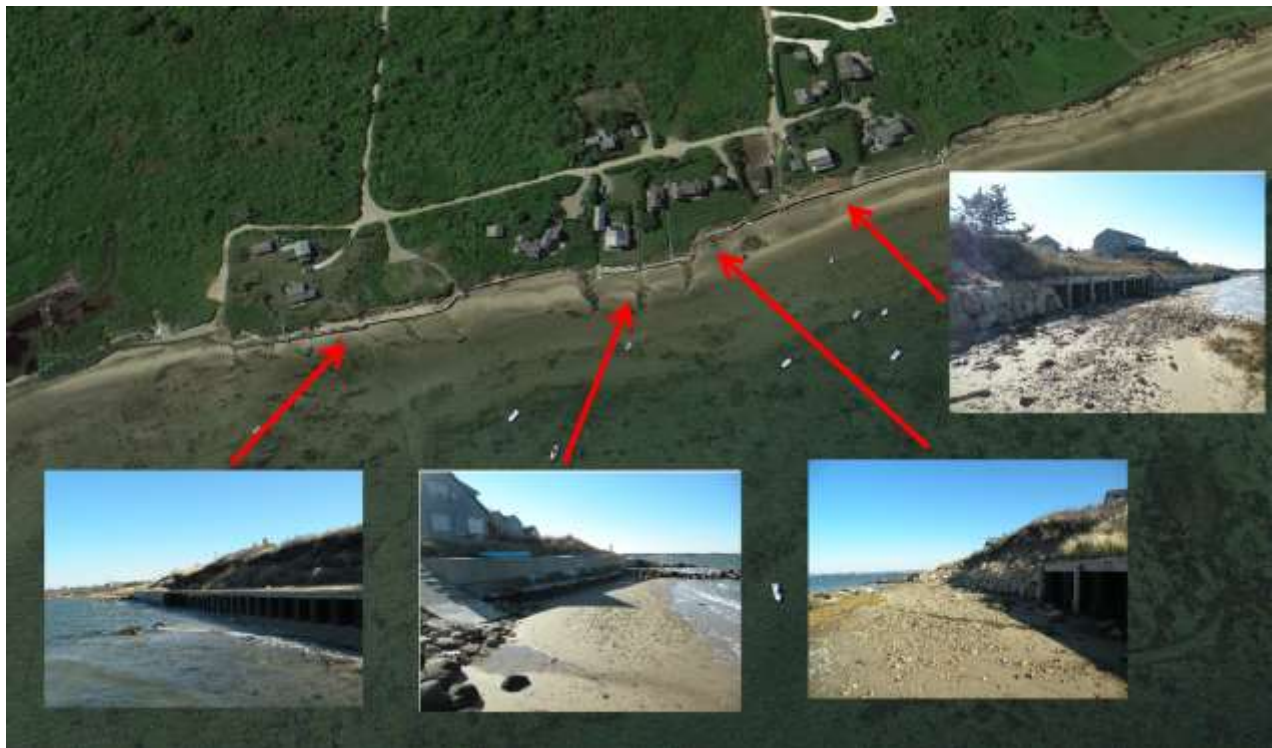
Figure 34: Aerial View of Quaise Road, Nantucket Harbor

Another example of idiosyncratic structures is the series of seawalls and groins along Quaise Road. This section has a combination of seawalls (wooden, cement, metal, and rock), rock groins, beach grass, and beach nourishment. From the permits we looked at, the different structures were installed one after another after the first installation of hard armoring. This is visible from the transitions in the styles of bulkheads along the road. After the first few installations of hard armoring the neighboring houses began experiencing the effects of scouring on their own property so they then installed their own bulkheads and groins. Figure 34 shows an aerial photograph with four images of the different style of bulkheads used.

While most of the structures we looked at relied on one style of erosion structure the section along Quaise Road used a combination of many different styles of hard armoring and soft structures.

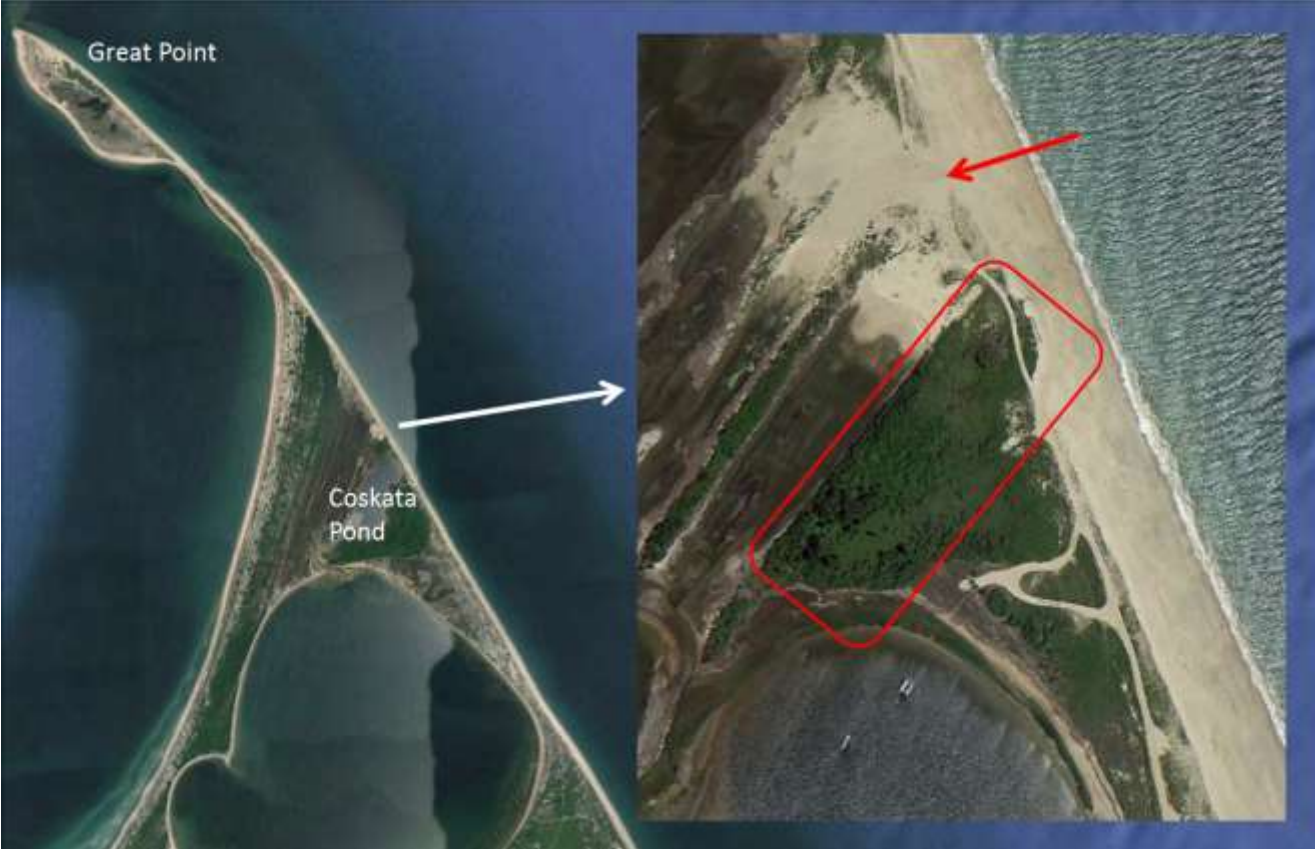
Figure 38: Aerial Photograph of the Natural Clay Deposit at Great Point

Figure 38 shows the stretch of coastline out to Great point with the land mass expanded to show detail. The red rectangle shows the section where this hard dirt is located and the red arrow points out the location next to it where the dune has been broken. This naturally occurring bulkhead has effects similar to a manmade bulkhead. The interruption of the natural dune causes increased energy at the end of this hard structure and causes scouring.
