Safeguarding the Churches of Venice, Italy:

A Computerized Catalogue and Restoration Analysis

An Interactive Qualifying Project

WORCESTER POLYTECHNIC INSTITUTE

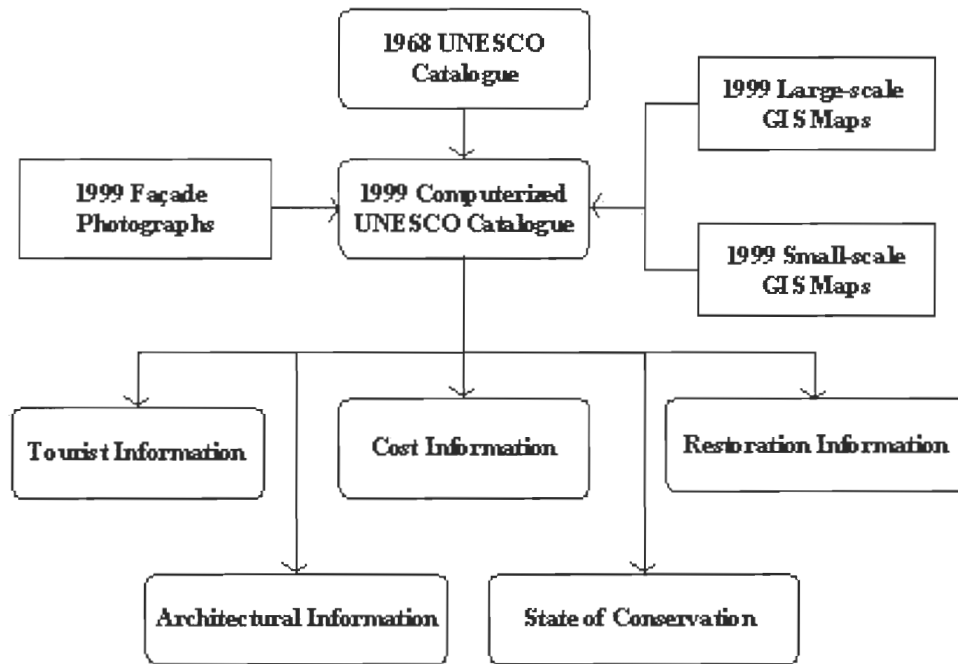
Figure 12: A flowchart showing database organization

The architectural database contains specific notes on all the churches, focusing on unique structural features, architectural style, architect, and functional descriptions. The restoration database contains descriptions of the structural damage within each church, structural measurements, and architectural features. The tourist database has information of a non-specialist nature: a brief history of the church, architectural type, hours of operation, location, entrance fee (if applicable), and a façade photograph. Appendix H shows the structures of the databases created for this project as well as detailed descriptions of the types of information in each table. Appendix F contains a few examples of the look of the new catalogue. The complete computerized catalogue can be found on the project CD. A complete copy of the catalogue can be printed from that file.

separating the overall database into smaller, more manageable pieces as seen in Figure 12. Several tables were created, containing architectural, historical, restoration, and tourist information.

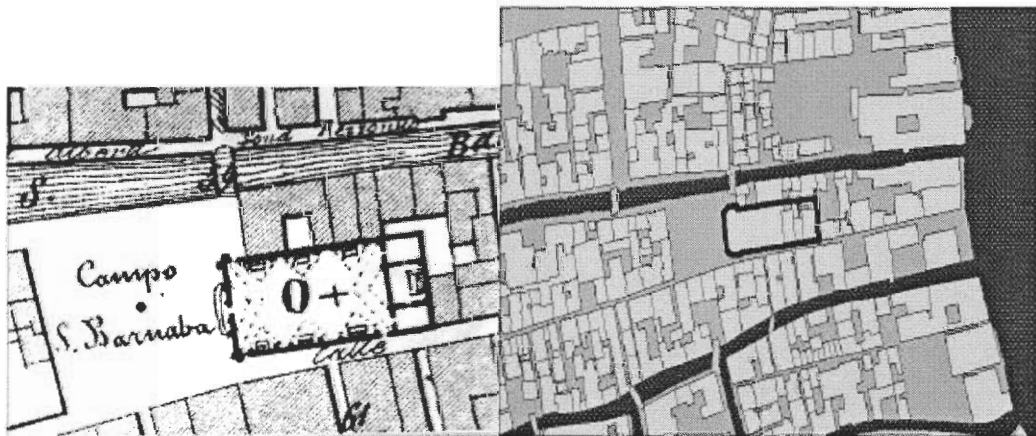
Figure 17: Maps from the catalogue of San Barnaba. On the left is a hand-drawn map from the original catalogue. On the right is a GIS-generated small-scale map.

The churches are pinpointed on two maps having different scales: a large scale map that shows the position of the church within Venice, and a small scale one that shows the

church and the surrounding streets. An example of each of these maps is shown in Figure 18 and Figure 19. The differences are apparent with a cursory evaluation of the maps. In the large-scale maps one will notice the differences in island shapes. This is due in large part to the fact that Venice has changed in some respects since the creation of the antique maps.
