Renovation of Alumni Gymnasium

A Major Qualifying Project

Worcester Polytechnic Institute

29 April 2014

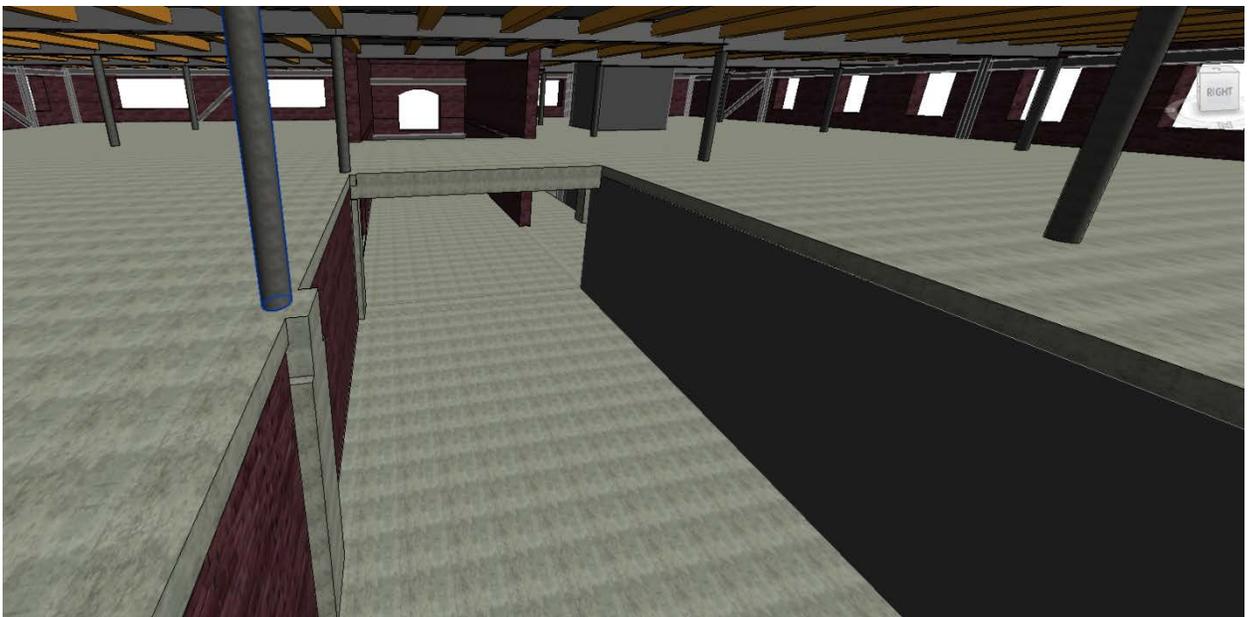
Figure 27 - BIM image of the future Atrium view

Developing a structural design for the new layout on Level 3 was another area of effort. WPI intends to open the space up on the main floor of the building by creating a Showcase Atrium. Partitions walls and stairs, shown in Figure 26, would have to be demolished to create this corridor and an opening in the existing concrete slab was necessary. This change would affect the lateral stability of the structure because an opening for new staircases would be created. The team designed a framing system to account for this change and resist the lateral load applied by wind and seismic forces. This system is shown in Figure 27.
