**Conductive, Convective, and Radiative Heat Performance Testing of Fire  
Attack Hoses**

**Major Qualifying Project Report:**

**WORCESTER POLYTECHNIC INSTITUTE**

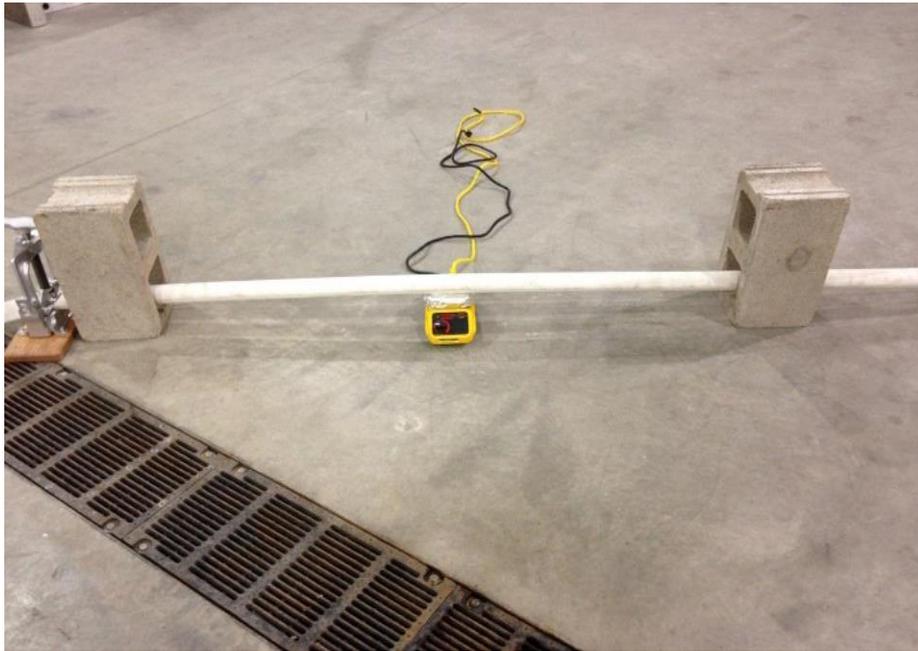
**Figure 1: First Hot Plate Iteration Design**

The original conduction test, which was dubbed the “Hot Plate Test”, involved draping a hose pressurized with air over a digital laboratory hot plate, supporting both ends of the hose, and recording time to initial pressure loss (See Figure 2). The hot plate was set to four successive temperatures: 350°C, 400°C, 450°C, and 500°C. There were four trials run at each temperature for each hose in the matrix. Air was the chosen medium, as it would not cause water damage to the electronic hot plate in the event of a failure. The hoses were pressurized to 110 +/- 7 psi, a realistic operational pressure for fire attack hoses. The set up for the first iteration of this design can be seen below in Figure 3. The entire procedure can be seen in Appendix C.

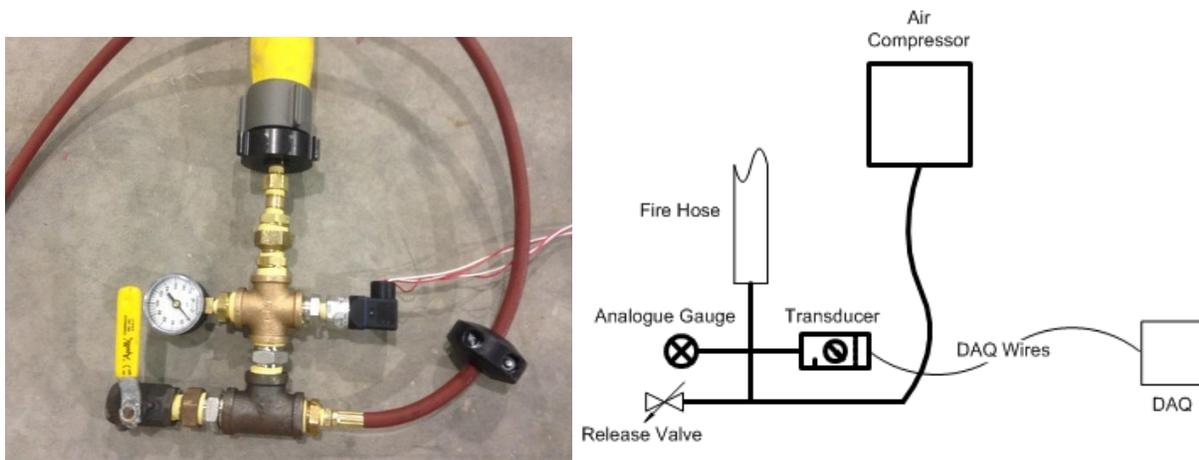
**Figure 2: First Iteration Pressure Rig**

Initially, this test was designed with the knowledge that the failure times would not emulate those that may be seen in a fire environment since air, not water, was used to pressurize the hoses. The hot plate test was intended solely to compare the four hose variables – weight per unit length, liner material, jacket material, and coating. The effect of water as a heat sink was seen as a consistent variable that could be effectively factored out of the testing scenario.

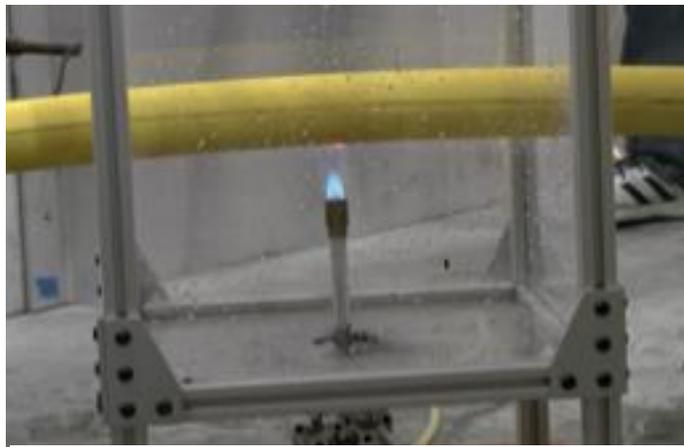
**Figure 3: Flame Chamber Test Set-Up**

The German DIN 14811: 2008-01 Flame Resistance Test was the foreign standard test ultimately chosen for replication in this study. This test involves subjecting a hose to ten seconds of flame impingement. The hose specimen is considered to have passed the test if it does not ignite, burst, or if it extinguishes itself within three seconds of removing the flame. The full procedure of this test can be seen in Appendix A. While an apparatus was built to replicate that used in this standard, it was not certified as an official test. Subjecting each hose in the test matrix to a replication of the DIN Test produced a case study of how U.S. hoses perform against a rigorous foreign standard specifically designed for municipal attack hoses. The experimental setup is shown in Figure 3 below. The compartment was built based on the recommended dimensions of DIN 14811: 2008-01 [9]. The walls were made of clear acrylic and the frame of extruded aluminum. Specifications such as the use of a Bunsen burner flame and the mode of heat transfer (flame impingement) were followed exactly. The non-trivial difference between the standard requirements and the test performed for this study was the number of trials per hose. A single trial was performed per hose as opposed to the five trials required in the standard. If three or more of these trials result in failure, the hose specimen is considered to have failed the DIN 14811: 2008-01 Flame Resistance Test.

Using the same test apparatus, each hose in the test matrix was also subjected to a second test, which is referred to as the "Flame Chamber Test". This involved the same set up, however the flame impingement was held constant until loss of water pressure could be observed. This "Flame Chamber Test" was intended to compare flame resistance performance among the hose array in terms of time to initial pressure loss. The testing procedure is given in Appendix B.

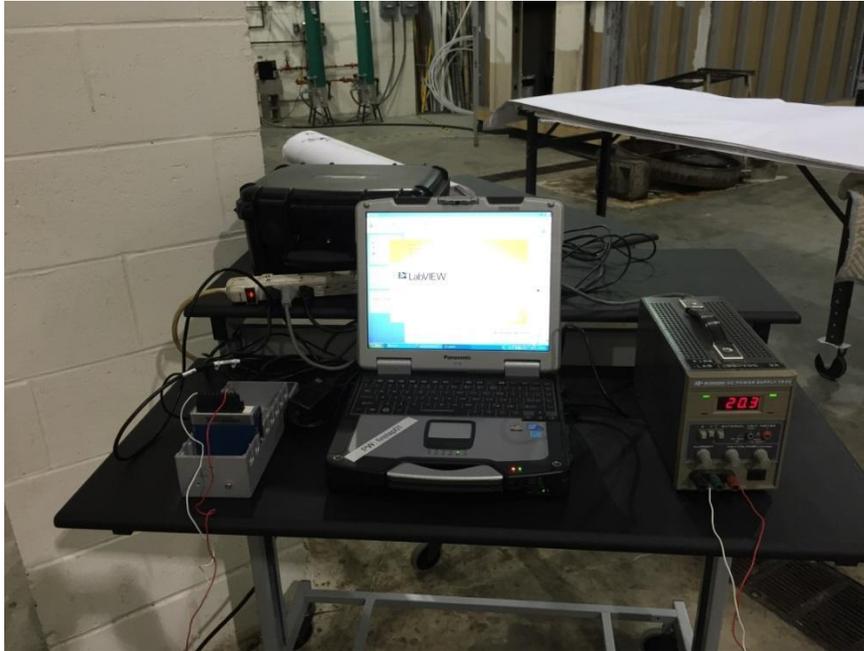
Figure 4: DAQ System

Automatic data collection was required for all testing instances and trials. All data was recorded through a basic data acquisition system (DAQ system). The system included a Texas Instruments DAQ chassis and analog module package for raw data collection, in addition to a LabVIEW 2013 virtual instrument (VI) program for live data collection and result output (See Figure 4).

The DAQ system was capable of measuring voltage data, which could be translated directly into pressure values. Voltage data versus time was collected via a pressure transducer and a power supply, which provided an excitation voltage to the transducer. The transducer outputted a 0-10 volt reading, which could be translated to pressure on a 0-200 psi scale (i.e. 1 Volt = 20 psi). The transducer was mounted to a “pressure rig” constructed of national pipe thread (NPT) piping that connected the pressure source to the fire hose.

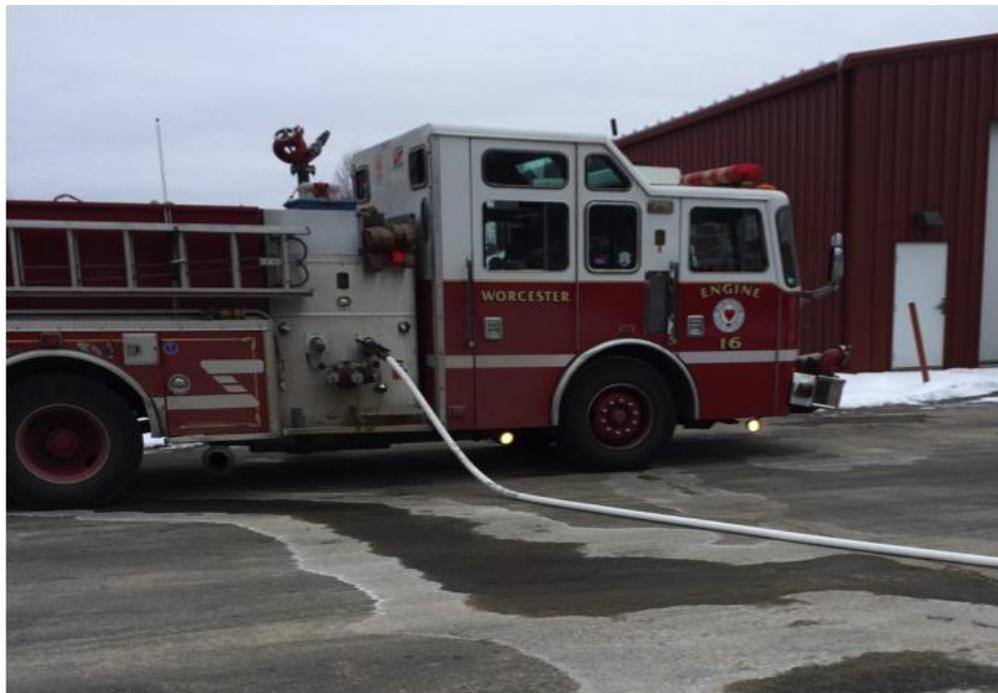
**Figure 5: WFD Quality Assurance Testing**

Before the hose array was subjected to any testing, each individual hose was removed from original packaging, checked for physical defects, pressurized to 250 psi for 5 minutes, and then checked for leaks by engine crews at the Worcester Fire Department (See Figure 5). A pressure of 250 psi is higher than any pressure achieved during actual testing. Therefore, this third party testing ensures there are no hose defects and that the quality of the hoses is sufficient prior to any data being collected.

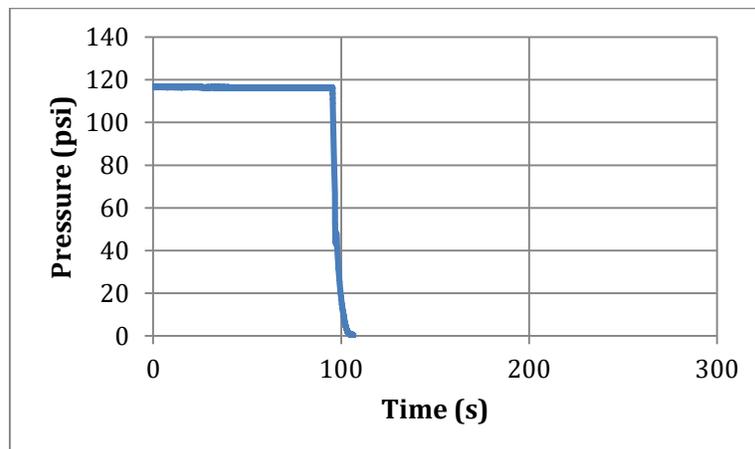
**Figure 6: Example Pressure Loss in EPDM Lined Hose Trial**

During this first iteration of hot plate testing, it was found that hoses displayed two different modes of failure that were dependent on liner material (i.e. TPU or EPDM). On one hand, EPDM lined hoses ruptured energetically, suffering an instantaneous and complete loss of pressure. On the other hand, TPU lined hoses slowly lost pressure through one or more pinhole-sized holes. Figures 6 and 7 below display pressure loss curves recorded from the hot plate trials of an EPDM and a TPU lined test hose, exemplifying the dissimilarity in time to total pressure loss.

These failure modes held true through all three hot plate testing iterations. Data was inconclusive as to whether EPDM or TPU hoses lasted longer until initial pressure drop; however, TPU lined hoses consistently took a longer time to reach a point of half-pressure when compared with EPDM lined hoses. The difference in failure modes is based on the thermo mechanical properties of the liner material. More specifically, EPDM is thermosetting while TPU is thermoplastic. When a heat flux is applied to the EPDM lined hoses, the outer jacket and coating are first melted away leaving the liner exposed. The application of heat caused the liner to build up interior thermal stresses until it eventually ruptures as seen in Figure 8 below. If these holes are large enough, they could render the hose incapable of delivering water to the nozzle at an adequate pressure to fight a fire.

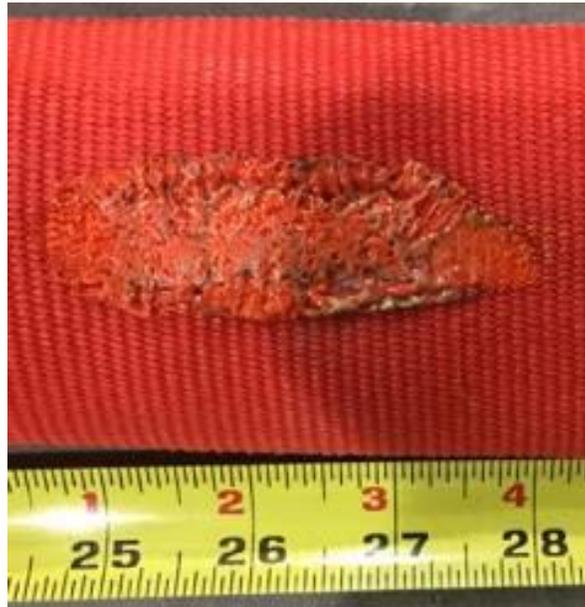
**Figure 9: TPU Hose Failure Example**

When the same heat flux was applied to a TPU lined hose, the jacket and coatings acted similarly by melting away and leaving the liner exposed as seen below in Figure 9. However, the liner also melted instead of building internal stresses. The pressurized water released slowly through pin-hole sized orifices that formed in the melting material at a much slower rate than any EPDM lined hose.

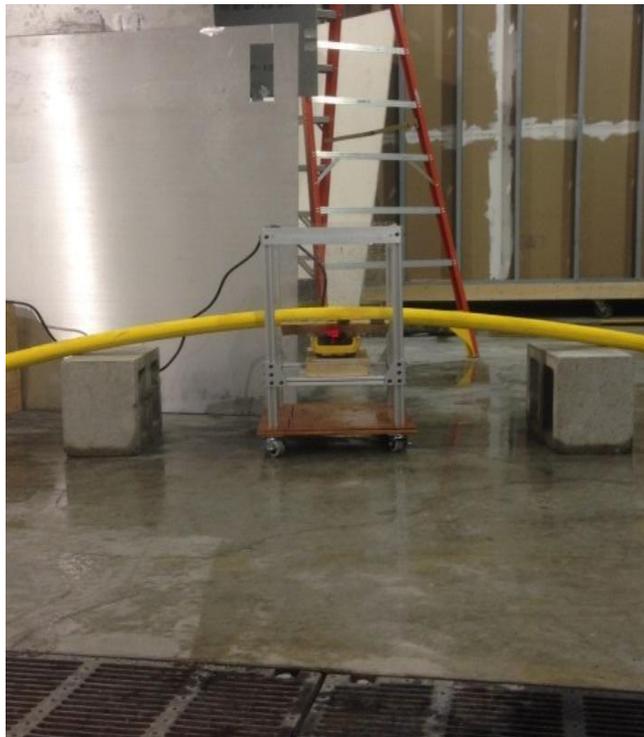
Figure 10: Second Iteration Hot Plate Design

The new apparatus utilized the chamber built for the DIN replication to contain water spray, which drained out a hole in the bottom of the compartment (seen in Figure 10). The hot plate was raised off the bottom of the chamber to prevent water pooling into its electrical components and to align it with the hose inlets. The hose itself was arced through the chamber such that the apex of the arc rested on the hot plate, but was smooth enough for complete contact. Both ends of the arc were supported by cinder blocks.

The pressure rig, originally intended for air, had to be redesigned to accommodate for water and a higher pressure. As shown in Figures 10 and 11, the rig consisted of a direct standpipe connection with two waterways: a pump (pressure washer) and a bypass. The bypass allowed the pressure rig and the fire hose to be quickly filled with water at a standpipe pressure of about 55 psi before the pump increased the pressure of the system to 150 psi.

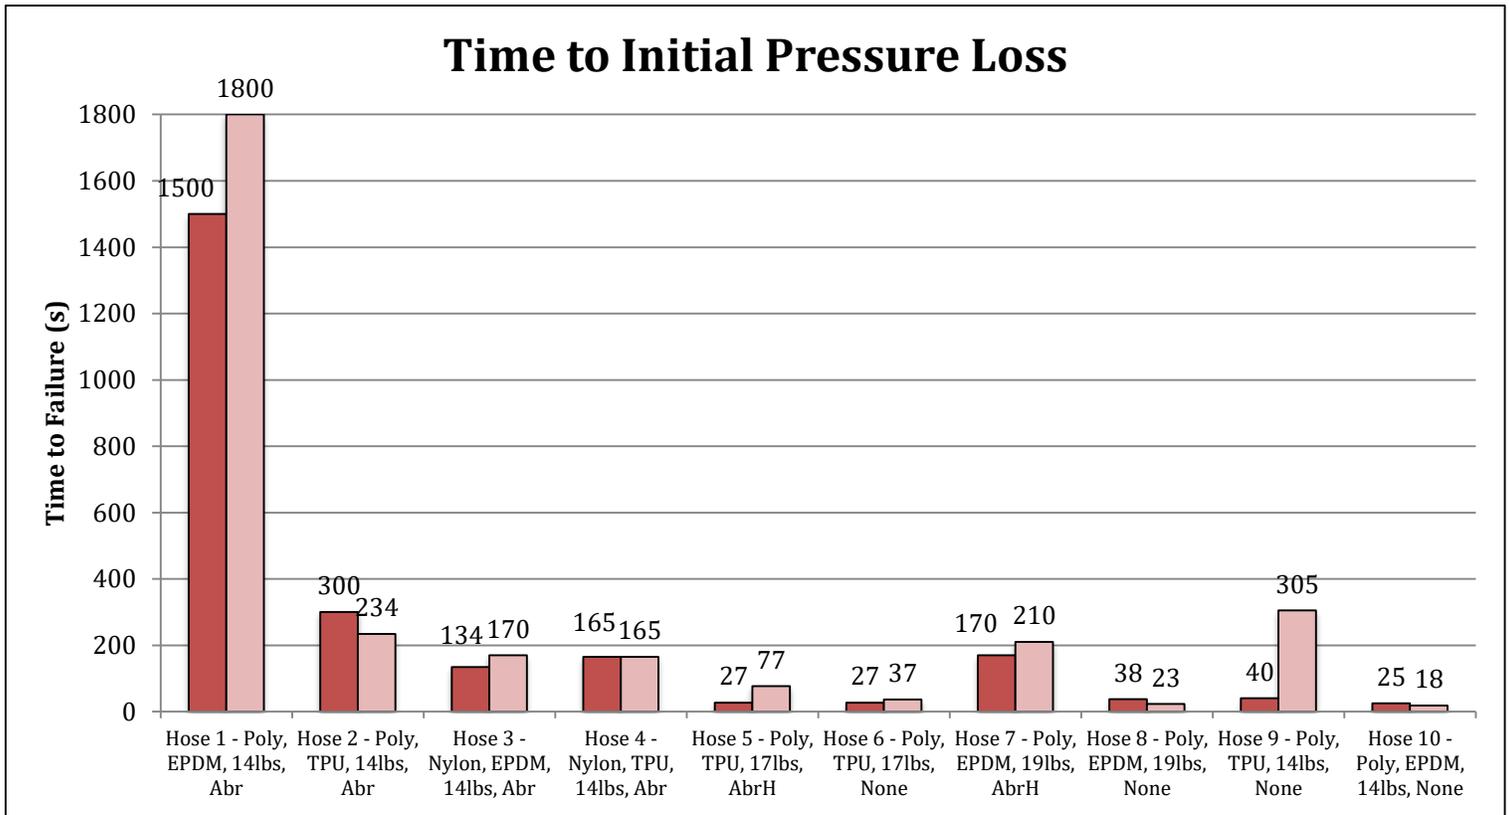
Figure 12: Second Iteration Hot Plate Initial Pressure Loss Results

Figure 12 below shows the recorded initial failure times of each test hose during the second iteration hot plate tests. A full parametric analysis was performed. There were two trials run on each hose, as represented by the pink and red bars. The resulting data presented a set of inconsistencies. Some trial sets produced similar failure times as seen for the trials of Hose 3, Hose 4 and Hose 7; however, other trial sets displayed very dissimilar failure times such as for Hose 1 and Hose 9. For instance, the Hose 9 test trials displayed a 153.6% difference in failure time even though the trials themselves were procedurally identical. The Hose 1 trials were also extreme outliers with failure times at least 20 minutes longer than those seen in any other hose trials. The physical differences between Hose 1 and the other hoses in the test matrix would not lead to such a drastic performance difference. Aside from these trial-based inconsistencies, the data as a whole could not produce conclusions related to how weight per 50ft, jacket material, or coating affected performance. The conclusion was drawn that a set of design flaws affecting data collection and accuracy must have been present. The factors most likely to have caused data inconsistencies are discussed below.

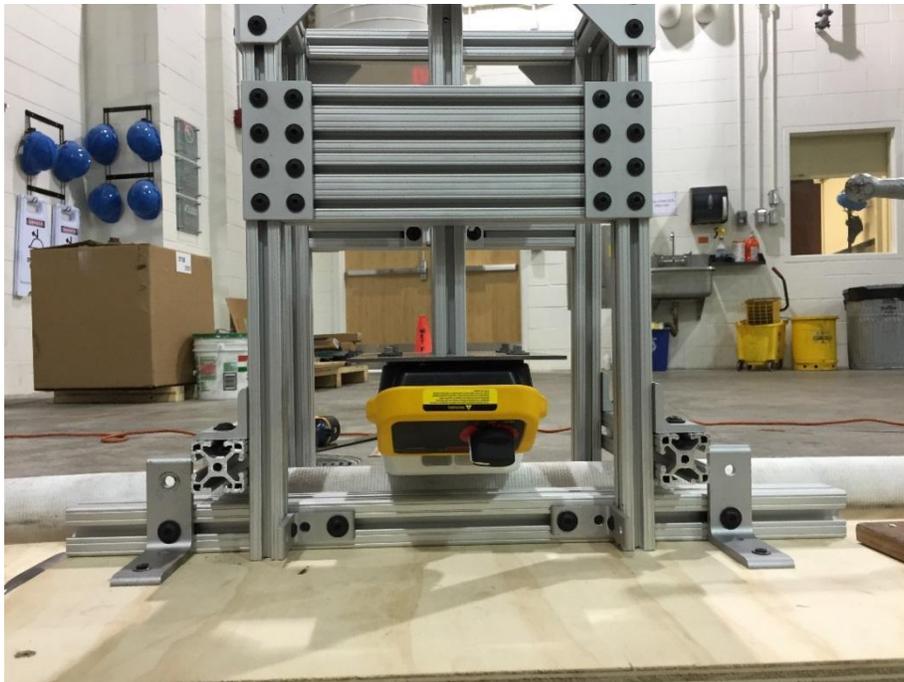
**Figure 13: Third Iteration Hot Plate Design Test Set-Up**

The third and final design iteration was aimed at addressing sources of error and inaccuracies that involved hose-to-hot plate contact. These arose and were identified during second iteration testing. The pressure rig and the DAQ system remained the same. The new apparatus consisted of an aluminum frame that houses a hose guide, clamps, and a linear slider mechanism that raised and lowered the hot plate onto the hose (See Figure 13). A labeled Solidworks diagram of the frame is also shown in Figure 14. The guide bars and adjustable clamps kept the test hose flat, horizontal and in the same position relative to the hot plate. The reversed orientation of the hot plate eliminated any water pooling on the plate surface. Furthermore, the rigid geometry of the frame and the hot plate's ability to translate up and down repeatedly created consistent hose-to-plate contact between trials. This procedure can be seen in Appendix E.

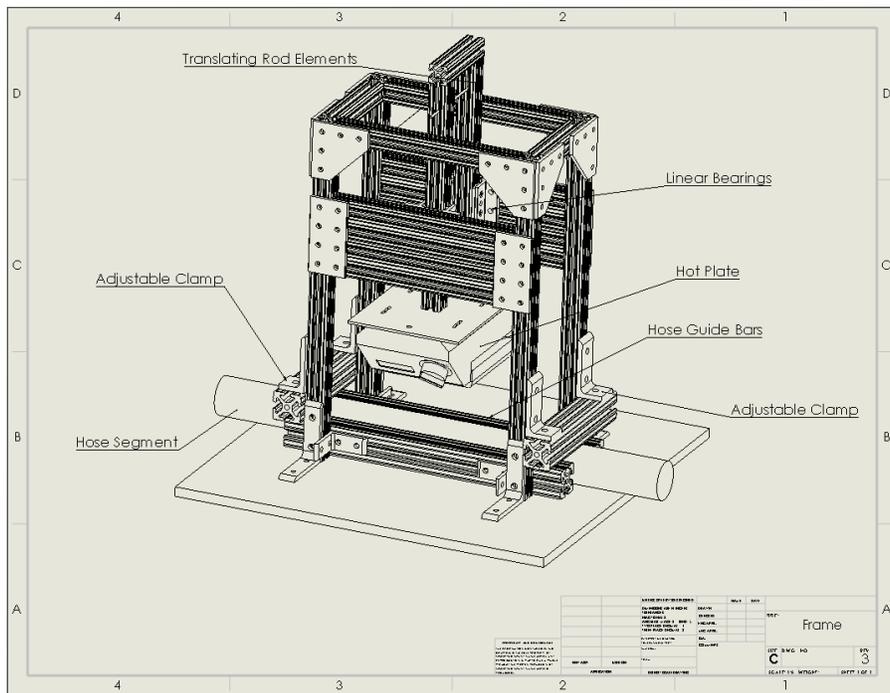
Figure 14: Third Iteration Hot Plate Design CAD File

The smoothness of translation affected the contact between the hose and the hot plate in addition to the hose guide and rigidity of the frame. The translating rods had to be able to slide through the bearings with minimum friction and no binding. The aluminum extrusions and linear bearings used in the design were not created with the high tolerances of more expensive, fluid lubricated linear rods and bearings. The mechanism used in this design was non-lubricated and required a larger amount of “play” to work properly. As a result, a discrepancy of four-to-six thousandths existed between the translating rods and the bearings. To test the smoothness of translation, a load cell analysis was conducted to ensure the force on the hose among multiple iterations of raising and lowering the hot plate would remain constant. As shown in Table 2, there was only a variation range of 0.128 N among all ten trials.

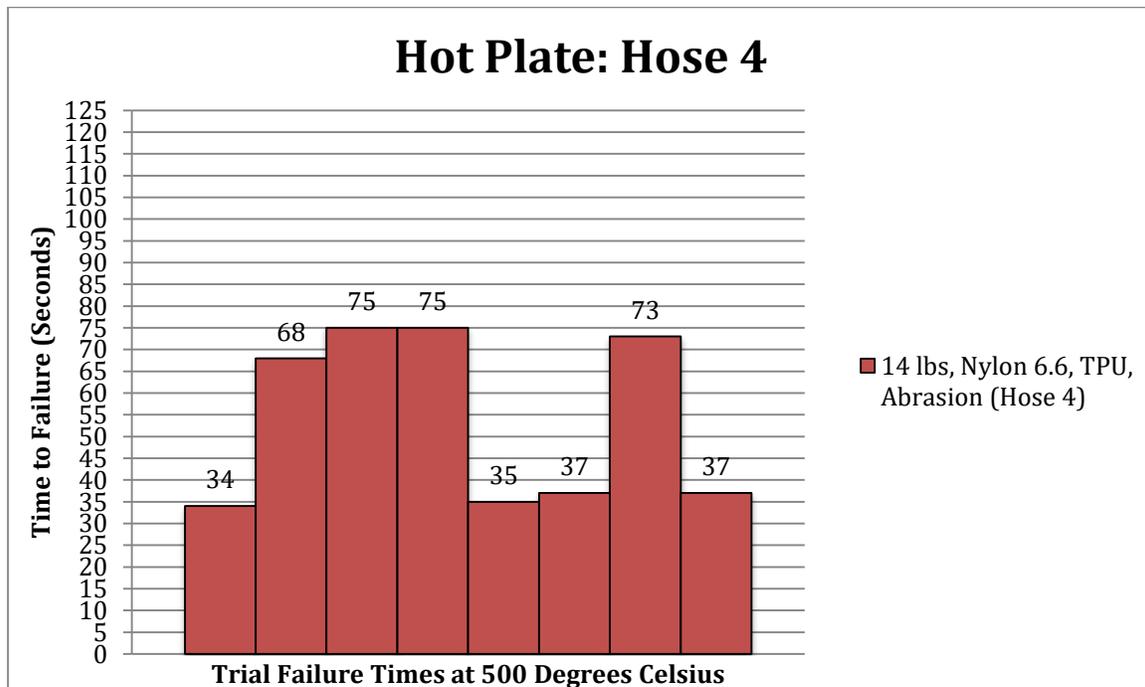
Figure 15: Third Iteration Hot Plate Test - Hose 4 Results

Only a limited amount of trials were performed on the third iteration design before inconclusive data patterns were observed. As seen in Figure 15 below, there were eight trials run on Hose 4 at the onset of the third iteration testing due to data inconsistency. These trials resulted in failure time data that displayed grouping. Four trials resulted in 34-37 seconds to failure while four resulted in 68-75 seconds. Three trials were also performed on Hose 3, although as shown in Figure 16 the trials resulted in three separate outcomes.

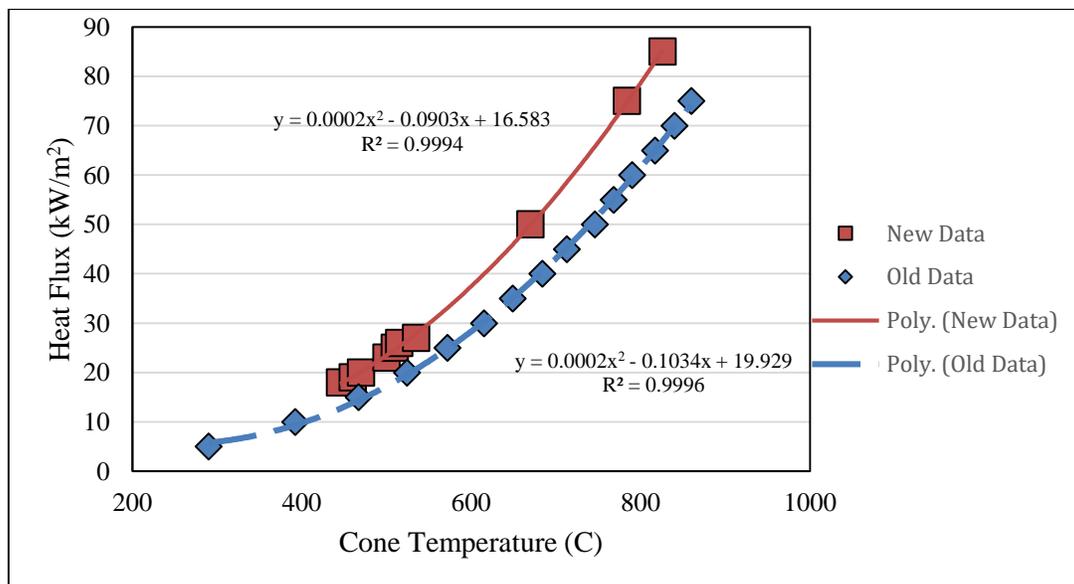
Figure 1: Old vs. New Cone Temperature Heat Flux Curves

Figure 1 below shows the cone temperature heat flux curves for the cone heater used in this testing prior to and after calibration. As shown, the new values found after the calibration yield a higher heat flux per cone temperature than the original values. For example, a set point of 392 degrees Celsius on the old curve would yield a heat flux of 10 kW/m<sup>2</sup>, while on the new curve it yields a heat flux of 11.9 kW/m<sup>2</sup>. The equations of the lines were used to calculate the heat fluxes that were actually used during testing.
