**SELF-HEALING COATINGS FOR STEEL REINFORCED  
INFRASTRUCTURE**

A Thesis

WORCESTER POLYTECHNIC INSTITUTE

Civil Engineering

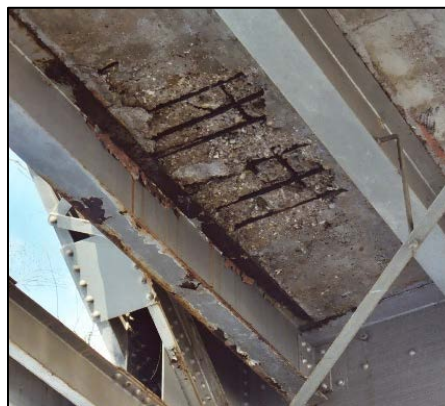
**Figure 2: Corrosion of steel reinforcement on the bridge deck of the Devil's Elbow Bridge in Missouri [6].**

Steel reinforced concrete, also known as structural concrete, was first adopted in the United States in 1889 for the construction of the Alvord Lake Bridge in San Francisco, CA (Figure 1) [1]. Since then, structural concrete was rapidly adopted as a building material. However, by the mid 1970's researchers recognized that the deterioration of bridge decks coincided with locations of deicing salt application and attributed this degradation to corrosion of the steel reinforcement caused by the ingress of chloride ions (Figure 2) [4].

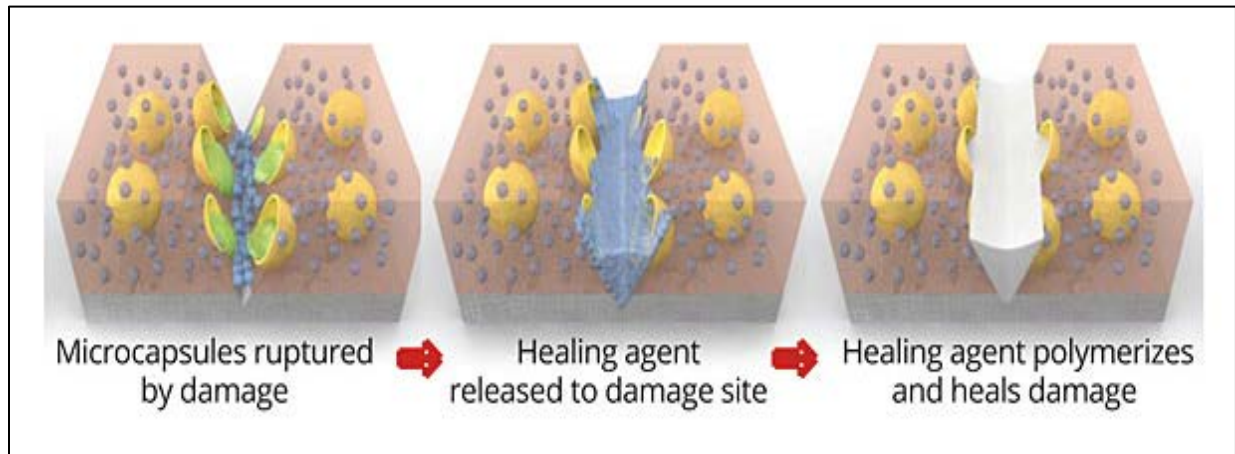
**Figure 7: Concept of self-healing coatings with microcapsules [24].**

Microencapsulation is of particular interest for the proposed research. This approach incorporates a core-shell microparticle into the epoxy matrix. When the epoxy coating is damaged, these microcapsules rupture and release the core substance, which oxidizes on the surface of the metal to form an impenetrable barrier (Figure 7).

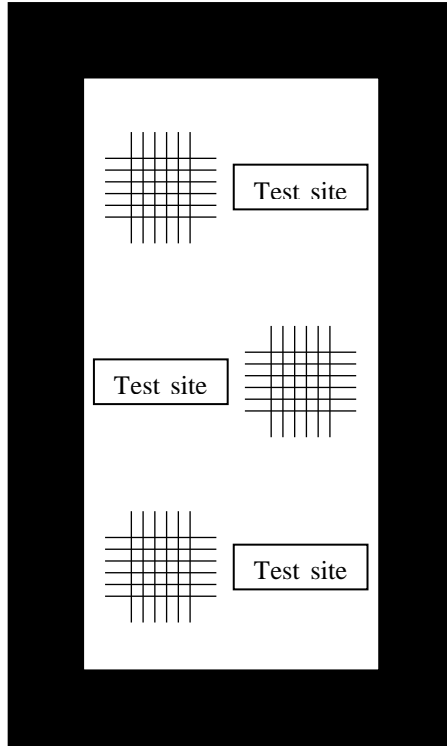
Figure 10: Schematic of adhesion samples displaying the three testing sites per sample

after being submerged in the aerated salt-water baths. Three adhesion tests were conducted per sample on one side, totaling nine adhesion results per week, per coating type (Figure 10).

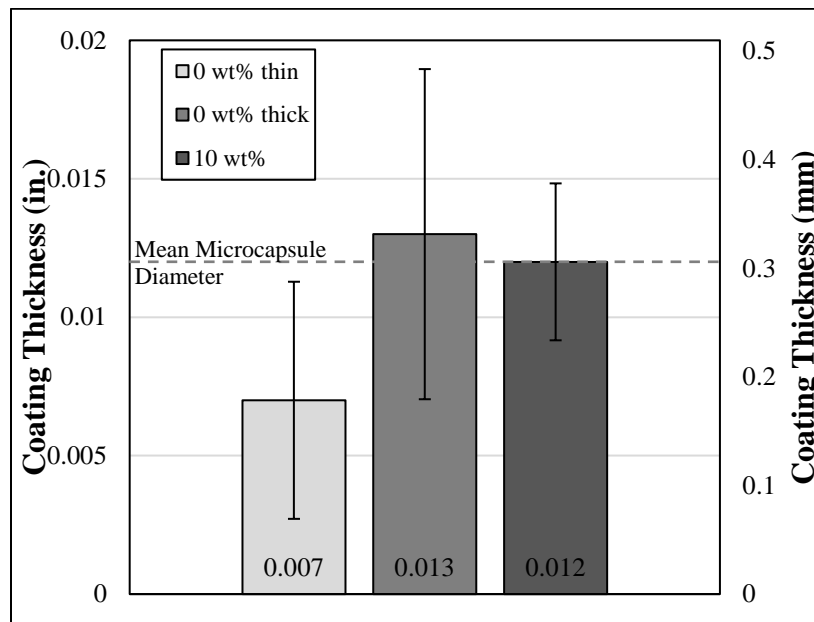
Figure 11: This graph compares the average coating thicknesses for the different samples. Also graphed is the mean microcapsule diameter to compare with the 10 wt.% samples.

The average coating thickness of 0 wt.% thin samples was  $0.007 \pm 0.004$  in ( $0.18 \pm 0.10$  mm) per side. The average thickness of 0 wt.% thick samples was  $0.013 \pm 0.006$  in ( $0.33 \pm 0.152$  mm) per side. The relatively high standard deviation for 0 wt.% coatings was believed to be a result from too much pressure applied to 0 wt.% thin samples and variable pressure applied to 0 wt.% thick samples while regulating the coating thickness with the squeegee. The average coating thickness of 10 wt.% samples was  $0.012 \pm 0.003$  in ( $0.31 \pm 0.076$  mm) per side. It was observed that the thickness of the 10 wt.% coatings was similar to the median microcapsule diameter documented by Carpenter and Loucks (2016) and small peaks formed at the location of microcapsules. This suggests that the 10 wt.% coating thicknesses are dependent on the size of the microcapsules and therefore lead to increased thickness (Figure 11).

There was a statistically significant ( $p < 0.05$ ) difference between the 0 wt.% thin and 10 wt.% coating thicknesses, with the 0 wt.% thin coating 42% thinner than the 10 wt.% coating. Similarly,

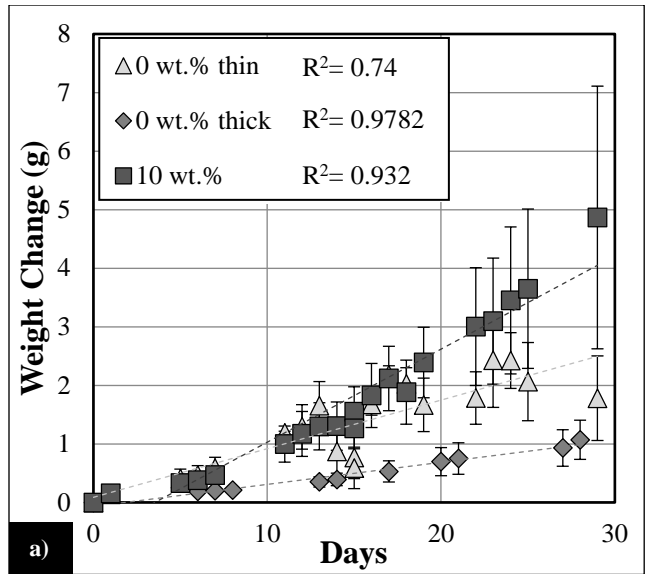
Figure 13: Analysis of impact damage samples for 0 wt.% thin, 0 wt.% thick, and 10 wt.% samples. a) Quantitative results of rust accumulation on samples measured by increase in sample weight with time b) Qualitative results of rust accumulation.

All samples were submerged in aerated salt-water baths and monitored periodically to analyze the progression of corrosion. Impact damaged 0 wt.% thin samples displayed a rate of corrosion of 0.003 oz./day (83 mg/day). 0 wt.% thick samples corroded at 0.001 oz./day (38 mg/day). The 10 wt.% samples corroded at 0.005 oz./day (147 mg/day) (Figure 13). 10 wt.% samples had the least corrosion resistance, quantitatively and qualitatively, among all impact damaged samples, followed by 0 wt.% thin and 0 wt.% thick samples, respectively. 0 wt.% thin coatings had a low  $R^2$  value which is possibly a result of the variably thin areas of coating corroding more than thicker regions (Figure 14).

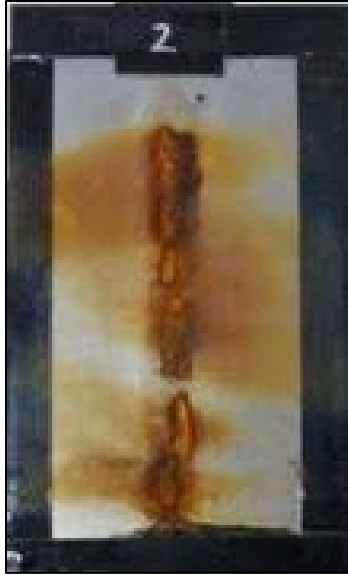
**Figure 14: Common rust formulation on 0 wt.% thin samples where squeegee was used with too much pressure leading to thinner coatings in the center of the samples and the accumulation of rust.**
