## Re-Design, Construction, and Validation of an Apparatus Used for Performance Testing of Fire Attack Hoses Subject to Conductive Heat Transfer

Major Qualifying Project Report

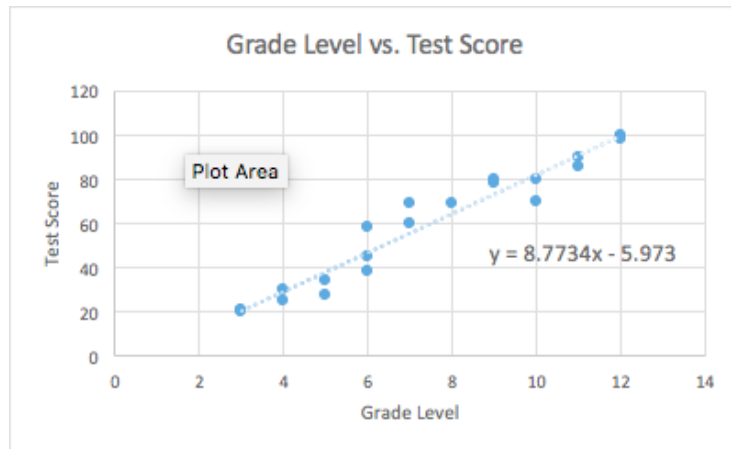
Figure 4: Example Linear Regression

Using Microsoft Excel, a line of best fit can be created using the slope value of 8.77 and the y-intercept of -5.97. The  $R^2$  value was around .94 and the p-value achieved was  $1.634 \times 10^{-12}$ , which are high and *extremely* low, respectively, signifying that the independent (grade level) and dependent (test score) variables are related in a statistically significant manner. Linear Regression Analysis can be run using the Data Analysis Toolpak of Microsoft Excel 2016 [20].

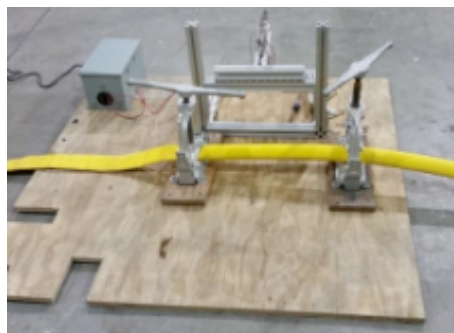
Phase 1 began with an evaluation of the original apparatus. Before making improvements, testing with the original apparatus was conducted in order to determine if the apparatus could produce repeatable and reliable results for a linear regression model. Following testing, the results showed that original apparatus had problems in its design, and those problems had to be analyzed. The existing apparatus was built to test hose performance when charged with air and exposed to a high heat conduction. Our group started by running hose performance tests using this apparatus, but replaced the air charged hose by a hose charged with water. Figure 5 below shows the previous apparatus.

*Figure 5: Original Conduction Apparatus*

From the table, it is shown that the time to failure varied between about 24 and 612 seconds, corresponding to a 2450% variance and a 220 second standard deviation. This variation in time to failure was unacceptably high, and showed that the apparatus lacked the ability to obtain consistent results. It is also important to understand that, as described in section 2.4 of this report, the heating element is controlled by a singular thermocouple. The apparatus also could not handle the water pressure, as the cantilever arm would be flung into the air causing a safety issue.

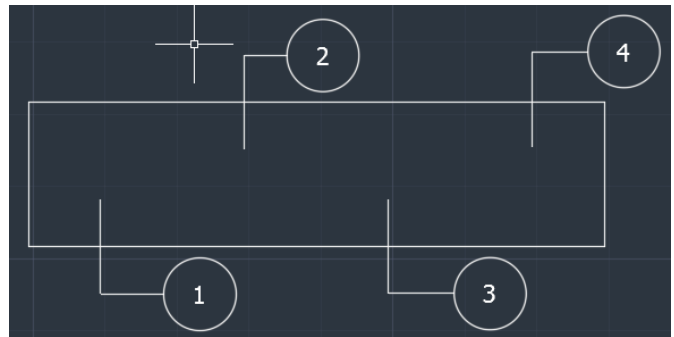
with the hose with a consistent temperature. The material that fit our needs of high thermal conductivity was copper, which has a thermal conductivity of 401 W/mK. In order to increase the likelihood that the heat would be uniformly distributed across the copper, we used Arctic Silver ceramic thermal cooling compound between the element and the copper. This compound allowed for more surface contact between the heating element and the copper. The next step was to collect temperature data along the copper block to see if the temperature range would be within our performance criteria. Temperature data had previously been collected by welding thermocouples to the element. However, the copper was nearly impossible to weld to. Our solution to this problem was to drill holes in the sides of the copper block that thermocouples could be inserted into, as seen in Figure 9 below. The length from hole 1 to hole 4 was four inches. Figure 10 shown below shows the copper block and the thermocouple locations on the sides.

Figure 10: Thermocouple Locations on Copper Block

With the insertion of the thermocouples, tests were carried out to measure the temperature difference along the copper block. The PID was set to 500°F and the temperatures were recorded. The tests showed the temperature between thermocouple 1 and 4 had a difference of 10 °F. This was within the performance criteria stated earlier. However, being that this would eventually need to withstand the failure of a charged hose, the thermocouples needed to be more secure, so that they would not fall out. First, we attempted to use the ceramic cooling compound on the thermocouples before sliding them into the holes on the side of the copper block. However, the thermocouples were still not secure. The solution was to use small pieces of copper wire to slide into the holes *with* the thermocouples. This provided the secure connection we needed to withstand hose failures, and also efficiently transferred heat from the copper block to the thermocouples.

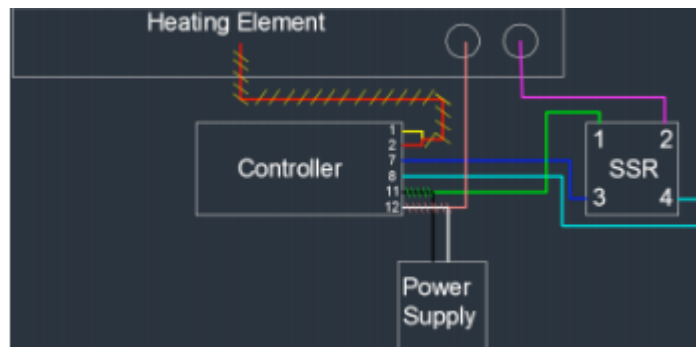
The power system used during the construction of the conduction apparatus included the wiring of the PID and a transducer. The PID wiring diagram is shown in Figure 11 below.

Figure 14: Wiring Diagram for Apparatus

The power supply listed is a 120V AC wall outlet, and the PID controller takes the thermocouple directly from the heating element and relays that to the labview data acquisition program. Labview also takes in the temperature from the thermocouples on the copper block and the voltage from the transducer.

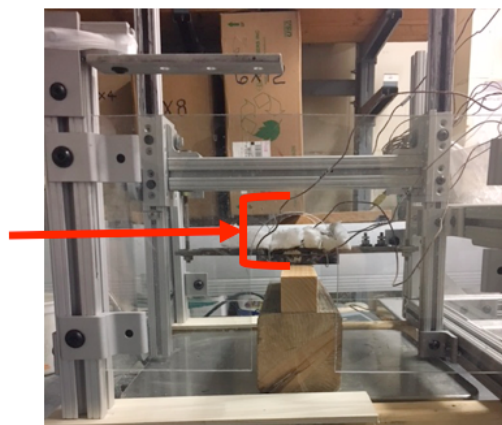
Once the apparatus was elevated, it became necessary to build up to the linear rail. This is because the linear rail does not slide all the way to the ground. It has bolts built into the 80/20 bars on which it slides that prevent it from sliding below a certain level. So, the next step was to determine the height range that the top of a 1.75" hose would sit during testing. This was determined by measuring the height of the clamps that the hose sits on during testing and considering the diameter of the hoses to be tested. We then used scrap wood, the top of which would represent the lowest height that the top of the hose would potentially sit during an actual test. The approximate range above this initial height can be seen below:

*Figure 16: Approximate Range of Initial Heights*

This range was an approximate span of just over one inch. Testing the force of the rail at other heights would be redundant because during testing with the whole apparatus, the top of a 1 3/4 in hose would never be outside of this range.

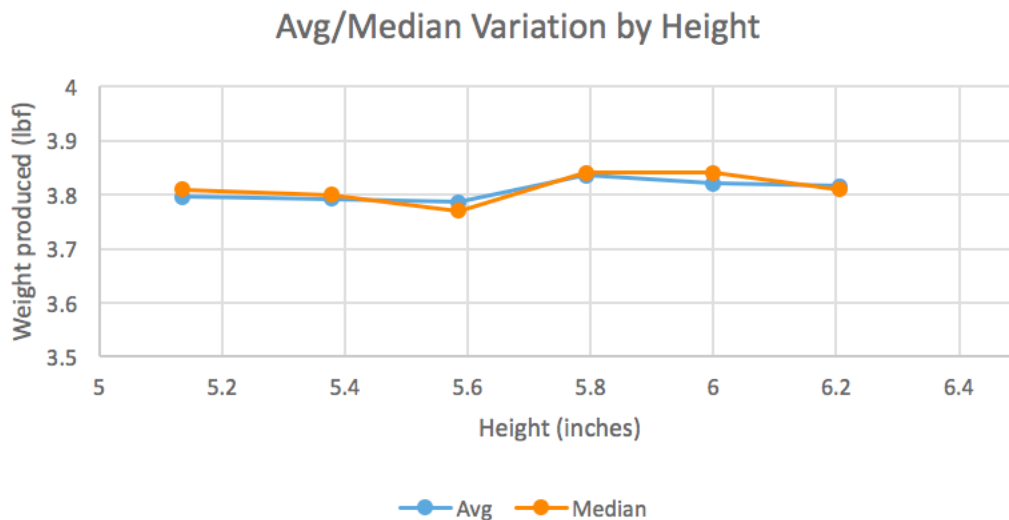
Figure 18 shows the variation by trial for each height while Figure 19 shows the median and average as height of the linear rail increases. They can be seen below:

Figure 19: Variation by Height

The mean force discrepancy was only 0.05 lbf. The variation in force for any of the trials was 0.15 lbf over a 1.1 inch height range. This is a 3.94% discrepancy, which is insignificant.

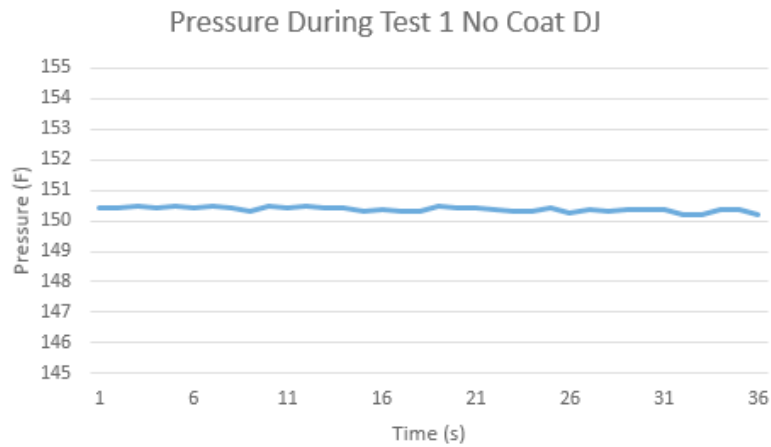
The results from the hose pressurization testing verifies this component of the apparatus, and is kept within the performance criteria of a +/- 7 psi range from the pressure experienced before and during the test until failure. The figure shown below shows the pressure remaining within the specified +/- 7 psi range during the first test of Kocheck hose DJ 17515-2 which has a polyester outer jacket, an EPDM liner material, and no coating. The figure shown below adequately represents the general pressure level experienced during all of the tests conducted.

Figure 20: Hose Pressurization Results

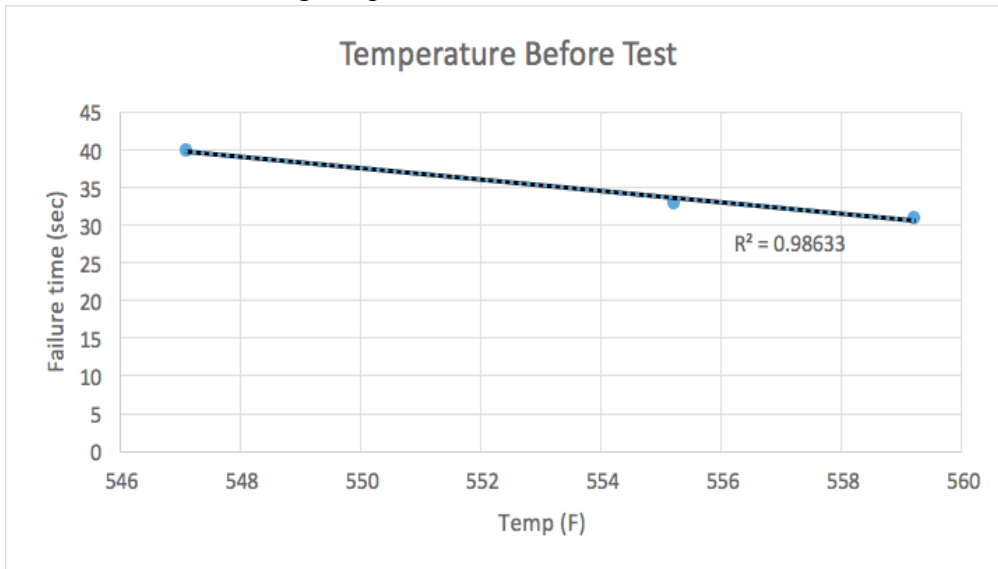
The visual representation of these test results can be seen in Figure 22, which displays the results of a linear regression analysis that produced an  $R^2$  value of 0.986, which shows a strong correlation between the starting temperature and the failure time of this hose.

Figure 22: Comparison of All Three Test Failure Times

The results of the tests showed that the apparatus could produce consistent data that was repeatable for a single hose. The results also showed that the apparatus can maintain its construction after several high-pressure hose failures. This led us to conclude that the apparatus was validated and could be used to compare the performance of different hoses.

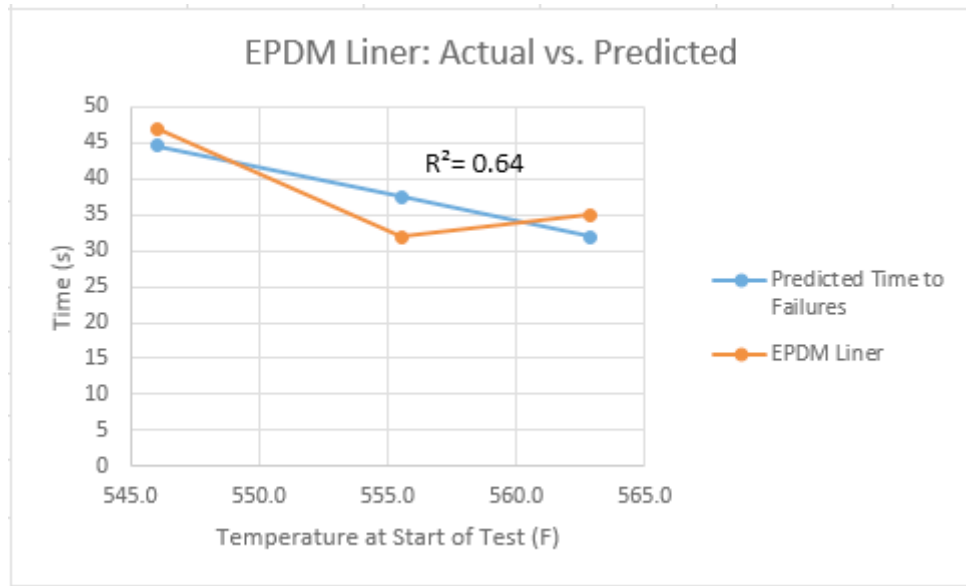
The figure below shows the actual failure times from the non-coated EPDM liner hose, the predicted time to failures, and the  $R^2$  value produced from the linear regression model.

Figure 30: EPDM Liner: Actual vs. Predicted

Based on the linear regressions, there is a moderate correlation between temperature at the start of the test and failure time for the TPU liner hose with an  $R^2$  value of 0.69 and for the EPDM liner hose with an  $R^2$  value of 0.64. Raw data from the actual vs. predicted graphs can be seen in Appendix B.
