Bus Envelope Optomization
by
Gabriel Kafka-Gibbons
A Major Qulifying Project
Submitted to the Faculty
of the
Worcester Polytechnic Institute
in partial fulfillment of the requirements for the
Degree of Bachelors of Science
In
Civil Engineering
December 2021

Individuals have been converting vehicles into livable spaces for generations and such practices are becoming common and increasingly socially acceptable. The project was developed to optimize a 1987 school bus into a space conducive of comfortable human life. The following areas were researched to understand the existing vehicle and develop tools for future renovation. The development of an accurate three-dimensional model of the frame, industry standard insulation research, and air and moisture leakage testing.

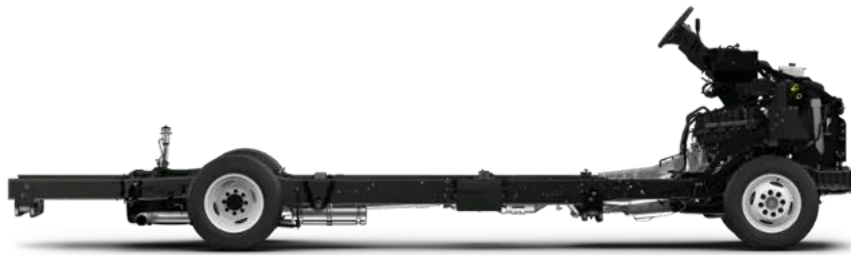
The Ford E350 is the most popular van in America and in this case the chassis is taken from that van and distributed to school bus manufacturing companies. The Collins Dictionary defines a chassis as "... the framework that a vehicle is built on." (1) Also pictured is the drivetrain exhaust and suspension.

Figure 1, Ford commercial chassis similar to the buses older chassis

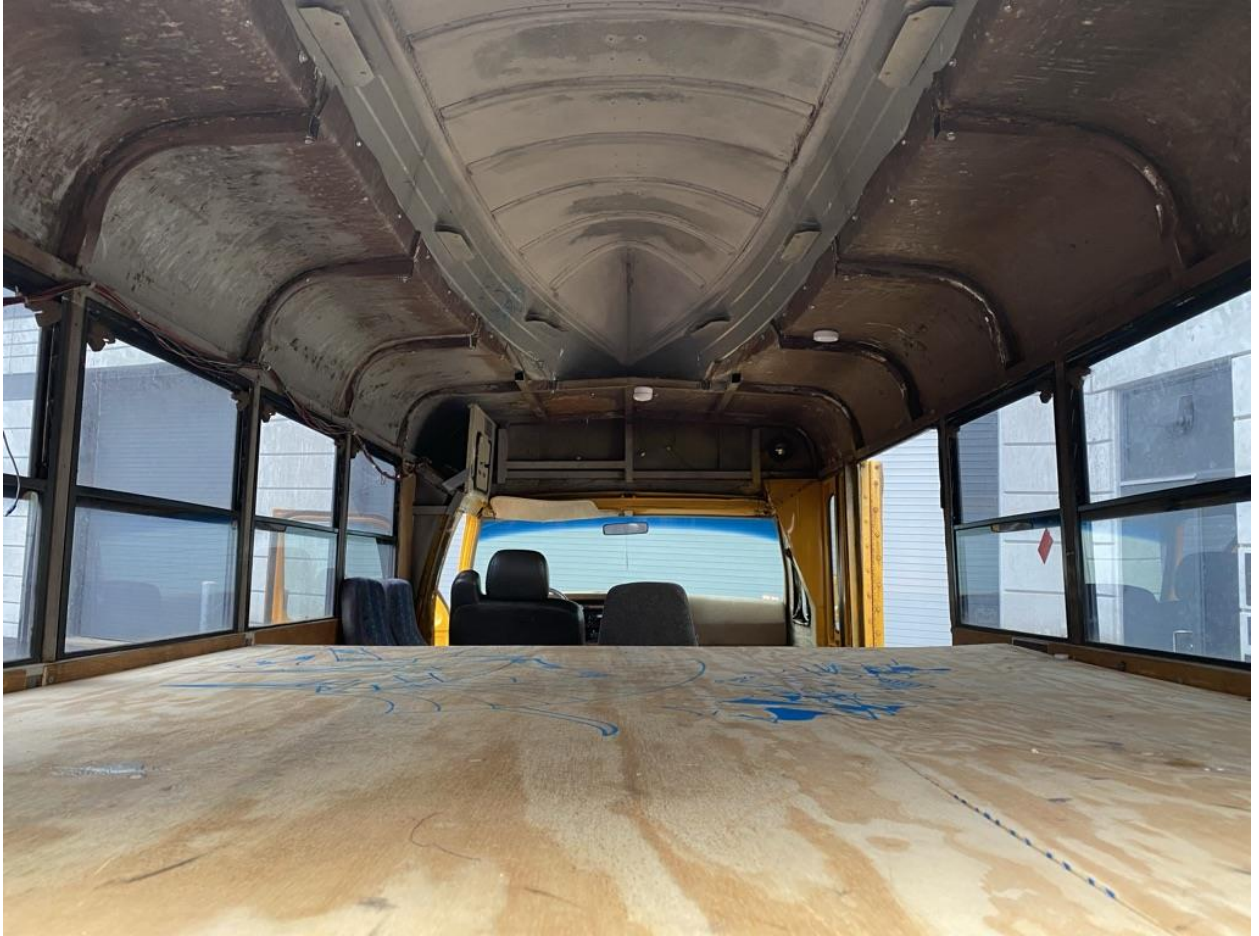
The envelope of the bus is the focus of the project. The structure that encloses the vehicle is the envelope. The structural elements of the envelope are comprised of 1.5-inch cubic steel members. These members create a frame covered with 1/16" sheet metal for the roof, typical bus windows hung up both sides, and a sheet metal floor with indents for the wheel wells. Shown in figure 2 is the steel frame.

Figure 2, bus 1.5” cubic steel frame and aluminum roof raise

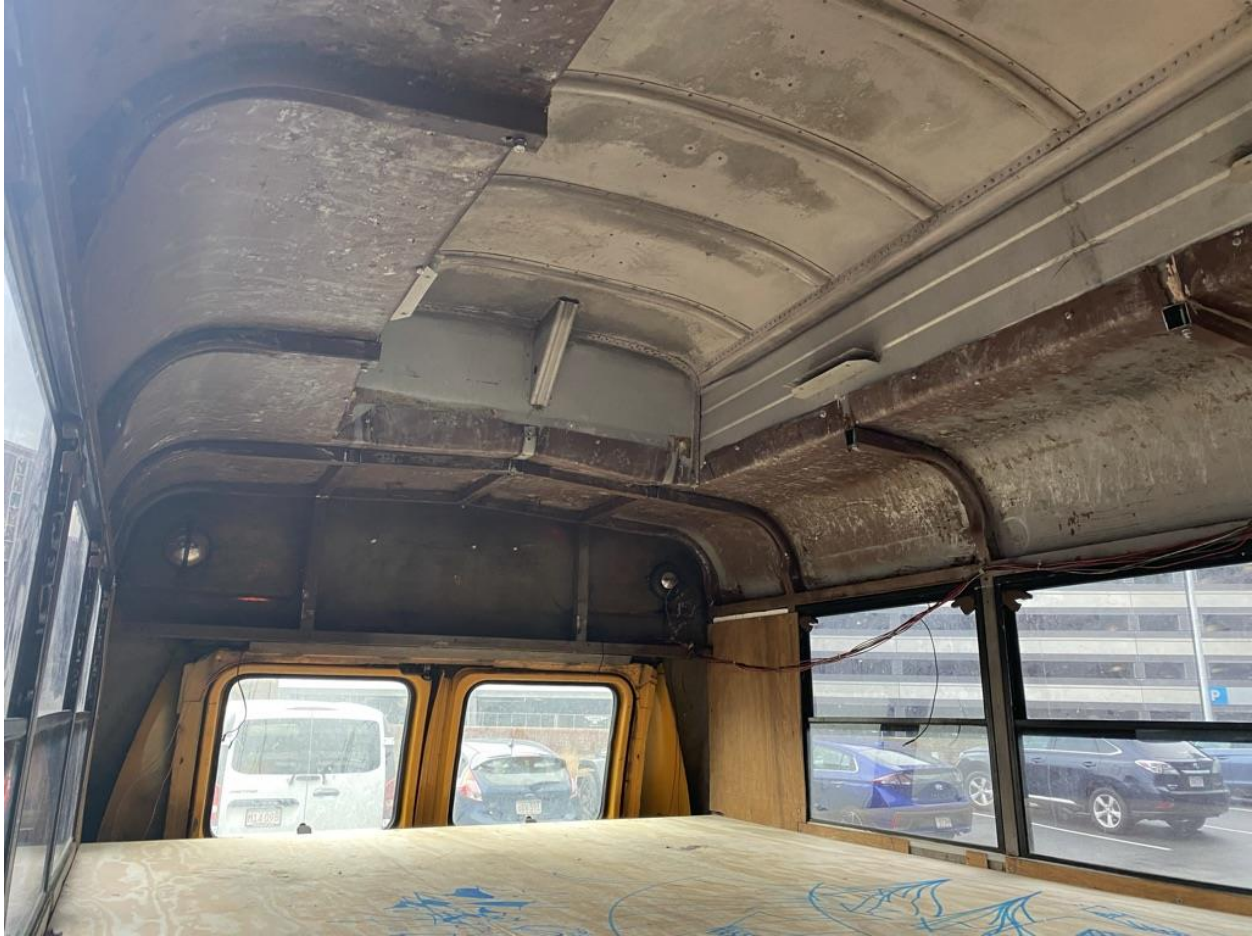
Additionally, a 12-foot aluminum boat has been secured to the frame of the roof and the area of the roof within the boat has been cut out to add extra headroom. This boat extension will be referred to as the “roof raise”. This will be a major consideration in the paper because although it created important head space in the living area, it also allowed for thermal and moisture weak points in the envelope. The roof raise is illustrated in figure 3.

Figure 3, aluminum boat roof extension

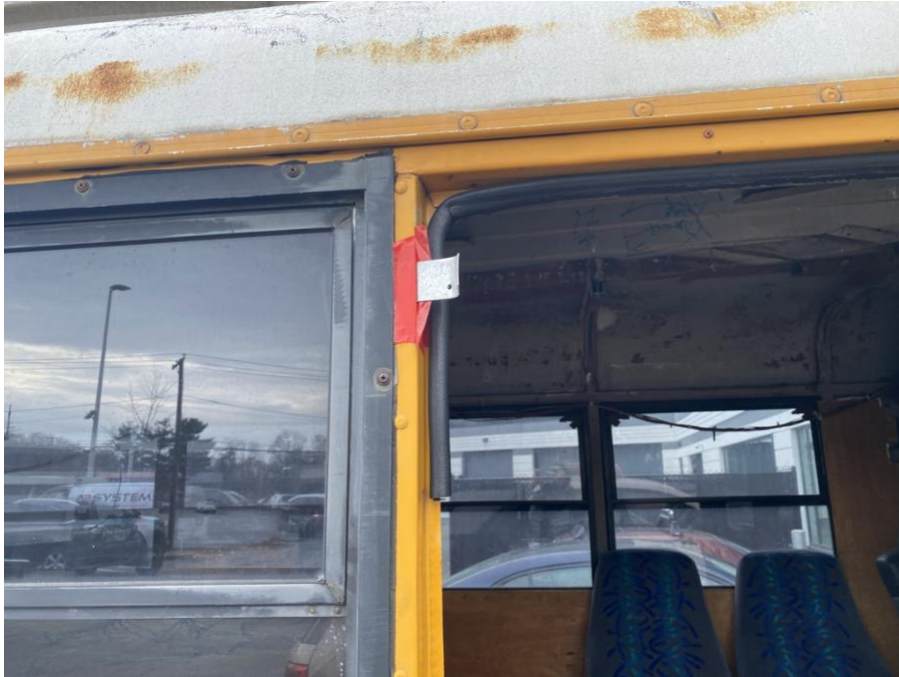
The blower door was installed in the handicap side door. For all three tests brackets were installed in the door frame to ensure the blower wouldn't pop out during positive pressure tests.

Figure 4, blower door bracket

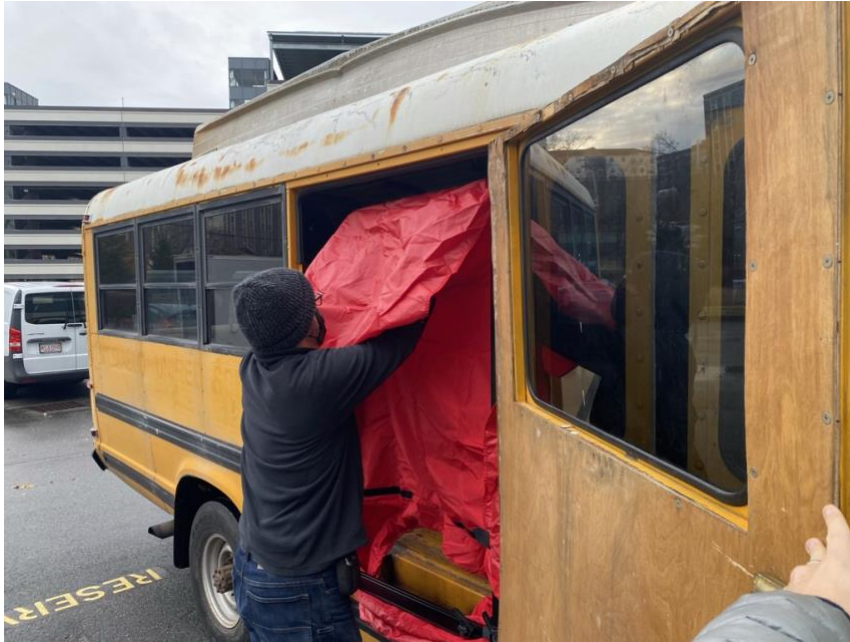
The frame was then sized and inserted with the red canvas material sealing the entry. As shown in figure 5, the frame was sized using sliding aluminum brackets. Figure 6 shows the frame fully installed, and the fan was inserted for the negative pressure test blowing out.

Figure 5, blower door canvas

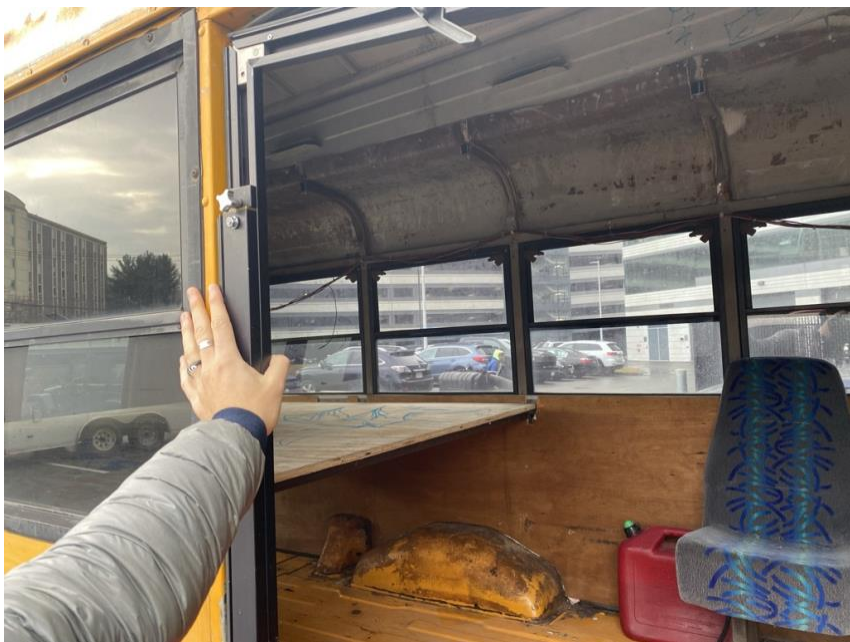
Figure 6, blower door frame

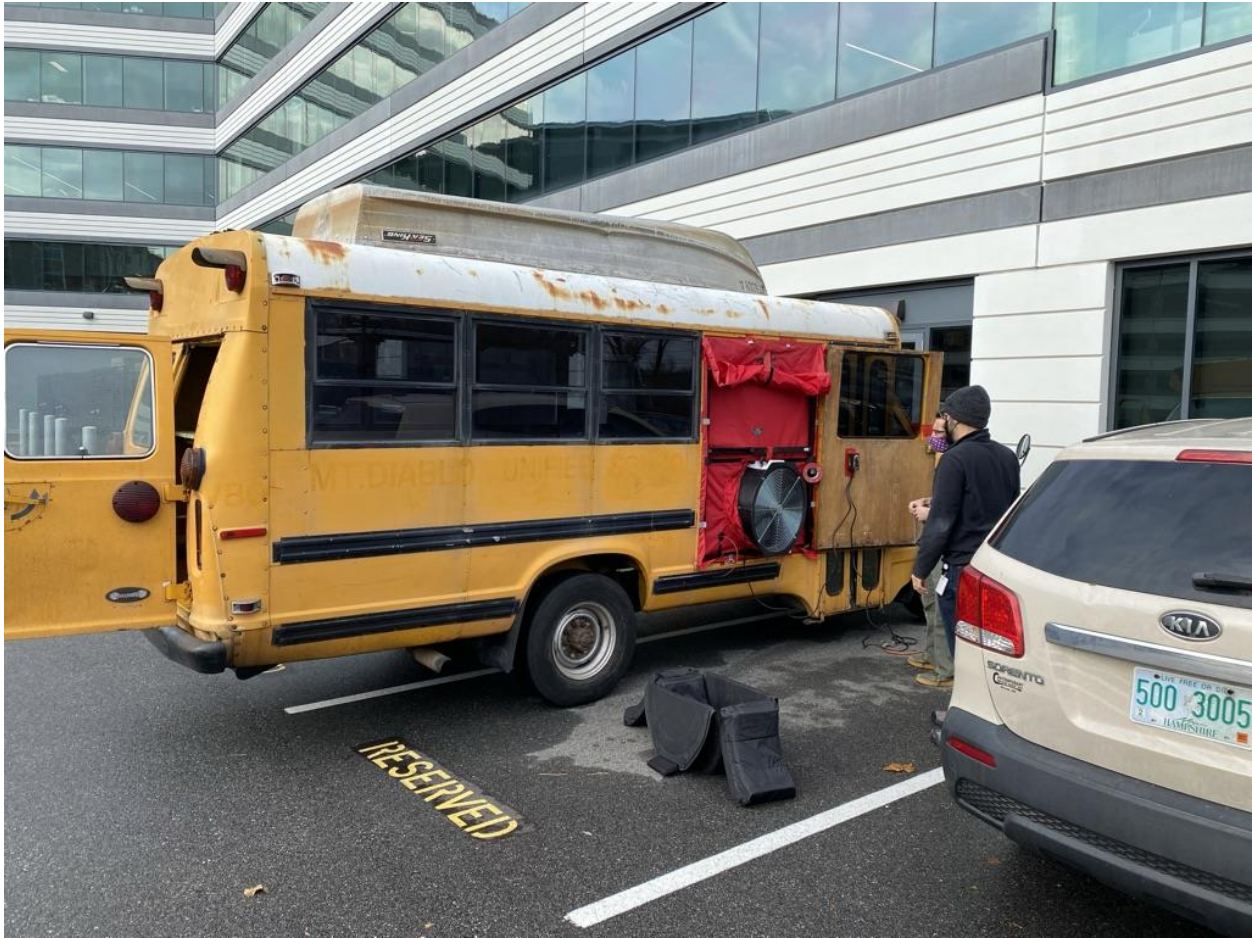
Figure 7, blower door installed for negative test

Once the blower door was fully installed as seen in figure 7, one of the DG700 pressure sensors was connected to the fan with reference to internal atmospheric pressure. The other DG700 was connected to the outside atmospheric pressure with reference to inside atmospheric pressure. All tubes end outside of the path of the blower.

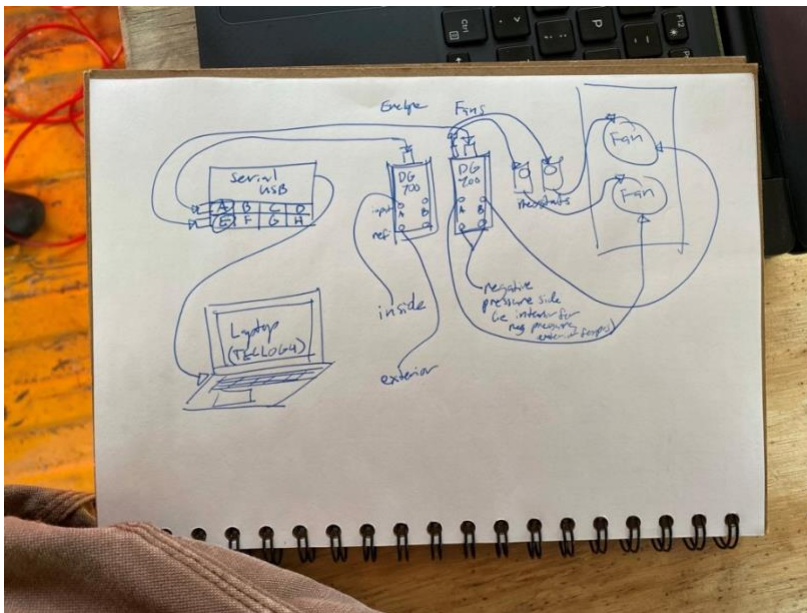
Figure 9, DG700 and blower door system diagram by Kimberly Lazar

As seen in figure 9, SGH employee Kimberly Lazar's diagram of the DG700 Teclog setup illustrated in figure 10. The test is performed by increasing the pressure over the fan in 10 Pascal increments. It was decided to conduct a 75 Pascal test where the test was started with a baseline

at a 0 pascal difference through the fan then collected about atleast 30 seconds of clean data at 10, 20, 30, 40, 50, 60, 70, and 75 Pascals. The difference in pressure was then scaled back down starting from 75 then 65, 55, 45, 35, 25, 15. The periods of time with the most consistent data at these points were selected. The fan was on “autopilot” where the fan adjusts to meet the set value pressure difference across the fan at the aforementioned points. Throught the test, the plastic “rings” were removed to allow for designated fan pressures. To begin, all of the rings were installed and the fan was sealed for the baseline test. The test began with ring B installed. When the fan couldn’t produce the pressure necessary rings were removed. After the test was conducted with the fan blowing out it was untaped and turned around for the positive test. The process was then repeated for the positive pressure test.

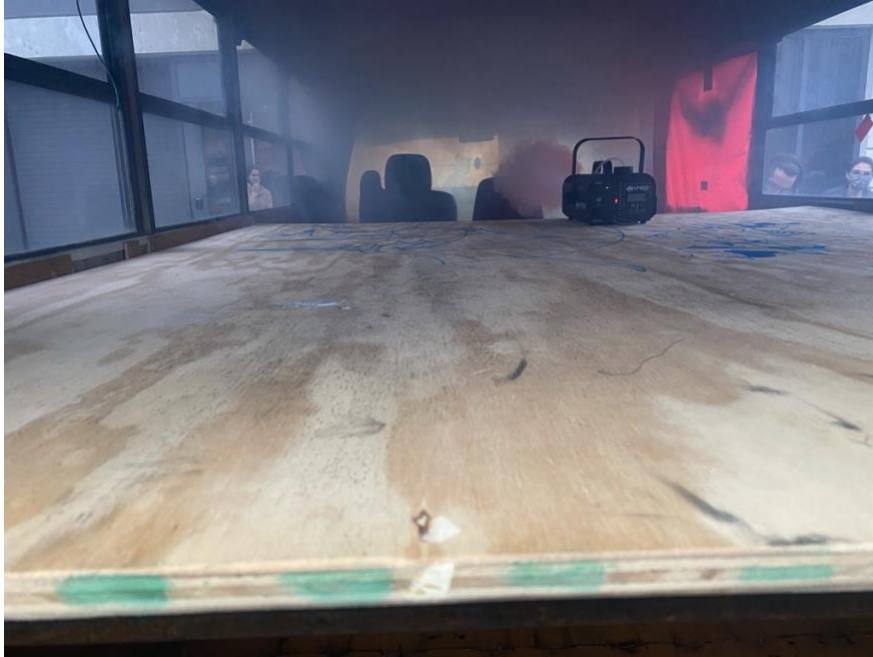
The third test was a positive pressure visual test using a fog machine. The fan was set up to blow into the bus and a power cord was routed throught the fan elastic section to power a fog machine. The fog machine was then started and filled the bus with fog with all elements sealed, then the blower was turned on and forced fog out of the vehicle to give a visual of the areas of greatest leakage.

Figure 10, Fog machine test

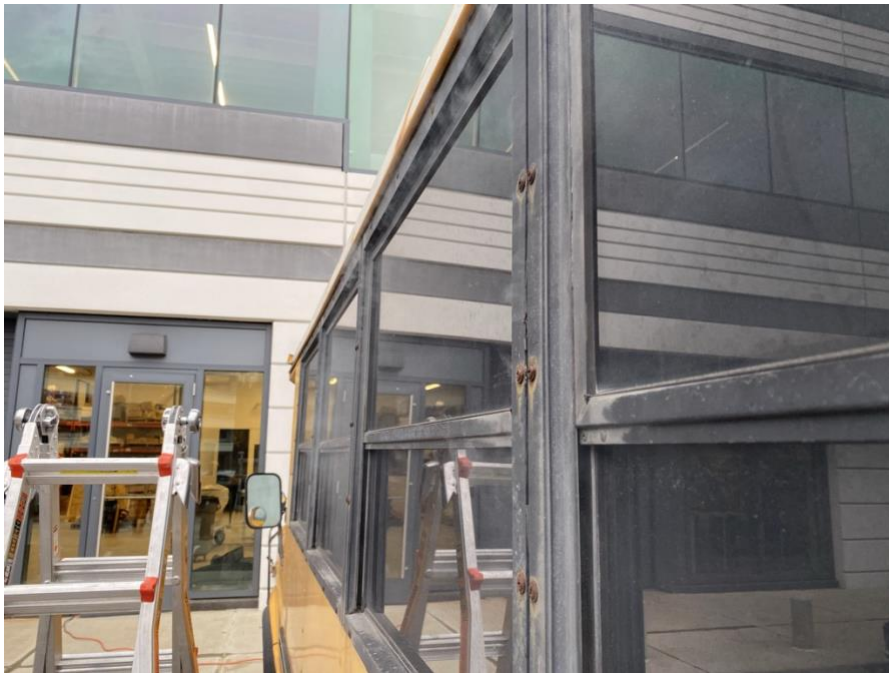
Figure 11, Fog positive pressure testing. The fog appears faint but was clear in person.

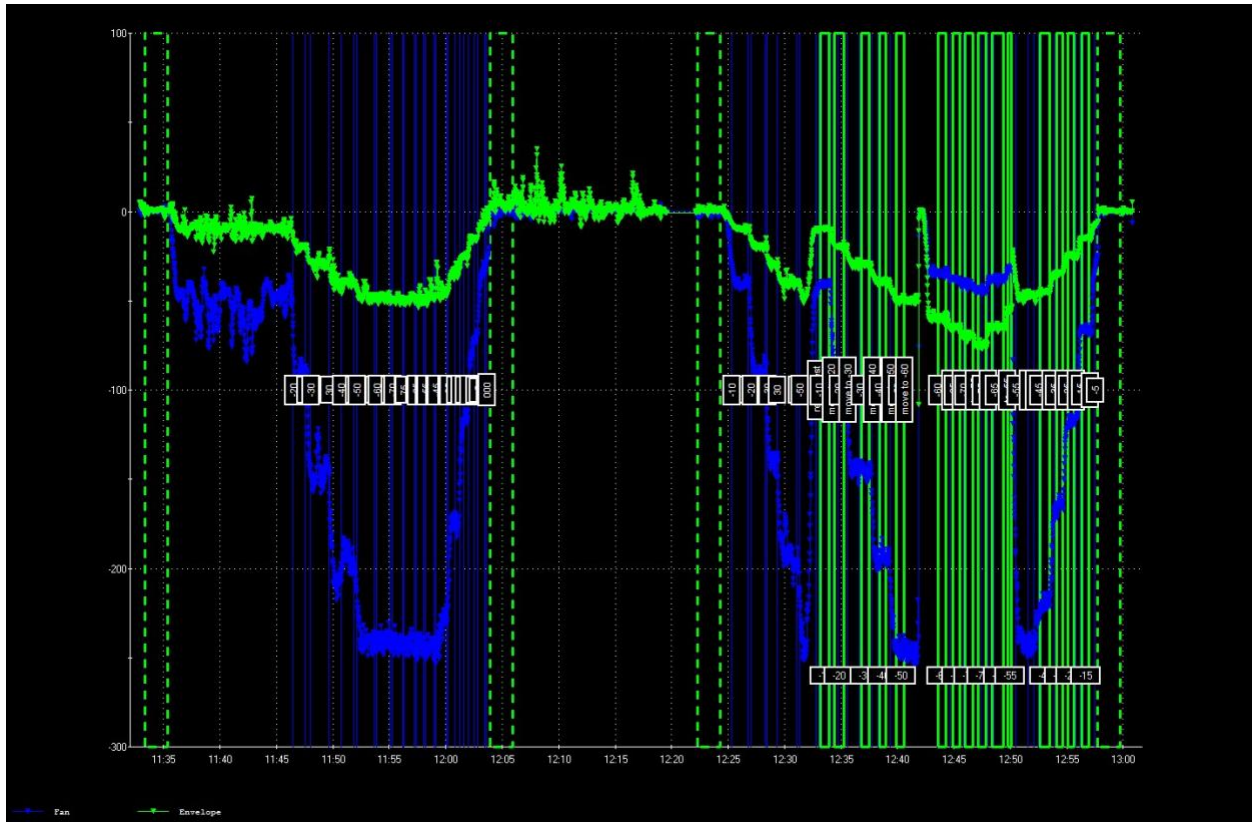
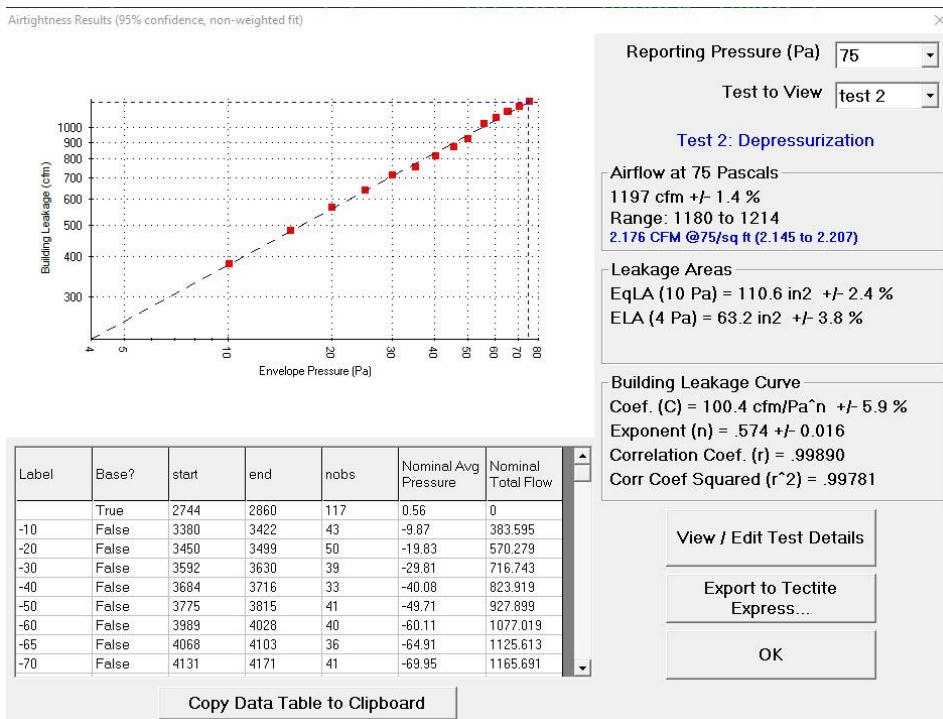
As illustrated in the methodology, the test is done by changing the pressure difference between the inside and outside of the envelope and recording how much air has escaped or entered the vehicle. As the delta pressure is increased the amount of air escaping increases. These data are taken over time. The resulting graph is illustrated in figures 13 and 14. The green line illustrates the pressure difference on the inside and outside of the vehicle. The blue line represents fan speed. The blower door setup automatically changes the speed of the fan to reach the pressure difference dictated by the program user. Figure 13 illustrates the negative pressure test where the fan was blowing air out of the bus creating a negative pressure in the vehicle. On the left side of the image the failed test can be seen. As the delta pressure was ramped up, the fan was unable to create delta pressure above 45 Pascals. We did not notice the data had plateaued and completed the test. The delta pressure was unable to reach the necessary delta pressure because the rings that are taken off to increase air flow were not removed as needed. The

program typically alerts the tester when a ring needs to be removed to reach a delta pressure but in this case the program did not alert the tester. For the second test seen on the right side of the image, the ring was removed when the testers manually observed the platue. The resulting test offered usable data that could be processed to produce figure 14. In Figure 14 one can see the data points extracted from the test in figure 13. The horizontal green lines on the right side of figure 13 show the areas of clean data selected to create the data points for different delta pressure levels. Notice the “envelope pressure” on the x-axis are at roughly 5Pa intervals. The resulting graph is the final metric for how airtight the envelope is. The negative pressure test yields a result of 2.176 CFM.

The overall result of negative pressure blower door testing is 2.176 CFM. This result means 2.176 cubic feet of air per minute enters the envelope when the internal pressure is 75Pa less than external atmospheric pressure.

Figure 13, negative pressure blower door results

Figure 14, negative pressure blower door results

Figure 15, negative pressure blower door results

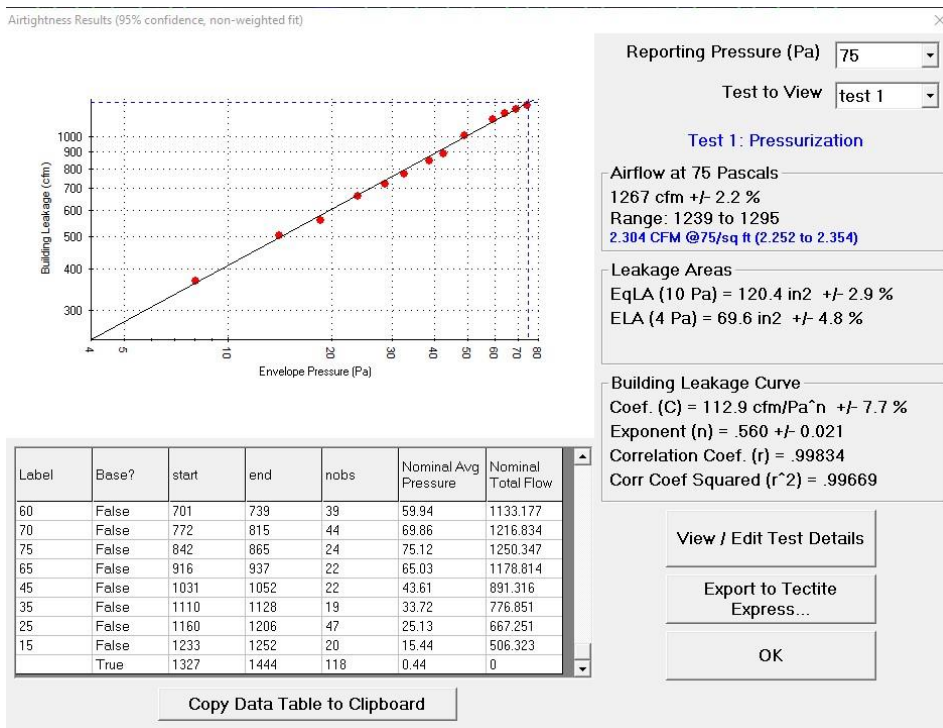
The positive pressure blower door testing was parallel to the negative pressure testing apart from the failure apparent in the early data of the negative test. The positive test went smoothly and the resulting data is in figure 16. The resulting cubic feet per minute for the positive pressure test is 2.304 CFM.

Figure 16, positive pressure blower door results

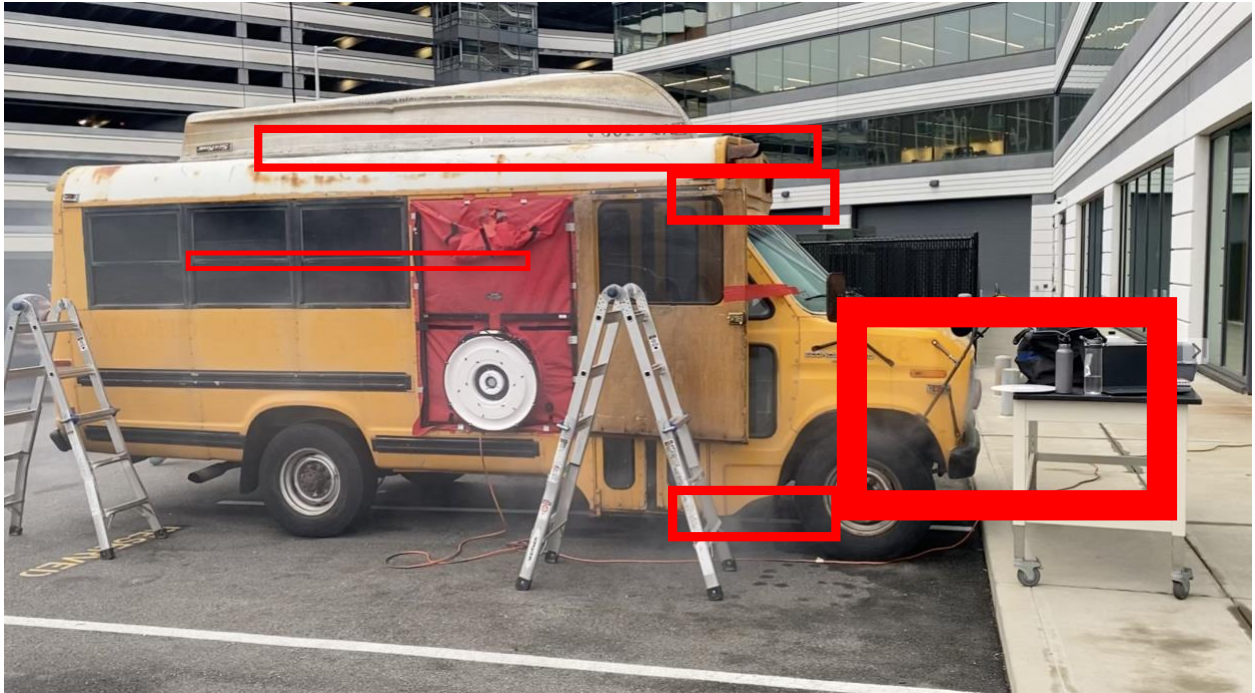
Figure 15, points of air leakage

The fog machine positive pressure test was performed last to identify the areas of greatest air leakage. It was discovered the holes in the floor of the bus initially drilled for the seats in the school bus were a major cause of leakage. All of the windows were quite leaky at the seam between the double hung windows. The lights were all relatively leaky. All entrances illustrated significant leakage. The point of attachment of the boat was a point of air loss. The front cabin demonstrated significant air leakage.

It is notable that positive and negative pressure tests yielded slightly different results. There is no significant conclusion because the differences between the tests were minor. If the results had been significantly different, that would be explained by a flap that is opening with positive pressure and closing with negative pressure or something of the sort. In this case the results were uniform. A typical building in Massachusetts would have a blower door result between .5 and 1CFM. Therefore, the bus is quite leaky in comparison to a typical building. This can be explained by the vehicles age, the leakiness of the doors and windows, and the holes present in the floor of the vehicle.

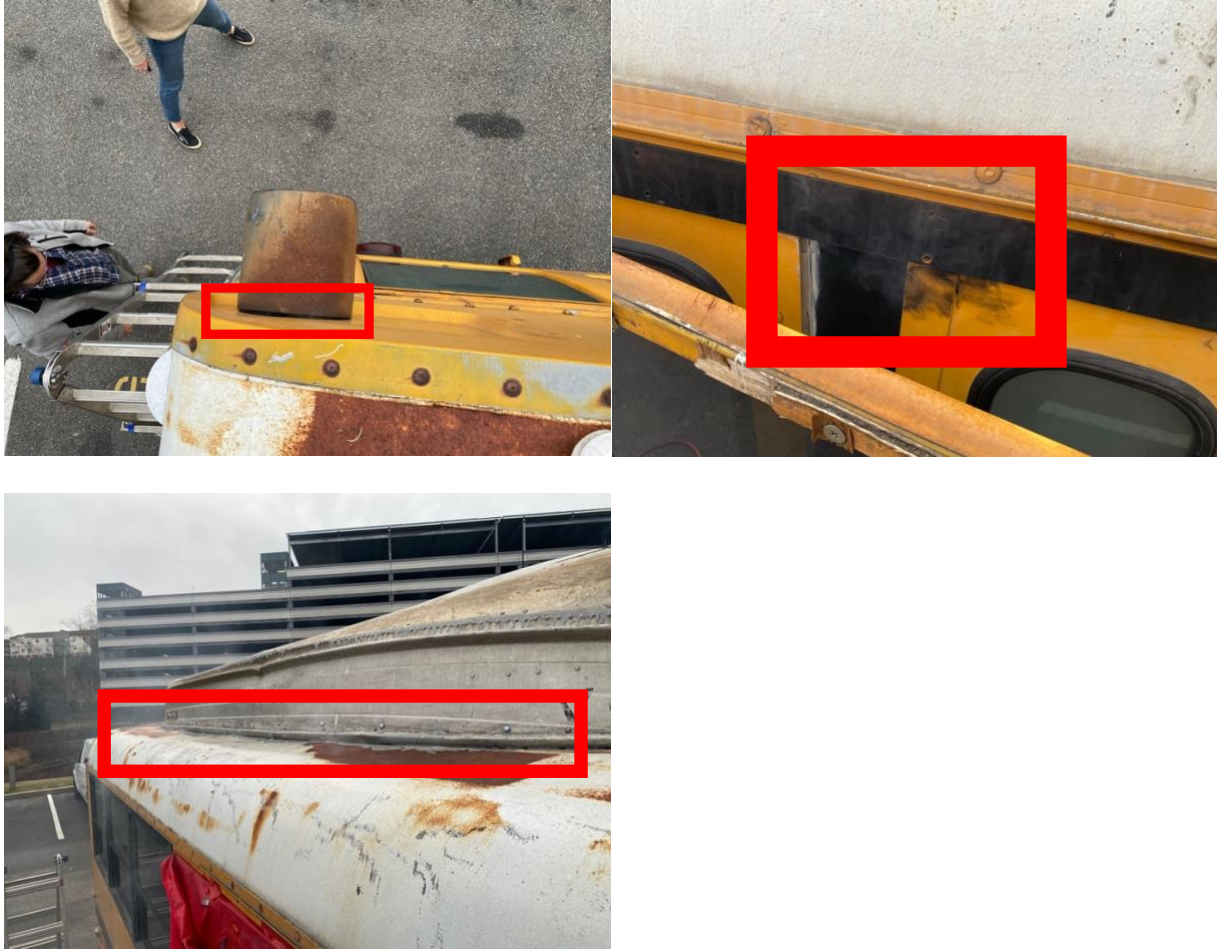
Figure 16, detailed photos of air leakage
