WORCESTER POLYTECHNIC INSTITUTE

MAJOR QUALIFYING PROJECT

IMPROVING ALUMINUM CAN PAINT COATINGS

Pacific Can Beijing & the Beijing University of Chemical Technology

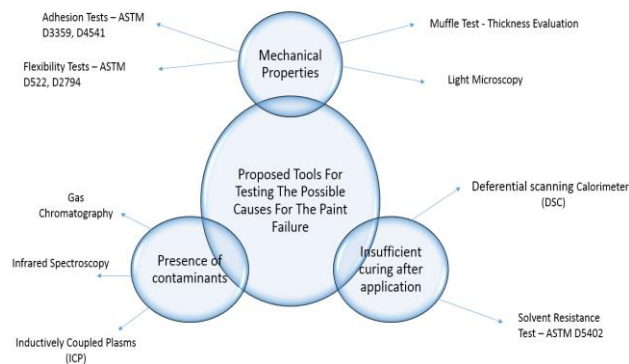
Figure 1 shows the different experimental techniques/methods proposed for each hypothesis

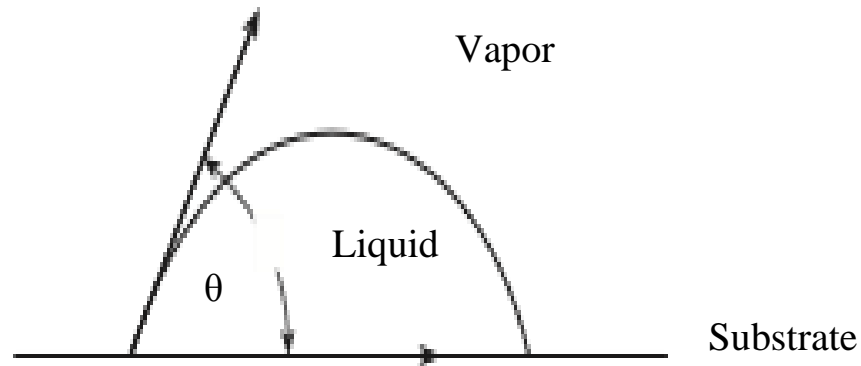
Figure 1 shows the contact angle between the coating and the substrate (Weldon, 2010).

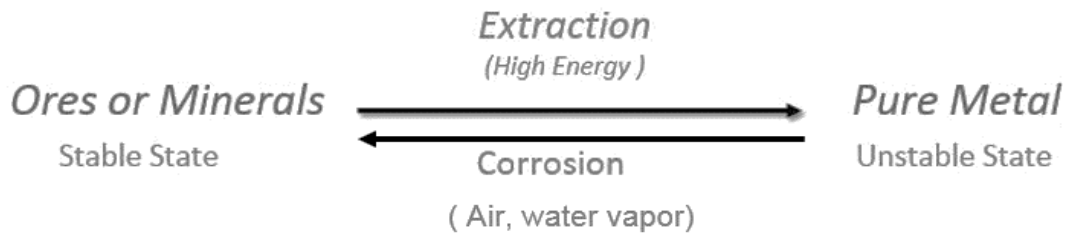
Figure 2 Figure 2 demonstrates the difference between extraction and corrosion.

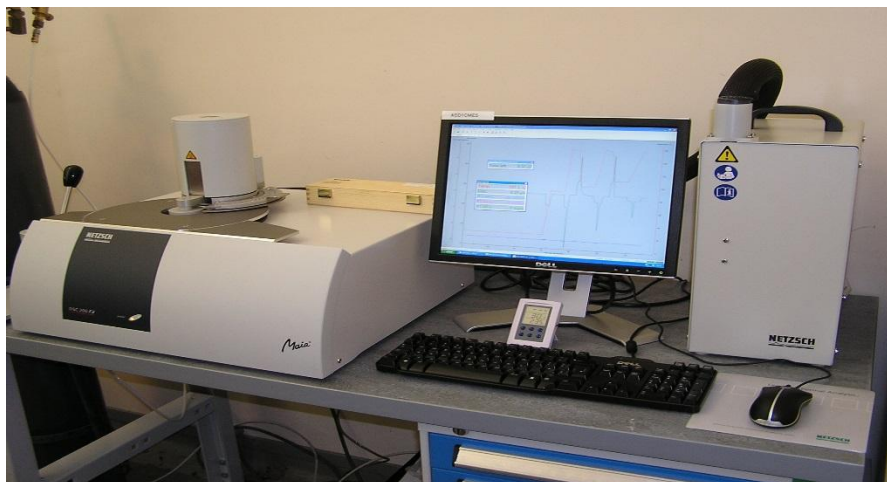
Figure 6 shows a typical image of a DSC (PerkinElmer, 2008).

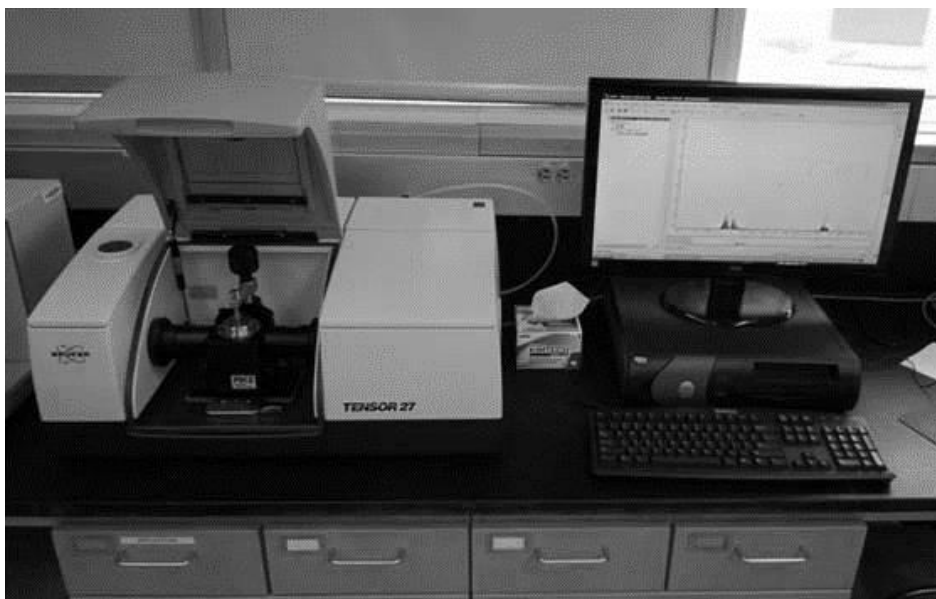
Figure 7 shows typical image of an Infrared Spectroscopy (Weldon, 2010).

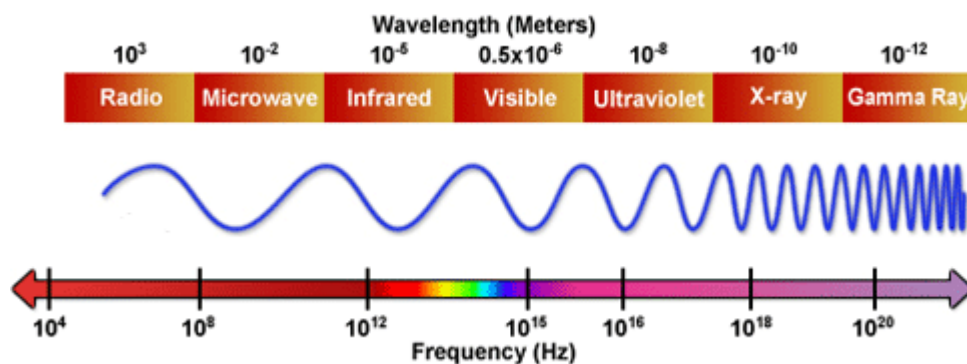
Figure 8 shows the full electromagnetic light spectrum (Weldon, 2010).

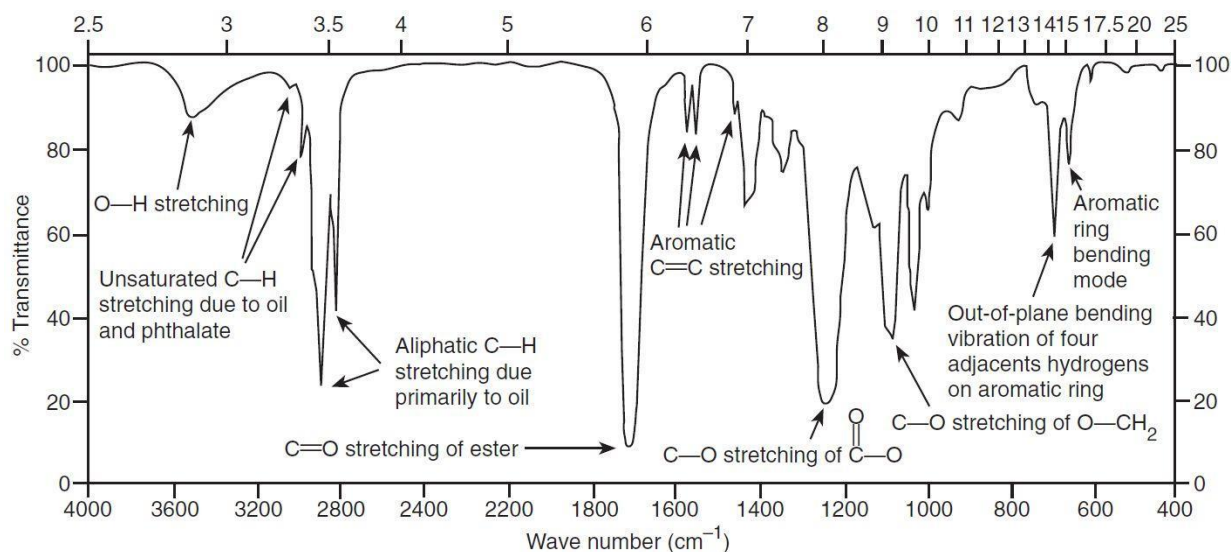
Figure 9 Show a typical plot generated by an Infrared Spectroscopy apparatus. The plot shows the unique wave number of several functional groups and their respective spikes (Weldon, 2010).

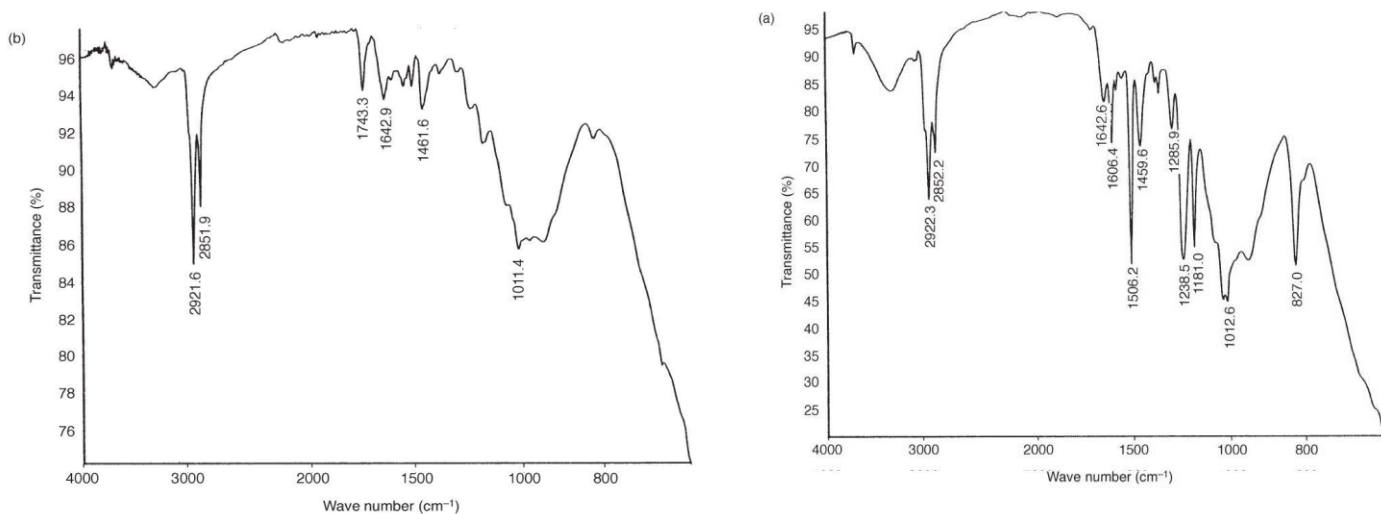
Figure 10 shows two identical paint samples: the one on the right is the control sample, while the left one is the same sample with some contaminants. The difference in the plot can be seen near the 1650 cm^{-1} band (Weldon, 2010).

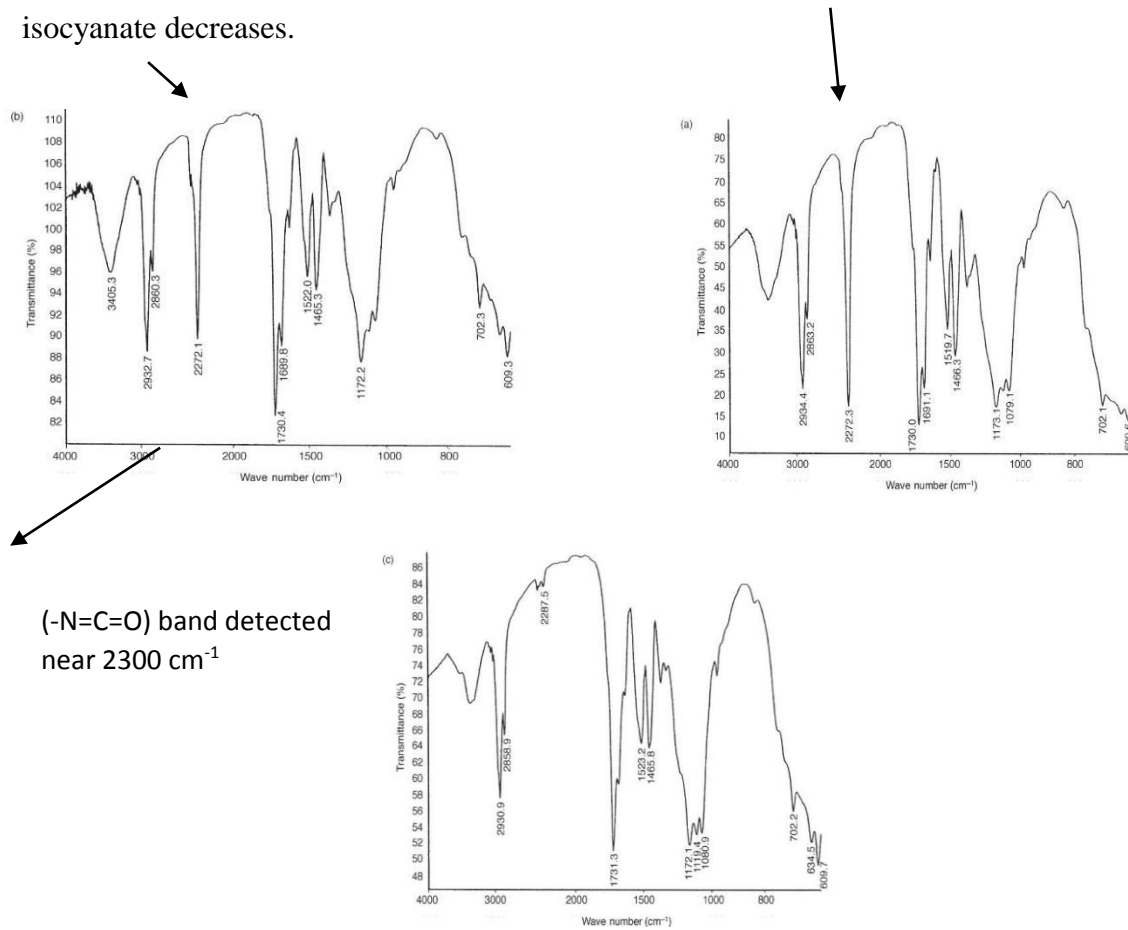
Figure 11 shows how the $(-N=C=O)$ band gradually disappear as the curing process starts (Weldon, 2010).

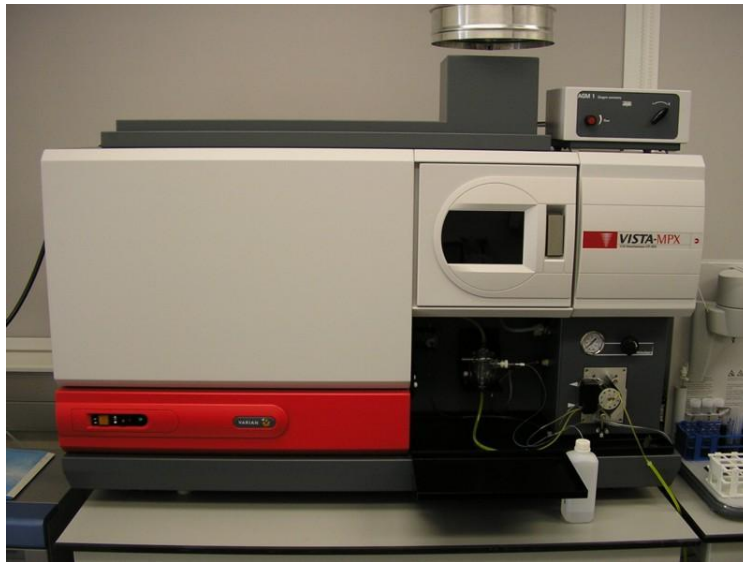
Figure 12 shows a typical picture of an ICP (Boss et al., 2004).

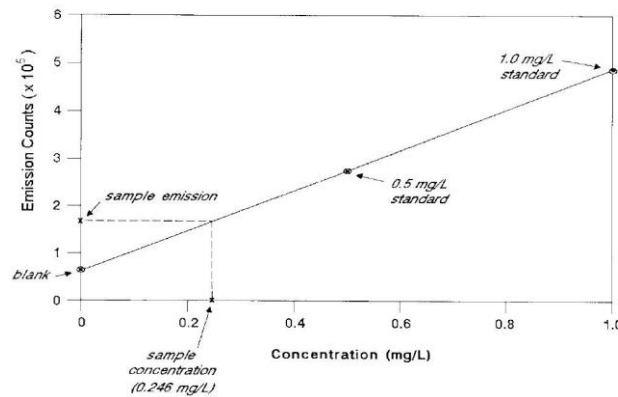
Figure 13 shows a typical ICP plot (Boss et al., 2004) in which the emission counts is plotted as a function of concentration.

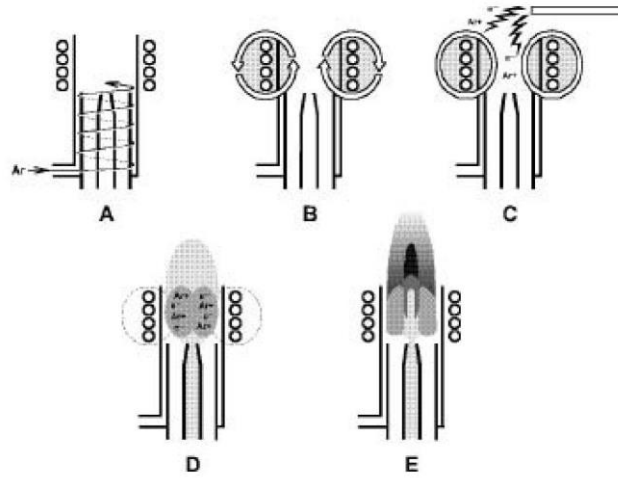
Figure 14 demonstrates the concept of inductive coupling (Boss et al. , 2004).

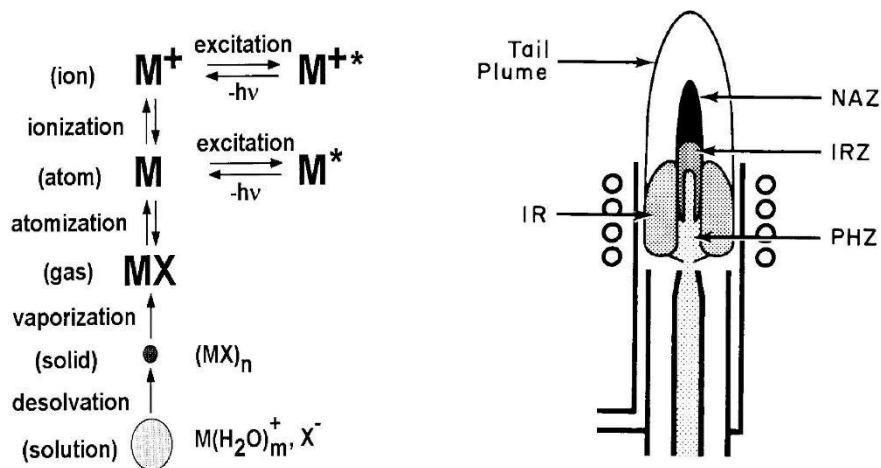
Figure 15 The five stages that a sample of an ICP test undergoes (Boss et al. , 2004)

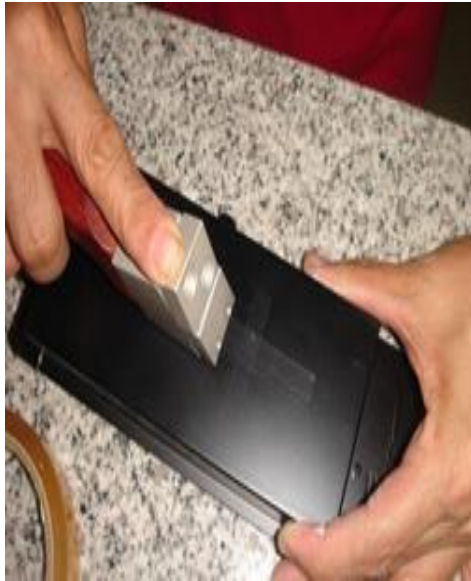
Classification of Adhesion Test Results		
Classification	Percent Area Removed	Surface of Cross-Cut Area From Which Flaking has Occurred for Six Parallel Cuts and Adhesion Range by Percent
5B	0% None	
4B	Less Than 5%	
3B	5-15%	
2B	15-35%	
1B	35-65%	
0B	Greater Than 65%

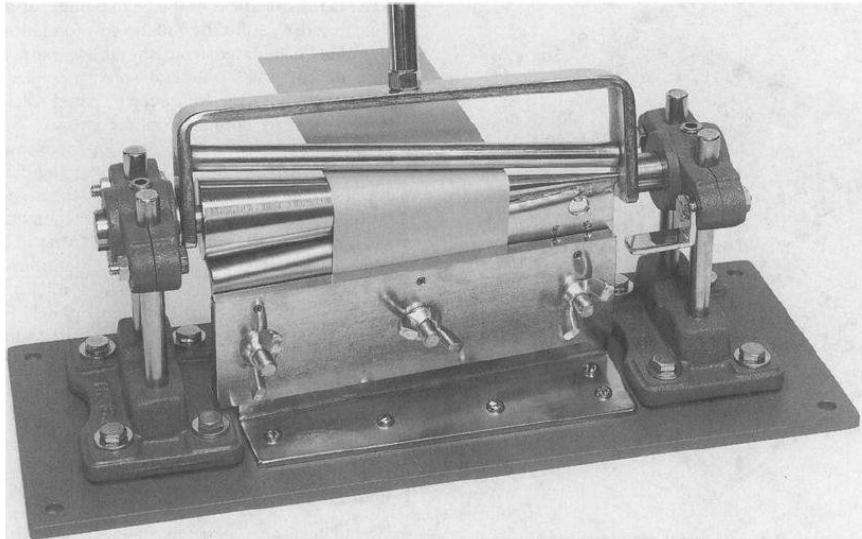
Figure 17 shows the apparatus that is used to test the flexibility of paints and coatings (Boxall and Fraunhofer, 1981).

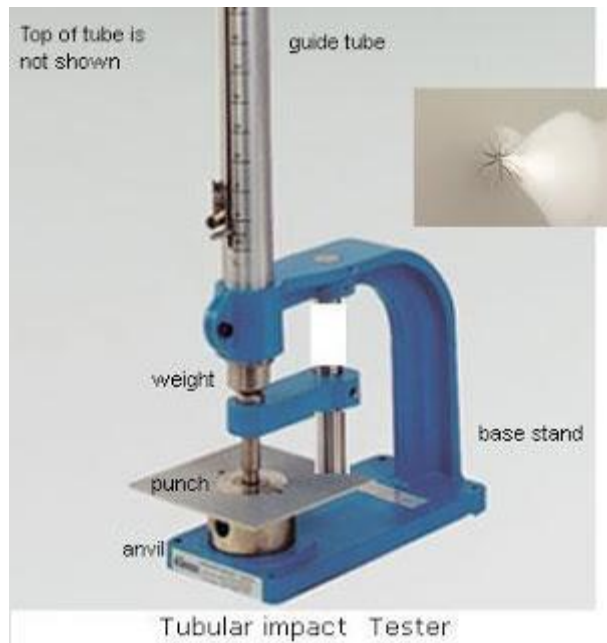
Figure 18 An impact tester (Boxall and Fraunhofer, 1981).

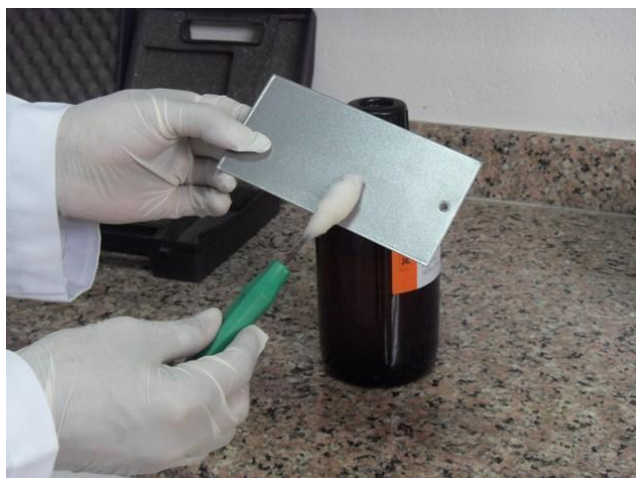
Figure 19 shows how the MEK test is performed: the MEK is applied to a Q-tip and then the Q-tip is used to rub the surface of the painted panel (Boxall and Fraunhofer, 1981).

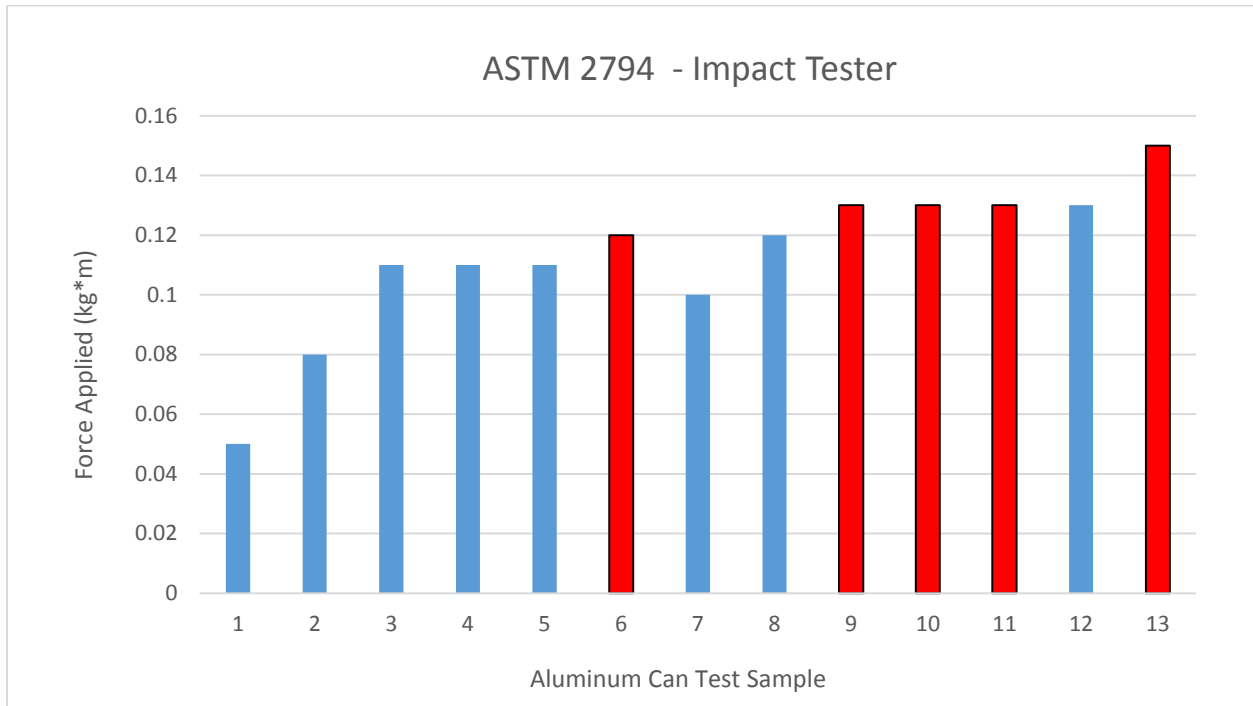
Figure 20 shows the test results from ASTM 2794. The x axis shows the test sample number and the y axis displays the amount of stress applied to the sample. The bar graphs are color coded; the blue graphs are the test samples that experienced no evident cracking where the red graphs are the samples where evident cracking occurred.

The ASTM D2794 – Resistance of Organic Coatings to the Effects of Rapid Deformation (Impact) test was to assess the adhesion of paint to its substrate when deformation occurs, as seen in the necking and flanging processes of production. Painted cans that had experienced paint failure were used to create approximately 3” by 3” panels for the tests. An impact tester was purchased offline while at the BUCT and was used to test the painted can panels. Paint failure, evident cracking, occurred at stresses ranging from .12 - .15 kg*m, with an average of 0.132 kg*m. The failure occurred due to the rapid deformation and bending of the substrate. The ASTM D2794 test provided the project team with significant data as to how much stress or rapid deformation the aluminum can paint coating can undergo. Below is a bar graph of the data from the ASTM D2794 testing, where each bar graph represents an individual test and the stress that was applied to the test sample. The bar graphs are color coded in blue and red, the blue graphs experienced no cracking and the red graphs experienced evident cracking. Due to the fact that the force applied to each test sample during the ASTM D2794 test is way more stress than the aluminum can will experience during the production process, the project team ruled out hypothesis #1 as a potential cause of paint failure during production at Pacific Can Beijing.

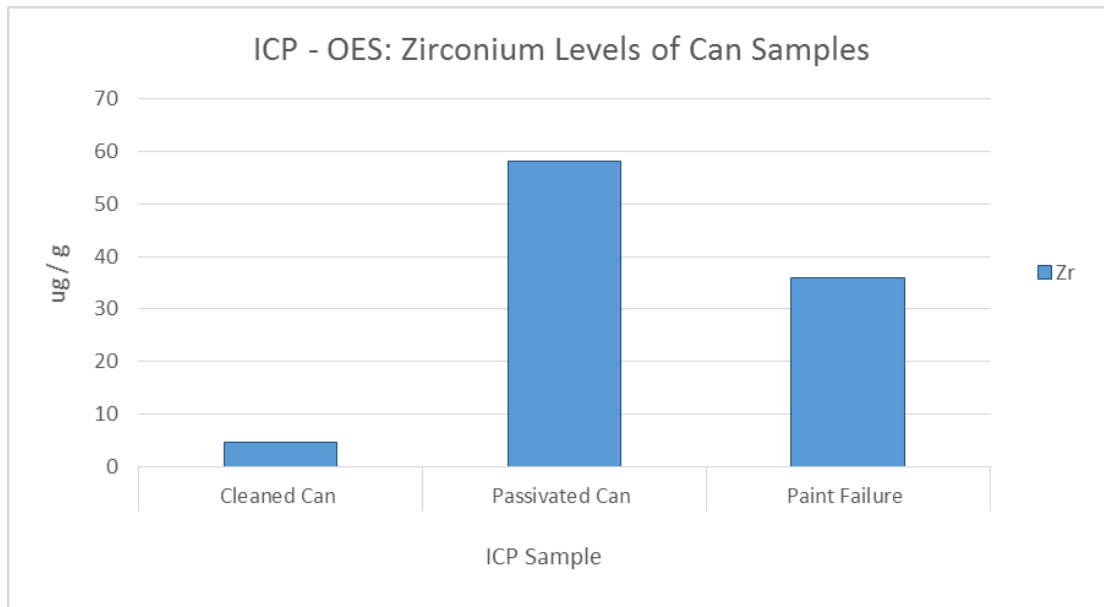
Figure 21 shows the ICP results. The y-axis represents the concentration of the metal Zr in ug/g while the x-axis represents the sample's condition.

The purpose of ICP – OES testing was to check for any contaminants within the paint coating that could affect the wetting of the different paint coatings, ICP testing can detect metals present in a solution with a concentration of as little as 10^{-15} . The ICP – OES could also determine whether or not the passivation membrane was present on the aluminum can that experienced paint failure. The membrane used in the pre-treatment of cans at Pacific Can is Alodine 404 developed and licensed by Henkel. The membrane contains small amounts of the metal Zirconium which could be detected by the ICP-OES. The paint coating project team conducted the ICP – OES testing at Tsinghua University where the test samples were made. Four different test samples were made by cutting cleaned cans, cleaned cans with a passivation membrane, a painted aluminum cans, and painted aluminum cans that had experienced paint failure and dissolving them in hydrochloric acid so that it can be injected into the ICP device. The ICP – OES test results are shown in *Figure 20* below.

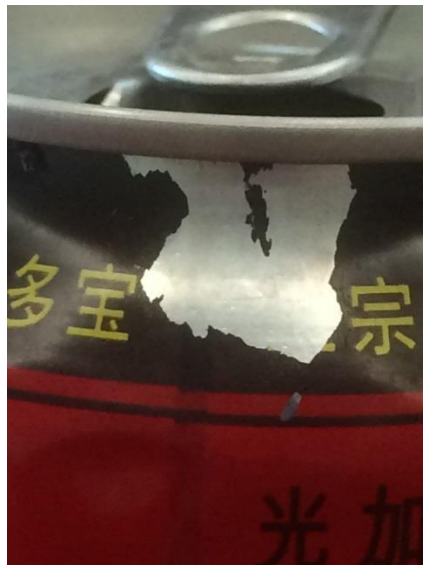
An example of paint coating failure on an aluminum can. This can is produced for the Chinese herbal tea company Jia Duo Bao, the company whose paint label experiences paint failure the most. The paint failure is due to the company's pasteurization process after the can has been filled, putting the entire can in a 120° C bath prior to be putting into cardboard packaging. This process is conducted so that the cold tea can doesn't condensate in the cardboard packaging causing the cardboard to become saturated and break.

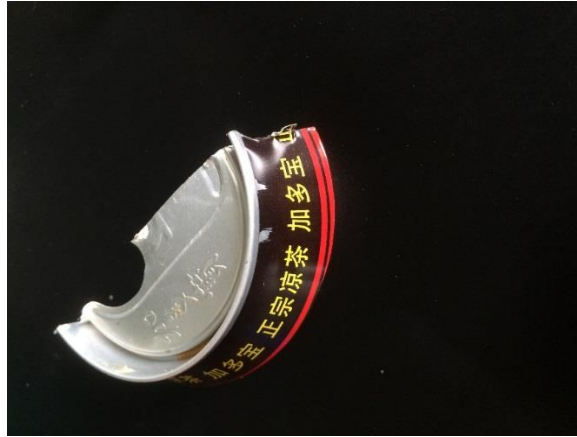
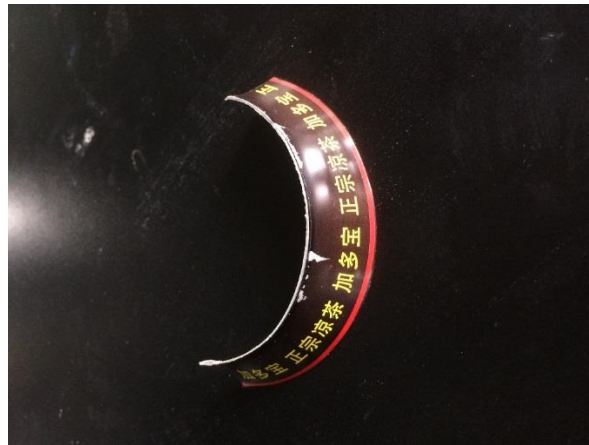
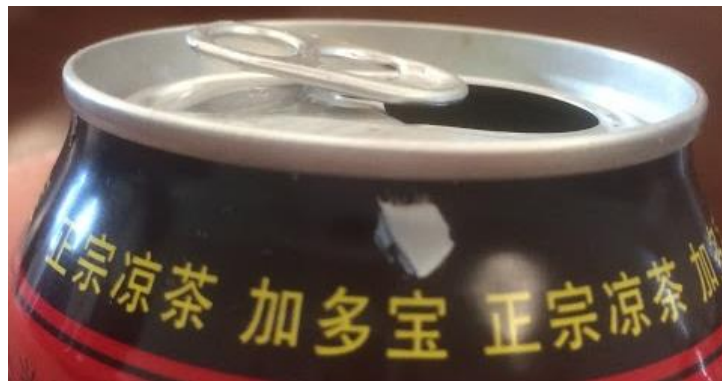
Paint coating failure on an aluminum can normally occurs at the top part of the can, where the can undergoes a lot of stress during the necking, flanging, and the application of the top of the can. The project team has determined that during these processes miniscule cracks are formed in the paint coating layer. The pasteurization process, the application of hot water to the exterior of the can to warm the can before packaging, then causes osmotic blistering to occur resulting in exterior paint coating failure.

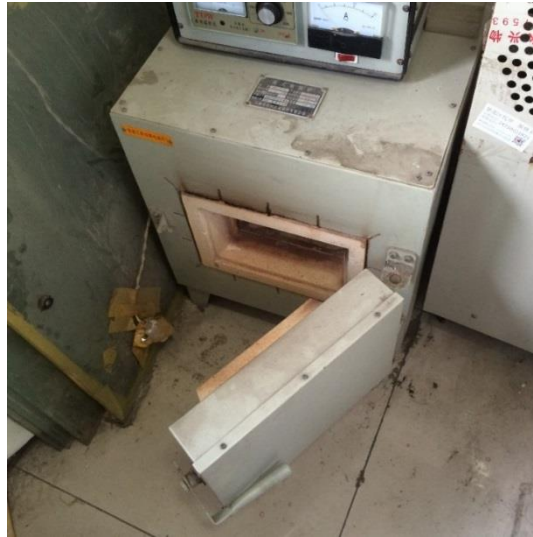
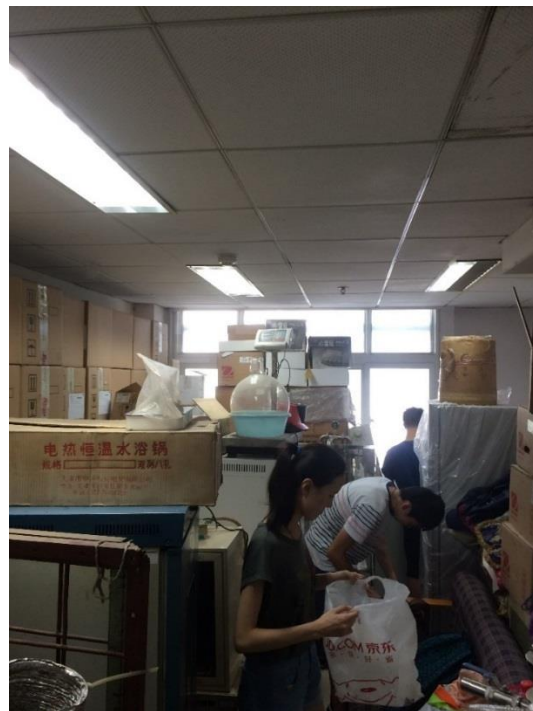
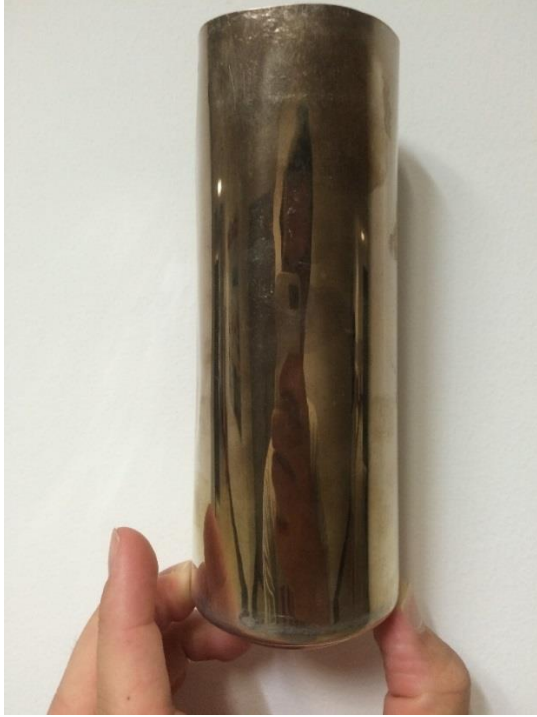
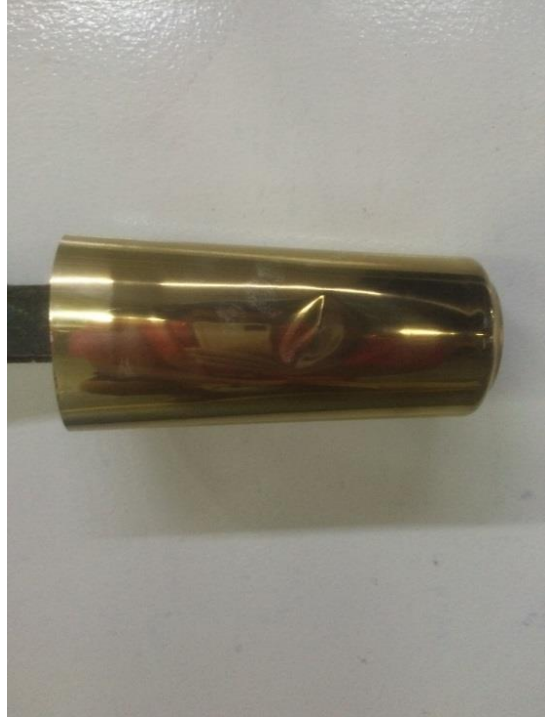
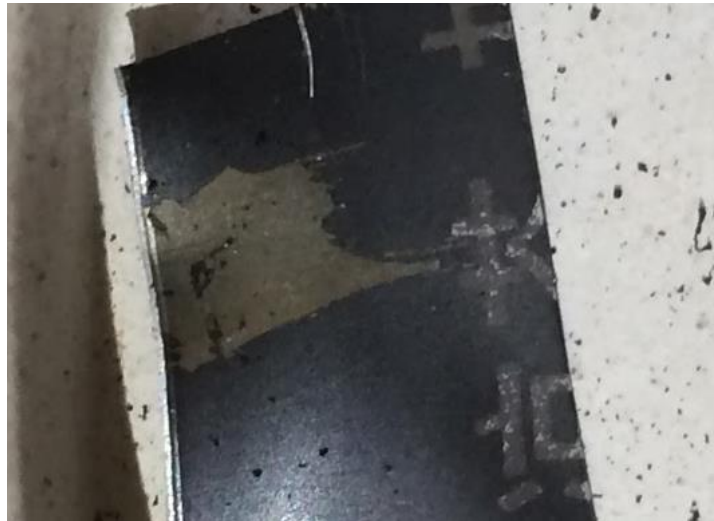
C.2 MUFFLE TEST

The first test that the project team was able to conduct at the BUCT was the muffle test, a test where a passivated aluminum can is placed in a muffle furnace for 5 minutes at 500° F to determine the thickness of the applied membrane based on the color of the can after heating. These two pictures depict the project limitations the project team experienced at the BUCT in regard to accessing testing materials. The muffle furnace used during testing was found in a closet and was relatively dirty, not the appropriate laboratory environment to conduct testing.

Despite conducting the experiment in a closet, the muffle test left the project team with good results. When taken out of the muffle furnace, the color of the passivated can was a dark brown, dark gold, light black, and purple color. The color of the can indicated that the passivation membrane applied to the aluminum can at the Beijing production site was too thick, a potential cause of paint failure. The thinner a paint coating is, the better it will perform and withstand to stress. Also, a can that had experienced paint failure was tested using the muffle furnace to see whether the passivation membrane remained of the can or it fell off with the failed paint coating. As you can see, the gold color of the aluminum where the paint coating has fallen off indicates that the membrane is still on the exterior of the can.

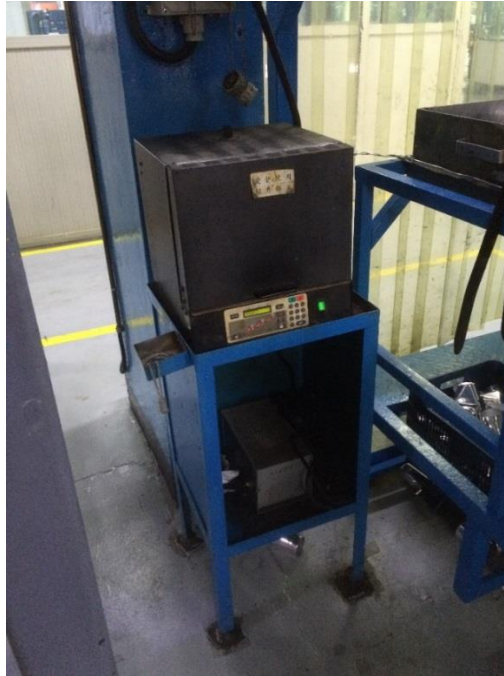
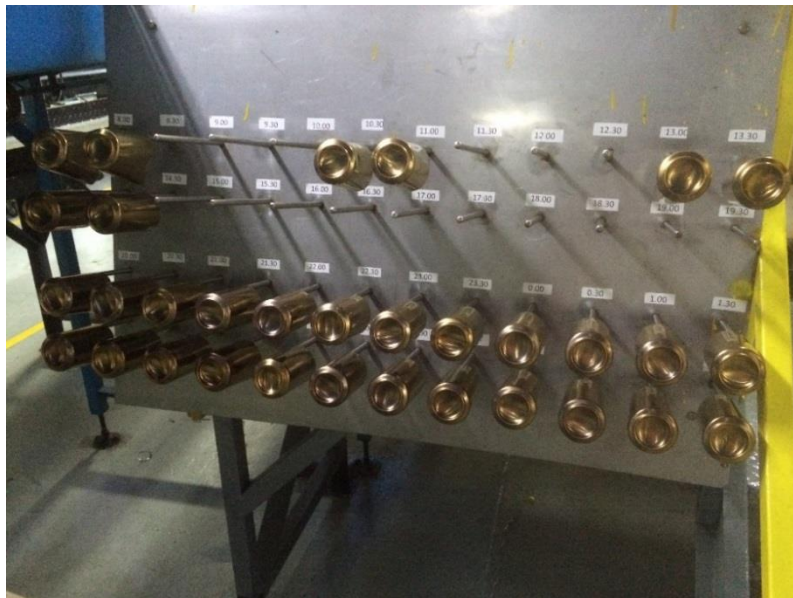
In order to ensure that we were properly conducting the muffle test, the project team conducted 10 separate muffle tests using Pacific Can Beijing's muffle furnace. The muffle test is conducted every thirty minutes at the Beijing production facility and the test results are stored on this board next to the muffle furnace. The engineering team at Pacific Can varies the thickness of the passivation membrane applied to aluminum can depending on the complexity of a beverage company's label. The project team recommends that Pacific Can engineering team reduces the thickness of the passivation membrane being applied to their cans by reducing the pH levels of the membrane bath. A thinner membrane will allow the organic beverage label paint coating to perform better and withstand to higher stress levels during production and packaging.

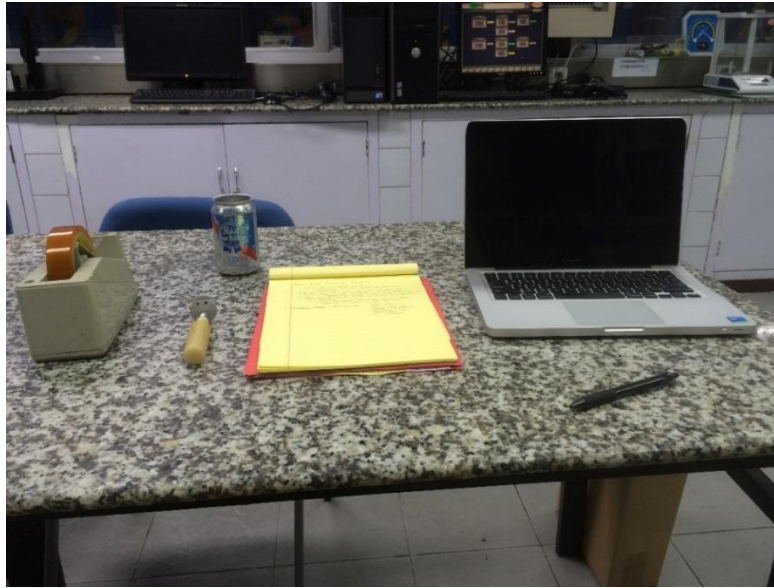
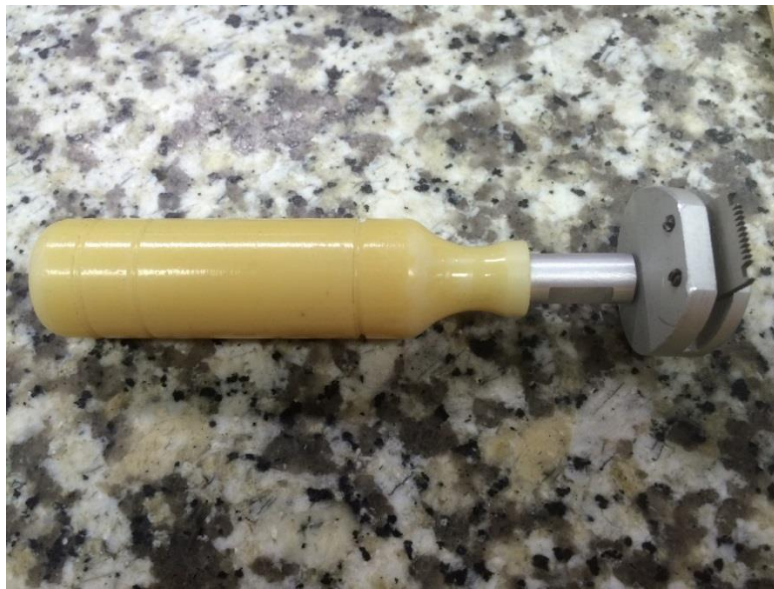
C.3 ASTM D3359 – MEASURING ADHESION BY TAPE TEST

The ASTM D3359 test was conducted twenty times in Pacific Can Beijing’s control lab using their cutting tool and tape. Just like the muffle test, ASTM D3359 is conducted on a daily basis on the control lab at Pacific Can to ensure the performance of their can’s paint coatings. During this test, the cutting tool seen in the second image was used to make an “X” cut in the exterior paint coating, cutting through the aluminum substrate. Scotch Premium Grade Transparent Cellophane tape was then applied to the cut and ripped off the substrate within 1-2 seconds of application. Using a scoring system provided by ASTM, each test sample was given a score based on the total area for the “X” cut that was removed from the substrate. All 20 test samples scored a rating of 5B, 0% of the area removed from the can. The project team determined that the paint coating develops the proper adhesion forces onto the aluminum can substrate, exceeding all our expectations.

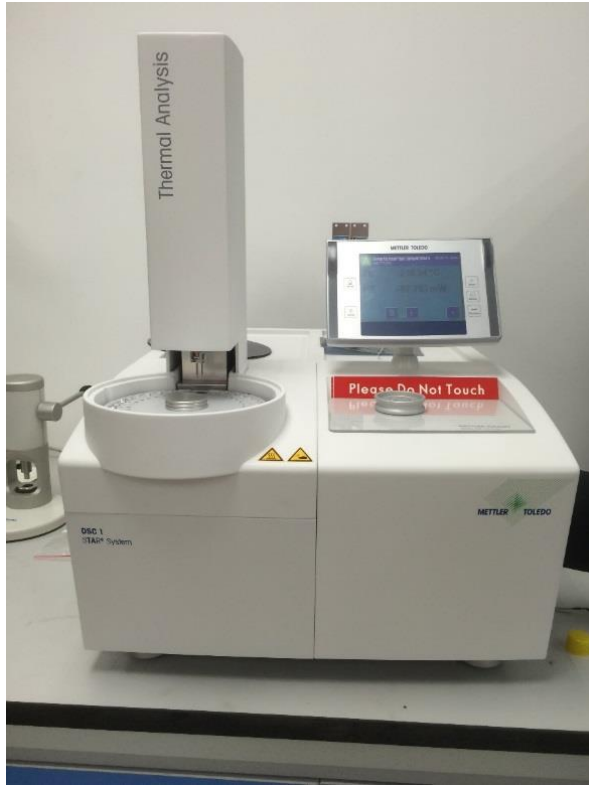
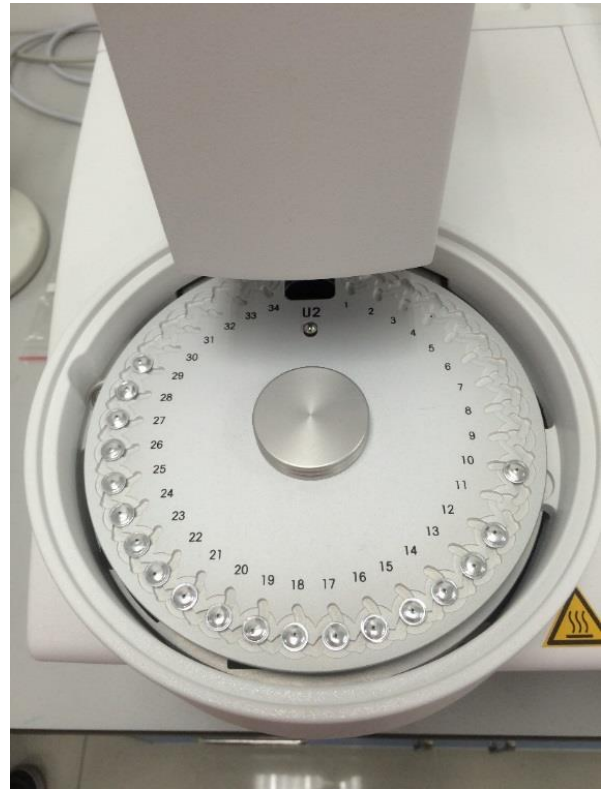
C.4 DIFFERENTIAL SCANNING CALORIMETRY (DSC)

Above, is the differential scanning calorimeter that was used to test a clean can, a passivated can, a high-quality can, and a can that had experienced paint failure at the BUCT. The differential scanning calorimeter allowed the project team to analyze the glass transition temperature T_G , changes in heat flow, and the changes in heat capacity of the thermosetting paint coatings used at Pacific Can. The samples of a paint coating are prepared differently than other types of DSC samples, a knife is scraped across a painted substrate and parts of the scraped off paint coating is used for the sample. Due to very insignificant data received after performing the DSC, we believe that the DSC samples were improperly prepared by our Chinese partners while the project team attended a conference at Beihang University. The glass transition temperature was not able to be determined from the data received from the conducted test. The project team recommends that Pacific Can continues DSC testing to better understand how their thermosetting paint coatings cure during the three drying processes during production.

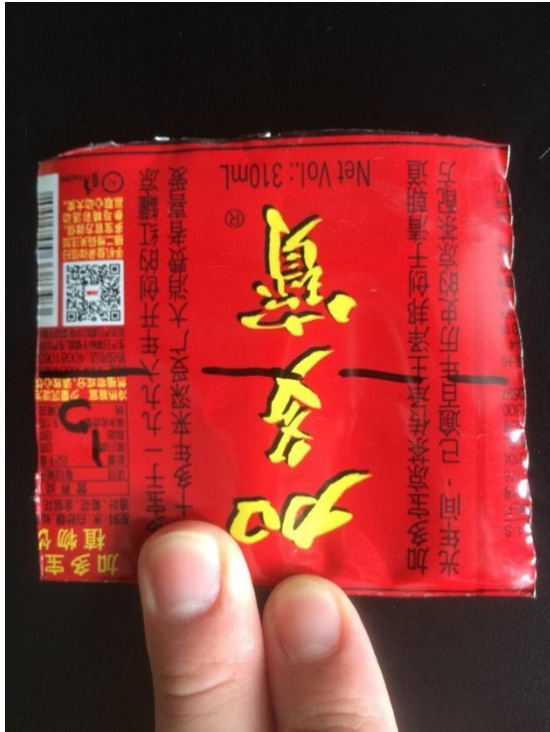
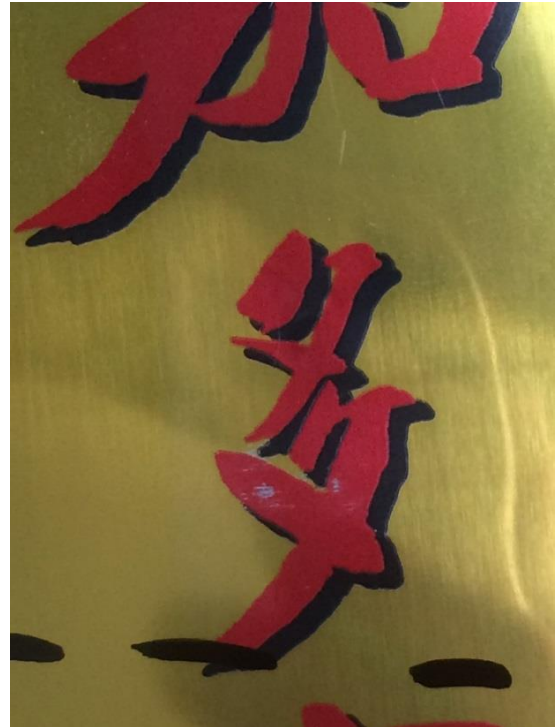
C.5 ASTM D5402 – ASSESSING THE SOLVENT RESISTANCE OF ORGANIC COATINGS USING SOLVENT RUBS

A total of twelve ASTM D2794 tests were run in a BUCT laboratory that was given as project space to the project team, 4 passivated can test samples, 4 high-quality cans, and 4 cans that had experienced paint failure. The ASTM D2794 test allowed the project team to analyze the solvent resistance of the organic, exterior label paint coating on the aluminum can. Thermosetting paint coatings become more and more resistant to solvents during their curing process and should develop a high resistance prior to the final exterior paint coating is applied to a substrate. As a result, the ASTM D2794 test analyzed whether the solvent resistance of the passivation membrane was high enough, developing high adhesion forces between the exterior paint coating and the passivation membrane during curing, and was able to withstand chemical attack. Square test samples were cut from the three different types of cans and a line was made across the center of the sample, the bottom half of the test sample acted as the control in order to properly compare the area of the sample that was rubbed (as seen in the first picture “C1”). Methyl ethyl ketone was applied with a Q-tip to the top half of the test sample in under one minute with twenty five double rubs, one swipe across the substrate to the right and one swipe back across the substrate to the left. After the methyl ethyl ketone was applied to the test sample, the sample was inspected for de-glossing or loss of hardness. Two of the high-quality cans experienced minor de-glossing, as seen in the second picture, the remaining samples showing no sign of de-glossing or loss of hardness. As a result, the project team determined that a proper solvent resistance was developed during the curing process of the passivation membrane.

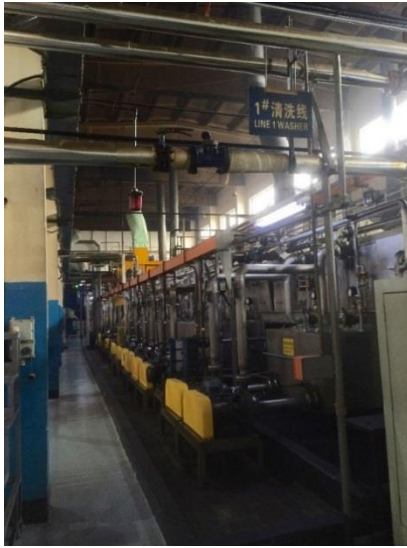
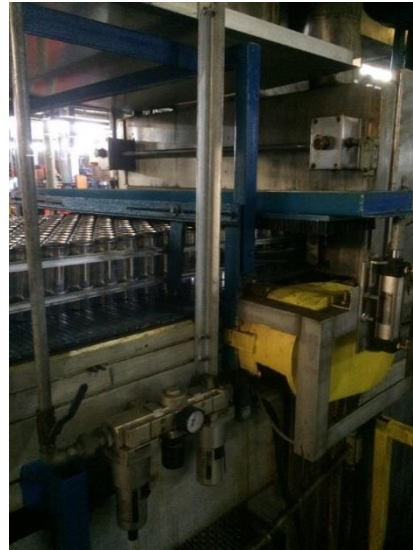
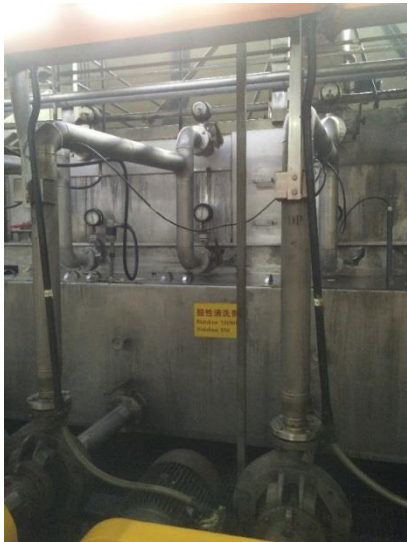
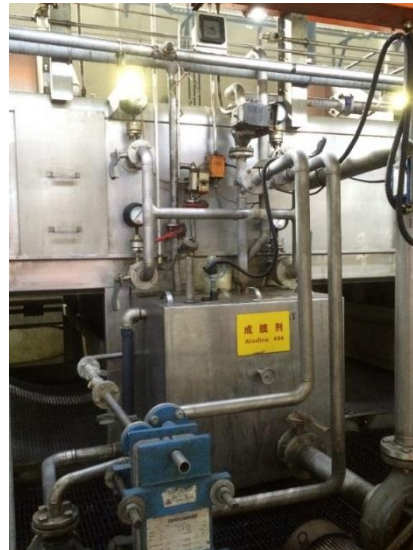
After the aluminum has been molded into the shape of a can, it must undergo a series of washes and passivation before the beverage label paint can be applied to the exterior of the can. The top left picture depicts Line Washer #1 at the Pacific Can Beijing production facility, one of the three major parts of production observed and analyzed by the project team. In the Line Washer, a conveyor belt full of aluminum cans (seen entering the Line Washer in the top right photo) undergo seven processes including a prewash, cleaning, water rinsing, passivation, water rinsing, and a deionized water rinsing followed by the first drying process. The prewash and cleaning stages can be seen in the bottom left picture where Ridoline 120 W and Ridoline 550, an aqueous solution containing hydrogen fluoride, is sprayed over the cans to wash off any contaminants, oils, or lubricants left on the cans. The bottom right picture depicts the process of applying the passivation membrane, Alodine 404, to the can during stage four of the line washer. The membrane properly prepares the aluminum substrate for the application of the exterior paint label, creating hydrogen bonding between the organic paint coating and the substrate.

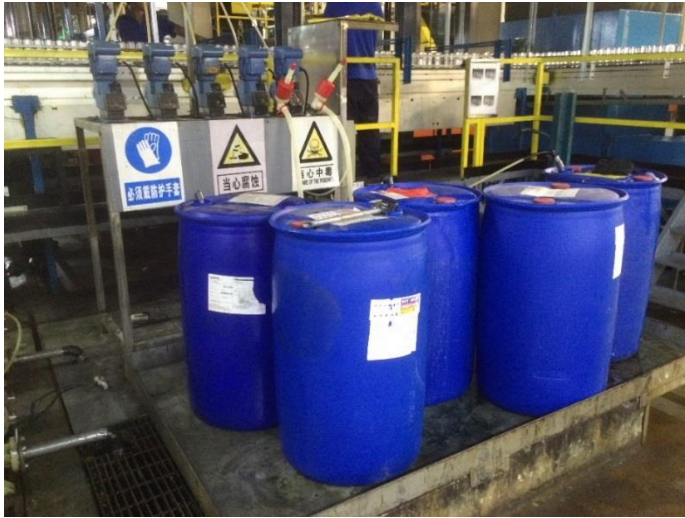
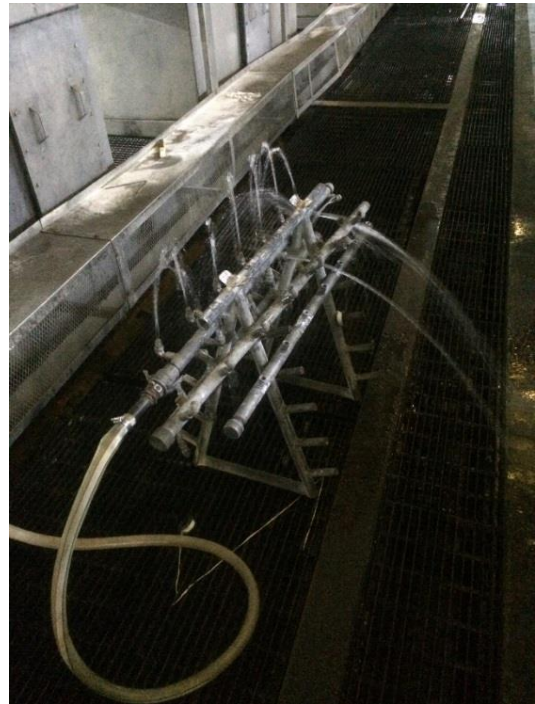
The Line Washer was one of the three potential causes of paint failure during the production process of Pacific Can because the surface of the aluminum can must be properly cleaned and free of all contaminants before the passivation membrane is applied. Also, if the passivation membrane is not properly applied to the aluminum substrate it would result in a defective paint coating due to the improper preparation of the aluminum substrate. The Alodine 404 (passivation membrane) Process Bulletin by Henkel states that if problems regarding the adhesion of paint coatings occur that the Ridoline and Alodine stages should be analyzed. The above pictures depict the supply of the chemicals used in the Line Washer and the type of spray nozzles that are used in the line washer to properly wet the aluminum cans with each stage of the line washer. The project team recommended that Pacific Can buys mixers for each of the blue barrels in order to ensure that the concentration of the cleaners and membrane bath used in the Line Washer is consistent throughout the barrel life of each chemical. The project team determined that the sprayers not properly wetting the aluminum cans or having a clog was not a cause of paint failure due to monthly maintenance that Pacific Can conducts in order to ensure the proper performance of the line washer. .

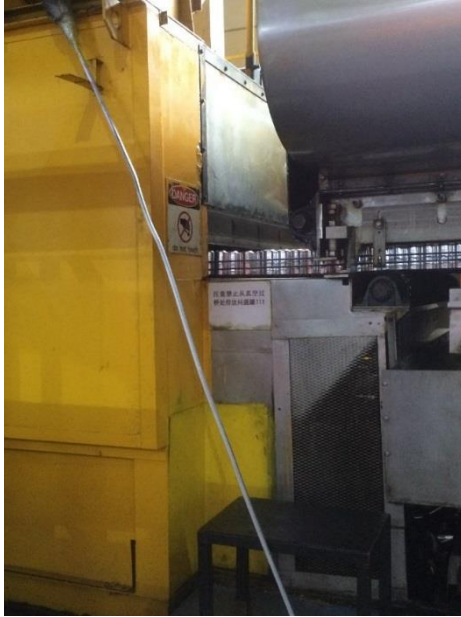
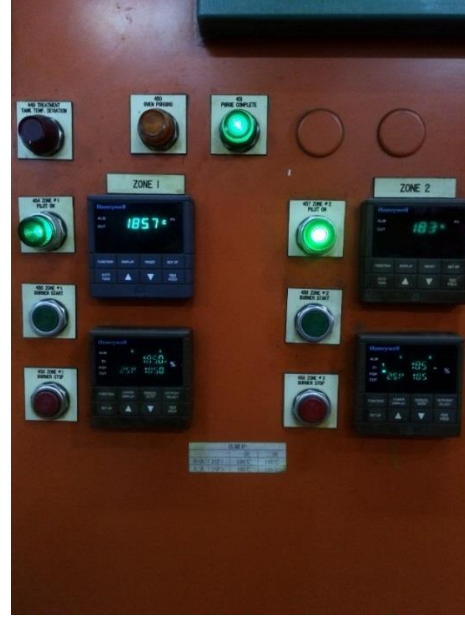
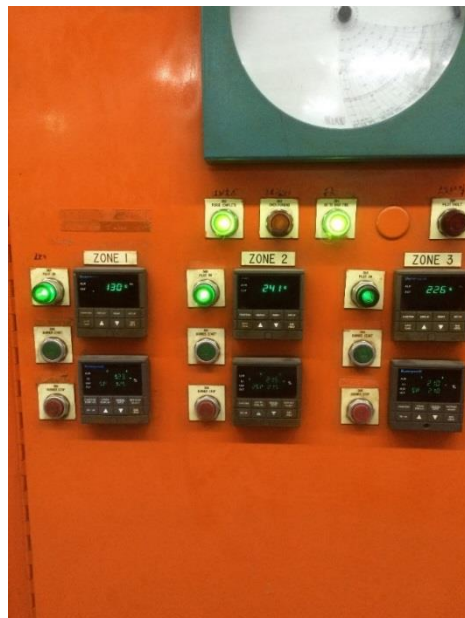
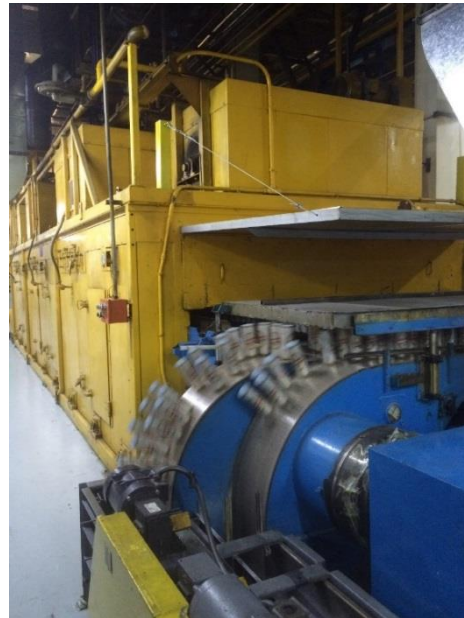
The can undergoes three different drying processes during production, once after the Line Washer (top left picture), once after the exterior paint label is applied, and once after the interior lacquer is applied to the can (bottom right picture). The three different drying ovens were the second part of the production process that was heavily observed and analyzed as a potential cause of paint failure on aluminum cans, due to internal stress experienced by paint coatings. The operating temperature of each drying oven was analyzed to ensure that the can's thermosetting paint coatings underwent a proper curing process. Differential scanning calorimetry and the ASTM D5402 tests were conducted to better analyze how the aluminum can paint coatings cured during each drying process.
