WORCESTER POLYTECHNIC INSTITUTE

MAJOR QUALIFYING PROJECT

IMPROVING ALUMINUM CAN PAINT COATINGS

Pacific Can Beijing & the Beijing University of Chemical Technology

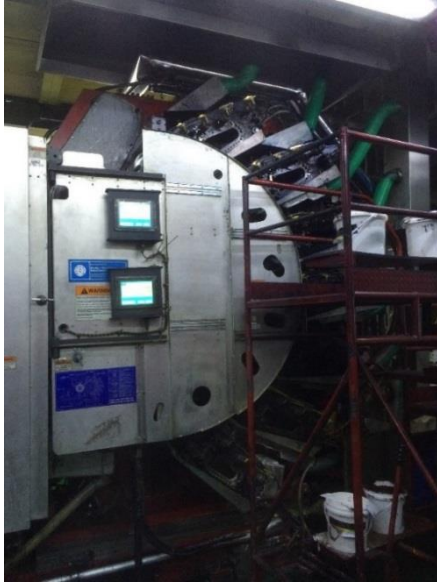
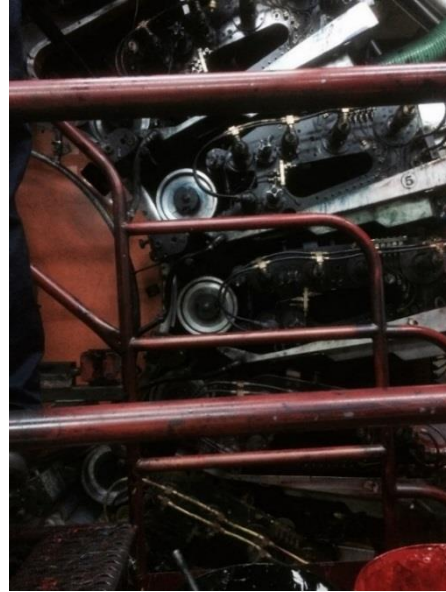
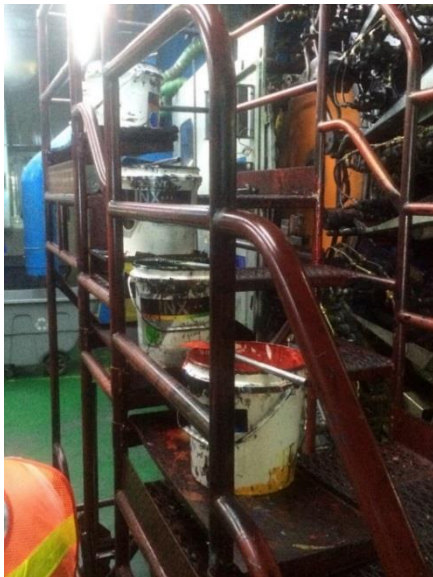
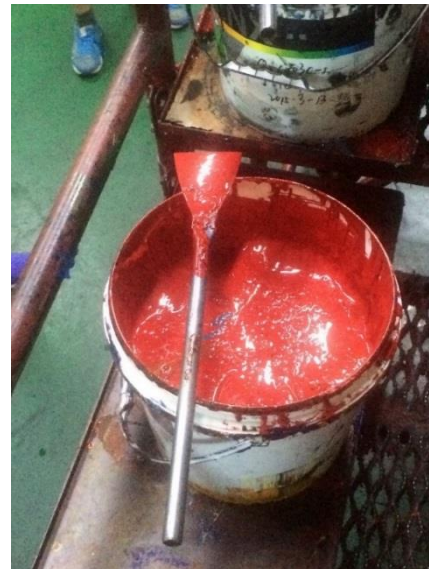
The four pictures above is where the aluminum can beverage label is applied to the exterior of the can, after the can has been properly passivated (top left). The application of the exterior paint label to the aluminum can was not analyzed extensively by the project team because the rapid pace at which the paint application occurs, around 1800 cans per minute, allowing for the mass production of aluminum cans. As you can see in the top right, each roller contains one color that is to be applied to the can and the label paint is added to each tray as needed. As you can see in the bottom right picture, there is contamination of the red paint with yellow and blue paint. The project team recommended that contamination of paint should be avoided and the paint should be properly mixed prior to being added to each paint tray.

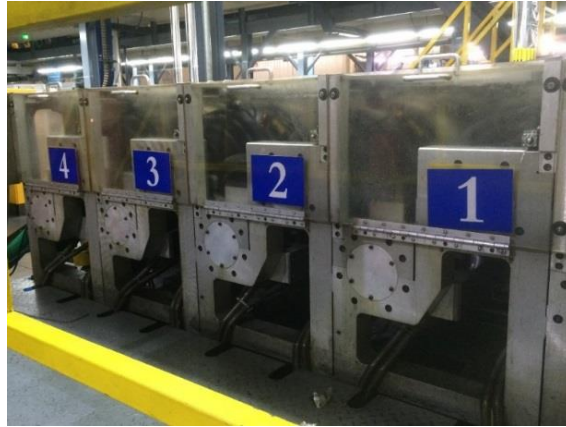
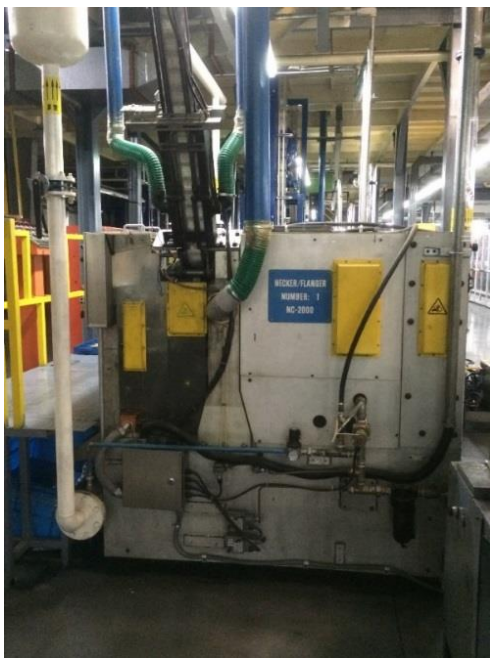
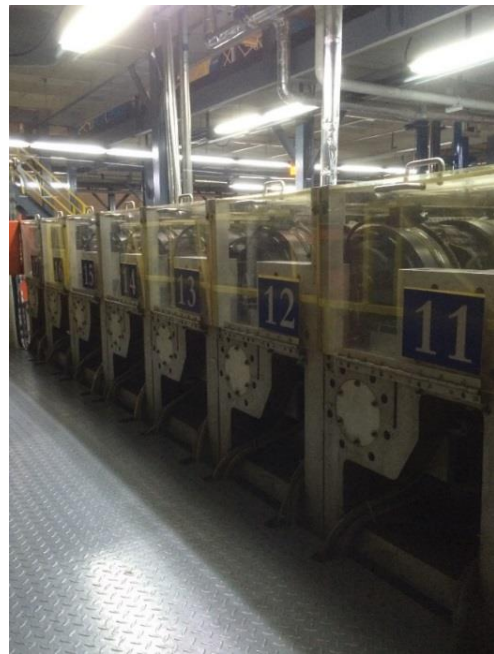
The third and final part of production that was heavily observed and analyzed by the project team was the necking and flanging process that the can undergoes before it is checked for quality by X-ray and sent to packaging. The project team originally hypothesized that the stresses occurred during these processes and the movement along the conveyor belt caused paint failure due to mechanical stress. The project team determined this hypothesis was false due the fact that paint failure doesn't occur at the Pacific Can production facility and the can is carefully bent and stretched through a seventeen stage process, only creating miniscule cracking in the exterior paint coating. The project team did determine that paint failure occurs due to the combination of this miniscule cracking and osmotic blistering from rigorous pasteurization processes at the Jia Duo Bao Herbal Tea Company. Prior to packaging, the herbal tea can undergoes a hot water bath at 120° Celsius to destroy pathogens in the tea and to prepare the can for packaging. The hot water easily seeps into the cracks created during production and create an osmotic cell, eventually leading to the paint failure of the exterior coating.
