**PRESERVING THE LIGHTHOUSES OF MARTHA'S VINEYARD**

Martha's Vineyard Historical Society

Date: 8-20-99

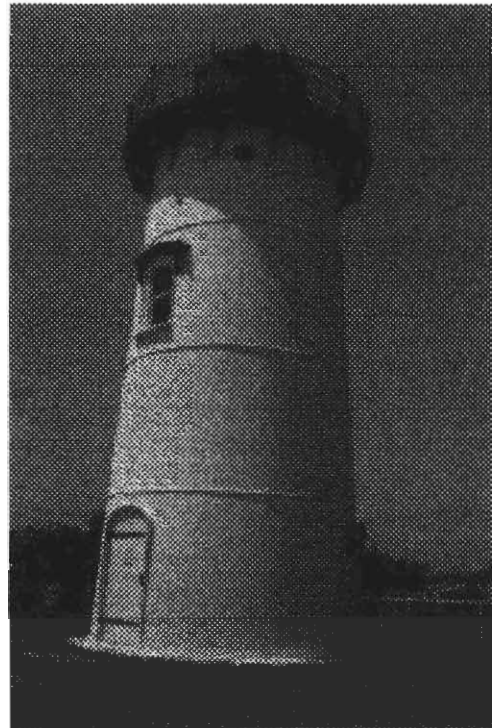
Figure 8

surface problem, save for the concrete skirt outlining the base of the structure, shown to the left here. There is no real concern for damage to the stability of the lighthouse due to this damage. A simple

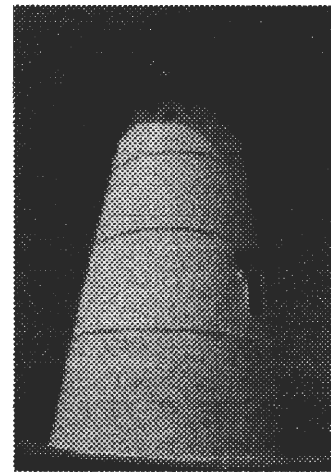
**Figure 18**

The exterior of the Edgartown lighthouse is in fair condition. There are no major visible problems, but a few points of interest are to be noted here. First, the windows are made of plywood with a frame painted on them, as depicted to the right. There are rust crack lines

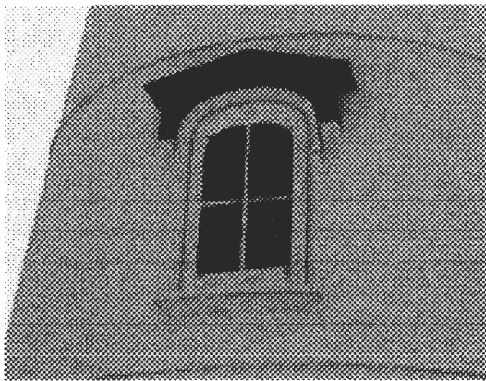
**Figure 19**

where the modular sections meet at the base leading up to the first ring, shown to the left. The south-facing window is deteriorating at an alarming rate. There are cracks and paint failure at the weld, accounting for leakage. The black paint is slightly tinted blue, due to certain pigments in the paint fading faster than others are. There is exposed rebar, ribbed metal bars used to reinforce concrete, on the upper concrete foundation. There is a massive hole in

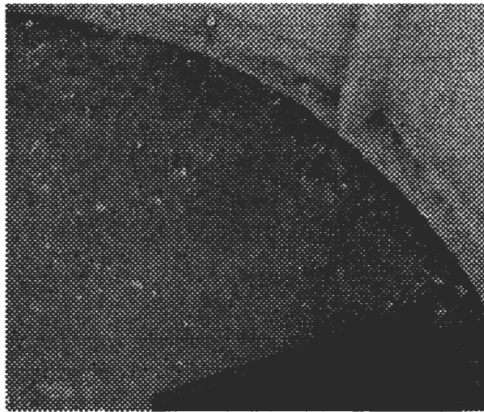
**Figure 24**

The floor of the inner cupola section is covered with rust, and littered with paint chips from the ceiling, window sills, and the vent cover on the ceiling. The rust on the floor can be solved with a high-traffic floor epoxy, and the paint on the inside of the cupola section needs to be

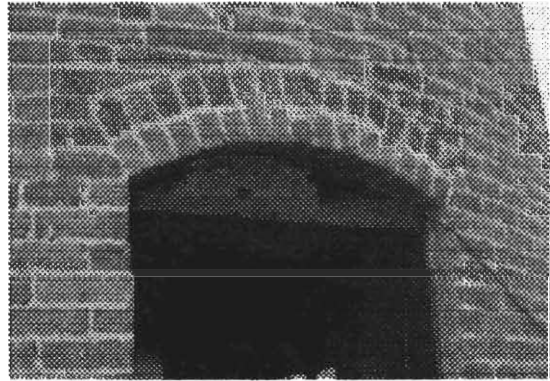
**Figure 32**

**Figure 31**  
the entrance door is completely rusted away, as pictured to the right here. It seems the rain is running inside under the eave, and corroding the metal from years of rain. The porous brick gives the water a good surface to cling to as it runs down the side. There is

no drip/run deflector above the door, which might stop most of this rust. To finish the exterior inspection, a barrel is buried a few feet away from the lighthouse in the surrounding grass, shown to the right. A closer inspection indicates it was an oil barrel with a Boston, Massachusetts, origin. The barrel contains what appears to be rainwater; however a closer

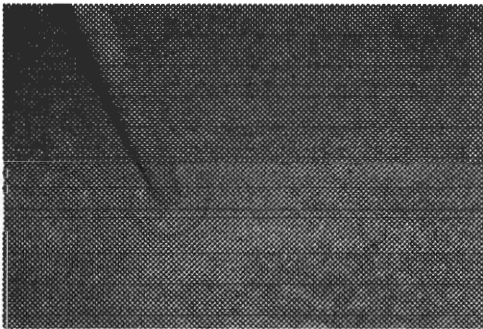
**Figure 35**

not to be used, they should be filled in with real brick. Each of the metal landings on the staircase leading up the inside has some surface rust on them. Shown to the left is an example of one of the landings. As mentioned earlier, these need to be de-rusted, and repainted with a high-traffic

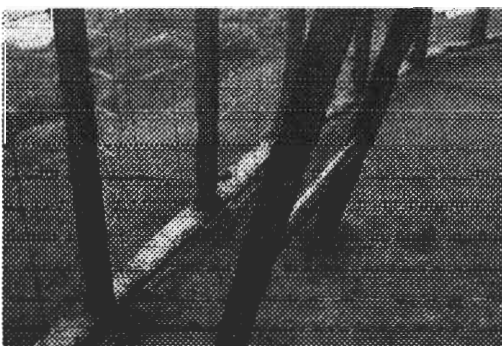
**Figure 37**

currently clinging to the brick. This mold needs to be scrubbed off of the wall to provide the healthiest conditions possible for people in the structure.

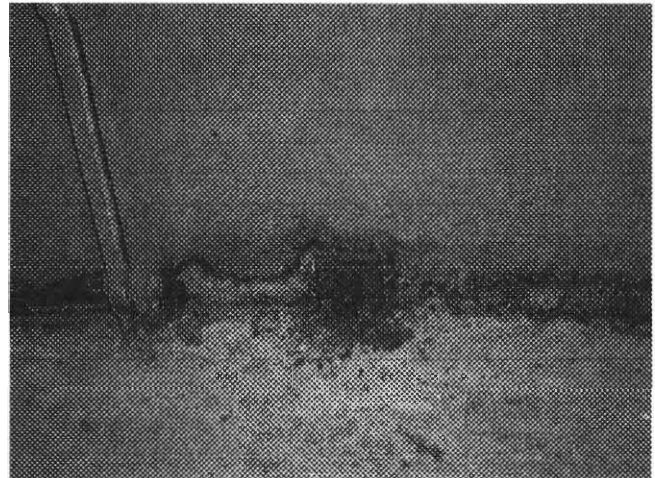
Figure 40

Rusting on the inside of the lighthouse is caused by inadequate ventilation. Water accumulates at the base of the lighthouse on the inside and is very slow to leave. This has caused the anchor brackets of the lighthouse to corrode and they are no longer structurally sound. The lack of brackets should not cause a problem. According to Jeff Harvey, “A

hurricane couldn't blow this lighthouse over even with no brackets.” The puddle patterns on the floor indicate that water is frequently introduced to the interior of the lighthouse.

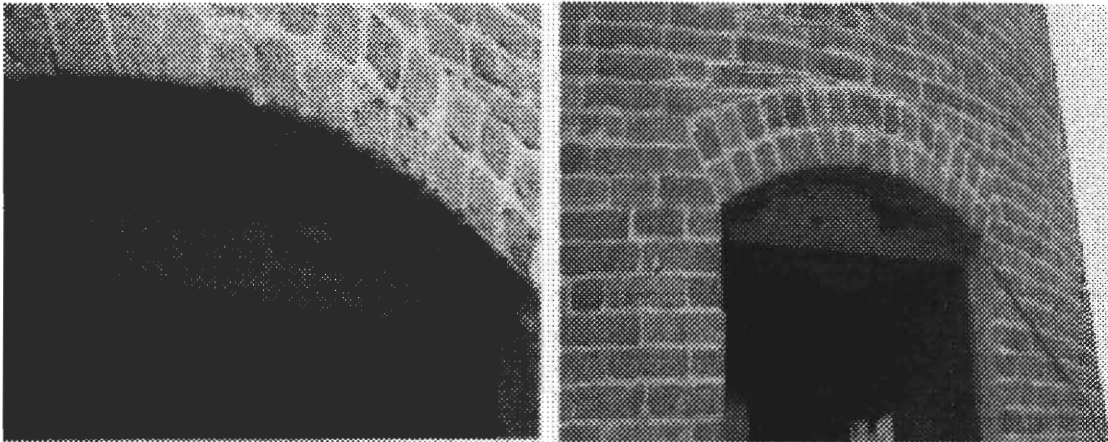
**Figure 56**

The door leading into the tower is in need of some serious work, and has been for some time. Both pictures show that the panel above the entrance has rusted away completely in

a number of places. This is another source of moisture infiltration, and should be replaced.

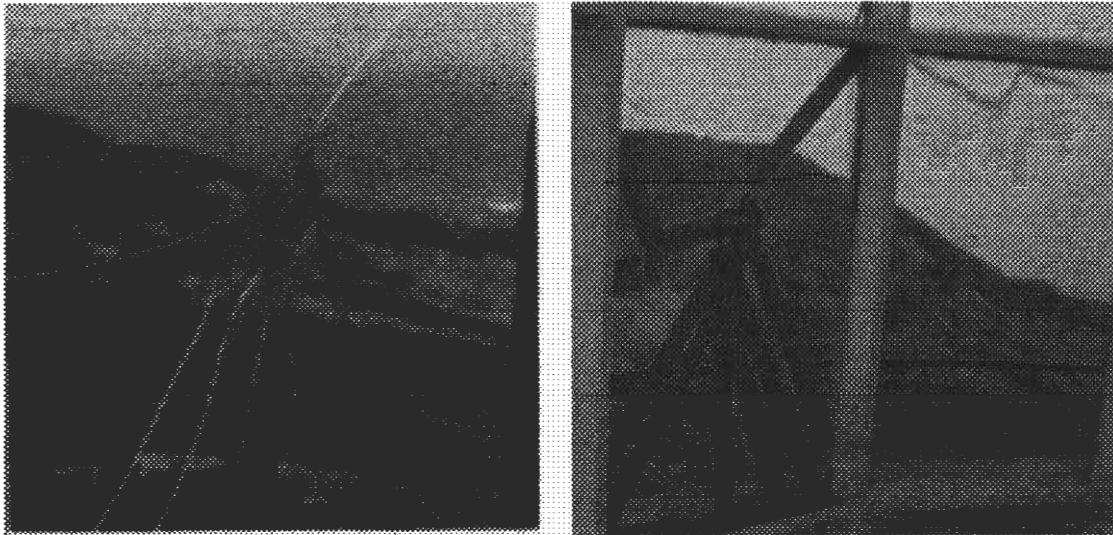
**Figure 57**

The final area of comparison at the Gay Head light is the window panes in the lantern room. The pictures below are of the same pane two years apart. In the first picture the pane is cracked and seems to be sealed with a sort of caulk or glue. This should have

been a temporary solution, but it was not. Instead of replacing the pane, the seal was reinforced using duct tape. As well as being aesthetically displeasing, this solution is unsafe and unsuitable. While this might not be the responsibility of the keeper, the Coast Guard should have been informed to remedy the situation properly.
