RIO PIEDRAS CONSERVATION MANAGEMENT PLAN

RÍO PIEDRAS AT
THE AQUEDUCT COMPLEX

May 2009

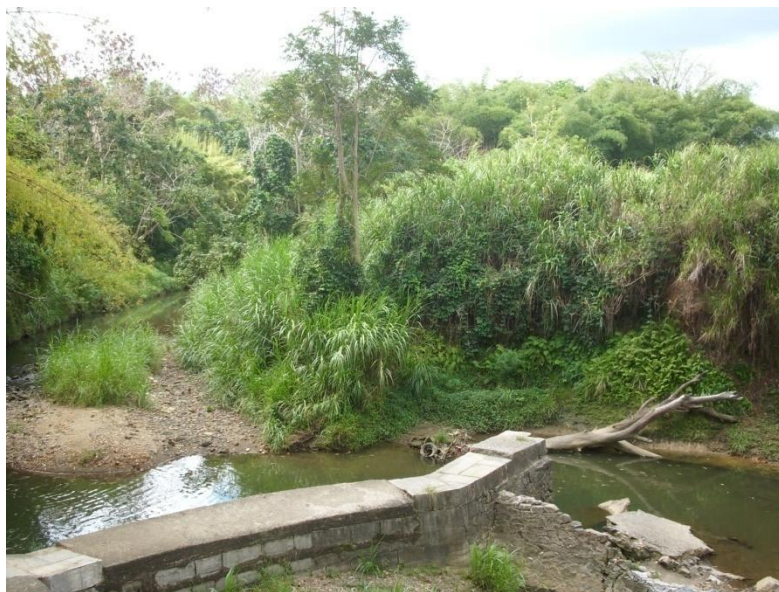
Figure 6: Overview of Zone 1

On the urban side, intervals -1 and 1 are grouped together to form the sixty-meter Zone 1. The intervals contain areas of mostly grass and brush as demonstrated in Figure 6. There is relatively little shade cover since there are so few trees. Within the zone, clay, mud, and rock beaches make up the bank, which is steep and eroded. Little human debris is present in either

interval other than the debris collection in the water. In the water of Interval 1, a collection of natural debris has created a dam which diverted water flow from its normal path that can be seen

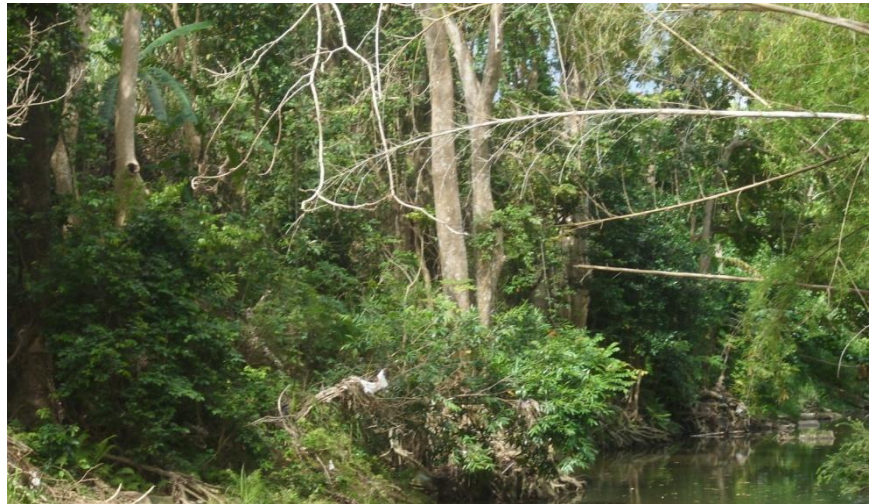
Figure 9: Zone 2 at Left

Intervals 2, 3, and 4 are grouped together to form the ninety-meter Zone 2. There are many trees that have root structures reaching into the river. These trees provide good shade cover for the river bank. The bank was steep and difficult to traverse because of extending roots, dense undergrowth, and moss covered rocks. There is an abundant amount of natural and human debris, but there were no large objects found. This zone distinguishes itself because of its canopy cover and related vegetation, a deeper water level, and the presence of rocks along the bank. The features of the zone can be seen in Figure 9.

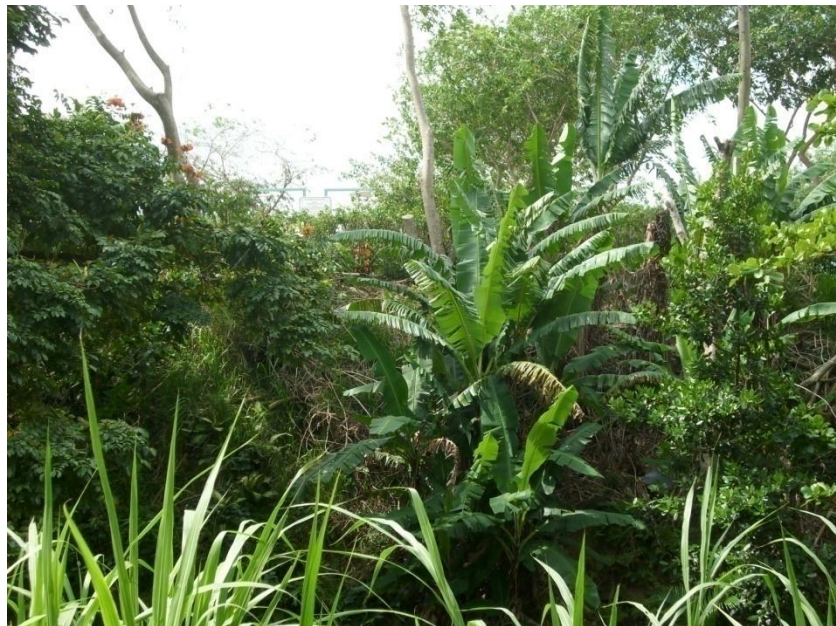
Figure 12: McArthur Palm and Zone 3 (Building in Far Background)

contribute to the shade cover are the African Tulip, Indian Almond, and Indian Padauk (*Pterocarpus indicus*). Though there is a variety of tree species, they are all sparsely located throughout the zone. The fairly abundant Areca Palm is the most populated tree species in the area. Zone 3 also contains Elephant Grass and Papiro grass, both of which do not have a significant presence. *Calopogonium coeruleum* also appears within the zone, but is located in a few isolated places. The shade cover within the zone is good because of the large tree species contributing to the canopy. The team found a few seedlings of larger trees which are a good sign that the zone is recovering to help control the erosion and temperature. Zone 3 holds nine invasive species. Although they have a low population, the African Tulip, Indian Almond, Indian Padauk, McArthur Palm (*Ptychosperma macarthurri*), and Areca Palm are the major species contributing to the ecosystem. An example of the rare McArthur Palm and the other vegetation of Zone 3 can be seen in Figure 12. To view the abundance and characteristics of species in Zone 3, see Appendix VII.

The soil samples from Zone 3 are varied from place to place. The first sample, taken from the top of the bank, is a loose soil that contains rocks with a small amount of roots and organic matter. This soil is prone to erosion as there are not enough roots to hold the soil in place. The second sample was taken at the end of the zone and contains hard

packed clay that was very slippery. The packed clay contains a few minute roots. The sample exhibits the zone's typical bank close to the water's edge. This type of bank allows for the growth of moss, small shrubs, and small grasses. Consequently, the bank is eroded and very steep. The first sample has a density of 0.765 g/cm^3 while the second sample has a density of

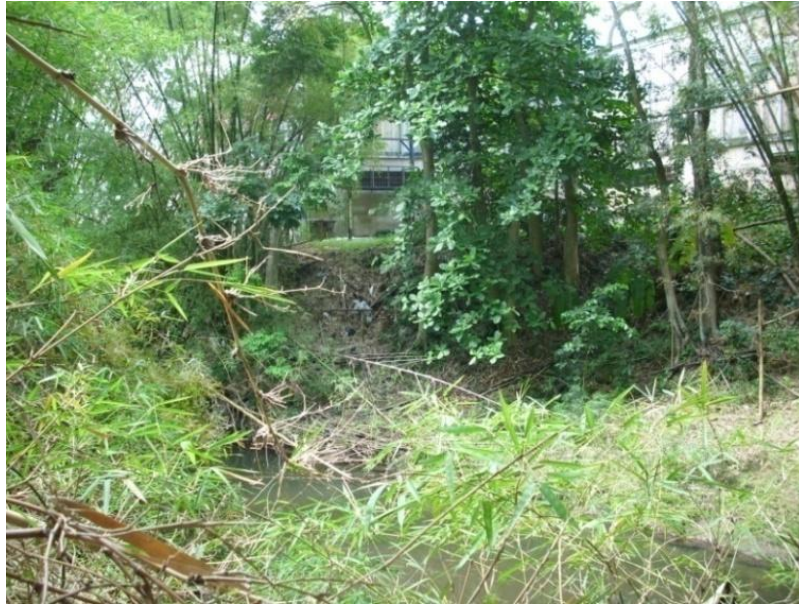
Figure 14: View of Zone 4 from Aqueduct Side, Building and Fence Present

cover consists largely of Bamboo, positioned at the peak of the bank where the riparian zone meets a concrete foundation and fence. There are also scattered trees within the zone and little undergrowth. Some of the debris items, erosion, and bank composition can be seen in Figure 13. The resulting weak soil has caused Bamboo trees to upend and they are on

the verge of falling into the river. The moss covered banks are very steep and house various sized rocks. This zone distinguishes itself because it accommodates Bamboo and is surrounded by numerous buildings. These features may be the cause of the severe erosion and urban dumping that also distinguish the zone. Recognizable features can be seen in Figure 14 and Figure 15.

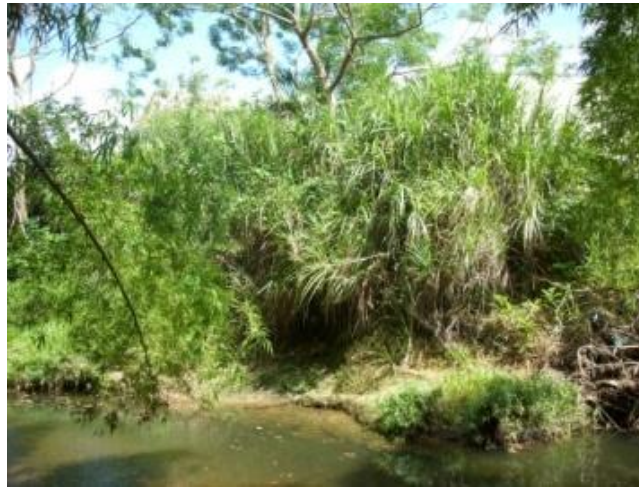
Figure 18: Typical Bank of Zone 6

Intervals 13-20 are grouped together to form the two hundred forty-meter long Zone 6, the largest and final zone of the urban side. The steep bank is totally covered by tall grasses and ferns, represented in Figure 18. There are scattered trees at the outer extents of the riparian zone, but they offer no shade cover for the river. There is loose sediment in the riverbed, resulting in deep mud. In Intervals 19 and 20, there is an

erosion guard (mesh fence) covering the steep grade with vegetation growing through the holes. There is a fence and parking lot less than ten meters from the river's edge in these two intervals. The zone has little human or natural debris due to the barrier of excessive grasses. Our group also witnessed a stream of dirty runoff coming from one of the buildings into the river. This zone distinguishes itself because of the excessive grasses, lack of shade, and noticeable erosion. Examples of the zone characteristics are shown in Figure 19.

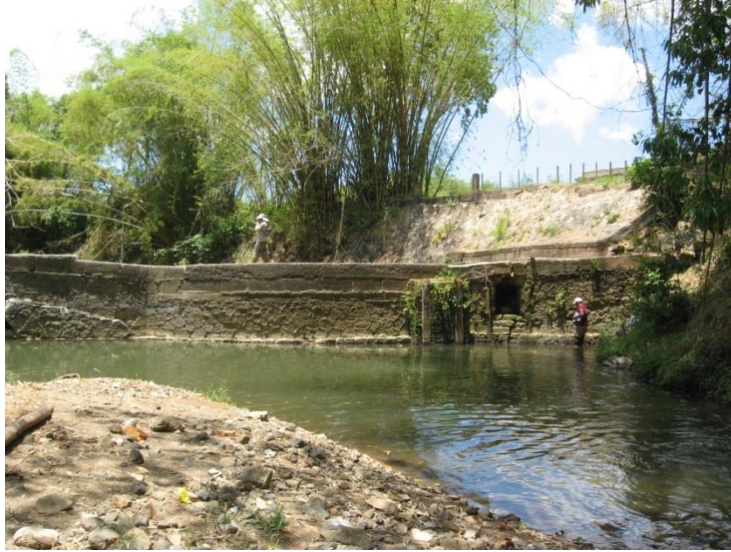
Figure 23: End of Zone 7 at the Aqueduct

located throughout the zone. Other than Bamboo, the other prevalent species is *Guarea guidonia*, or Muskwood. Wild coffee (*Casearia guianensis*), Jagua Box Genip (*Genipa americana*), and Muskwood are solely present in Zone 7. This is likely due to the aqueduct rock wall that spans thirty meters and separates the zone from other vegetation. The lone invasive species is the abundant Common Bamboo. To view the abundance and

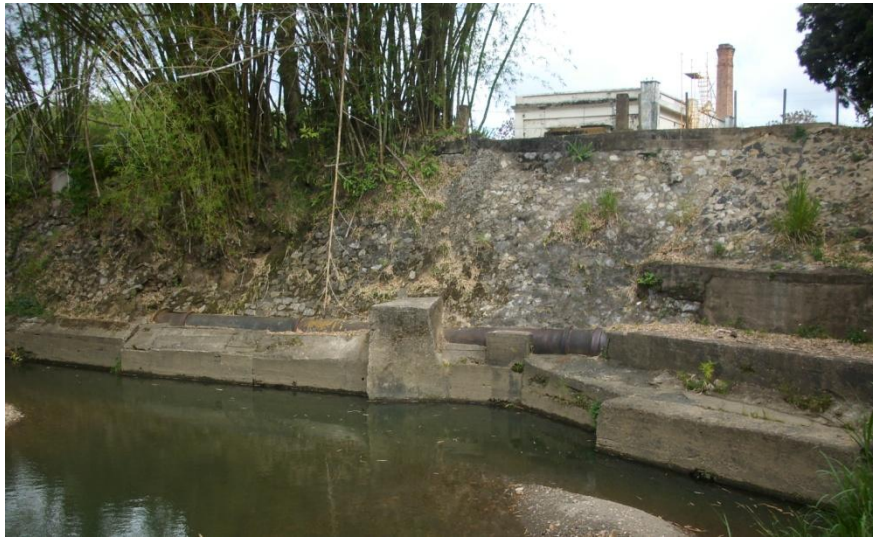
Figure 24: Aqueduct Concrete Wall of Zone 8

Interval 1 makes up the thirty-meter long Zone 8. This zone houses the rock wall which is part of the dam as shown in Figure 24. At the top of the wall at the end of the zone, there is a cluster of Bamboo, but no other noticeable vegetation. The zone has only little human debris such as bathing suits and containers. This zone is distinguished by the large rock wall and lack of vegetation.

Zone 8 houses only three invasive species. There is only a small patch of vegetation at the peak of the bank following the rock wall that makes up most of the zone. The vegetation patch in Zone 8 is comprised of mostly Bamboo, while younger tree species are also present. The small patch contains Bamboo, *Citrus sp* (tree species), and an African Tulip. The concrete and rock wall of the aqueduct prevents the growth of vegetation.

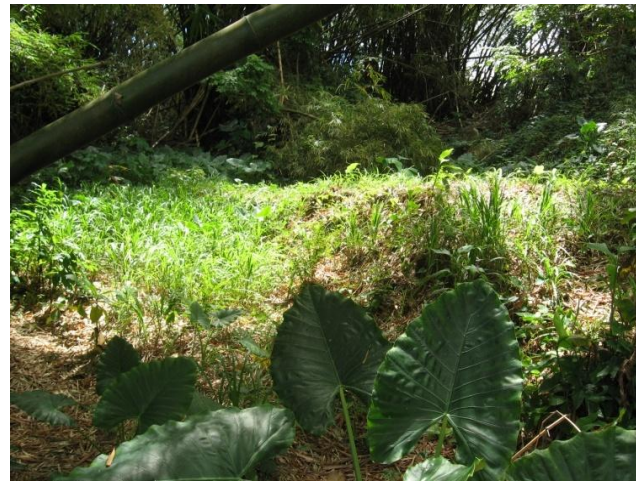
Figure 28: Large Riparian Zone of Zone 11

Intervals 6 through 15 make up the three hundred-meter Zone 11. This is the largest zone on either side of the river. The vegetation consists of frequent Bamboo and scattered trees, which all combined contribute fair shade cover for the zone. Some areas have grasses and undergrowth. Throughout the zone, fallen Bamboo lies on the bank along with a small amount of human debris. A majority of the bank is steep, although there is a section where the bank's grade is suitable. In this area, the riparian zone stretches for over thirty meters away from the water's edge. This section can be seen in Figure 28. This zone distinguishes itself because it has Bamboo, scattered trees, and a wide riparian zone.

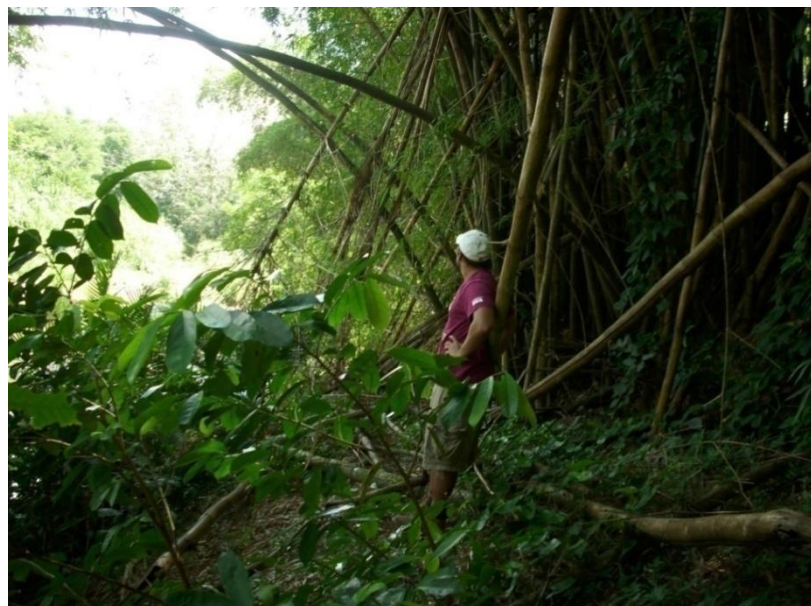
Figure 30: Team Member within Zone 12

stable with a good grade, but in places the grading is sheer. The decent grade within Zone 12 can be seen in Figure 30. There is no human or natural debris in any part of the zone. This zone distinguishes itself because there is comparatively little Bamboo and no human debris.

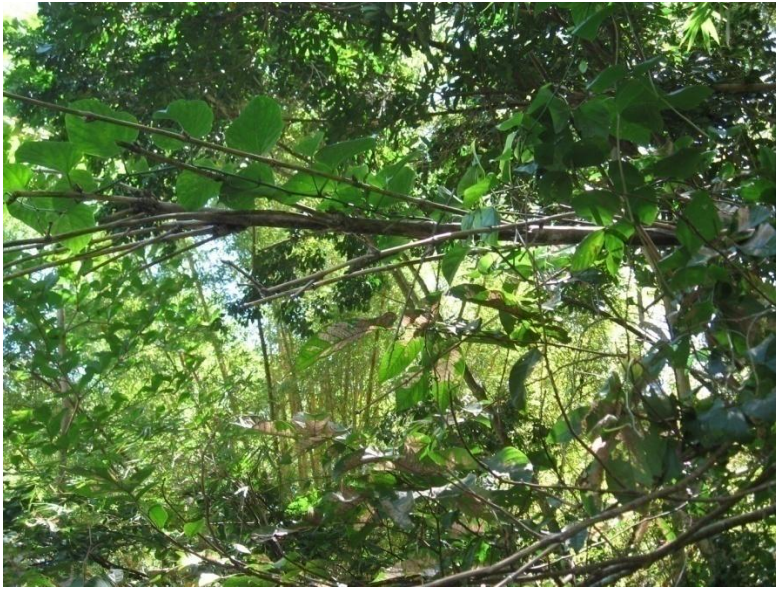
Figure 33: Vines within Zone 13

Zone 13 houses three species of trees, two of which are native. The two native trees, the Escoba Colorada and Maga (*Thespesia grandiflora*) are both more prevalent than the invasive *Triplaris*. These species give good shade cover to the zone, but a large contribution is also given by Bamboo. Two other abundant species of shrubs are Metallic Alocasia and Higuillo (*Piper hispidum*). Two abundant vine species which are native and located in Zone 13 are *Calopogonium coeruleum* and Puerto Rican Hemp Vine (*Mikania*). The vines are demonstrated in Figure 34 to display the abundance within the area. The only grass species found in the zone is the moderately abundant and invasive Papiro (*Cyperus involucratus*). To view the abundance and characteristics of species in Zone 13, see Appendix XVII.

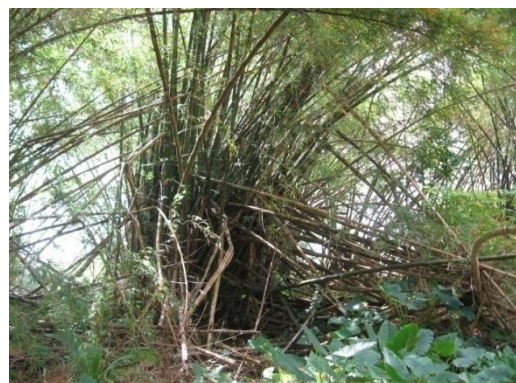
Figure 37: *Bambusa vulgaris*

Bambusa vulgaris (Common Bamboo) is an invasive species from south Asia and is found in Zone 4 and Zones 7 through 13 of the river. This is the most abundant plant on the aqueduct side, especially in Zone 10 where it is the lone species found. Bamboo is most known for its extremely fast growth rate and its cluster growth pattern. It can grow to a height of 16 meters and has an average root depth of 0.6 meters.

The clusters of Bamboo create a complex matrix of roots that helps prevent erosion. Bamboo is able to grow in any soil type and in a wide range of pH values making it an adaptable plant. It has the ability to thrive in any circumstance which is why it is so widespread throughout the river. However, it disrupts and kills competing plants because it grows quickly

is found in clusters, allowing other native species to grow. A typical Bamboo cluster is seen in Figure 37.

and blocks sunlight. Although Bamboo does help with erosion, The Trust should control the spread of the species. Additionally, we recommend the removal of the dead Bamboo debris that

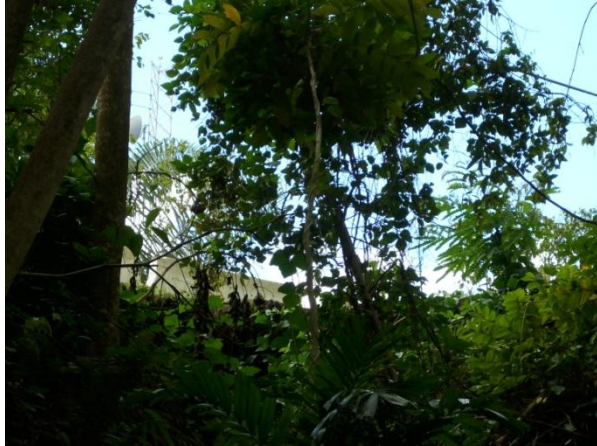
Figure 38: *Calopogonium coeruleum*

Calopogonium coeruleum is a native perennial legume vine, found in all six zones on the urban side. *Calopogonium coeruleum* is also found in Zones 9 and 13 on the aqueduct side. It was

found growing across the ground as well as growing up surrounding trees. It will sprout roots any time it comes in contact with moist soil. *Calopogonium coeruleum* can grow in a wide variety of soil types and prefers a low pH. One of its main characteristic is the ability to smother weeds that are trying to grow. Therefore, our team suggests that Fideicomiso allow the vine to

grow undisturbed because it can alter the weed growth. A typical occurrence of the species is seen in Figure 38.

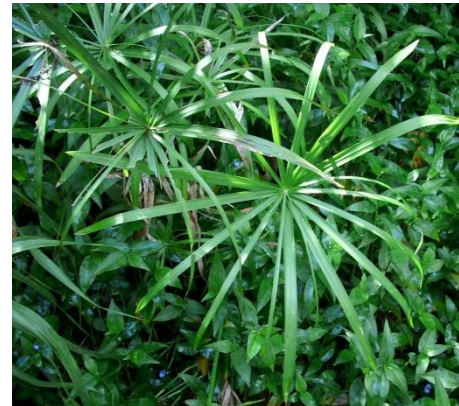
Figure 39: *Cyperus involucratus*

Cyperus involucratus (Papiro) is an invasive grass species originating from Africa. It is found on the aqueduct and urban sides in Zones 2, 3, 5, 6, 9, and 13. It grows to a height of one meter and is found on the edges of banks or up to 400mm of water. Papiro prefers direct sun light or light shade. This plant is a persistent grass that is very difficult to eradicate yet does not have any

adverse effects upon the ecology. For this reason we suggest to let the plant continue to grow and focus more of the time and effort on adding and removing other plants. A good example of a Papiro is seen in Figure 39.

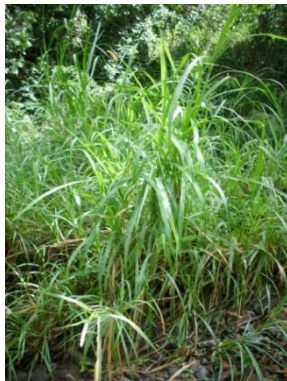
Figure 40: *Pennisetum purpureum*

Pennisetum purpureum (Elephant Grass) is an invasive grass species originating from the plains of Africa. It is found in Zones 1 through 6, 9, 11, and 12. The plant grows to a height of 3 meters with a root depth of 0.4 meters. It can grow in any soil type however it prefers growing in soil with a pH of 5.2 – 6.8. Elephant grass is tall, fast growing, and spreads easily. It blocks sun light from reaching the ground

smothering any seedling that is trying to establish itself. We recommend the removal of the dense Elephant Grass in Zones 1 and 6. This will open up areas for the implementation of the tiered vegetation system. However in order to protect the young trees from the Elephant Grass, monthly trimmings or weeding is suggested. Typical Elephant Grass growth is seen in Figure 40.

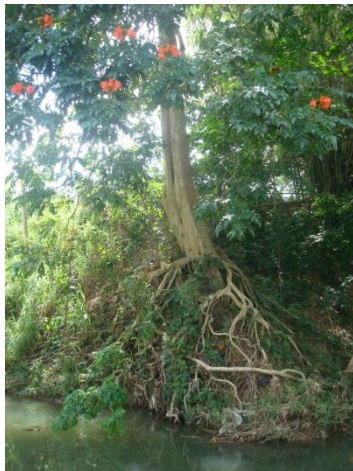
Figure 41: *Spathodea campanulata*

Spathodea campanulata (African Tulip) is an invasive tree species originating from the tropics of Africa. It is found in Zones 1 through 6, 8, 9, 11 and 12. African Tulip is a fast growing tree that grows to 20 - 35 meters. The tree is also a fast spreading species that can grow in virtually any soil type. It is a main contributor to secondary forests in the moist parts of Puerto Rico. This is because its seeds germinate readily once in contact with moist soil. Although the African Tulip is an aggressive, invasive, species our group suggests letting the present African Tulips continue undisturbed. Yet, control the spread of the species by removing the seedlings and small trees. We recommend leaving the current trees because it has positive features

such as shade cover and root structure that can immediately benefit the area. An African Tulip Tree found on the aqueduct side is shown in Figure 41.

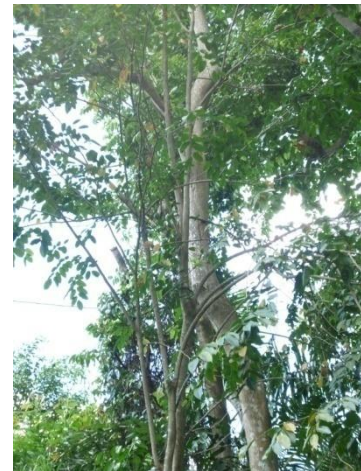
Figure 42: *Terminalia catappa*

Terminalia catappa (Indian Almond) is an invasive species that originates from Asia and the Indian sub-continent. It is found in Zones 2, 3, 9, 11, and 12. It can grow to a height of 14 meters and has an average root depth of 0.85 meters. It prefers coarse to medium aggregated soils with a pH level of 6.0 – 7.5. Unlike the other invasive species in the area, the Indian Almond does not have a fast spreading rate. The Indian Almond is commonly found in flood plains because it requires moist soil in order to germinate and grow. It provides strong shade cover because of the large leaves and stabilizes soil with the deep roots, which is why we suggest The Trust let the present trees continue on its natural course. Yet, control the spread by removing seedlings. The Indian Almond Tree is seen in Figure 42.
