Designing a Culvert Management System for the Town of Spencer, MA

A Major Qualifying Project

Date: March 26, 2015

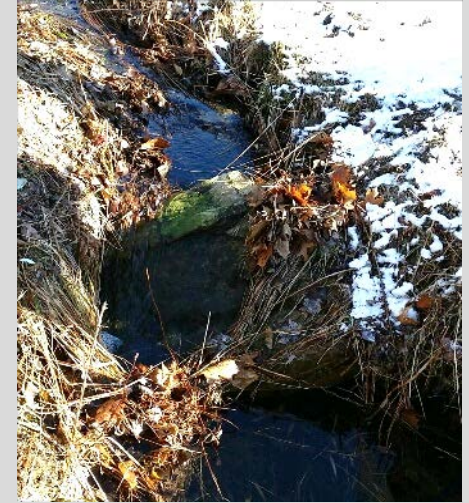
OUTLET

- ❖ Inlet and outlet were almost completely submerged -> could lead to flooding especially with runoff
- ❖ Large rock blocking most of outlet
- ❖ Significant cracking through road above culvert

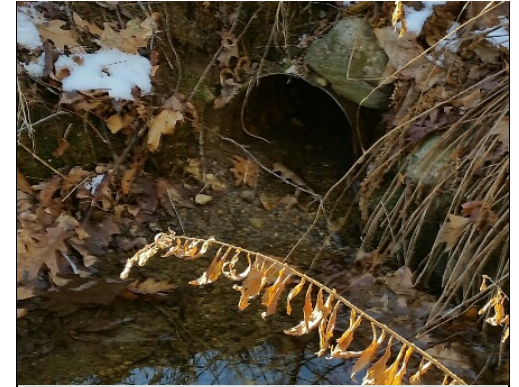
OUTLET

- ❖ Seems to be used for storm runoff rather than a consistent stream flow
- ❖ Tree down right next to outlet

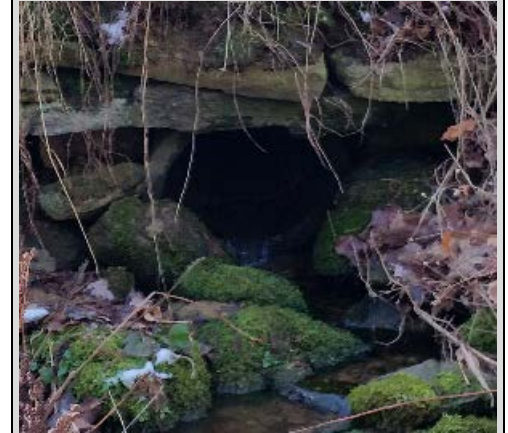
OUTLET

- ❖ Headwall is in poor condition
- ❖ Road was recently paved above culvert

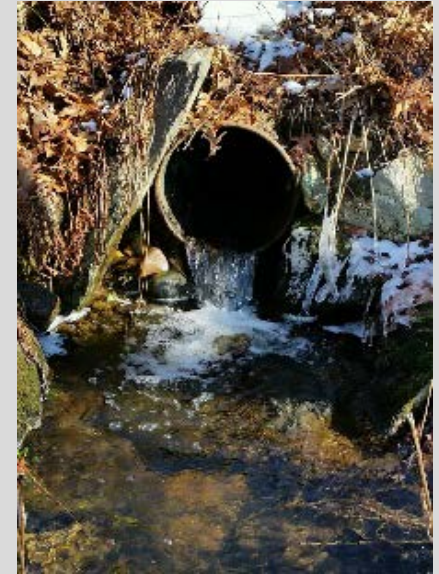
OUTLET

- ❖ Half the road is recently paved above culvert
- ❖ Concrete pipe at inlet and metal pipe at outlet
- ❖ Stream flow internally cascades from one half to the other

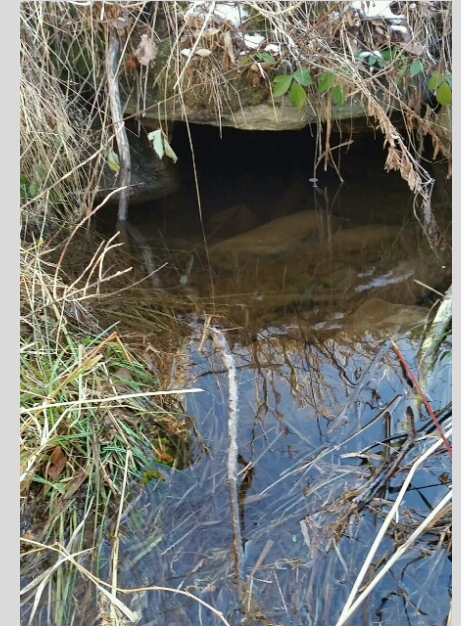
OUTLET

- ❖ Chain link fence about 5' in front of inlet
- ❖ Bog being filled by underground tributaries
- ❖ Inlet and outlet are almost submerged
- ❖ Large amount of scour on outlet side

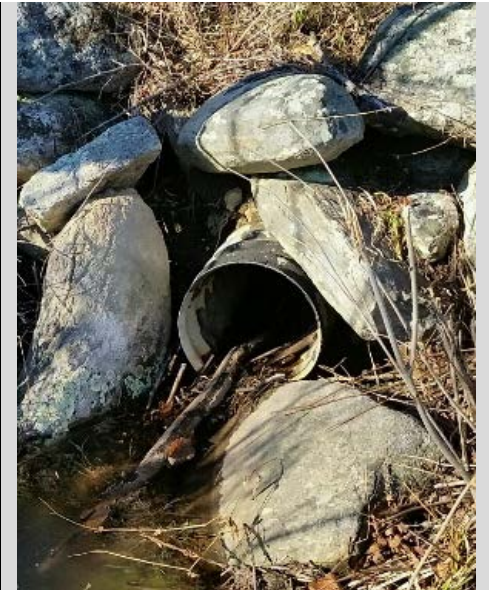
OUTLET

- ❖ Bog being filled by underground tributaries
- ❖ Both inlet and outlet are surrounded by debris
- ❖ Underground stream feeding inlet from both directions

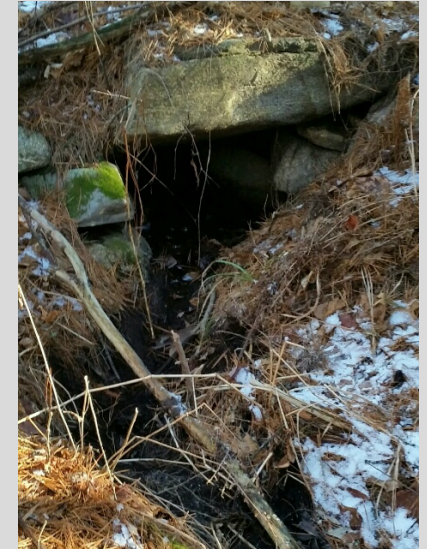
OUTLET

- ❖ Significant pothole on road above crossing
- ❖ Stream goes underground after outlet for about 5 ft. then resurfaces and leads to a wetland

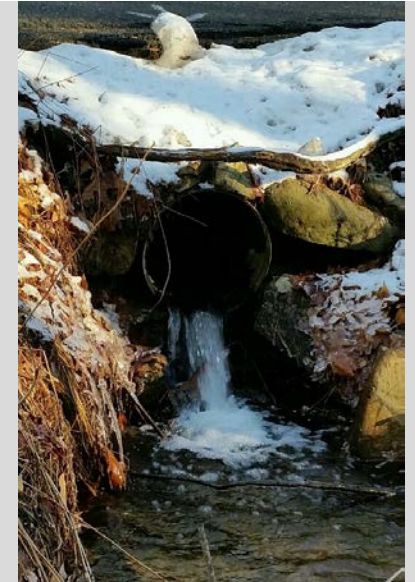
OUTLET

- ❖ About 50 ft. from outlet stream becomes a wetland area
- ❖ Multiple hydraulic jumps within first 20 ft. downstream
- ❖ Rocks and debris gathering at inlet

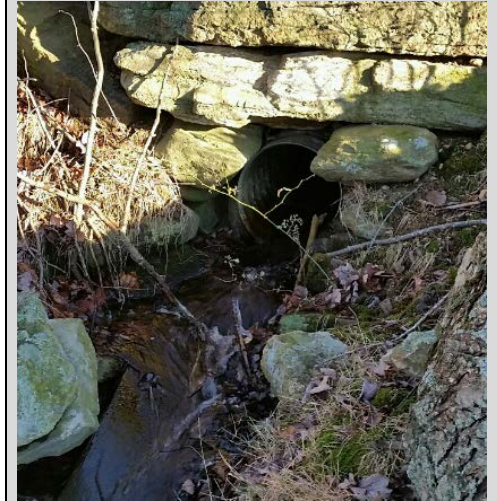
OUTLET

- ❖ Inlet is a rectangular dam
- ❖ Fish passage here is impossible as stream ends at horse farm on West side

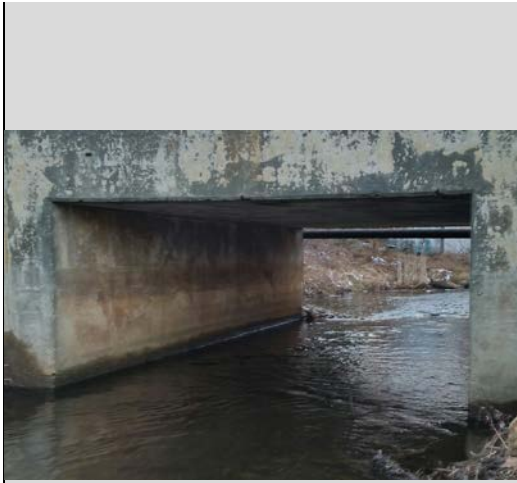
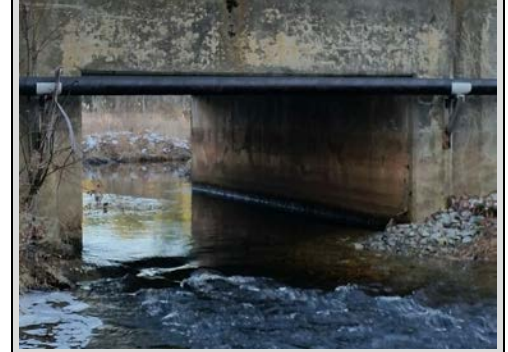
South Spencer Road 10

Characteristic	Field Observation
Date observed	12/14/2014
Type	Open-Bottom Box
Width x Height	12' x 5' 6"
Length	27'
Funding	Town
Stream Name (Tributary)	Cranberry River
Water Depth	18"
Outlet Drop	N/A

Structural assessment results:
good condition (0.84/1)

- ❖ Built in 1938
- ❖ Bridge No. – S-23-019
- ❖ Small scour pool at outlet

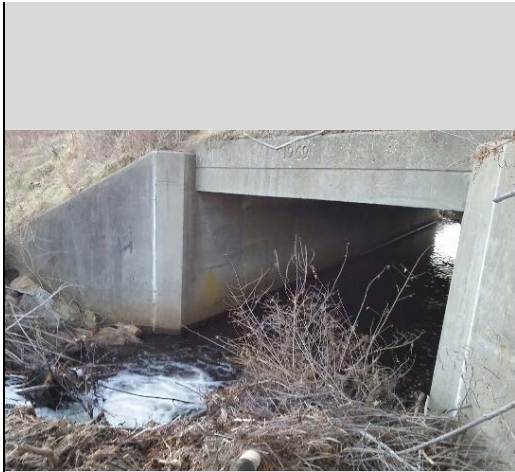
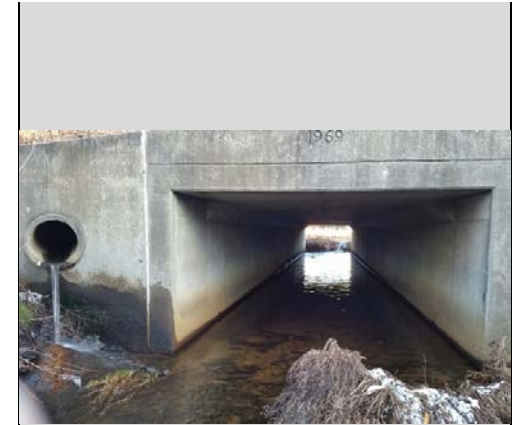
South Spencer Road 11

Characteristic	Field Observation
Date observed	12/14/2014
Type	Box
Width x Height	12' x 6' 7"
Length	68'
Funding	MassDOT
Stream Name (Tributary)	Muzzy Brook
Water Depth	12"
Outlet Drop	N/A

Structural assessment results:
good condition (0.80/1)

- ❖ Built in 1956
- ❖ Bridge No. – S-23-022
- ❖ Large wetland area on inlet side
- ❖ Beaver dam at inlet creating fast waterfall (restricted fish passage)
- ❖ Runoff pipe contributing to stream on outlet side
- ❖ Sulfur-like smell in area

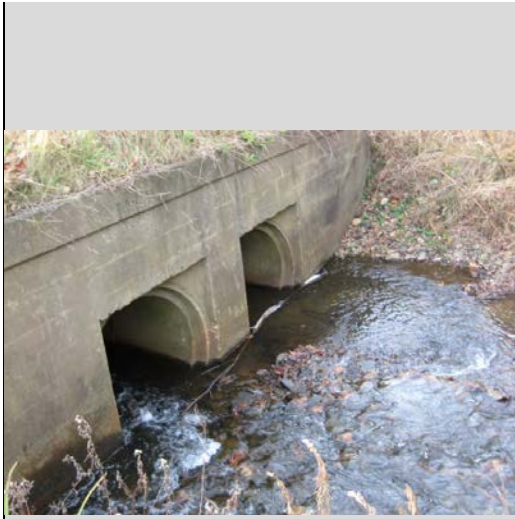
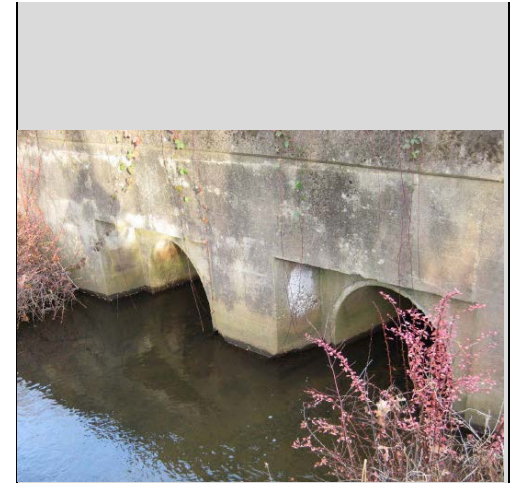
West Main Street 1

Characteristic	Field Observation
Date observed	11/22/2014
Type	Double Pipe
Diameter	48"
Length	44'
Funding	Town
Stream Name (Tributary)	Muzzy Brook
Water Depth	18"
Outlet Drop	N/A

Structural assessment results:
good condition (0.89/1)

- ❖ Large scour pool on outlet side
- ❖ Small scouring at inlet
- ❖ Culvert constricts stream natural bank width

- Box replacement

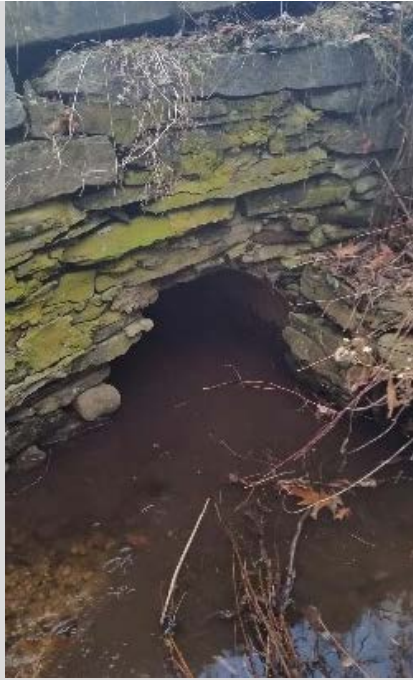
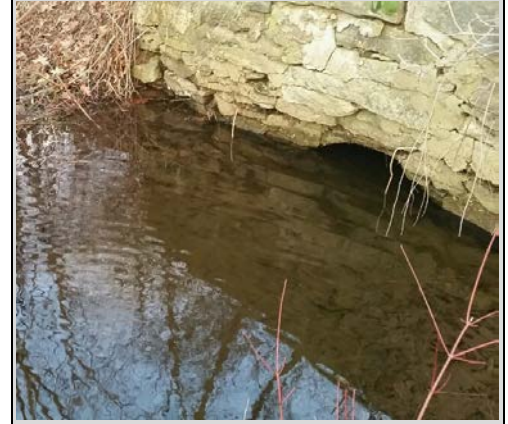
Meadow Road 1

Characteristic	Field Observation
Date observed	12/18/2014
Type	Concrete Pipe
Diameter	36"
Length	60'
Funding	Town
Stream Name (Tributary)	unknown
Water Depth	22"
Outlet Drop	N/A

Structural assessment results:
fair condition (0.63/1)

- Scouring and Erosion
- Road Condition
- Submerged Outlet

- ❖ Lots of litter in area
- ❖ Outlet is almost submerged
- ❖ Water is very deep and widening outlet area
- ❖ Turns into wetland area downstream

- Box replacement

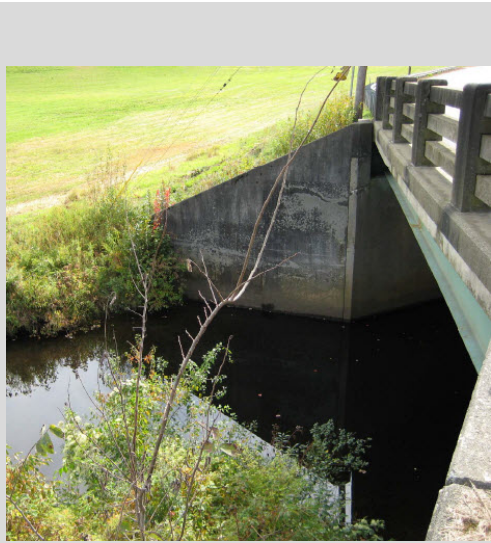
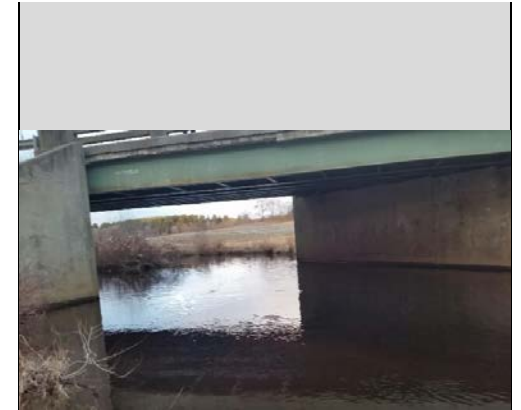
Meadow Road 2

Characteristic	Field Observation
Date observed	12/18/2014
Type	Open-Bottom Box
Length x Width	45' x 12'
Length	32'
Funding	MassDOT
Stream Name (Tributary)	Seven Mile River
Water Depth	24"
Outlet Drop	N/A

Structural assessment results:
good condition (0.71*/1)

- ❖ Built in 1952
- ❖ Bridge No. – S-23-002
- ❖ Scour pools developing at inlet
- ❖ Mild constriction of river

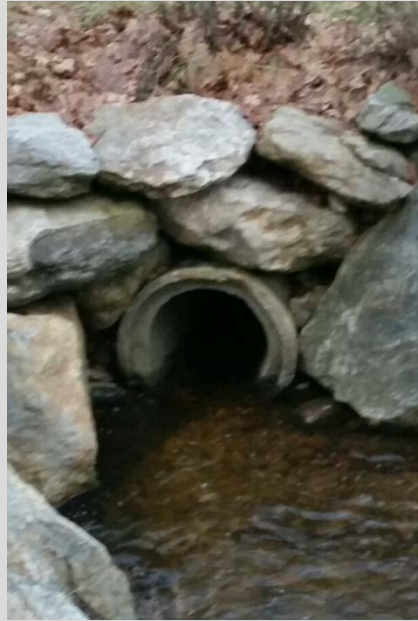
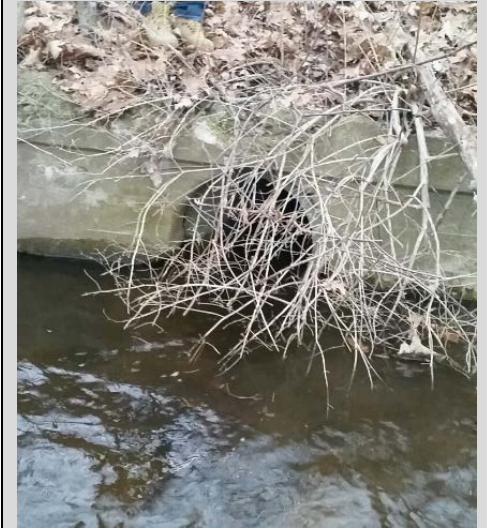
North Spencer Road 1

Characteristic	Field Observation
Date observed	12/18/2014
Type	Concrete Pipe
Diameter	24"
Length	31'
Funding	Town
Stream Name (Tributary)	unknown (Seven Mile River)
Water Depth	10"
Outlet Drop	N/A

Structural assessment results:
good condition (0.78/1)

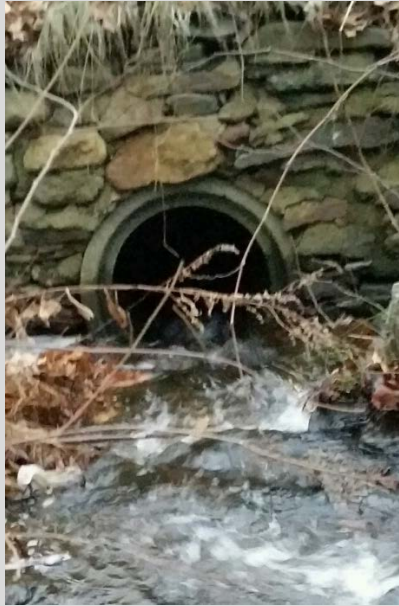
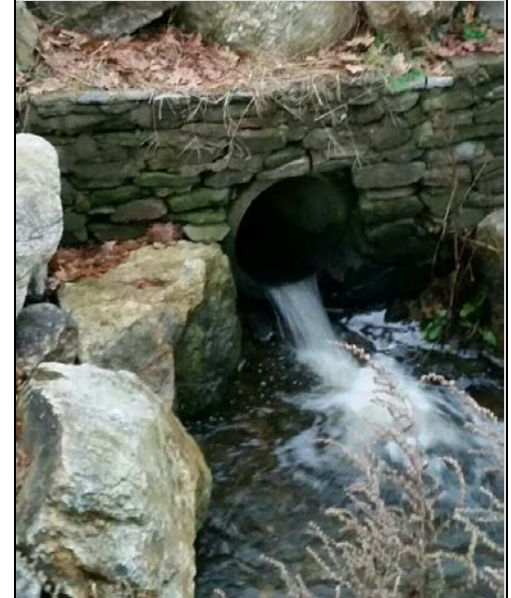
North Spencer Road 2

Characteristic	Field Observation
Date observed	12/18/2014
Type	Concrete Pipe
Diameter	24"
Length	40'
Funding	Town
Stream Name (Tributary)	unknown (Seven Mile River)
Water Depth	2"
Outlet Drop	10", Freefall

Structural assessment results:
good condition (0.77*/1)

- ❖ Headwall is in poor condition
- ❖ Multiple hydraulic jumps within 30 ft. upstream
- ❖ Mild constriction of stream
- ❖ Leads into pool separating this culvert from North Meadow Rd Culvert 2

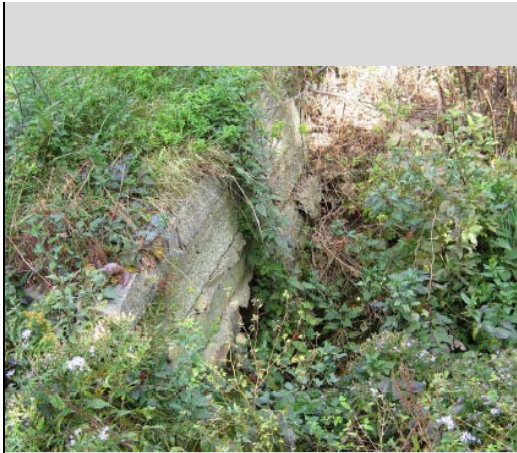
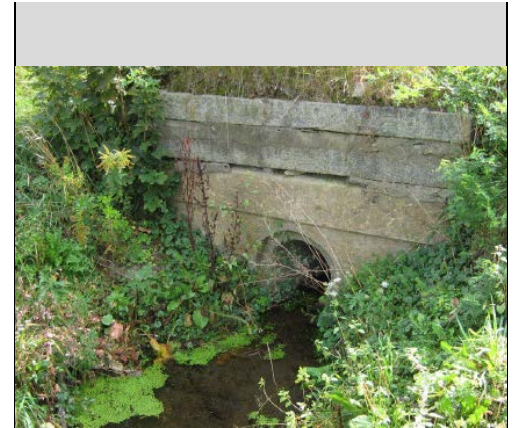
North Spencer Road 3

Characteristic	Field Observation
Date observed	11/22/2014
Type	Metal Pipe
Diameter	32"
Length	129'
Funding	Town
Stream Name (Tributary)	unknown (Seven Mile River)
Water Depth	5"
Outlet Drop	4" to stream bed

Structural assessment results:
fair condition (0.67/1)

- ❖ Sound like a physical barrier is present inside
- ❖ Mild constriction of stream
- ❖ Skewed alignment of stream

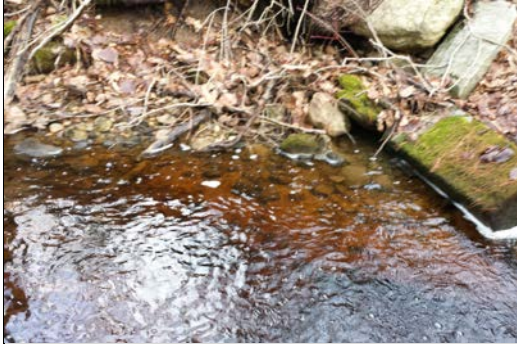
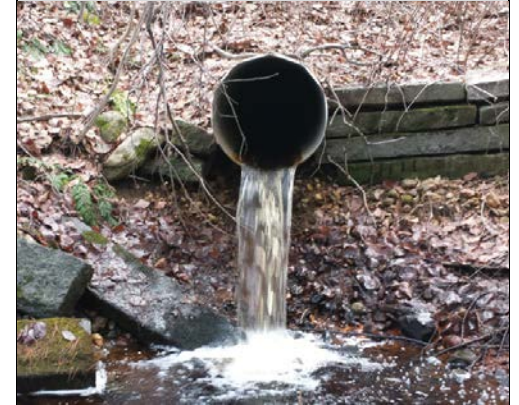
North Spencer Road 5

NOTE BROWN WATER AT OUTLET

Characteristic	Field Observation
Date observed	12/18/2014
Type	Metal/Concrete Pipe
Diameter	24"/30"
Length	120'
Funding	Town
Stream Name (Tributary)	unknown (Seven Mile River)
Water Depth	5"
Outlet Drop	48", Freefall

Structural assessment results:
fair condition (0.67*/1)

- * Embankment
- Scouring and Erosion
- Pipe in two pieces
- Road Condition

- ❖ Dried out pipe to the right of outlet approx. 5 ft. high
- ❖ Water is brown and has distinct smell
- ❖ Concrete pipe on inlet side
- ❖ Metal pipe on outlet side
- ❖ Significant outlet drop
- ❖ Embankment experiencing some erosion

- Pipe replacement (match slope of stream and increase capacity)

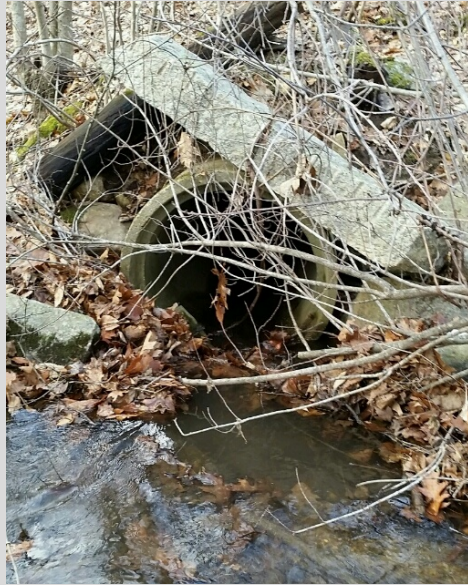
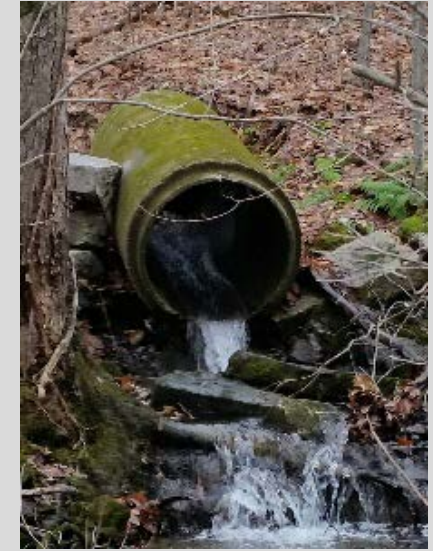
North Spencer Road 6

Characteristic	Field Observation
Date observed	12/18/2014
Type	Concrete Pipe
Diameter	30"
Length	100'
Funding	Town
Stream Name (Tributary)	unknown (Seven Mile River)
Water Depth	1.5"
Outlet Drop	13", Freefall

Structural assessment results:
fair condition (0.60*/1)

- * Embankment
- Scouring and Erosion
- Pipe in two pieces
- Road Condition
- Clogging
- Low Flow

- ❖ Pipe is broken at outlet
- ❖ Significant outlet drop
- ❖ Wetland area leading to inlet
- ❖ Runoff pipes leading to pool directly before inlet

- Pipe replacement

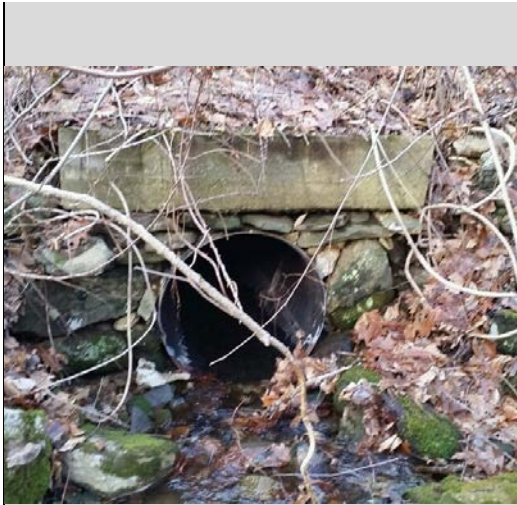
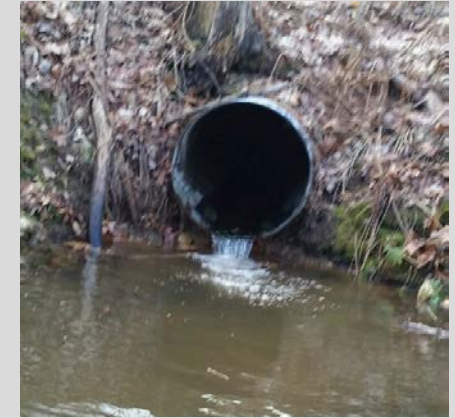
North Spencer Road 7

Characteristic	Field Observation
Date observed	12/18/2014
Type	Metal Pipe
Diameter	30"
Length	48'
Funding	Town
Stream Name (Tributary)	unknown (Seven Mile River)
Water Depth	1"
Outlet Drop	2", Freefall

Structural assessment results:
fair condition (0.73/1)

- ❖ Side road off of Rt. 31, crossing runs underneath it
- ❖ Constricting culvert about 40 ft. upstream
- ❖ Wetland area with low flow and ponding
- ❖ Large scour pond at outlet

- Adjust stream path through wetland area
- Pipe replacement

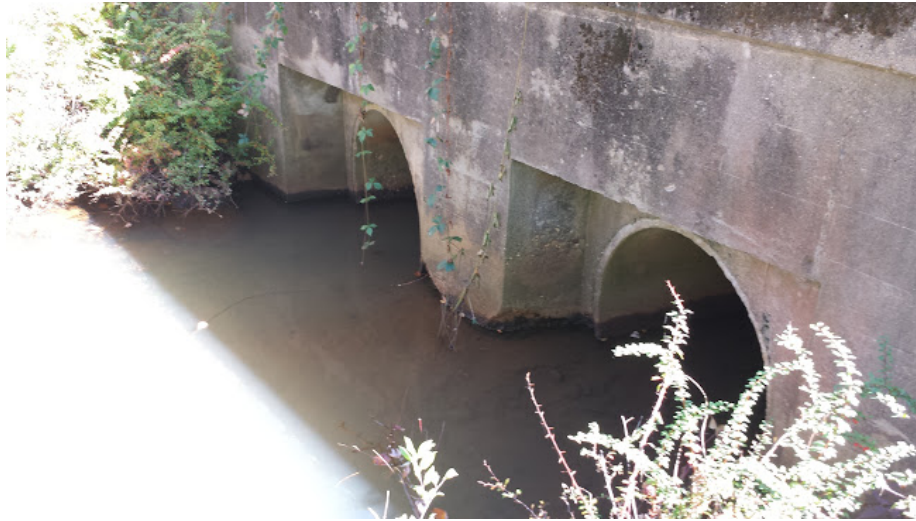
Figure 4 - Double Arch Culvert (Photo: Ryan Bagge, 2014)

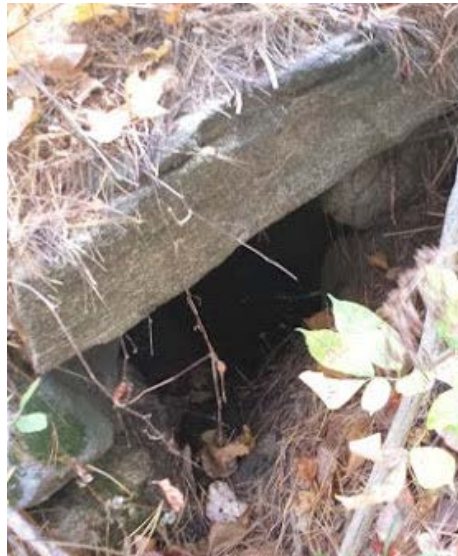
Figure 5 - Stone Masonry Embedded Culvert (Photo: Ryan Bagge, 2014)

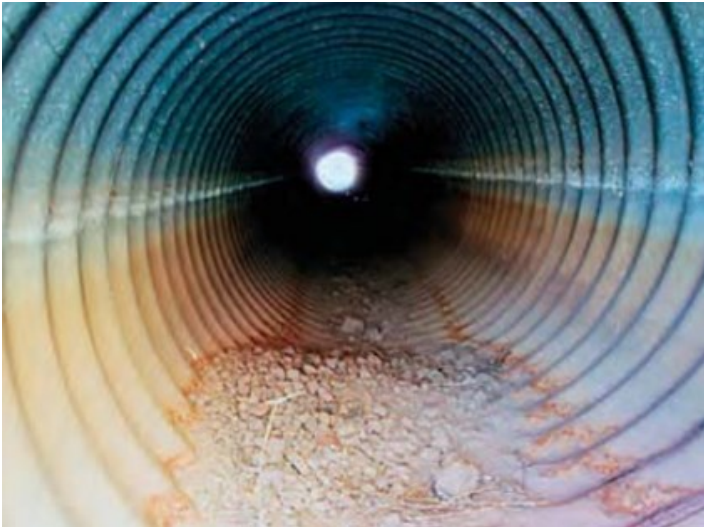
Good

No visual damage or only superficial corrosion or scaling of the invert.¹

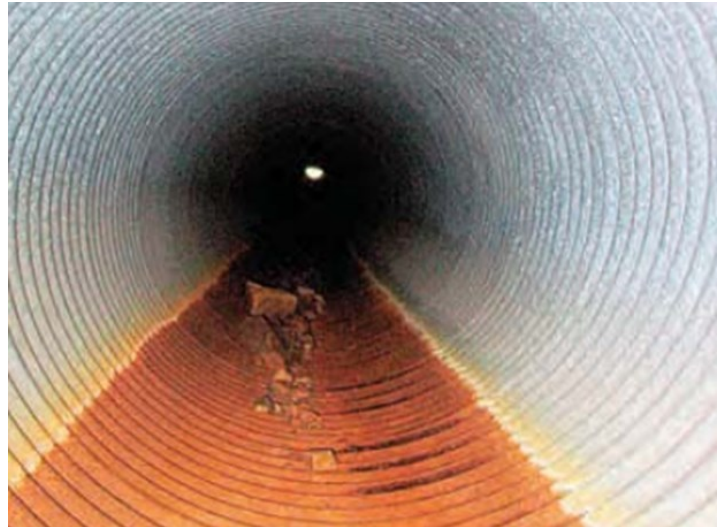
Fair

Minor corrosion and pitting, no holes or distortion. Cannot penetrate metal with sharp point of geology hammer. Minor isolated spalls in concrete.¹

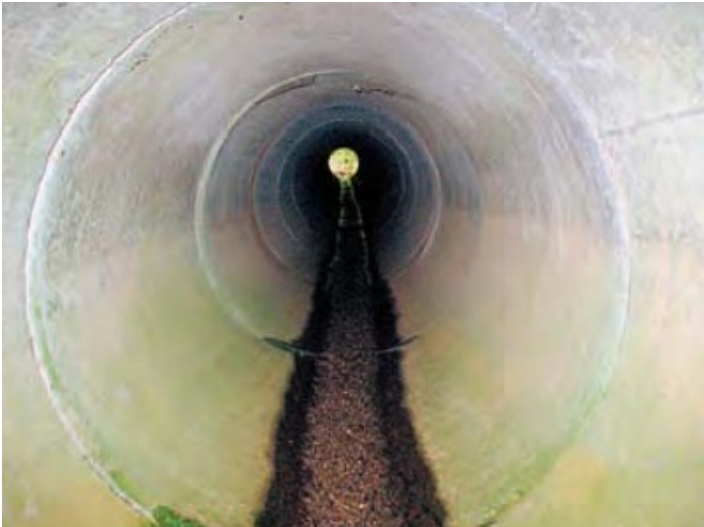
Good

Joints and seams are tight with no openings.¹

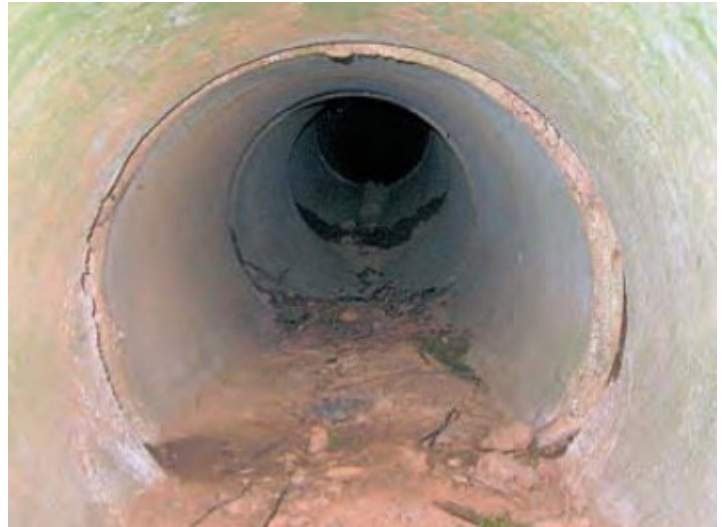
Fair

Minor separation of joints and seams up to 1", minor backfill infiltration.¹

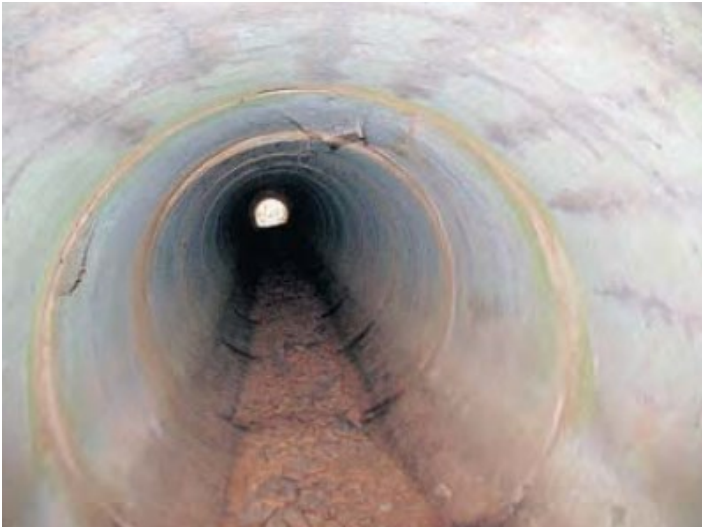
Good

No visual evidence of cracking, or only minor hairline cracking at isolated locations, or minor scaling of invert.¹

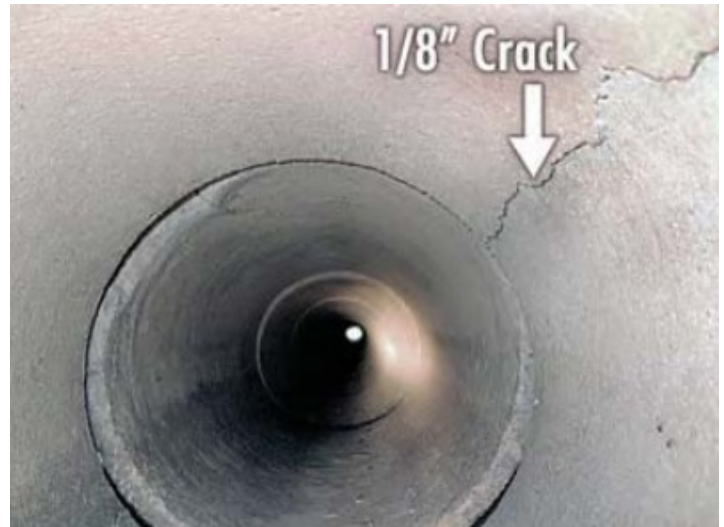
Fair

Longitudinal cracks less than 1/8" in width, spalls up to 1/4" deep.¹

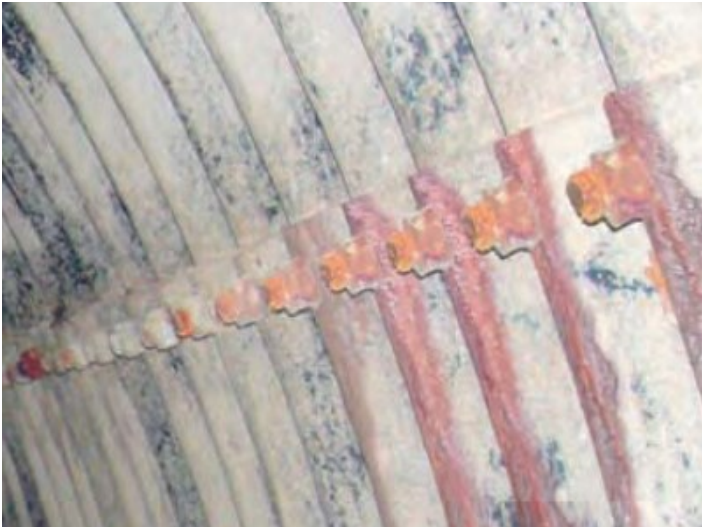
Good

No visual evidence of cracking along bolt holes or seams.¹

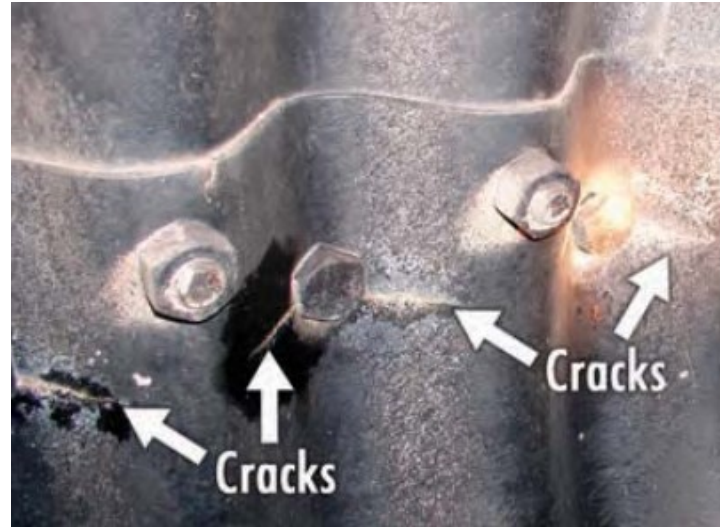
Fair

Minor cracking around bolt holes or seams at isolated sections.¹

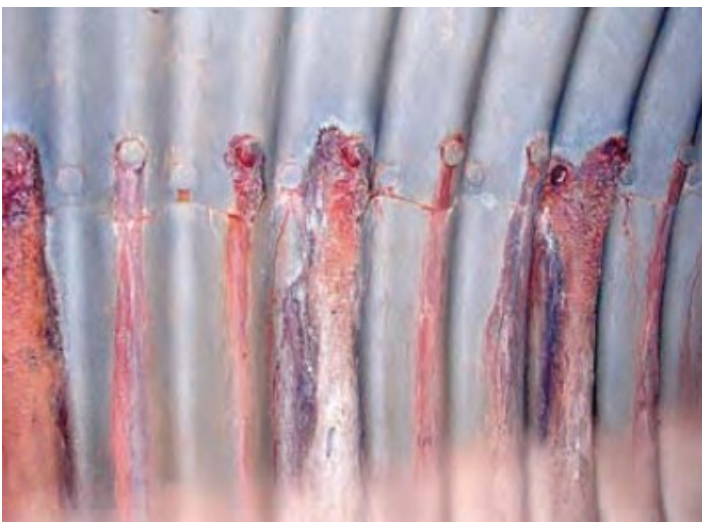
Poor

Significant cracking and/or deterioration along bolt holes and isolated seams of plates.¹

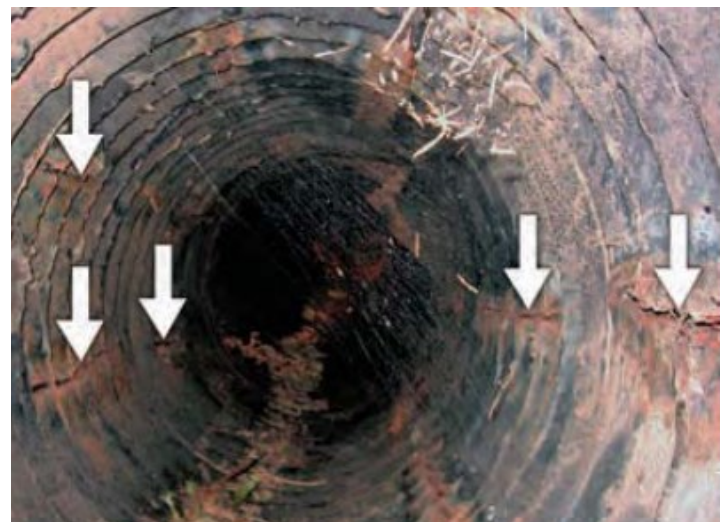
Critical

Severe cracking and or deterioration along bolt holes and along seams of plates.¹

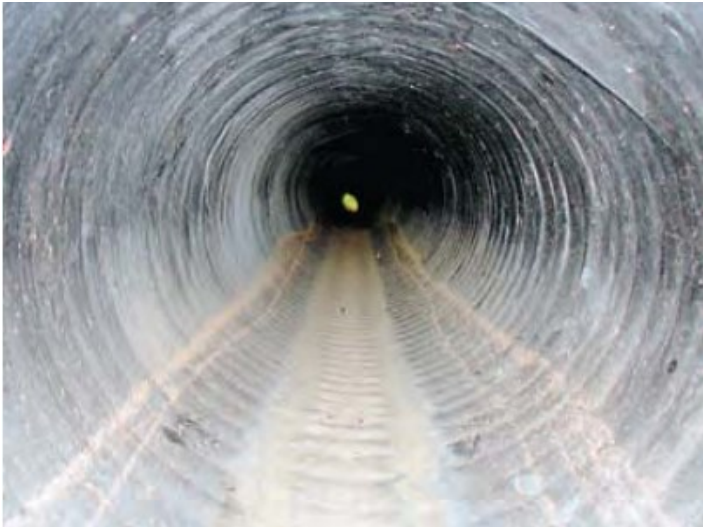
Good

No visual evidence of damage, cracking, or rips in the culvert material.¹

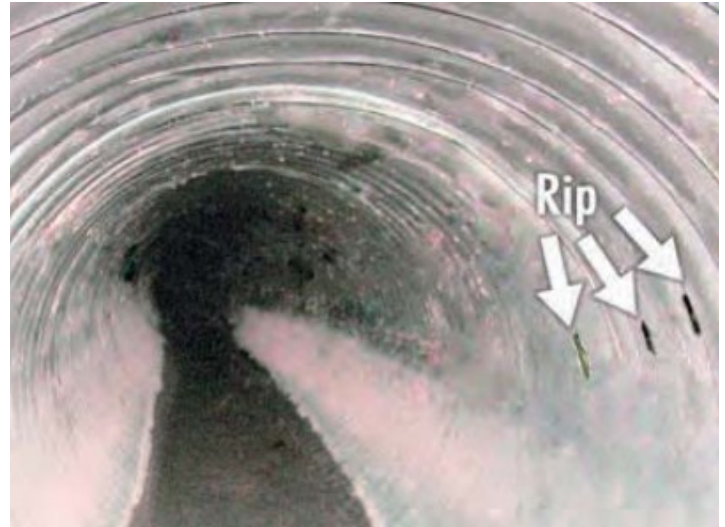
Fair

Minor isolated rip or tear caused by debris less than 6" in length and 1/2" in width. Minor cuts or gouges to end sections from maintenance or construction activities.¹

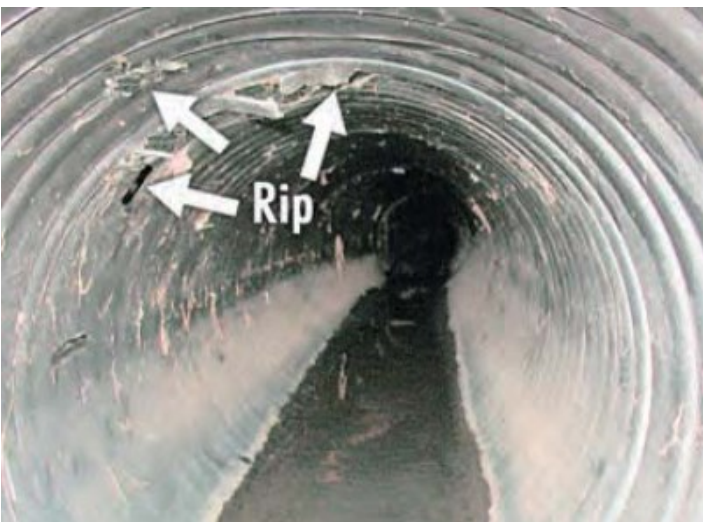
Poor

Cracking, splits or tears over 6" in length and up to 3/4" in width. Openings in pipe causing loss of backfill material.¹

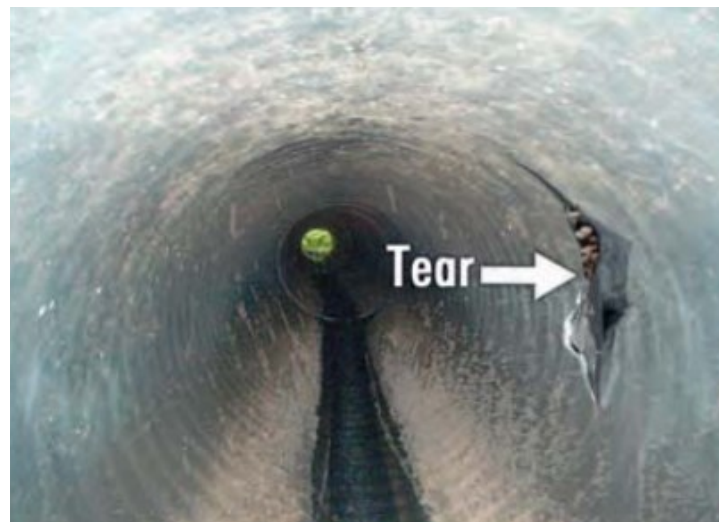
Critical

Cracking, splits, punctures, or tears over 6" in length and over 1" in width. Openings in pipe causing loss of backfill material.¹

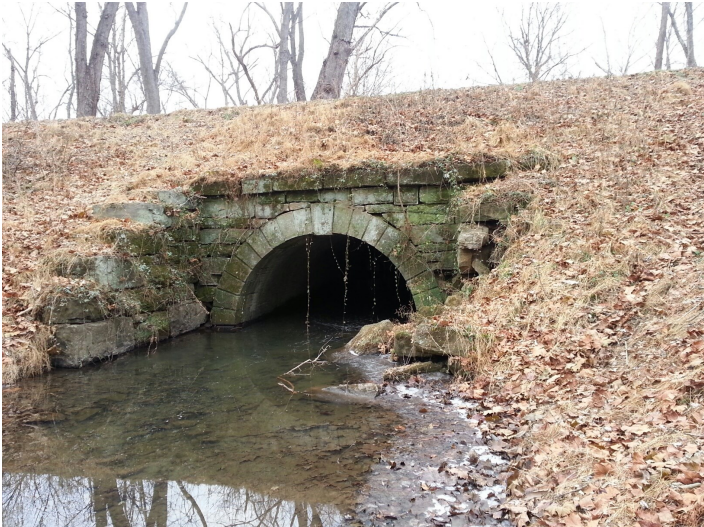
Good

Little or no deterioration. Masonry may have minor weathering (mortar joints are sound). Joints have no leakage.³

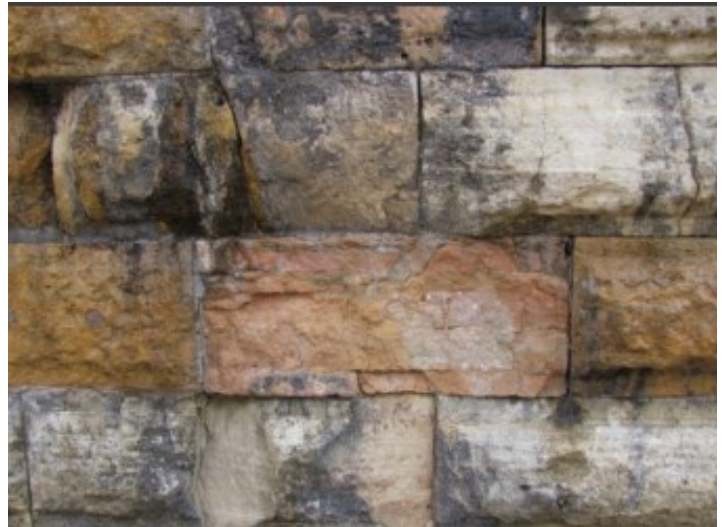
Fair

Minor to moderate deterioration. Masonry may have moderate weathering or cracking (mortar joints may have minor deterioration). Joints may have minor separation, misalignment, or leakage.³

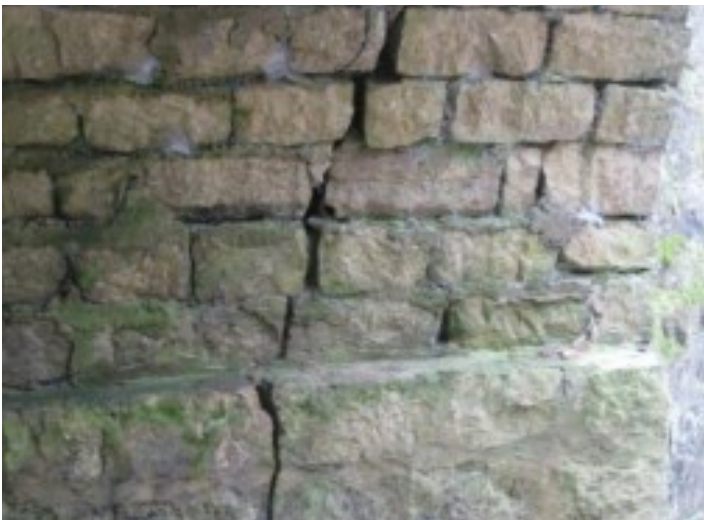
Poor

Extensive deterioration, but the function or structural capacity of the culvert has not been significantly impaired. Masonry may have weathering or cracking. Joints may have significant separation, misalignment, or leakage (there may be evidence of backfill infiltration).³

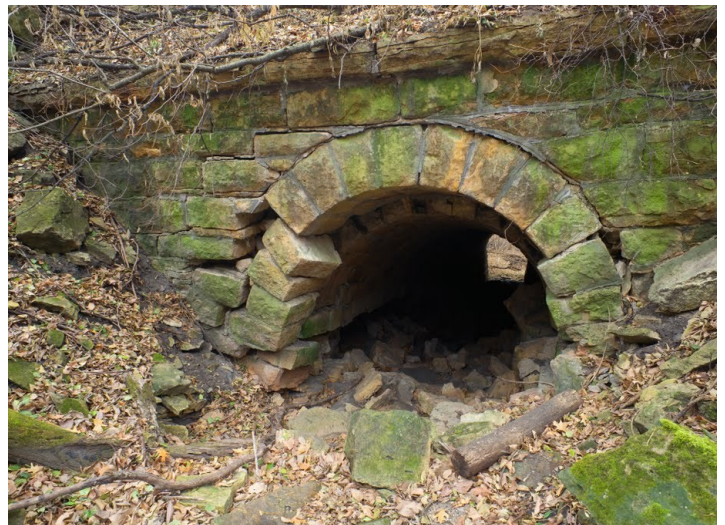
Critical

Culvert has severe or critical deterioration. Function or structural capacity of the culvert has been severely impacted—immediate repairs or structural analysis may be required. Masonry may have severe weathering or spalling. Joints may have severe misalignment or leakage.³

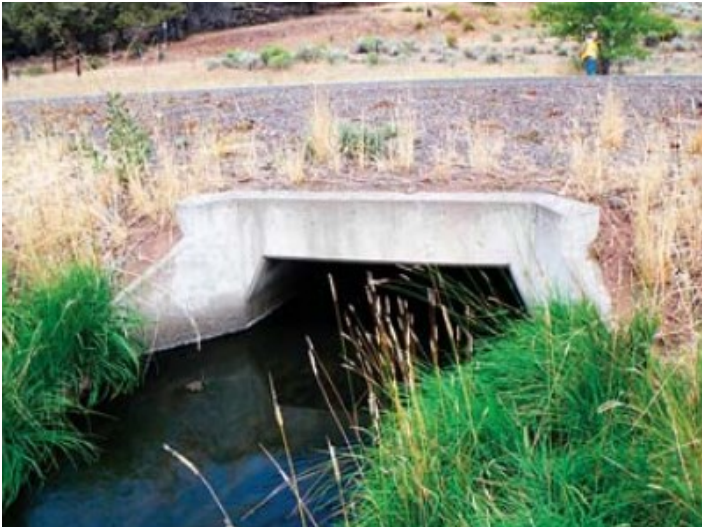
Good

Little or no cracking, rotation, or displacement. Light concrete scaling, metal corrosion, or other surface deterioration.⁴

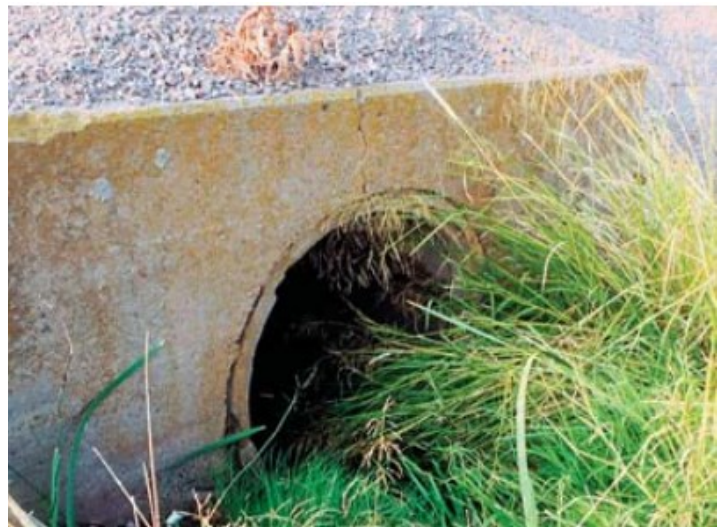
Fair

Minor cracks and spalls in concrete. Minor rotation and/or displacement with gap in barrel seam. Minor footing exposure.⁴

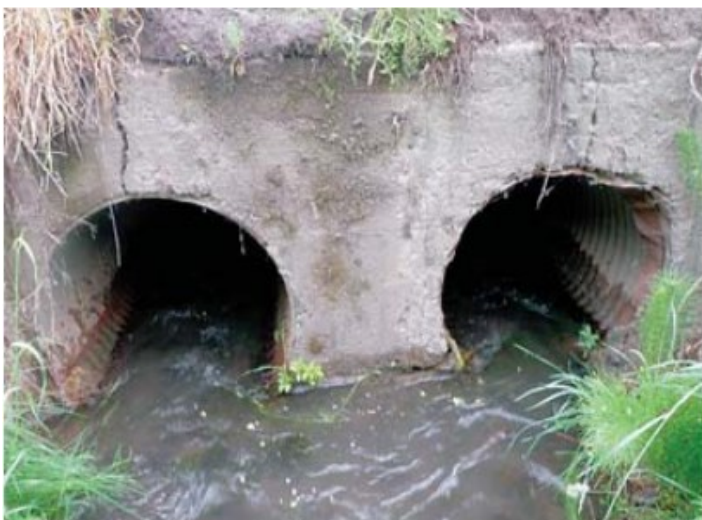
Poor

Area affected by cracking and spalling is >50% and/or rebar exposed. Significant displacement at cracks or wall rotation causing a gap at the wall-to-barrel interface >4". Footing exposed and undermined.⁴

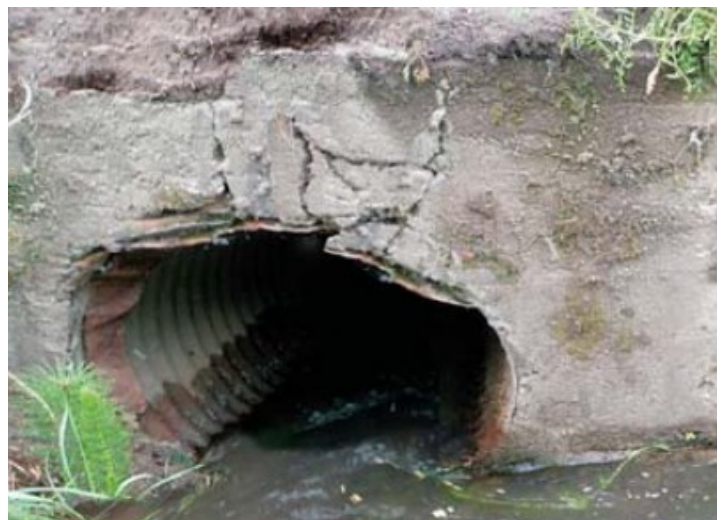
Critical

Partially or totally collapsed, with resultant damage to embankment and/or roadway damage.⁴

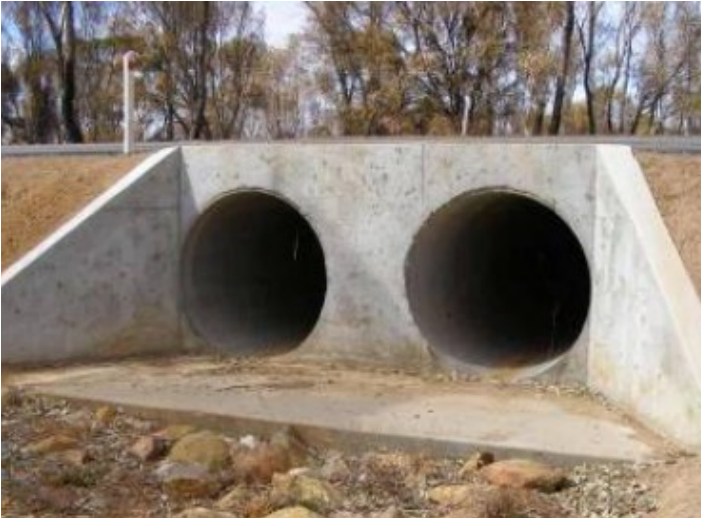
Good

No cracking, piping, or undermining.⁴

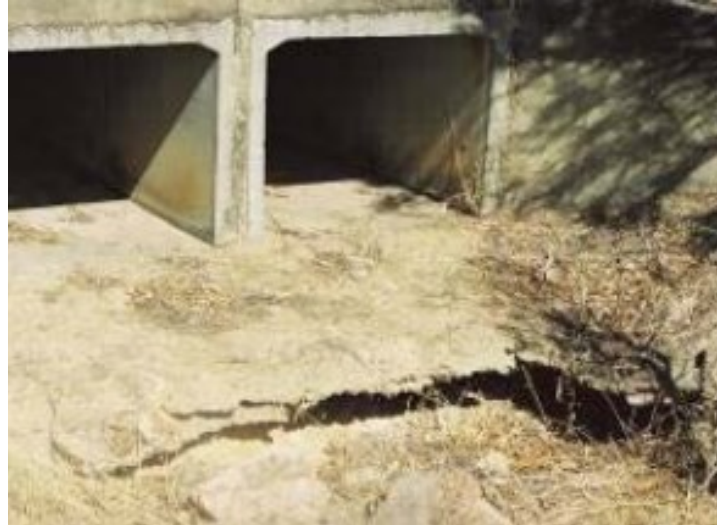
Fair

Minor cracking but no visible piping or undermining.⁴

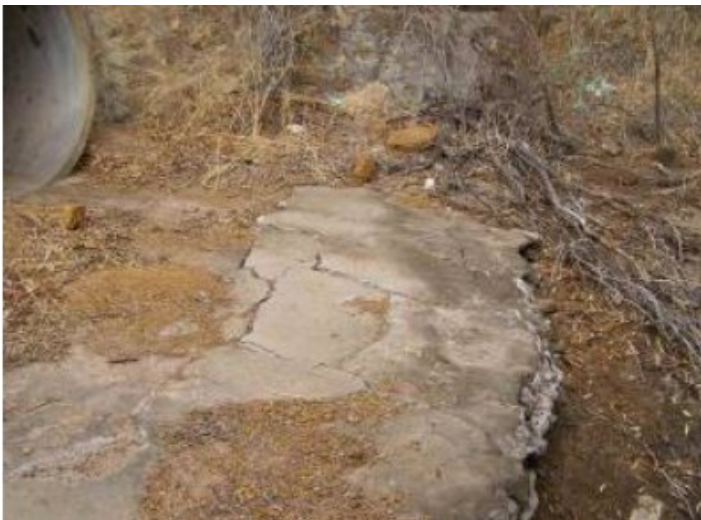
Poor

Significant cracking affects >50% of apron.
Significant piping or undermining.⁴

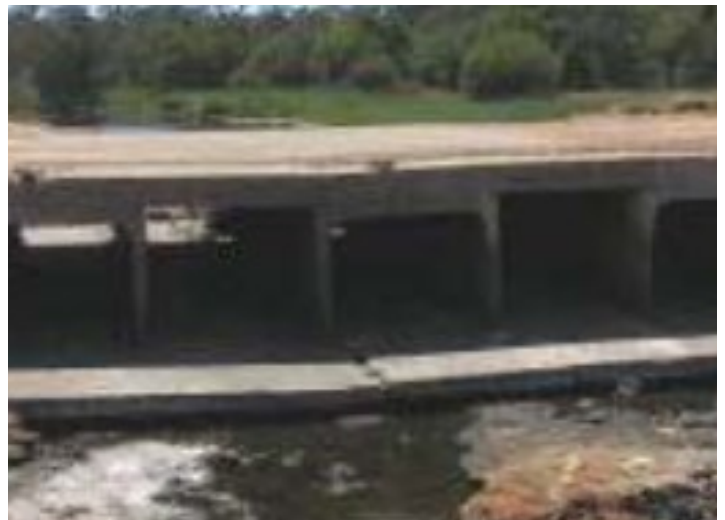
Critical

Partially or totally collapsed, significantly effecting performance and/or causing embankment and/or roadway damage.⁴

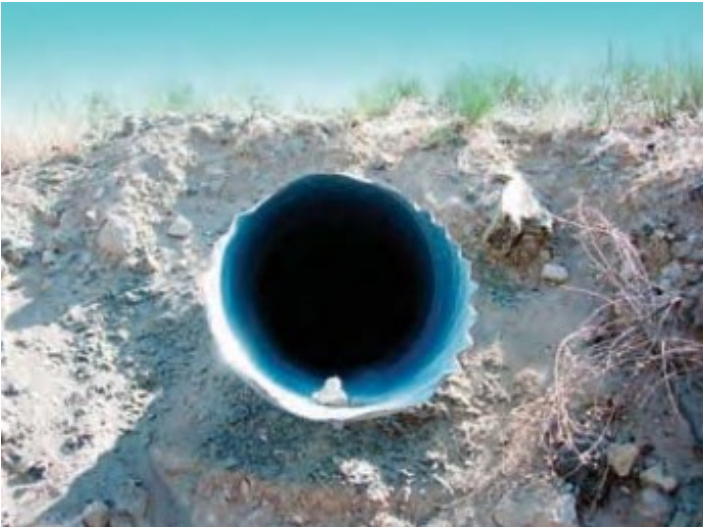
Good

No signs of flow through embankment on outside of culvert barrel.¹

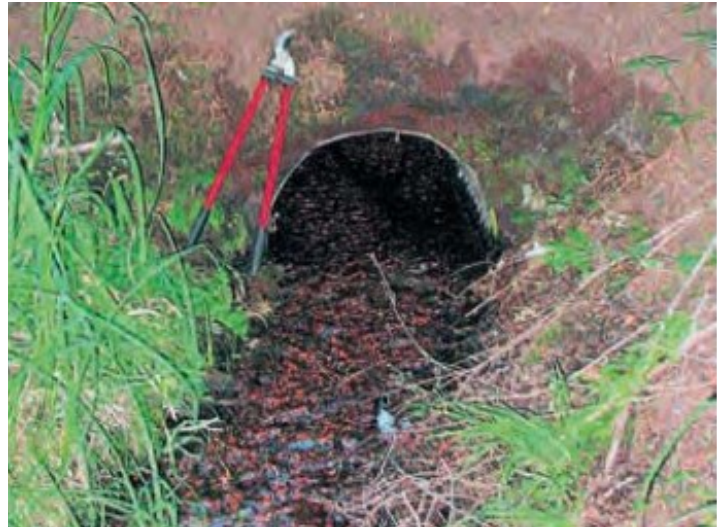
Fair

Embankment moist only in areas surrounding culvert barrel. No evidence of flow or sediment transport observed.¹

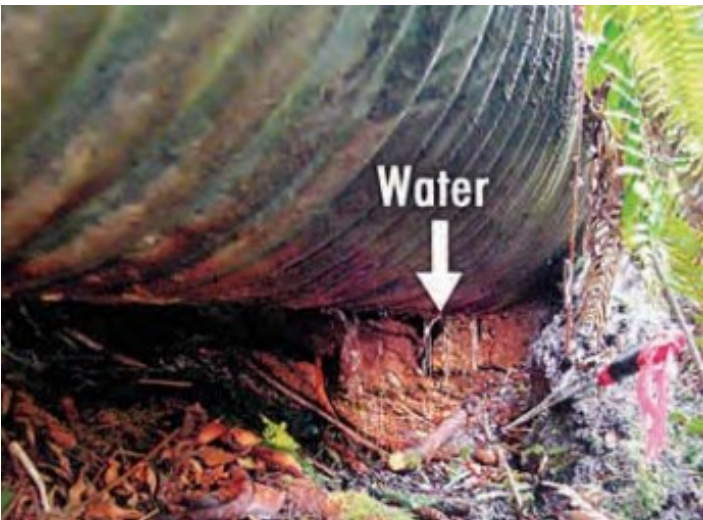
Poor

Evidence of seepage through the embankment along the outside of the culvert barrel, sediment transport not observed.¹

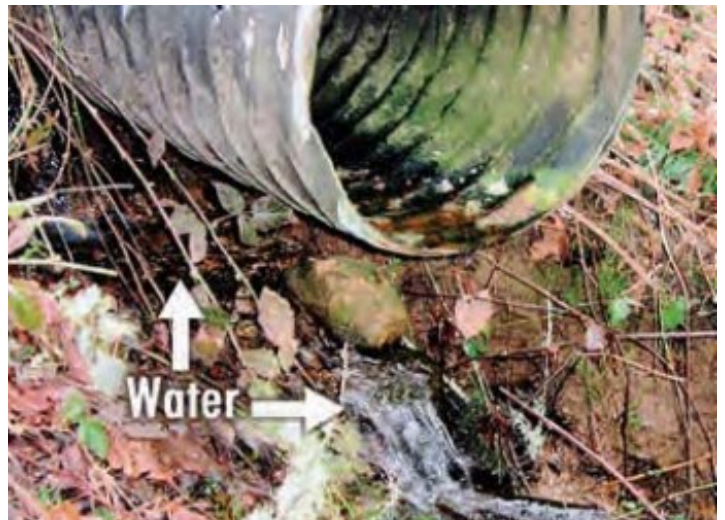
Critical

Evidence of flow through embankment along the outside of culvert barrel. Evidence of sediment transport observed.¹

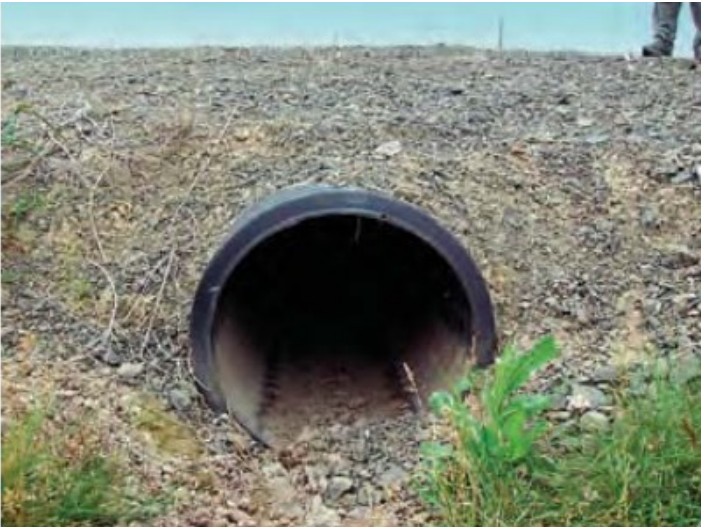
Good

No visual evidence of culvert undermining or exposed footings. Only minor scour hole is present. Culvert span to scour hole depth ratio is greater than 10.¹

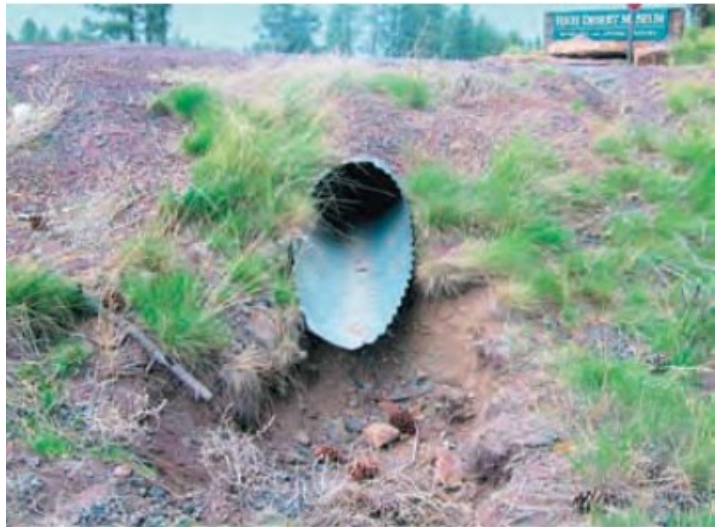
Fair

Minor undermining of the culvert barrel or top of footing is exposed. Culvert span to scour hole depth ratio is between 5 to 10.¹
