Designing a Culvert Management System for the Town of Spencer, MA

A Major Qualifying Project

Date: March 26, 2015

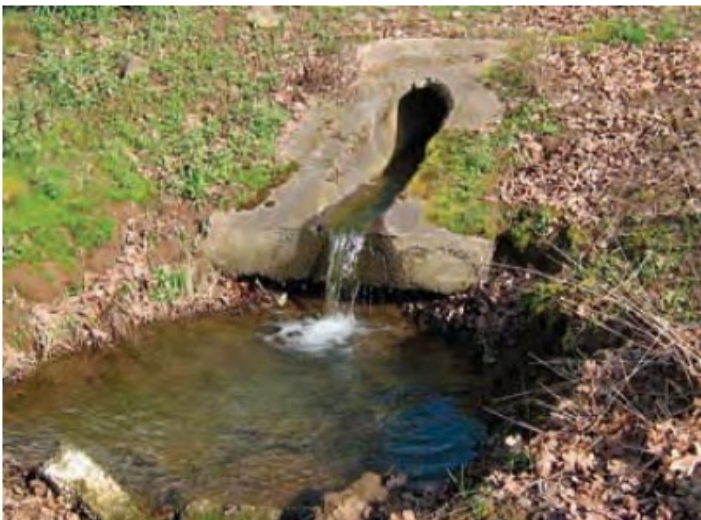
Poor

Significant undermining of the culvert barrel or undermining of the footing. Culvert span to scour hole depth ratio is between 2 to 5.¹

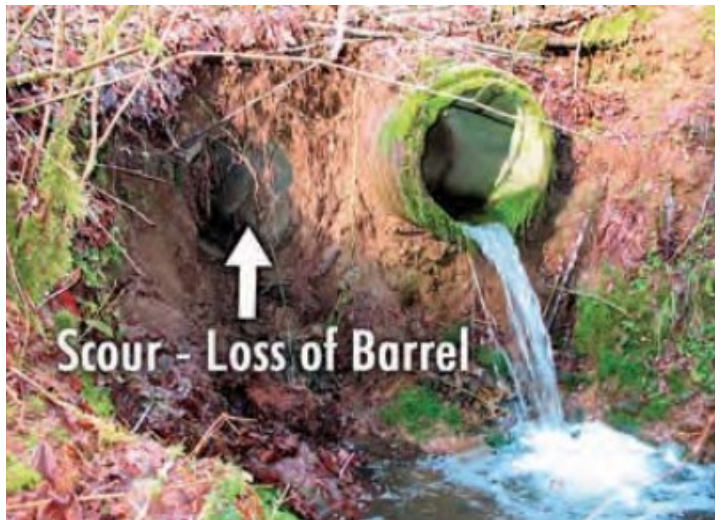
Critical

Extensive undermining of the culvert barrel or footing. Culvert span to scour hole depth ratio is less than 2.¹

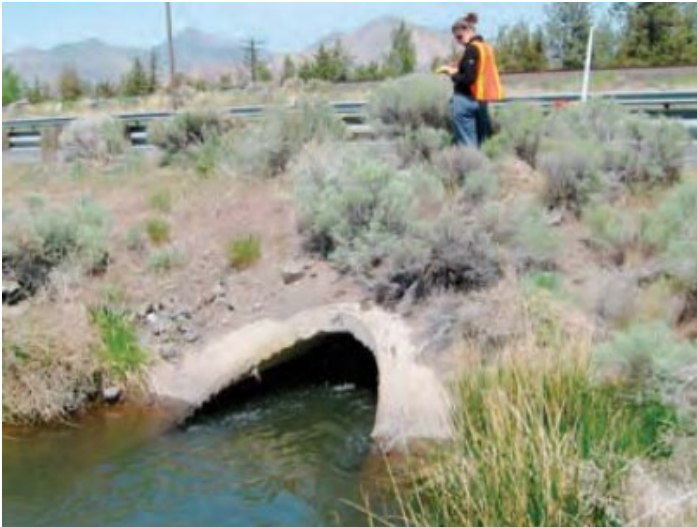
Good

Angle measured from upstream channel to centerline of culvert barrel is from 0-15 degrees.¹

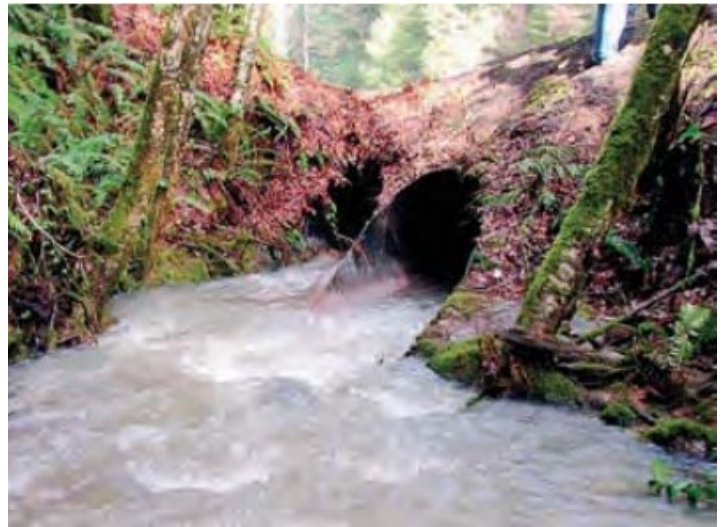
Fair

Angle measured from upstream channel to centerline of culvert barrel is from 15-45 degrees.¹

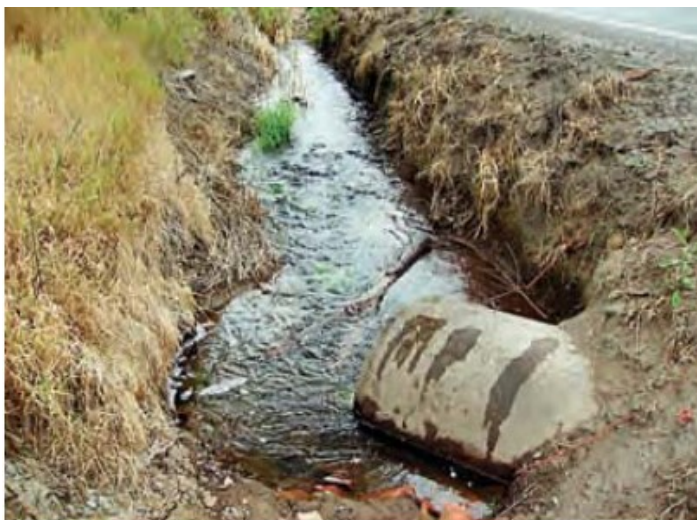
Poor

Angle measured from upstream channel to centerline of culvert barrel is from 45-75 degrees.¹

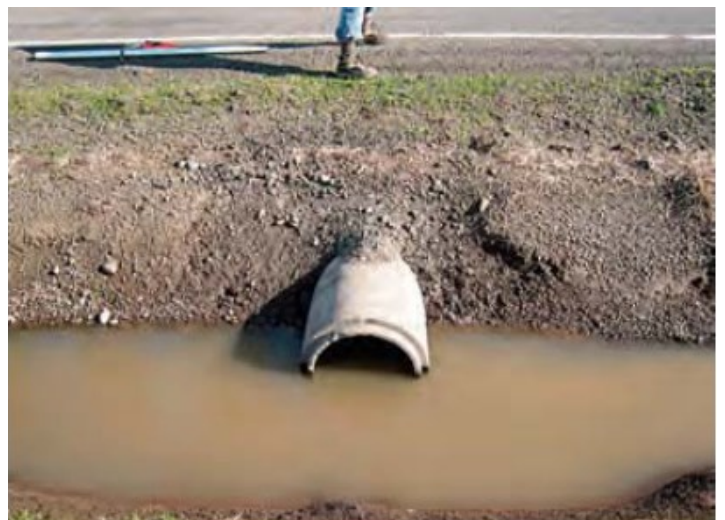
Critical

Angle measures from upstream channel to centerline of culvert barrel is larger than 75 degrees.¹

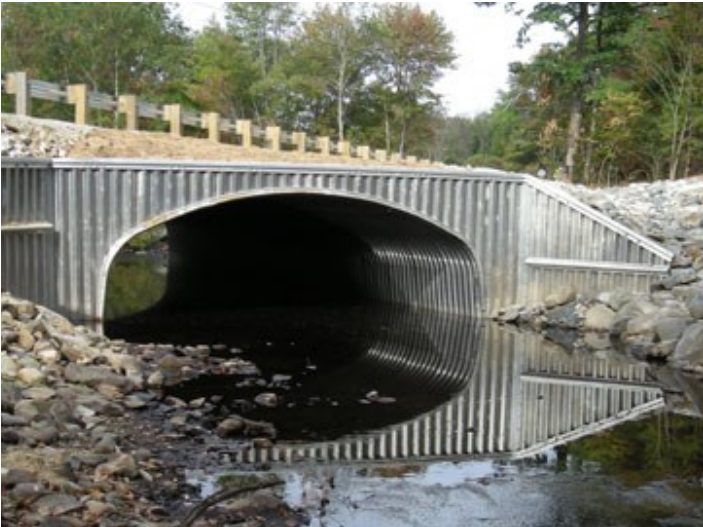
Good

Little or no deterioration. Concrete - minor cracking, leaching, or scaling. Masonry - minor weathering (joints are sound). No footing exposed.³

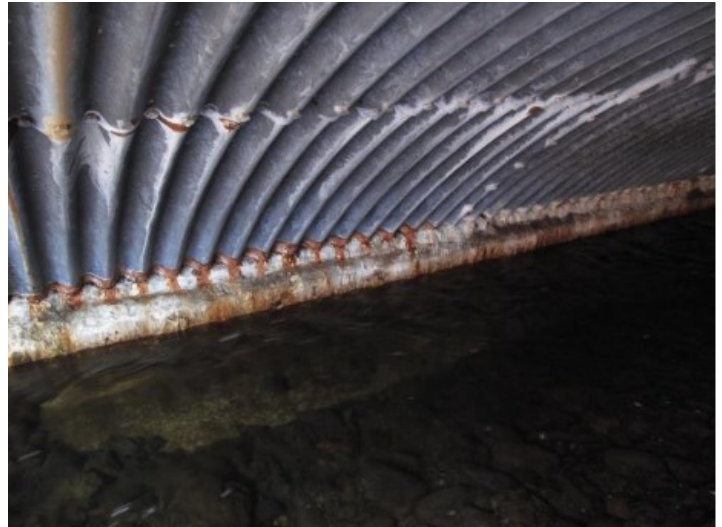
Fair

Minor to moderate deterioration. Concrete - moderate cracking, scaling or leaching (minor delamination or spalling). Masonry - moderate weathering (minor joint deterioration). Slight settlement or undermining. Minor footing exposure.³

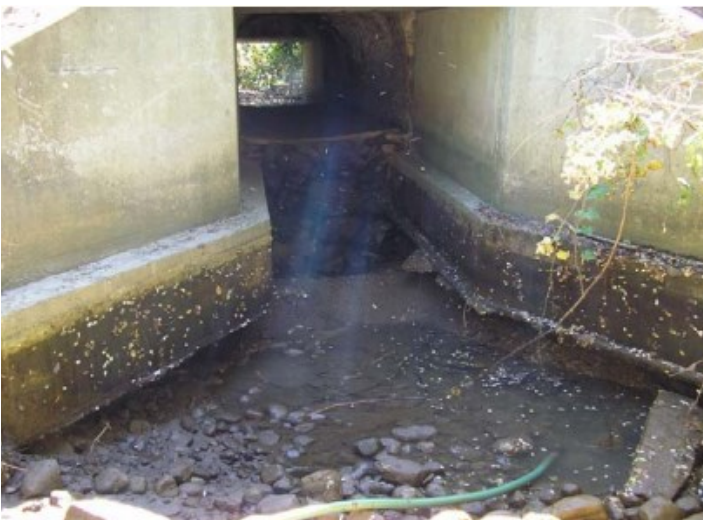
Poor

Extensive deterioration. Concrete - extensive cracking, scaling or leaching (delamination or spalling may be prevalent). Masonry - extensive weathering (significant joint deterioration). Significant settlement or undermining. Footing exposed and undermined.³

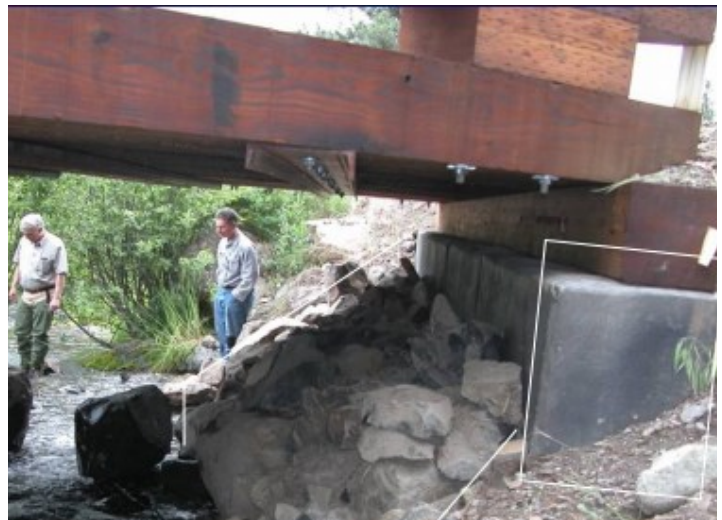
Critical

Severe or critical deterioration. Function or structural capacity of the culvert has been severely impacted - immediate repairs or structural analysis may be required. Concrete - severe cracking, scaling, delamination, or spalling. Masonry - severe weathering (failed joints or displaced masonry blocks) Severe settlement or undermining.³

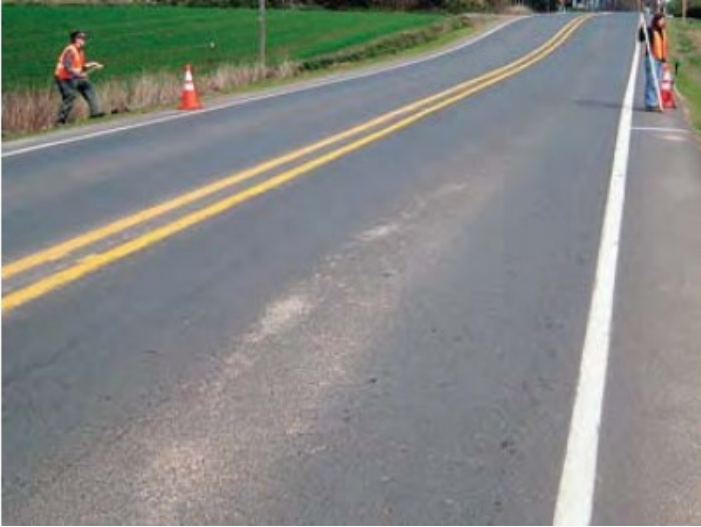
Good

Pavement has no visible defects, small cracks, or maintenance patches.¹

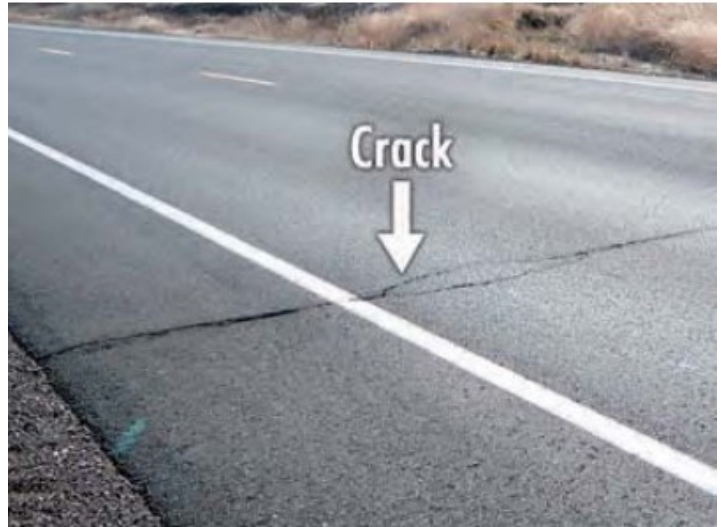
Fair

Minor isolated cracking and spalled areas.¹

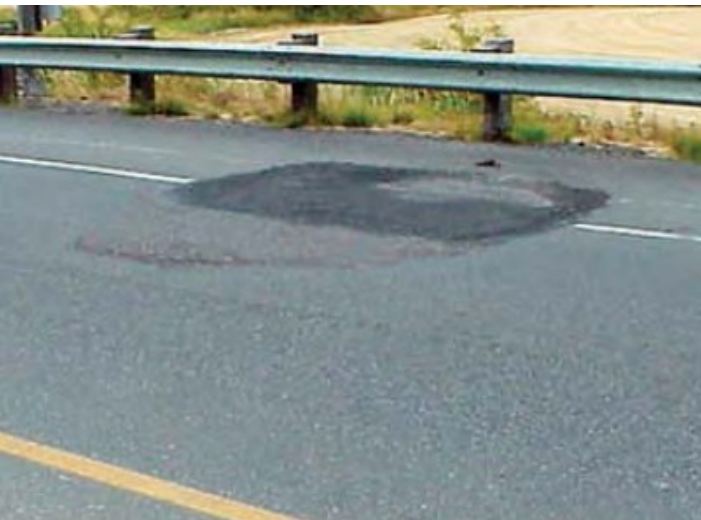
Poor

Significant cracking, spalling, potholes, or maintenance patches affecting up to 20% of any single travel lane or shoulder.¹

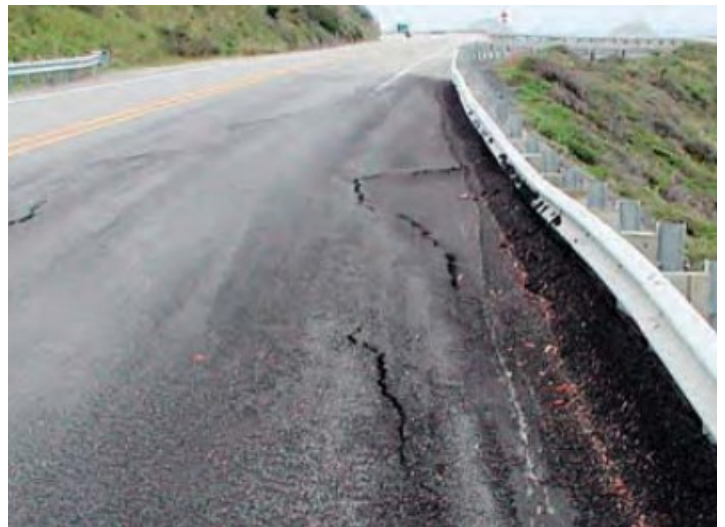
Critical

Extensive cracking, spalling, potholes, or maintenance patches affecting 20% or more of any single travel lane or shoulder.¹

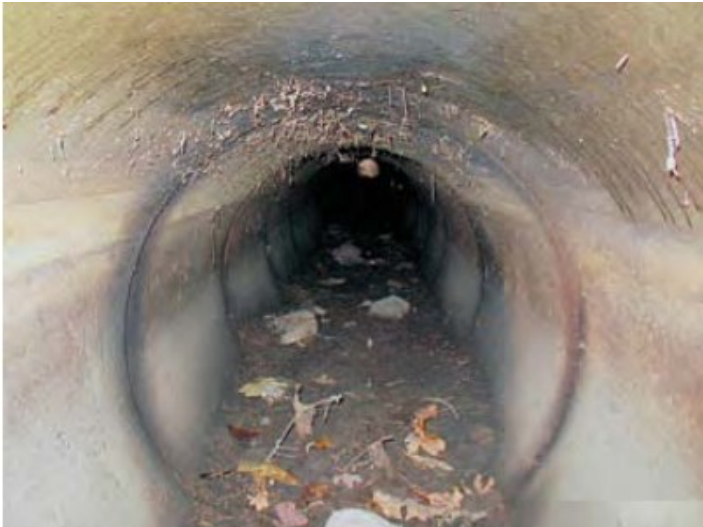
Good

Blockage occupies less than 10% of opening.¹

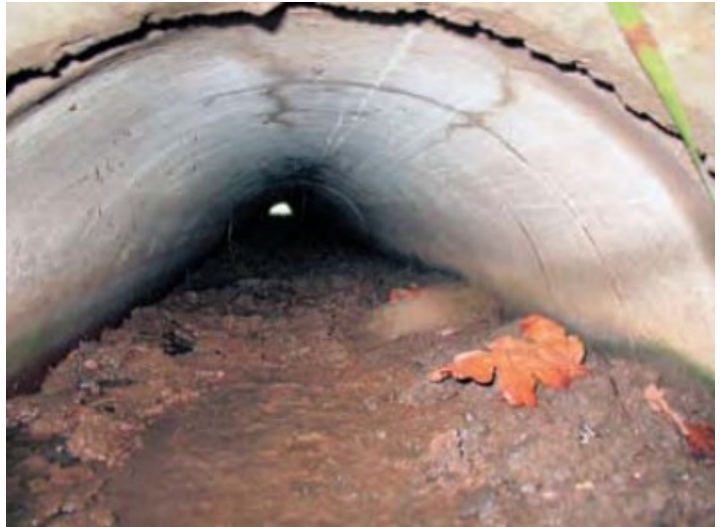
Fair

Blockage occupies 10-30% of opening.¹

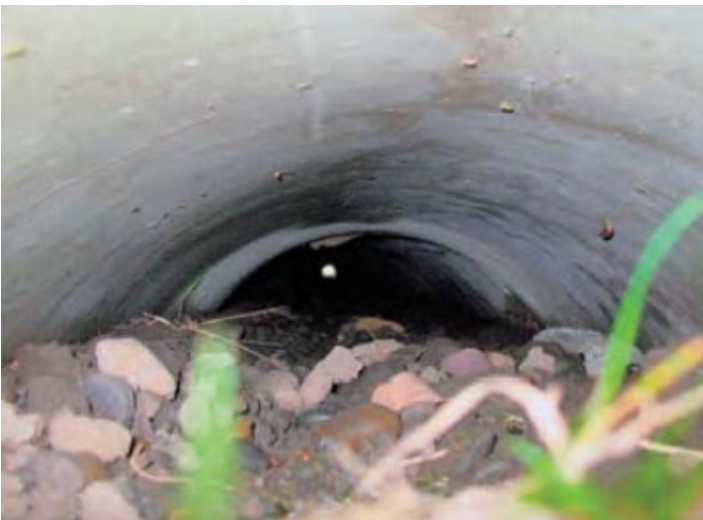
Poor

Blockage occupies 30-75% of opening.¹

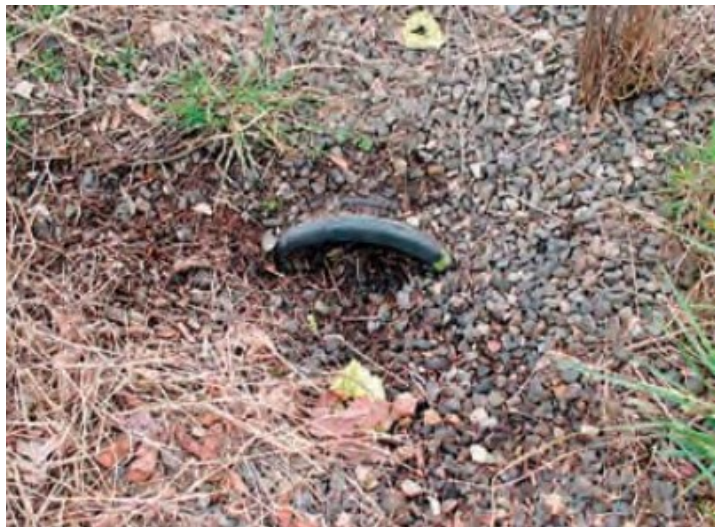
Critical

Blockage occupies >75% of opening.¹

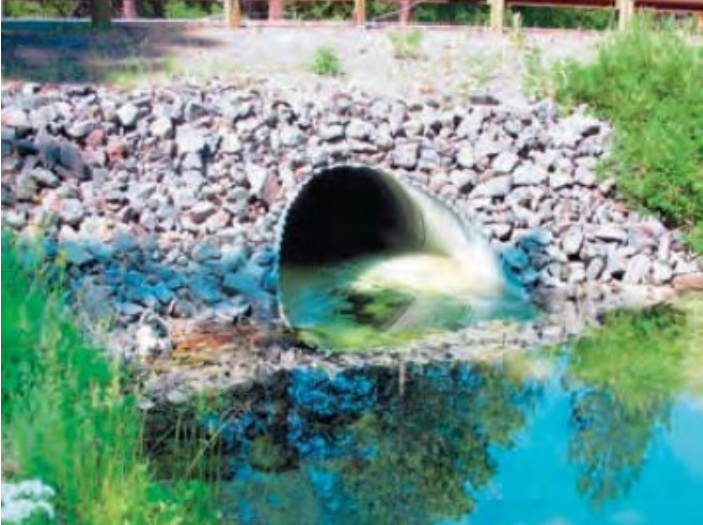
Good

No noteworthy deficiencies which affect the condition of the embankment protection.¹

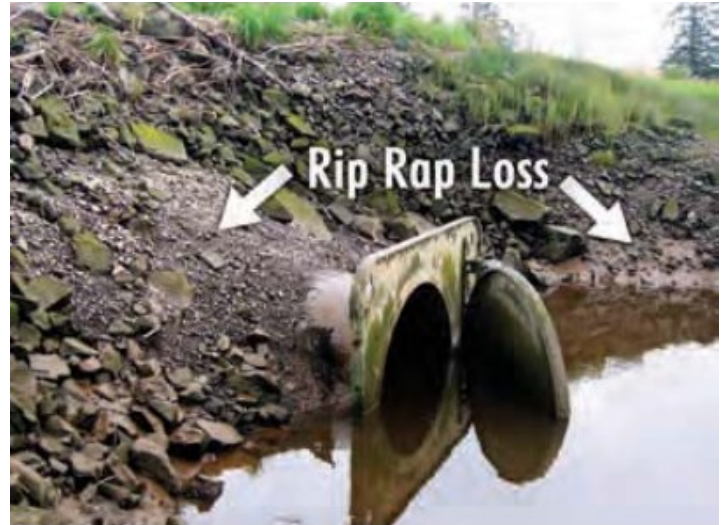
Fair

Riprap starting to wash away, minor erosion, and embankment protection is in need of minor repairs.¹

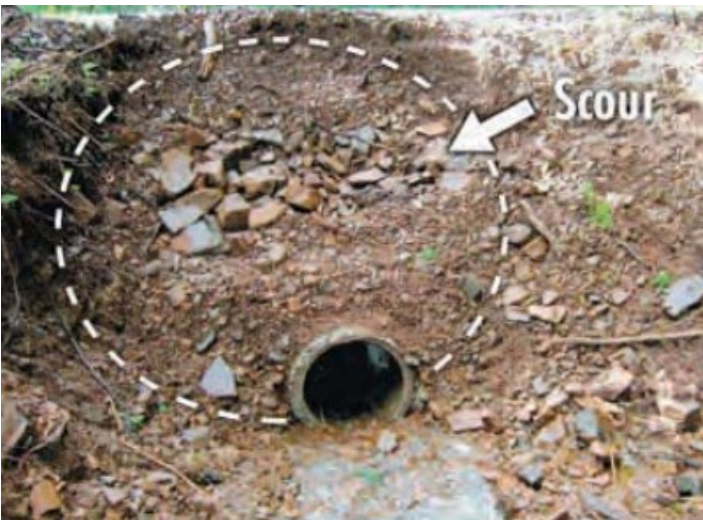
Poor

Embankment protection is severely undermined causing significant erosion of embankment and should be reviewed for repairs.¹

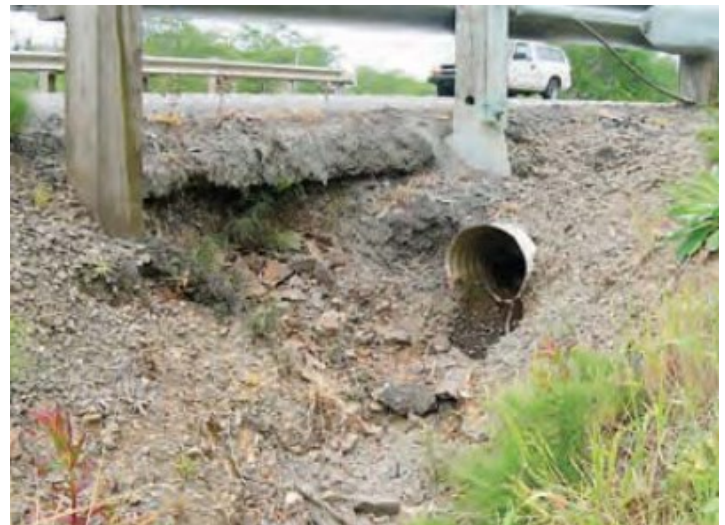
Critical

Embankment protection has failed causing severe scour of embankment and threatening the stability of the roadway embankment.¹
