Brutalist Building Retrofit

A Major Qualifying Project
Submitted to the Faculty
of the
WORCESTER POLYTECHNIC INSTITUTE
in partial fulfillment of the requirements for the
Degrees of Bachelor of Science in Architectural Engineering

March 23, 2018

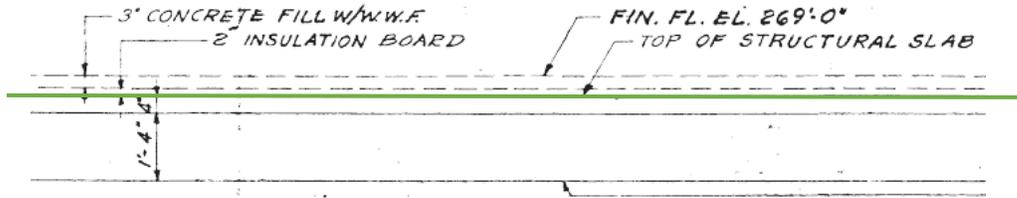
Figure 33: Cross-Section C1-1 showing the exterior (below the green line) and interior (above the green line) layers of the Art Studio floor.

We observed 18 horizontal cracks running North to South along the underside of the art studio bridge and along the interior of the art studio (Table 1 **Error! Reference source not found.**). The horizontal cracks observed on the interior and exterior are not the same crack due to the following reasons. First, we observed 5-10 interior cracks per art studio room as well as multiple long interior cracks running along the hallway as shown in Table 1.2. We observed and recorded 22 exterior cracks as shown in Appendix D. The exterior cracks were much more spread out along the 646 ft Art Studio Bridge and did not extend as long. Overall, we observed more interior cracks than exterior cracks. Second, according to the drawings, there is a layer of insulation between the exterior concrete ribs and the

interior concrete floor slab, meaning that the interior concrete and exterior concrete are two separate pours (Figure 33 **Error! Reference source not found.**).

The Cross-Section show that there are two different concrete members separated by the green line that represents the top of the exterior concrete slab. The horizontal cracks on the exterior and interior do not match up. This is an important observation because it illustrates that the exterior rib cracks do not extend through the entire width of the concrete and does not indicate a localized structural failure.

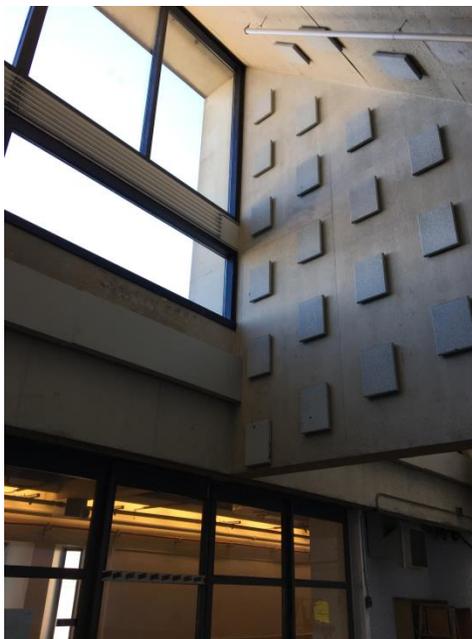
Many of the mechanical systems are exposed, and the floor is polished concrete. The North wall of the building is painted concrete with small windows, and it borders the hallway. The wall that separates the hallway and the studios is also painted concrete, and the walls separating the studios are drywall. The South wall is concrete covered in panels used as pin boards. Looking up, the ceiling above the hallway is flat exposed concrete. In the studios, the ceiling slopes up to large North-facing windows and small South-facing windows. We observed that the ceiling and glazing in the studios are supported by beams perpendicular to the exterior walls, but do not appear to have any supports other than those. The ceiling is exposed concrete and has acoustic panels attached to it (See Figure 36 **Error! Reference source not found.**). The ceiling and floor show cracking and staining.

Figure 36: North-facing window and acoustic panels inside one of the studios.

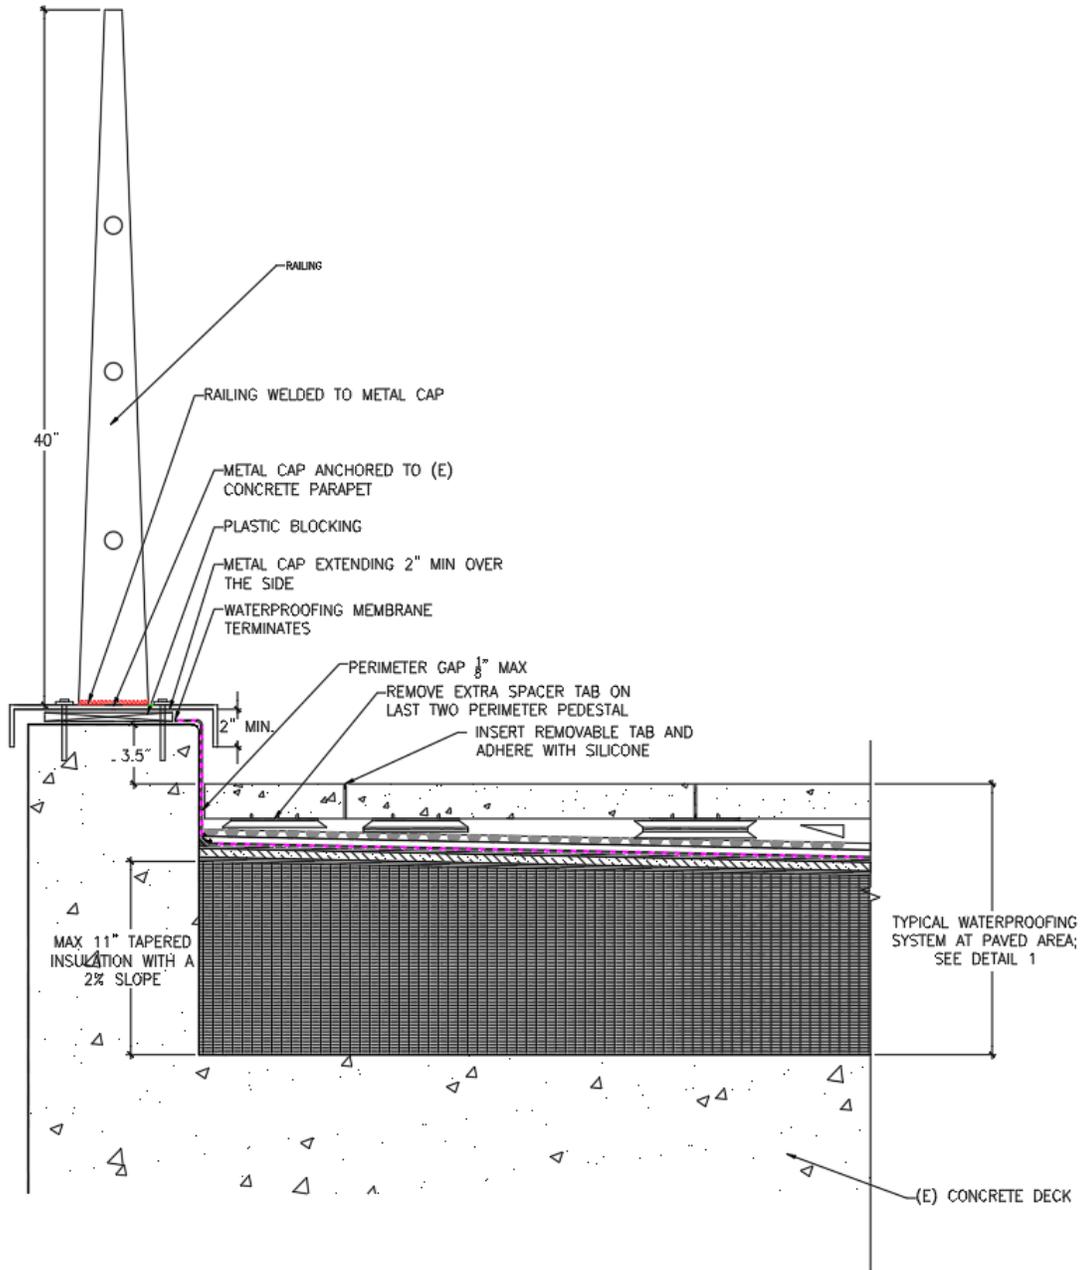
Figure 51: Detail showing how the waterproofing system terminates at the edge parapet.

One challenge in waterproofing a roof is figuring out how to end the membrane. Building B already has an existing 1'7" concrete parapet. For safety reasons an aluminum metal railing will be added on top of the existing parapet to reach the required height of 42 inches. The waterproofing

membrane will go up the existing parapet and end under the added metal cap and railing as show in Figure 51.

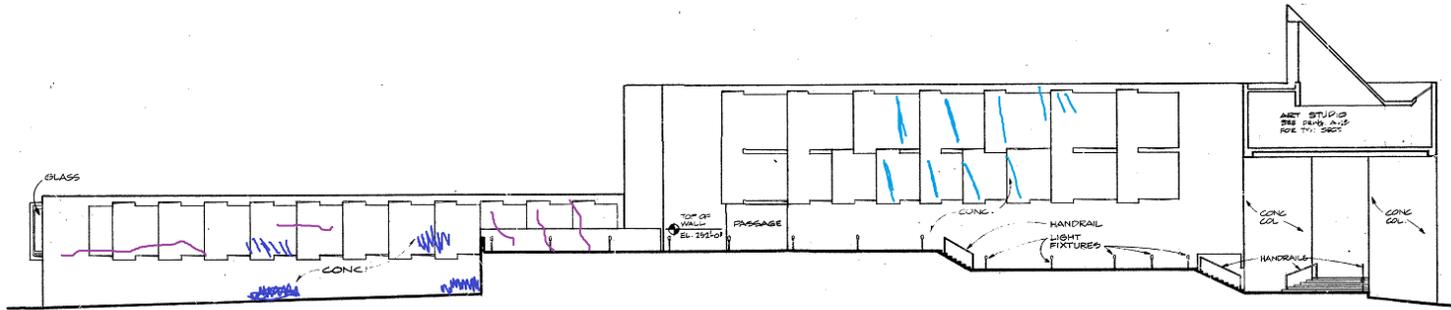
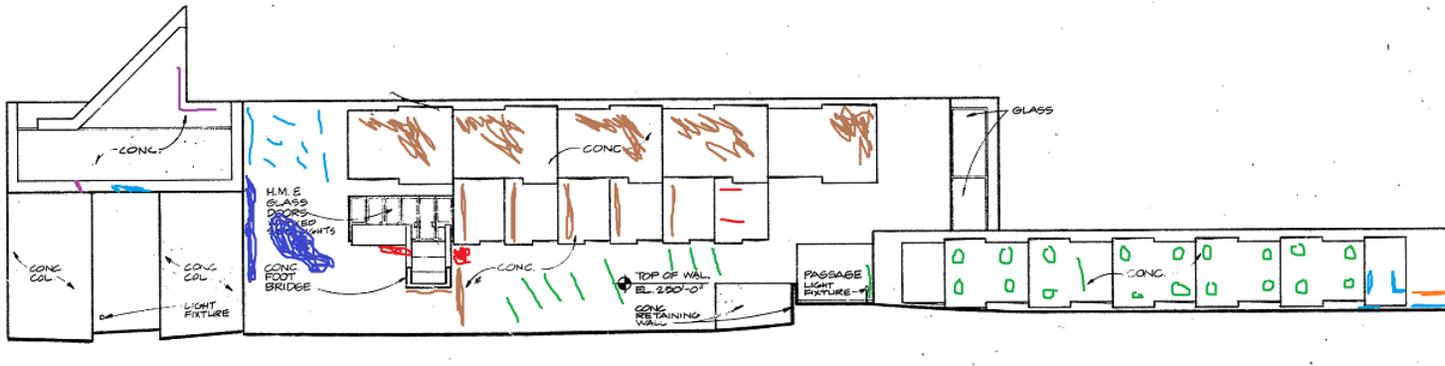
BE-12 WEST ELEVATION
MUSIC & ART

Observations of the West and East elevations of the Art Studio.

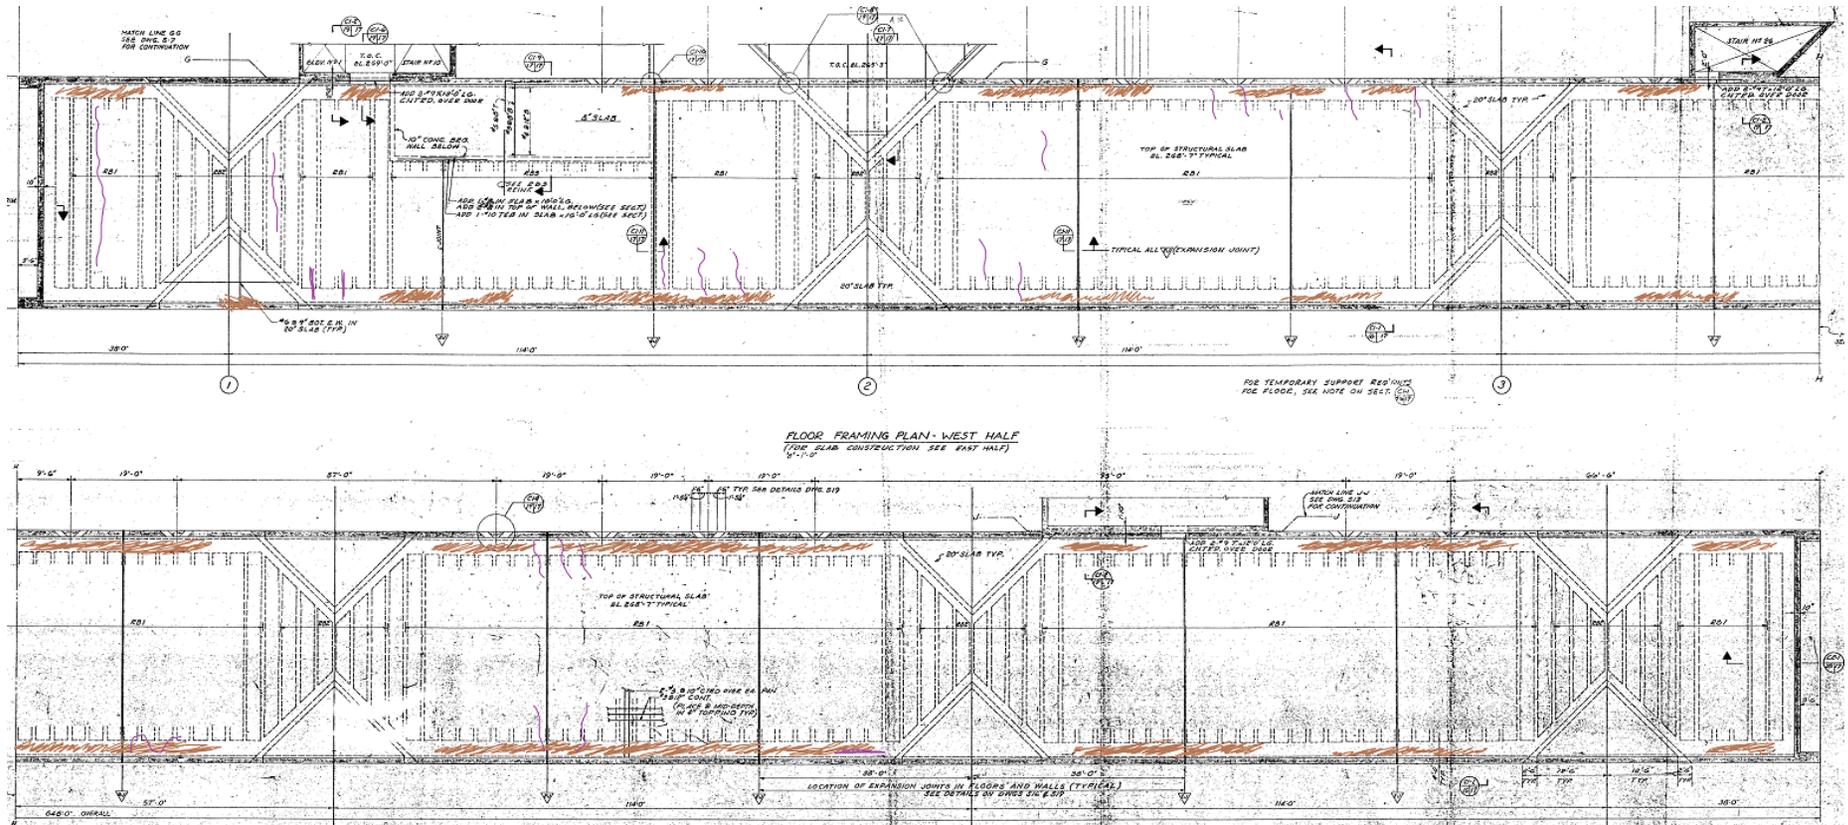
Observations of the West and East halves of underneath the Art Studio.
