Investigation of Fire Impact on Structural Steel through Case Studies

A Thesis Report

WORCESTER POLYTECHNIC INSTITUTE

Date: May 4, 2006

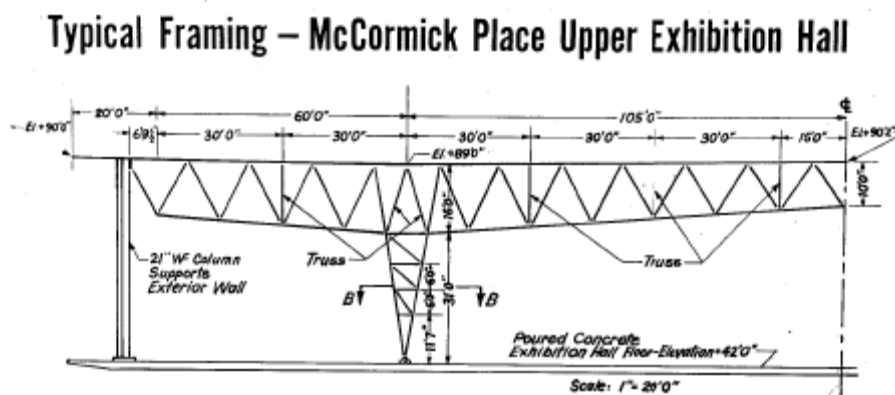
Figure 6 - McCormick Place Roof Truss (Jensen, 1967).

McCormick Place was a large exhibition hall that stood on the shore of Lake Michigan in Chicago, Ill. It was constructed in 1960 of reinforced concrete and structural steel and consisted of 3 levels of exhibition space, a large theater, restaurants, and a variety of other rooms and supporting spaces. Large steel trusses supported the roof of the structure; they spanned 210 feet column to column and cantilevered 80 feet on either side, as can be seen below in Figure 6.

At the time of the fire, McCormick Place was hosting the National Housewares Manufacturers Association Show, which occupied two levels of the hall. The booths for this show were constructed of plywood, fabrics, and other combustible materials that produced a large fire load. The fire began at around 2 a.m. on January 16, 1967 as an electrical fire. It quickly consumed the entire 3rd floor and spread down to the 2nd floor by way of melted expansion joints. The exhibition portion of the hall was not protected with automatic sprinklers and the exposed structural steel was not protected from fire exposure. Lack of fire protection caused excessive heating of the truss members, which then led to the collapse of the roof (Jensen, 1967).

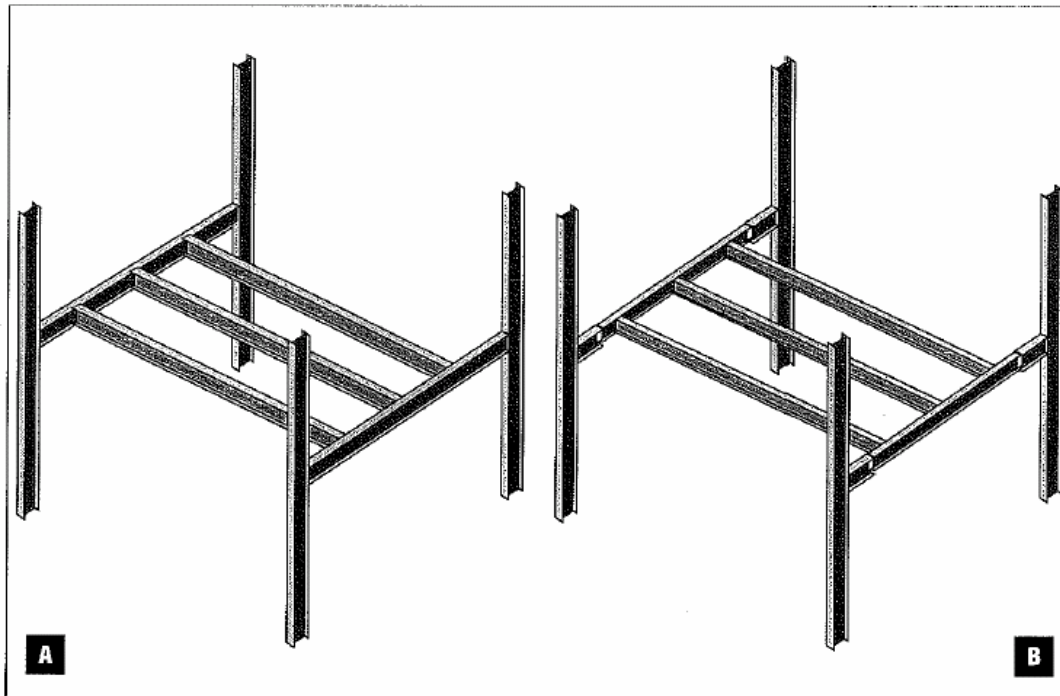
Figure 8 - Interior Bay Framing of WTC 5 (Barnett, 2002)

World Trade Center 5 was a nine-story office building that was completed around 1970. Fire in this building broke out due to debris that impacted the building from the collapse of the World Trade Center towers on September 11, 2001. The subsequent fires caused shear connectors of the column tree assemblies to fail initiating collapse from the eighth floor through the fifth floor. The roof and ninth floor (which contained no column trees) as well as the fourth floor and floors below experienced no collapse. The column tree assemblies and conventional framing systems can be seen in Figures 7 and 8 below.

Figure 4-3 Typical interior bay framing in WTC 5. (A) Floor 9 and roof level. (B) Floors 4, 5, 6, 7, and 8.

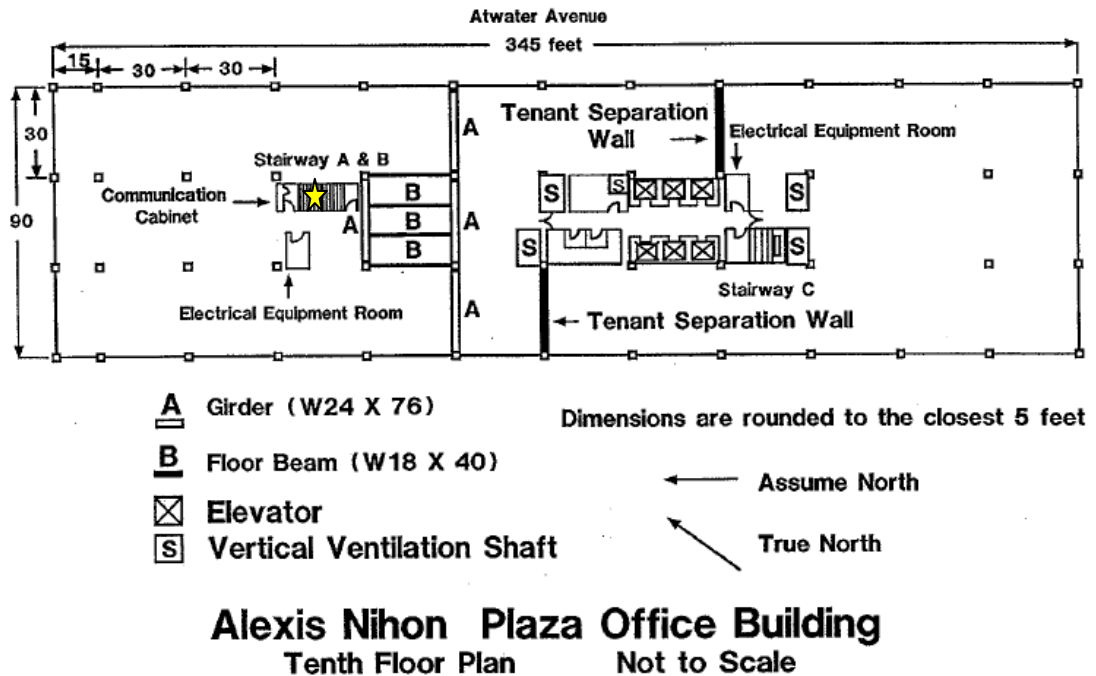
Figure 9 - Alexis Nihon Tenth Floor Layout

The ten-story office building (referred to as the 15-story office building in the official report) that was part of the Alexis Nihon Plaza was built atop a five-story shopping/parking facility sometime after 1950. On the evening of October 26, 1986 at around 5 p.m., a fire broke out on the 10th floor and spread through stairwell B (see Figure 9) up to the 16th floor (there was no 13th floor). Although the source of the fire was undetermined, it was believed to have started in a communications cabinet next to stairwell B.

The ten-story office building was constructed of a structural steel frame of 11 – 30 ft. by 30 ft. bays and 3 – 15 ft. by 30 ft. bays, as can be seen in Section 3.3, Figure 9. The girders (W24x76's), beams (W18x40's), columns and metal decking were all fire-protected with sprayed-on mineral fiber providing a 2 – 1/2 to 3 hour fire rating for the members. “The girder – to – column, beam – to – column, and beam – to – girder connections were made using double clip angles,” which were “welded to the beams and bolted to the columns or girders,” (Isner, 1986).

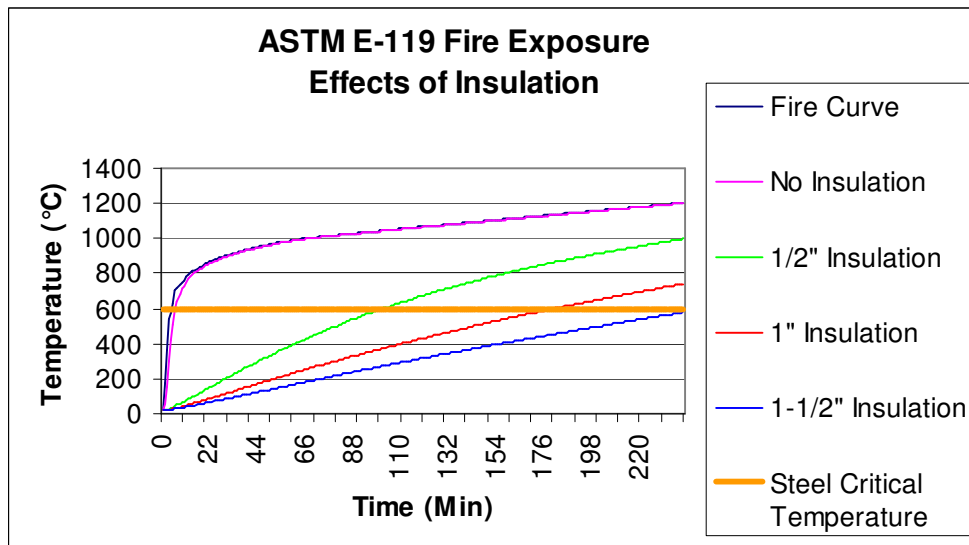
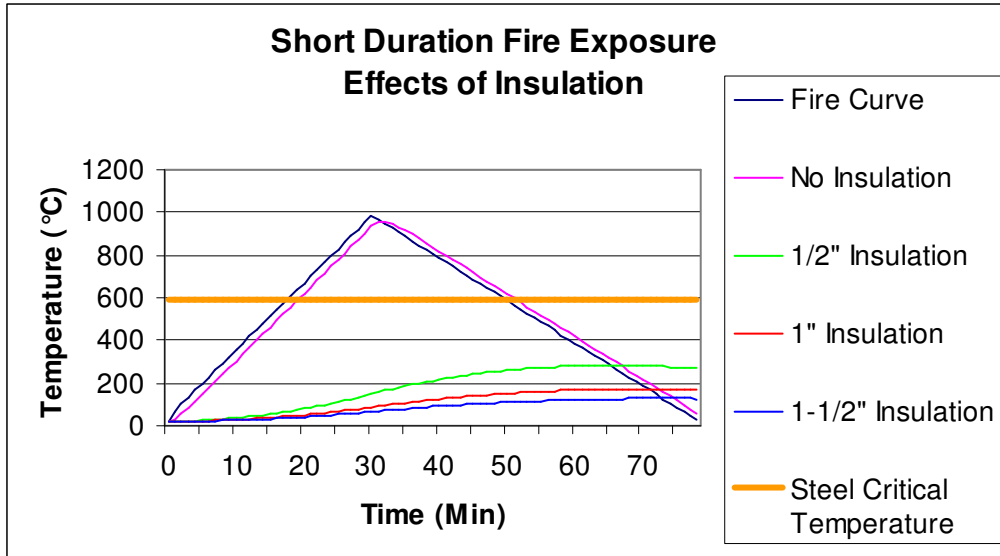
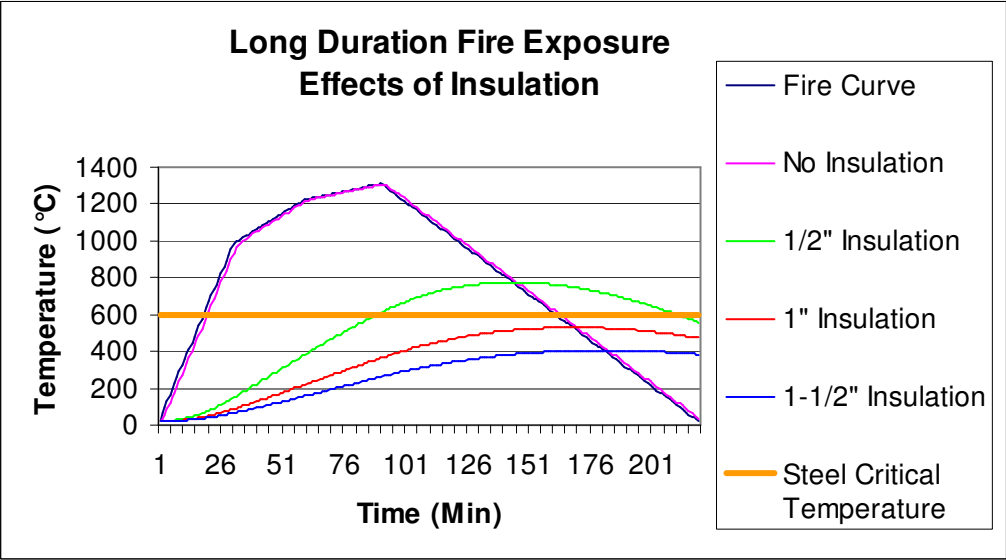
Figure 14 –Effect of Variable Insulation Thickness on Steel Temperatures

Figure 17 - Effect of Variable Insulation Thickness on Steel Temperatures

Figure 20 - Effect of Variable Insulation Thickness on Steel Temperatures

As seen in the graphs, Figures 14, 17, and 20, above the use of any thickness of spray-on insulation would have reduced the temperatures of the steel truss significantly during all three design fires. In each case the greatest reduction of heat occurs early in the fire which is important because it may have given the fire department sufficient time to get the fire under control before excessive heating and structural instability occurred.

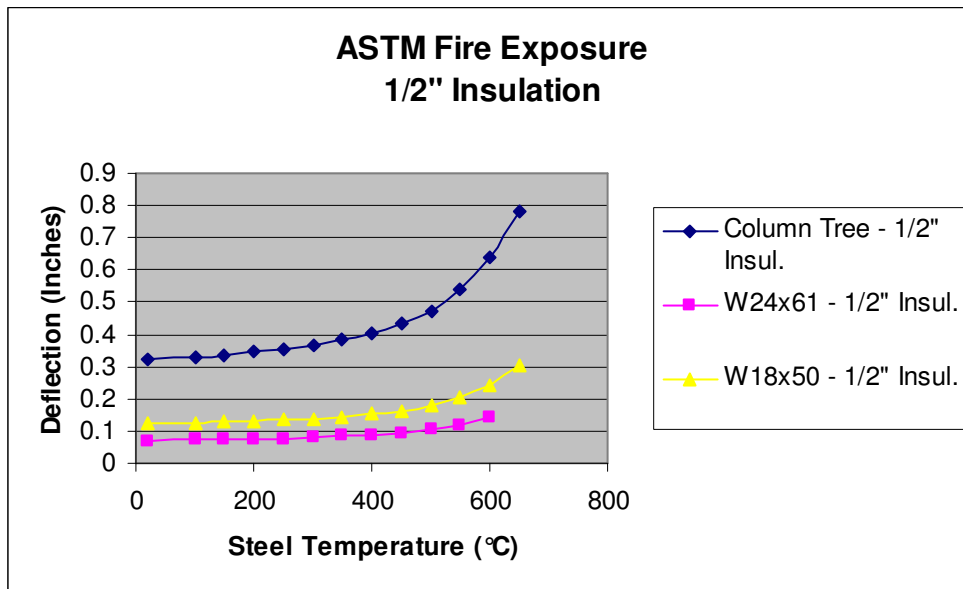
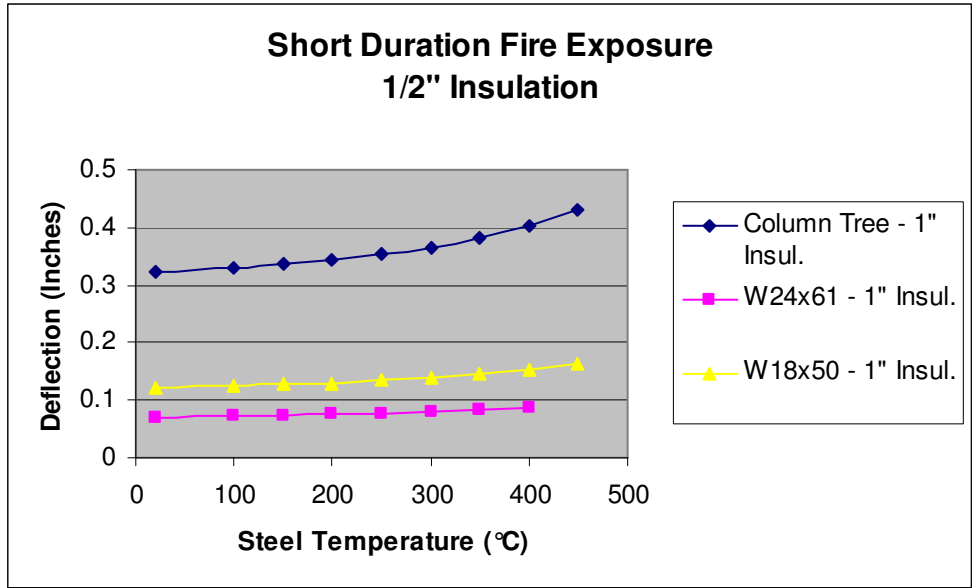
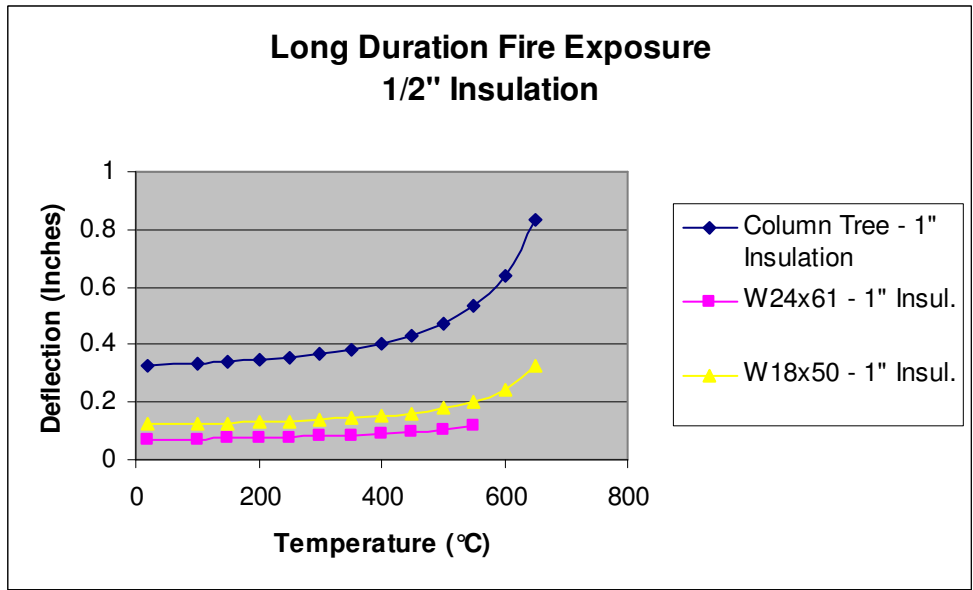
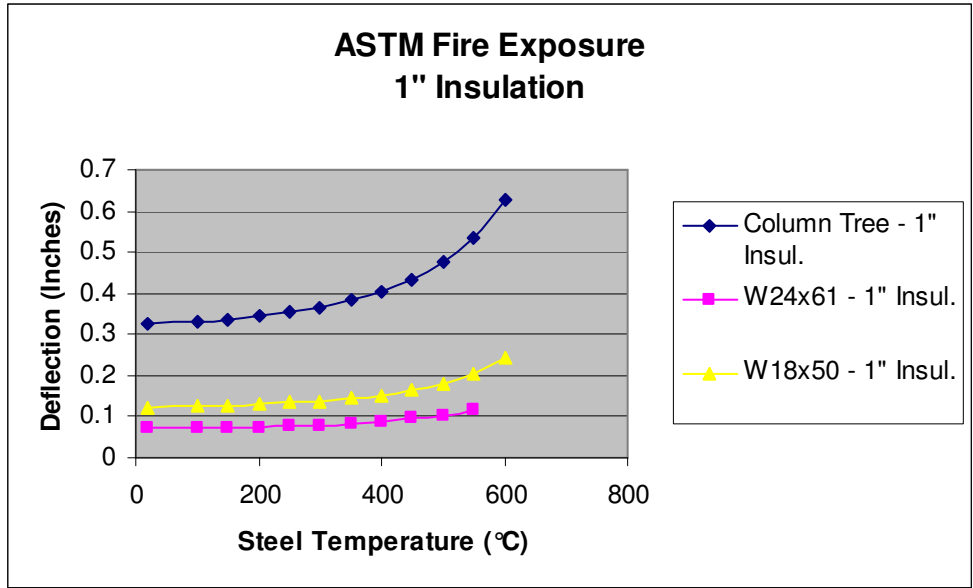
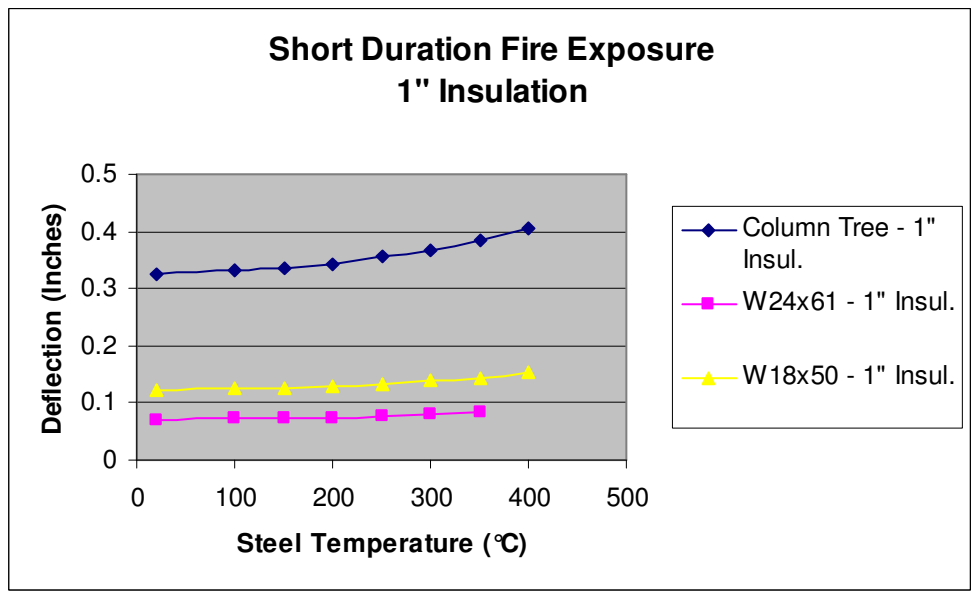
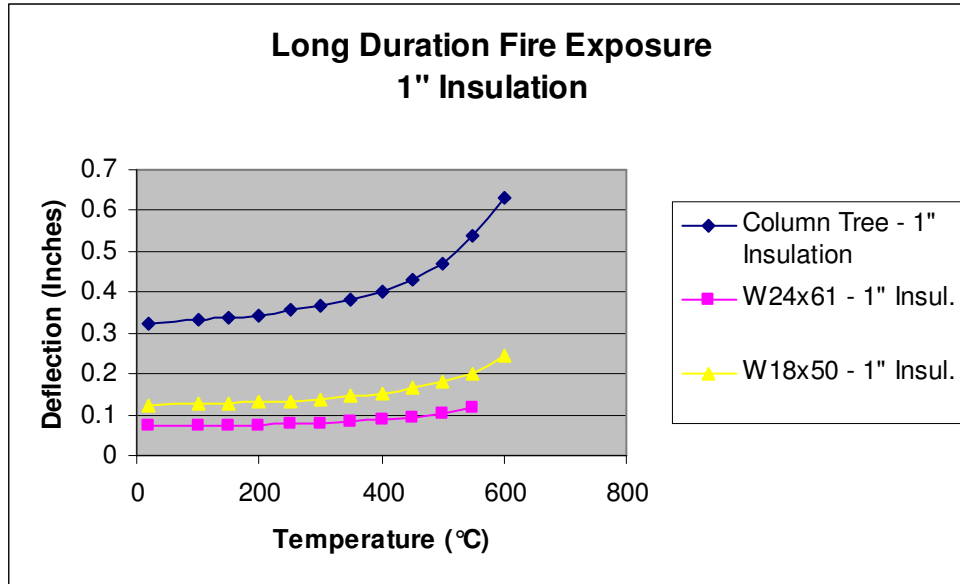
The deflections for each of these systems for exposure to the three different fire exposures previously mentioned can be seen in the figures 23, 24, and 25 below for 1/2" insulation thickness.

For all three insulation thicknesses, one can see that the behavior under the ASTM E-119 curve and the long duration fire are very similar. It can also be seen that as the insulation thickness becomes greater, the deflection drops. An interesting point to note from these graphs is the similarity in behavior of the deflection patters, but the large difference in the amount of deflection between the continuous beams and the column tree assembly.

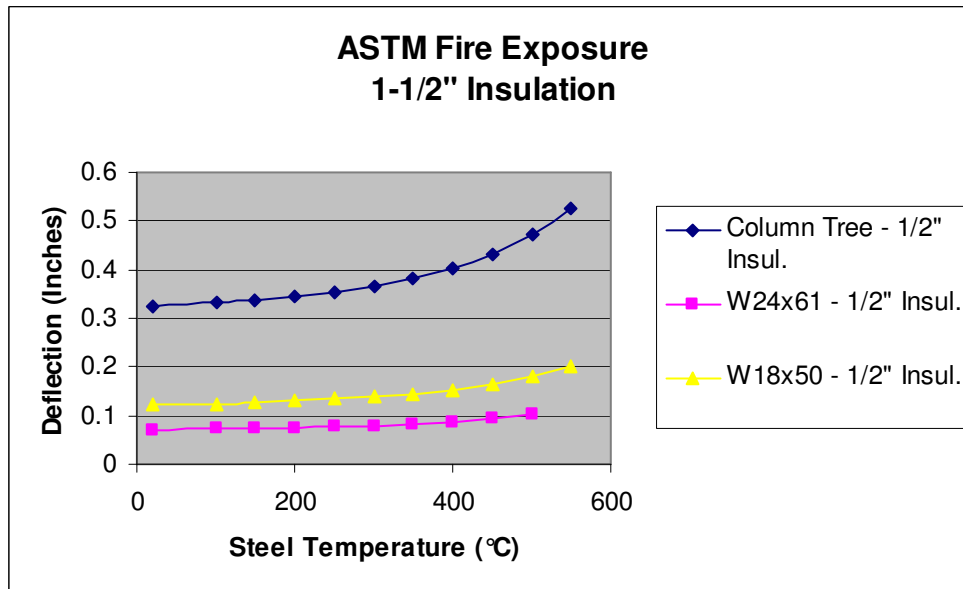
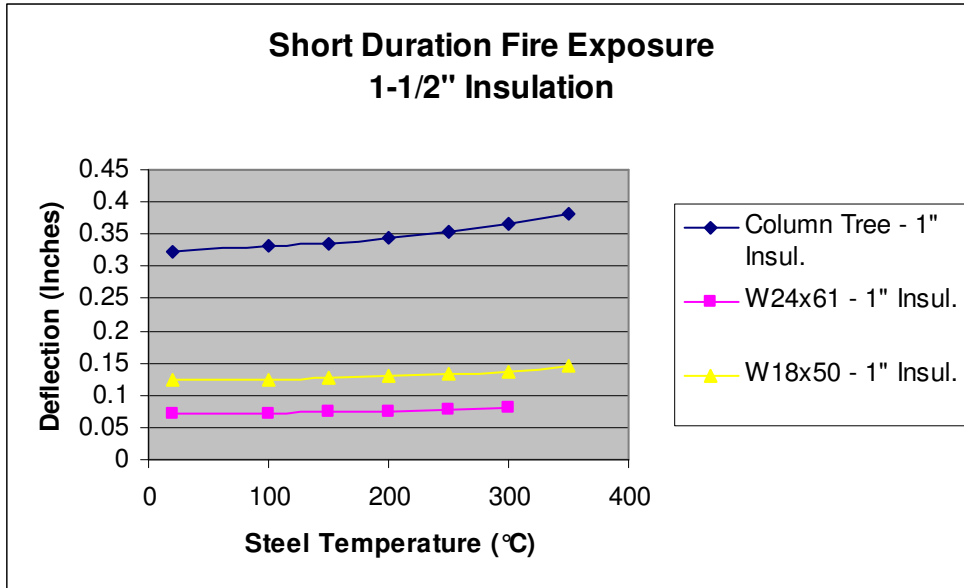
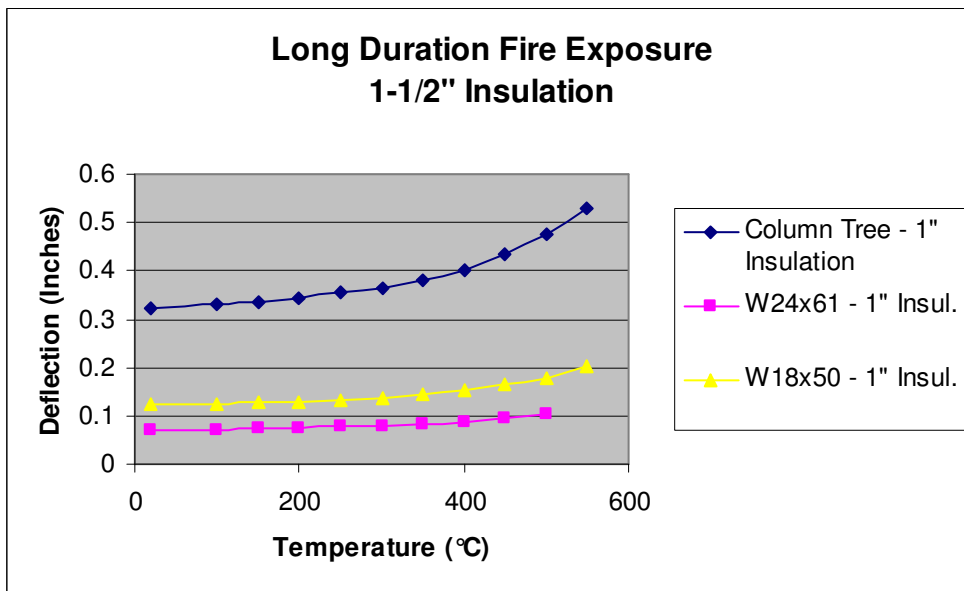
The next three graphs show the deflection for the original and alternative framing systems with 1-1/2" insulation thickness, subjected to the three design fires.

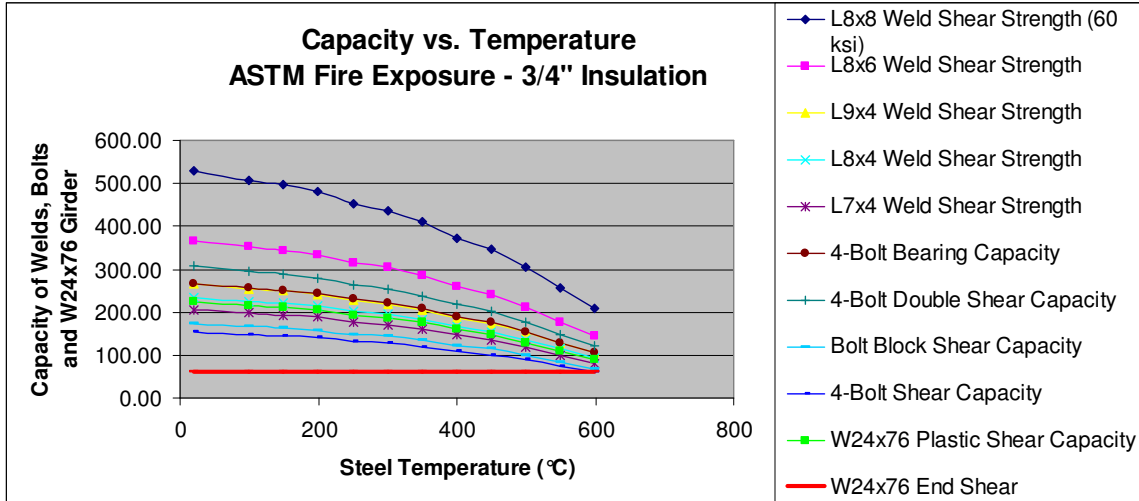
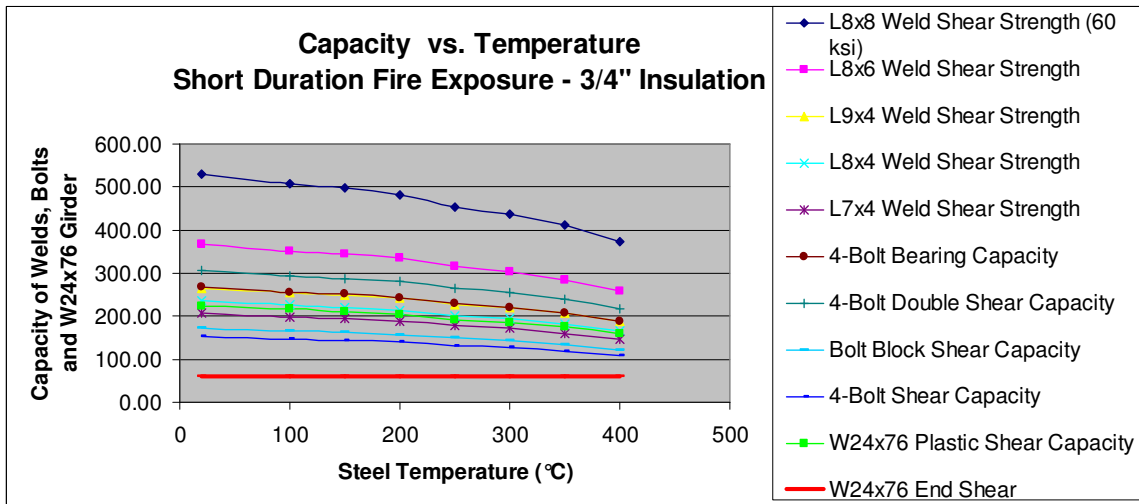
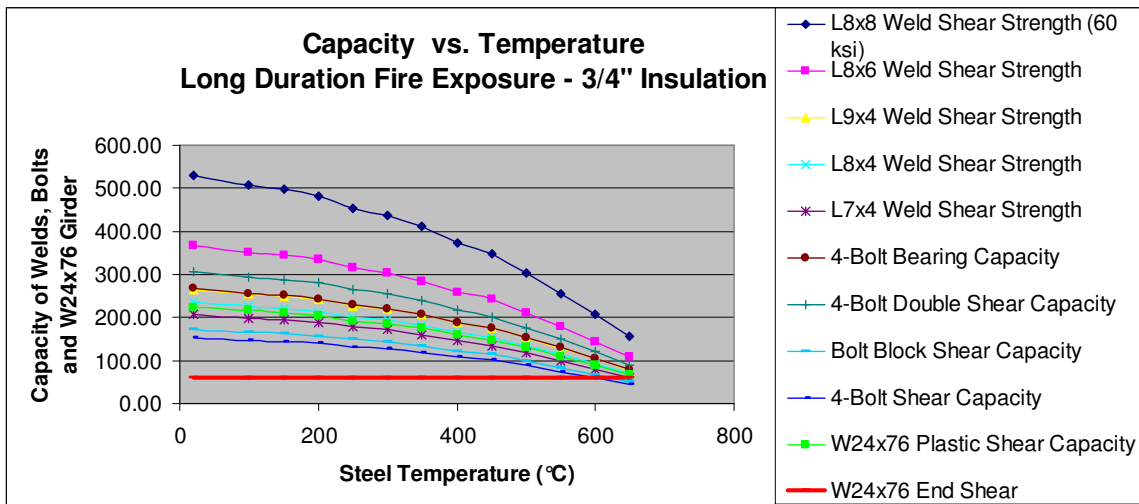
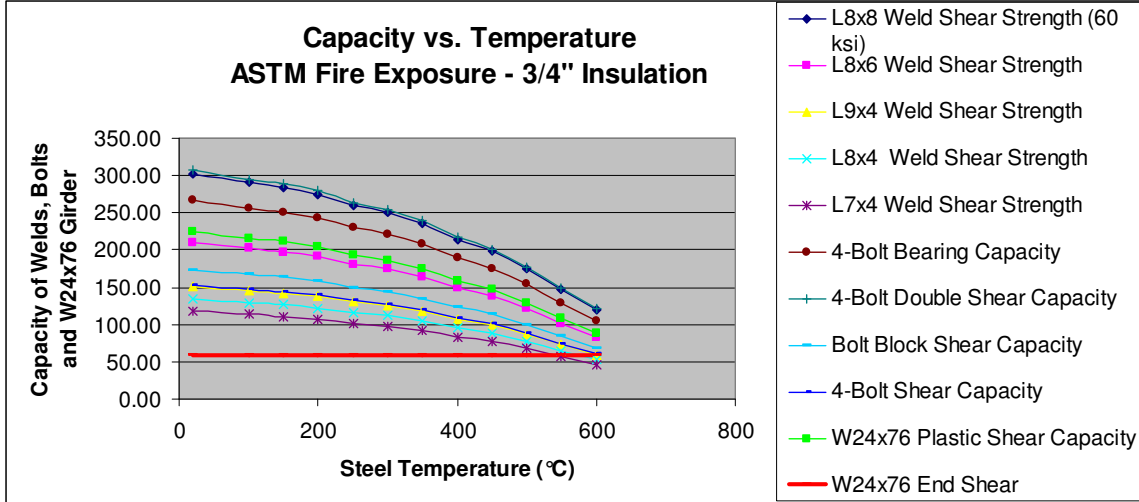
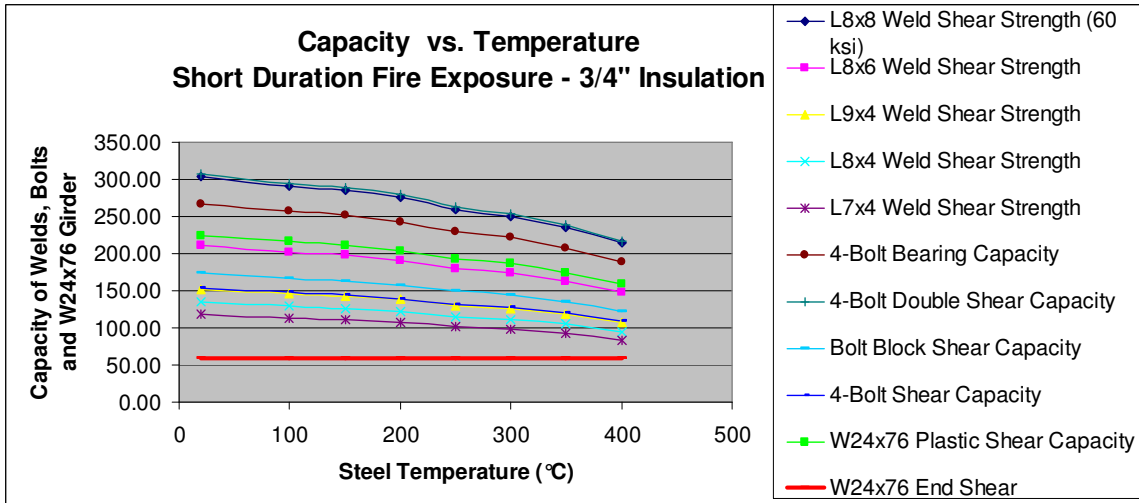
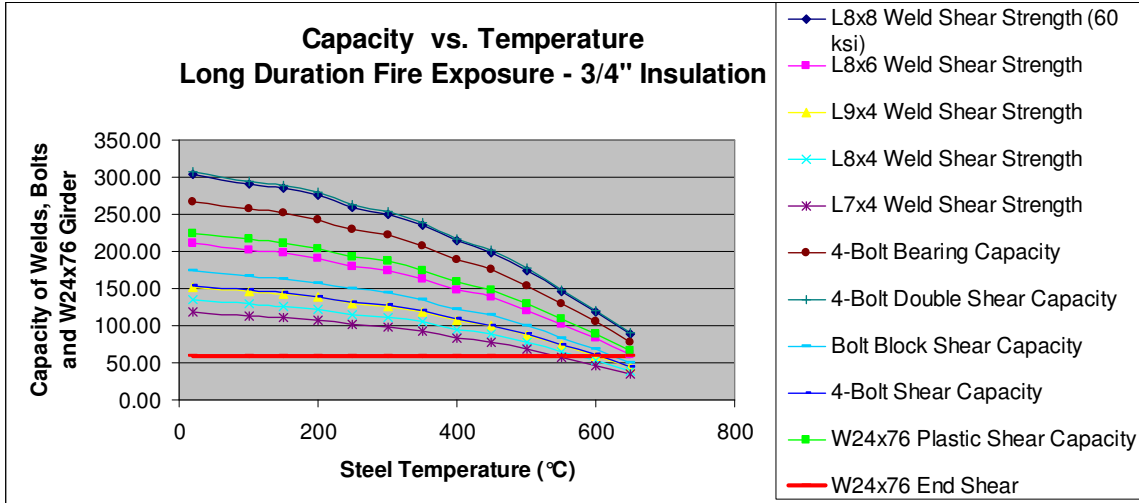
strength, or the number of bolts for each connection. Data on the connections could not be found in a wider search of the literature. To get a range of data for analysis, angles of various sizes were used to calculate the shear capacity of the welds and the tensile, shear, double shear, bearing, and block shear capacities of the bolts. The capacities are calculated based on geometry and material properties; they would be compared with the forces predicted by analyses. Weld capacity is calculated using the moment produced from the girder, and the length of weld, which changes with the size of the clip angle. The shear capacities of the welds, bolts, and girder can be seen in the graphs below. The bolts were calculated for an L8x8x1/2" angle and an L8x8x1/4" angle. The shear capacities of the welds were calculated for weld metal with both a 60 ksi and 70 ksi tensile strength. The steel temperatures were calculated for 1/2", 3/4", 1", and 1-1/2" insulation thickness for the three fire exposures. The 3/4" insulation thickness is the thickness that was present in the original design. To illustrate the difference in shear capacities of the structural elements, the capacities of the welds, bolts and girder were placed on a single graph for each of the three design fires. The solid red line seen in these graphs is the end shear produced by the girder on the connections. The three graphs shown below in Figures 35-37 are for a 1/2" angles and a 7/16" fillet weld with a 60 ksi electrode. The 60-ksi weld metal was chosen because it produces the worst-case scenario.

The three graphs shown below, Figures 38-40, illustrate the shear capacities for the elements listed above, for a variably sized 1/2" angles and a 1/4"-60 ksi weld.

By looking at the twelve graphs above, the difference in strengths of variably sized $\frac{1}{2}$ " angles with $\frac{7}{16}$ " welds to variably sized $\frac{1}{4}$ " angles with $\frac{1}{8}$ " welds is obvious. Below are tables summarizing the modes of failure by temperature for each of the cases illustrated.

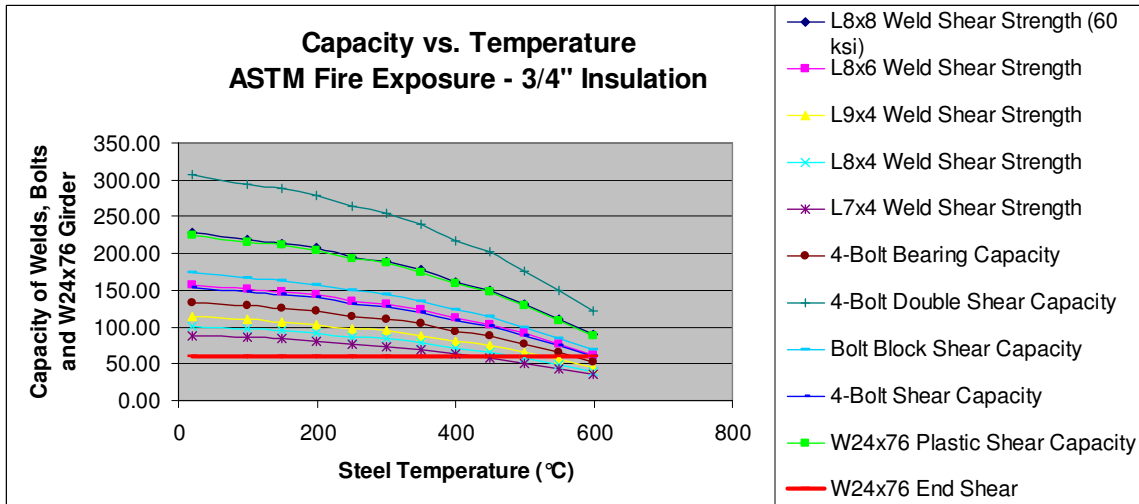
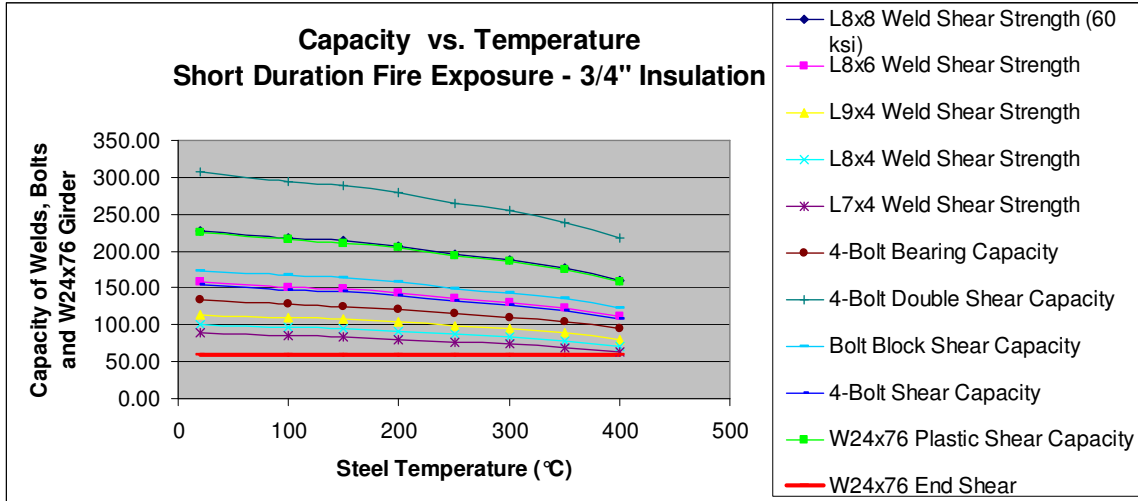
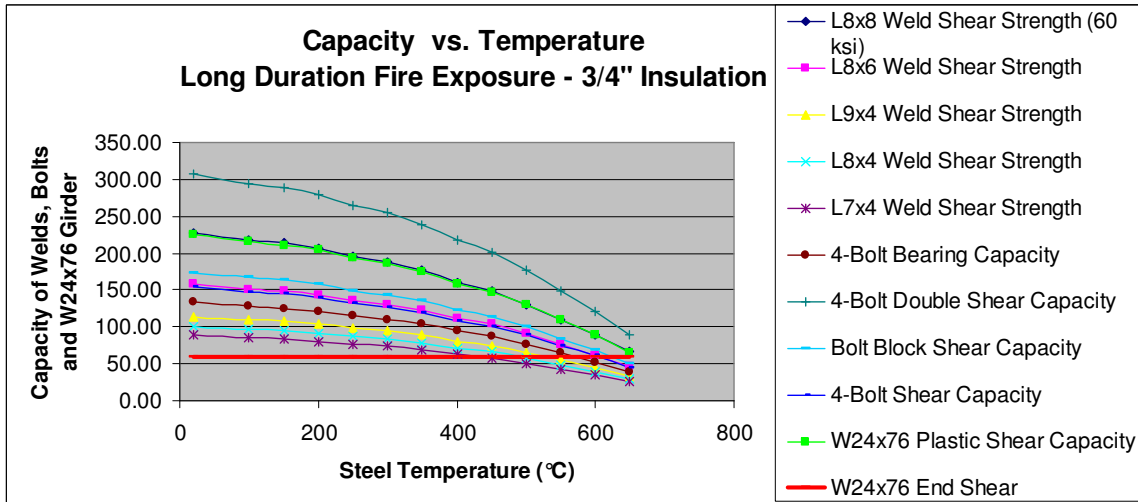
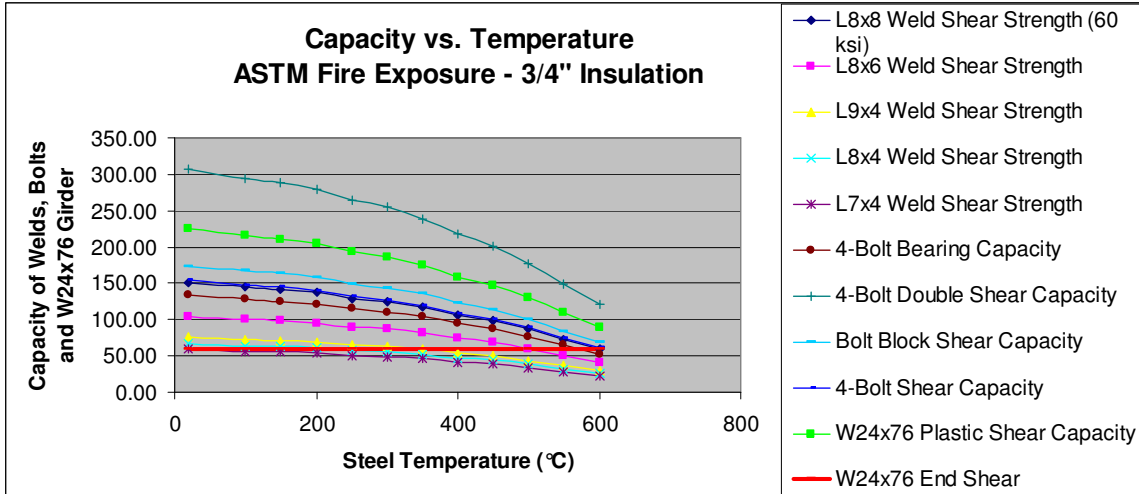
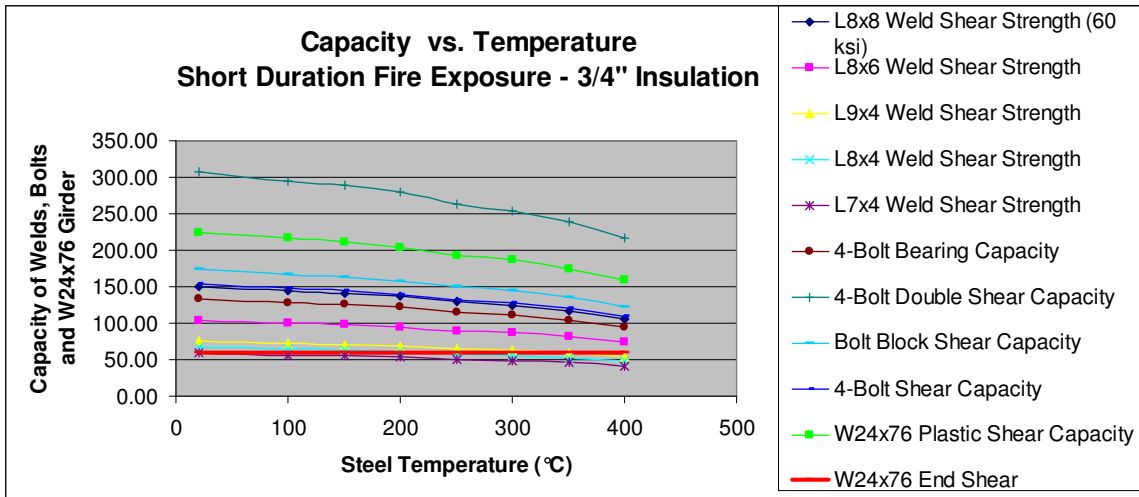
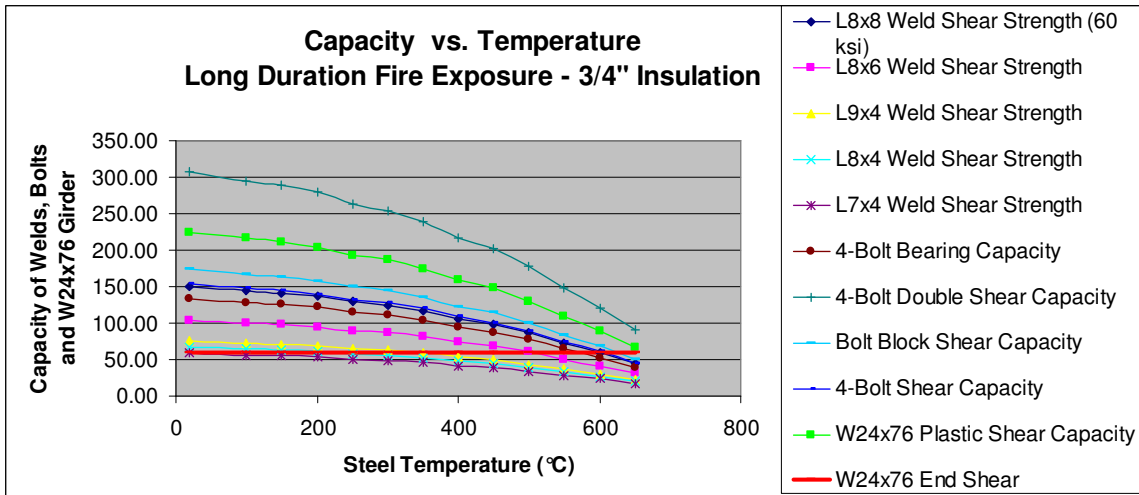
The three graphs below are the shear capacities of the structural elements for 1/4" angles with a 3/16" - 60 ksi weld.

The final three graphs shown are the shear capacities of the structural elements for a 1/4" angle and a 1/8"-60 ksi weld.

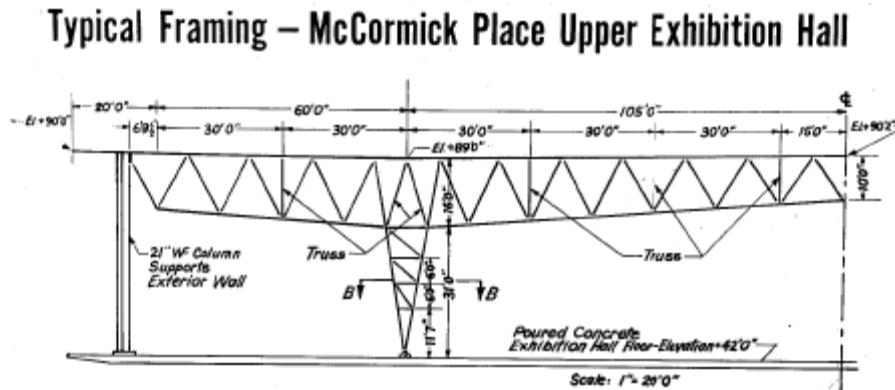
Figure 1 - McCormick Place Roof Truss (Jensen, 1967)

The trusses were 16' deep above the rigid frame support, 10 feet deep at the center, and 5'-3-1/2" deep at the cantilevered end. The truss and rigid frames that supported them were constructed of W14 wide flange members and were stabilized by smaller trusses running perpendicularly, similar to bridging. The column portion of these frames were protected from fire with a sprayed-applied fiber and encased "with metal lath and Gypsum vermiculite plaster," (Jensen, 1967) up to a height of 20 feet, but the trusses did not have any fire protection applied to them.

Once the fire broke out, it spread rapidly through the exhibition hall. Lack of fire protection caused excessive heating of the truss members, which then led to the collapse of the roof approximately an hour after the fire began (Jensen, 1967). It was stated that "the roof trusses started to buckle in the center, pulling the roof loose from the columns at the walls," (Juillerat, 1967).

The analysis performed in this investigation does not determine the mode of failure, however, it was discussed in the investigative report from observation that the trusses buckled in the center and a collapse of the roof ensued. This is the most probable situation since the compression members (bottom chord of the truss) would have heated the quickest and experienced warping and twisting due to the extreme temperatures produced by the fire. The center of the truss also did not have any diagonal members to support the top and bottom chord and therefore had the least resistance to failure as compared to the other pieces of the truss.

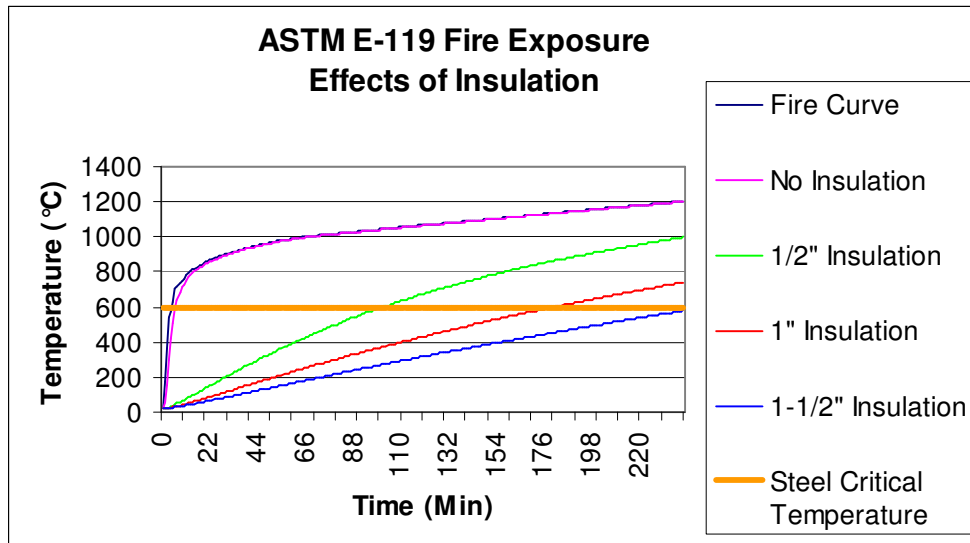
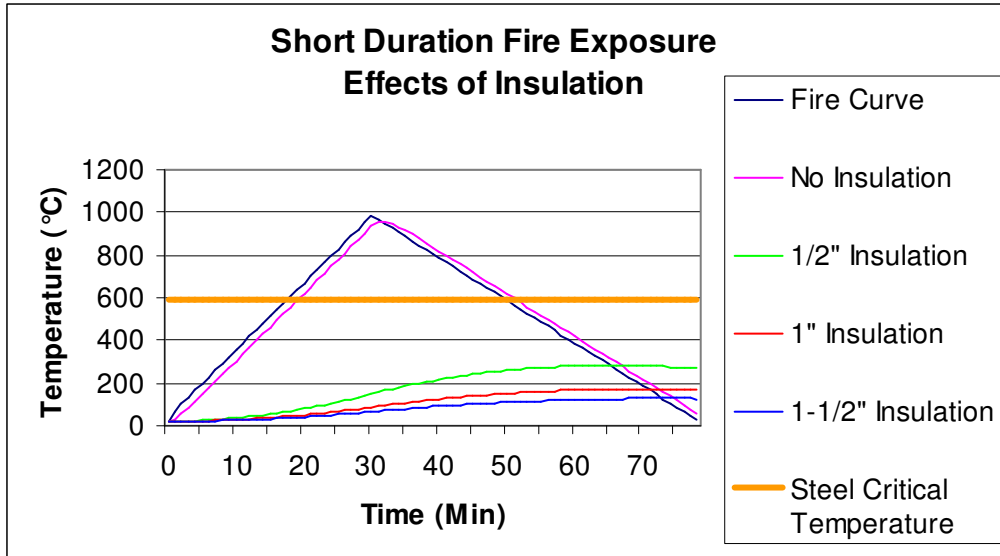
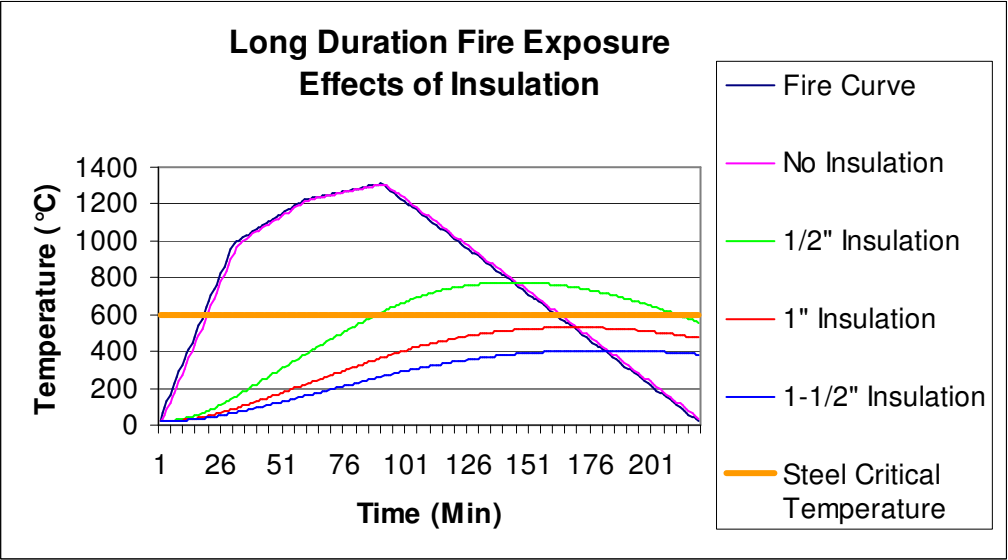
Figure 52 –Effect of Variable Insulation Thickness on Steel Temperatures

Figure 55 - Effect of Variable Insulation Thickness on Steel Temperatures

Figure 58 - Effect of Variable Insulation Thickness on Steel Temperatures

As seen in the graphs, Figures 6, 9, and 12 above the use of any thickness of spray-on insulation would have reduced the temperatures of the steel truss significantly during all three design fires. In each case the greatest reduction of heat occurs early in the fire which is important because it may have given the fire department sufficient time to get the fire under control before excessive heating and structural instability occurred.
